Engineering Report

5 Riverbrook,
New Street,
Abbeyfeale,
Co. Limerick,
V94 H2AD.

Limerick City & County
Council,
County Hall,
Dooradoyle,
Limerick.

Job Ref No.: L162

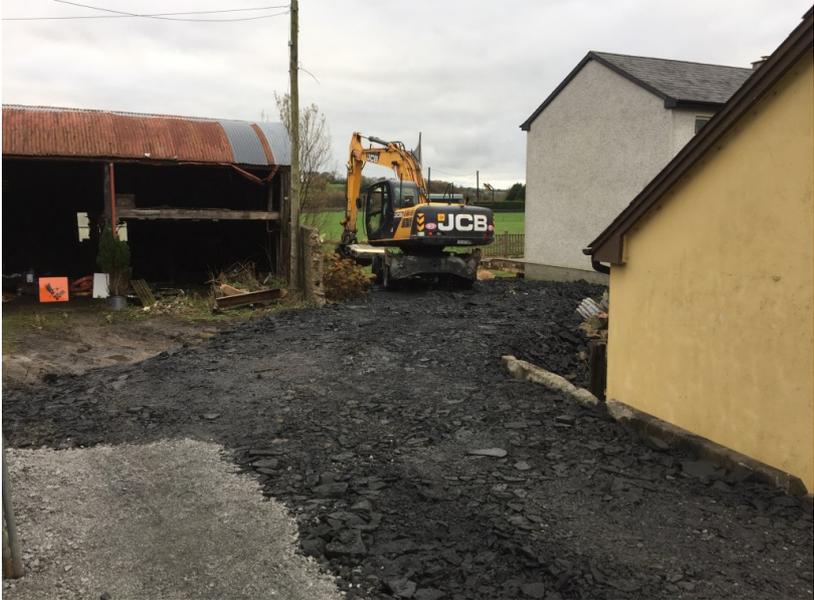
No.	Date	Photo & Description
1	04/12/17	<p>Temporary Access Road Formed</p>

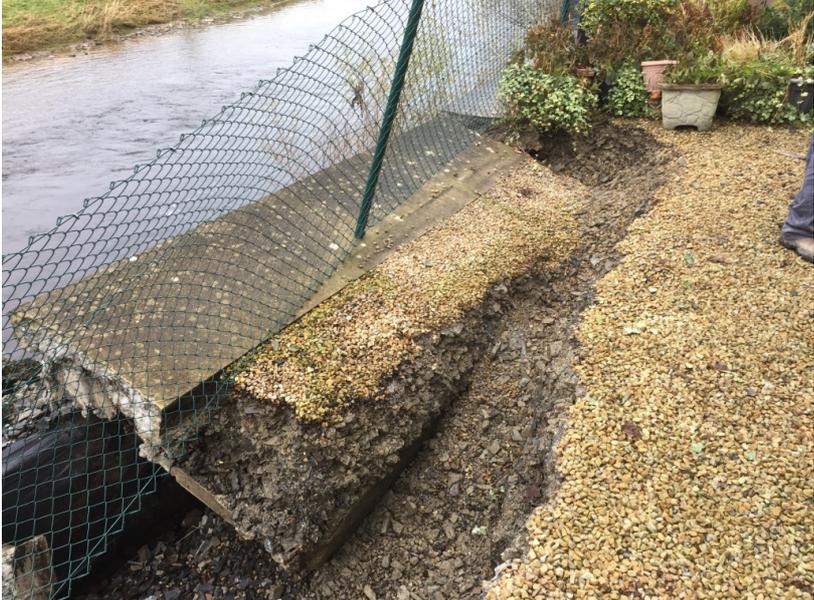
- A failure plane has opened up behind the remaining gabions and there is also evidence of movement at the front of the car-park. Therefore, there is a high risk that the gabions along this section of the river, having already moved, could collapse with the next high water event. Providing sand bags or tonne bags along the already collapsed section will have little benefit to a section of potentially unstable wall further down-stream.
- If sand bags or similar were to be installed, they would have to return into the bank for a minimum of 2 metres to prevent the flow of the river penetrating in behind any such temporary wall.

2	04/12/17	<p>Failure of ground at rear of house</p>

Given the height of the existing foundations of Number 5 Riverbrook relative to the river bank level, and their close proximity, there is a real danger of a partial collapse unless remedial works are carried out. For this reason we advise that the house remains vacant until works are carried out and also that the adjoining car-park is not used as there is a danger of failure of the retaining wall in this location.

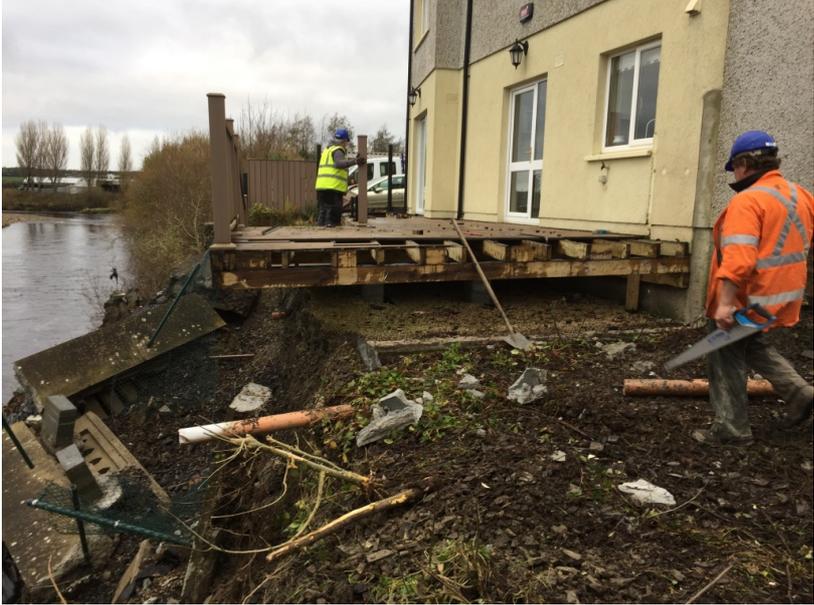
Roadbridge Ltd. were commissioned to demolish dangerous structures at the rear of No. 5 Riverbrook including the boundary wall with Leahy's (Please see attached map in Appendix B of this report for property arrangement) and decking, both of which were overhanging the collapsed river bank. Trial holes were also opened up at the rear left and right hand corners of the site.

No.	Date	Photo & Description
3	04/12/17	<p>Dangerous structures at rear being removed.</p>

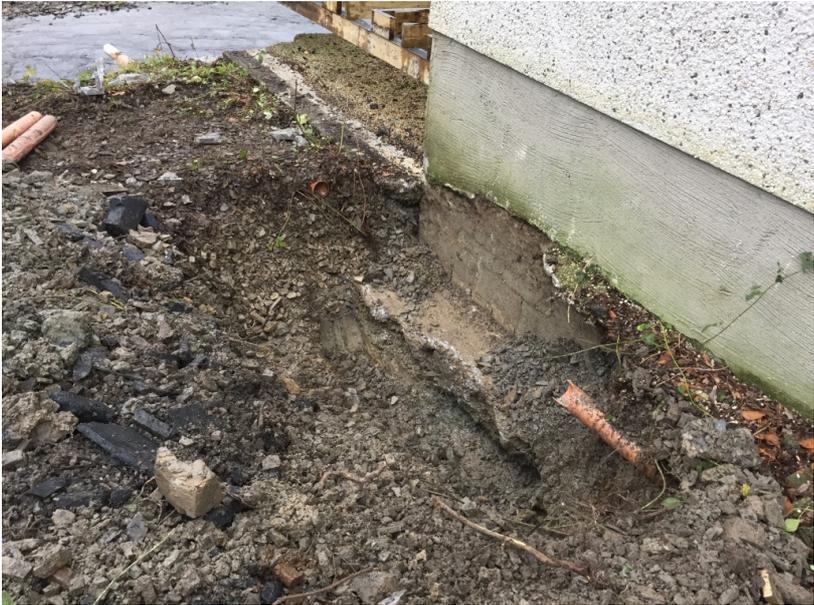
The foundations of the house appear to be conventional strip footings which are 1.5 metres below ground floor level to top of foundation, which is approx. 2.5 metres above river bank level. The strip footings are approx. 250 millimetres deep and are bearing on a firm, cohesive clay.

4	04/12/17	<p>View of exposed foundation.</p>
