Project Opera, Bank Place, Rutland St., Patrick St., Ellen St. and Michael St., Limerick

Architectural Heritage Report

22 November 2018

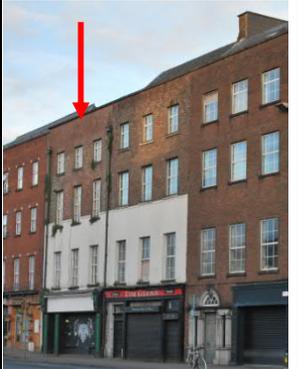
Address	Building Description	RPS	NIAH Candidate Protected Structure	Condition Issues/LCC Remedial Works/Survey Notes
<p>4 Rutland St</p>

<p>The buildings on Rutland Street are some of the earliest surviving Georgian terraces in Limerick city, having being built following the construction of the Mathew Bridge in 1761-62.</p> <p>4 Rutland Street is a three-bay four-storey over basement red brick building built as a townhouse. Moulded stone limestone sills retained to the brick front elevation.</p> <p>Largely rebuilt, including roof and rear elevation. New wall mid-plan. Front rooms (to Rutland St) retained, rear area including staircase rebuilt. Ground floor all new finishes.</p>	N/A	N/A	<p>LCC remedial works not carried out to this building.</p> <p>Some staining to plasterboard indicating water ingress accelerating in recent years (not visible in 2007 when initially surveyed)</p>

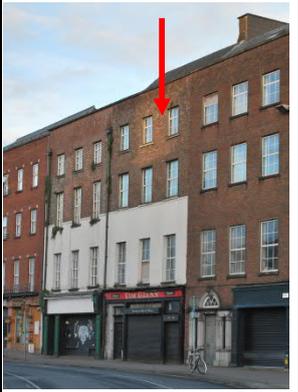
5 Rutland St	<p>The buildings on Rutland Street are some of the earliest surviving Georgian terraces in Limerick city, having being built following the construction of the Mathew Bridge in 1761-62.</p>	N/A	Reg. No. 21513009	LCC remedial works not carried out to this building.

<p>5 Rutland Street is a three-bay four-storey over basement red brick building built as a townhouse, which retains its original limestone doorcase incorporated within a partially surviving nineteenth-century shopfront.</p>		Candidate Protected Structure	<p>Building is generally as per initial inspections, with further water ingress visible to the party wall with No. 4.. The basement and shop have been cleared out and have not been in use for a number of years. Opening up of some of the plasterboard linings has revealed some additional features, such as dado rails in place to upper floor rooms. Elements of early roof structure are also in situ.</p>

<p>Significant internal joinery surviving, including the original mid-18th century staircase.</p>				<p>The top flight of the staircase has been badly damaged by the insertion of a crude fire lobby. The balustrade to this area was removed causing damage to the balusters. The balustrade is retained to the building and all elements not in situ should be placed in to safe keeping for later restoration.</p>
6 & 7 Rutland St	<p>The building comprises a five-storey over basement building on the site of two earlier residential plots. It is situated at a point along Rutland Street where the street kinks which results in a non co-linear façade line. It comprises in-situ reinforced concrete (RC) structure with external RC columns and 4no. internal columns supporting flat RC slabs</p>	Doorway RPS 317	Reg. No. 21513008 (Doorway)	LCC remedial works not carried out to this building.

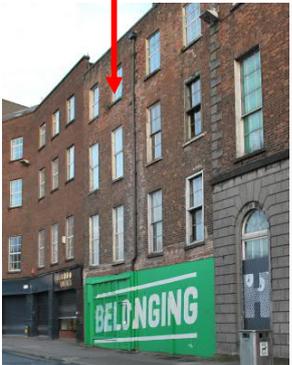
Address	Building Description	RPS	NIAH Candidate Protected Structure	Condition Issues/LCC Remedial Works/Survey Notes
<p data-bbox="204 416 336 443">8 Rutland St</p>

<p data-bbox="507 416 788 757">Late-18th/e. 19th C, No. 8 Rutland Street retains many interior features, particularly the staircase and joinery items. Terraced two-bay four-storey over basement building having exposed Flemish bond brick front and rear elevations. A pair with No. 9.</p> <p data-bbox="507 853 772 1093">20th century two-storey concrete block flat roofed outbuilding to rear, having concrete floors and a corrugated roof. This building forms part of No. 9 Rutland Street</p>	N/A	N/A	<p data-bbox="1102 416 1430 723">LCC remedial works carried out. Work has heavily damaged lath and plaster and cornices to ceilings which were intact when initially surveyed in 2007, but has stabilised the building and allows access. The roof is leaking and some areas of floors are water damaged at the upper level.</p> <p data-bbox="1102 757 1414 853">Joinery items such as staircase, window and door architraves recorded in 2007 are still in situ.</p> <p data-bbox="1102 887 1422 1059">Some water ingress has caused the deterioration of the condition since the 2007 survey, but not to the extent of No. 9 Rutland St, which is a pair with this building.</p> <p data-bbox="1102 1093 1406 1189">Basement intact and in original form. Props to brick arch to underside of pavement above.</p>

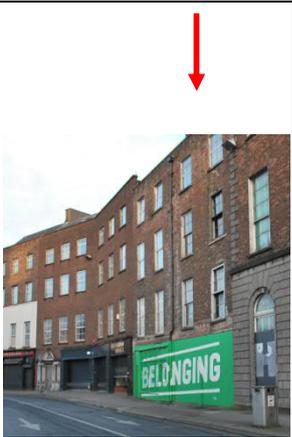
<p data-bbox="204 1223 336 1249">9 Rutland St</p>

<p data-bbox="507 1223 788 1570">Late-18th/e. 19th C, No. 9 Rutland Street has been very heavily altered to the basement and ground floors. Terraced two-bay four-storey over basement building having exposed Flemish bond brick front and rear elevations. A pair with No. 8.</p>	N/A	<p data-bbox="935 1223 1034 1283">Reg. No. 21513007</p> <p data-bbox="935 1317 1034 1413">Candidate Protected Structure</p>	<p data-bbox="1102 1223 1430 1989">LCC remedial works carried out. Work has damaged lath and plaster and cornices to ceilings but has stabilised the building and allows access. Wide brick arch to rear return, first floor, has been propped. The building has deteriorated since the 2007 record was made. There has been a high level of water ingress to the party wall with No. 8 which has severely affected floor timbers. Dry rot fruiting bodies in this area, including to LCC remedial works support. Fireplace to the front room, first floor, has been removed. Elements of the balustrade have been lost to upper floors. Wall and ceiling linings (modern and historic) have been removed to most areas. Internal walls are brick nogged.</p>

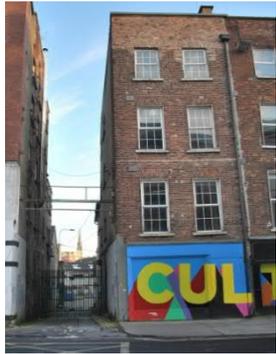
<p data-bbox="204 1292 328 1319">1 Patrick St</p>

<p data-bbox="502 1292 783 1740">Likely 18th century. No. 1 Patrick Street is a terraced two-bay four-storey over basement house having a shopfront and retail unit inserted to the ground floor, probably in the late-19th century. The main entrance is located off Glovers Lane, and comprises a round headed cut stone lugged architrave incorporating a fanlight.</p>	N/A	N/A	<p data-bbox="1098 1292 1437 1852">LCC remedial works have been carried out, including insertion of steel frames to support walls and to prop floors and the removal of cementitious render to the parapet and its repair. Floors are in very poor condition. Internal linings have been removed to the ground floor, including the lath and plaster ceiling, exposing the wall fabric and floor joists. Part of the external wall to the laneway is constructed of stone. Sections of run plaster cornice and later moulded timber cornice have been exposed</p>

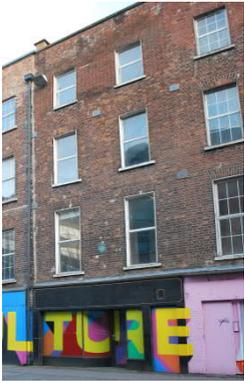
Address	Building Description	RPS	NIAH Candidate Protected Structure	Condition Issues/LCC Remedial Works/ Survey Notes
2 Patrick St

<p>Likely e. 19th C. No. 2 Patrick Street is a terraced two-bay four-storey over basement house having a shopfront and retail unit inserted to the ground floor, probably in the later 19th century. There is a pitched M-profile roof having imitation slate and shared with No.3 Patrick Street. Two-storey flat roofed extension to rear.</p> <p>This building, along with No. 3 Patrick Street, has been stripped out and all finishes internally are modern, including the staircase and partition walls.</p>	N/A	N/A	<p>LCC remedial works have been carried out, including propping of floors.</p> <p>Condition has deteriorated in recent years. All modern internal finishes. Ground and first floors are of concrete with new timber floors over.</p>
3 Patrick St

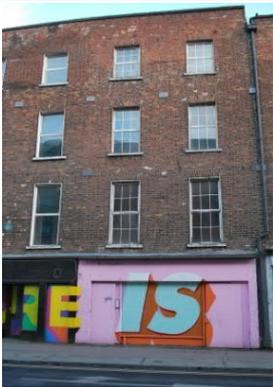
<p>No. 3 Patrick Street is a terraced two-bay four-storey over basement house having a shopfront and retail unit inserted to the ground floor, probably in the later 19th century. There is a pitched M-profile roof having imitation slate and shared with No.2 Patrick Street. Limestone cills to windows of front elevation. Two-storey brick structure having lean-to corrugated roof adjoining to rear.</p> <p>This building, along with No. 2 Patrick Street, has been stripped out and all finishes internally are modern, including the staircase and partition walls</p>	N/A	N/A	<p>LCC remedial works have been carried out, including propping of floors.</p> <p>Condition has deteriorated since initial 2007 survey. Remedial works have exposed structural fabric. Some original lath and plaster ceilings and timber floors retained to this building (ground and first and hall), with new floors laid over (which has altered floor levels).</p>

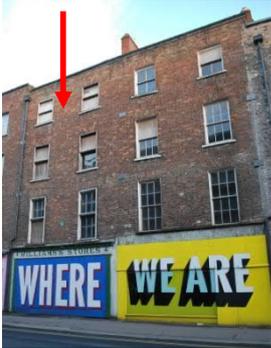
Address	Building Description	RPS	NIAH Candidate Protected Structure	Condition Issues/LCC Remedial Works/Survey Notes
<p>4 Patrick St</p>

<p>Late 18th/e.19th C. No. 4 Patrick Street is a terraced two-bay four-storey over basement house having a shopfront and retail unit inserted to the ground floor, probably in the 19th century. The front elevation is of exposed Flemish bond brick with the rear elevation of rubble stone construction having brick to the window openings. Stone cornice running across Nos. 4 and 5 Patrick Street. Exterior mews building retained. Built as a pair with No. 5.</p> <p>Shop front, shop fittings and interior fabric of significance.</p>	N/A	<p>Reg. No. 21513005</p> <p>Candidate Protected Structure</p>	<p>No structural LCC remedial works carried out to the building. Metal roof constructed to the mews building (this was previously a slate roof).</p> <p>All fabric has been retained to the main building, but the condition has deteriorated in recent years. Evidence of water ingress to corner of front room, against party wall with No. 3. Damage to this corner on all floors. Severe subsidence of floors. Shop fittings and shop display window are also retained.</p> <p>Floor has been lost to the mews building.</p>

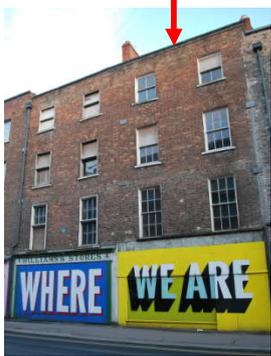
<p>5 Patrick St</p>

<p>Late 18th/e.19th C.</p> <p>No. 5 Patrick Street is a terraced two-bay four-storey over basement building having an exposed Flemish bond brick front elevation and a mixed rubble limestone and brick (to surrounds) rear elevation. Stone cornice running across Nos. 4 and 5 Patrick Street. Pitched roof having imitation slate and brick (rebuilt) chimneystack. Limestone cills to windows of front and rear elevation. 20th century two-storey concrete block flat roofed extension to rear, having concrete stairs and floors. Major alterations have been carried out to the interior of No. 5, However, some original elements remain intact.</p>	N/A	<p>Reg. No. 21513069</p> <p>Candidate Protected Structure</p>	<p>LCC remedial works have been carried out, including propping of floors, but not to all areas.</p> <p>Condition has deteriorated considerably in recent years. Sheeted timber ceiling to the shop floor visible above suspended ceiling. Double leaf panelled doors between main rooms of first floor area retained with architrave. One architrave to front room lost since initial survey. Remainder of building has a high level of modern finishes. Staircase is modern.</p>

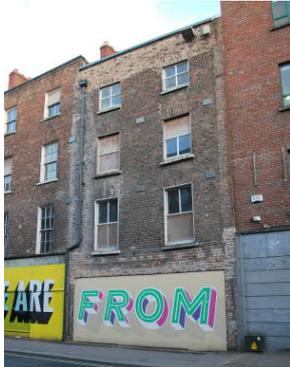
Address	Building Description	RPS	NIAH Candidate Protected Structure	Condition Issues/LCC Remedial Works/Survey Notes
<p>6 Patrick St</p>

<p>Late 18th/e. 19th C. No. 6 Patrick Street is a terraced two-bay four-storey over basement house having a shopfront and retail unit inserted to the ground floor. The front elevation is of exposed Flemish bond brick with the rear elevation of rubble stone construction. There is a modern single storey flat roofed extension to the rear.</p> <p>The interior of No. 6 lost many of its original fixtures and fittings when it was converted to flats.</p>	N/A	N/A	<p>LCC remedial works carried out. Work has extensively damaged the lath and plaster and cornices to ceilings but has stabilised the building and allows access. Modern internal partitions cut down in height.</p> <p>Staircase is retained but is in poor condition.</p> <p>Condition deteriorates further on upper floors. High level of deterioration of fabric since initial survey.</p>

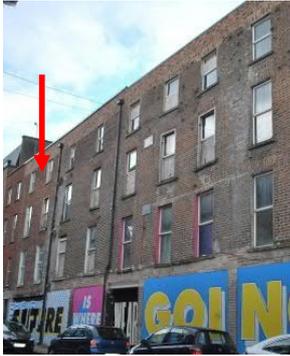
Address	Building Description	RPS	NIAH Candidate Protected Structure	Condition Issues/LCC Remedial Works/Survey Notes
4 Ellen St

E. 19th C, No. 4 Ellen Street is a terraced two-bay four-storey over basement house having a modern shopfront inserted to the ground floor. The front elevation is of exposed Flemish bond brick with the rear elevation of rubble stone construction having brick to the window openings.	N/A	N/A	LCC remedial works carried out. Floors reinforced. Parapet rebuilt.
5 Ellen St

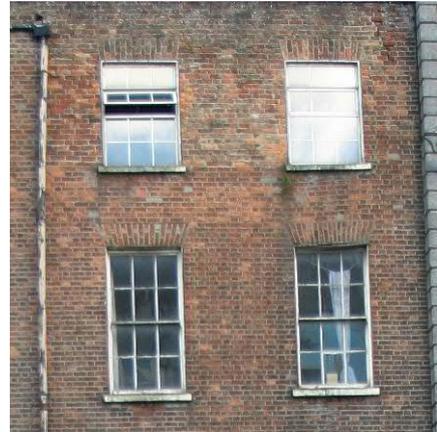
Brick Damage- Rutland Street

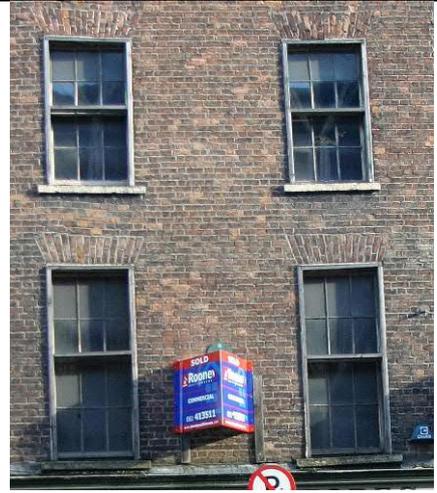
Brick Damage – 4 Patrick Street
