Appendix 19-1 Asbestos Survey Report

## ASBESTOS SURVEY REPORT

**Location: The Cleeves Site,  
North Circular Road, Limerick**

**Report No. PE24-1226**

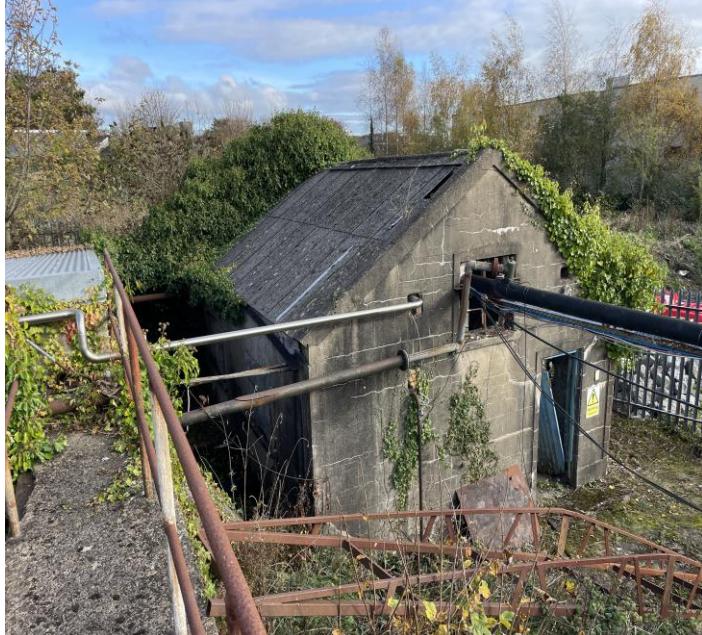
Survey Date	6.11.2024	Sample No.	BS 222501
Survey Company	Phoenix Environmental Safety Ltd.		
Testing Laboratory.	G & L Consultancy Ltd.

Created By	Eoghan Hickey
Date	12th November 2024
Site Details	The Cleeves Site, North Circular Road, Limerick
Client Name	Limerick Twenty Thirty Strategic Development DAC
Survey Type	R/D Asbestos Survey
Site Ref	PE 24-1226
Building Ref.	Building 1
Location	Roof areas
Extent/ Amount	90 m <sup>2</sup> total approx.

MATERIAL ASSESSMENT		PRIORITY ASSESSMENT	
Product type	Cement sheeting	Normal occupant activity	N/A
Extent of damage	Damaged	Likelihood of disturbance	N/A
Surface treatment	Cement	Human exposure potential	N/A
Asbestos type	Chrysotile	Maintenance activity	N/A
Material assessment score: N/A		TOTAL SCORE: N/A	Priority assessment score: N/A

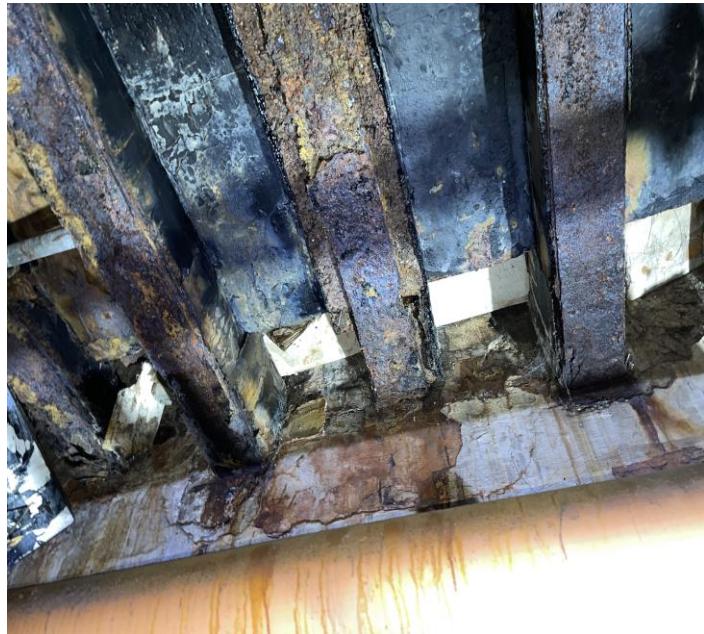
Survey Date	6.11.2024	Sample No.	BS 222504
Survey Company	Phoenix Environmental Safety Ltd.		
Testing Laboratory.	G & L Consultancy Ltd.

Created By	Andrew Hickey
Date	12 <sup>th</sup> November 2024
Site Details	The Cleeves Site, North Circular Road, Limerick
Client Name	Limerick Twenty Thirty Strategic Development DAC
Survey Type	R/D Asbestos Survey
Site Ref	PE 24-1226
Building Ref.	Building 2
Location	Ceiling
Extent/ Amount	Not quantified

MATERIAL ASSESSMENT		PRIORITY ASSESSMENT	
Product type	Insulation board	Normal occupant activity	N/A
Extent of damage	High	Likelihood of disturbance	N/A
Surface treatment	Unsealed	Human exposure potential	N/A
Asbestos type	Chrysotile & Amosite	Maintenance activity	N/A
Material assessment score: N/A		TOTAL SCORE: N/A	Priority assessment score: N/A

The asbestos insulation board (AIB) should be removed under controlled conditions by a specialist asbestos removal contractor and disposed of as asbestos waste before the demolition works commence. The upper floors in Building 2 were inaccessible to assess the quantity of the material

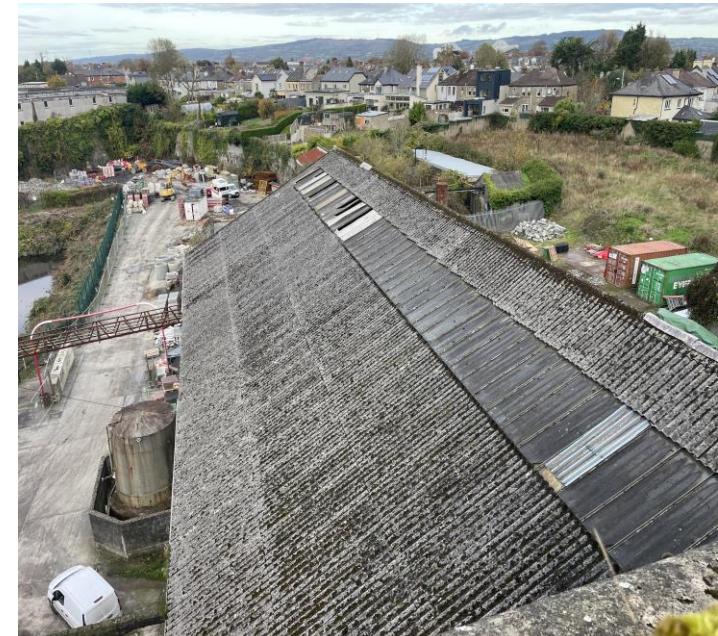
Survey Date	6.11.2024	Sample No.	BS 222507
Survey Company	Phoenix Environmental Safety Ltd.		
Testing Laboratory.	G & L Consultancy Ltd.

Created By	Andrew Hickey
Date	12th November 2024
Site Details	The Cleeves Site, North Circular Road, Limerick
Client Name	Limerick Twenty Thirty Strategic Development DAC
Survey Type	R/D Asbestos Survey
Site Ref	PE 24-1226
Building Ref.	Building 3
Location	Roof & sides of building
Extent/ Amount	720 m <sup>2</sup> approx.

MATERIAL ASSESSMENT		PRIORITY ASSESSMENT	
Product type	Cement sheeting	Normal occupant activity	N/A
Extent of damage	High	Likelihood of disturbance	N/A
Surface treatment	Cement	Human exposure potential	N/A
Asbestos type	Chrysotile	Maintenance activity	N/A
Material assessment score: N/A		TOTAL SCORE: N/A	Priority assessment score: N/A

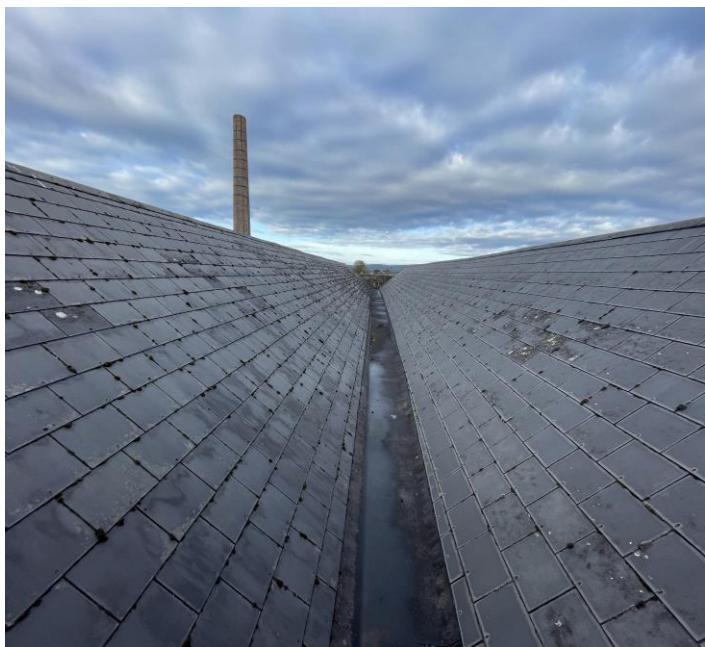
Survey Date	6.11.2024	Sample No.	BS 222513
Survey Company	Phoenix Environmental Safety Ltd.		
Testing Laboratory.	G & L Consultancy Ltd.

Created By	Andrew Hickey
Date	12th November 2024
Site Details	The Cleeves Site, North Circular Road, Limerick
Client Name	Limerick Twenty Thirty Strategic Development DAC
Survey Type	R/D Asbestos Survey
Site Ref	PE 24-1226
Building Ref.	Building 4
Location	Roof
Extent/ Amount	600 m <sup>2</sup> approx.

MATERIAL ASSESSMENT		PRIORITY ASSESSMENT	
Product type	Cement slates	Normal occupant activity	N/A
Extent of damage	Low	Likelihood of disturbance	N/A
Surface treatment	Cement	Human exposure potential	N/A
Asbestos type	Chrysotile	Maintenance activity	N/A
Material assessment score: N/A		TOTAL SCORE: N/A	Priority assessment score: N/A

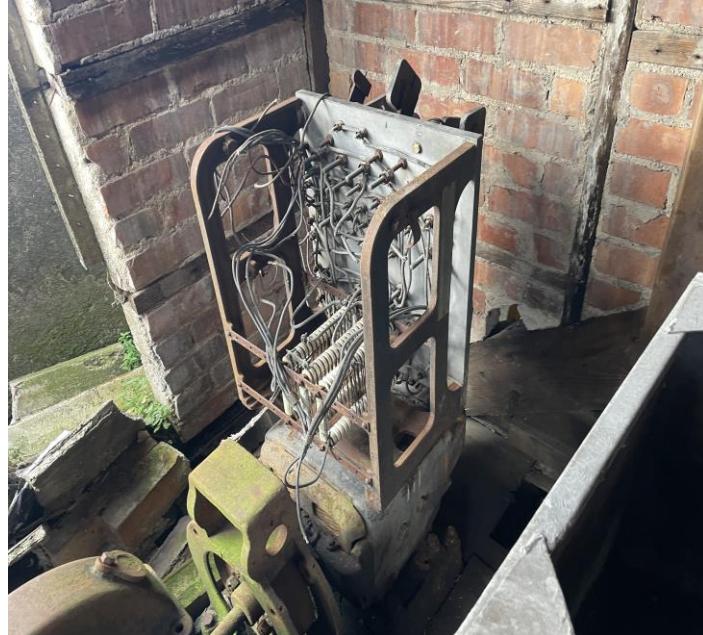
Survey Date	6.11.2024	Sample No.	BS 222511
Survey Company	Phoenix Environmental Safety Ltd.		
Testing Laboratory.	G & L Consultancy Ltd.

Created By	Andrew Hickey
Date	12th November 2024
Site Details	The Cleeves Site, North Circular Road, Limerick
Client Name	Limerick Twenty Thirty Strategic Development DAC
Survey Type	R/D Asbestos Survey
Site Ref	PE 24-1226
Building Ref.	Building 4
Location	Lift motor room
Extent/ Amount	Electrics

MATERIAL ASSESSMENT		PRIORITY ASSESSMENT	
Product type	Rope	Normal occupant activity	N/A
Extent of damage	Low	Likelihood of disturbance	N/A
Surface treatment	Textile	Human exposure potential	N/A
Asbestos type	Chrysotile	Maintenance activity	N/A
Material assessment score: N/A		TOTAL SCORE: N/A	Priority assessment score: N/A

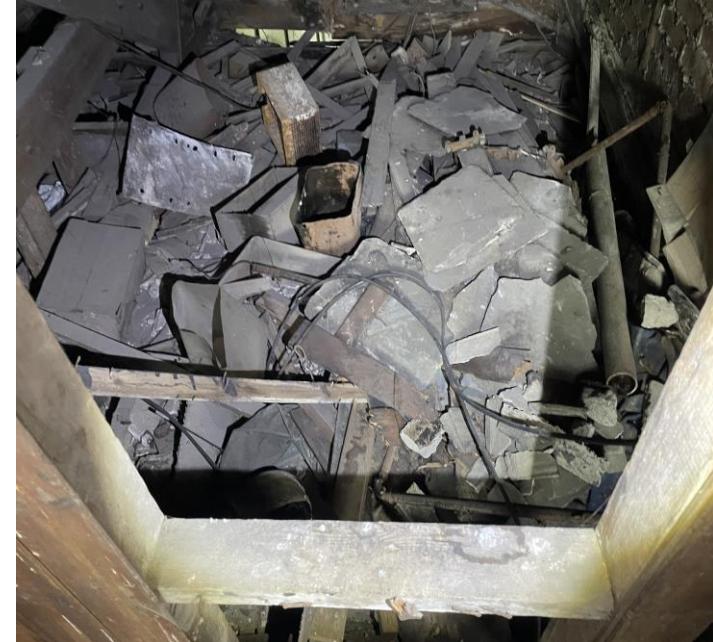
Survey Date	6.11.2024	Sample No.	BS 222515
Survey Company	Phoenix Environmental Safety Ltd.		
Testing Laboratory.	G & L Consultancy Ltd.

Created By	Andrew Hickey
Date	12th November 2024
Site Details	The Cleeves Site, North Circular Road, Limerick
Client Name	Limerick Twenty Thirty Strategic Development DAC
Survey Type	R/D Asbestos Survey
Site Ref	PE 24-1226
Building Ref.	Building 4
Location	Attic
Extent/ Amount	Beside lift motor room

MATERIAL ASSESSMENT		PRIORITY ASSESSMENT	
Product type	Cement & Insulation board debris	Normal occupant activity	N/A
Extent of damage	Medium	Likelihood of disturbance	N/A
Surface treatment	Unsealed	Human exposure potential	N/A
Asbestos type	Chrysotile & Amosite & Crocidolite	Maintenance activity	N/A
Material assessment score: N/A		TOTAL SCORE: N/A	Priority assessment score: N/A

The cement and insulation board debris should be removed under controlled conditions by a specialist asbestos removal contractor and disposed of as asbestos waste before the demolition works commence.

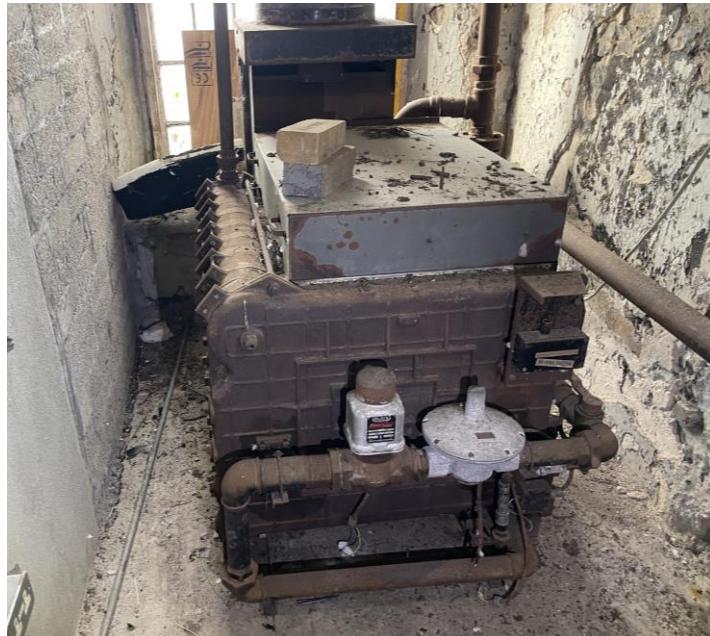
Survey Date	6.11.2024	Sample No.	BS 222518
Survey Company	Phoenix Environmental Safety Ltd.		
Testing Laboratory.	G & L Consultancy Ltd.

Created By	Andrew Hickey
Date	12th November 2024
Site Details	The Cleeves Site, North Circular Road, Limerick
Client Name	Limerick Twenty Thirty Strategic Development DAC
Survey Type	R/D Asbestos Survey
Site Ref	PE 24-1226
Building Ref.	Building 4
Location	3rd floor
Extent/ Amount	Boiler unit

MATERIAL ASSESSMENT		PRIORITY ASSESSMENT	
Product type	Thermal insulation	Normal occupant activity	N/A
Extent of damage	Low	Likelihood of disturbance	N/A
Surface treatment	Sealed	Human exposure potential	N/A
Asbestos type	Chrysotile	Maintenance activity	N/A
Material assessment score: N/A		TOTAL SCORE: N/A	Priority assessment score: N/A

The thermal insulation should be removed under controlled conditions by a specialist asbestos removal contractor and disposed of as asbestos waste before the demolition works commence.

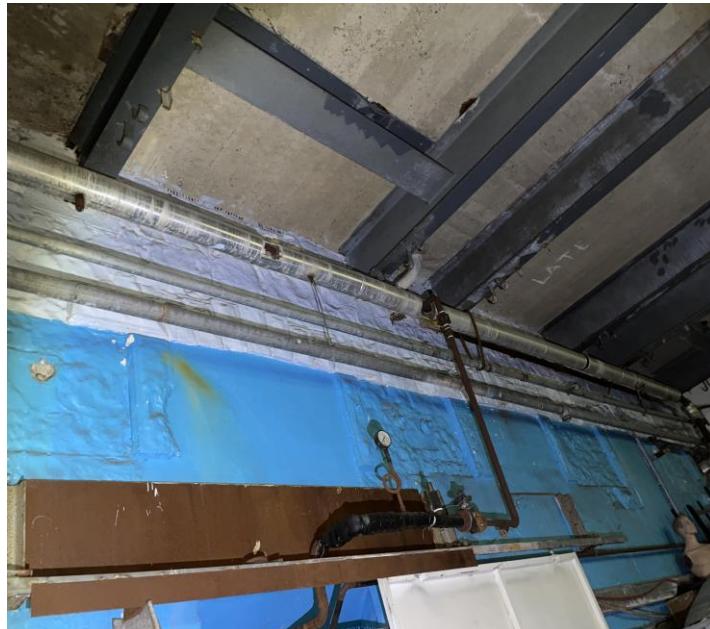
Survey Date	6.11.2024	Sample No.	BS 222521
Survey Company	Phoenix Environmental Safety Ltd.		
Testing Laboratory.	G & L Consultancy Ltd.

Created By	Andrew Hickey
Date	12th November 2024
Site Details	The Cleeves Site, North Circular Road, Limerick
Client Name	Limerick Twenty Thirty Strategic Development DAC
Survey Type	R/D Asbestos Survey
Site Ref	PE 24-1226
Building Ref.	Building 4
Location	Ground floor
Extent/ Amount	23 linear meters approx.

MATERIAL ASSESSMENT		PRIORITY ASSESSMENT	
Product type	Thermal insulation	Normal occupant activity	N/A
Extent of damage	Medium	Likelihood of disturbance	N/A
Surface treatment	Within metal casing	Human exposure potential	N/A
Asbestos type	Amosite	Maintenance activity	N/A
Material assessment score: N/A		TOTAL SCORE: N/A	Priority assessment score: N/A

The thermal insulation should be removed under controlled conditions by a specialist asbestos removal contractor and disposed of as asbestos waste before the demolition works commence.

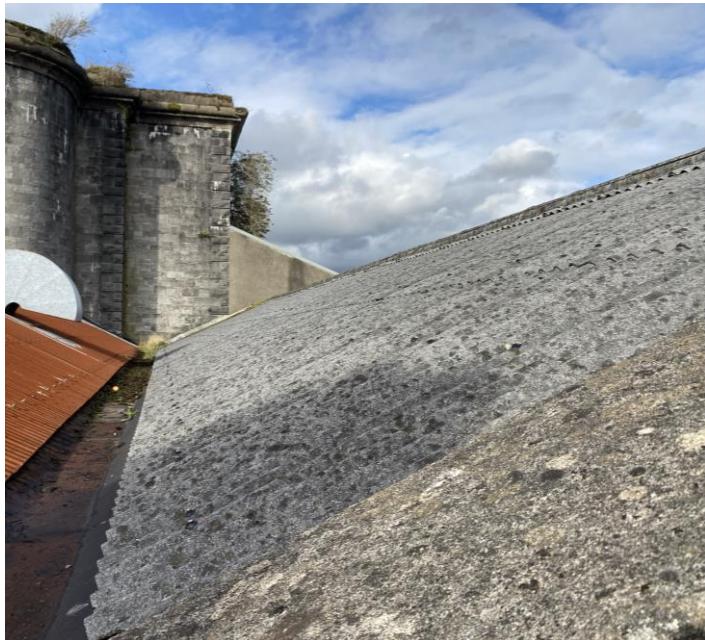
Survey Date	6.11.2024	Sample No.	BS 222524
Survey Company	Phoenix Environmental Safety Ltd.		
Testing Laboratory.	G & L Consultancy Ltd.

Created By	Andrew Hickey
Date	12th November 2024
Site Details	The Cleeves Site, North Circular Road, Limerick
Client Name	Limerick Twenty Thirty Strategic Development DAC
Survey Type	R/D Asbestos Survey
Site Ref	PE 24-1226
Building Ref.	Building 5
Location	Roof
Extent/ Amount	270 m <sup>2</sup> approx. floor area

MATERIAL ASSESSMENT		PRIORITY ASSESSMENT	
Product type	Cement sheeting	Normal occupant activity	N/A
Extent of damage	Weathered	Likelihood of disturbance	N/A
Surface treatment	None	Human exposure potential	N/A
Asbestos type	Chrysotile & Amosite	Maintenance activity	N/A
Material assessment score: N/A		TOTAL SCORE: N/A	Priority assessment score: N/A

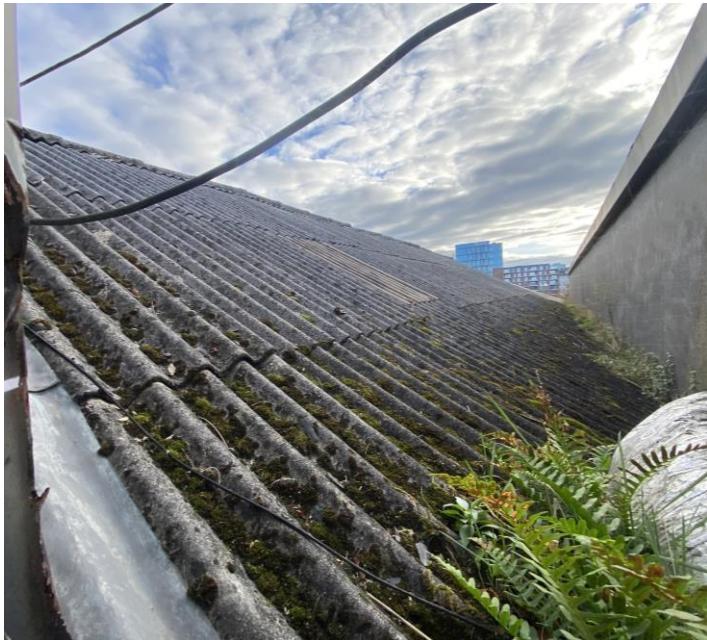
Survey Date	6.11.2024	Sample No.	BS 222527
Survey Company	Phoenix Environmental Safety Ltd.		
Testing Laboratory.	G & L Consultancy Ltd.

Created By	Andrew Hickey
Date	12th November 2024
Site Details	The Cleeves Site, North Circular Road, Limerick
Client Name	Limerick Twenty Thirty Strategic Development DAC
Survey Type	R/D Asbestos Survey
Site Ref	PE 24-1226
Building Ref.	Building 7
Location	Roof
Extent/ Amount	160 m <sup>2</sup> approx. floor area

MATERIAL ASSESSMENT		PRIORITY ASSESSMENT	
Product type	Cement sheeting	Normal occupant activity	N/A
Extent of damage	Weathered	Likelihood of disturbance	N/A
Surface treatment	None	Human exposure potential	N/A
Asbestos type	Chrysotile & Amosite	Maintenance activity	N/A
Material assessment score: N/A		TOTAL SCORE: N/A	Priority assessment score: N/A

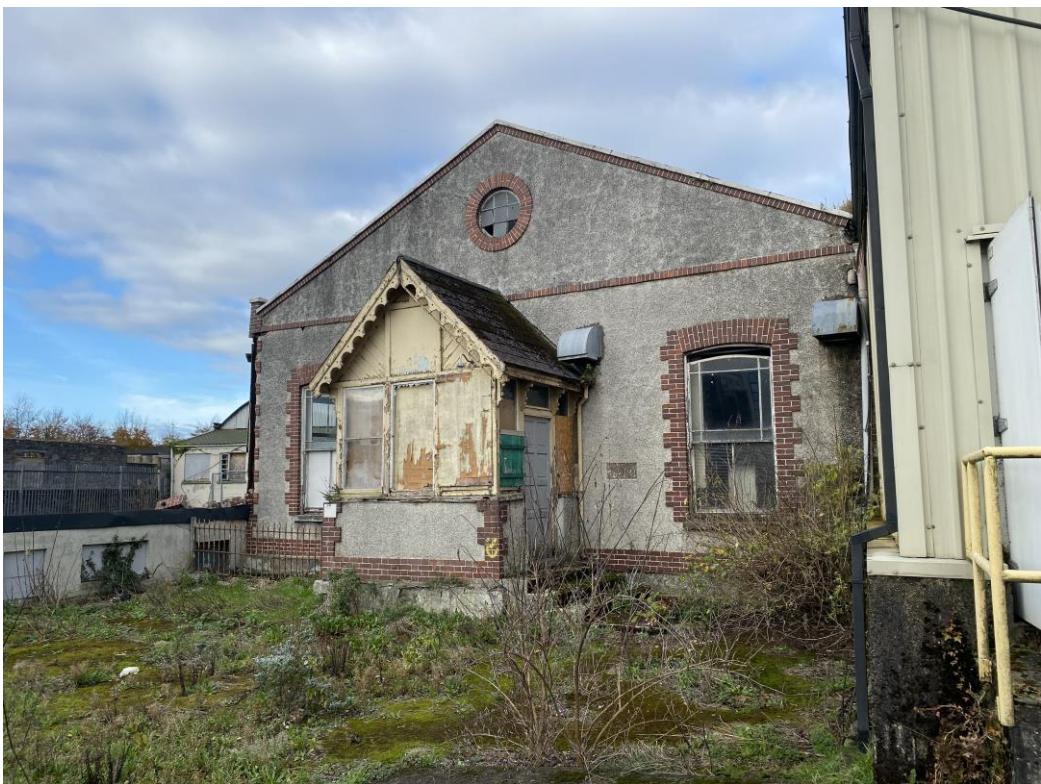
View of the slates on the rear porch roof

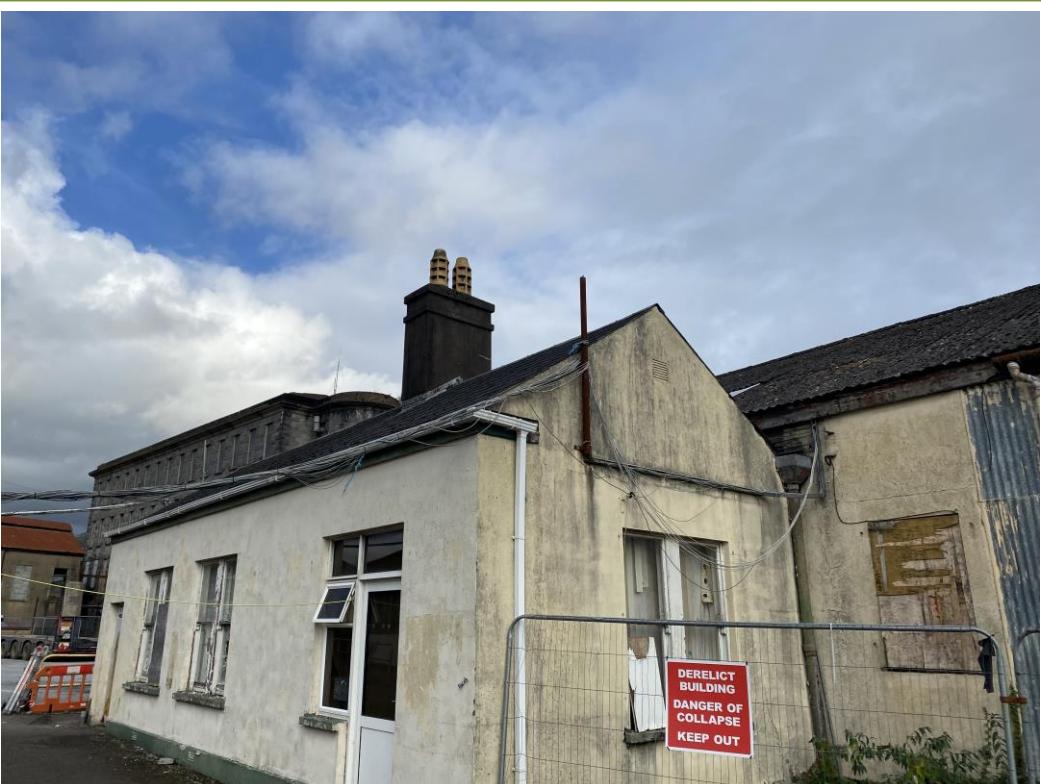
View of the side building which contains the asbestos cement slates

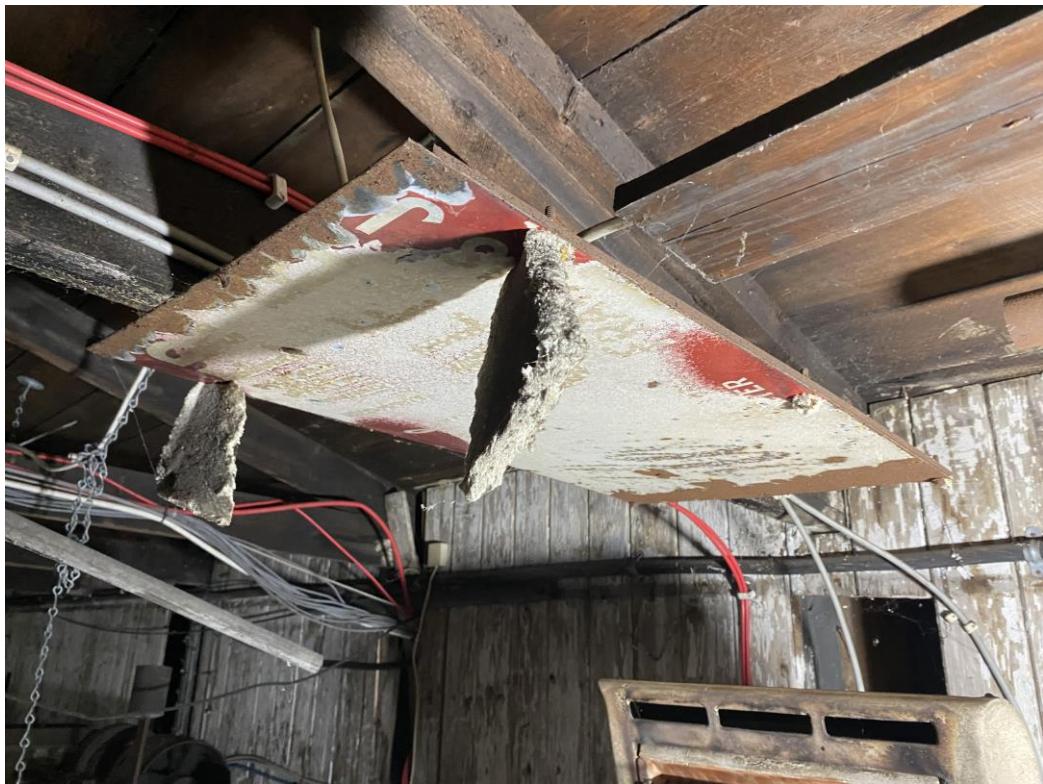
Closeup view of the remaining millboard on one of the panels over the heater

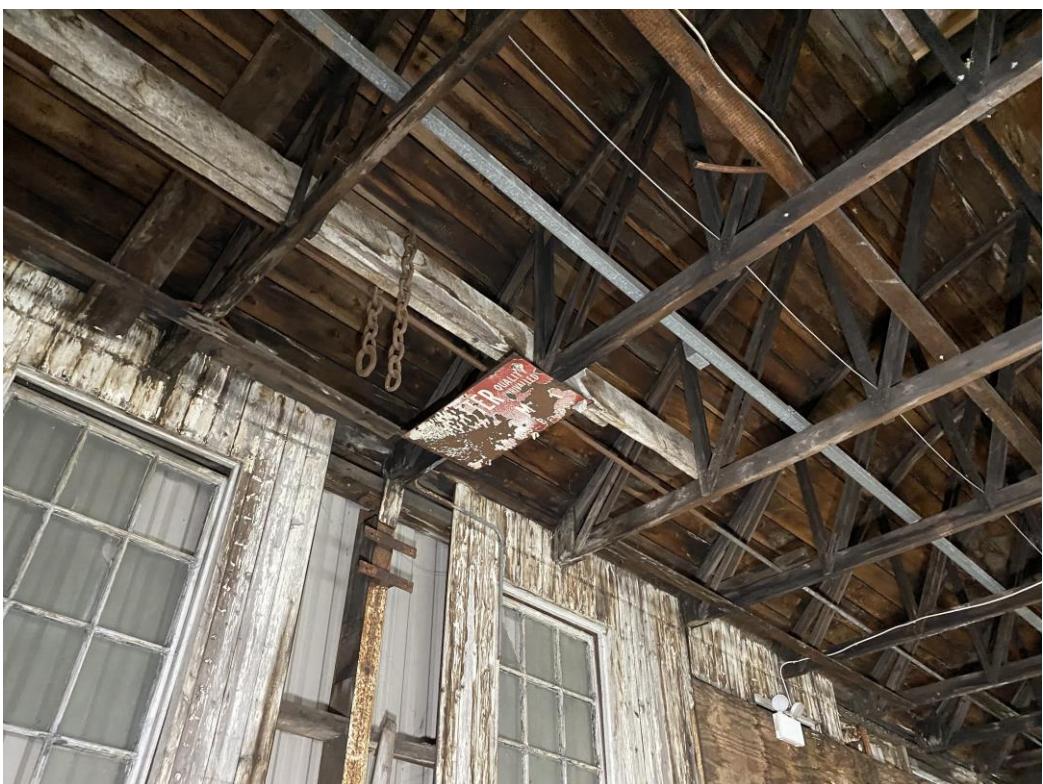
View of the other panel which was originally over a heater

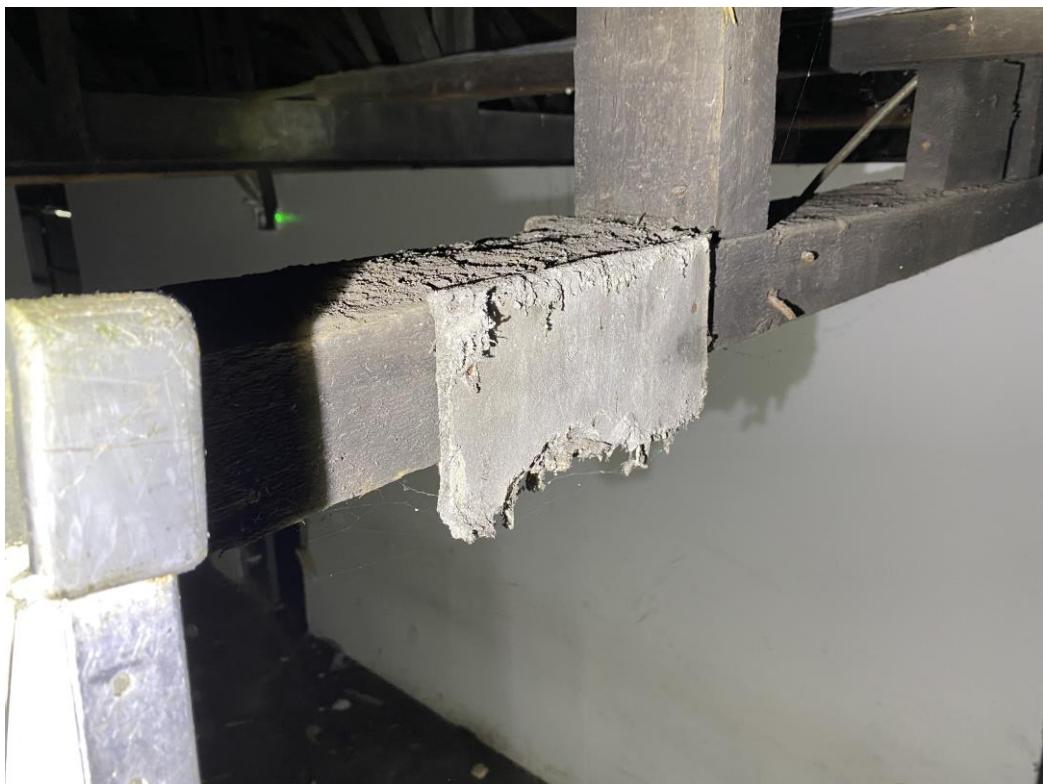
Closeup view of the remaining millboard on the lower level of the truss

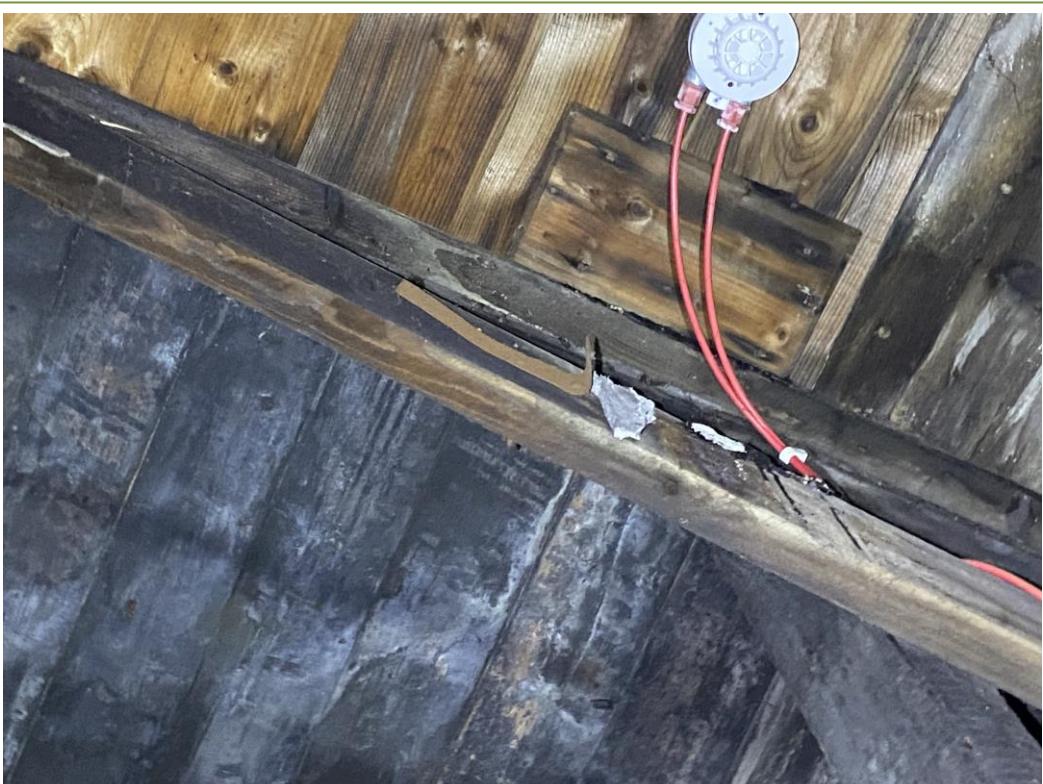
View of the remaining millboard on the higher level of the truss

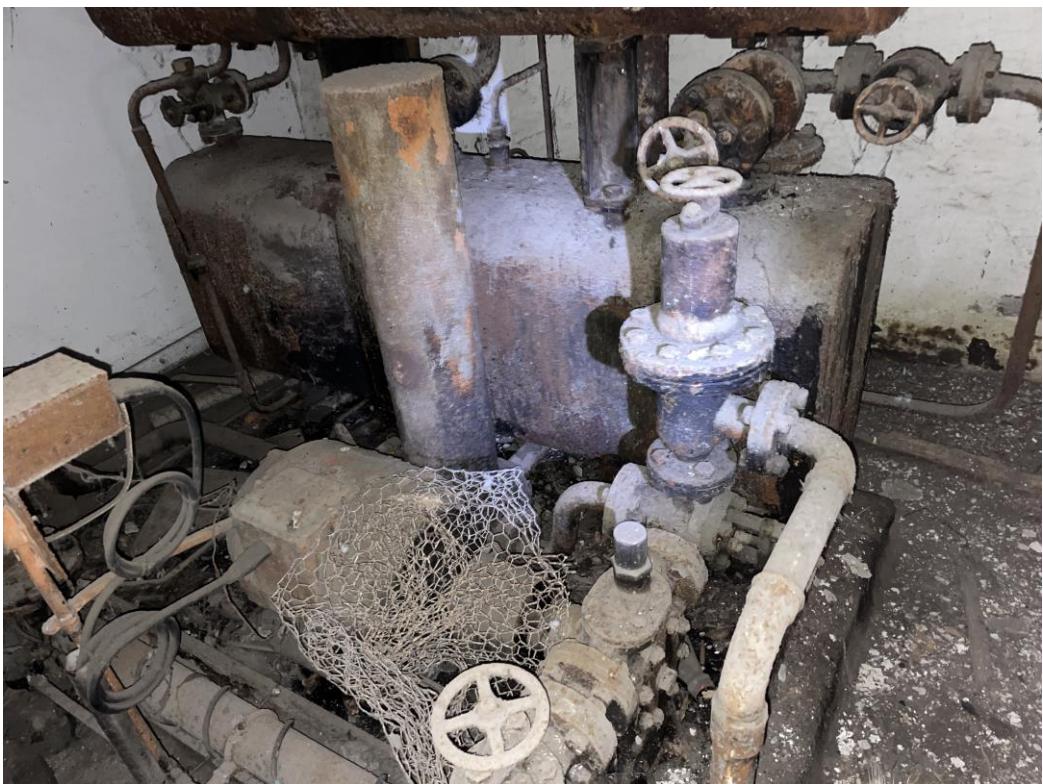
Asbestos containing thermal insulation residue on the boiler unit in the boiler room

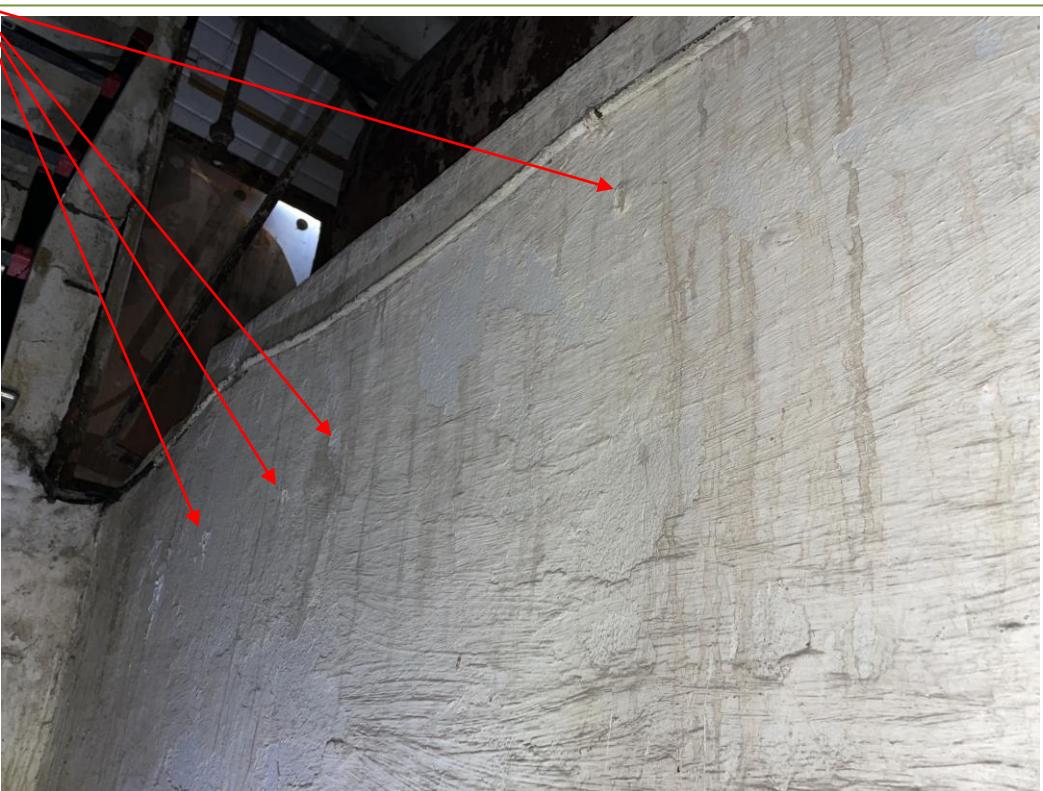
Asbestos containing thermal insulation residue on the walls and pipework in the boiler room

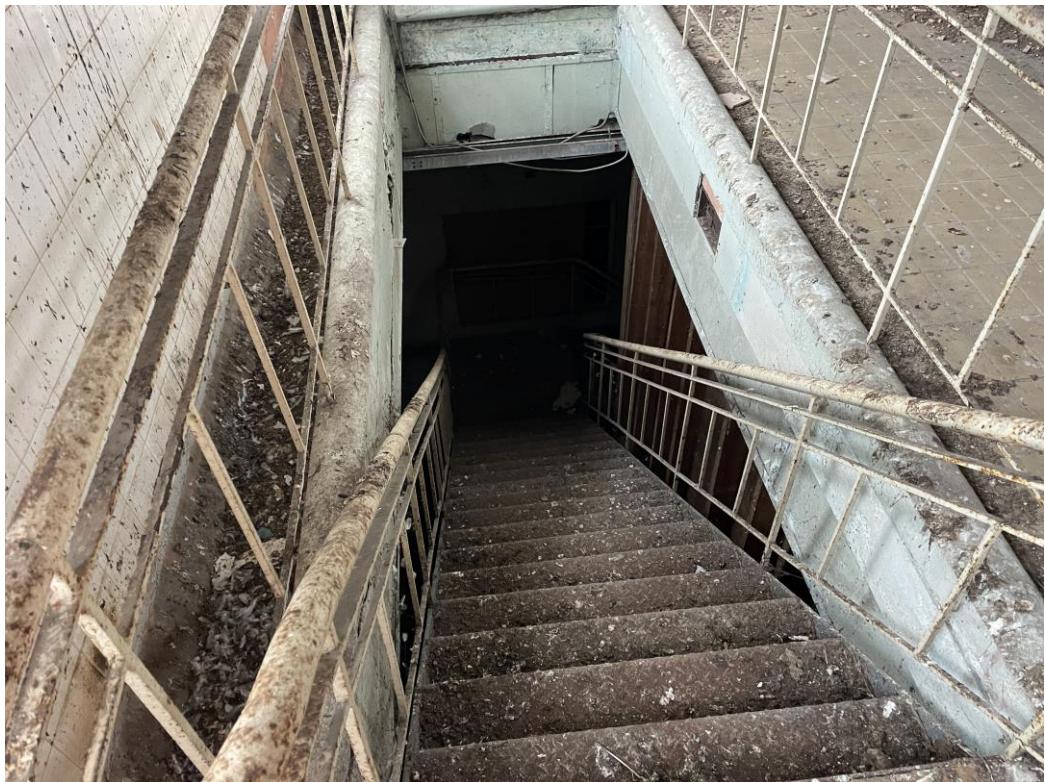
Asbestos insulation board on the walls of the stairs to the 1<sup>st</sup> floor in Building 12

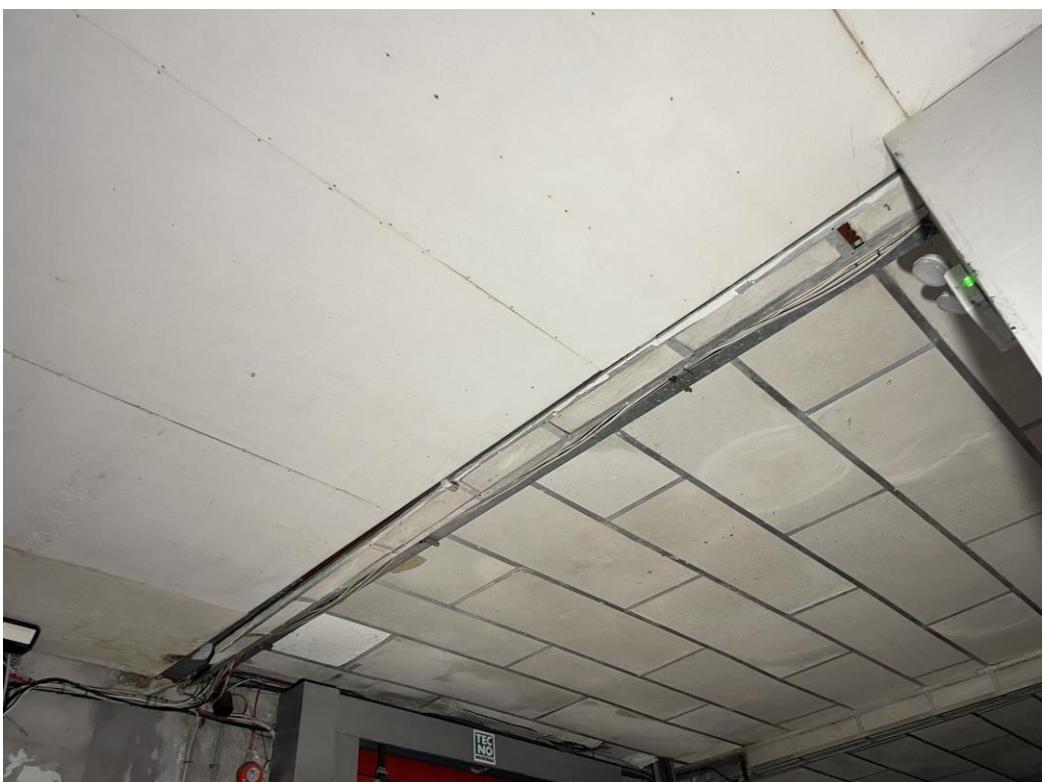
Asbestos insulation board on the ceiling and around the beams in Building 12

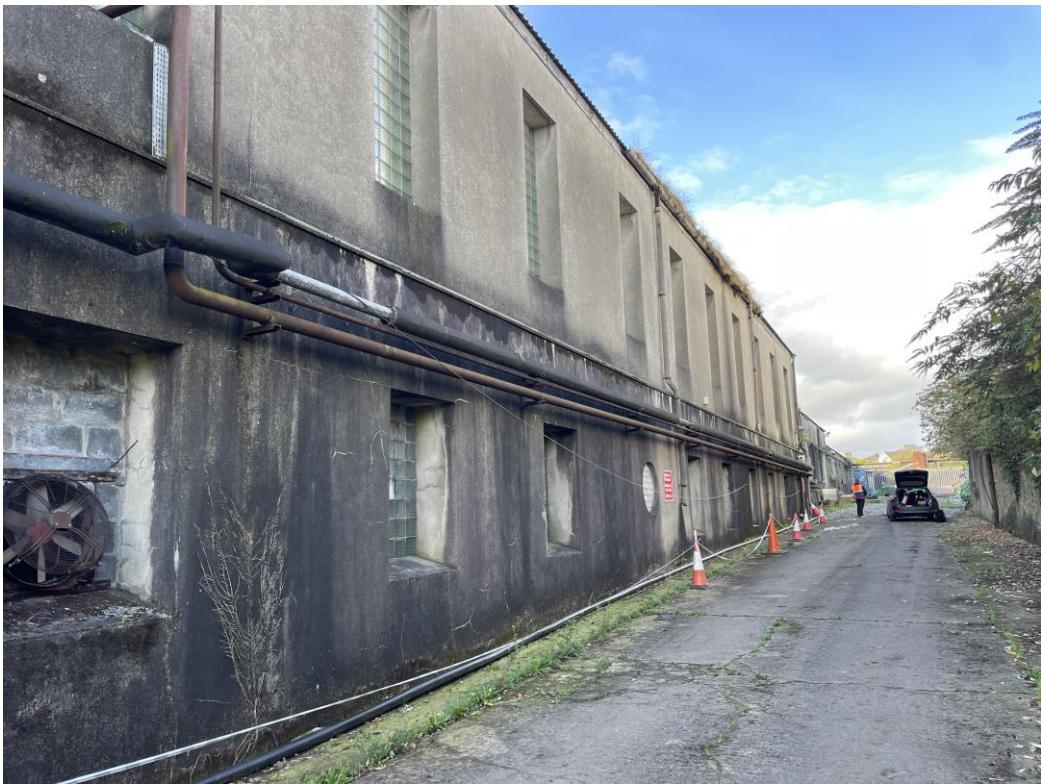
View of the asbestos cement gutters and downpipes on building 4

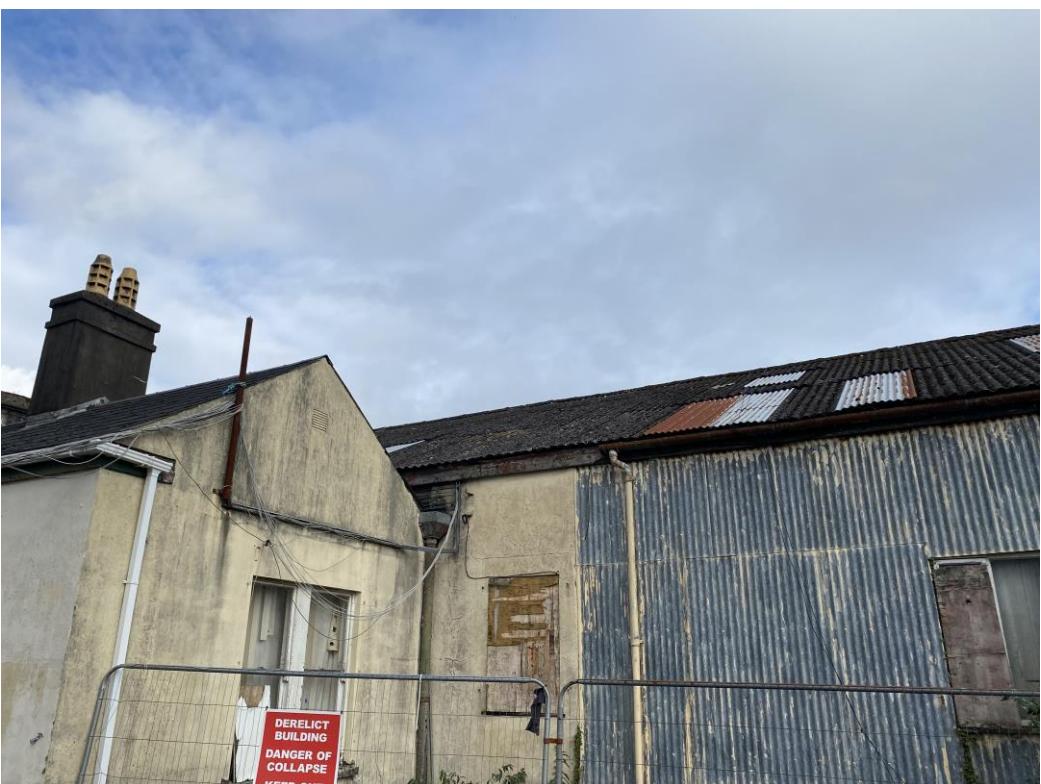
View of the asbestos cement gutters and downpipes on building 9

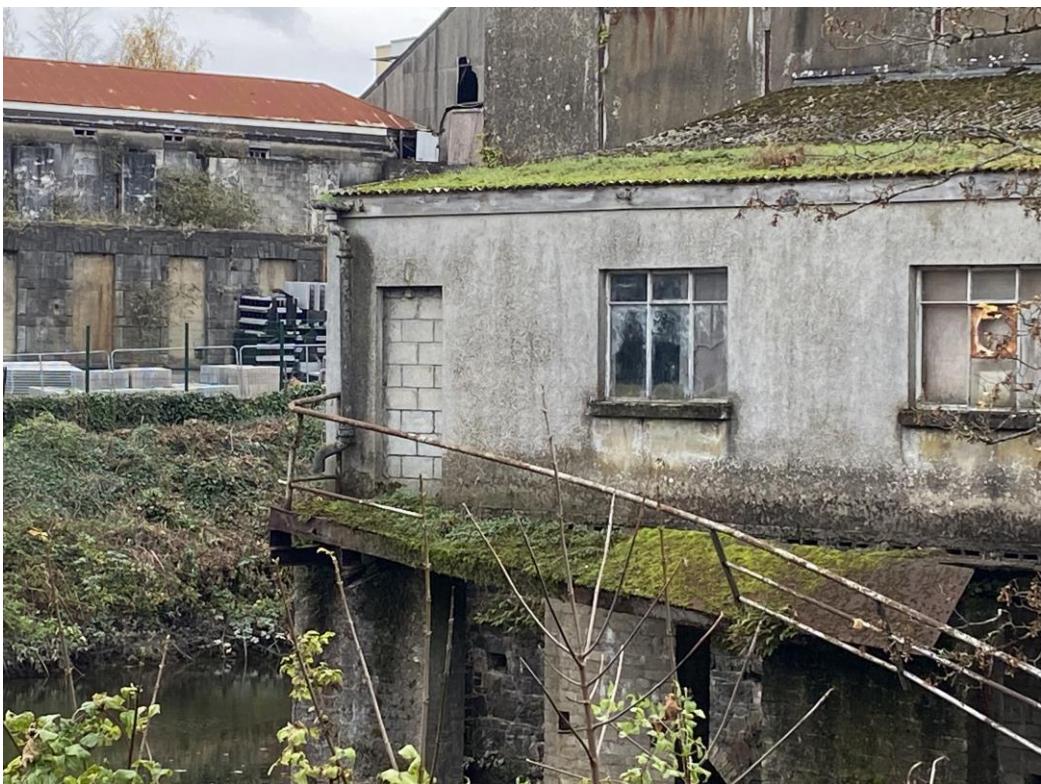
View of the asbestos cement gutters and downpipes on building 14

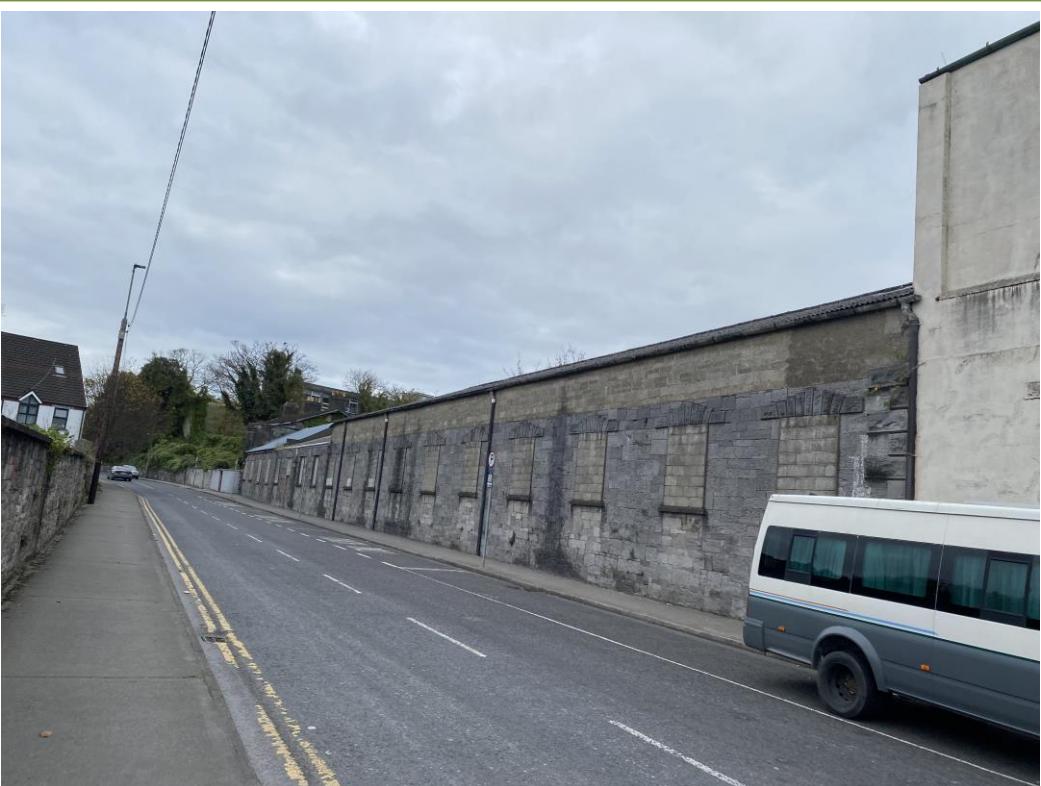
View of the asbestos cement gutters and downpipes on building 15

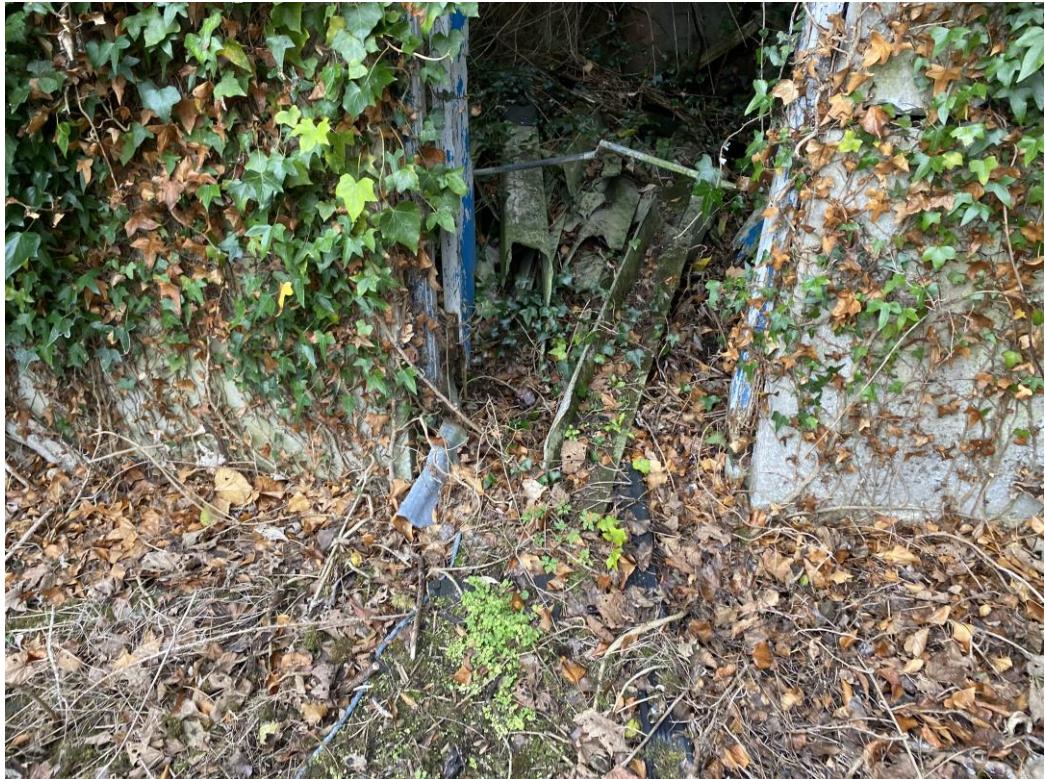
Asbestos cement debris in the rear of Building 17

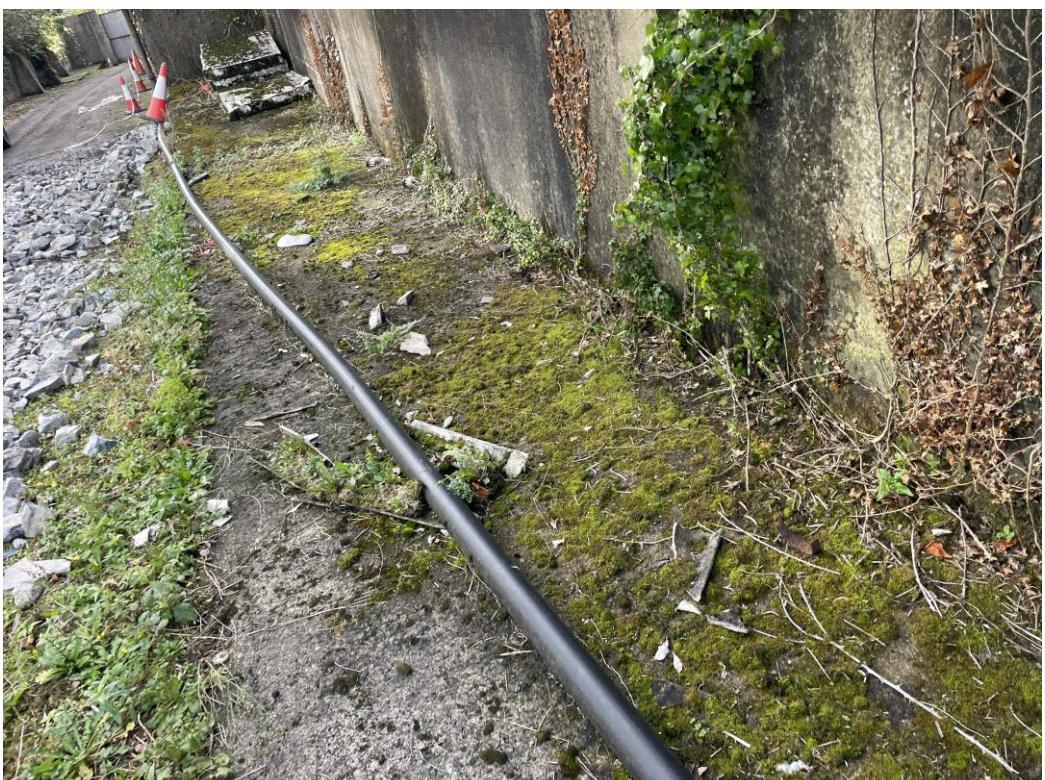
Asbestos cement debris along the rear of building 4

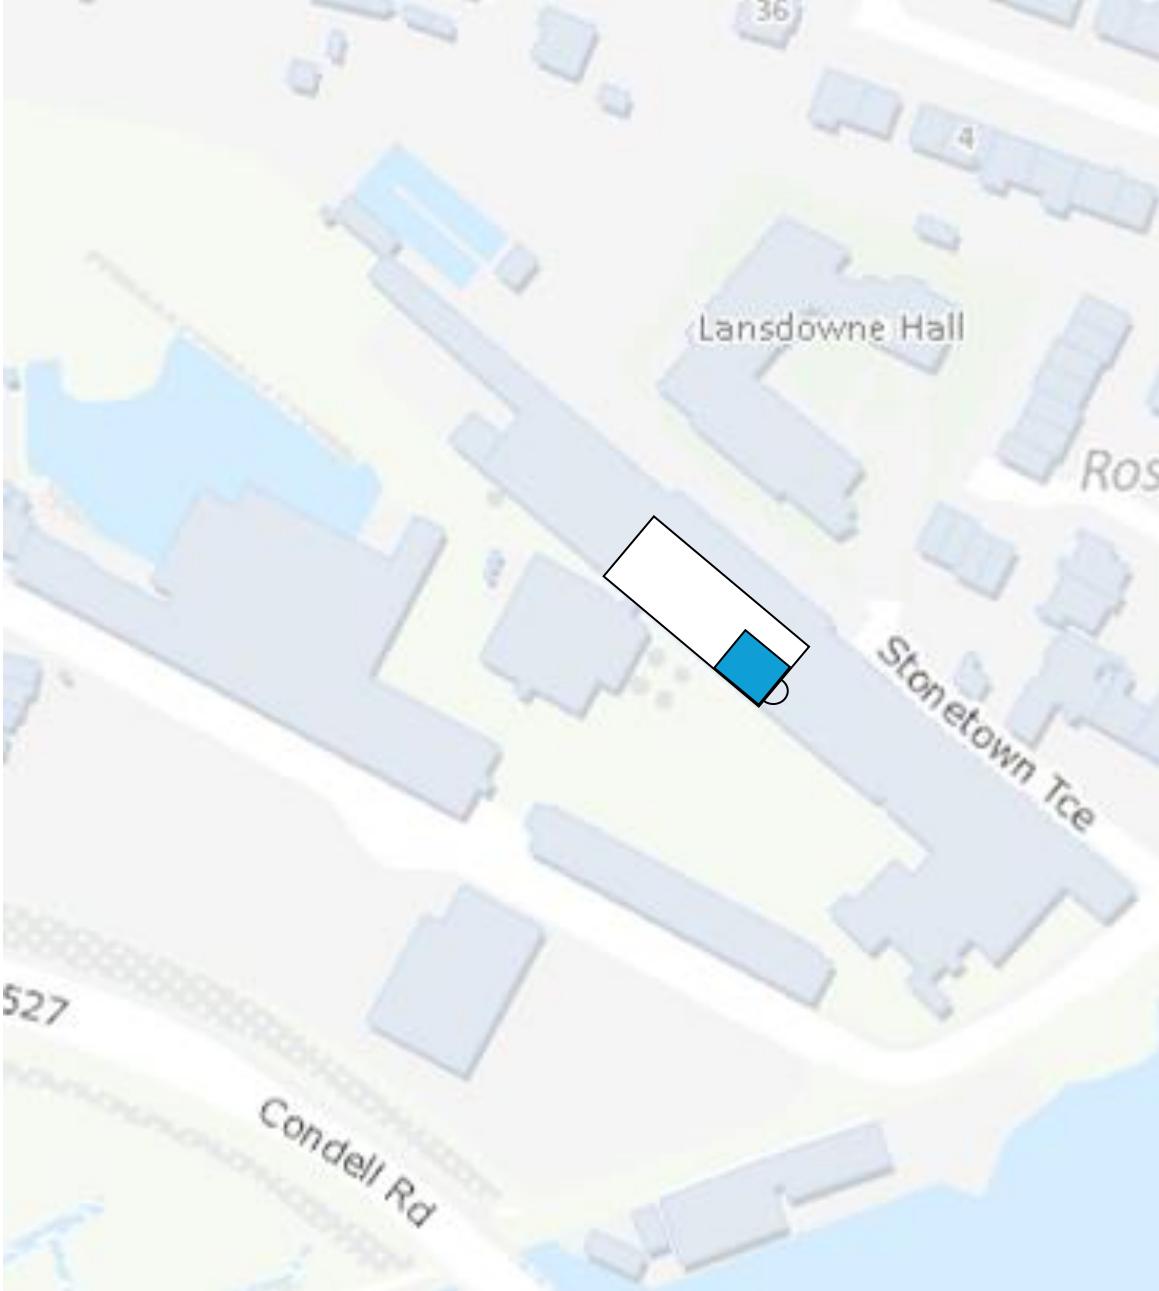
<p>Area where asbestos containing thermal insulation was identified on the boiler unit</p>
Note:	Cement debris, CAF gaskets and asbestos rope were identified throughout the site
Note:	Asbestos containing debris was identified in the attic area beside the lift motor room
Note:	Asbestos rope was identified on the electrics in the lift motor room
