Appendix 19-1 Asbestos Survey Report

## ASBESTOS SURVEY REPORT

**Location: The Cleeves Site,  
North Circular Road, Limerick**

**Report No. PE24-1226**

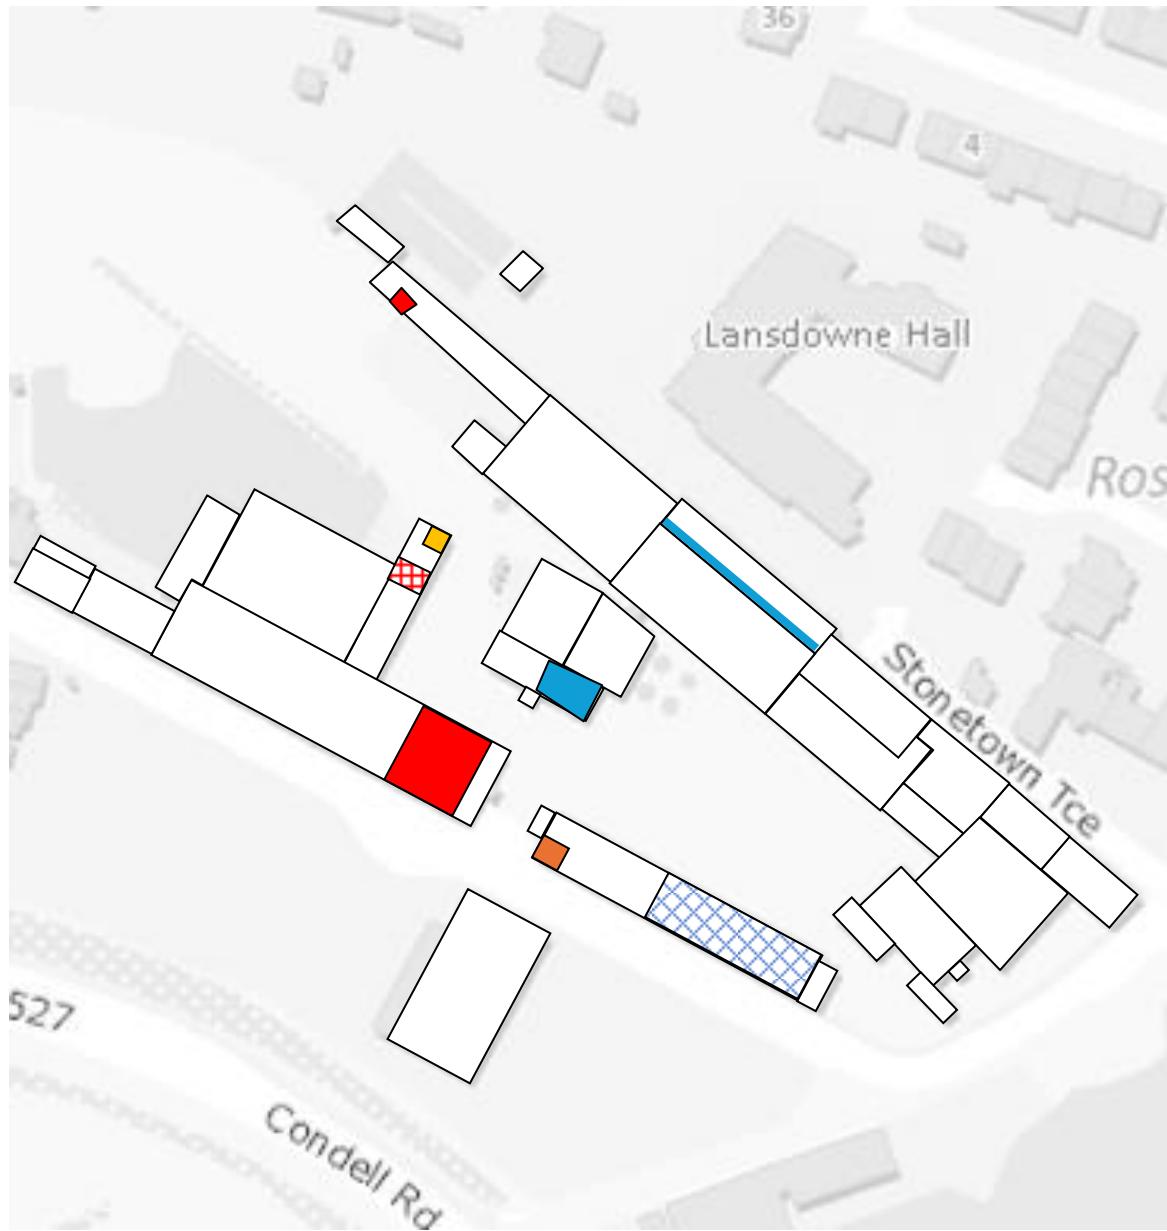
Area where asbestos insulation board (AIB) was identified
	Areas where asbestos thermal insulation was identified
	Areas where asbestos millboard was identified
	Area where asbestos insulation board was presumed
	No access
<b>Note:</b>	Cement debris, CAF gaskets and asbestos rope were identified throughout the site

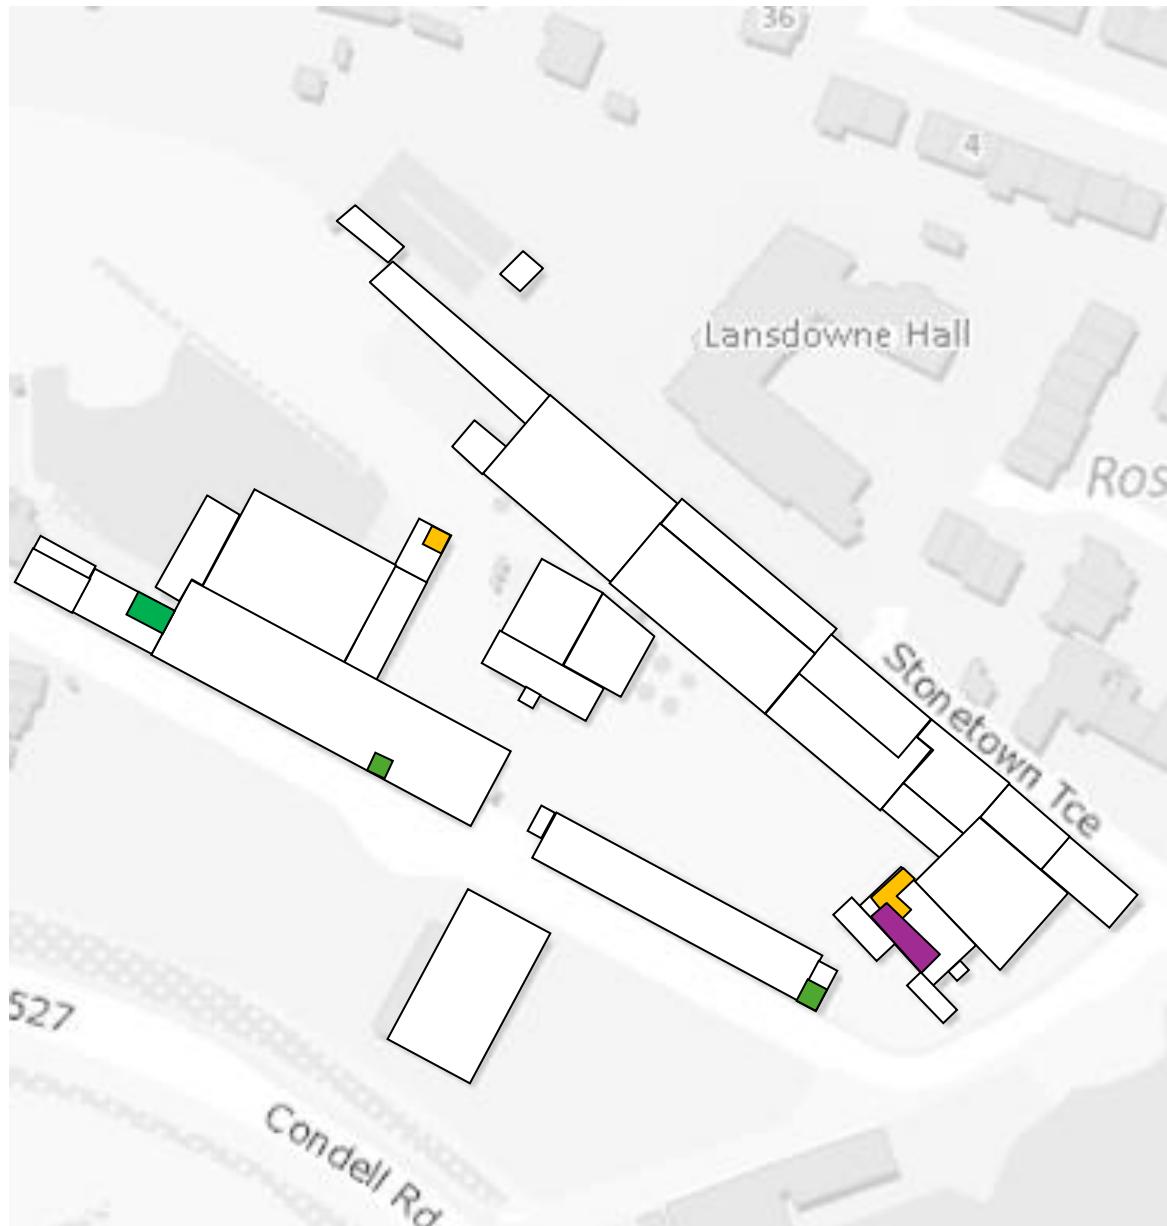
Areas where asbestos containing paper backed lino was identified
