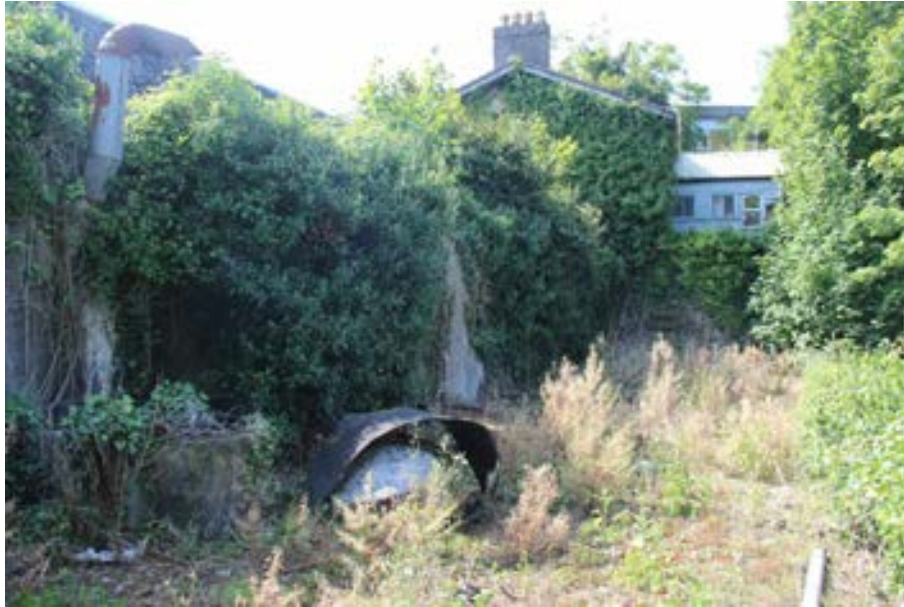
The north circular road elevation is constructed of coursed ashlar natural limestone, with margined and rusticated quoin stone and window opening arches. The rear elevation is heavily overgrown with vegetation. The rear walls are rendered with a cementitious mortar, where visible.

Photograph 4 General view of the rear of the Cheese Plant complex. Note overgrowth to rear walls.

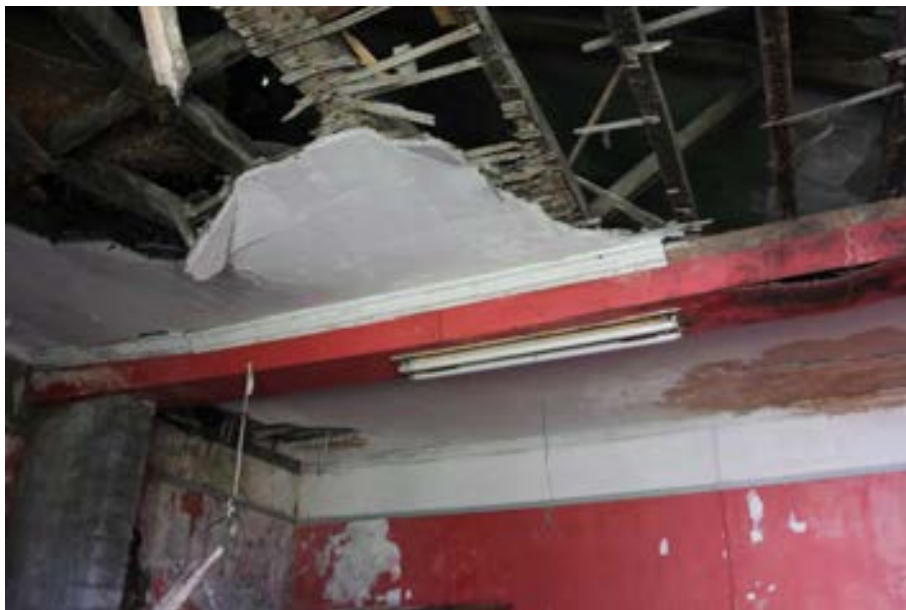
The ceilings to the end room have failed locally, with the roof structure exposed internally.

Photograph 6 View of the failed ceiling of the end room. Note laths and sections of coving.

The remnants of plaster coving are evident to the ceiling, all in very poor repair and most likely not original.

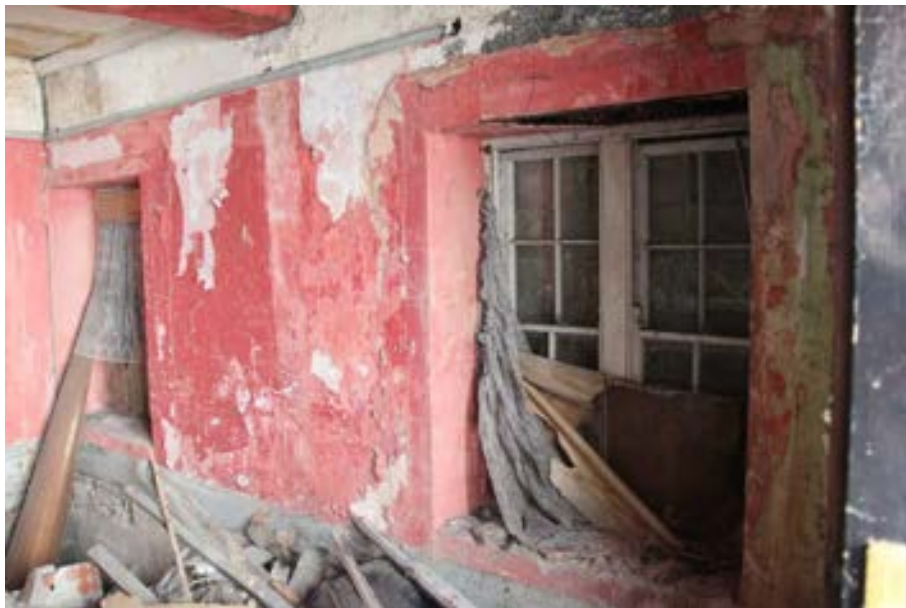
The end room walls appear to have been drylined (evident from the failed window soffit).

Photograph 8 View of the internal elevation of the external wall to the end room.

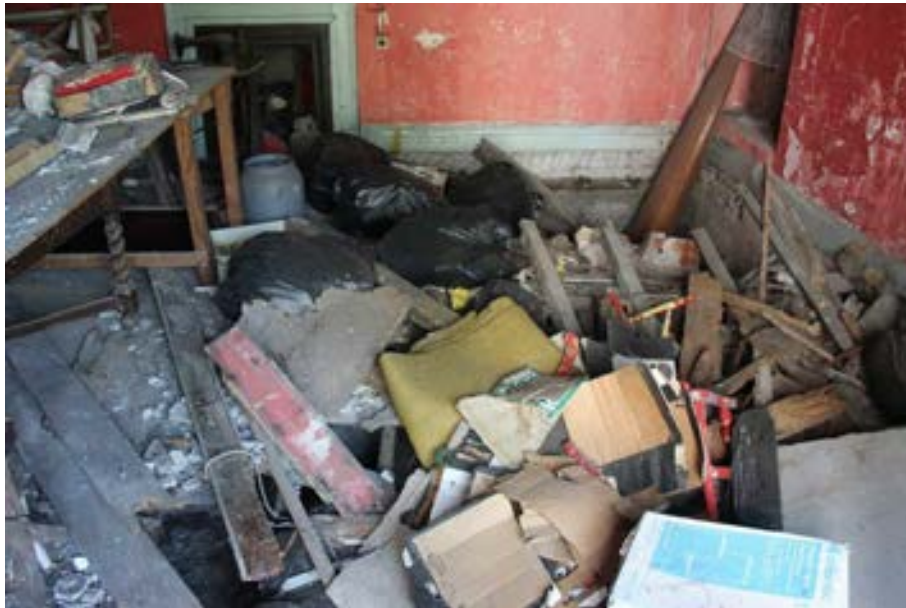
The main section of the building is finished with a concrete floor, the end room is finished with a sprung timber floor, now long since failed.

Photograph 9 View of the floor of the end room. Sprung timber floor. Failed.

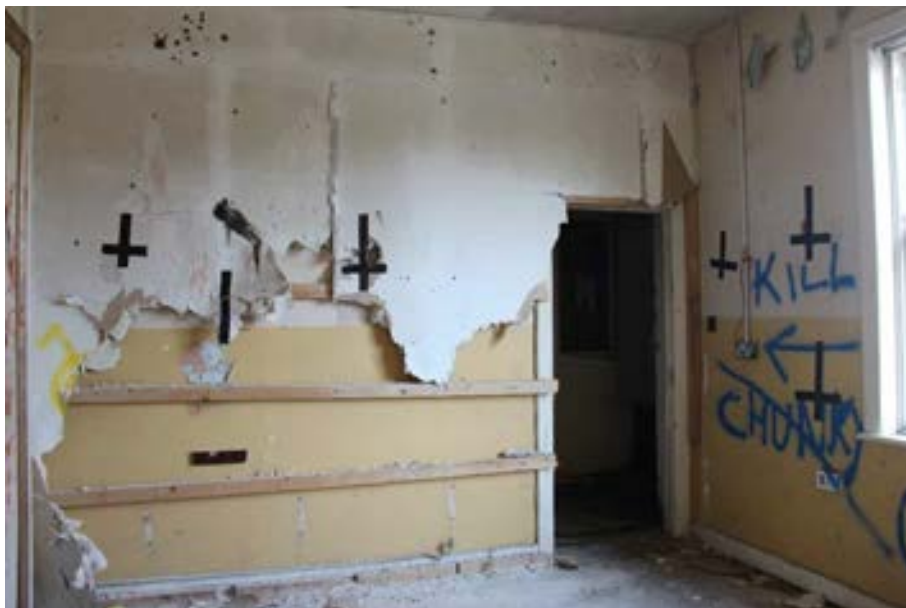
The internal walls to the “welfare” building are drylined modern plaster slabs, with a skimmed and painted finish. The original internal wall finishes are noted to be visible, which are rendered mass masonry.

Photograph 8 View of the damaged internal lining within the “welfare” building.

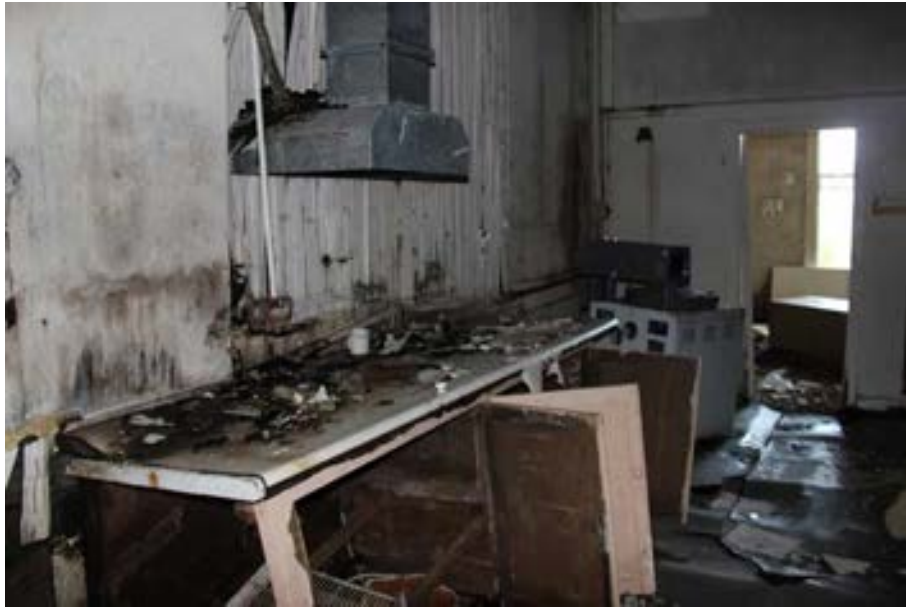
There are timber sprung floors within the remainder of the rooms of the buildings, most notably to the laboratories.

Photograph 15 Laboratory with an example of the timber sprung floors, all decimated with rot now.

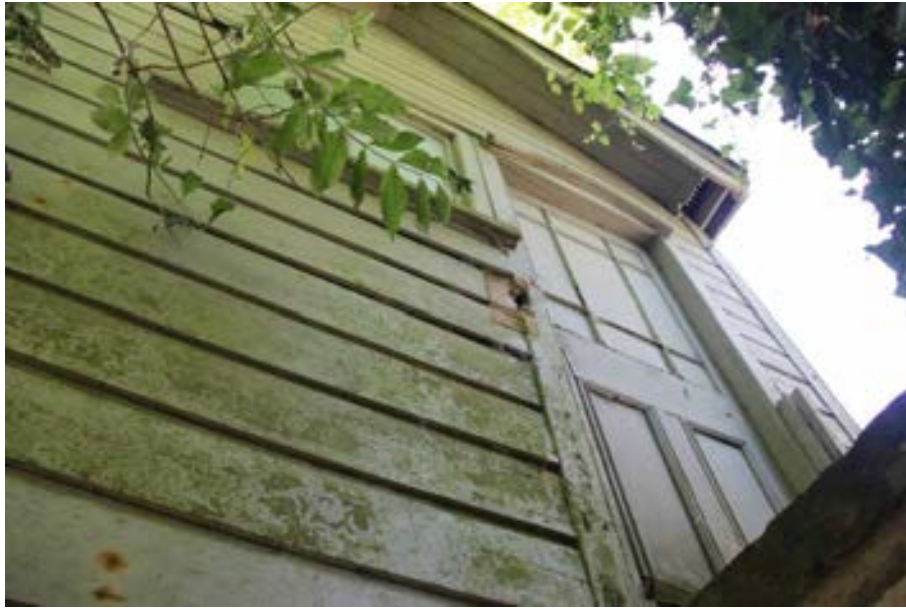
Photograph 34 - Blacked off Return Annex door with glazing painted out.

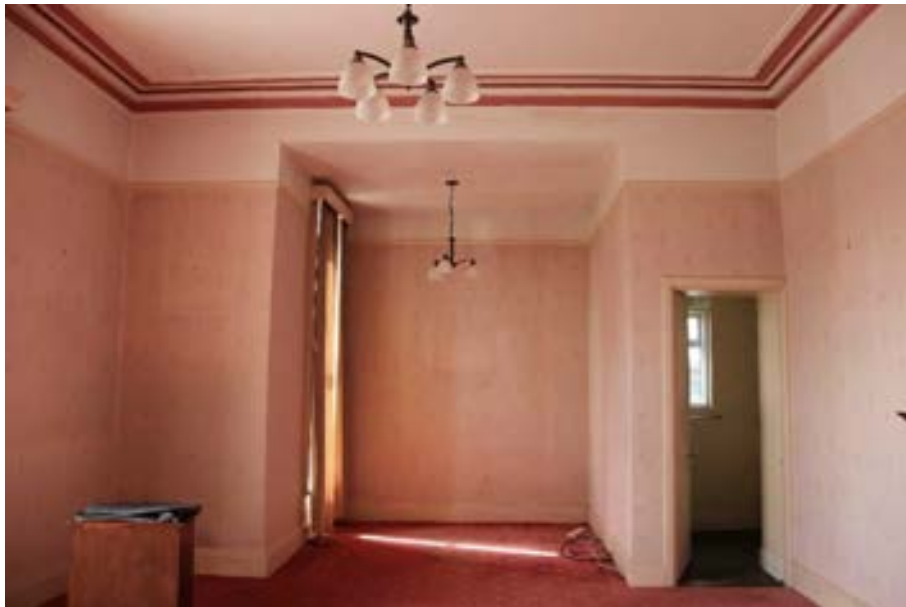
Photograph 19 - Original gable wall broken through to provide for modern extension.
