Building Record Report

Building 14 Semi Detached Houses
Former Cleeves Condensed Milk Factory

Client: Limerick 2030

Date: 15th of October 2025

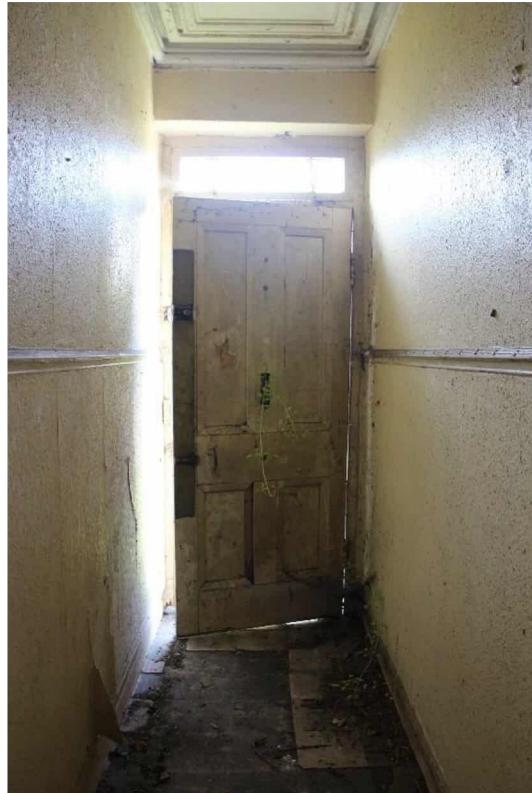
Main entrance door is a four-panel timber door and may be original. On the external side it is faced with ply sheeting with brass knob protruding. The door frame is still in place and paint layers, now peeling, reveal earlier paint coats. The overhead transom light is intact and appears original. The rear door is timber three panelled door with two lower timber panels and an upper glazed series of panes, that are stained glass. The upper section of this feature matches the transom light at the main entrance door. There is a third door from the kitchen that would have led into a lean-to extension (no longer extant). This is of timber vertical boards with a brass knob.

Photograph 6 - Internal face of Entrance door.

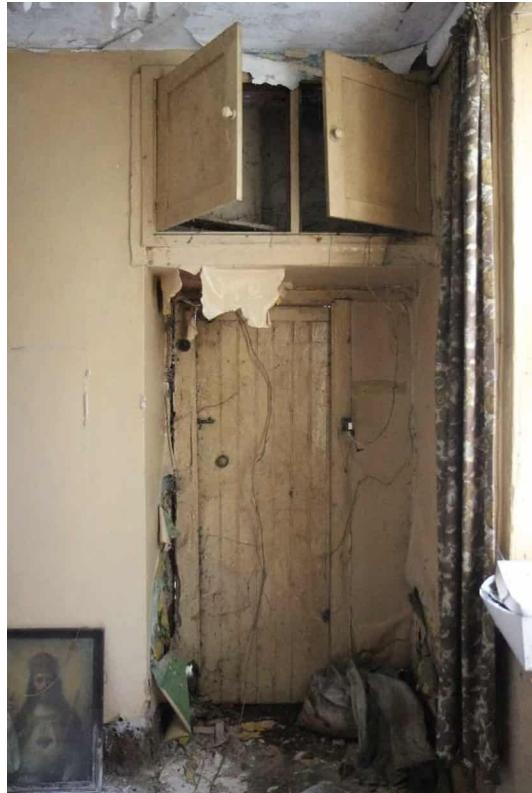
Photograph 8 - Internal face of door from exiting Kitchen into former lean-to.

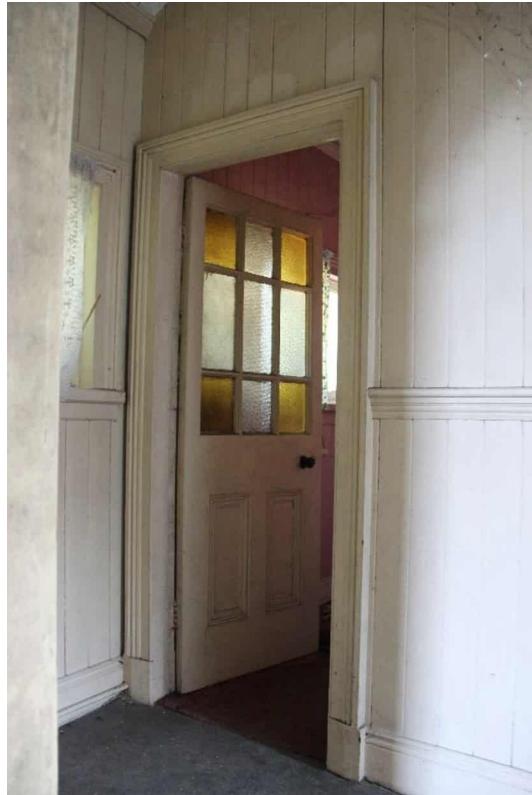
Return Annex doors are timber with upper frosted glazing panel with stained glass. The main building doors are 4 panel solid timber doors with painted wooden and Bakelite knobs.

Photograph 25 - Return Annex timber door with glazed upper section.

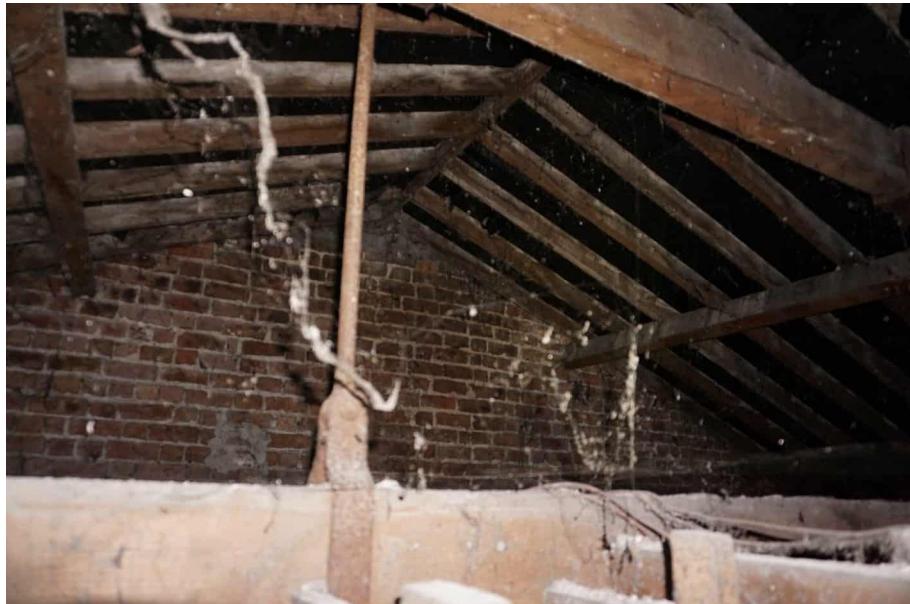
Attic has a cut timber roof consisting of cementitious replacement slates on bitumen underlay on original timber rafters on purlins with truss supports. Cast iron hangers are used to tie the truss members. The original lime parging is evident between the joists.

Photograph 26 - Roof Space indicating cast iron hanger.

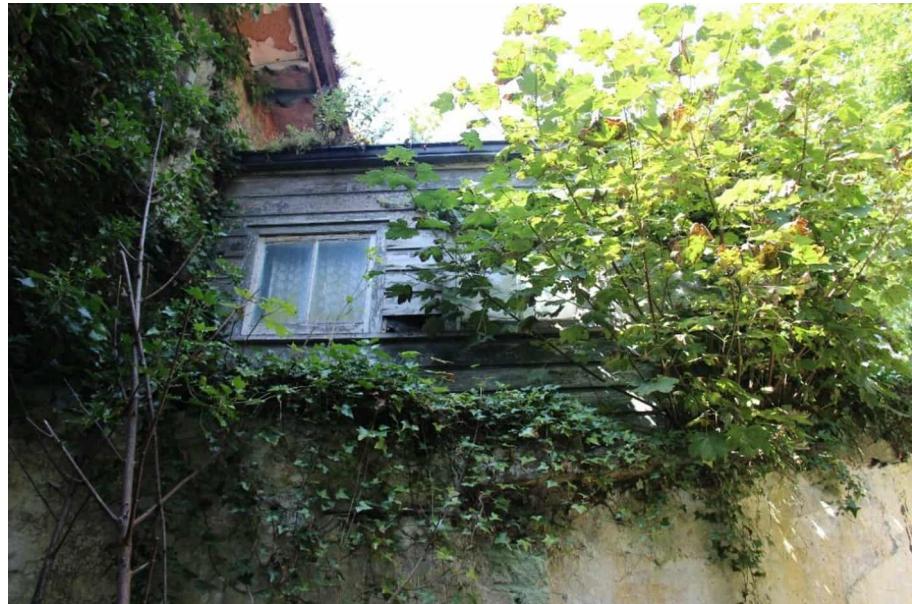
Photograph 28 - Return Annex with corrugated iron roof.

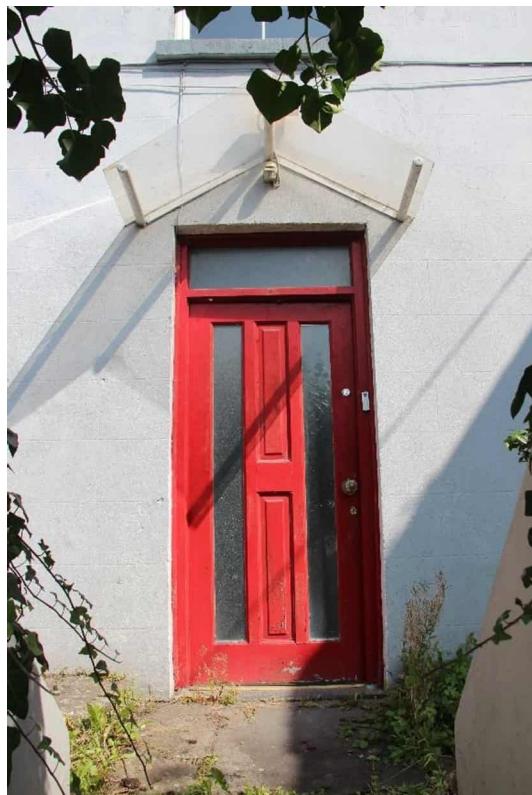
Main entrance door is a replacement timber 4 panel door with vertical panels. Two of these are light strips and there is a vent light overhead. The opposing back door is a replacement PVC double leaf door with 4 panels, where the upper two are glazed.

Photograph 32 - Modern replacement main entrance door.

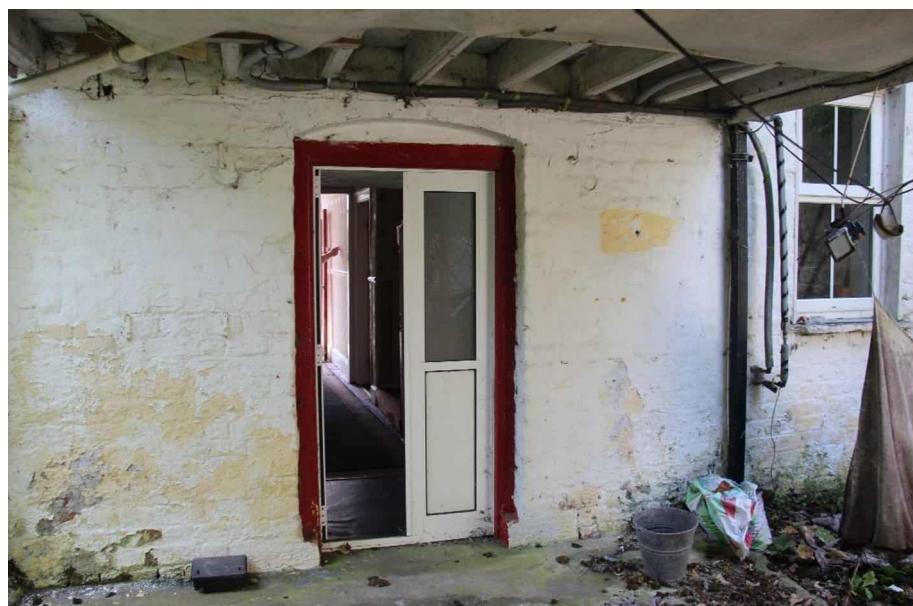
Photograph 33 - Modern replacement two leaf rear door.

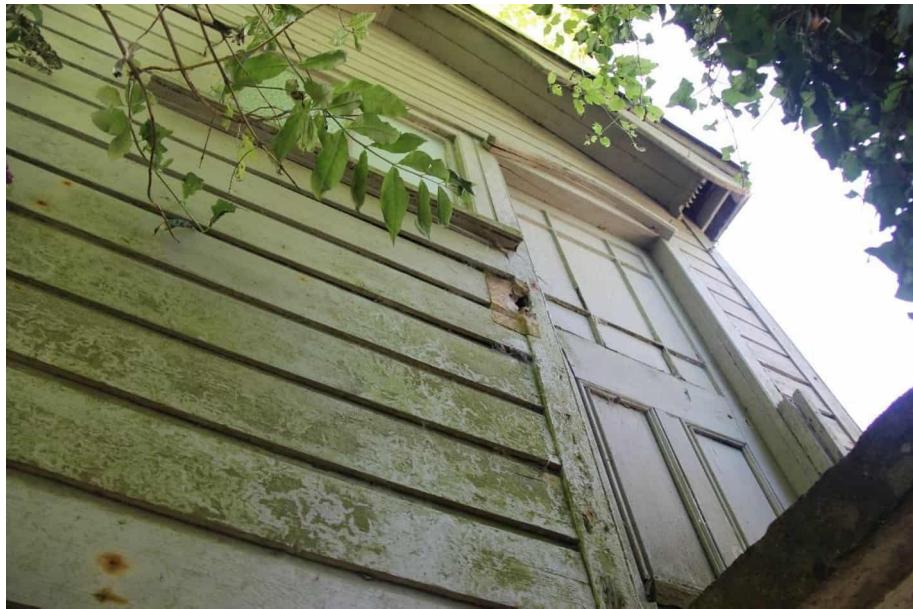
There is a door to the rear of the Annex Return, but this is hidden internally and therefore non-accessible. This door appears to give access onto a bridge to the upper garden, now no longer accessible from this property.

Photograph 34 - Blacked off Return Annex door with glazing painted out.

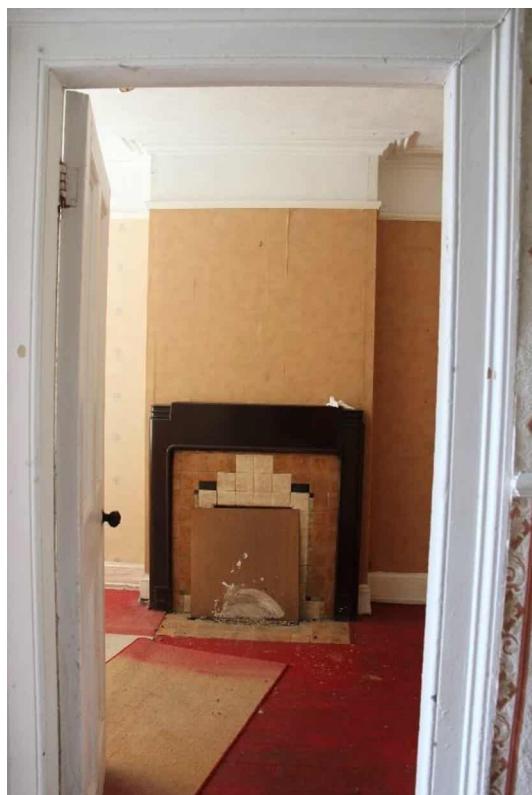
There is a fireplace in each of the front rooms. These have replacement modern (1970/1980s) timber and tile surrounds. There is also a flue in the kitchen, and this is currently repurposed as a storage area. Dimensions indicates that prior to its new use, a range cooker may have been located in the opening.

Photograph 36 - Replacement fireplace surround Room 1st LHS.

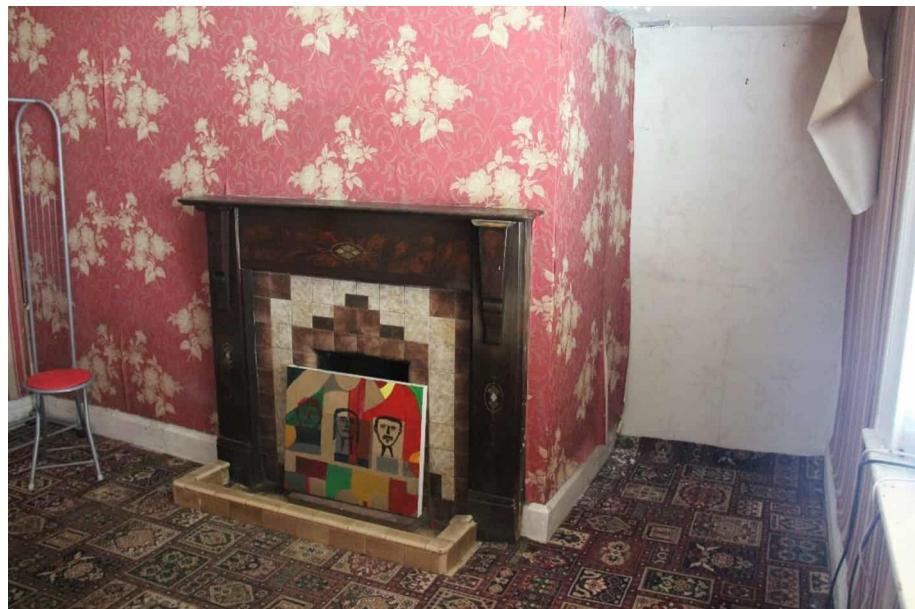
Photograph 37 - Replacement fireplace surround room 1st RHS.

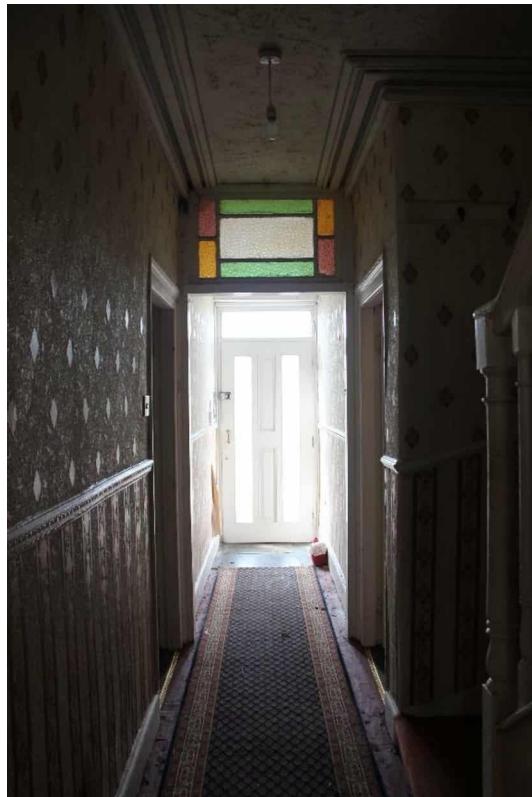
- There is a stained-glass rectangular vestibule screen at high level along the hall corridor. This serves to separate the hall from the rest of the corridor. Doors to all internal rooms sit to the far side of this subtle demarcation.
- A second demarcation occurs with the use of the stairs' landing. The back door, w.c. and kitchen are placed at and/or behind this.
- W.C. has meat hooks, or similar, hanging from the lath-and-plaster ceiling.
- The staircase is recessed and barely visible from the front door, ensuring privacy.
- The Hall corridor and front rooms have ceiling coving.

Photograph 41 - Stained glass vestibule screen to separate Hall.

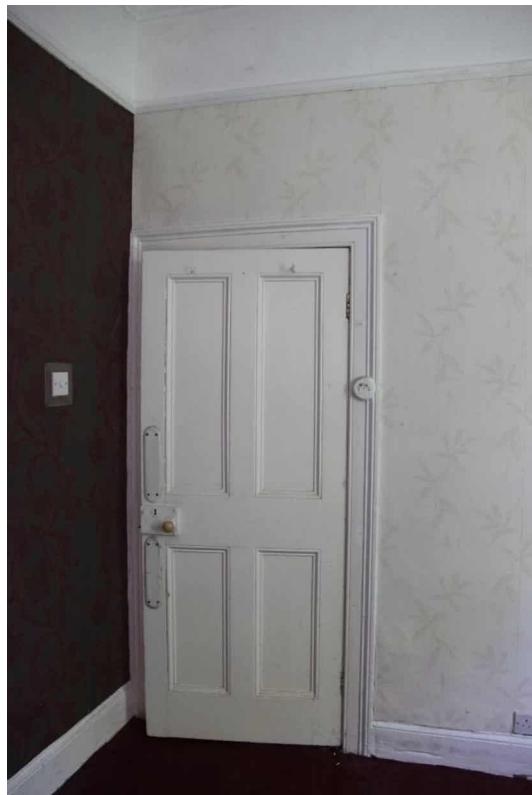
All door opes have architraves and these may have lead paint thereon. To be investigated.

Photograph 46 - Four panel door with brass doorknob.

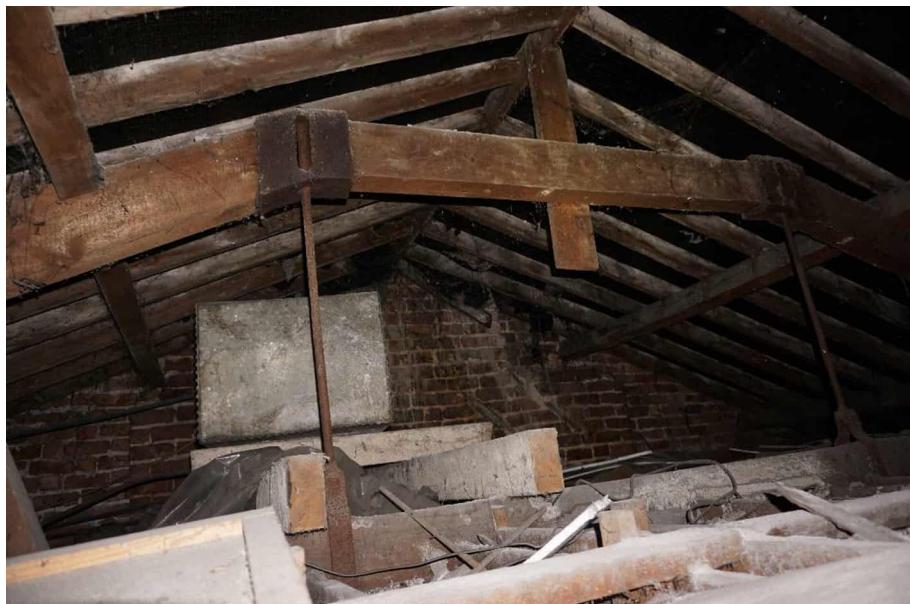
Attic has a cut timber roof consisting of cementitious replacement slates on bitumen underlay on original timber rafters on purlins with truss supports. Cast iron hangers are used to tie the truss members. The original lime parging is evident between the joists.

Photograph 48 - Truss with cast iron hanger.

Roof Timbers / Trusses (with Wrought Iron elements)	High Quality slow grown softwood rafters and trusses. Trusses also	In very good repair.	For the use of repair / replacement of defective timber in windows and doors of historic buildings, or repair of fabric with joinery elements, with the provenance confirmed.
