## Building Record Report

Building 16 Fernbank House  
Former Salesians Secondary School

**Client:** Limerick 2030

**Date:** 15<sup>th</sup> of October 2025

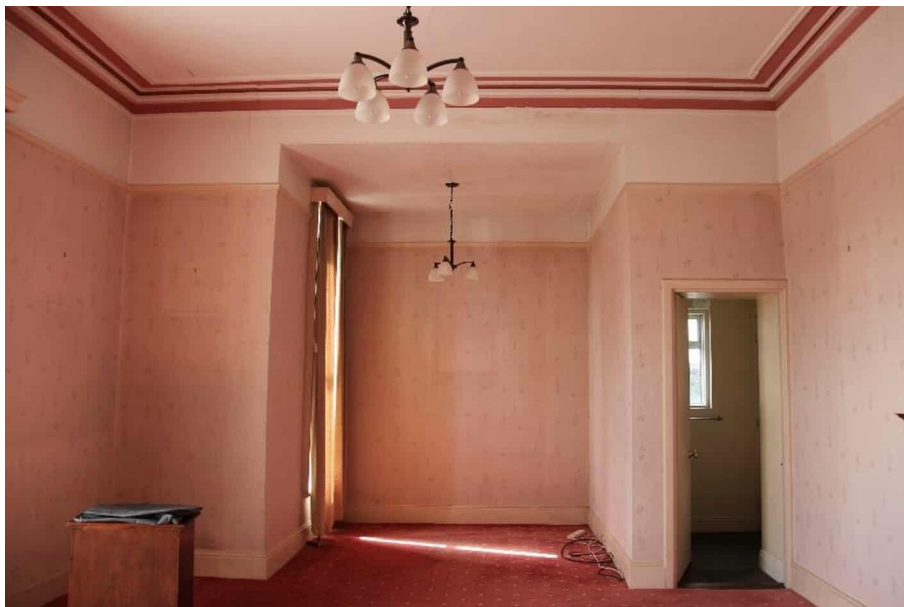
**Photograph 19 - Original gable wall broken through to provide for modern extension.**

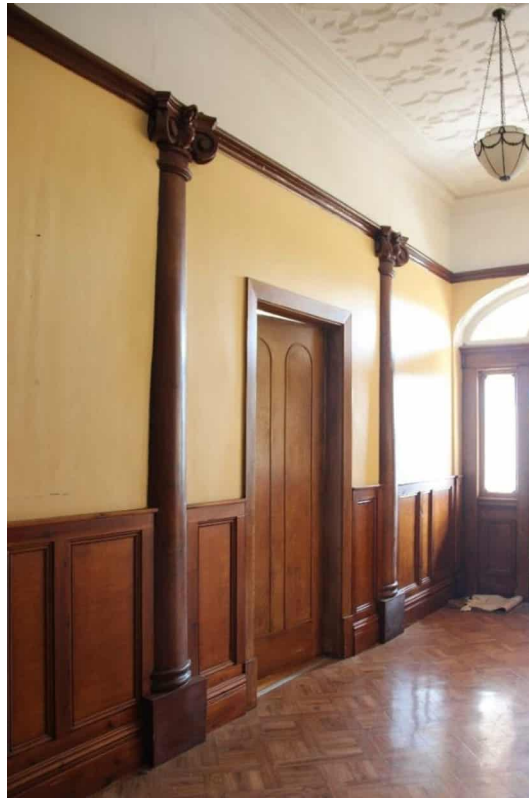
Doors off the hall in the earlier building are a mixture of 2 and 4 panels solid timber doors with a stained glass upper section to the door under the stairs. We are of the opinion that these may be replacement doors as they are not uniform in style.

**Photograph 25 - a 2-panel solid timber door opposes a 4-panel solid timber door in the main hall.**

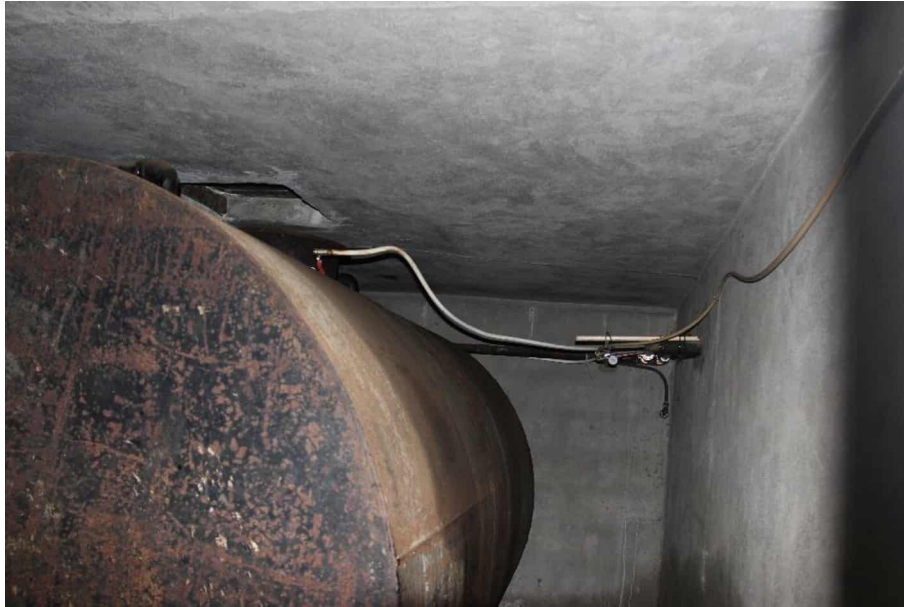
**Photograph 36 - Small basement rooms house the oil tanks and burner. Electrical distribution boards may also be located here.**

Before the removal of any plant, it is recommended that a full asbestos survey be conducted.

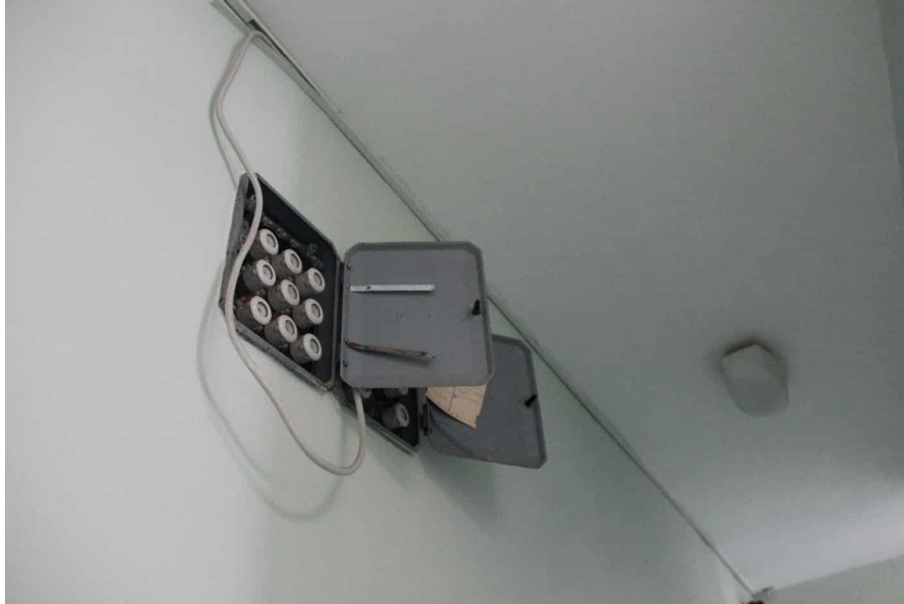
**Photograph 58 - Fuse box on 2nd floor.**

The services installations are noted to be mostly modern, with fluorescent tubed fittings throughout the buildings, modern electrical sockets and light switches mounted to the walls etc. The fuse box on this floor requires updating and as this building has been dormant, a fully electrical audit and assessment is advised. It is recommended that prior to moving any plant, that an asbestos survey be conducted.

The services installations are noted to be mostly modern, with fluorescent tubed fittings throughout the buildings, modern electrical sockets and light switches mounted to the walls etc. It is recommended that prior to moving any plant, that an asbestos survey be conducted.
