**Opera Site: Bank Place, Rutland St., Patrick St., Ellen St.
and Michael St., Limerick.**

Existing Building Individual Records.

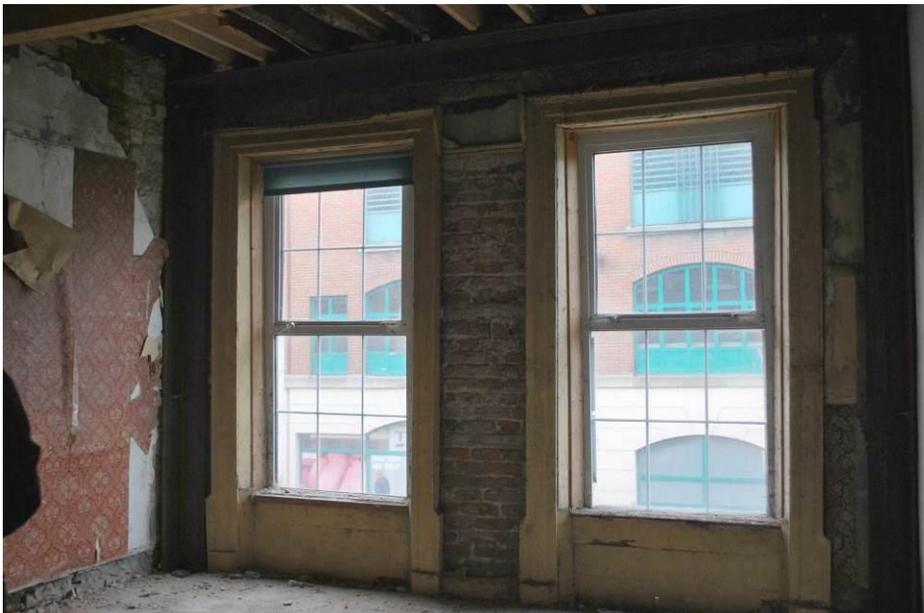
Fig. 1: Front room, first floor, showing lugged architraves to windows.

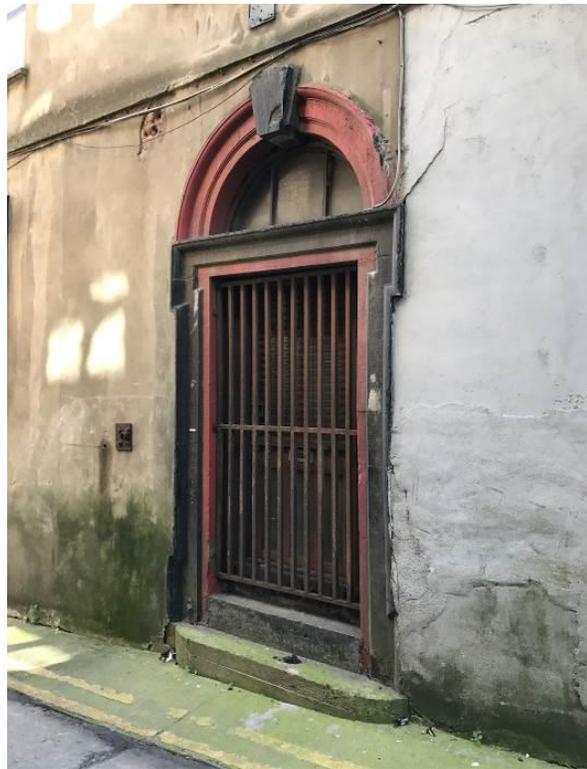
Fig. 7: Limestone doorcase to laneway.

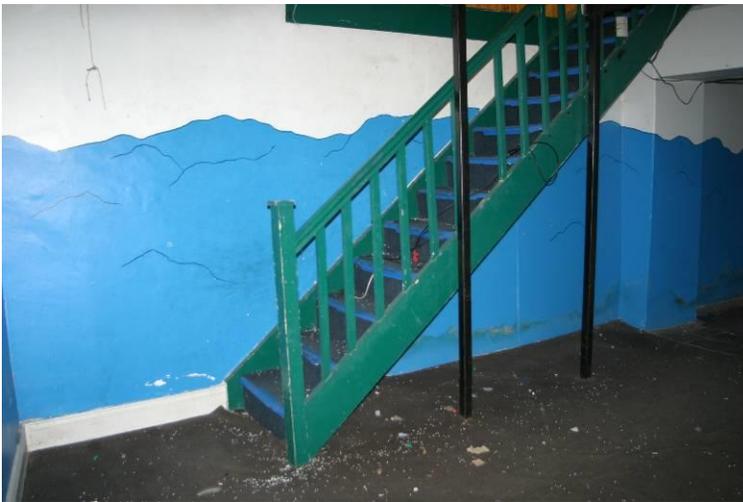
Front room of basement showing access stairs.

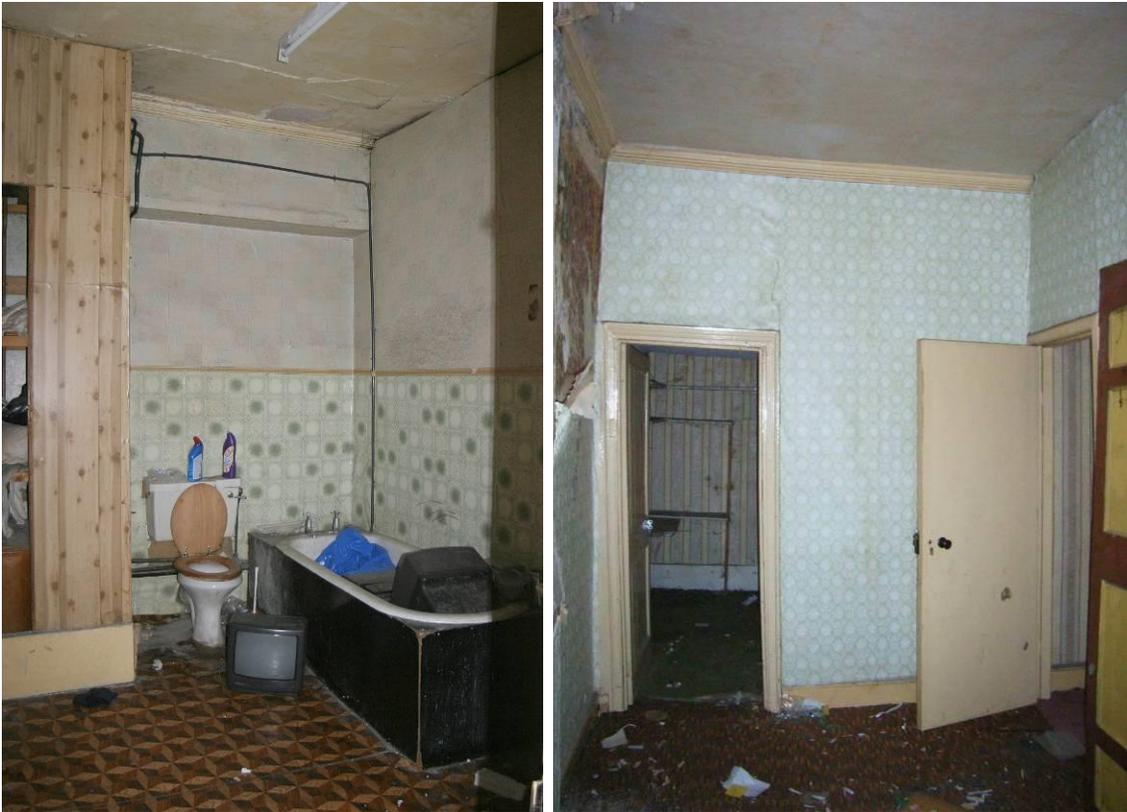
Rear room, second floor, which has been subdivided with a modern stud partition. Note the doorway leading to a small area beneath the stairs (above right).

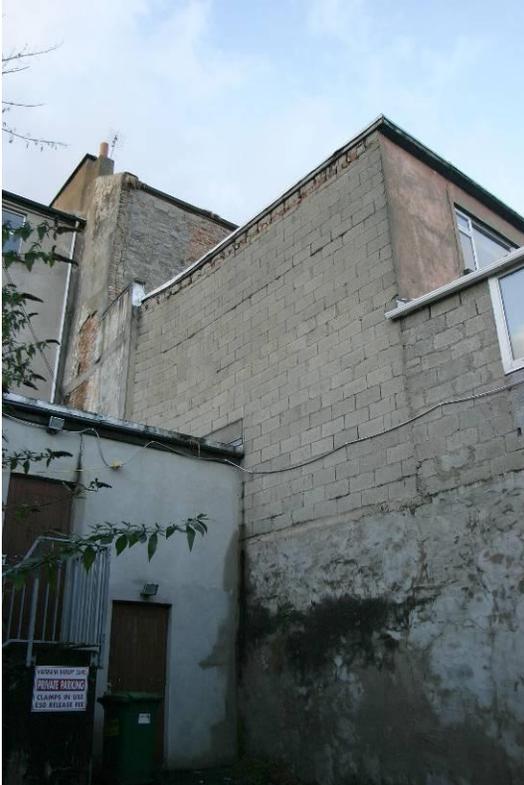
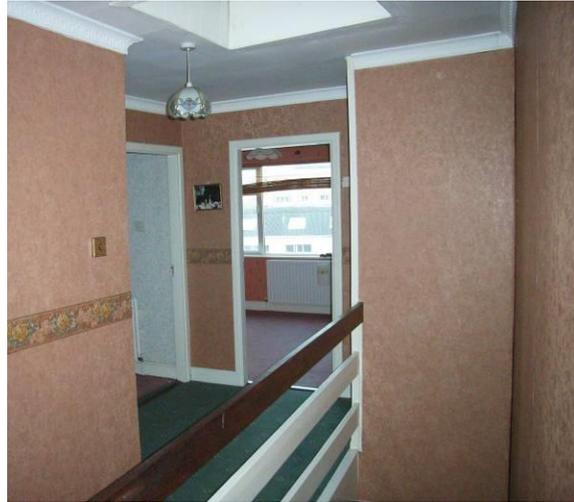
View of exterior (left) and top floor (above) of additions to the rear.

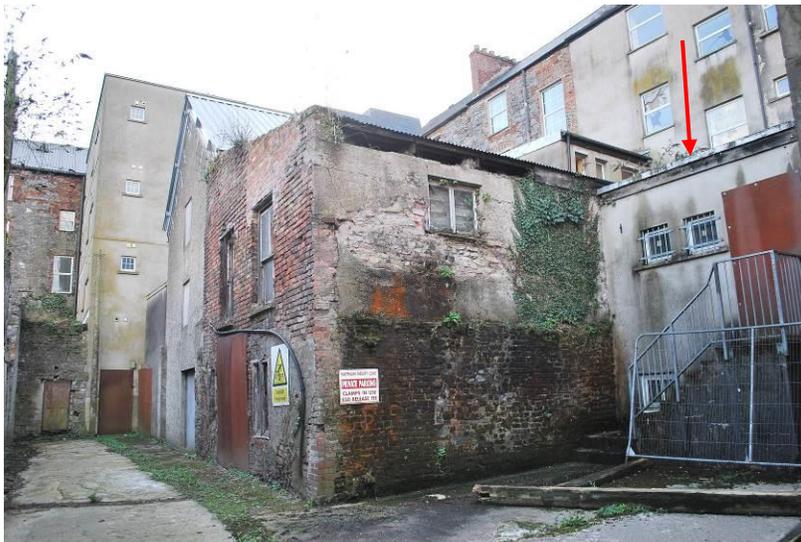
Fig.1: Laneway to rear, with the extended ground floor of 2 Patrick St. indicated.

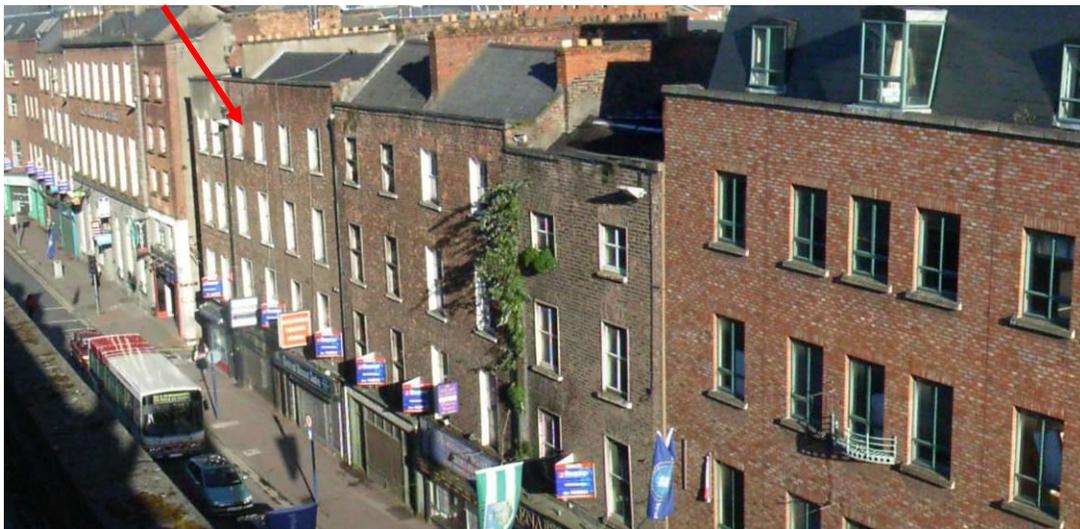
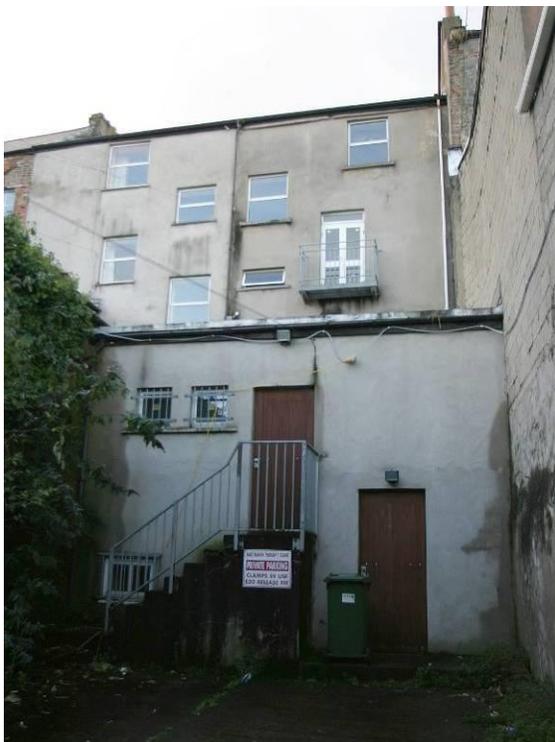
Images showing the front (above) and rear (left) elevations of 2 Patrick Street.

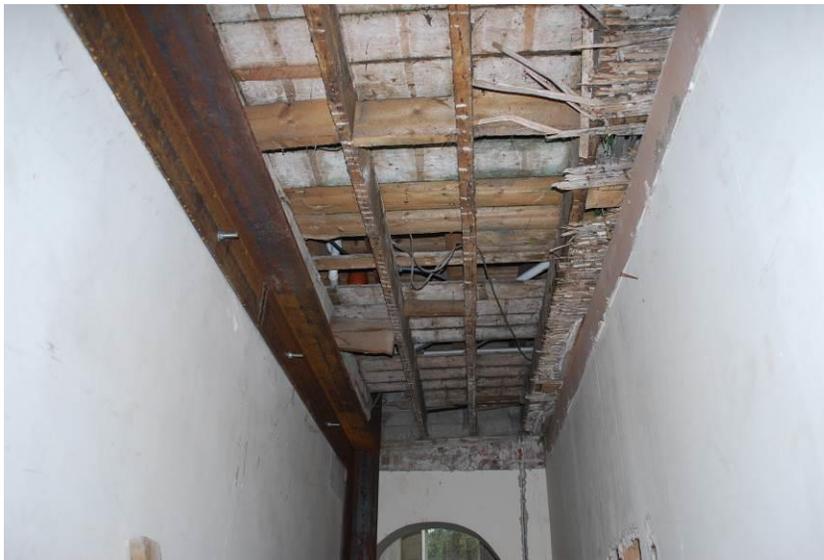
Fig 1: Steel beam inserted at ground floor level and ceiling removed to hall exposing remnants of historic timber floor and lath and plaster retained to this area of the building.

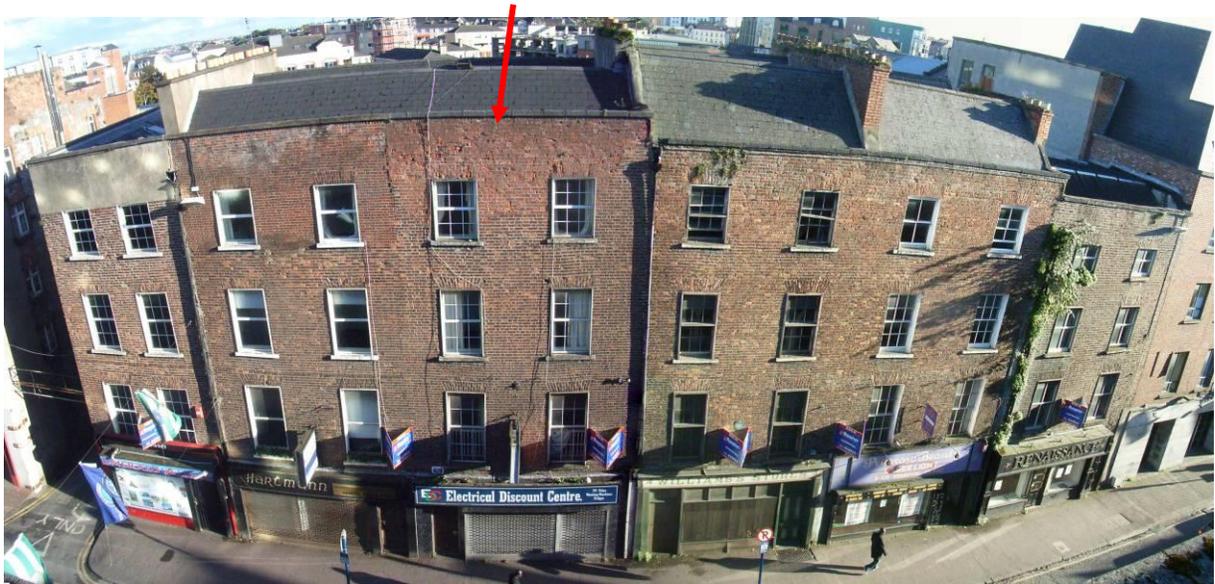
View of this section of Patrick Street (above), with No. 3 indicated, and the building adjoining to the rear, accessed from the laneway (below).

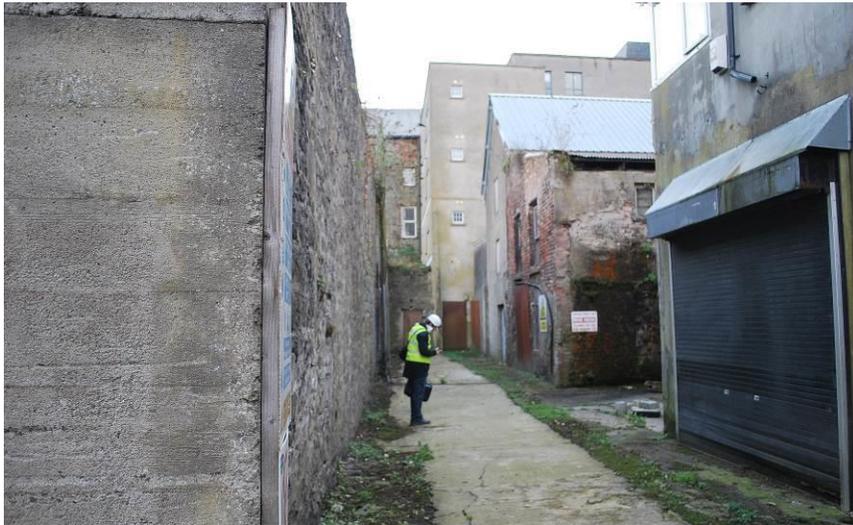
Fig. 1: New corrugated roof to the mews building of 4 Patrick St., as seen from the rear laneway.

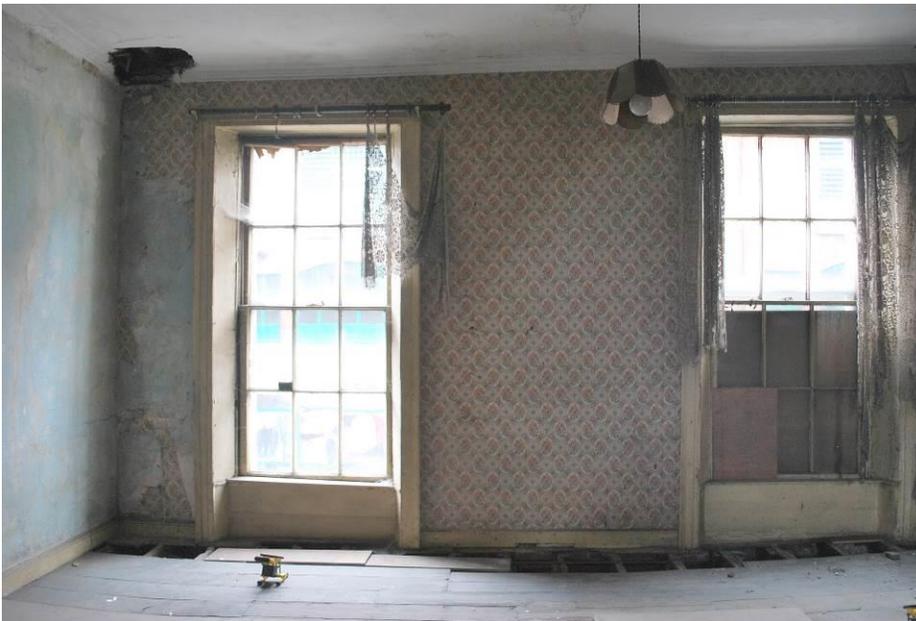
Fig. 5: Front room, first floor.

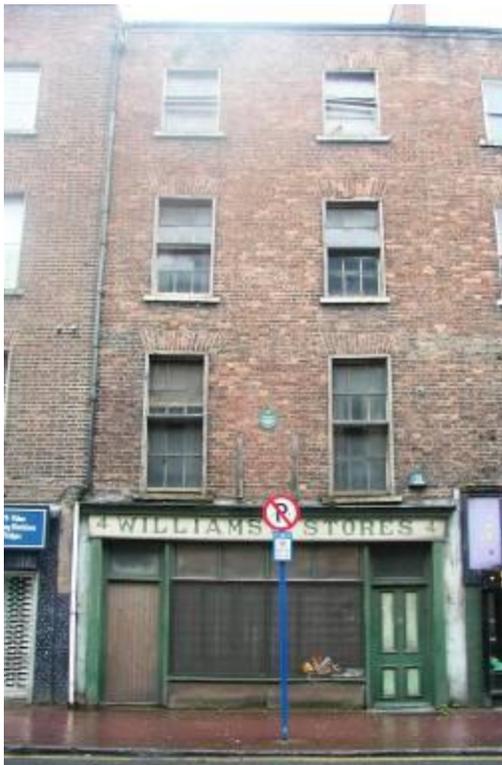
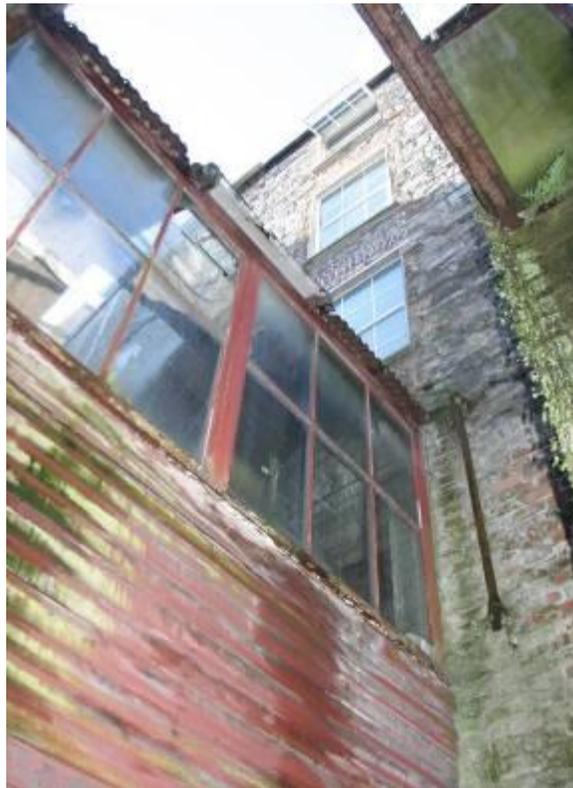
Front elevation of No. 4 (above) and rear elevation, showing glazed link to mews (above left).

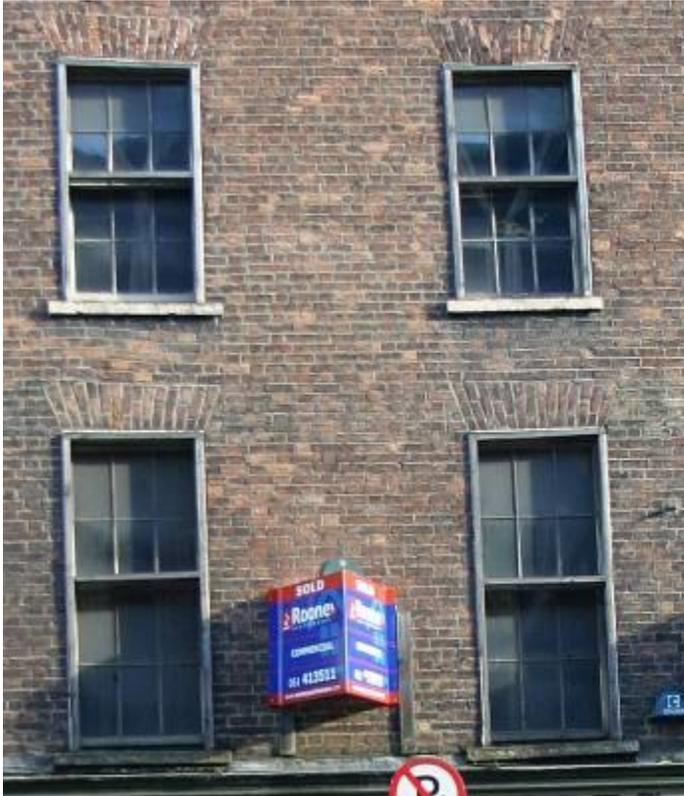
Detail of front elevation showing early timber sash windows (above left) and window to first floor, front room (right).

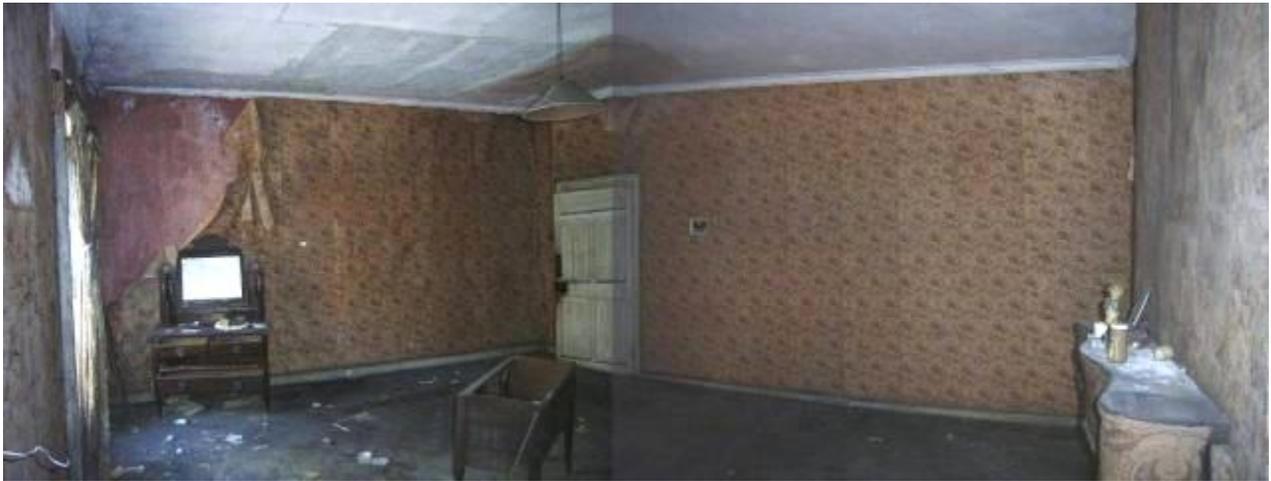
General view of front room 1

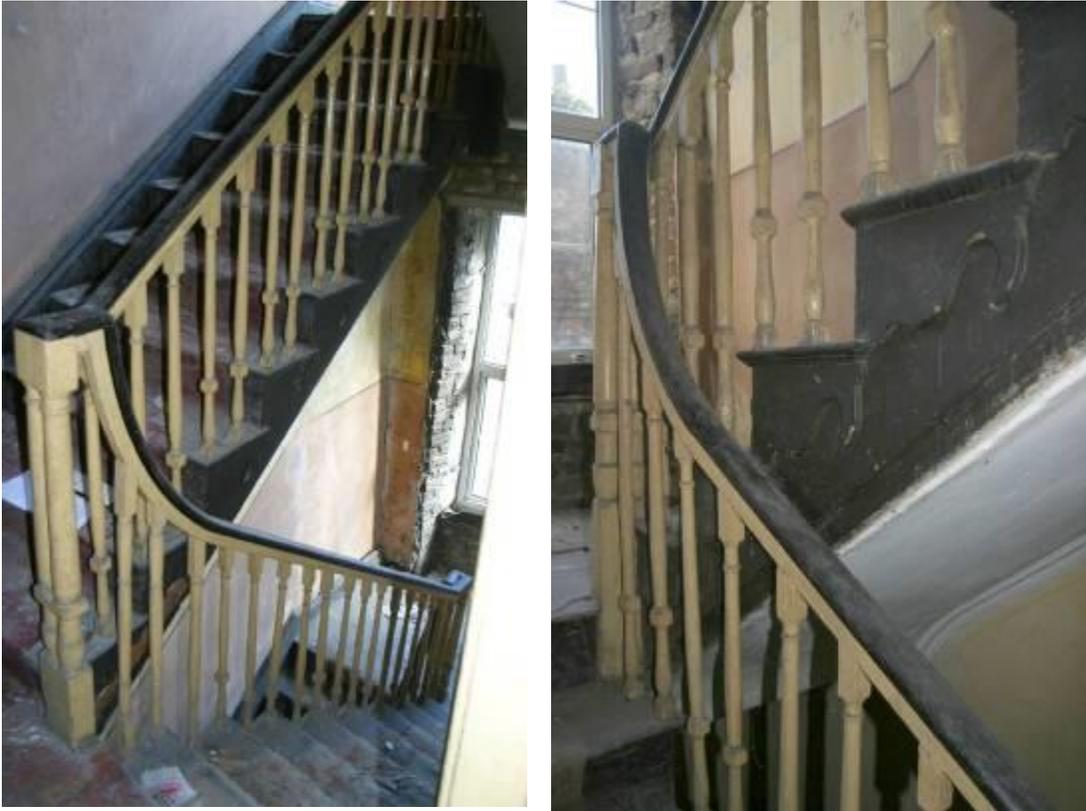
Details of staircase, showing drop handrail, carved tread ends and cornice to soffit.

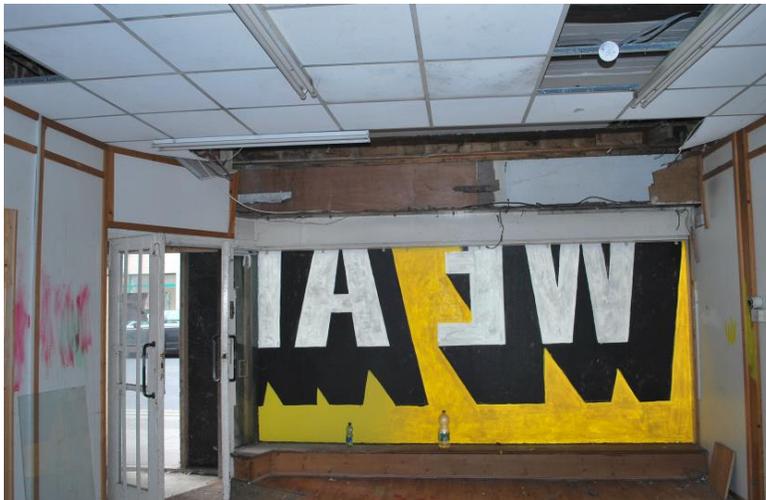
Fig. 1: Ground floor retail unit; sheeted timber ceiling retained above modern ceiling tiles.

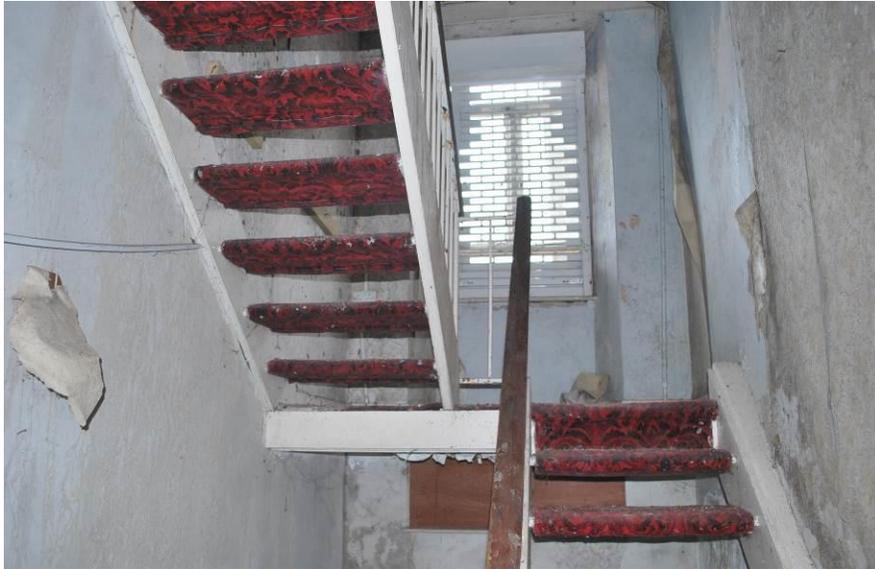
Fig. 3: 20th century replacement staircase.

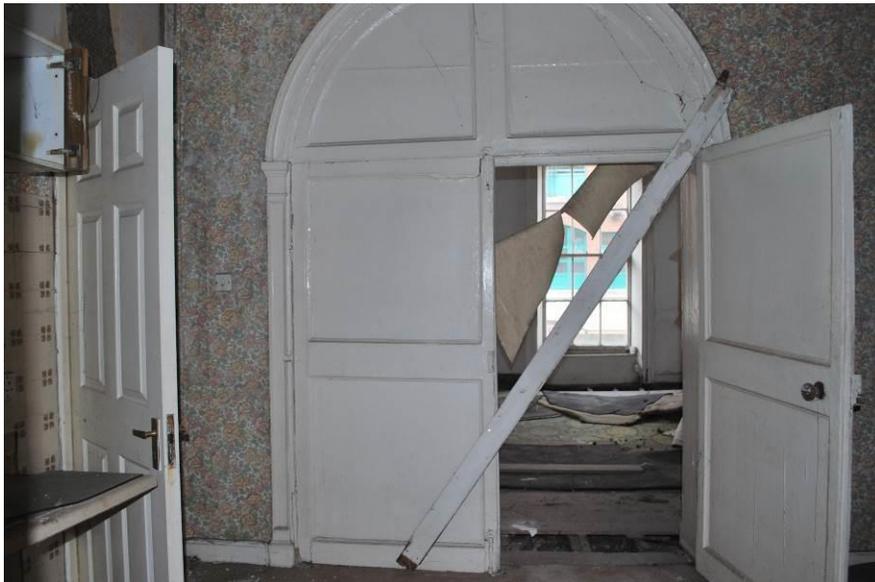
Fig. 4: Original double leaf door in arched opening retained to first floor.

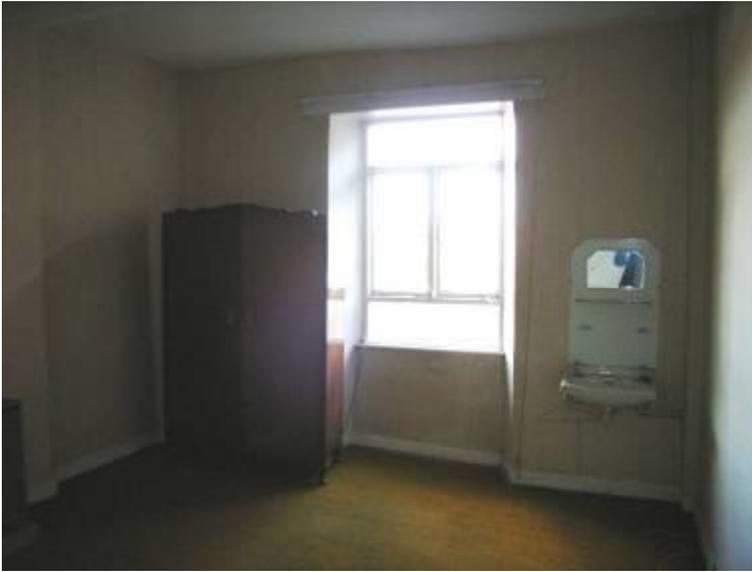
View of rear room, second floor.

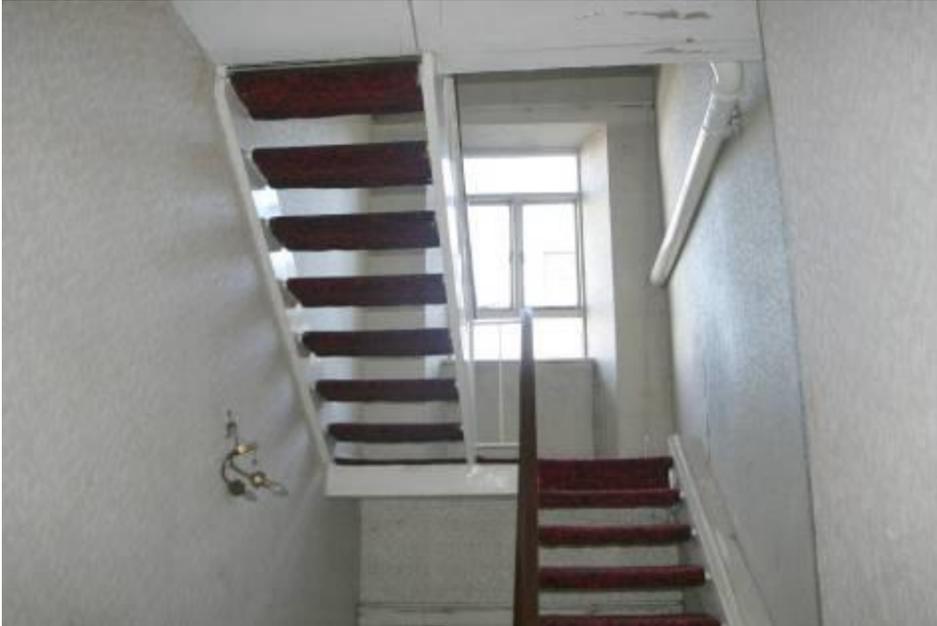
View of replacement staircase.

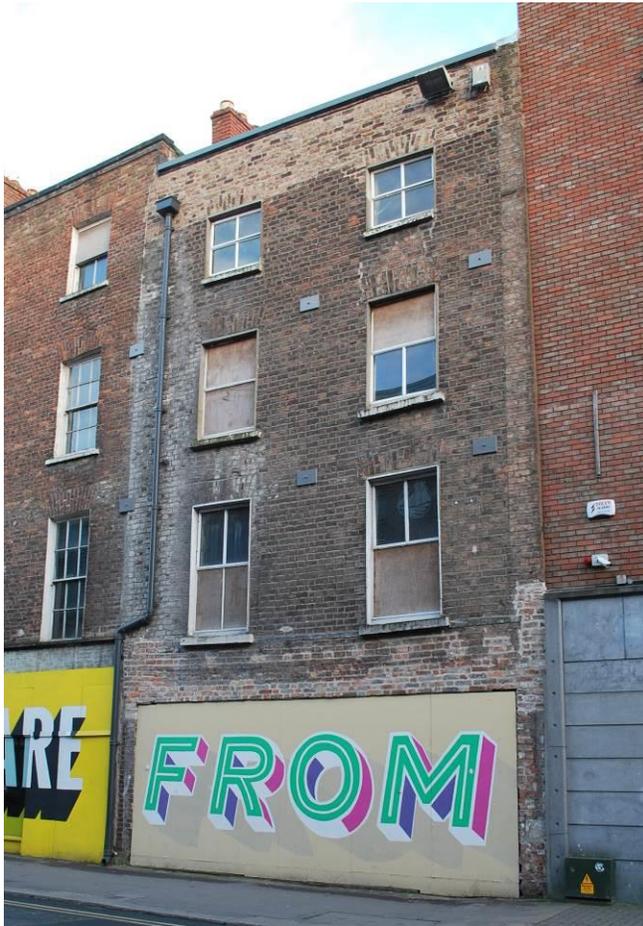
6 Patrick St., Project Opera Site, Limerick

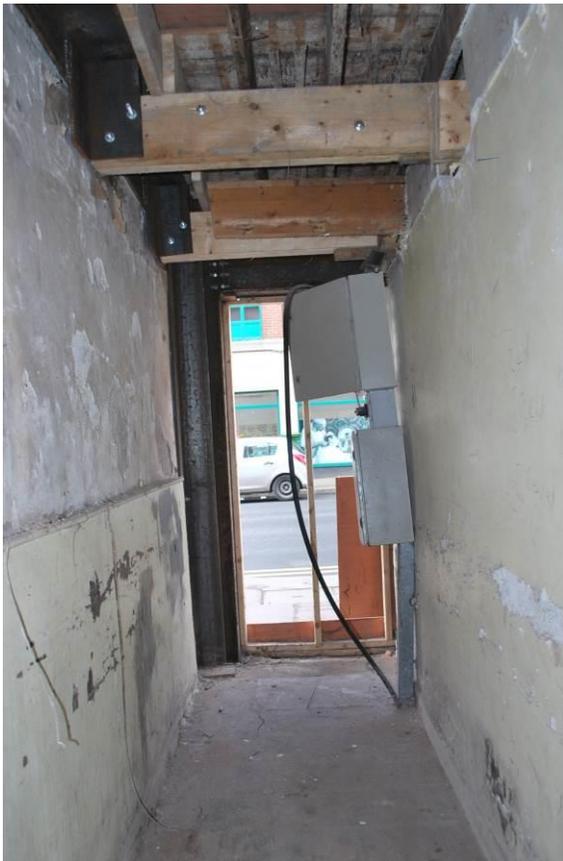
Fig. 1: Entrance hall, remedial works.

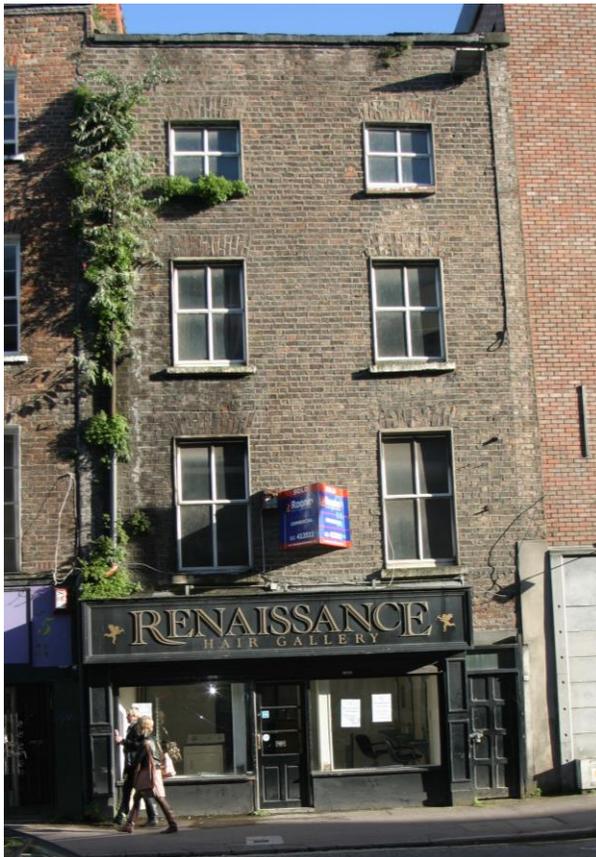
View of front elevation.

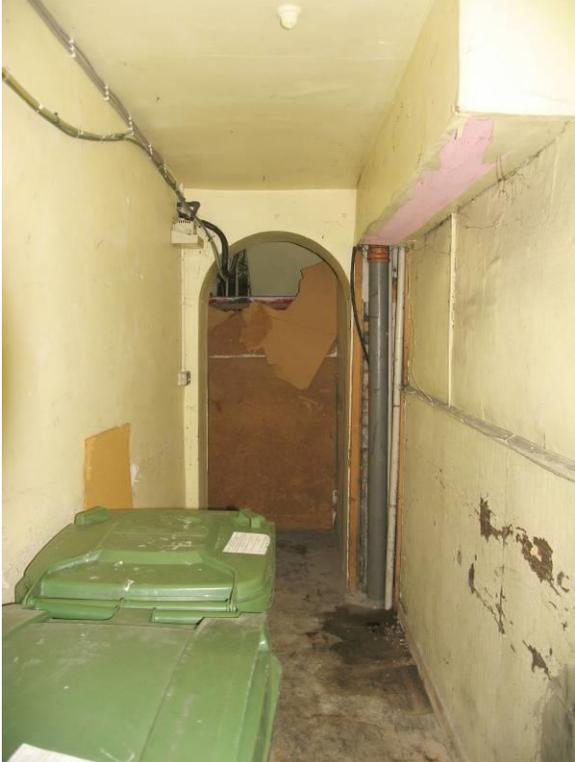
Front hall, towards staircase.

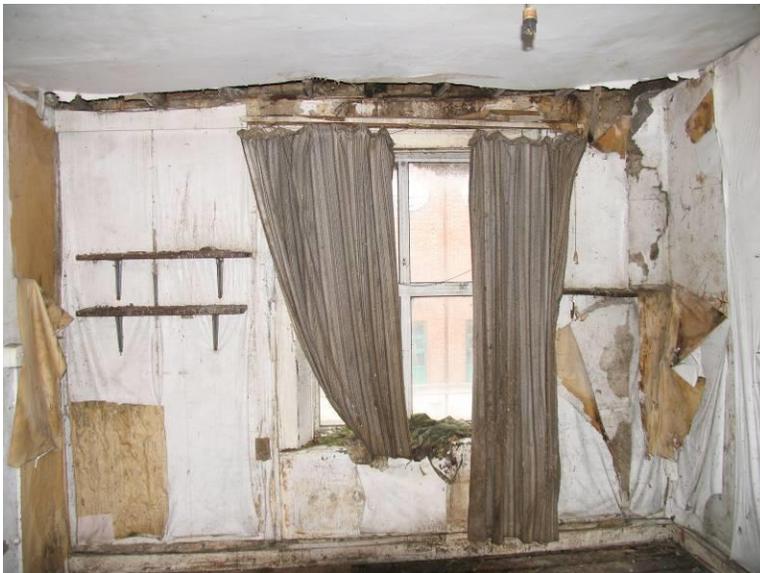
View of main front room (above) and timber panelled doors and architraves leading to the front rooms (right).

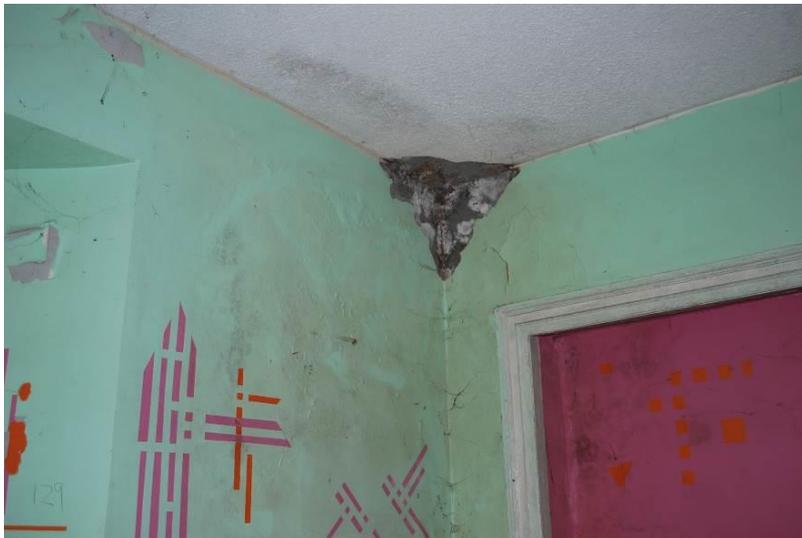
Fig. 1: Outbreak of rot, second floor.

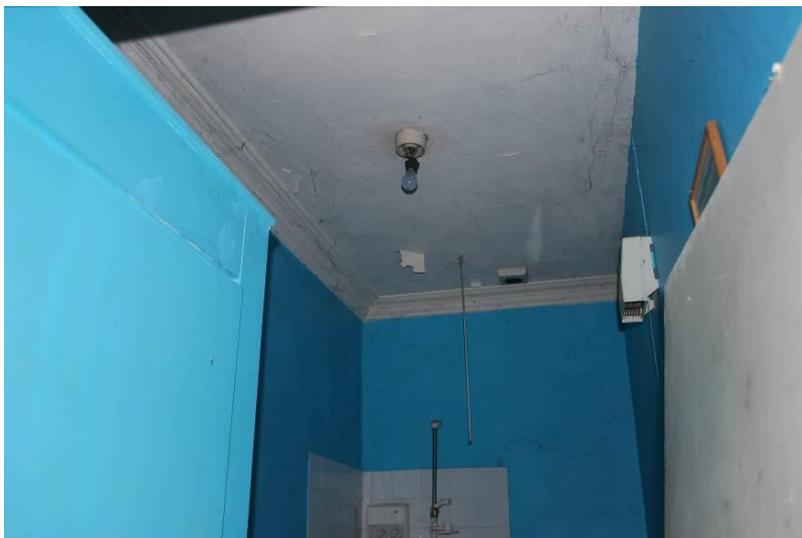
Fig. 2: Section of cornice retained (room subdivided), second floor.

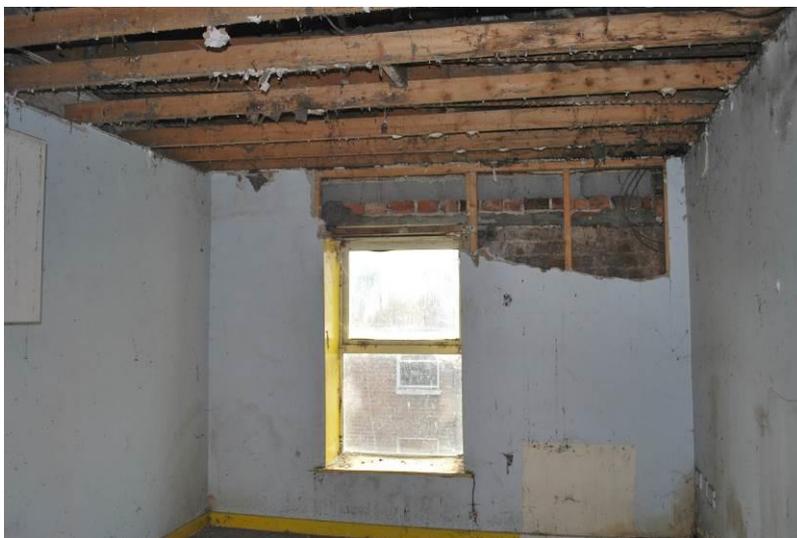
Fig. 4: Front room, third floor, showing repaired parapet.

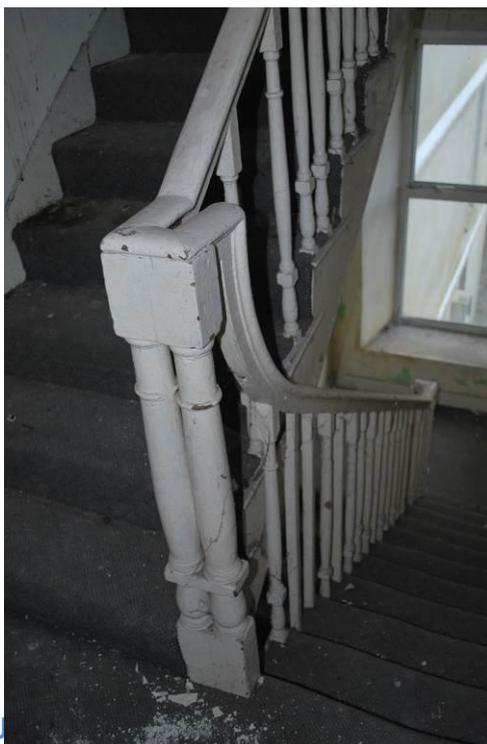
Fig. 5: Second of historic staircase retained to upper floors.

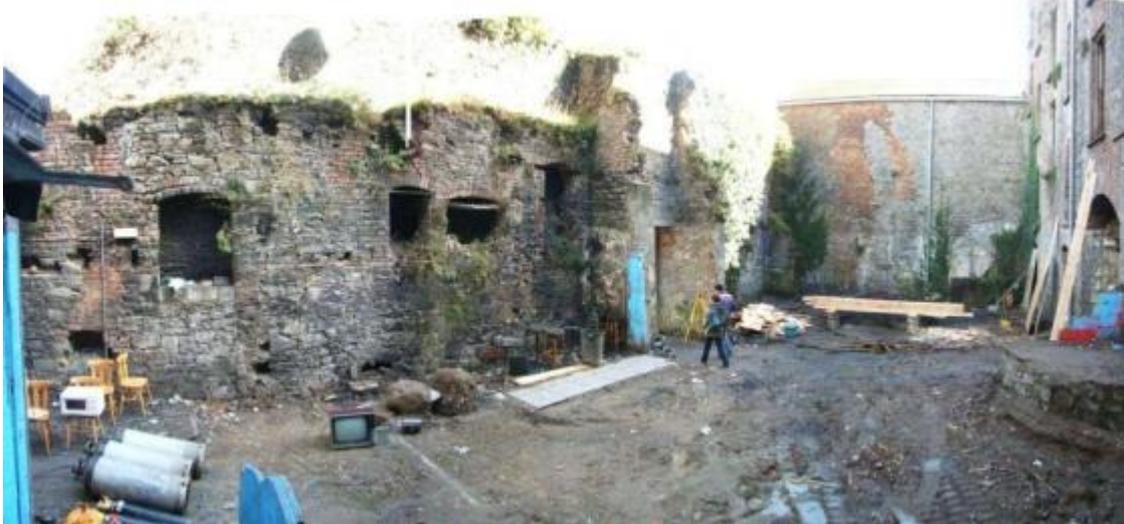
View of the large rear yard to 4 Ellen Street and the adjoining terrace, showing the remains of the large structure to the rear.

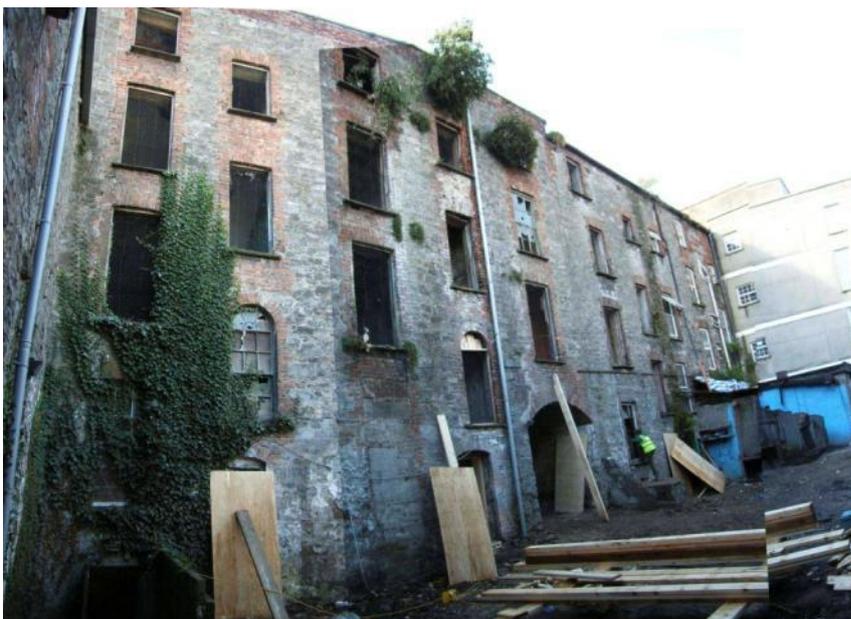
View of the rear of the Ellen Street terrace showing how few windows remains to the rear elevations.

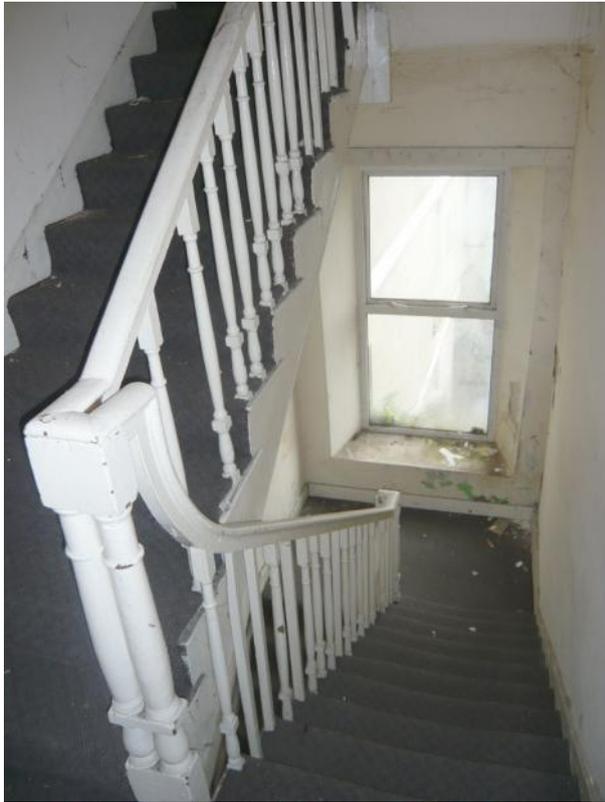
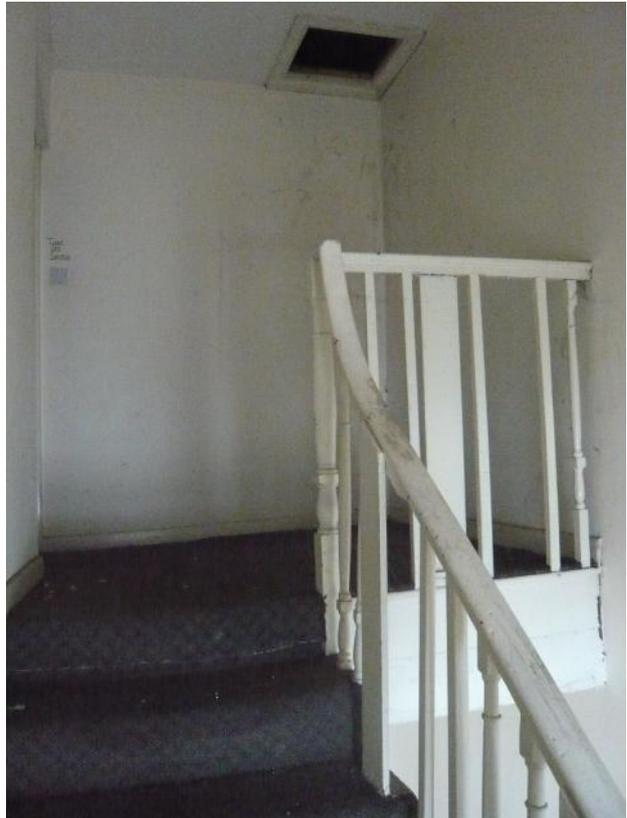
General view of staircase (above left) and view of top landing (above right).

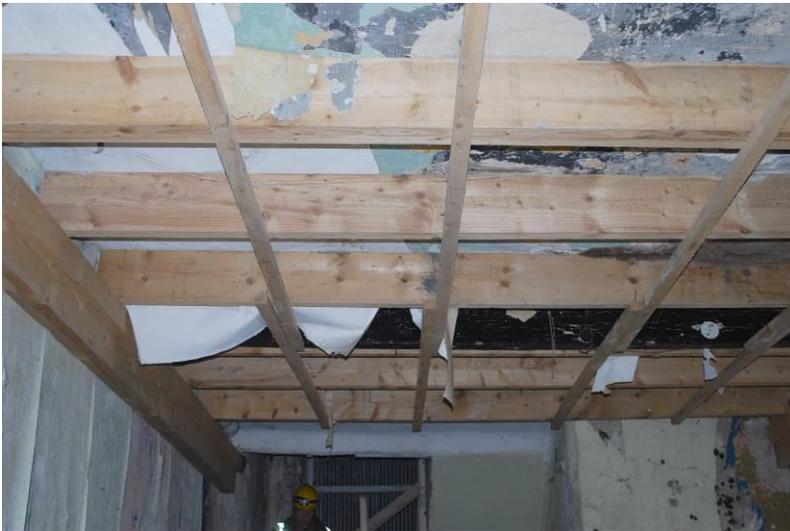
Fig. 1: Works to reinforce floors (ceiling to ground floor).

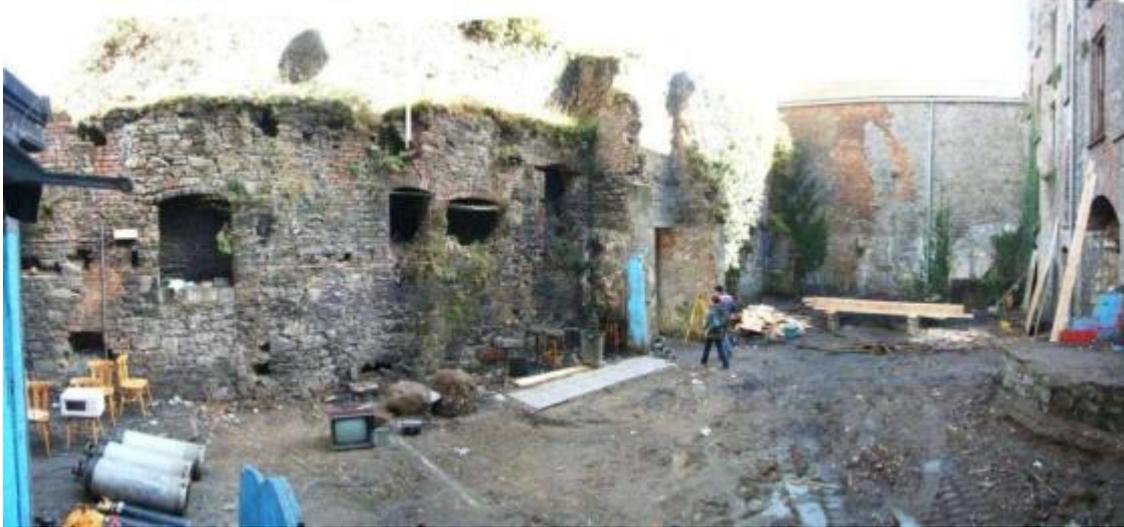
View of the large rear yard to 5 Ellen Street and the adjoining terrace, showing the remains of the large structure to the rear.

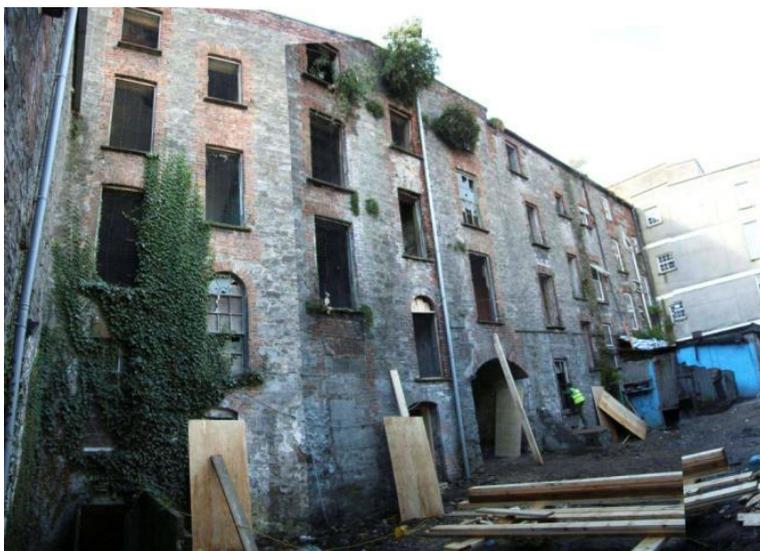
View of the rear of the Ellen Street terrace showing how few windows remains to the rear elevations.

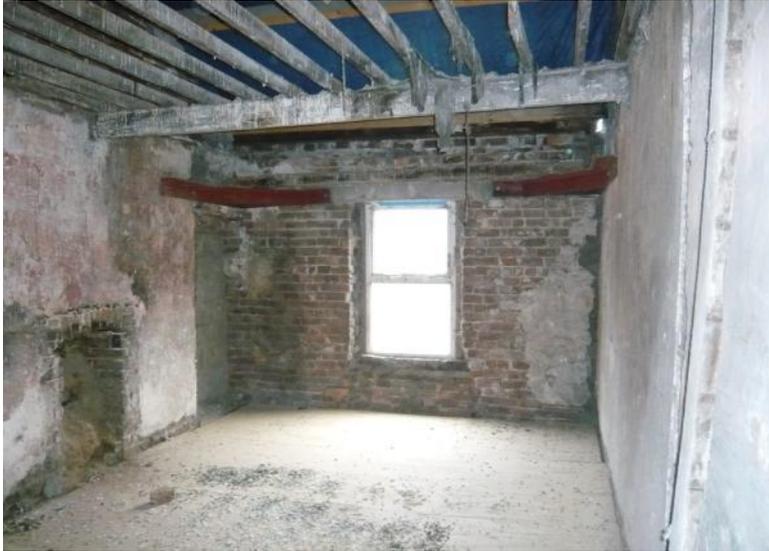
View to the front of the room.

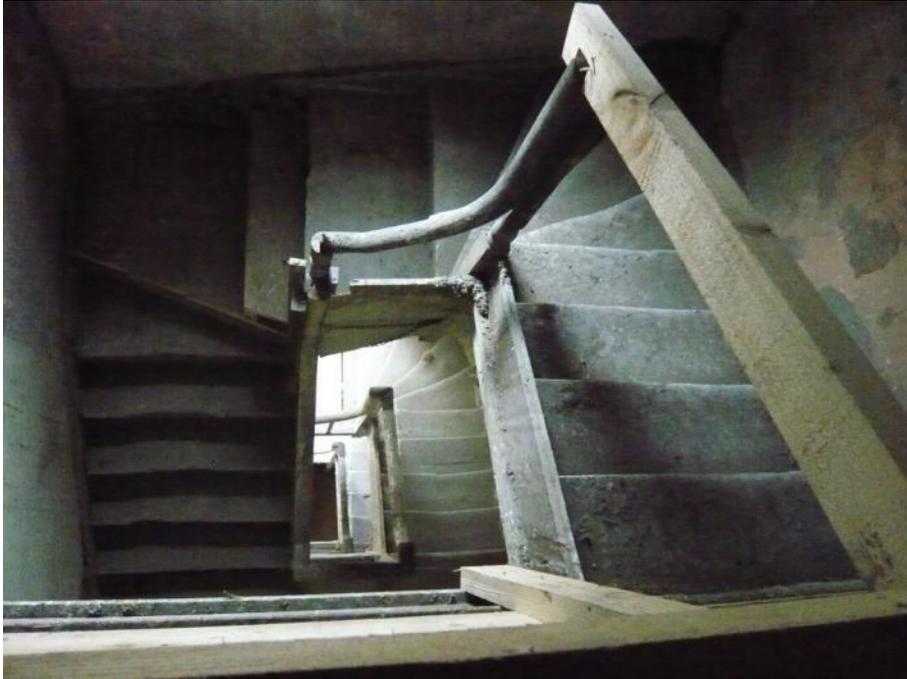
View from top floor of staircase.

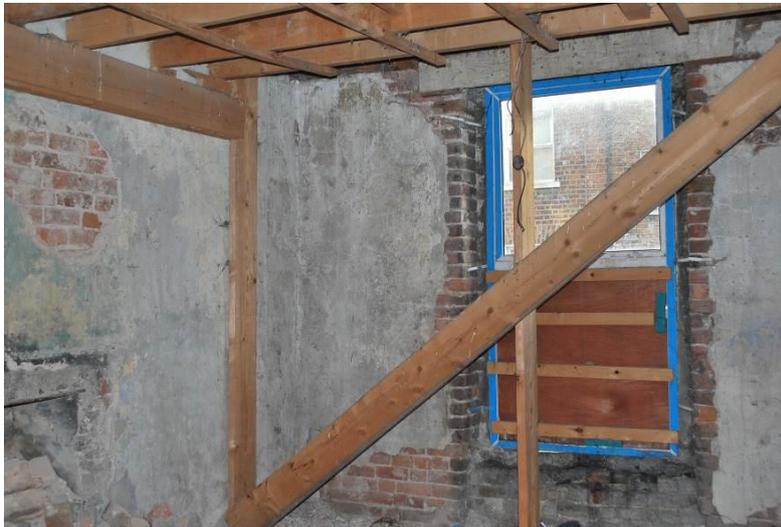
Fig. 1: Temporary structure to prop upper floors, carried out 2007.

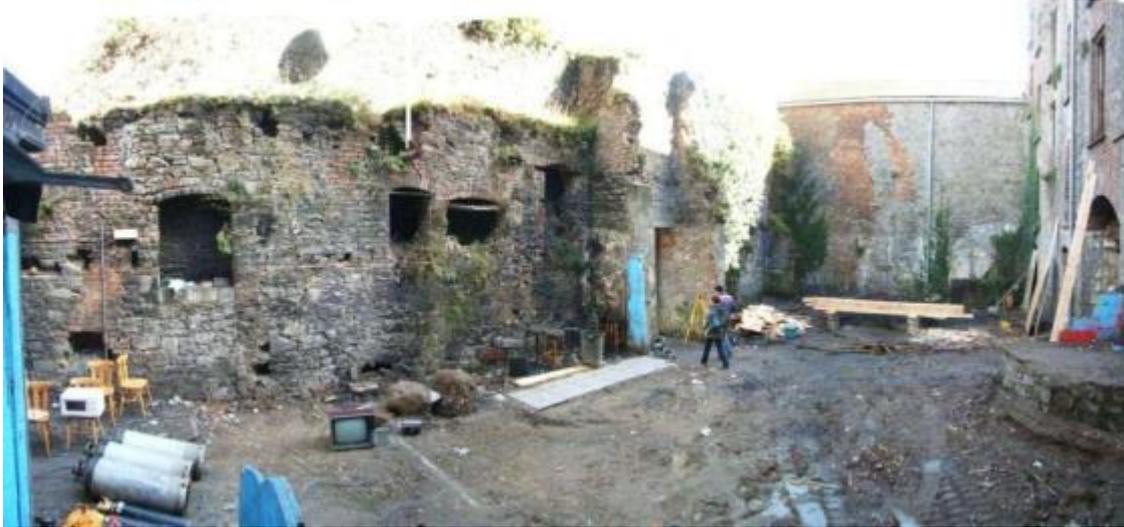
View of the large rear yard to 6 Ellen Street and the adjoining terrace, showing the remains of the large structure to the rear.

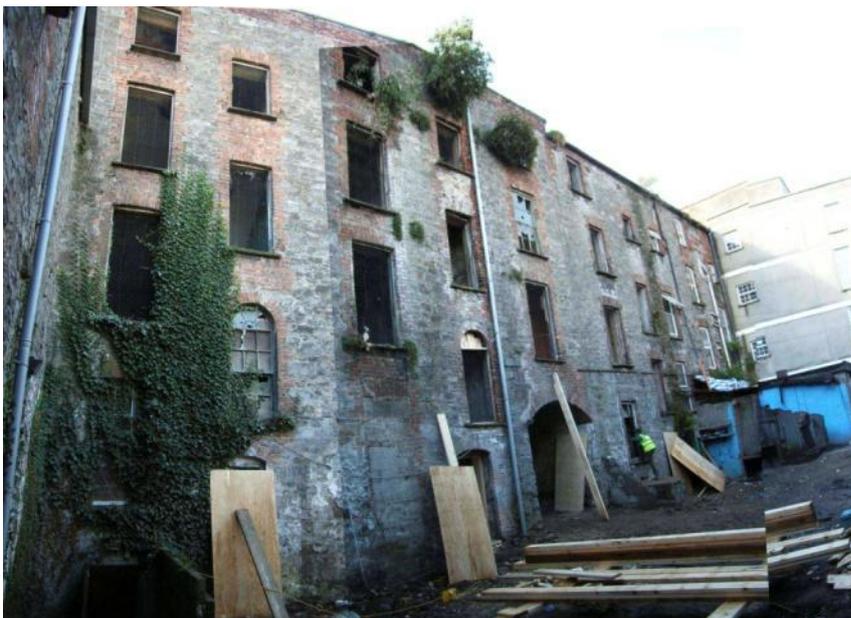
View of the rear of the Ellen Street terrace showing how few windows remains to the rear elevations.

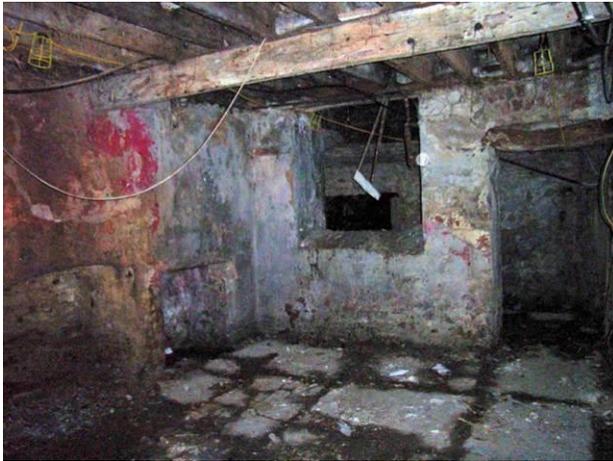
The front room of the basement.
