**Opera Site: Bank Place, Rutland St., Patrick St., Ellen St.
and Michael St., Limerick.**

Existing Building Individual Records.

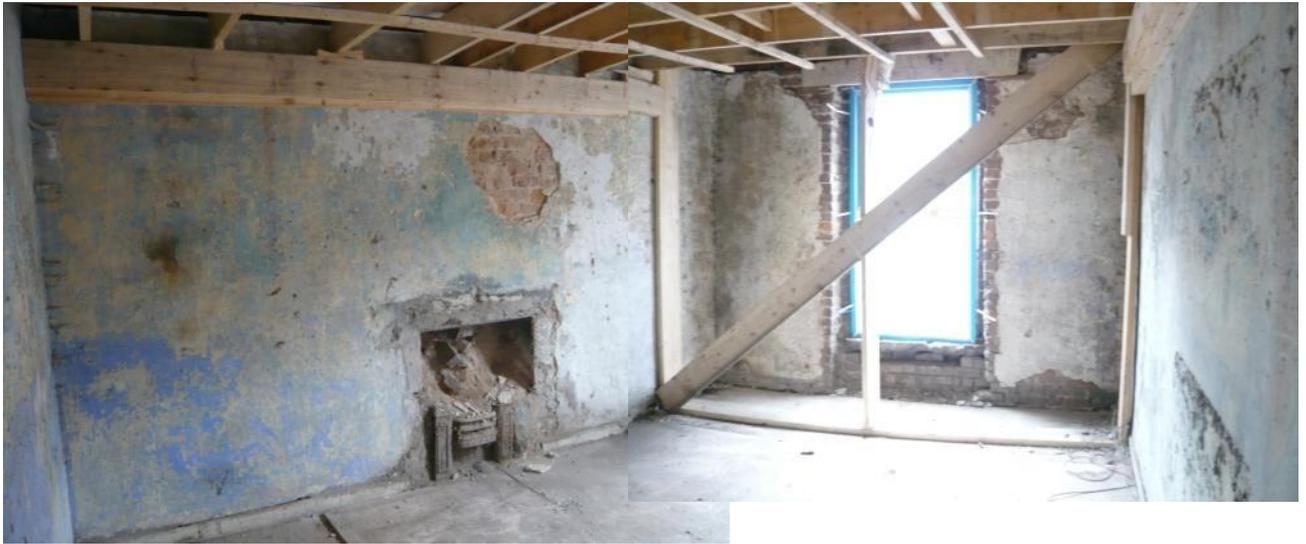
- Ceiling: Lath and plaster ceiling in poor condition.
- Floor: Timber boards to floor.
- Walls: Plastered and painted walls. Some plaster missing.
- Joinery: Door removed but architrave retained. Window architrave removed.
- Fireplace: Fireplace but fire surround removed. Cast iron raised hob grate retained.

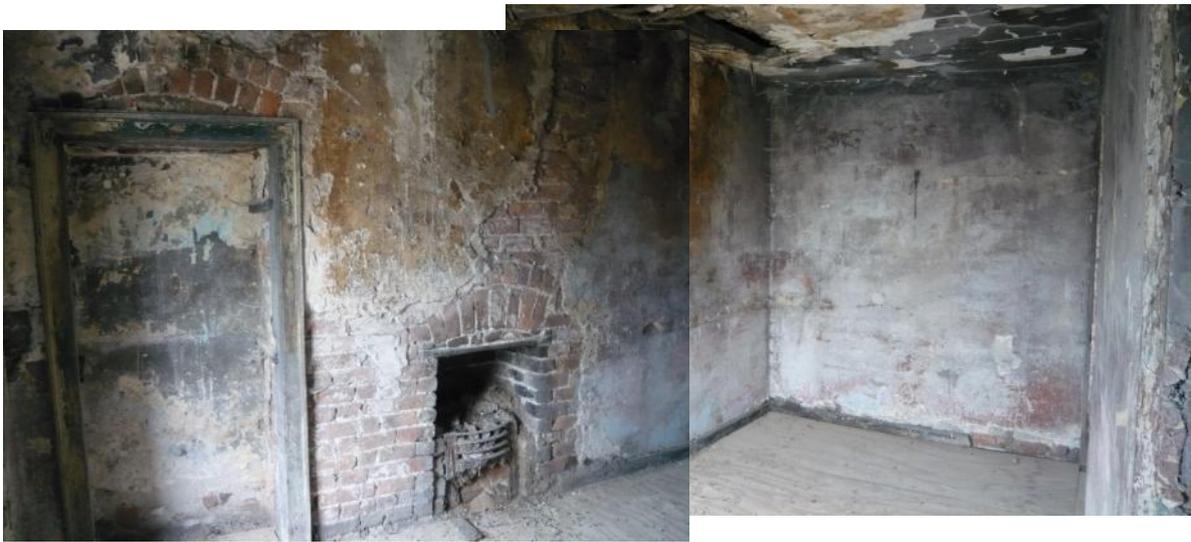
View of rear room, showing fireplace.

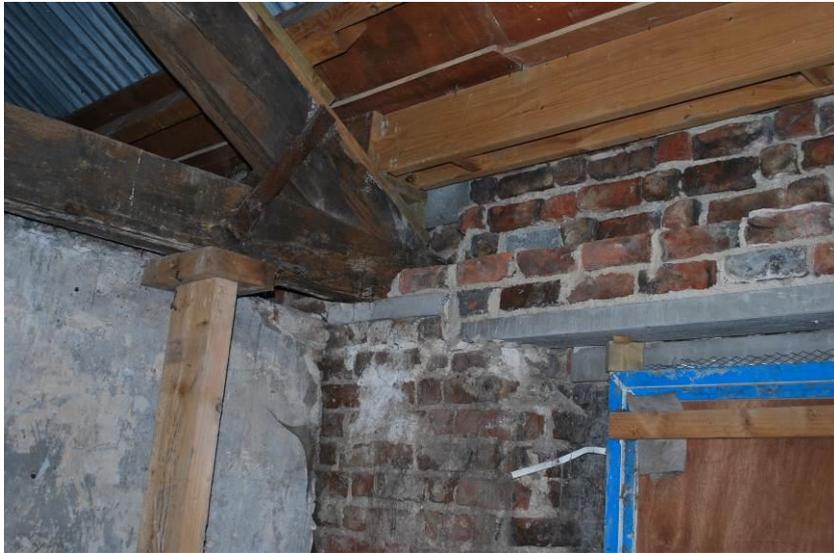
Fig. 1: Parapet rebuilt, new window head. Second floor, front façade.

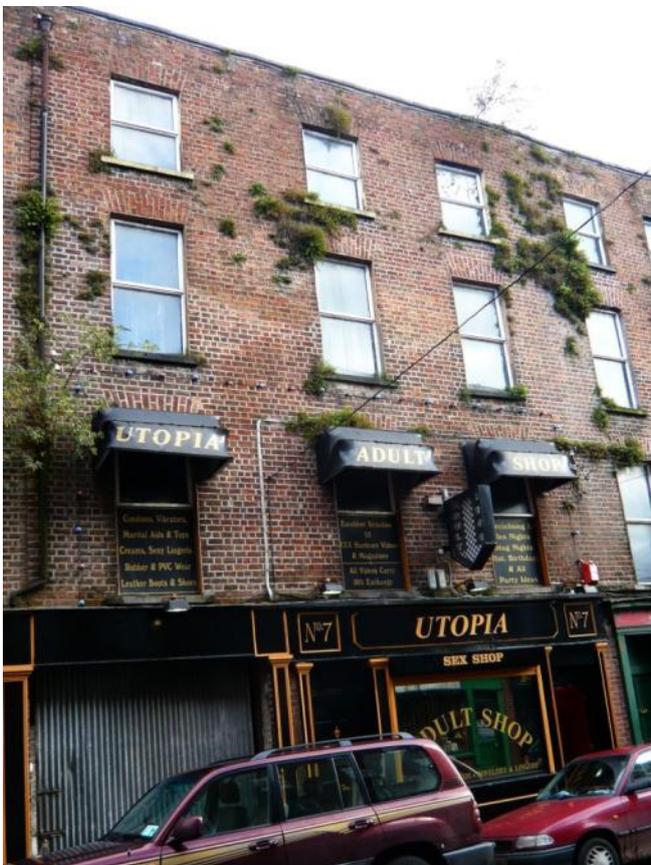
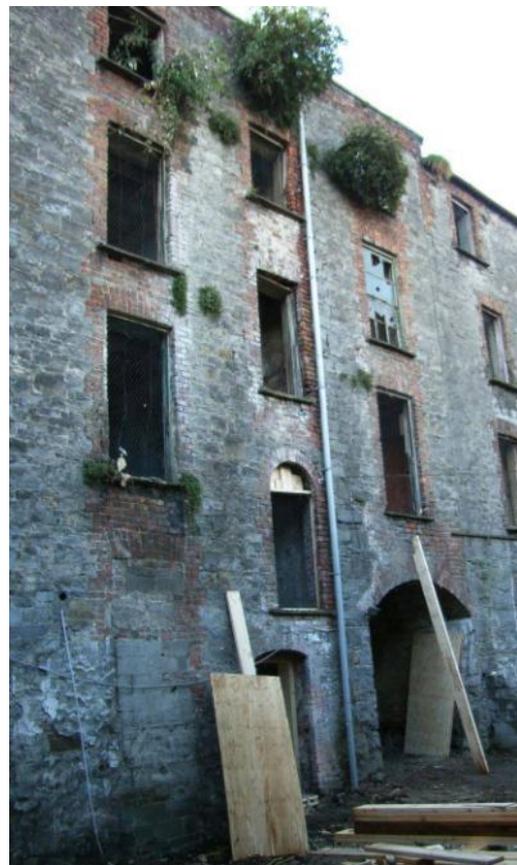
Views of the front and rear elevations of 7 Ellen Street.

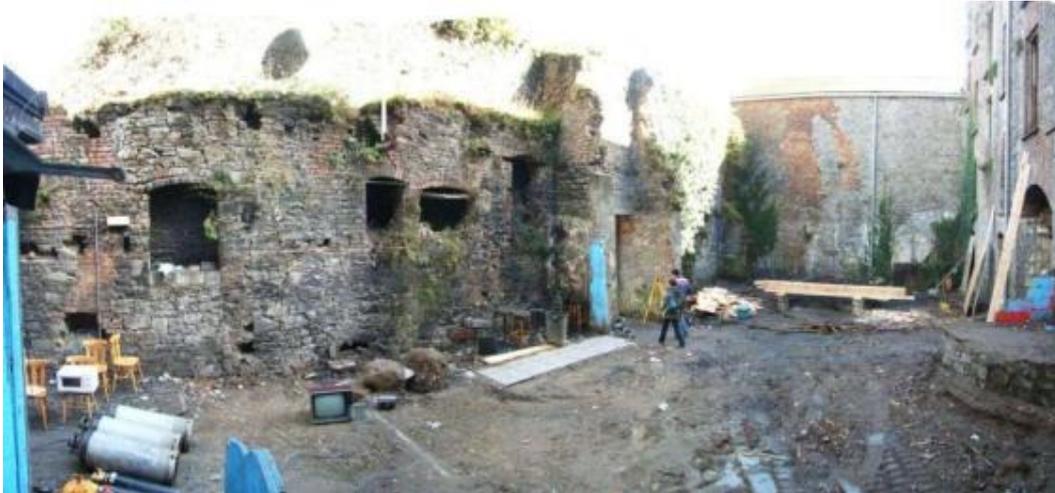
View of the large rear yard to 8 Ellen Street and the adjoining terrace, showing the remains of the large structure to the rear.

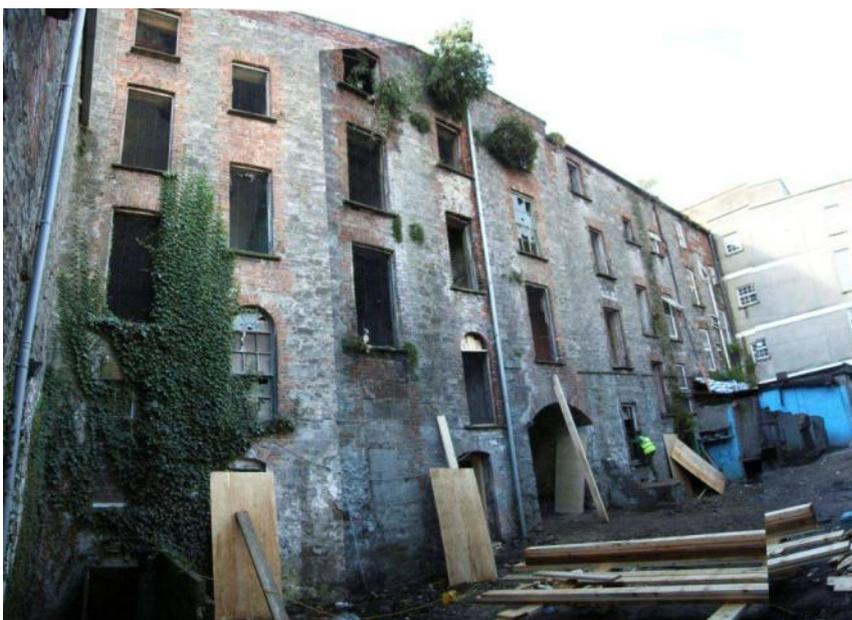
View of the rear of the Ellen Street terrace, showing how few windows remain.

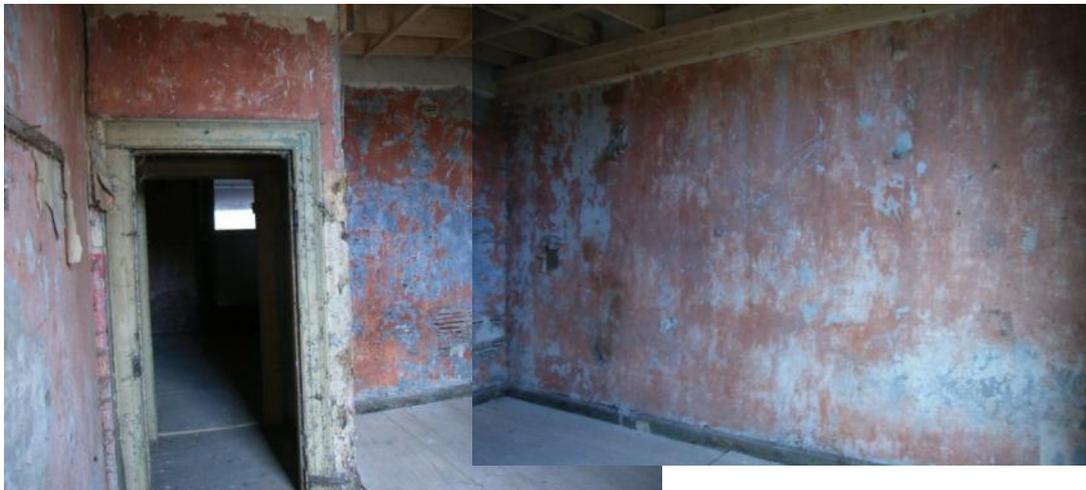
General view of rear room.

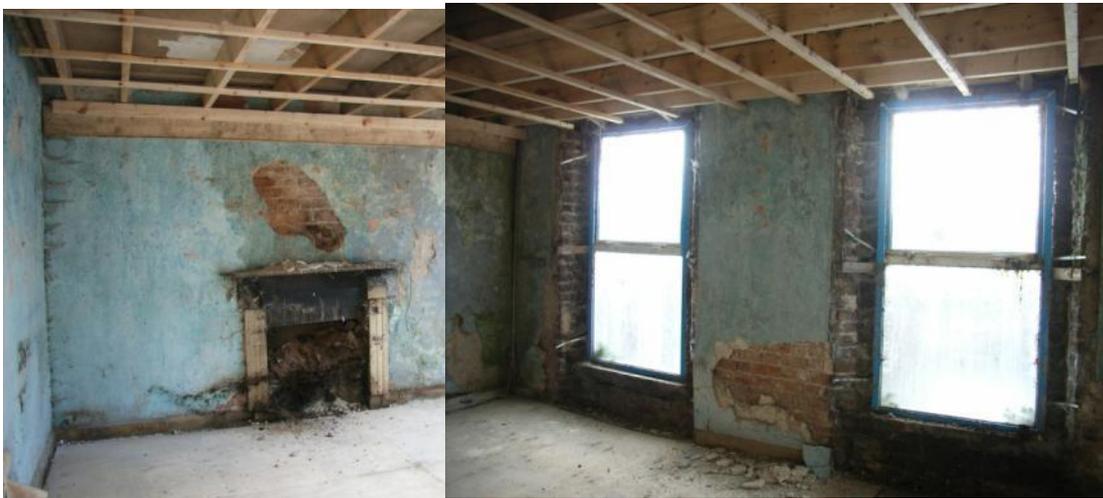
General view of front room.

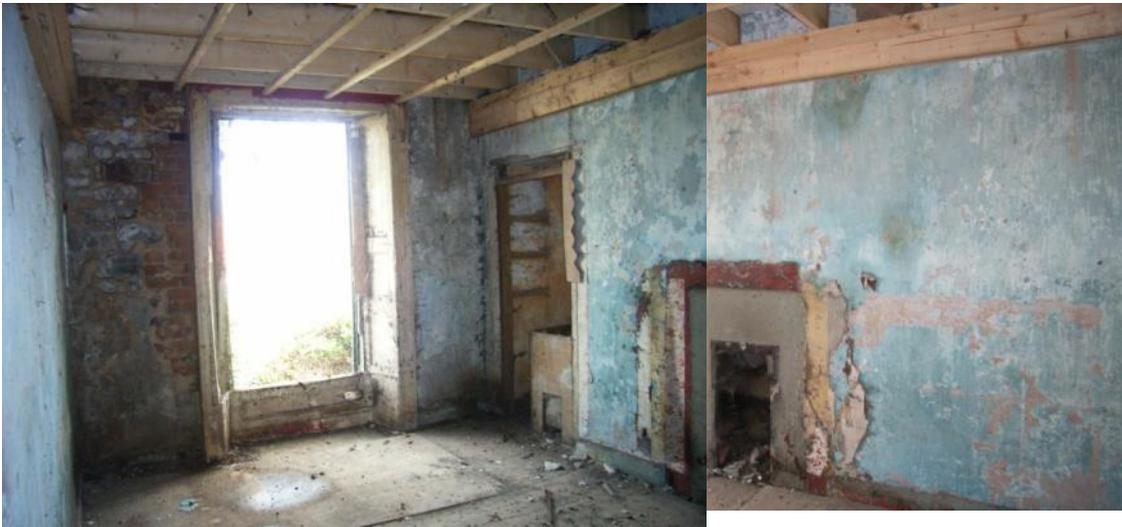
General view of the rear room, showing mural cupboard and window architrave.

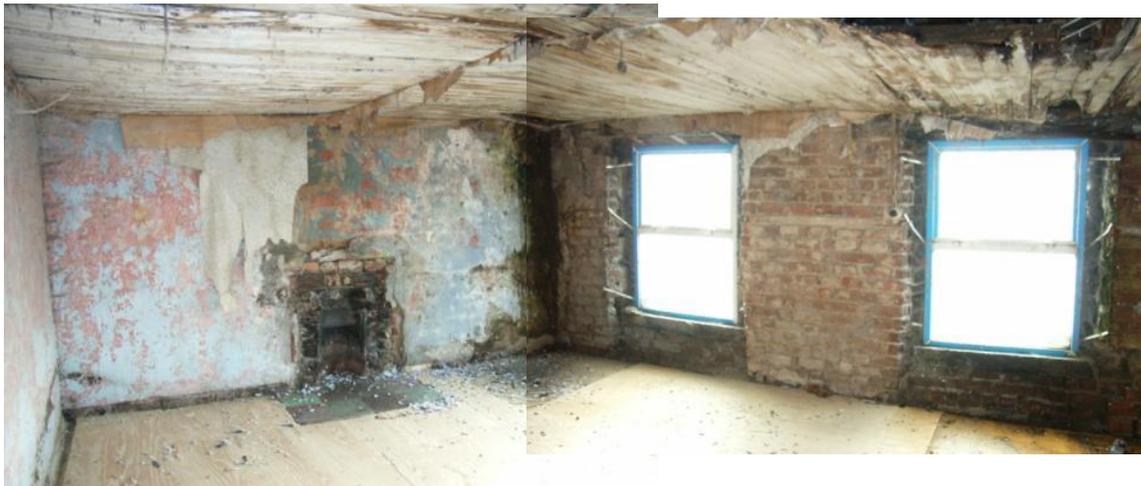
General view of the larger front room.

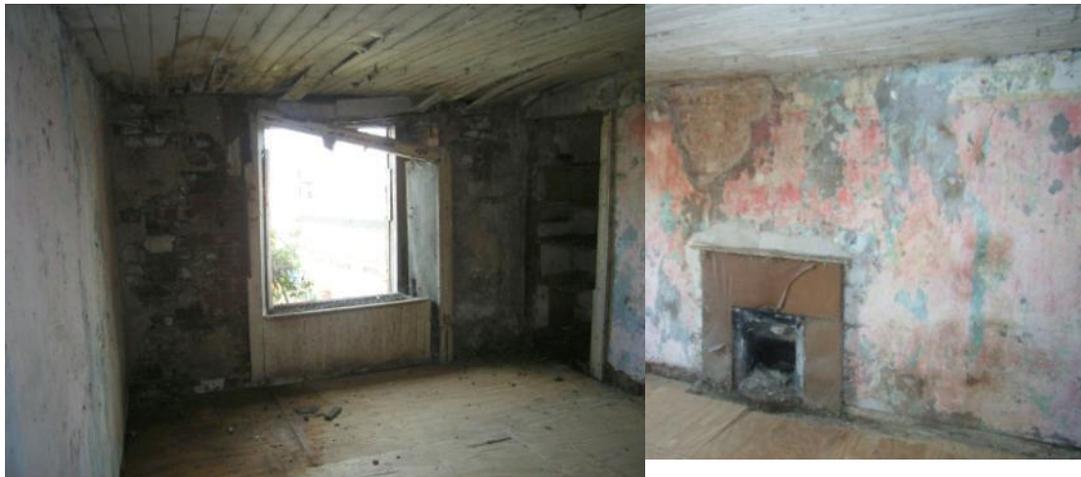
General view of the rear room, showing mural cupboard and window architrave.

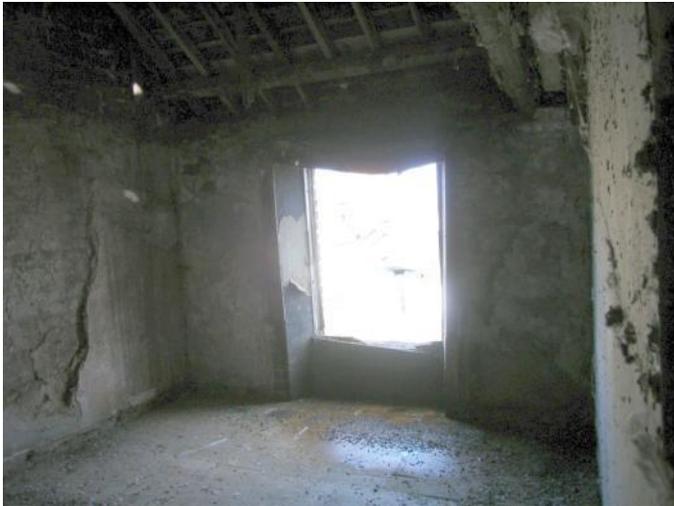
- Ceiling: Ceiling completely removed.
- Floor: Timber boards to floor.
- Walls: Walls plastered and painted but areas of plaster missing.
- Joinery: Some areas of skirting intact. Part of window architrave retained. The doors have been removed. The moulded door architraves to the door opening is retained.
- Fireplace: No fireplace.

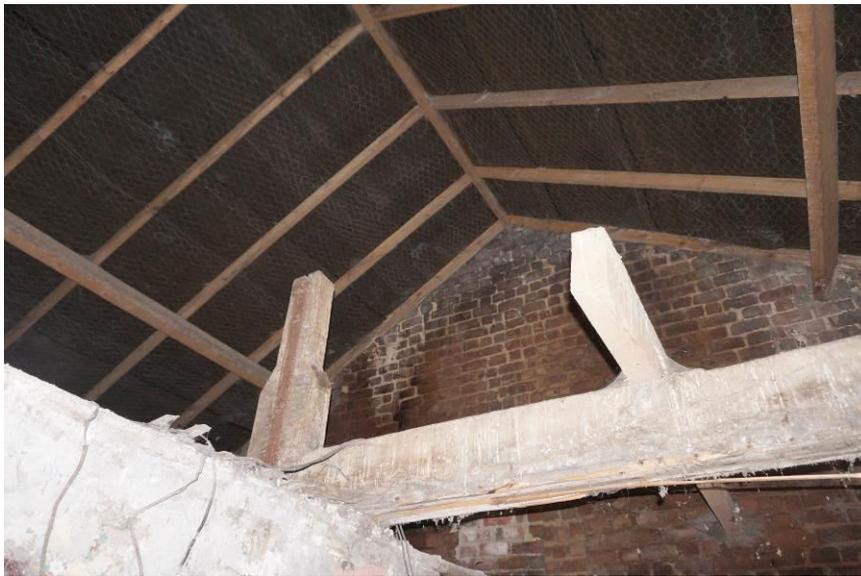
This building is particularly intact and retains interior architectural details such as staircase, architraves, fire places and plasterwork. (Figs. 4&5) While this building retains a basement, the majority of this basement area is inaccessible, and forms part of an extended basement and cellar area for No. 9 Ellen St.

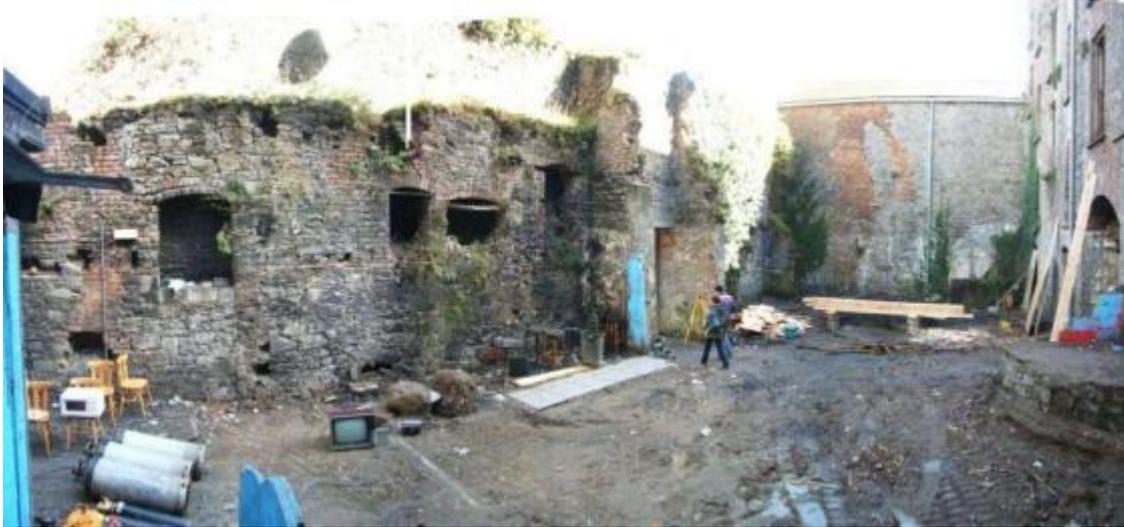
View of the large rear yard to 8 Ellen Street and the adjoining terrace, showing the remains of the large structure to the rear.

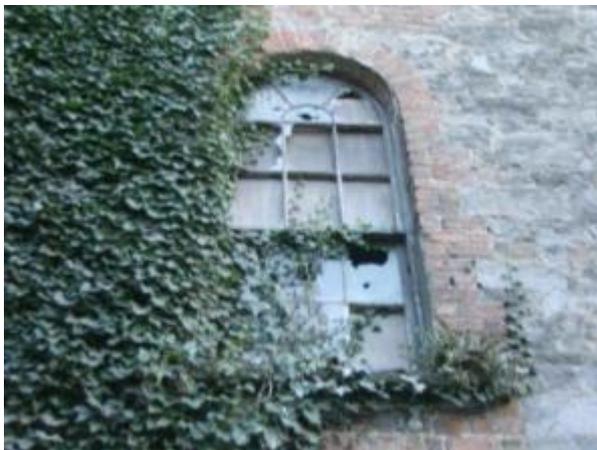
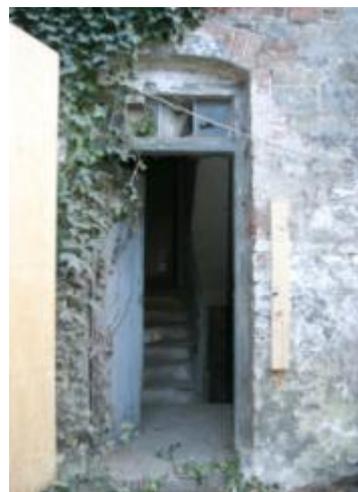
Round headed window retained to the rear elevation and door with overlight to ground floor.

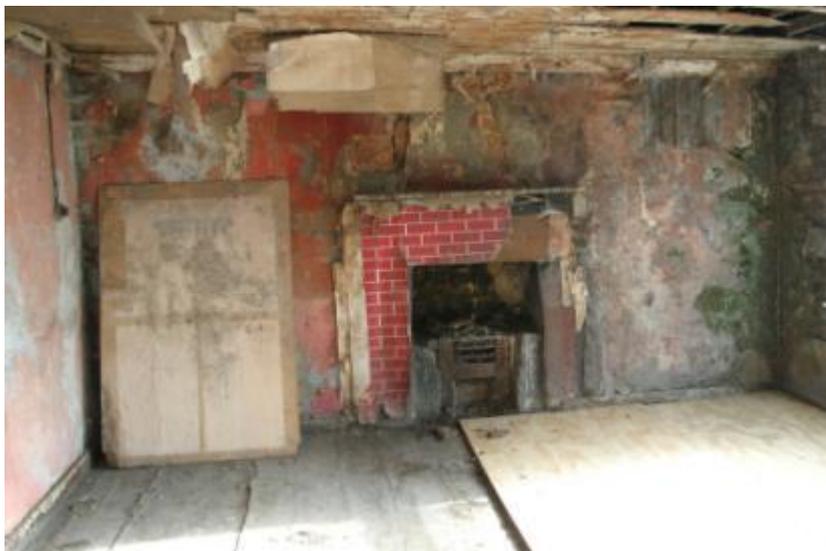
View of front room showing fireplace and hearth.

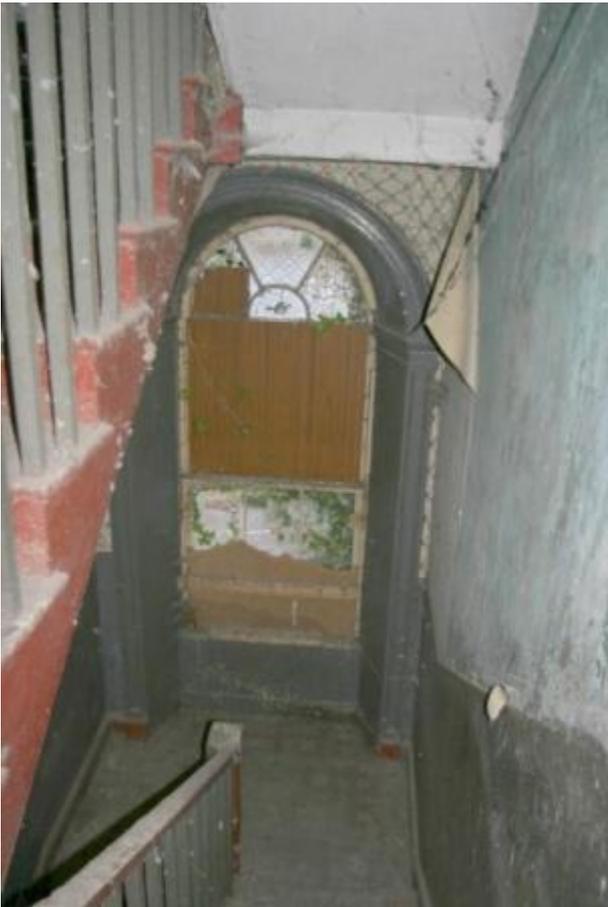
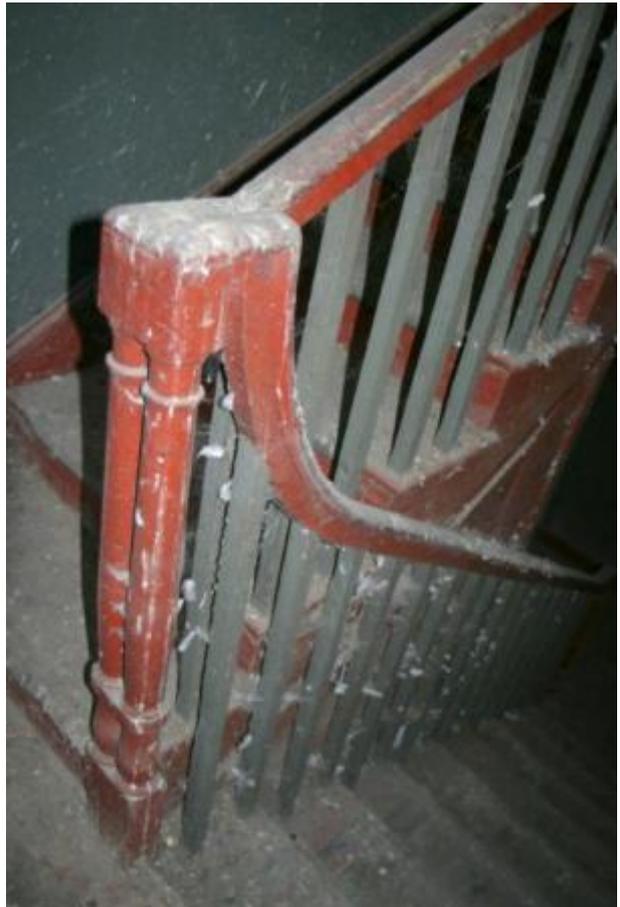
View of the round headed window between the ground and first floor (above left) and a detail of the balustrade showing the dropped handrail (above right).

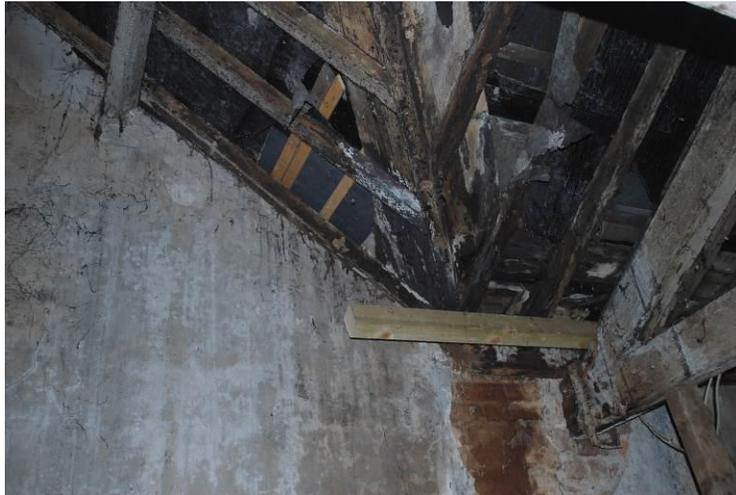
Fig. 1: Water ingress, top floor.

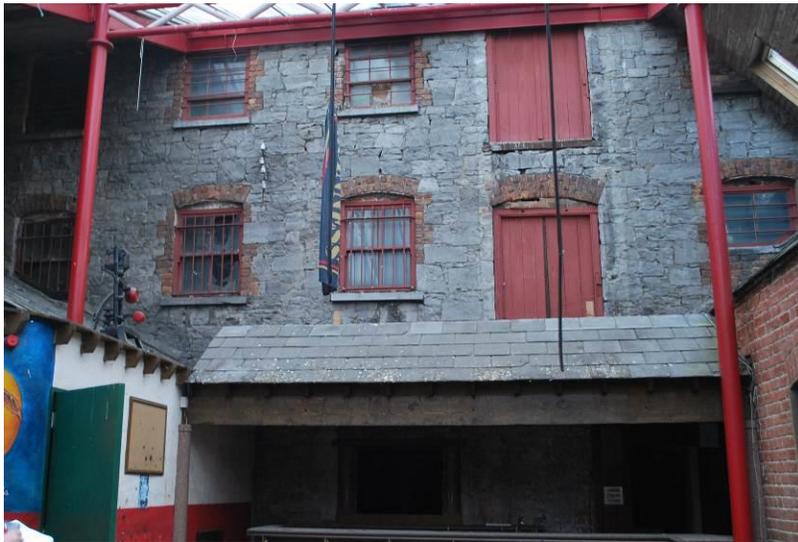
Fig. 4: Timber sash windows.

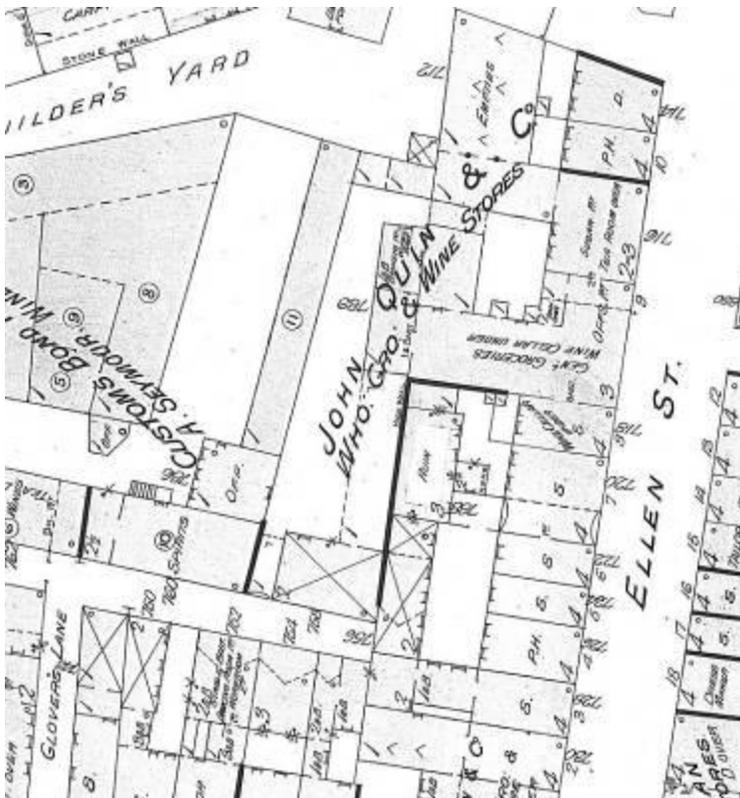
Detail from Goad Fire Insurance Plan of 1897.

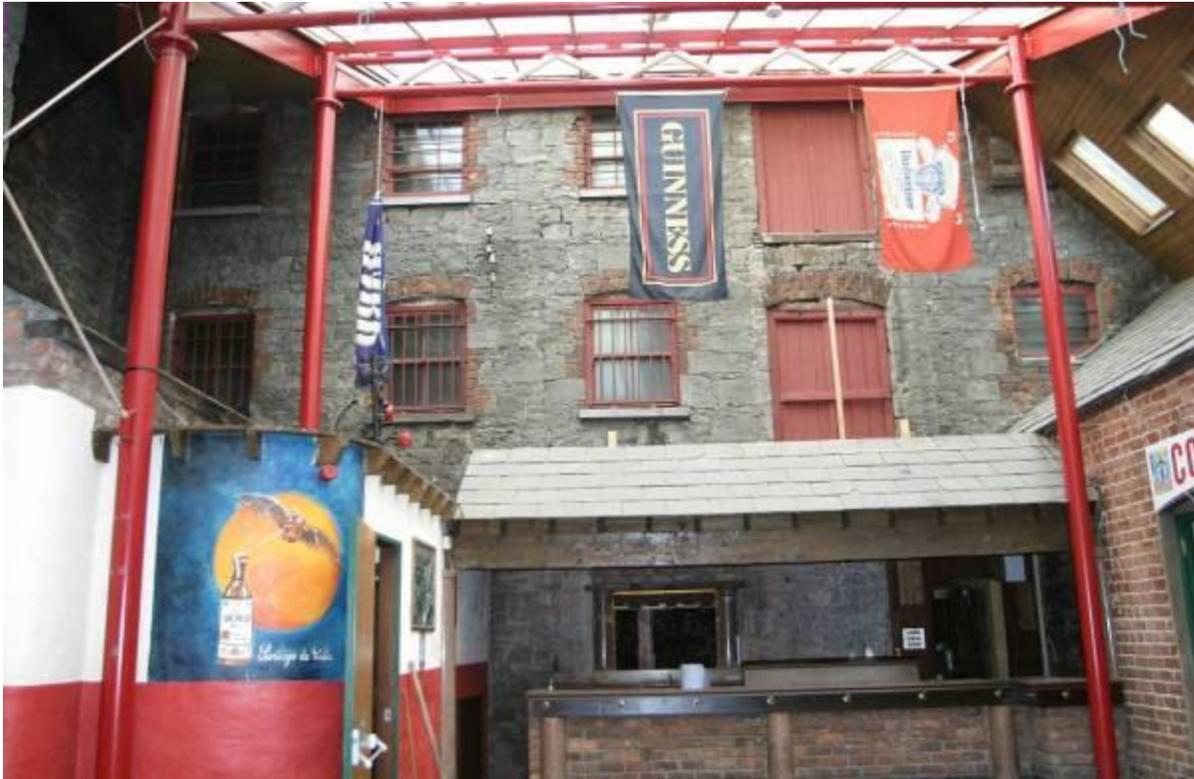
View of courtyard, showing the timber sash windows and sheeted timber doors of the larger warehouse building.

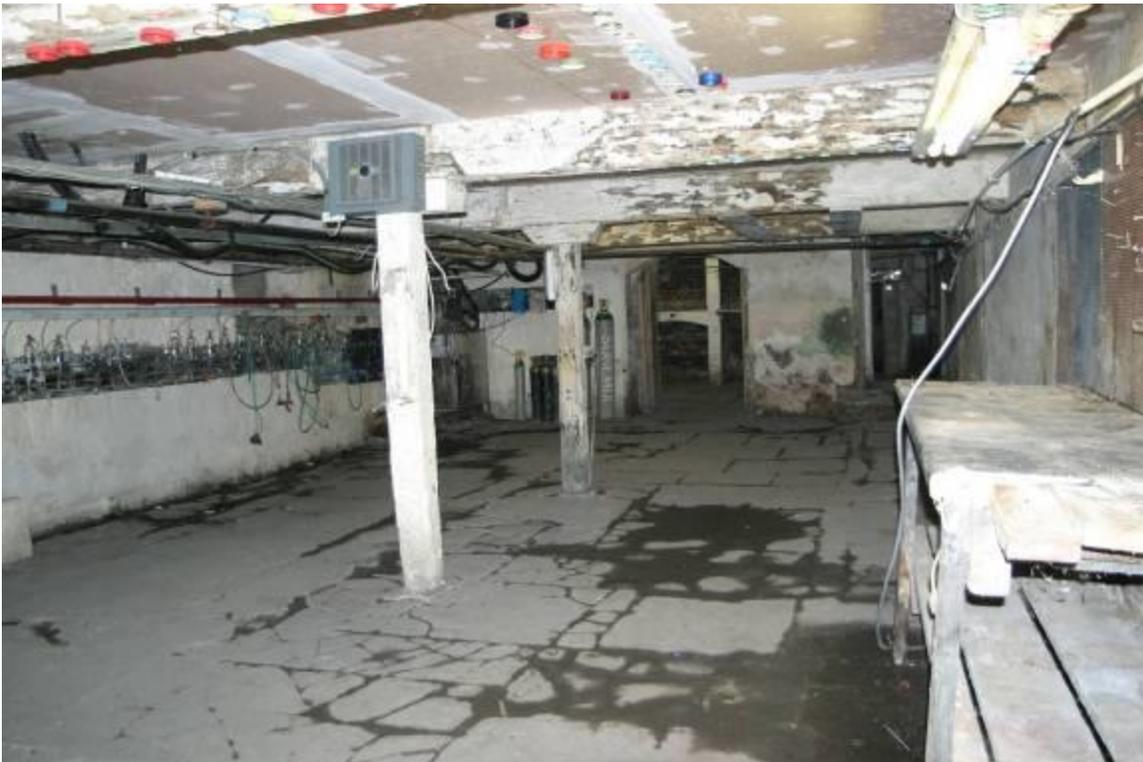
View of main basement area, from rear of building towards the front.

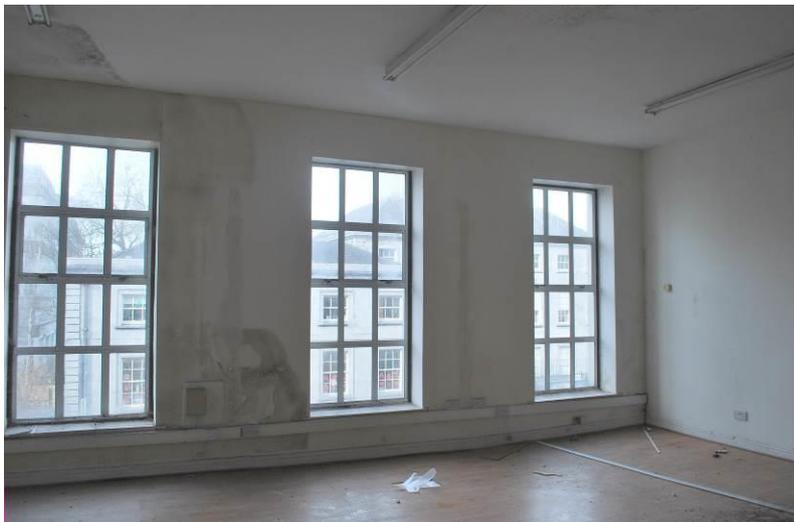
Fig. 1: Staining from water ingress visible to first floor, front room.

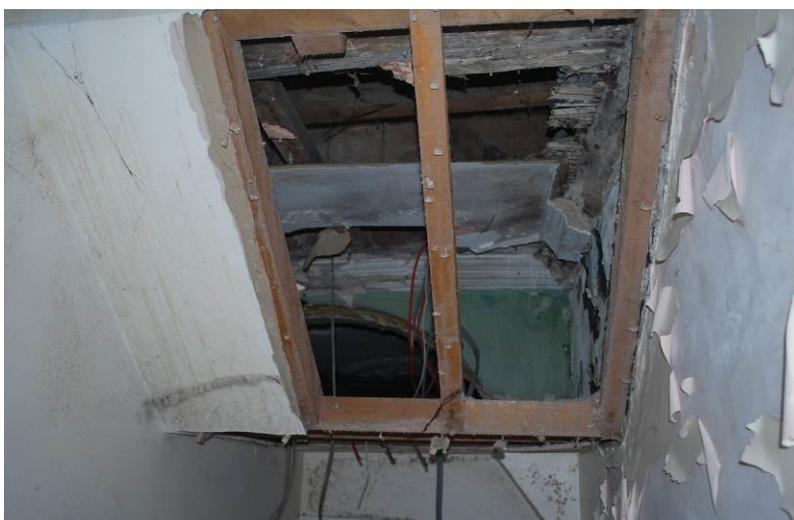
Fig. 2: Opening up works have revealed remnants of original plasterwork to

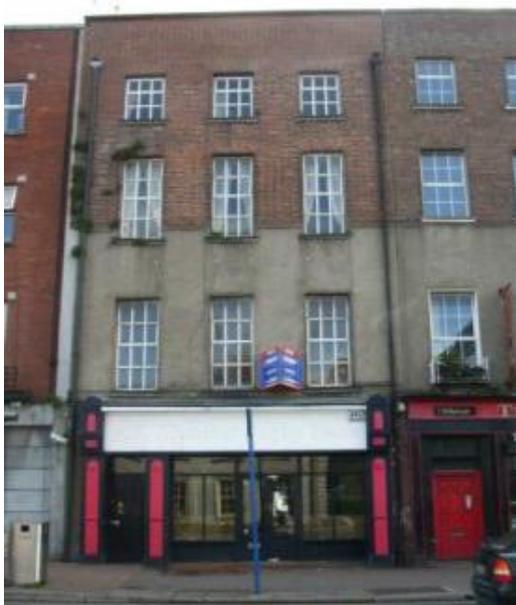
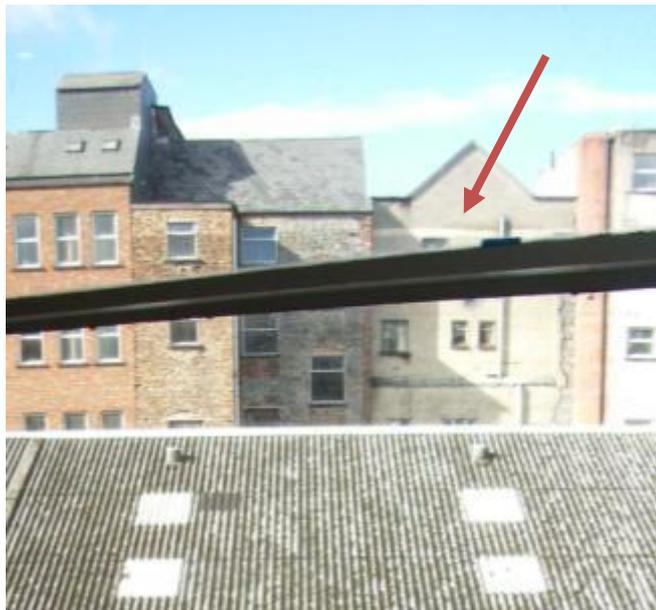
Front elevation of 4 Rutland Street (above left) and view of rear (above right, to the right of the picture).

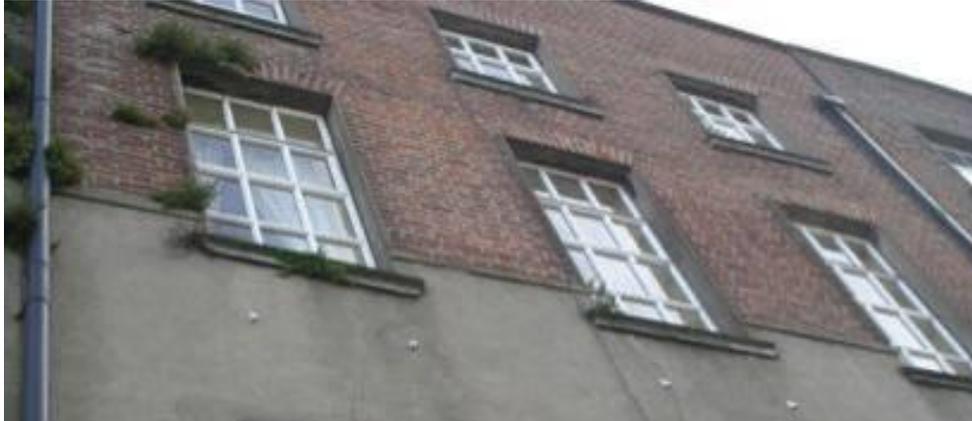
Detail of front elevation showing limestone sills.

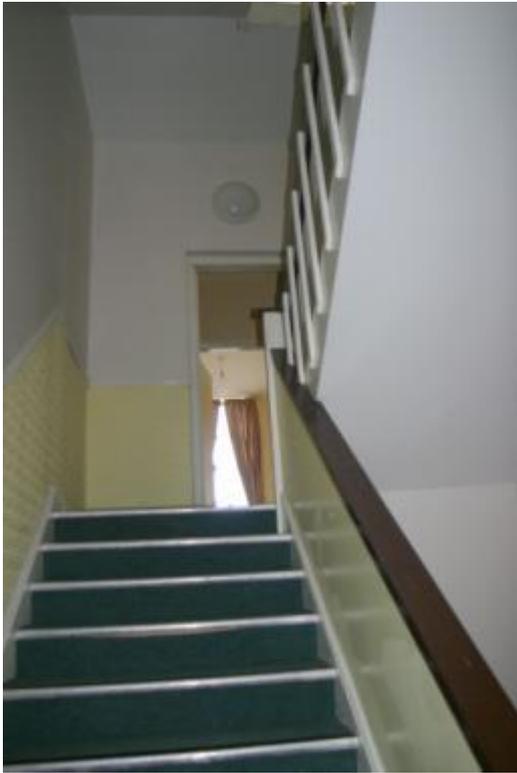
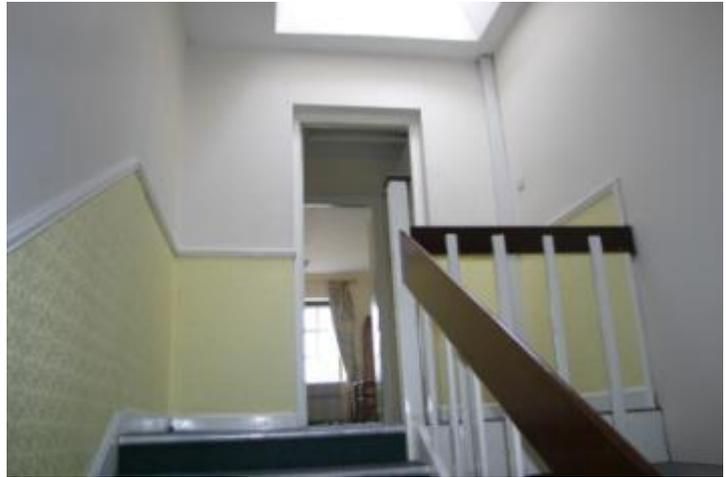
General views of the staircase.

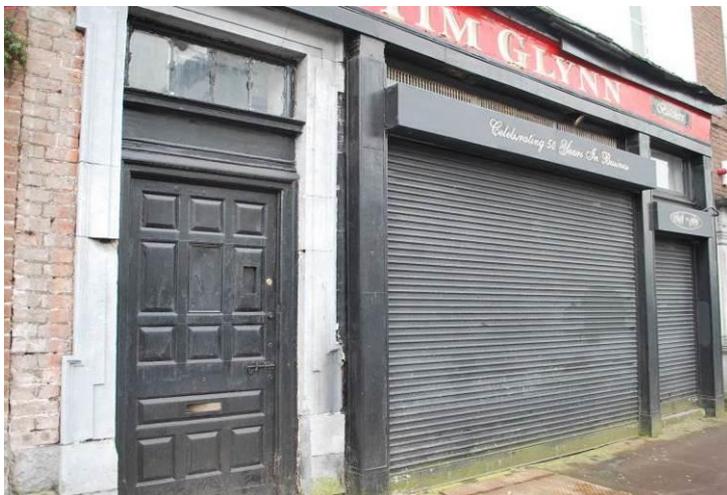
Fig. 1: Shopfront and main entrance door which retains a cut limestone surround.

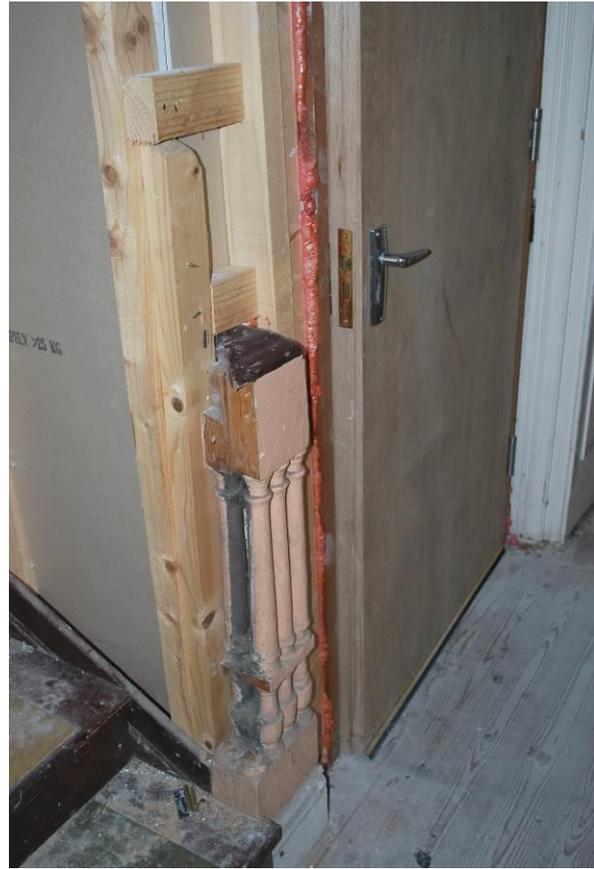
Fig. 4: Lobby inserted to stair landing and damaged balustrade.

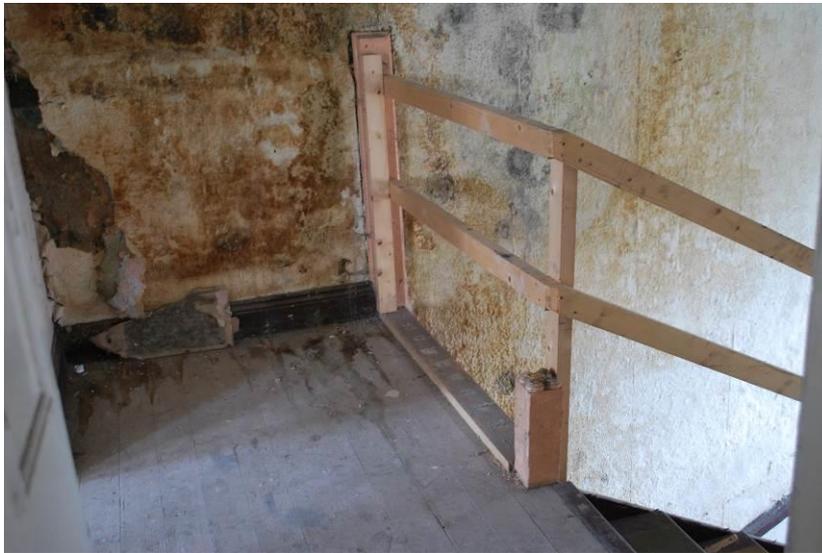
Fig. 5: Top landing with balustrade removed and broken newel post.

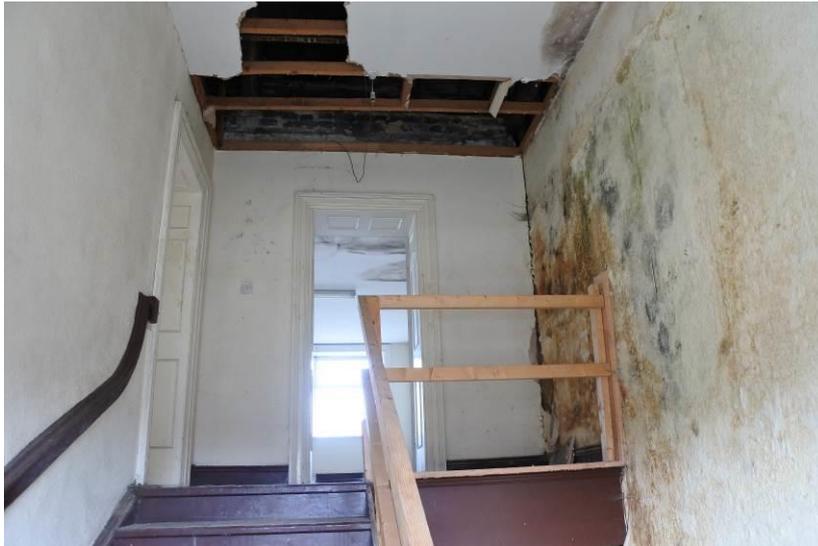
Fig. 6: Area of water ingress, party wall to No. 4 Rutland St.

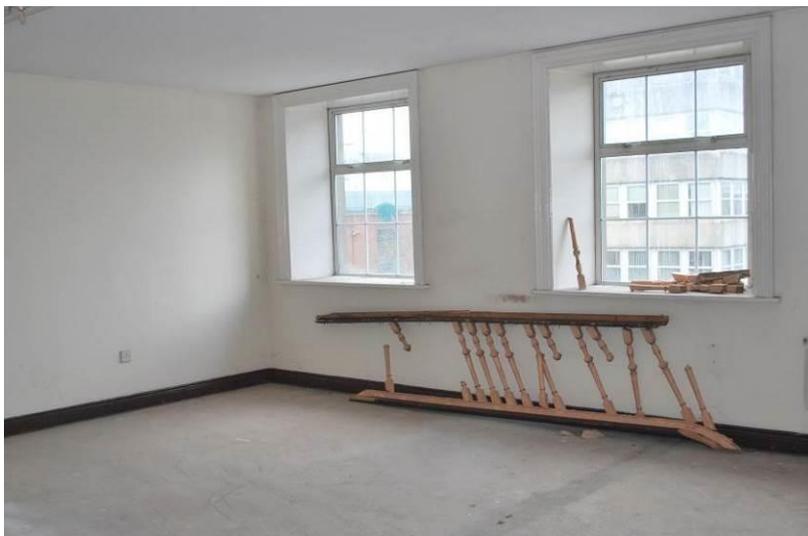
Fig. 7: Removed and damaged section of balustrade.

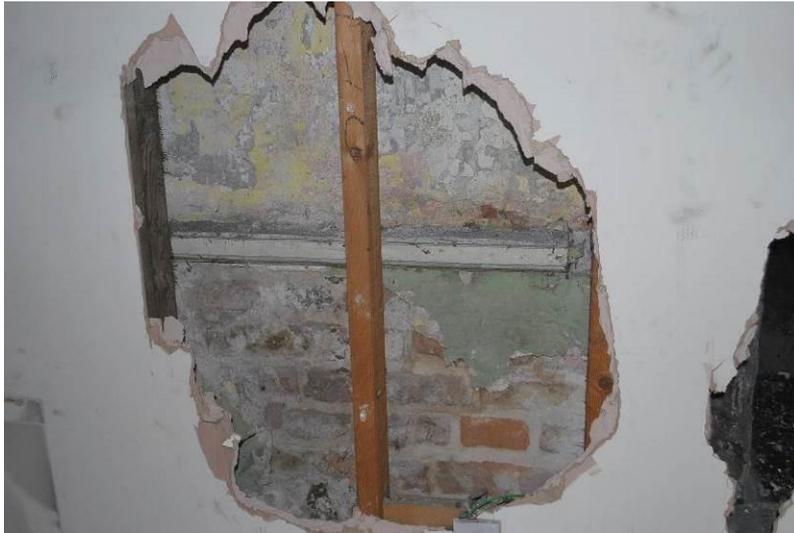
Fig. 8: Revealed section of dado rail to upper floor.

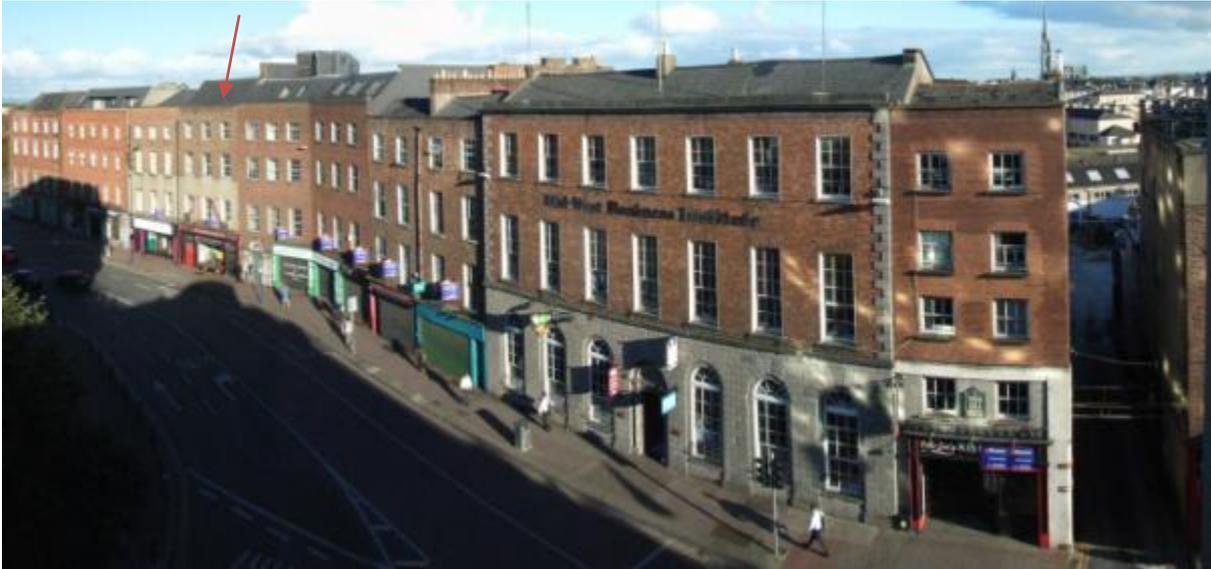
Panoramic view of Rutland Street showing 5 Rutland Street.

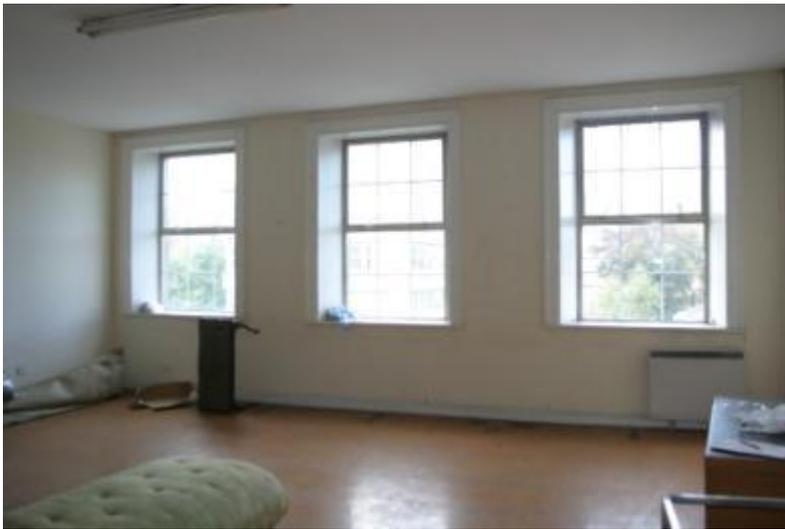
View of the front room, second floor, towards front elevation.

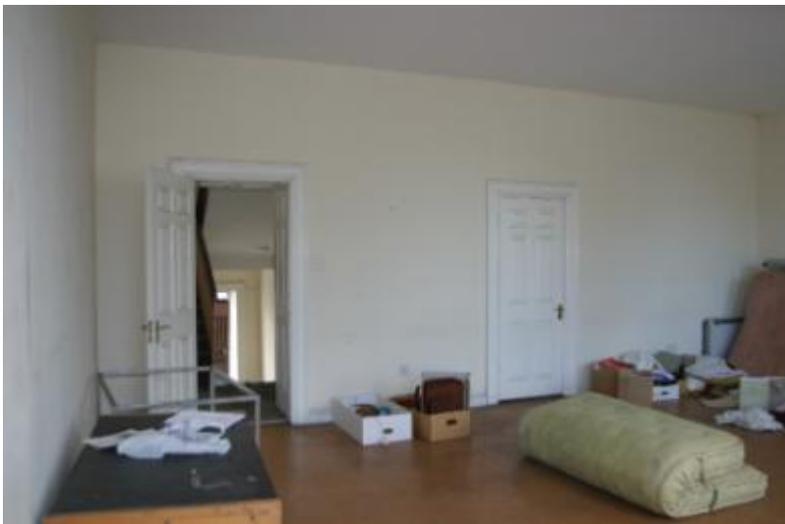
View of the front room, second floor, towards the rear, showing modern replacement doors.

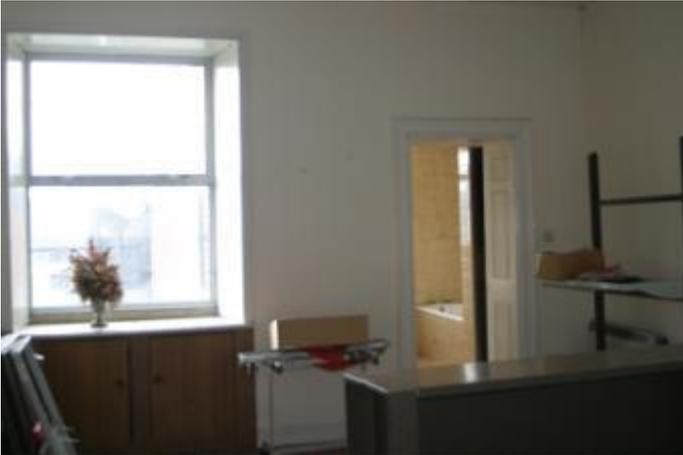
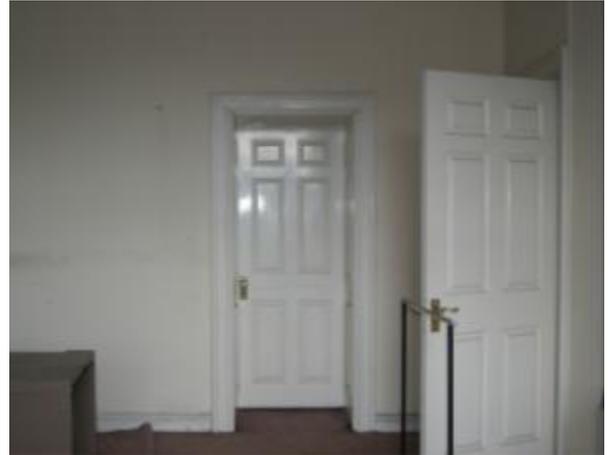
Views of the rear room, second floor.

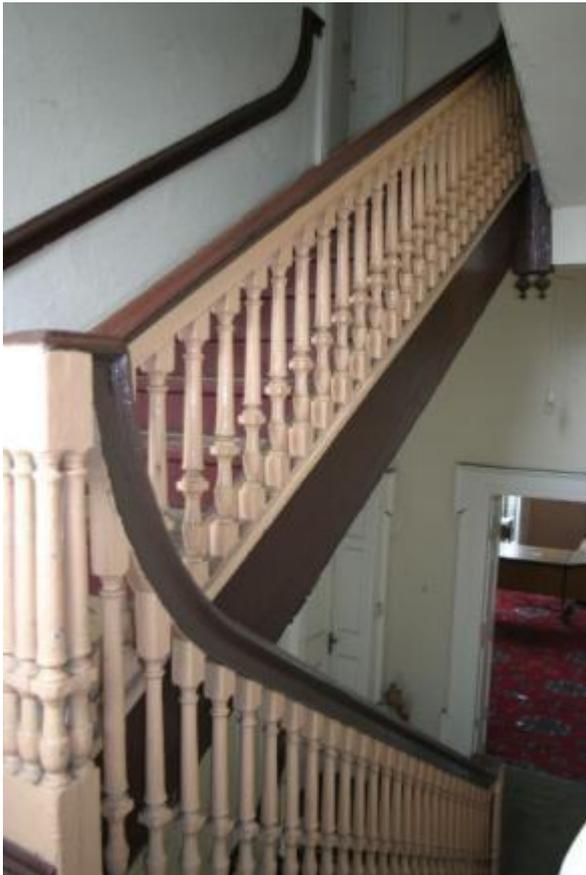
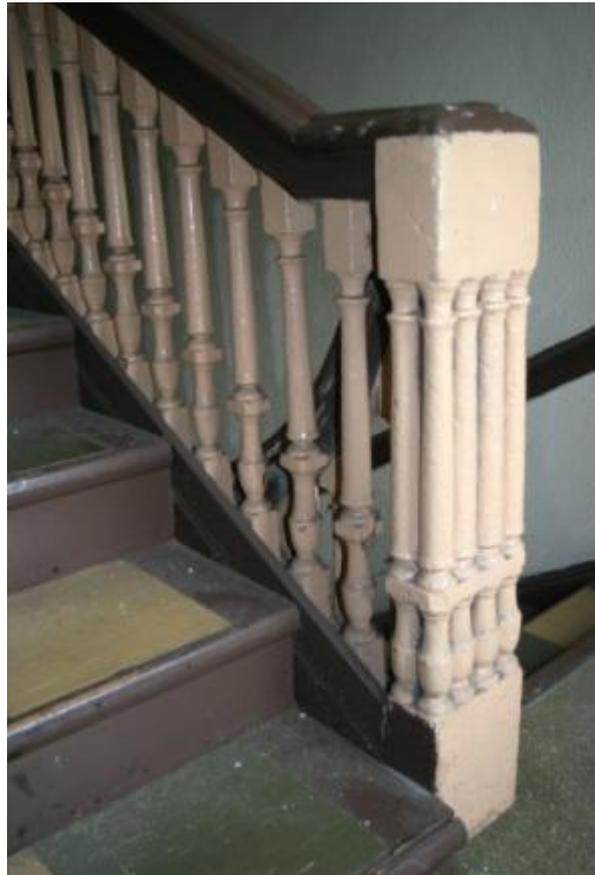
Details of staircase, showing the drop handrail, turned balusters and clustered balusters to landings.

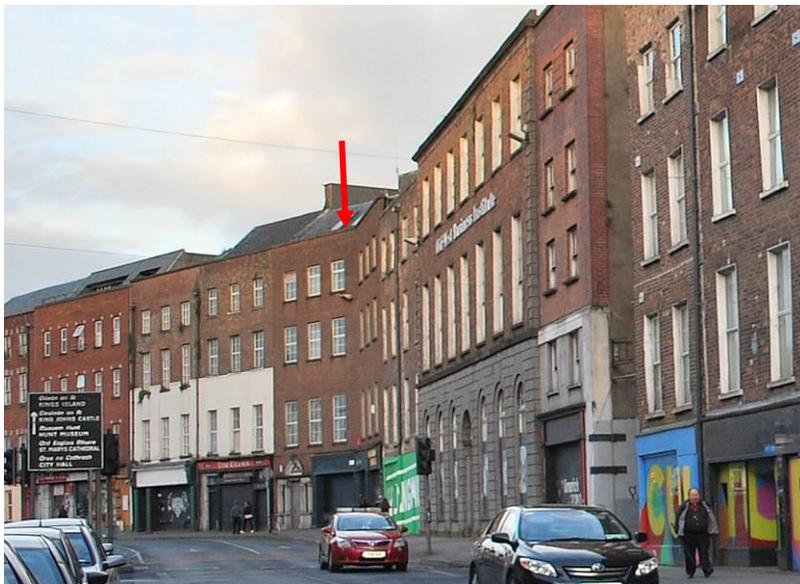
Fig. 1: Location of 6-7 on Rutland Street.
