**Opera Site: Bank Place, Rutland St., Patrick St., Ellen St.
and Michael St., Limerick.**

Existing Building Individual Records.

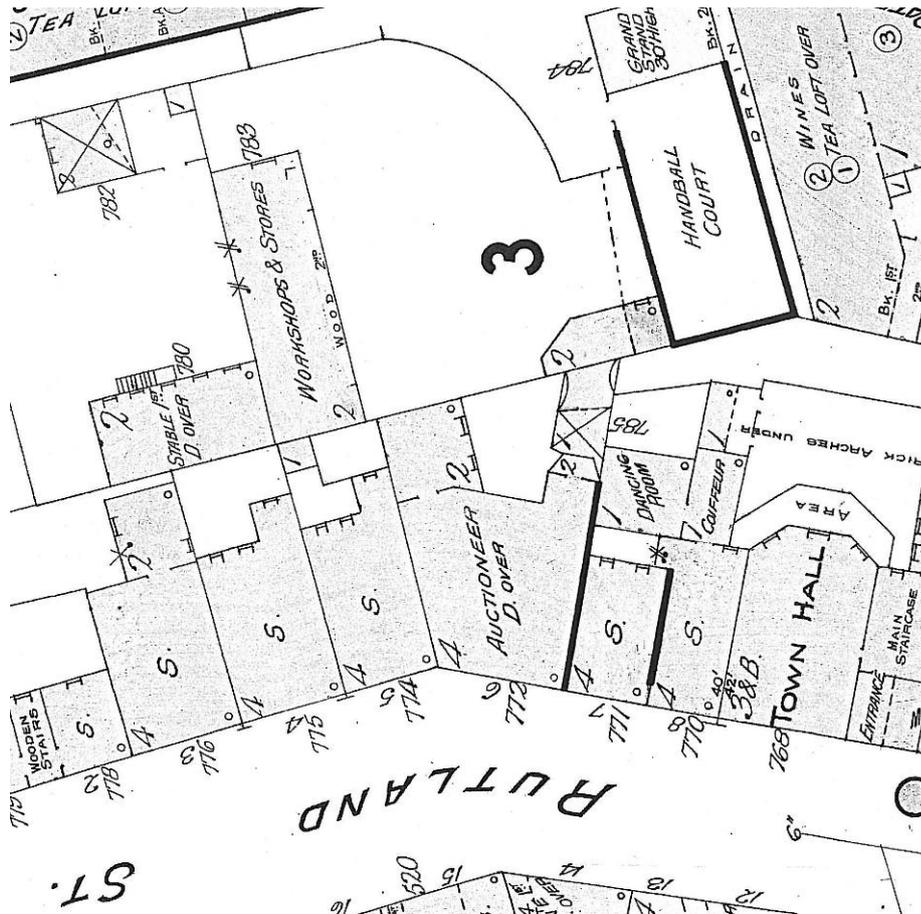
Extract from Goad Insurance Plan, 1897, showing 6 and 7 Rutland St. (here 5 and 6 Rutland St.) and the distinctive kink in the street line. The buildings illustrated on this map were demolished in the 1980s and replaced with the existing building.

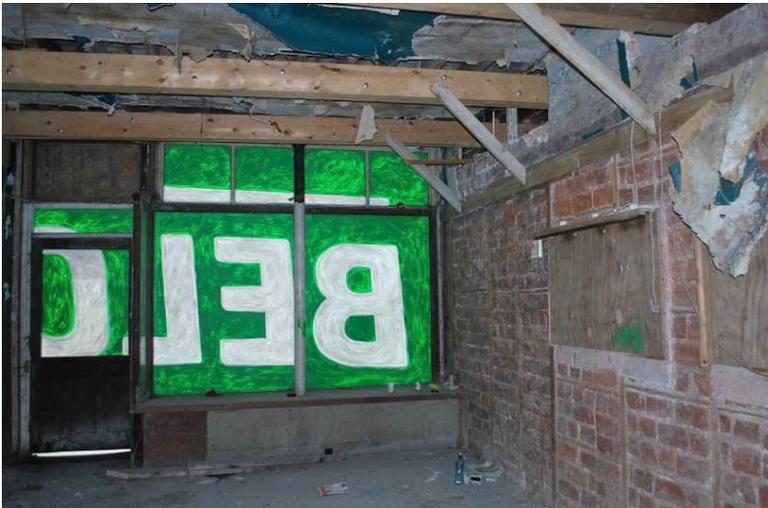
Fig. 1: Ground floor, front room, showing brick nogged walls between entrance hall and retail area.

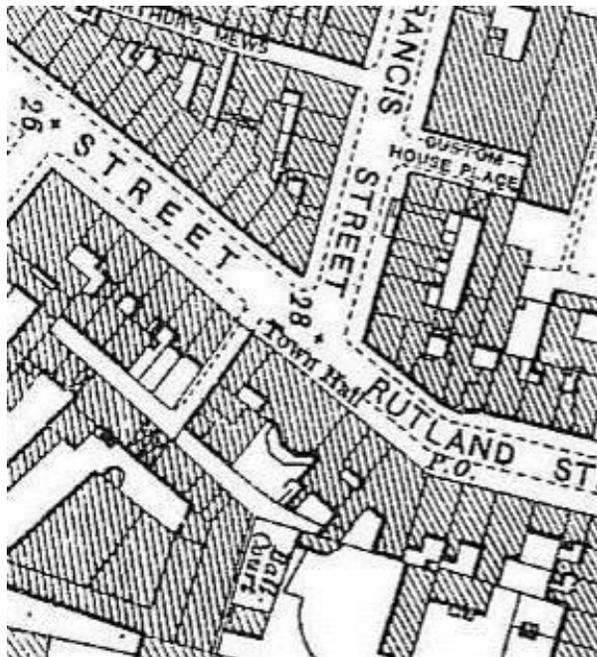
OS map surveyed in 1900.

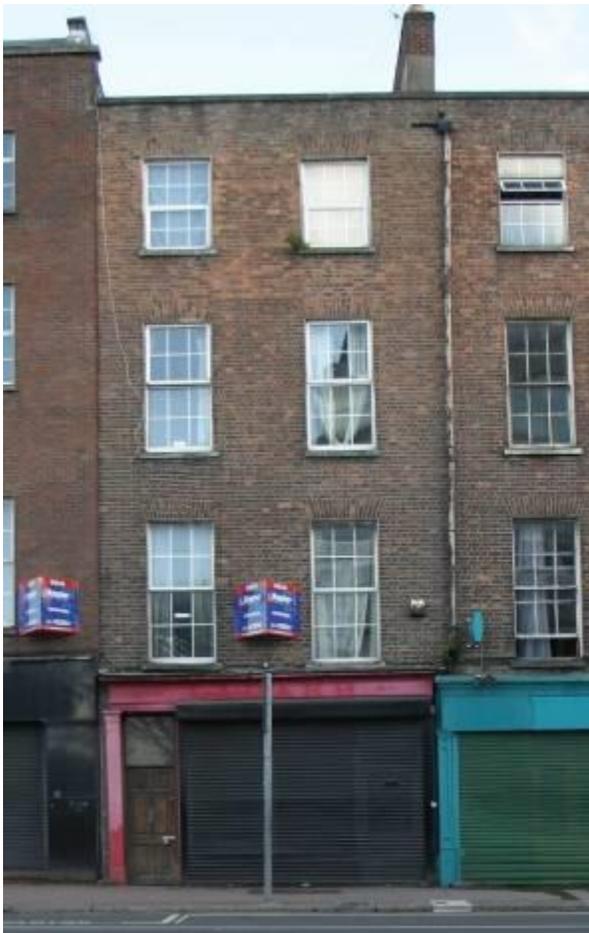
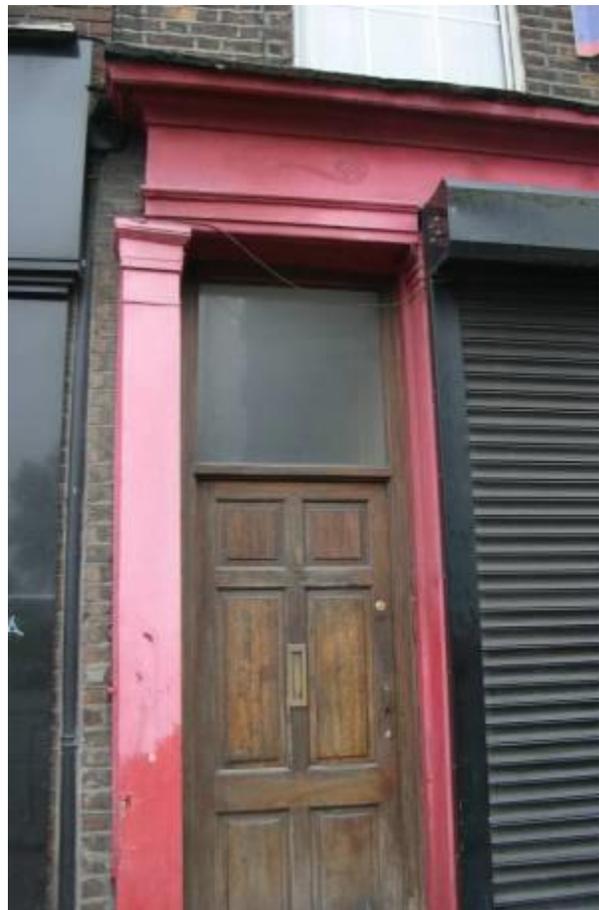
View of front elevation, showing exposed brick (above left) and detail of shopfront (above right).

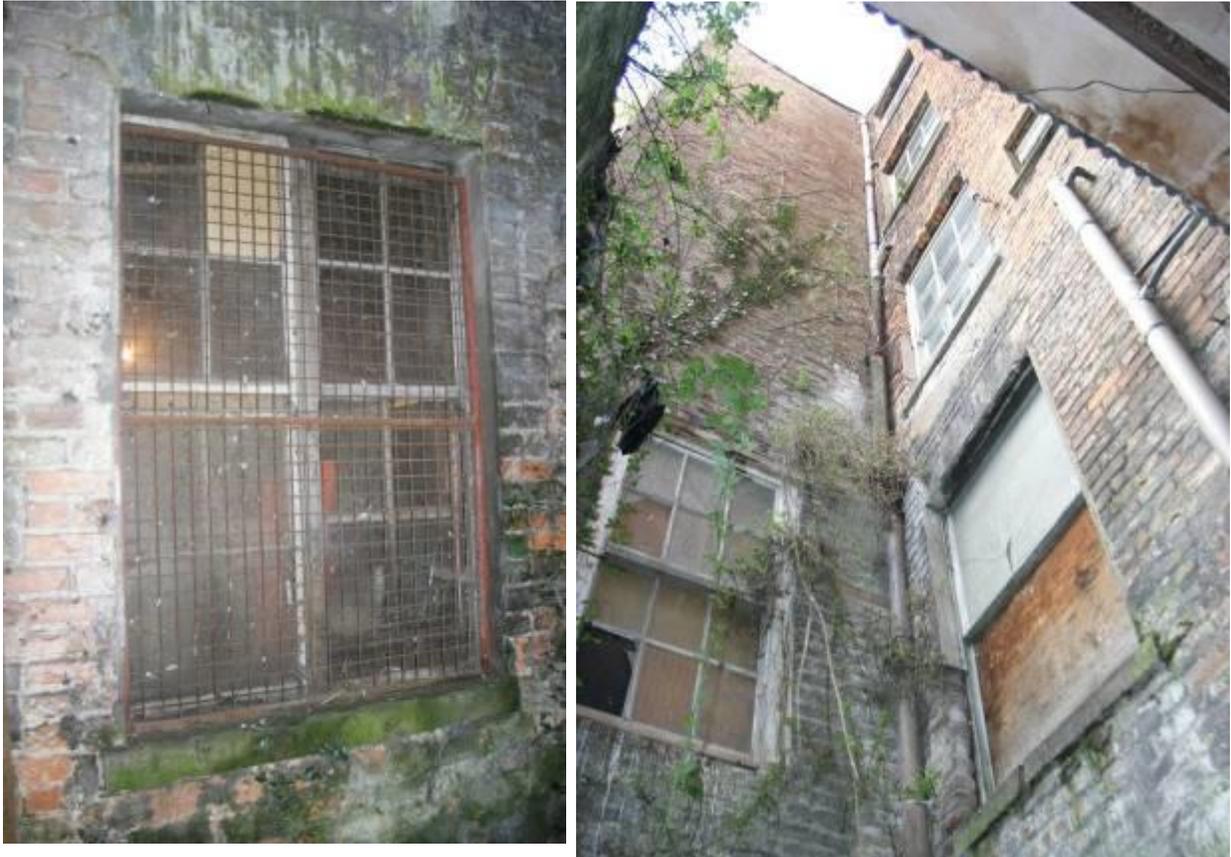
Rear elevation windows; at basement level (above left) and the remainder of the windows (above right).

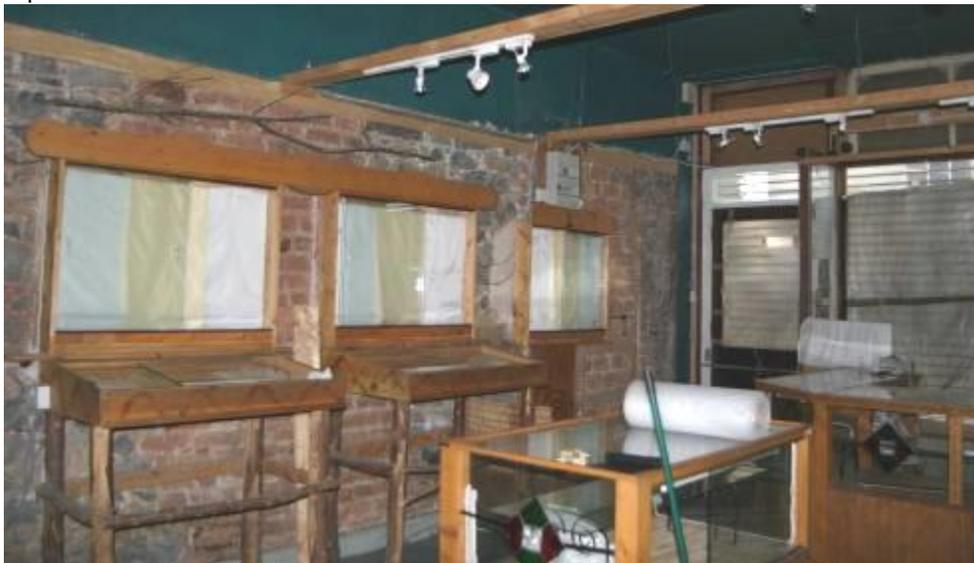
View of retail area to ground floor, showing part of shopfront and exposed walls.

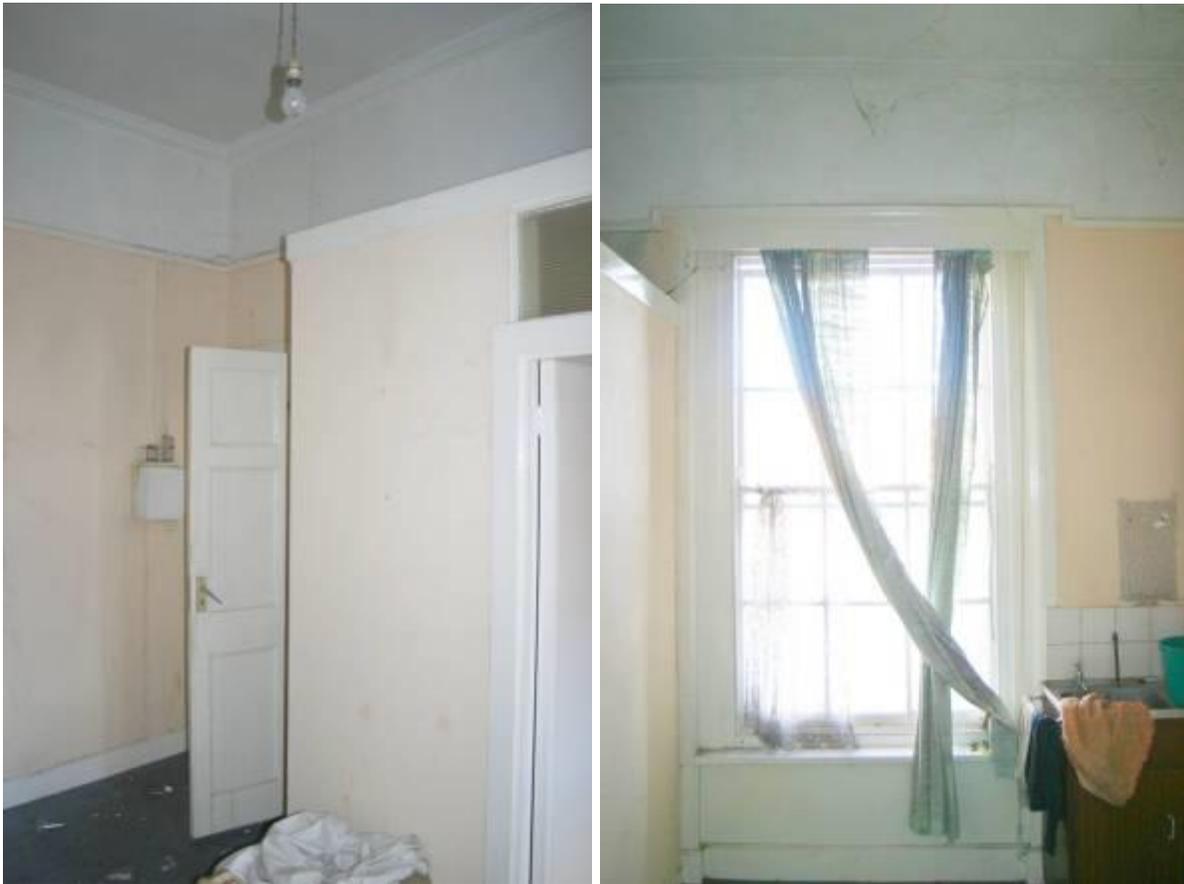
Views of rear room, showing door to landing and corner of partitioned area (above left) and window (above right). Note the cornice to the ceiling.

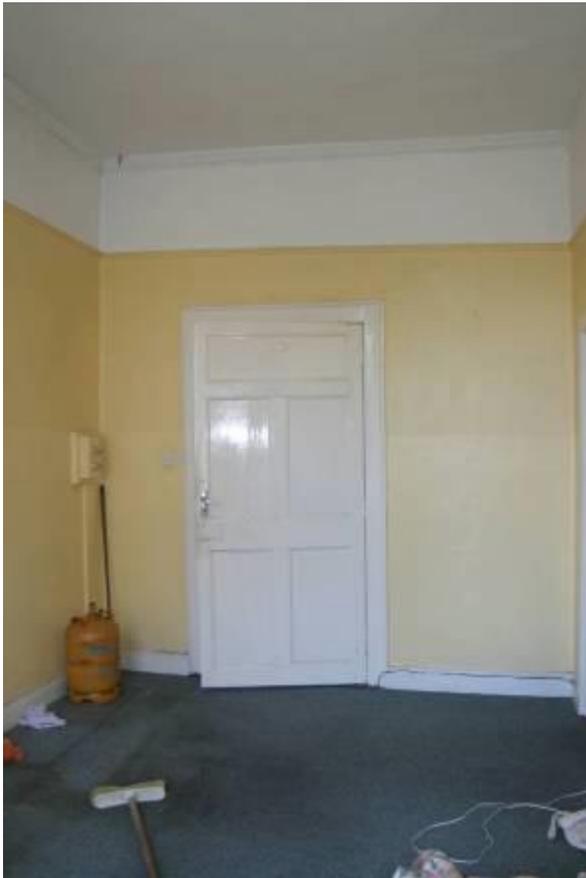
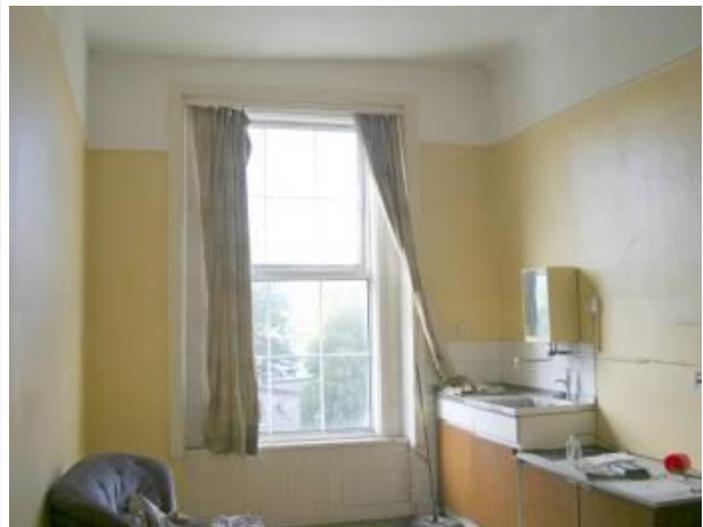
View of one half of front room, showing panelled door leading from the landing.

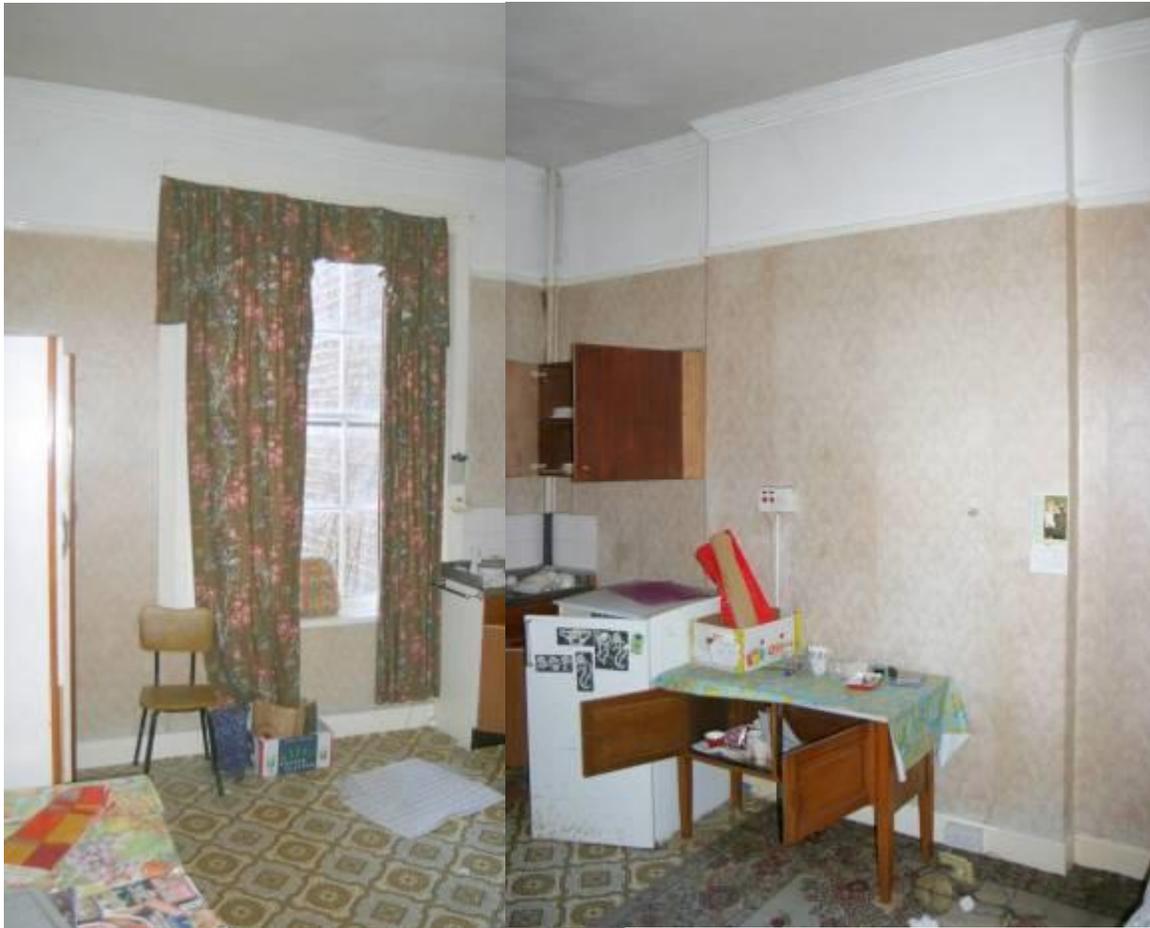
View of rear room, showing chimney breast, cornice and picture rail.

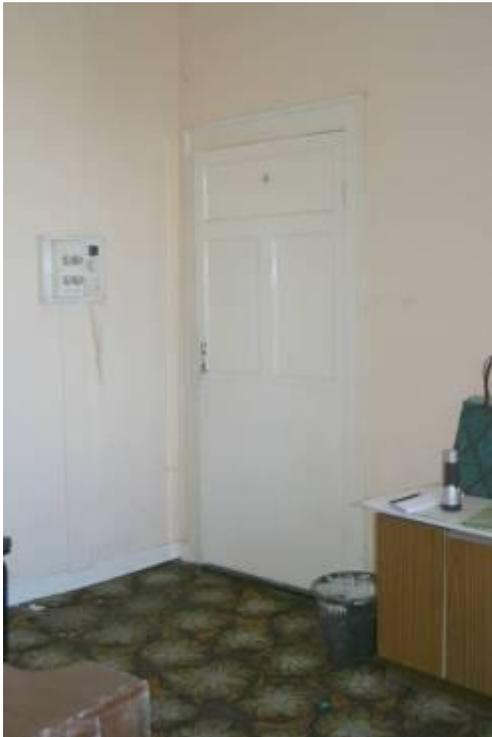
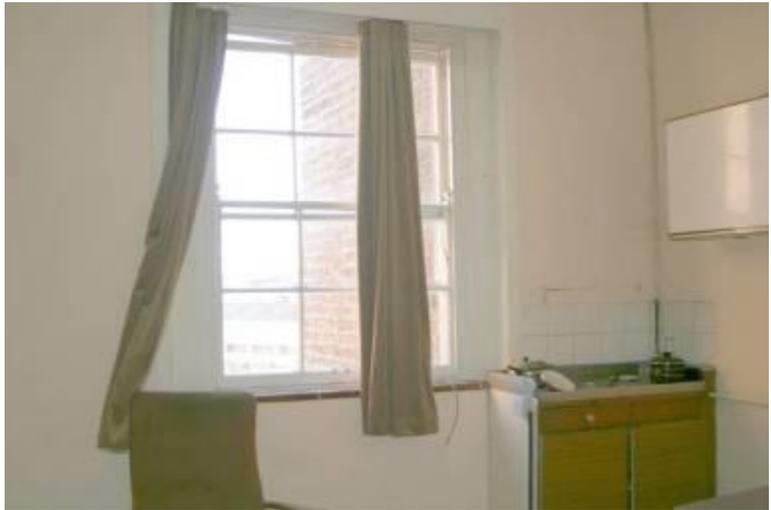
View of rear room showing panelled door (left) and replacement sash window (above).

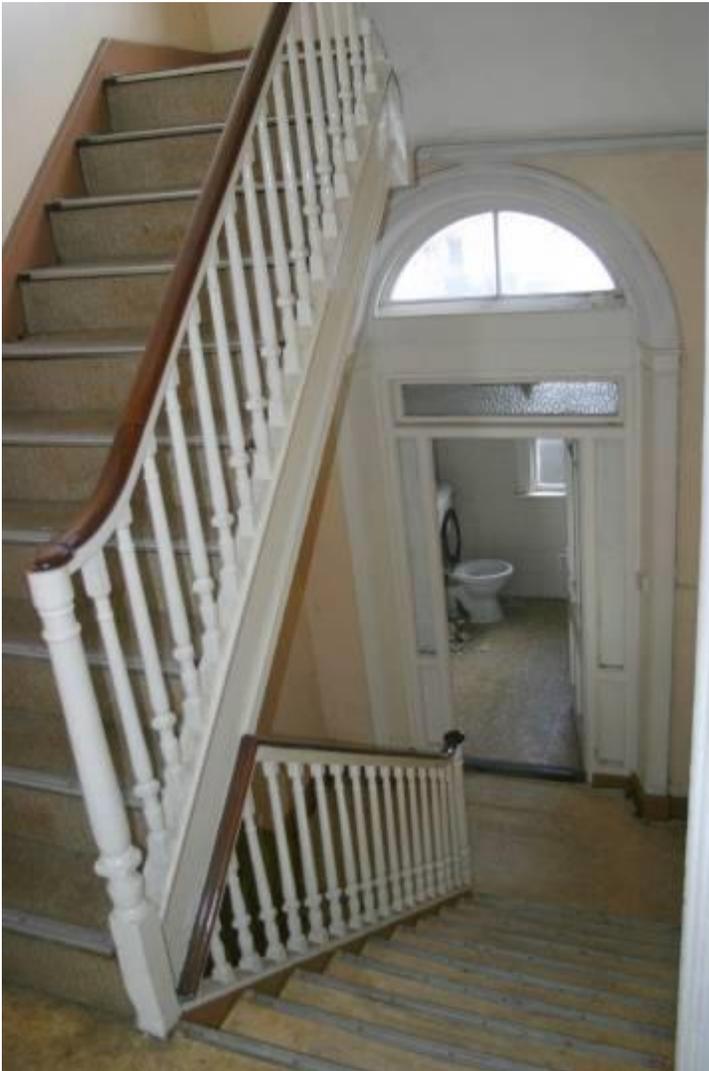
View of staircase showing round-headed opening to the half landing between ground and first floor levels, which was originally a window opening.

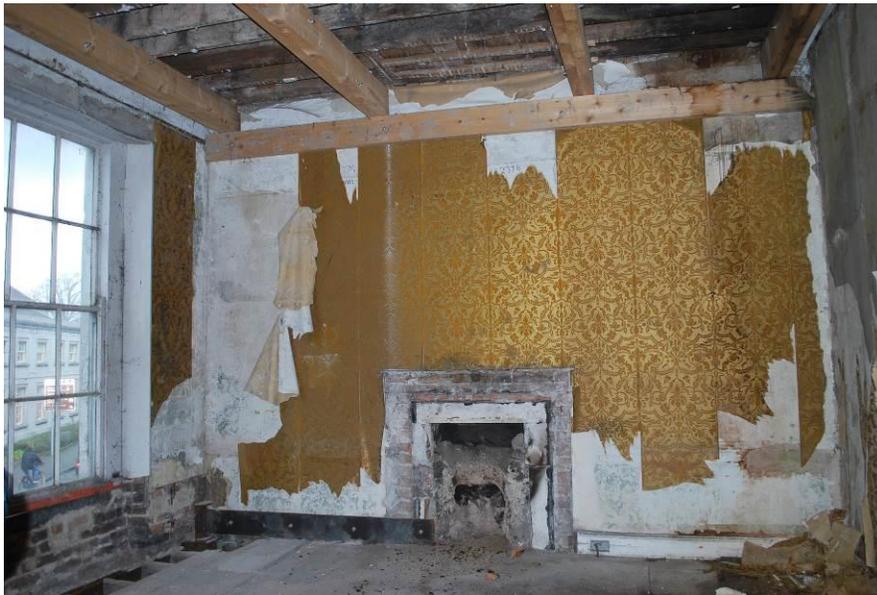
Fig. 1: First floor, front room, showing remedial structural works. The fire surround has been removed since this building was recorded in 2007.

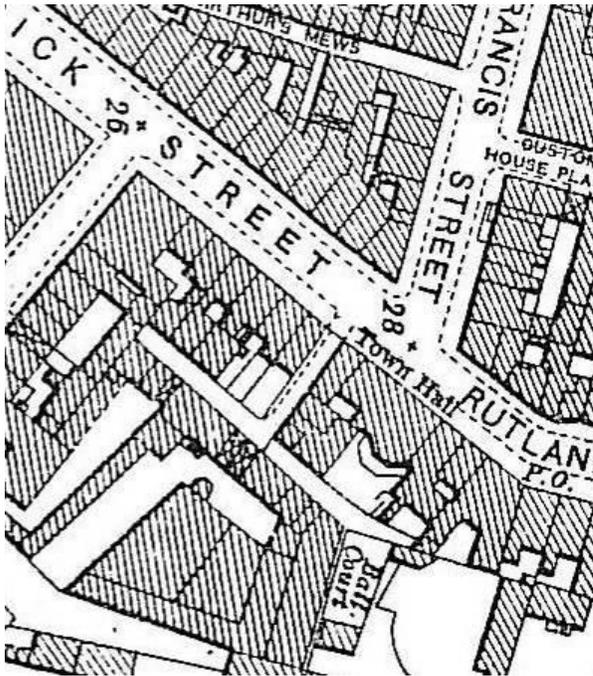
OS map surveyed in 1900.

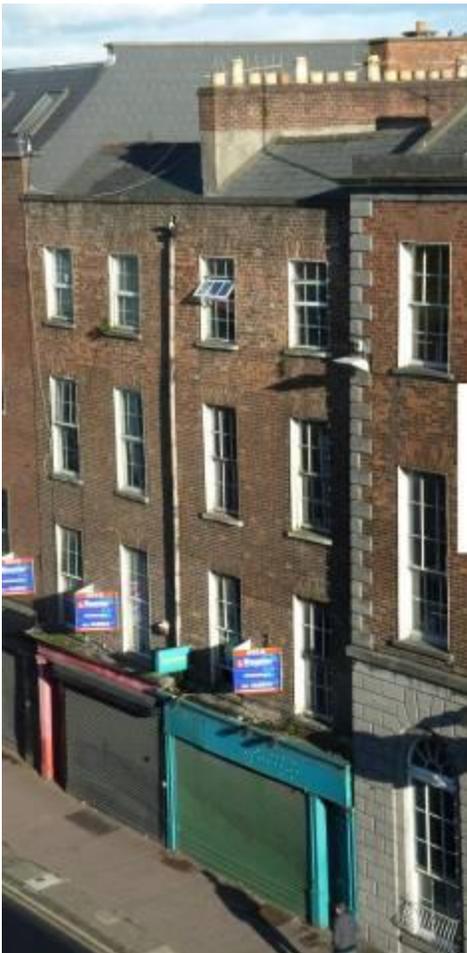
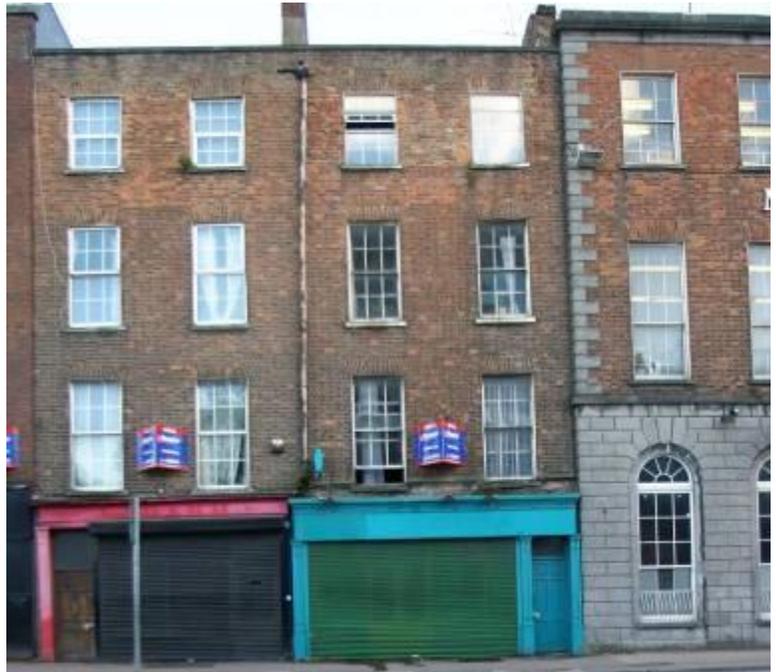
Views of the roof and front elevation of No. 9.

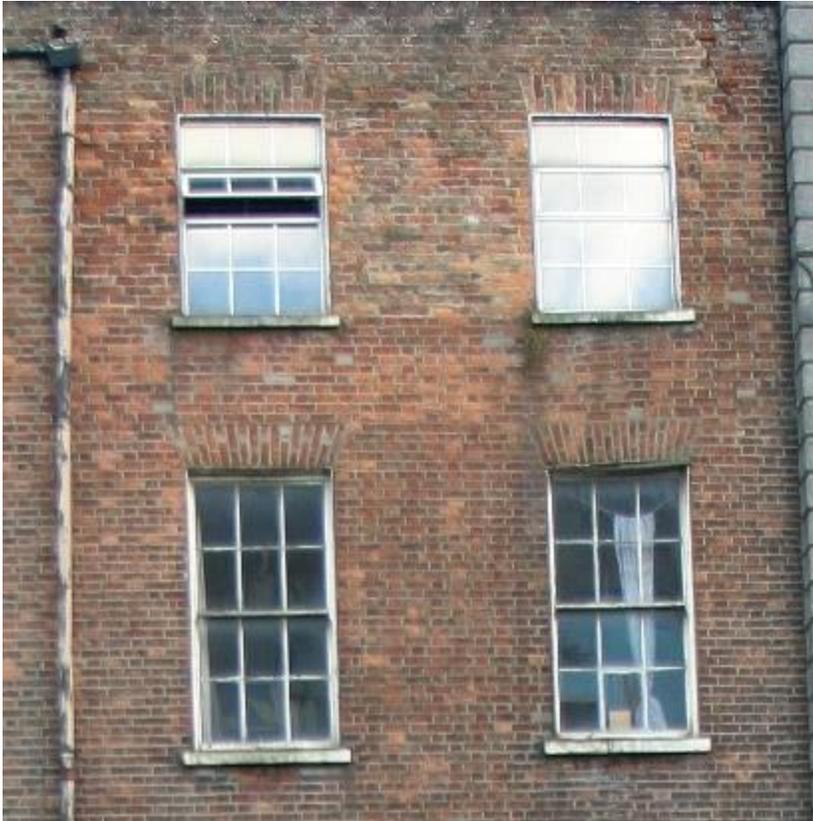
Detail of front elevation, showing timber replacement windows on the second floor, and uPVC to the third floor.

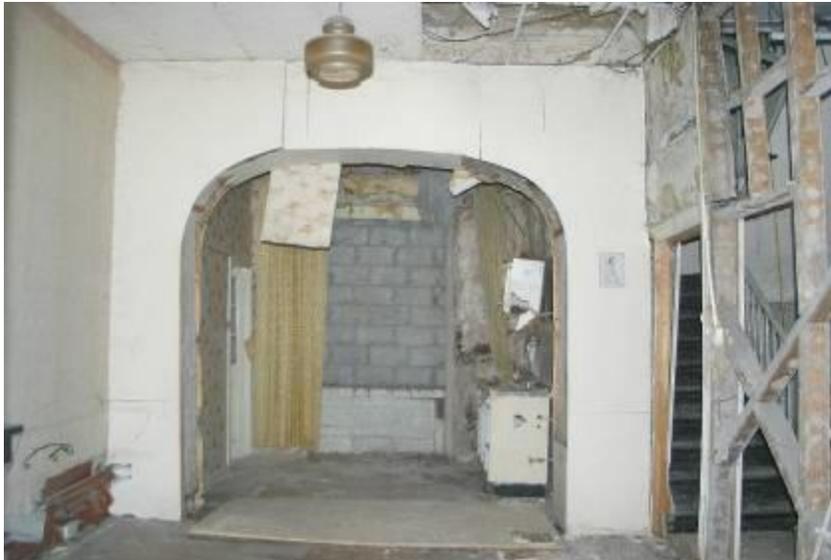
View from rear room to rear of building, showing original rear wall and blocked up window opening.

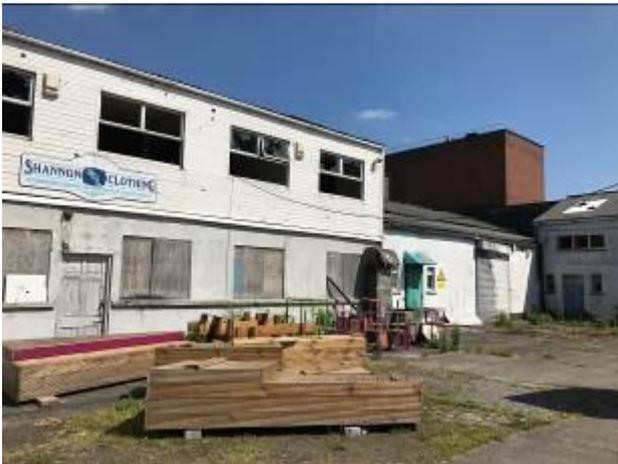
Fig. 1: Northern range of the building.

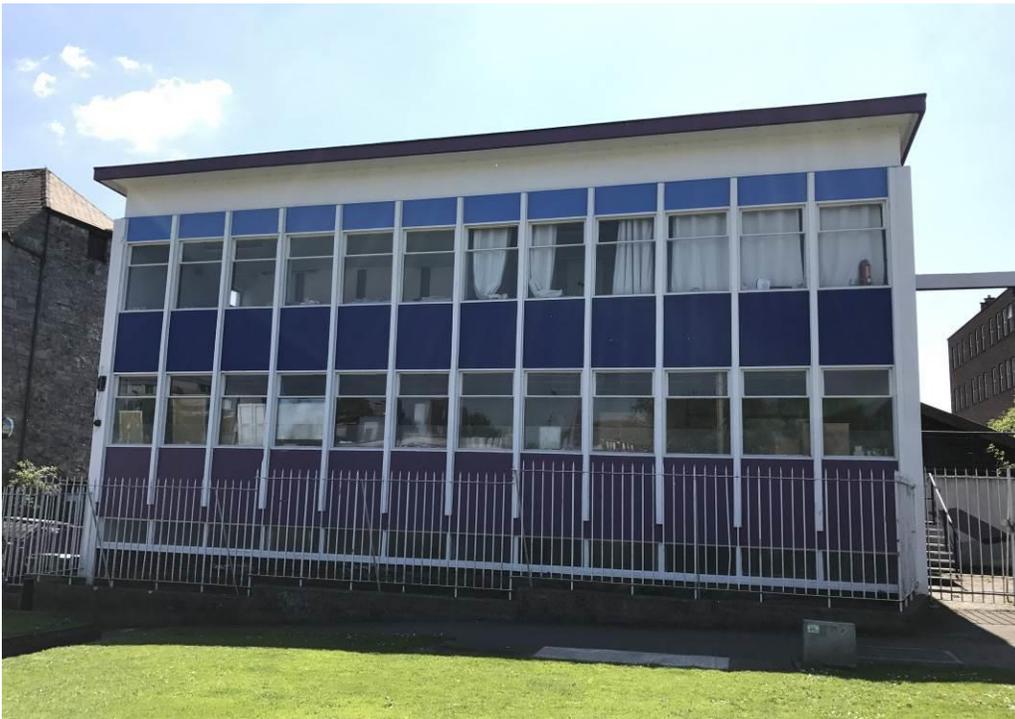
Fig. 1: Bank Place elevation.

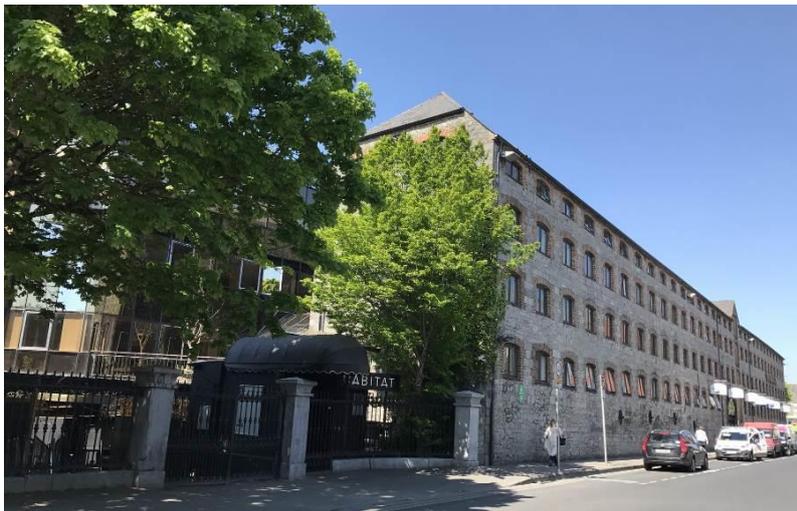
Fig. 1: The granary, from Michael St.

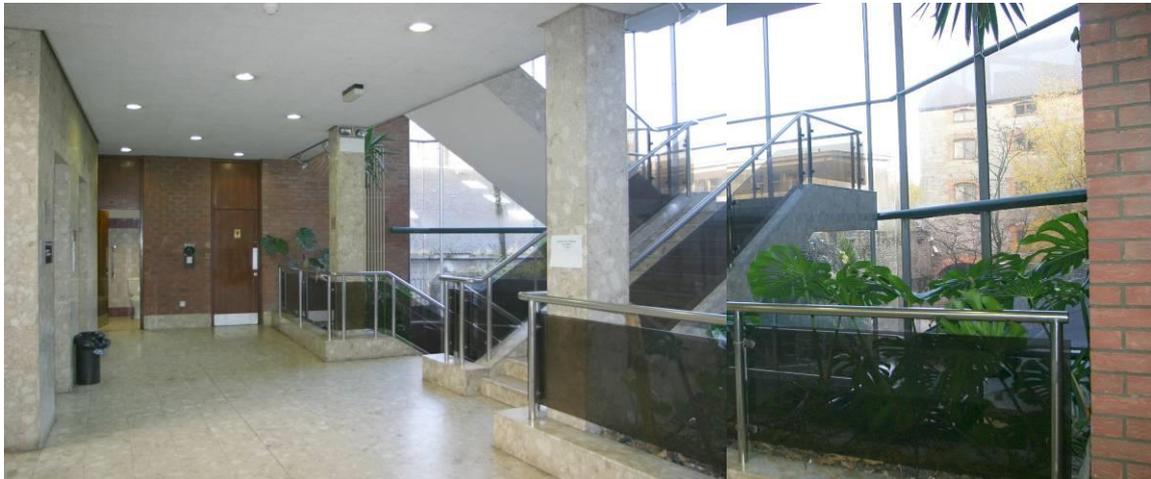
Composite photograph of the lobby/stairwell area, ground floor.
