A UNIVERSAL DESIGN STATEMENT

Job/Drawings No: CRP01-FCBS-1A-02-DR-AA-2052
Revision No: P03
CRQ - FLAX MILL PHASE 1 REPAIR
PROPOSED SECOND FLOOR PLAN

Ref: 01-FCBS-1A-XX-DR-AA-2201
FLAX MILL PHASE 1 REPAIR
R STRATEGY - SW ELEVATION ZONE 1
50 @ A1 / 1:100 @ A3
ath Studio Checked: JS
FCBS Project No: 2024

Job/Drawng No	Revision	CRP01-FCBS-1A-XX-DR-AA-2203
CRQ - FLAX MILL PHASE 1 REPAIR	P05	
REPAIR STRATEGY - SW ELEVATION ZONE 3

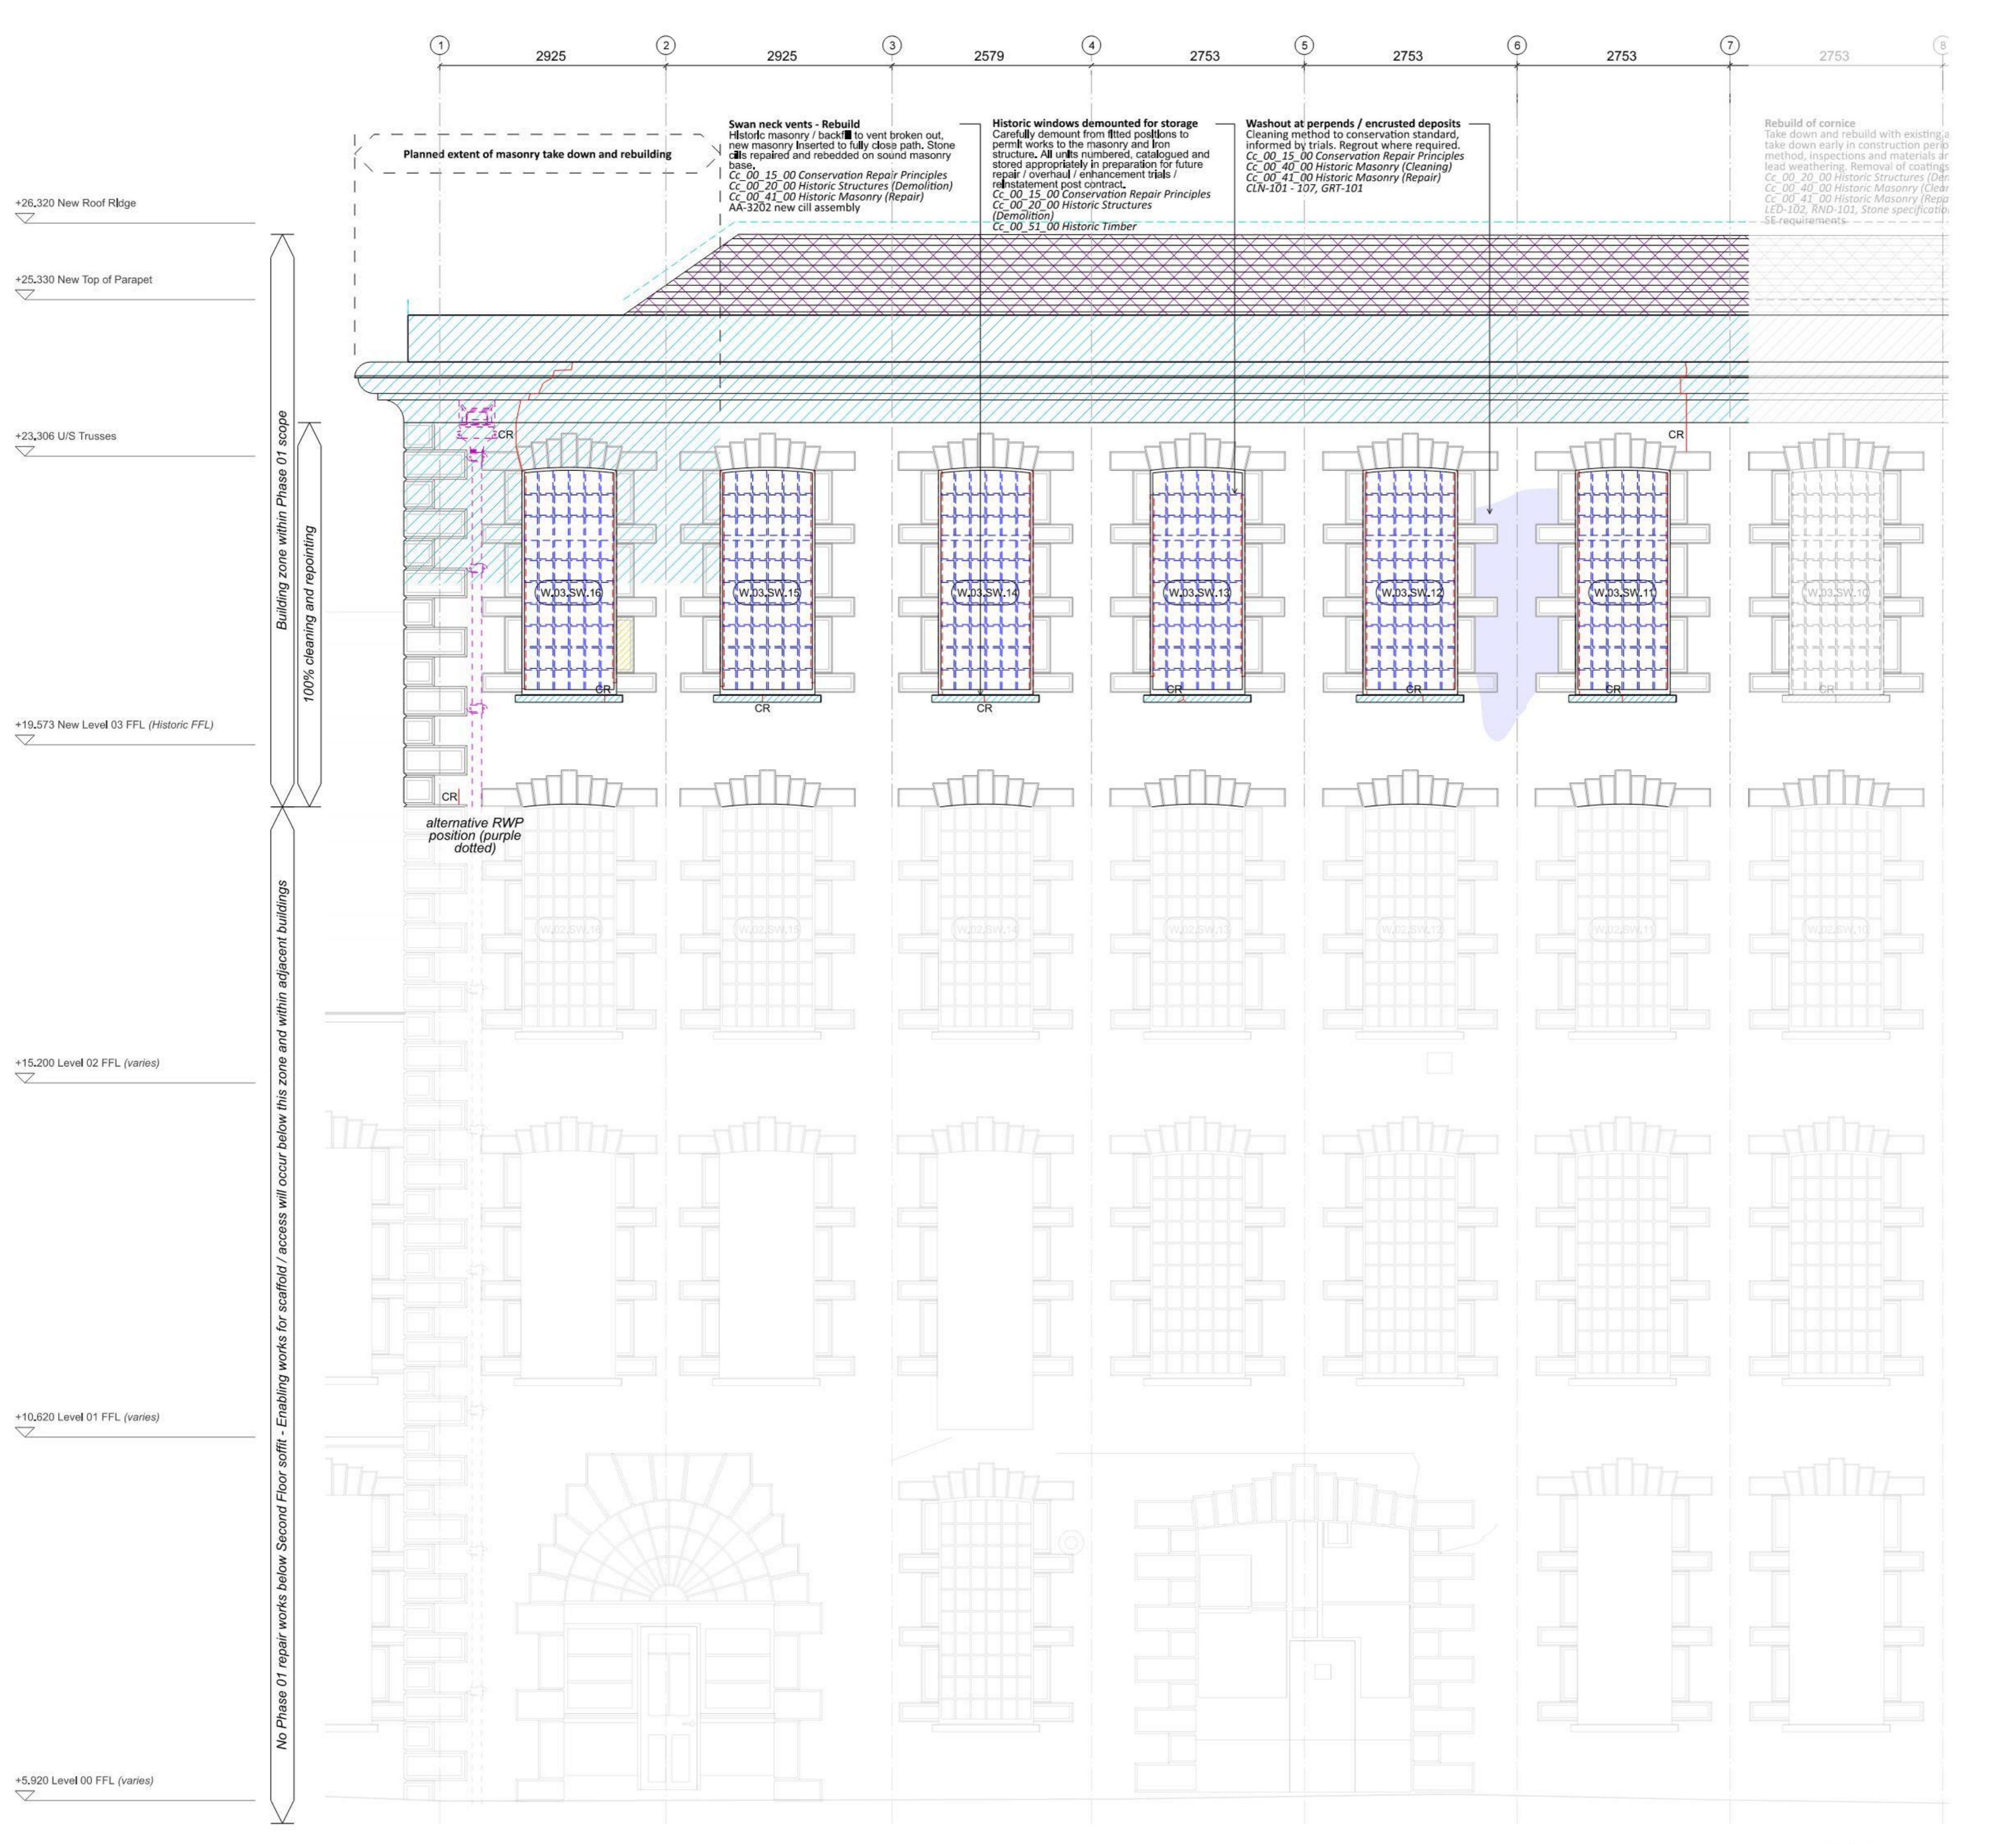
REPAIR STRATEGY PROPOSALS		
REBUILDS OF PARAPET		
Arrangement / Condition: Solid brick construction with Roman cement finish. Later additions and bittorrentings applied in place. Surface water ingress has occurred, deteriorating. Render cracked and missing, parapet saturated, plant growth well established, masonry disrupted and failing particularly at NW. See existing detail and Materials Analysis.		
Objective: Repair and stabilise failing defects.		
Works Description: Take down and rebuild with existing and new masonry, extents to be informed by trial take down early in construction period to inform understanding and proposals / method, inspections to inform approach. New render and lead weathering. Additional masonry courses for edge protection. Removal of coatings. See proposed detail and Materials Analysis.		
Key Drawings / Specifications: Cc_00_15_00 Conservation Repair Principles Cc_00_20_00 Historic Structures (Demolition) Cc_00_40_00 Historic Masonry (Repair) Cc_00_41_00 Historic Masonry (Repair) LED-103, BRK-101, RND-101, AA-3201 & AA-3204 parapet rebuild SE requirements

REBUILD OF CORNICE		
Arrangement / Condition: Presumed stone substrate with run in stone cornice / lime mortar in torus profile. Widespread cracking, delamination, some evidence of plastic repairs, vegetation growth, stonework displaced and failing at NW gable. See existing detail.		
Objective: Rebuild of cornice to remediate defects.		
Works Description: Take down and rebuild with new stone, extents to be informed by trial take down early in construction period to inform understanding and proposals / method, inspections and materials analysis to inform approach. New render and lead weathering. Removal of coatings. See proposed detail and Materials Analysis.		
Key Drawings / Specifications: Cc_00_15_00 Conservation Repair Principles Cc_00_20_00 Historic Structures (Demolition) Cc_00_40_00 Historic Masonry (Cleaning) Cc_00_41_00 Historic Masonry (Repair) LED-102, RND-101, Stone specification

RENEWAL / OVERHAUL OF RAINWATER DRAINAGE SYSTEM		
CONSERVATION AND UPGRADE OF COMPONENTS		
Arrangement / Condition: Original system comprising individual cast iron valleys and parapet gutters, discharging to 2nd cast iron chutes and downpipes. Gutter heads and downpipes with red putty. Some thinning, pitting and holes present. Some fractures at edges due to thermal stress and little opportunity for movement. Many timber bearers failed and replaced with masonry propping. Some sections missing. See existing details, Infrastruct Report and gutter repair schedule.		
Objective: Remediate failing structural members through repair and section replacement as required. Original fabric and historic repair elements to be retained where viable.		
Works Description: Seek retention of timber and downpipes. Rafter removal and replacement. Removal of failed castings from main chutes and downpipes. Renewal of sections in conservator. New cast iron chutes and downpipes at gables - Renew through removal of lift overrun. Repair types as specification, inspections to inform repair approach. See proposed detail and truss repair schedule.

Special Notes: Cc_00_15_00 Conservation Repair Principles Cc_00_20_00 Historic Structures (Demolition) Cc_00_40_00 Historic Masonry (Repair) Cc_00_41_00 Historic Masonry (Repair) SE requirements		
PLANNED EXTENT OF MASONRY TAKE DOWN AND REBUILD		
Objective: To address masonry jacking caused by water ingress and corrosion of iron band.		
Works Description: Masonry carefully disassembled through phased approach. Iron band removed and masonry reinstated with new units.		
Key Drawings / Specifications: Cc_00_15_00 Conservation Repair Principles Cc_00_20_00 Historic Structures (Demolition) Cc_00_40_00 Historic Masonry (Repair) Cc_00_41_00 Historic Masonry (Repair) AA-3211 iron band removed at pier 5 Cc_00_15_00 Conservation Repair Principles		
SWAN NECK VENTS - REBUILD		
Arrangement / Condition: Through-wall swan neck vents with route of flue traversing floor levels. Terminations below cill externally and above window heads into the internal face of masonry envelope via a square metal grille. Internal termination is a square metal mesh backfill. Grilles remain present. Spandrel historically reconstructed with new masonry and cement sloping clin on inner face. See existing detail.

Objective: Formal closure of flue to omit through-flue void.		
Works Description: Historic masonry / backfill to vent broken, new masonry inserted to fully close path. Stone cells repaired and rebated to original profile. See proposed detail.		
Key Drawings / Specifications: Cc_00_15_00 Conservation Repair Principles Cc_00_20_00 Historic Structures (Demolition) Cc_00_40_00 Historic Masonry (Repair) Cc_00_41_00 Historic Masonry (Repair)		
SWAN NECK VENTS - RESTORE IRON VENT GRILLES		
Arrangement / Condition: Cast iron grille situated above window heads forming termination of through-wall swan neck vents. Informally filled historically with masonry / backfill / plaster. See existing detail.		
Objective: Vents overhauled and reinstated as part of formal closure of flue.		
Works Description: Overhaul by iron foundry, off-site in workshop where required. Allow for new castings where existing have failed. See proposed detail.

Objective: Historic windows demounted to permit Phase 01 repair. Store in workshop for re-use in future repair scheme.		
Works Description: Carefully demount from fitted positions to permit works to the masonry and iron structure. All units numbered, catalogued and stored appropriately in preparation for future re-use. Ensure reinstatement trials / reinstatement post contract. See window schedule.		
Key Drawings / Specifications: Cc_00_15_00 Conservation Repair Principles Cc_00_20_00 Historic Structures (Demolition) Cc_00_40_00 Historic Masonry (Repair) Cc_00_41_00 Historic Timber		
NEW PROTECTIVE LINING TO WINDOW OPENINGS		
Arrangement / Condition: Void to window openings will be present as a result of planned window demounting or failure of existing thermal protection.		
Objective: Openings to be secured in advance of reuse proposals.		
Works Description: Non-ventilated ply lining on timber frame. Key Drawings / Specifications: Cc_00_51_00-10 Plywood AA-8002 window boarding options SE requirements

REINSTATEMENT OF FLOOR AT PENETRATIONS		
Arrangement / Condition: Through-floor penetrations for services disturbed by demolition.		
Objective: Reinstatement of floor deck.		
Works Description: Remove services, consolidate / reinstate brick and/or concrete to original floor build-up.		
Key Drawings / Specifications: Cc_00_15_00 Conservation Repair Principles Cc_00_41_00 Historic Masonry (Repair)		
STONE CLEANING AND REPOINTING		
Arrangement / Condition: Solid wall comprising solid wall with hard lime and Limestone. Wall core of lime mortar, limestone red and clay bricks. Limestone dressed six sides, carved units with drafted margins and rock-faced body to jambs and arches, corbelled outwards. Units alternating tall and narrow stones each with iron dowels between.		
Objective: Fairly sound externally, some fracturing from either movement and/or damage of iron dowels. NW wall has some loss of face finish and some spalling evident in places.

Works Description: Ensure clean, sound base. Repair types as specified in proposed detail. See proposed detail.		
Key Drawings / Specifications: Cc_00_15_00 Conservation Repair Principles Cc_00_40_00 Historic Masonry (Cleaning) Cc_00_41_00 Historic Masonry (Repair) Cc_00_90_00 Historic Ironwork		
REMOVAL OF PLANT GROWTHS		
Arrangement / Condition: Growth well established around drainage, water tank and rainwater drainage paths.		
Objective: Remove to address causes of envelope deterioration.		
Works Description: Careful removal to conservation standard, informed by trials.		
Key Drawings / Specifications: Cc_00_15_00 Conservation Repair Principles Cc_00_40_00 Historic Masonry (Cleaning) Cc_00_41_00 Historic Masonry (Repair) Cc_00_90_00 Historic Ironwork CIN-105		
BEAM REPAIR / SE DESIGN		
Arrangement / Condition: Original cast iron beam - snapped or cut through web and flange.		
Objective: Repair.

Works Description: Conservation repair to beam as SE design, plated and / or stitching by specialists. Reinstate jack arch and make good around site of repair.		
Key Drawings / Specifications: Cc_00_15_00 Conservation Repair Principles Cc_00_41_00 Historic Masonry (Repair) Cc_00_90_00 Historic Ironwork Cc_00_41_00 Historic Masonry (Repair)		
WASHDOWN AT PERPENDS / ENCROSTED DUSTS		
Arrangement / Condition: Remediate mortar wash out comprising mineral deposits.		
Works Description: Cleaning method to conservation standard, informed by trials. Re-point where required, informed by trials.		
Key Drawings / Specifications: Cc_00_15_00 Conservation Repair Principles Cc_00_40_00 Historic Masonry (Cleaning) Cc_00_41_00 Historic Masonry (Repair) CIN-107		
NEW ROOF ACCESS HATCH		
Arrangement / Condition: Provide safe means of access to roof for building repair / maintenance.		
Works Description: Glazed opening light installed in roof pitch for maintenance use accessed via roof space ladder and platform. Recessed lighting to be fitted to new timber trussing for opening.
