Section 5 Application

DECLARATION ON DEVELOPMENT AND EXEMPTED DEVELOPMENT

**North East Wing & Gymnasium Block,
St. Joseph's Hospital, Limerick**

2.4 Historic Condition of Northeast Wing

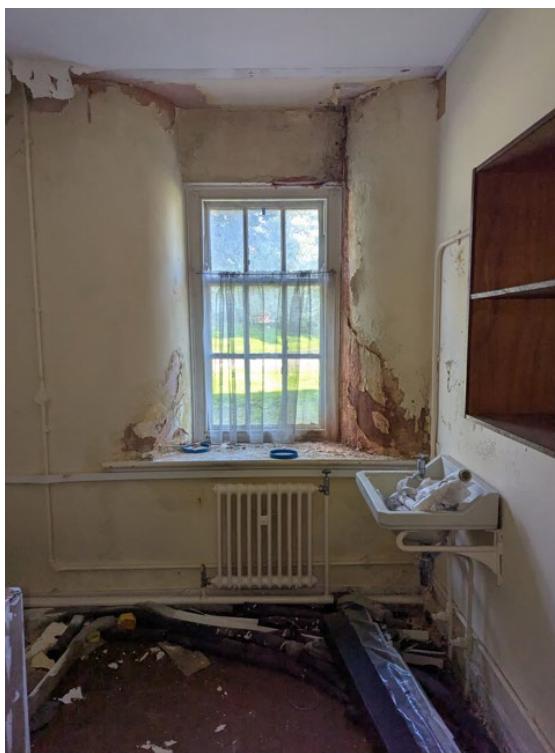
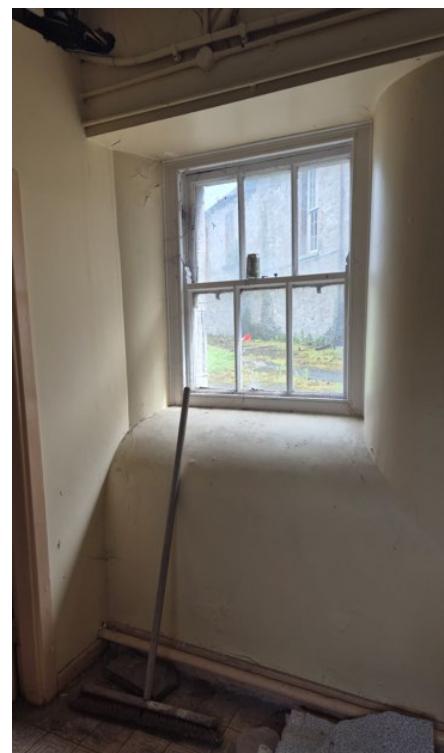
An examination of the original asylum plans reveals a different internal layout from what is currently in place. The spacing of the original windows on the façade of the NE Wing is inconsistent with marginally wider bays between some windows. Originally, internal walls were positioned centrally between window openings, creating 'sleeping rooms' that varied in width. It also originally featured a substantially wider corridor width than currently exists. In the modern layout and based on a review of the recently completed building survey, the rooms are all equal in width resulting the windows being off-centre in the rooms. In some cases, the partitions land near or on the attractive curved window reveal, detracting from the original architectural detail.

Two images of lower ground floor windows with curved window reveals and awkward partition placement

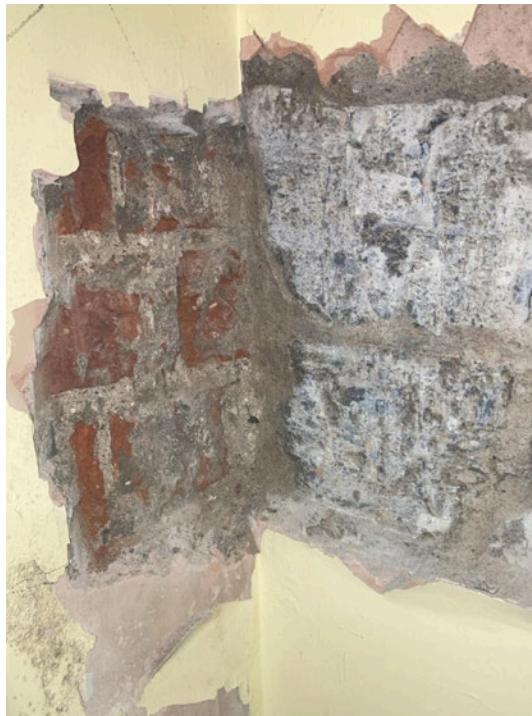
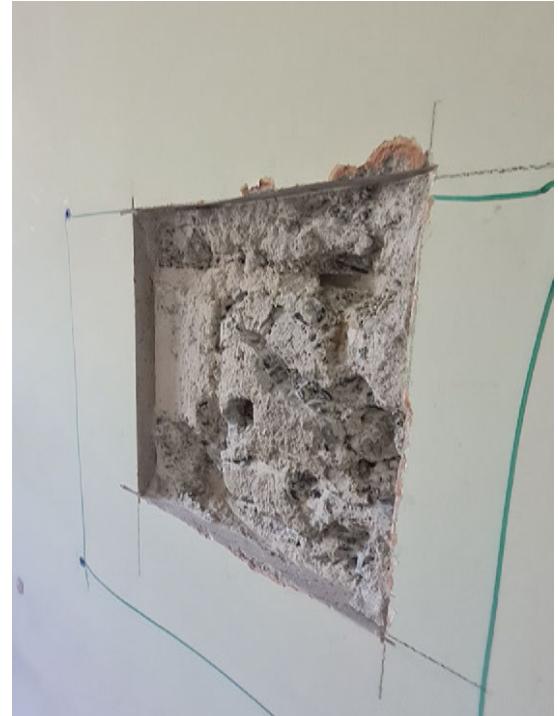
Following initial opening up works, the underlying structure of the internal partitions are visible. These walls consist of concrete blockwork inconsistent with the original construction.

Above: Opening up of Internal Partition Walls and internal/external wall junction

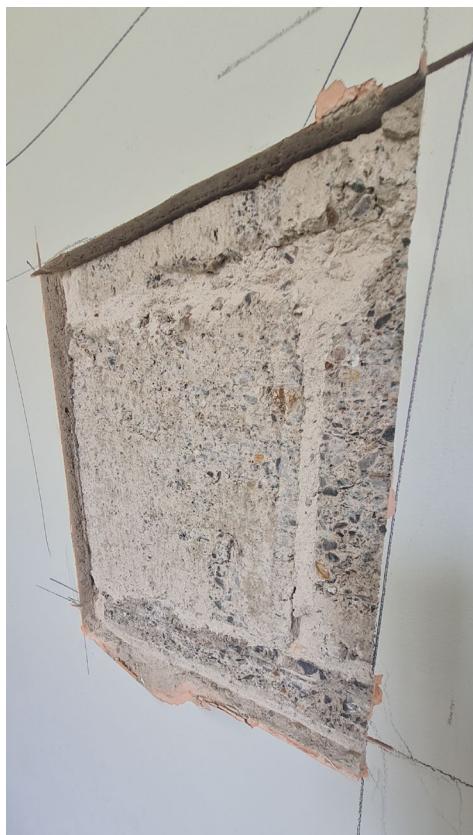
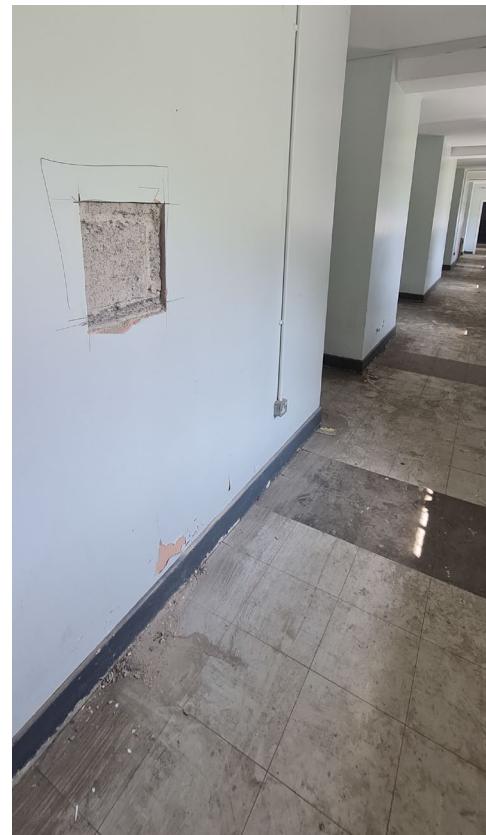
Above: Internal Corridor Wall opening up

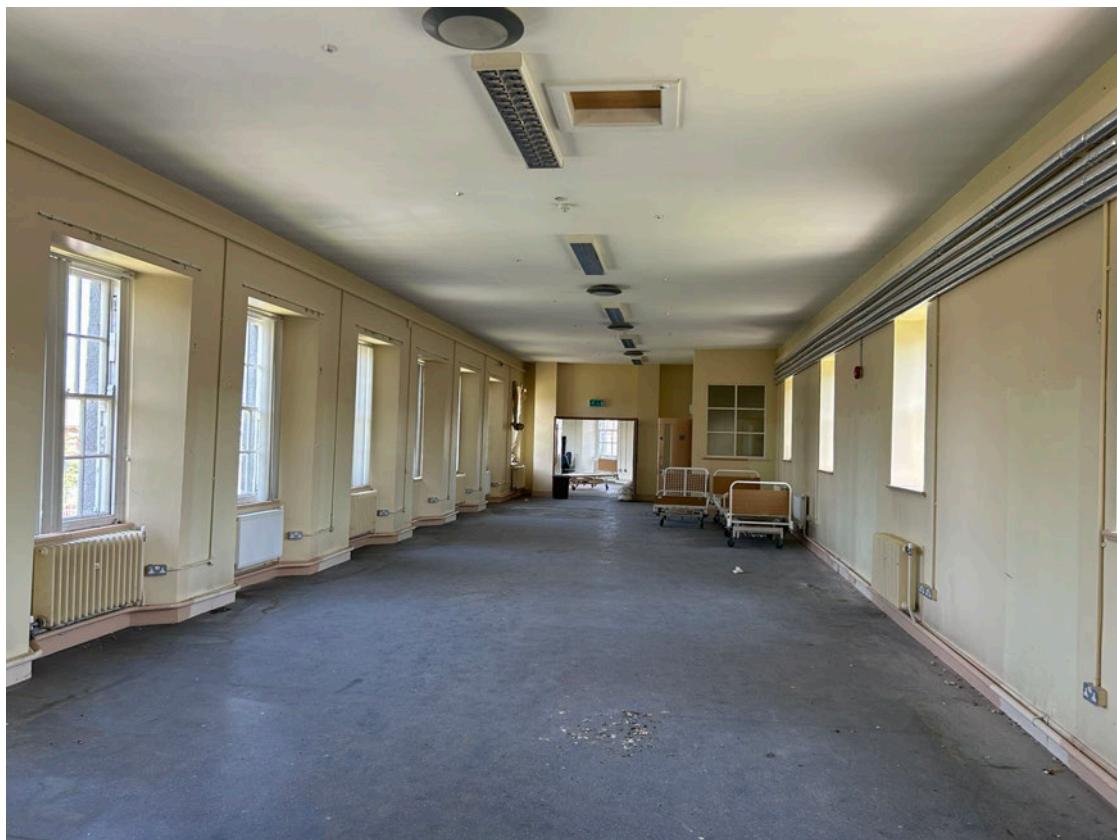
Above: Photo of Level 1 – no remaining internal walls exist

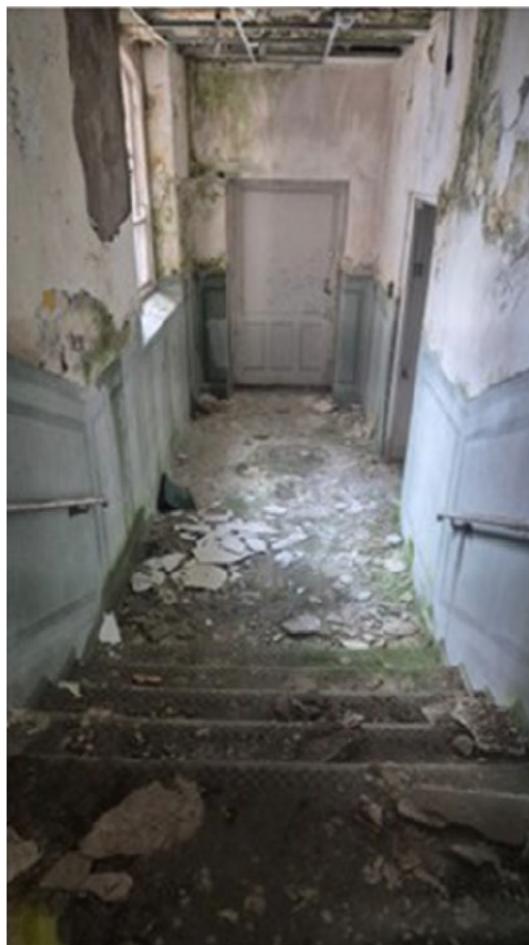
The existing plasterwork has failed in multiple areas because of water penetration and consequent salt efflorescence and biological colonisation. The plasterwork shows failure associated with moisture and salt-related deterioration processes (flaking paint, cracking of the plaster layers, granular disaggregate of plaster surface, salt efflorescence) as a result of moisture ingress from multiple pathways including external joint failures, and ingress via the roof and failure of the rainwater goods. The damage is widespread within the Gym Block at the link corridor and junction with the flat roof and extending into the gym itself, the lower ground floor of the NE Wing, the main stairway of the NE Wing and in what is known as the chapel on the first floor of the NE Wing. Further opening-up works are intended to take place on each level and the gym block to establish the extent and severity of plaster deterioration. In some instances, such as the chapel, the source of the incoming water has been addressed previously but the residual damage needs attending to.

Above: Gym Block Entry Way

Where the plasterwork shows failure beyond repair, it is proposed to be removed and walls left exposed for at least six months to allow desalination. The areas of sound plasterwork are to be retained as a basis for repair. This will remove extensive areas of defective material and impervious top plaster coatings which are inhibiting the breathing of the walls. From opening-up the wall a better sense of the buildings condition will be evident. The new lime plaster, once applied, will enable the walls to perform as designed and improve the appearance of internal finishes.

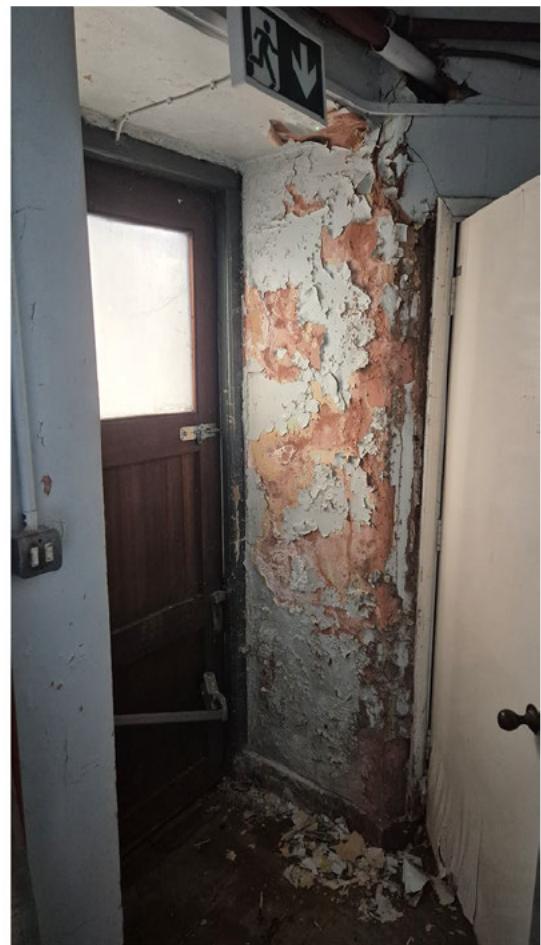
Above: Lower Ground Floor Conditions

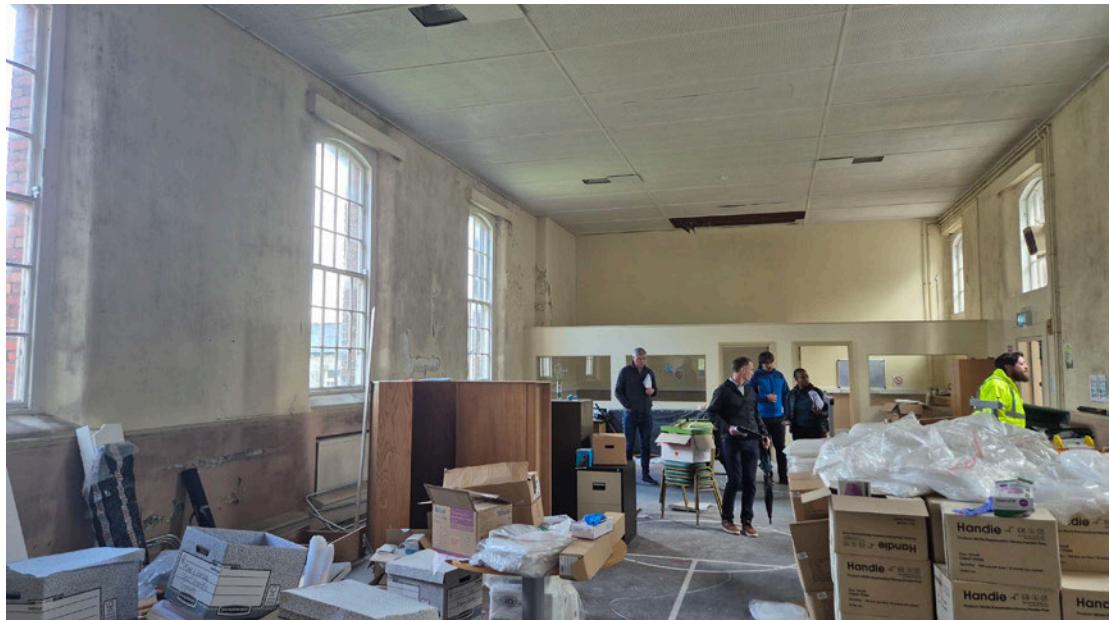
Above: Internal Conditions of gym block. Internal walls and suspended ceiling clear modern interventions

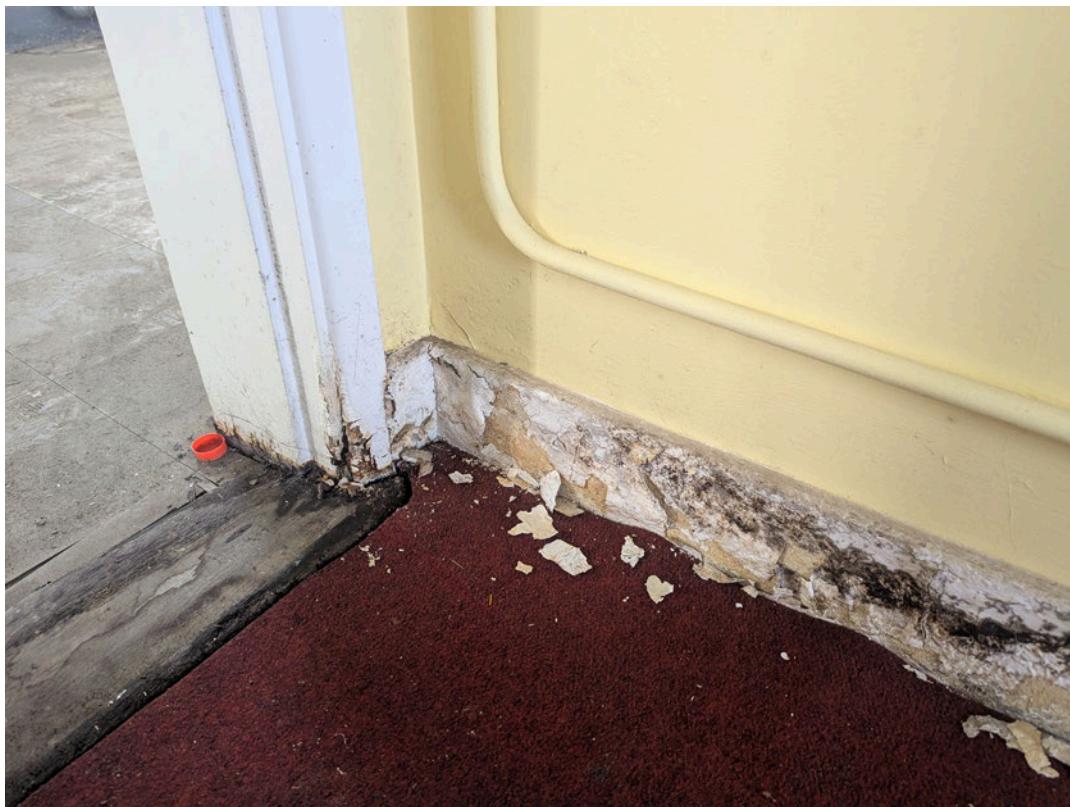
The existing concrete floor slab appears to lack a damp-proof membrane, as evidenced by saturated floor finishes, visible rising damp on residual furniture, and decayed timber skirtings and door frames. Although the original building dates back to the 1820s, the current concrete floor is not original. While concrete was used in some structures as early as the late 1800s, its widespread use in construction only became common in the early 20th century.

Above: saturated carpet, skirtings and rotten door frames

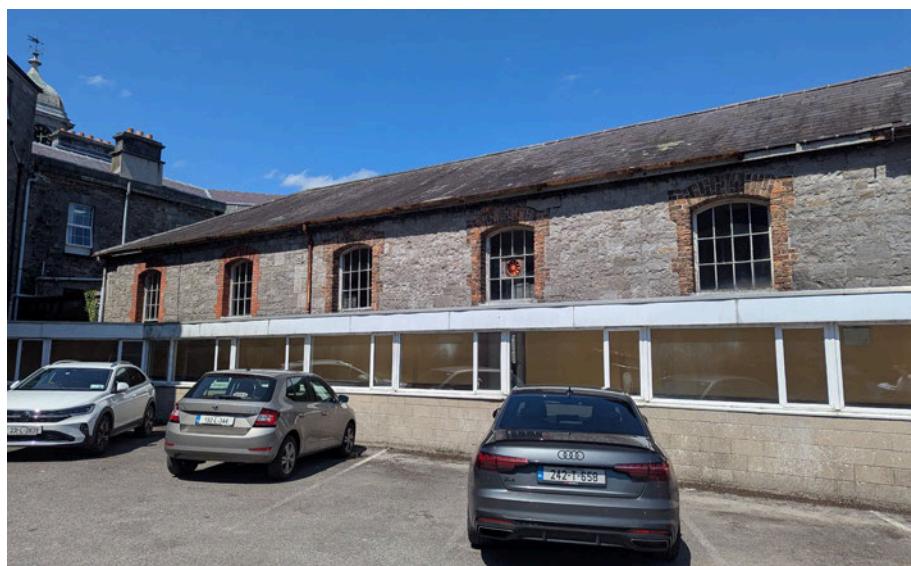
The link corridor to the south side of the gym block is a modern addition which is deemed obsolete. The corridor is built directly onto the exterior wall of the gym block which has been altered to accommodate it. The windows along the corridor have been raised, the original cill height indicated by the remaining window before the corridor. Internally, the formally exterior wall has been plastered over, covering the original stonework. Within the current footprint, between the main building, corridor and gym block is a contained, inaccessible space that is currently a point of overgrowth and visible dereliction.

Above: Modern Link Corridor

Due to it now being obsolete and no longer serving a function for the HSE, and its active distraction from the historic character of the building, the corridor is sought to be removed. Once the corridor removal has taken place, the cement-based render along the original stonework is to be removed. To restore the original condition of the building, localised repointing of brickwork to take place. Where windows and sill height were altered to accommodate link corridor, these alterations are to be reversed, using the existing original window opening as a point of reference to match sill heights and sash window design. With new access to junction between the main building and the gym block, plant growth can be removed and building condition assessed.

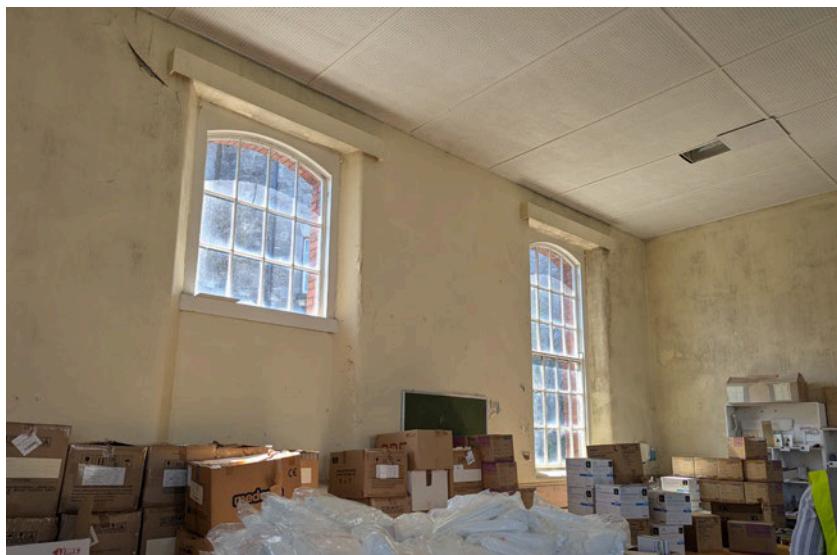
Above: Internal view of window alterations in Gym Block

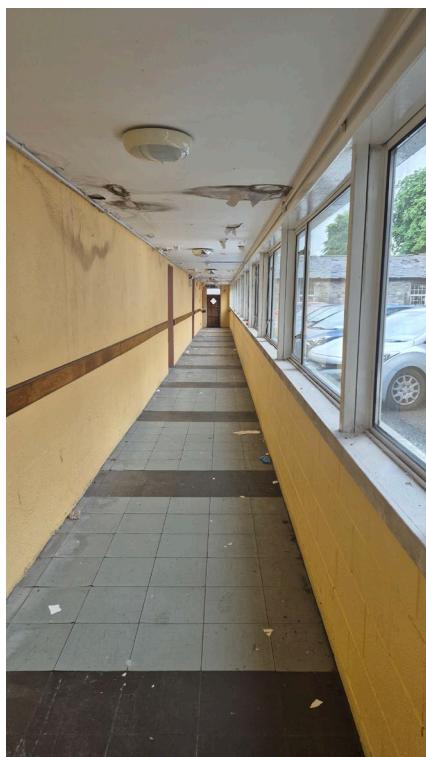
Above: Internal view of Link Corridor

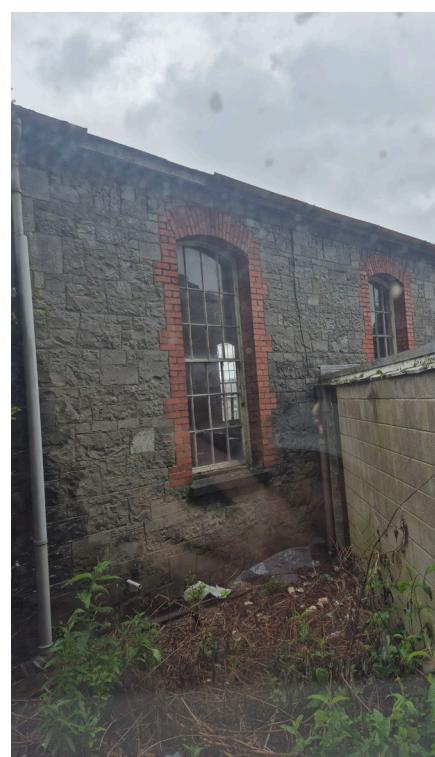
Above: Enclosed junction between Gym Block

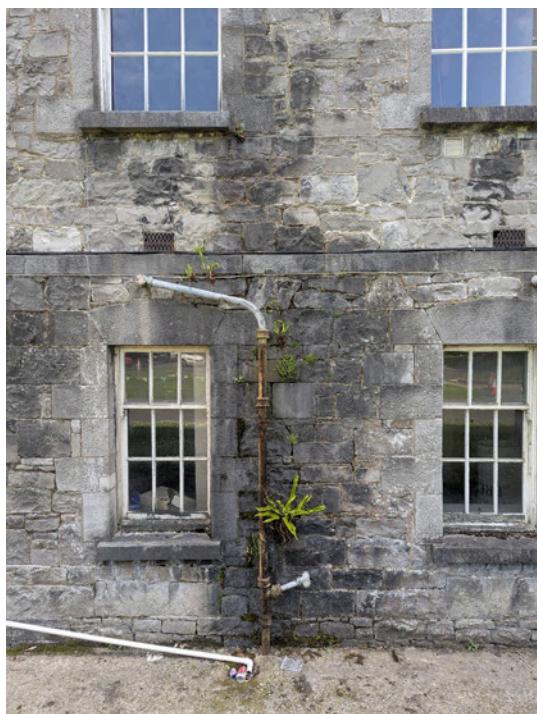
Above: Example of staining on North façade

It is necessary, for the long-term benefit of the building, to remove all existing cement-based pointing from the Northeast Wing and to repoint with a new lime-based mortar, more permeable than the surrounding historic masonry fabric in order to prevent future water-related failure of the external envelope and internal wall surfaces. It is also proposed to clean the stone staining.

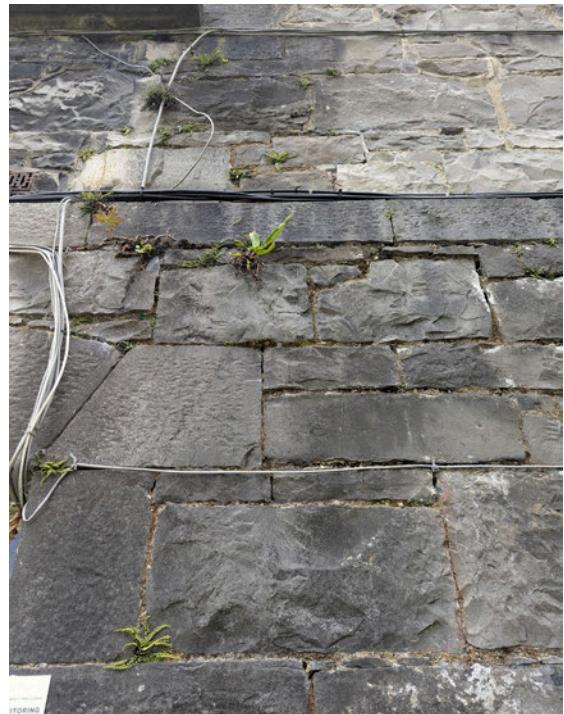
Above: Failed pointing and vegetation growth

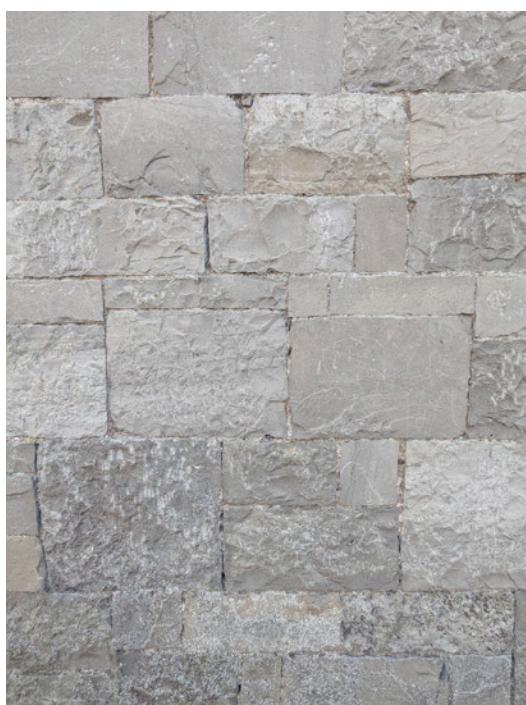
Above: Failed cement pointing

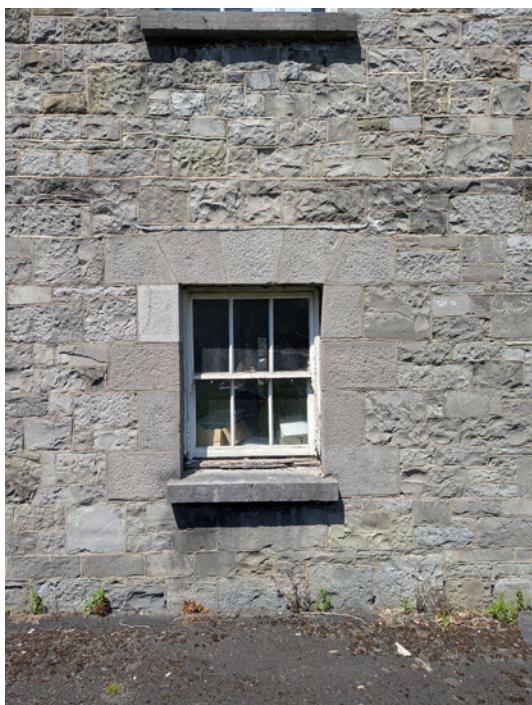
Above: Cement pointing largely intact on south elevation
