Re: Proposed Deletions from the Record of Protected Structures

Report to Members

Proposed Deletions from the
Record of Protected Structures of three buildings
located within the Functional Area of the
Newcastle West Municipal District:
Quilty's Thatched House, Ballinruane, Kilmeedy;
Flynn's Thatched House, Balliniska, Feohanagh;
O'Connor's Farmhouse, Clash North, Athea;

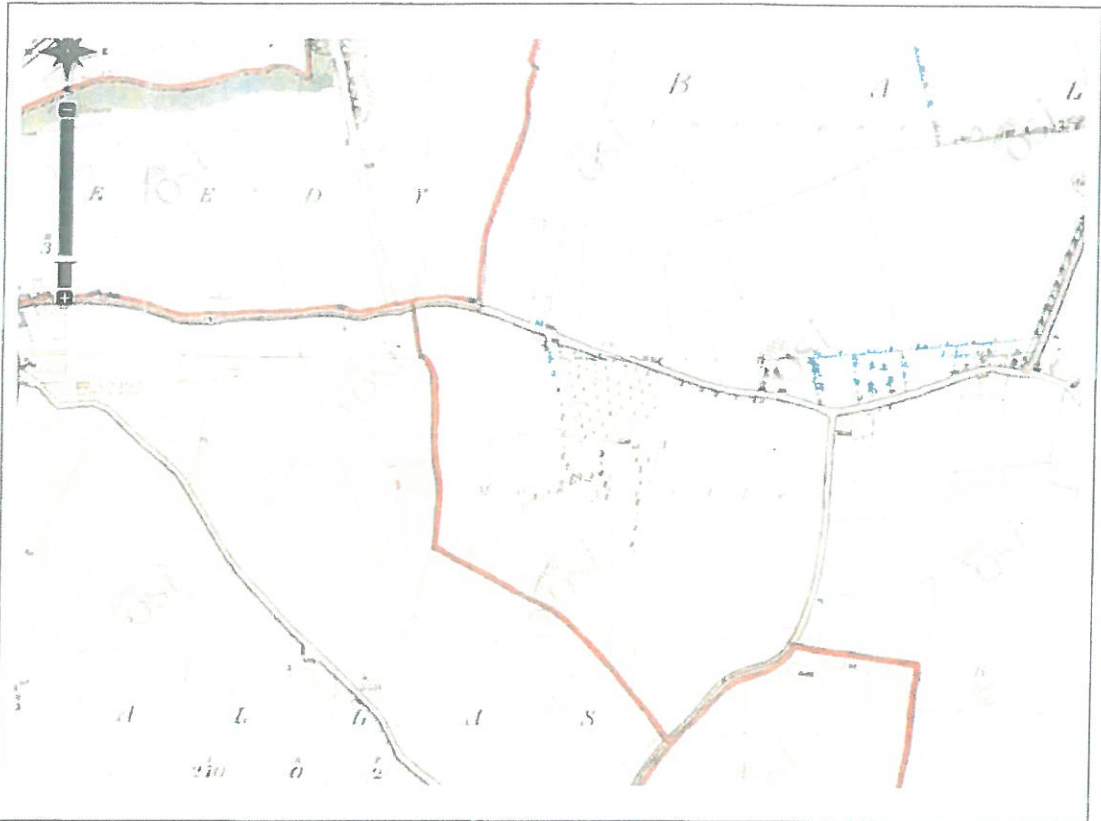
Fig. A(b): Quilty's Thatched House and its context with its accompanying shelter belts and gardens, as depicted on the Ordnance Survey's 6" Mapping dating to the 1840's. The location of the house is identified by the red reticule.

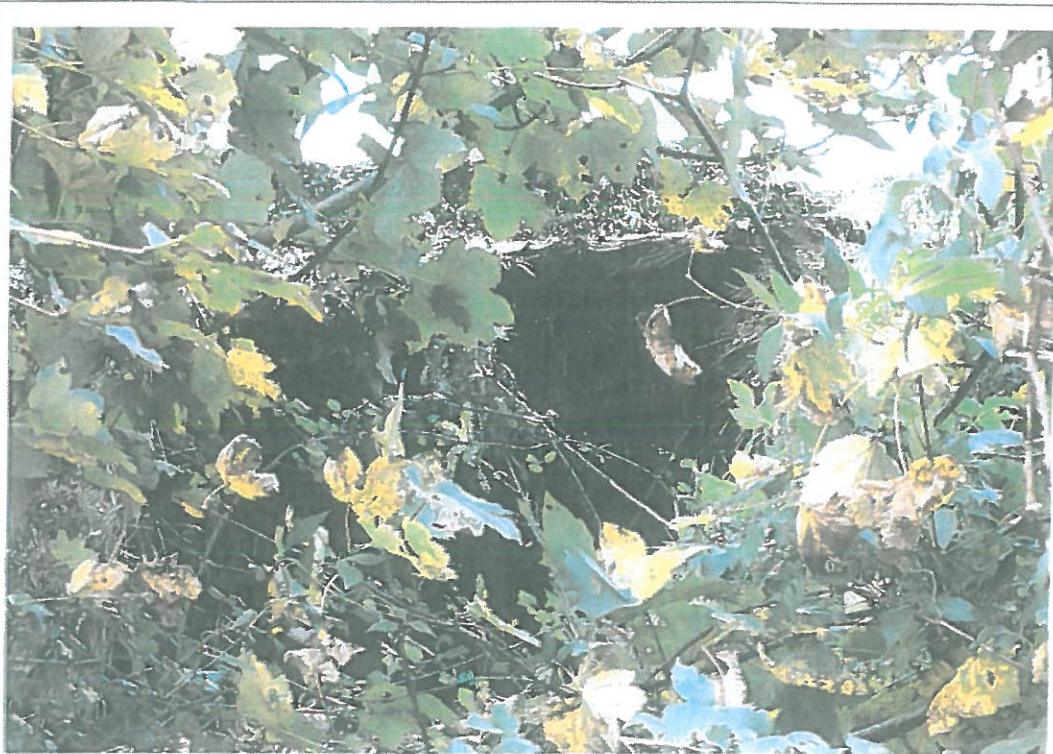
However, owing to the death of the grant recipient, and his elderly sister's consequent transfer to a nursing home on account of her frailty, the thatch fell into disrepair, allowing the elements to penetrate through to the roofing structure, which has suffered catastrophic failures in places (See Plates A1 and A2). These are impacting upon the structural soundness of the building- with a significant deflection (See Plate A3) and a number of cracks (See example contained in Plate A4) noticeable on the rear wall. Consequential failures and the establishment of wet and dry rots are to be seen within the building (See Plate A5).

Plate A2: Close up view of the collapsed area encircled in Plate A1.

As the property is considered to be beyond economic repair, it is recommended that Quilty's Thatched House, at Ballinruane, Kilmeedy, County R.P.S. Reg. No. 52, be deleted from the Record of Protected Structures maintained by Limerick City and County Council as it is considered that its protection is no longer warranted.

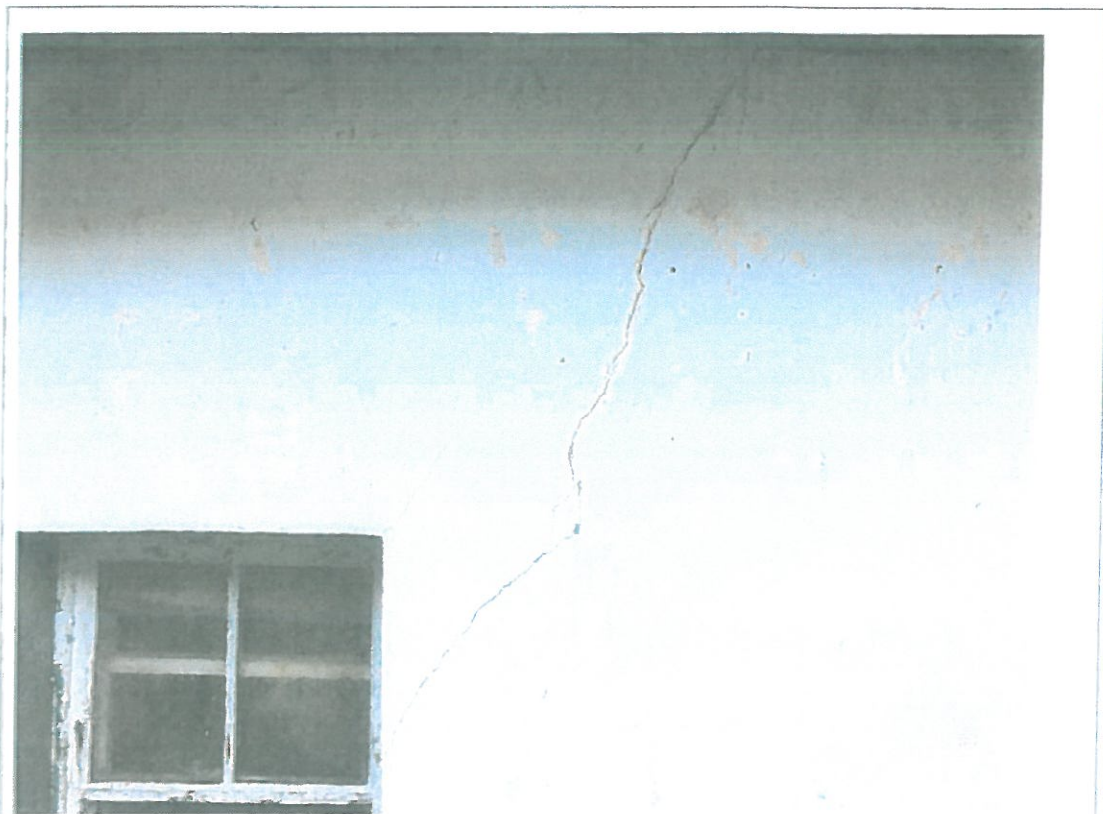
Plate A4: View of another diagonal crack in the rear wall of Quilty's, this one rising from a window opening up towards the eaves level of the house.

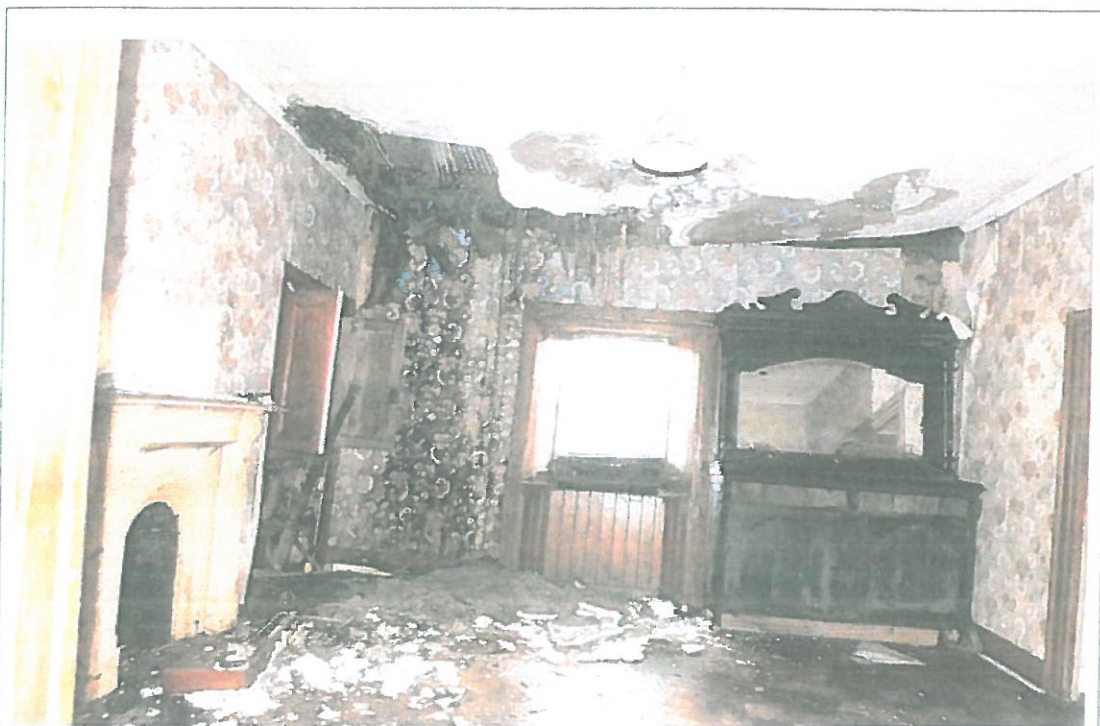
Plate A5: View of the parlour of Quilty's thatched house showing the collapsing ceiling beneath the failed roof and the evidence for rots across the ceiling.

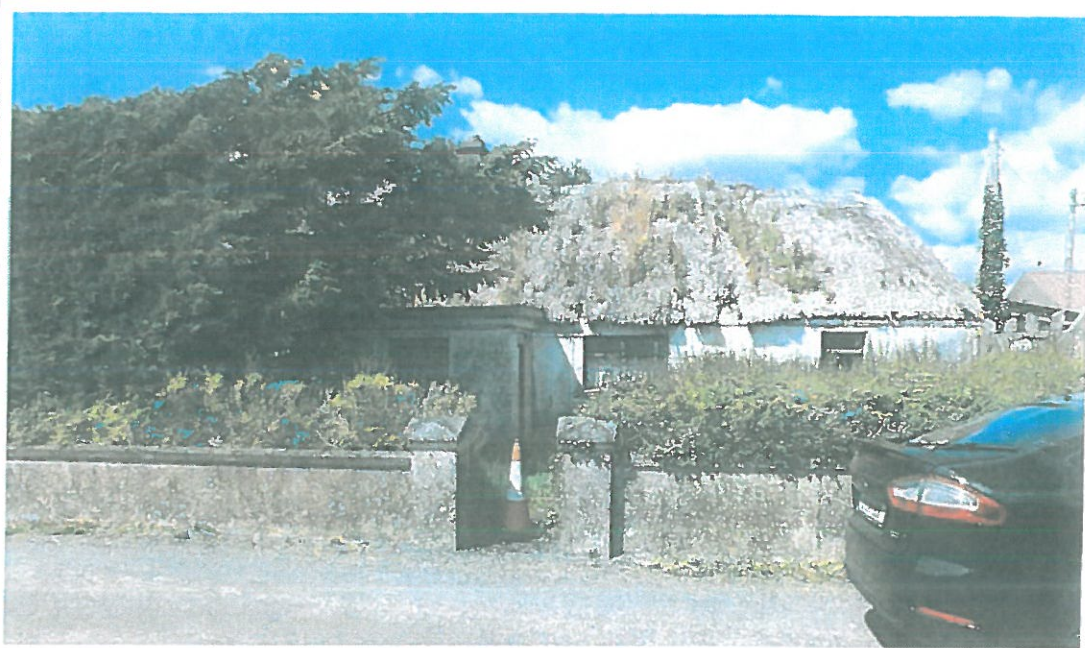
However, owing to the death of the then owner / occupier, the thatch fell into disrepair, allowing the elements to penetrate through to the roofing structure, which has suffered catastrophic failures in places (See Plates B1, B2, B3, and B4). These are impacting upon the structural soundness of the building- with a significant number of cracks (See example contained in Plate B4) noticeable on the rear wall. Consequential failures and significant collapses are to be seen within the building (See Plate BA5).

Plate B1: View of the principle (southern) elevation of Flynn's Thatched House from the roadside. Masked by the overgrown trees forming a hedgerow, the areas to the west of the porch have collapsed, while much of the remainder of the roofing cover has become invaded by plant growth.

Flynn's Thatched House, Record of Protected Structures County Reg. No.: 153, which is exhibiting significant structural failures, is considered (having regard to the cancellation of many conservation grant measures) to be beyond economic repair.

As the property is considered to be beyond economic repair, it is recommended that Flynn's Thatched House, at Balliniska, Feohanagh, County R.P.S. Reg. No. 153, be deleted from the Record of Protected Structures maintained by Limerick City and County Council as it is considered that its protection is no longer warranted.

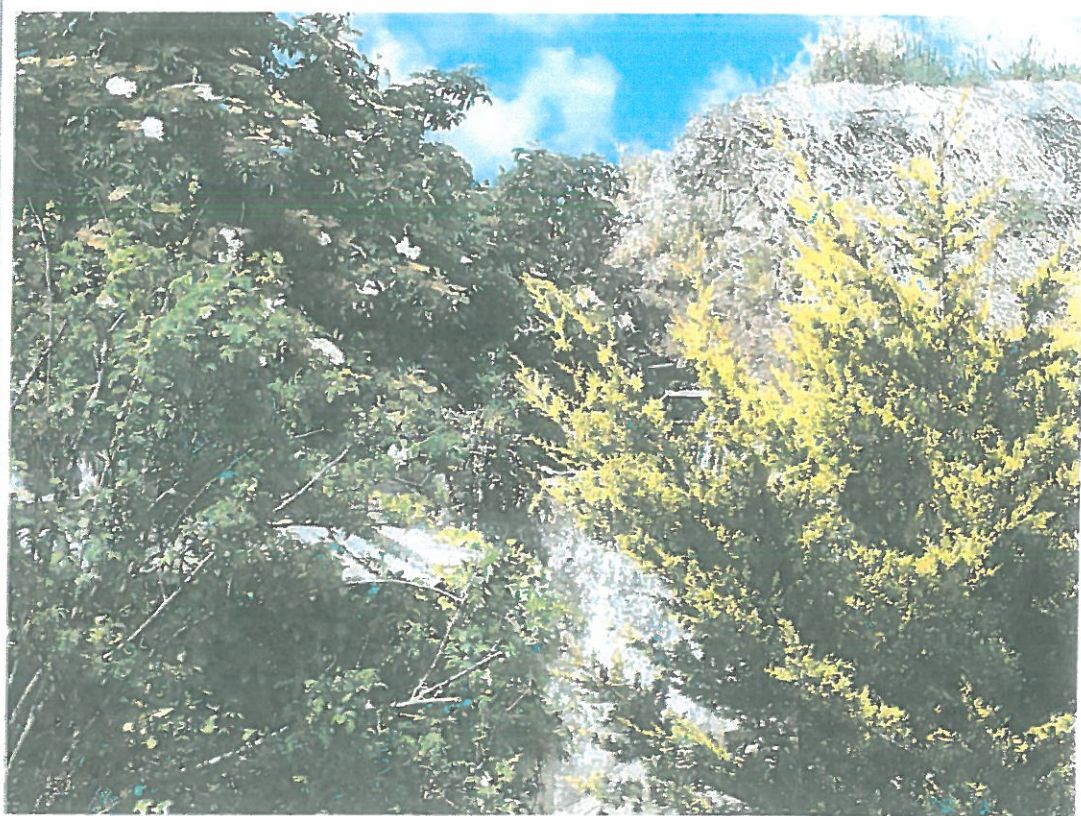
Plate B2: Close up view of the collapsed area at the western end of the thatched house (See Plate B3 also).

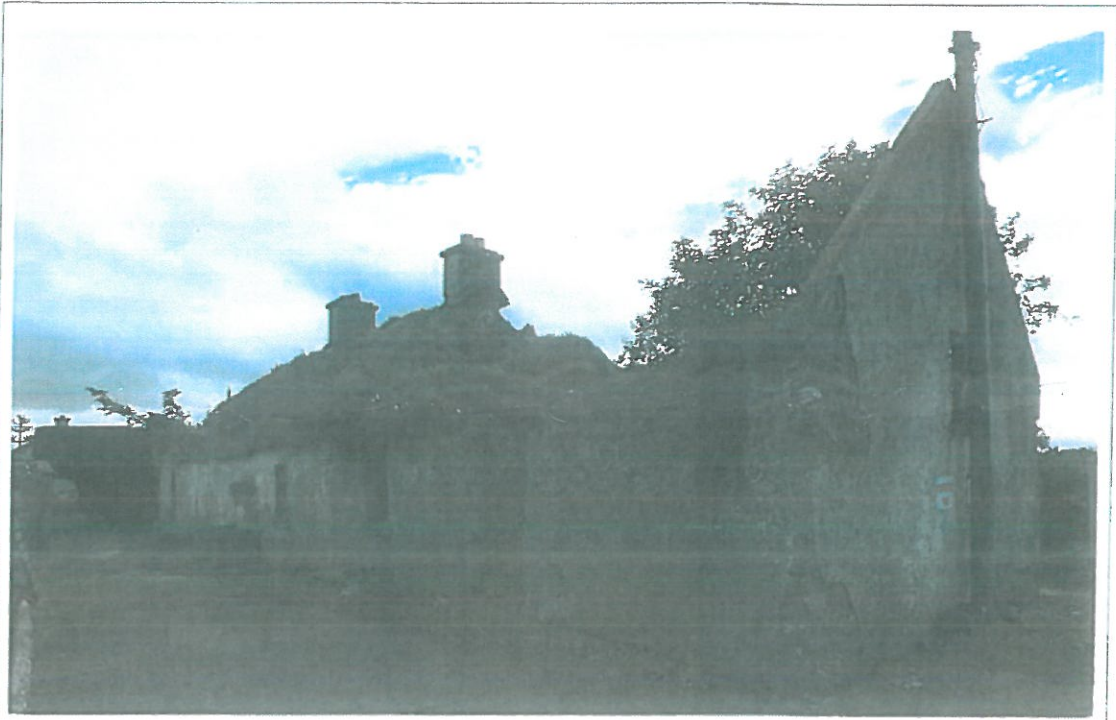
Plate B3: View of the rear wall of Flynn's Thatched House from the north-west showing the extent of the collapse shown in Plate B2.

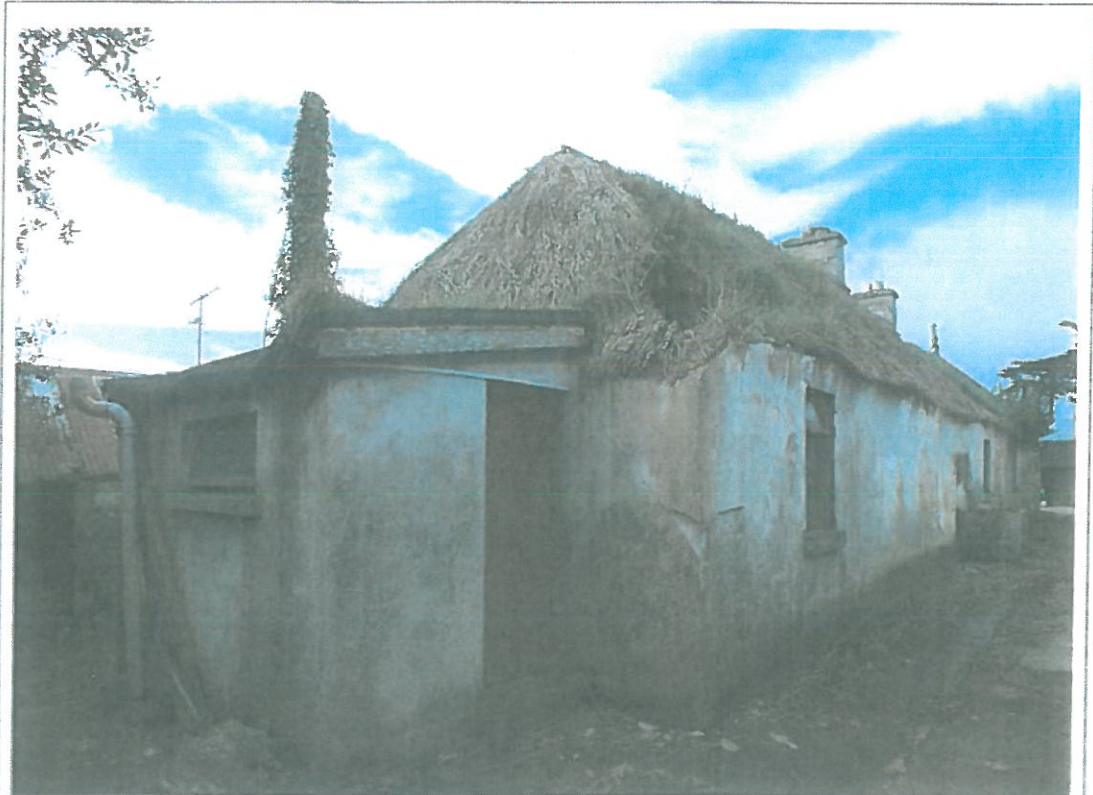
Plate B4: View of the eastern end of Flynn's, from the east-north-east. Note the void in the roofing cover, which has allowed moisture to penetrate with a consequent failure in the timbers forming the hip which have resulted, apparently, in a severe crack occurring on the return.

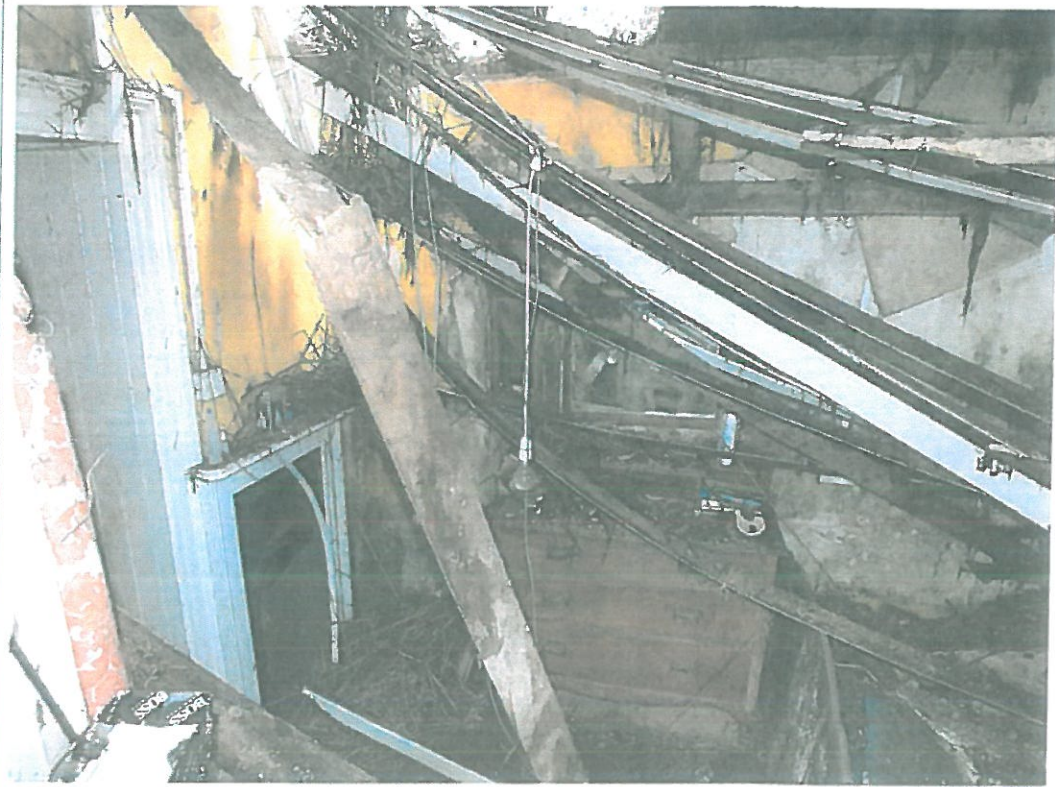
Plate B5: View of the bedroom at the eastern end of Flynn's Thatched House showing the collapsing ceiling beneath the failed roof.

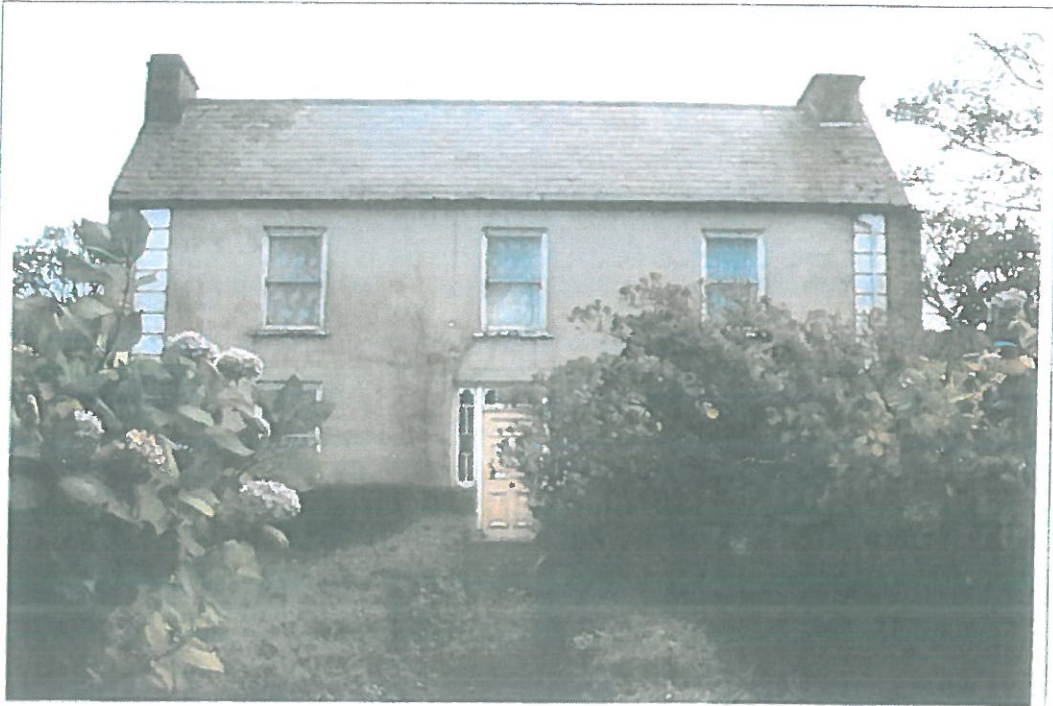
Report: Mr. O'Connor, having received planning permission in 1999 to demolish an early 20th century house, and to construct a bungalow on the location, decided on foot of the publicity surrounding the introduction of the protected structures' legislation to retain the building (See Plate C1) and to seek grant aid to conserve and restore it.

Plate C1: View of the principle (northern) elevation of O'Connor's Farmhouse, dating to November 2000. Apart from the timberwork, the only painted elements are the stucco quoins, which are not in line with the building's returns.

As the property is considered to be outside the scope of the built heritage legislation, it is recommended that O'Connor's Farmhouse, at Clash North, Athea, County R.P.S. Reg. No. 252, be deleted from the Record of Protected Structures maintained by Limerick City and County Council as it is considered that its protection is no longer warranted.

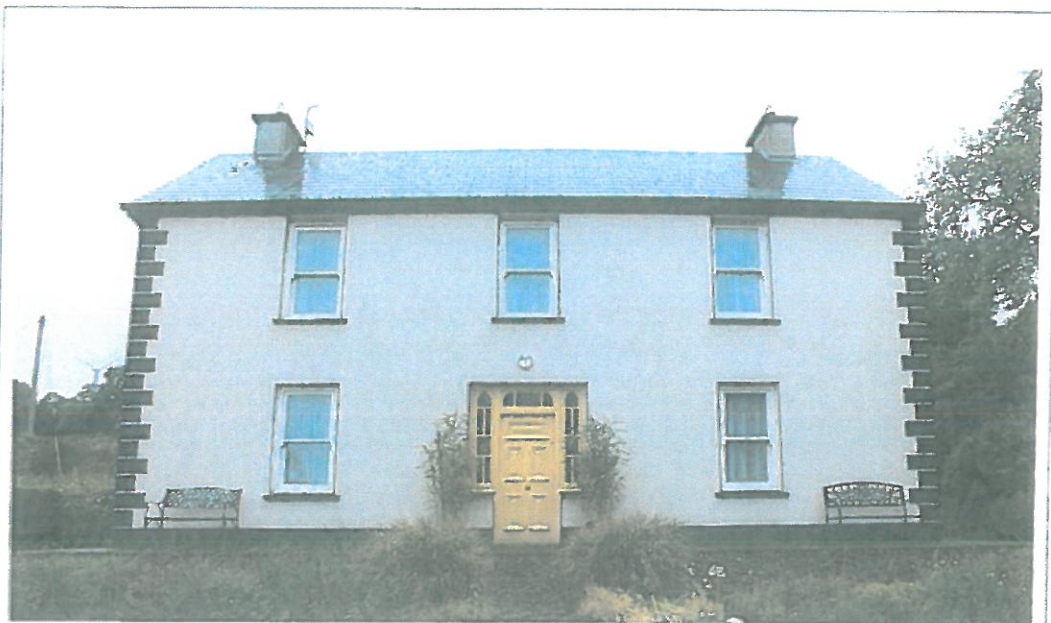
The planning authority is of the view that this should be accepted as distinguishing and important original fabric, such as the natural slate roofing cover (referred to specifically in Mr. O'Connor's original request to have the building added to the R.P.S.), glazing, and rainwater goods have been lost.

Plate C2: The current appearance of O'Connor's Farmhouse. In addition to the removal of historic fabric the building has been widened so that the chimneys, which themselves have been altered, are no longer in line with the gables.

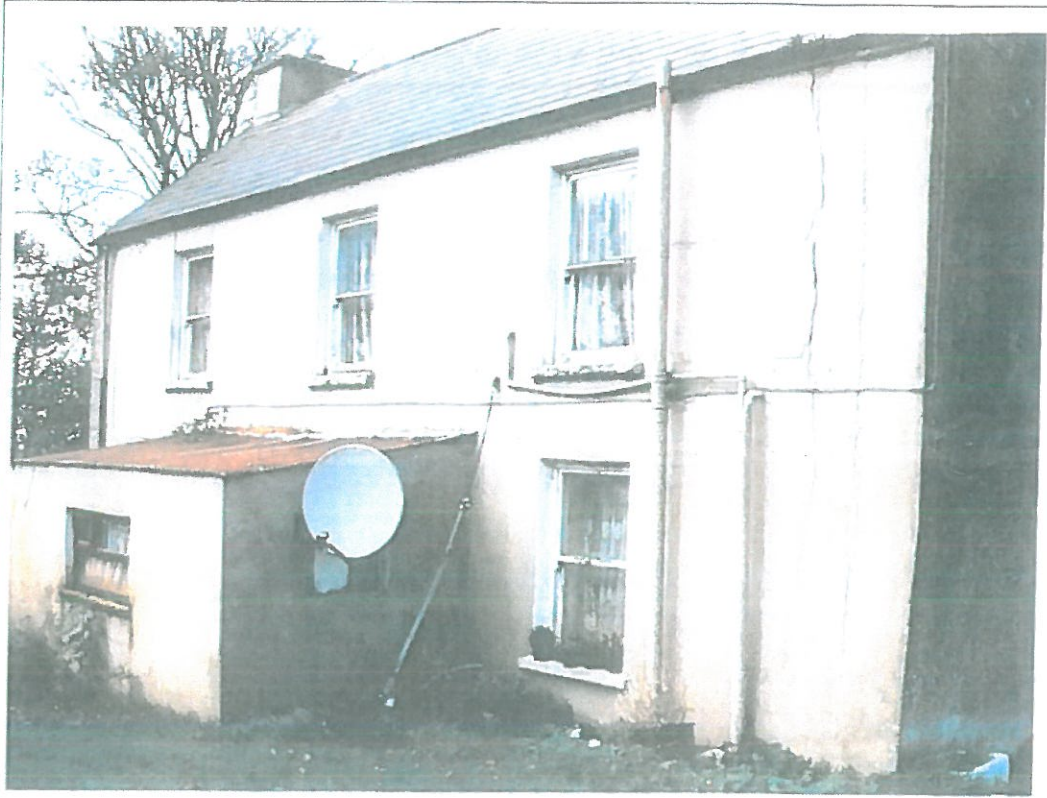
Plate C3: View of the southern (rear) elevation of O'Connor's Farmhouse, dating to November 2000, taken from the south-east.

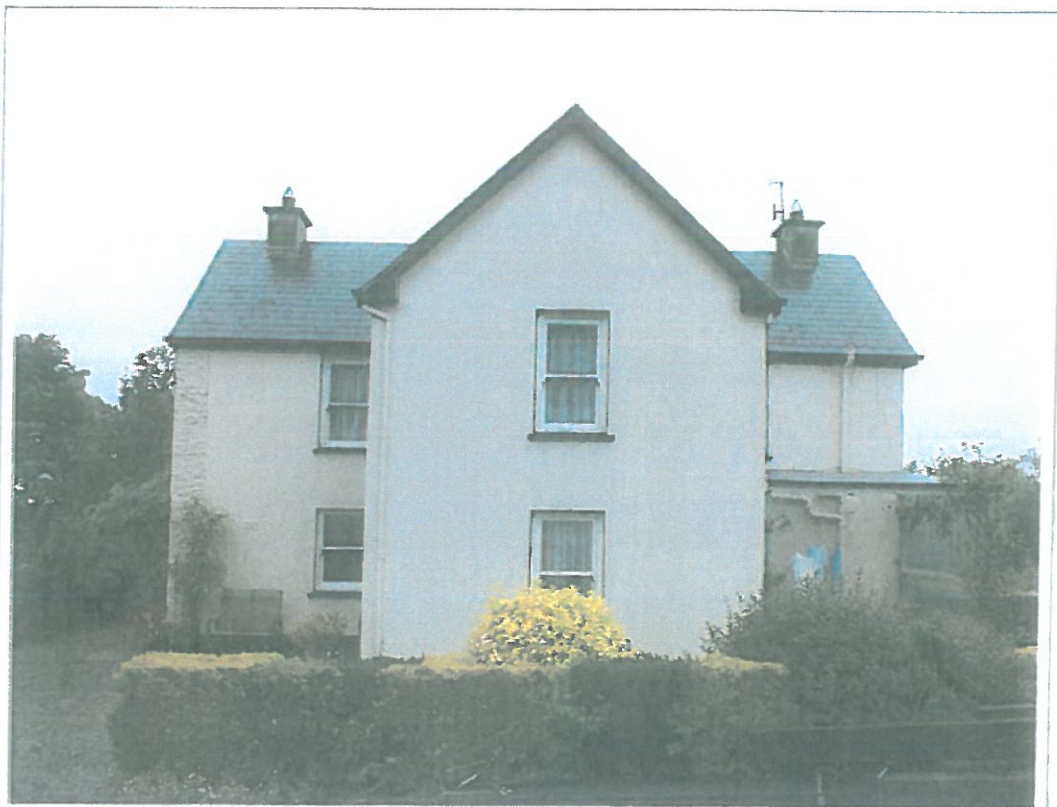
Plate C4: Current view of O'Connor's rear elevation, taken from the south.
