Walkability Assessment:

Three Bridges

Limerick Pedestrian Network

Route:	Three Bridges Walk
Assessment Date(s):	28 June 2020
Observations, mapping & report by:	Seamus Ryan & Aidan Hogan

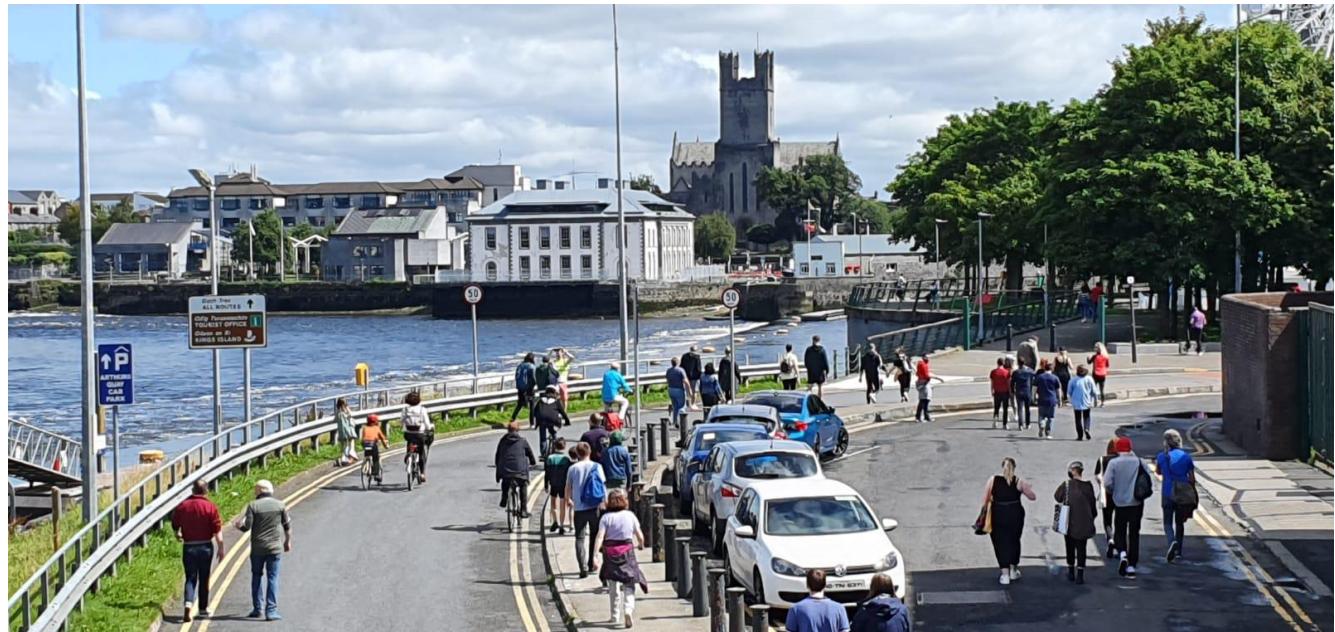
This 100 – 200m stretch between Sarsfield Bridge and Arthur’s Quay Park is the weakest link in the Three Bridges chain. The continuity of the walk is interrupted, requiring the pedestrian to execute two unassisted road crossings in order to continue on the Three Bridges route.

Absence of Safe Crossing Point (1) - There is no footpath under Sarsfield Bridge on the river side so pedestrians must (and we have observed pedestrians doing so) cross the road without any way of stopping traffic. Likewise there are no drop kerbs to facilitate wheelchair users.

Defective Pedestrian Signals - The traffic lights across Honan's Quay to Arthur's Quay Park are confusing and dangerous for the pedestrian. As half of the road has been blocked off for years as part of the old Dunnes site, a pedestrian coming from the quays finds themselves on the centre median, where there is no pedestrian crossing button. To access the button, they have to cross half of the street, press the button, and then return to the centre median. Neither pedestrian crossing button appears to be working to summon a green man. Fault verified numerous times, waiting for 10 minutes each time with no success.

- In the immediate term, **fix the pedestrian lights** between Honan's Quay and Arthur's Quay
- Provision of two **raised pedestrian crossings** (one quayside and one between Honan's Quay and Arthur's Quay Park)
- Provision of c. **100m of new footpath** on both sides between Sarsfield Bridge and Arthurs Quay Park.
- Slight **realignment (chicane) of the road** approaching Sarsfield Bridge to reduce the speed of motor traffic travelling under the bridge
- While the above recommendations assume the retention of the existing road use and are 'incremental' in nature, Limerick Pedestrian Network recommends a more fundamental change to the road use in this area, namely **removing through-traffic from the South Quays** to provide a truly pedestrian priority zone. See Recommendation no. 3 for further detail.

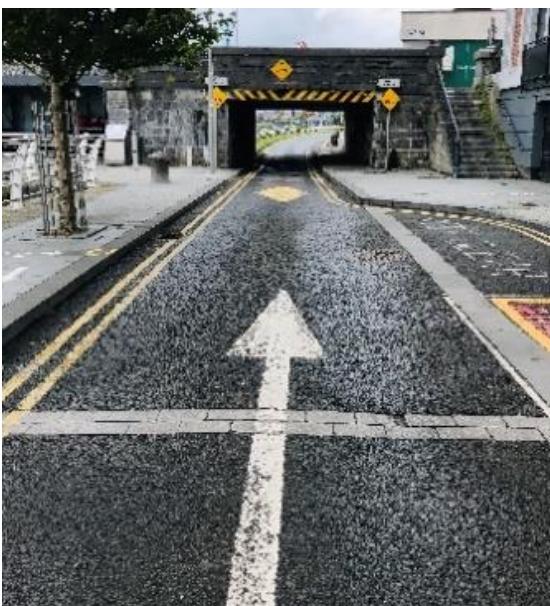
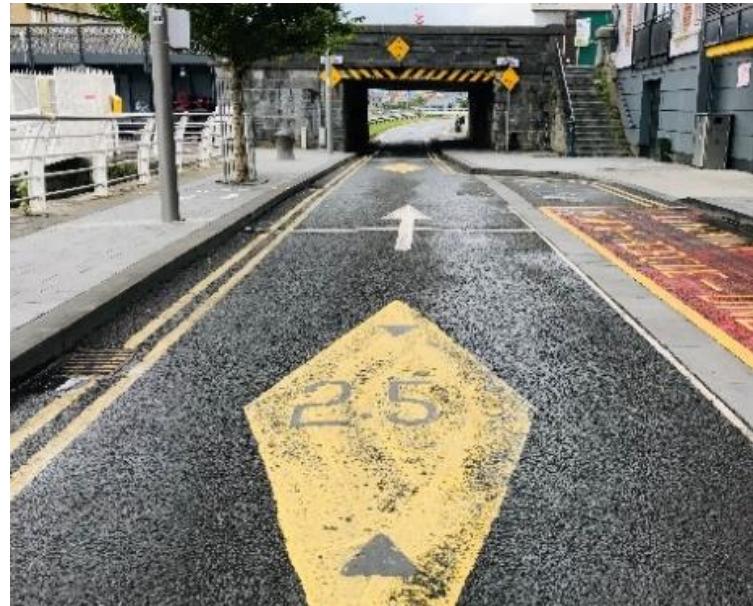
Clear Priority for Motor Traffic - Approaching the Sarsfield Bright underpass, there is clear priority for cars. Arrows painted on the road encourage motorists to go faster, which they do. All the 'caution' signage is aimed at protecting the bridge and vehicles. There is no signage or visual signals to warn drivers of damaging pedestrians. While the relatively narrow carriageway width acts to slow speed slightly, cars get a straight and unobstructed path under the bridge, whereas pedestrians must cross the road with no drop kerbs or zebra crossing to help.

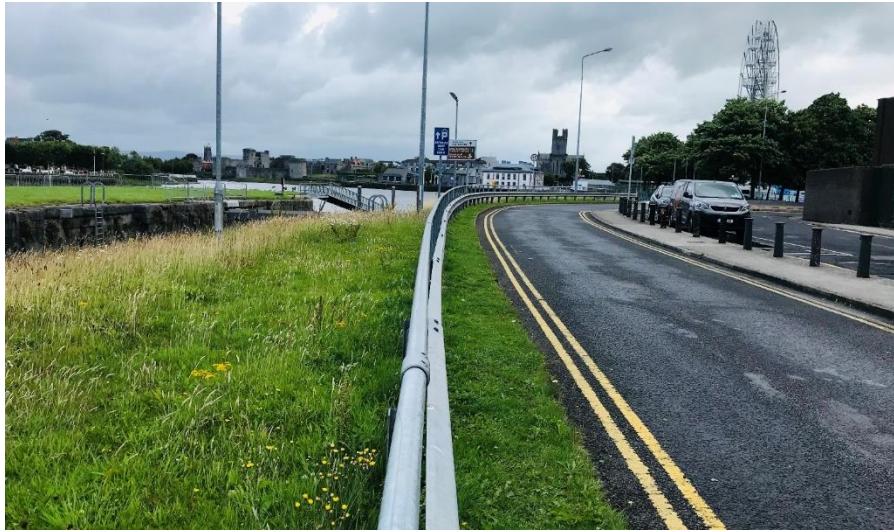
Absence of Footpath on River Side - There is room on the left here for a pedestrian pathway on the river side to provide a continuous and safe link from the quays to Arthur's Quay Park. Installing a pathway here would very much alleviate the current problem where pedestrians have to negotiate a narrow path before looping back into the park.

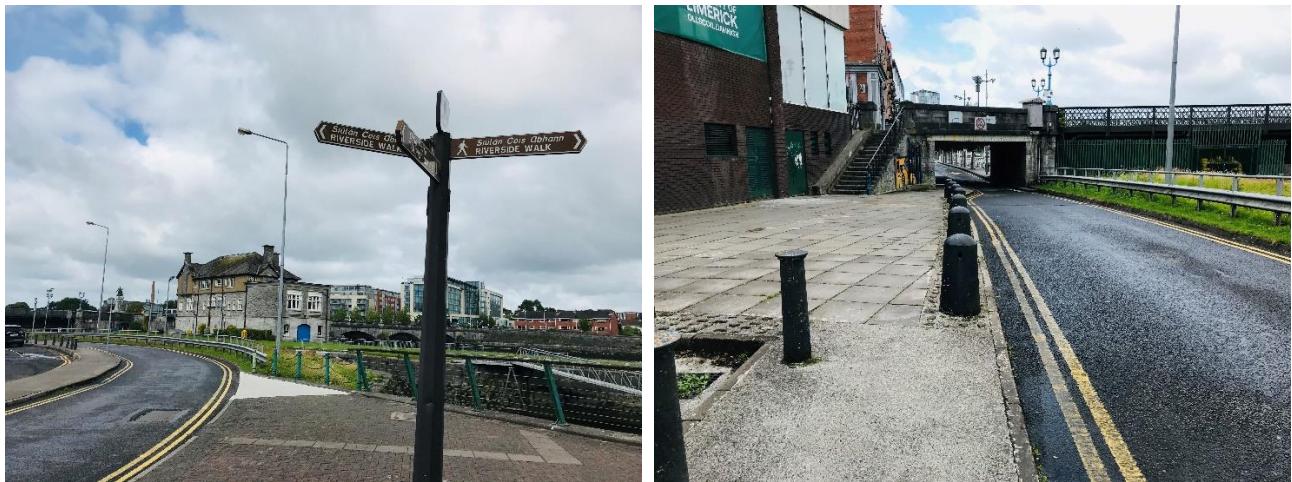
Absence of Safe Crossing Point (2) - Away from the traffic lights, the beginning of the path on the Arthur's Quay Park side offers a dropped kerb but there is no corresponding dropped kerb on the other side of the street.

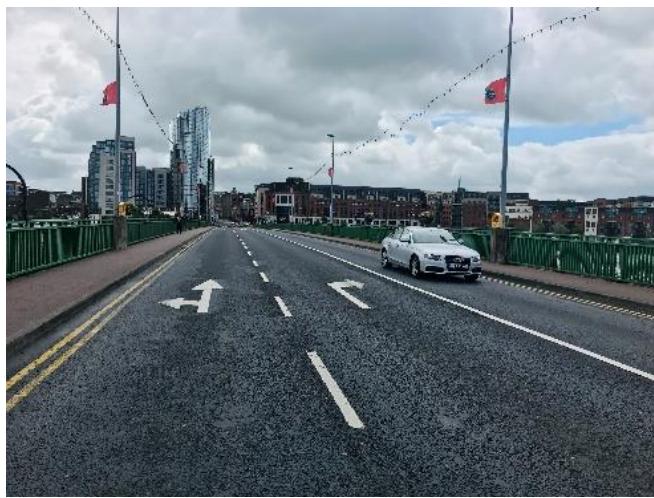
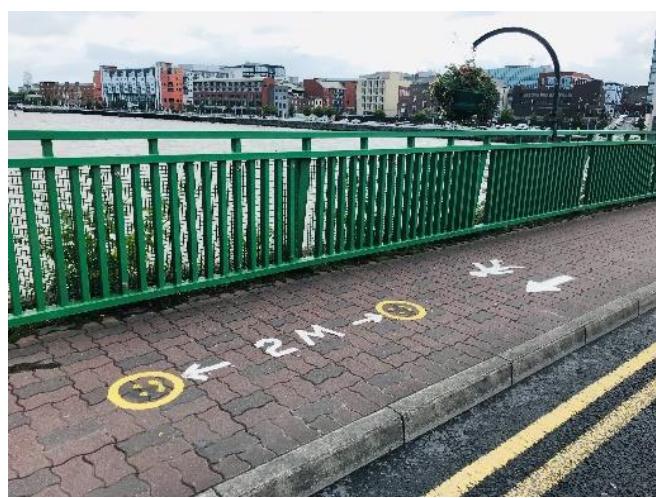
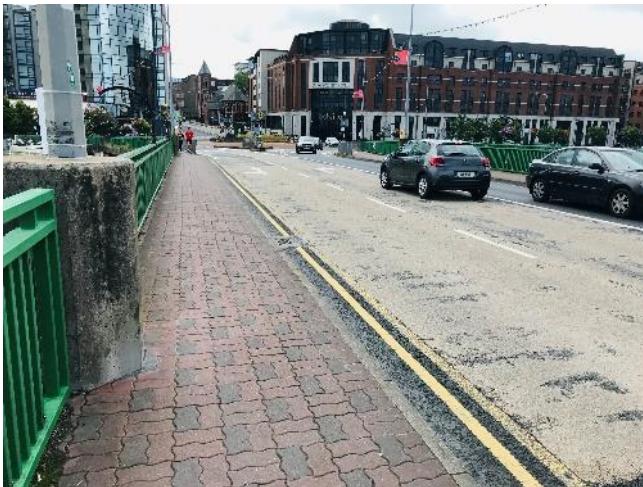
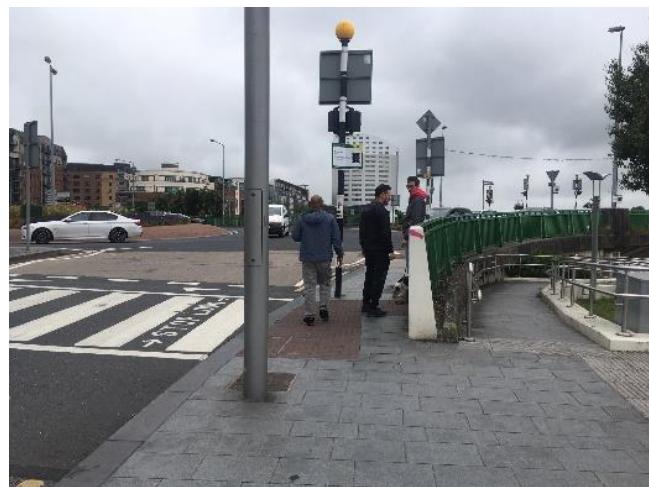
- **Poor Space Allocation** - 3 lanes of traffic (at least 8m) for motor traffic compared with 1.8m footpaths for pedestrians. Note that there is not enough room to paint the 2m COVID social distancing arrows *across* the footpath width!

- **Pinch Points Along Bridge** - Note that concrete encasements of light poles further reduce the effective width of the footpaths to 1.55m.
- **Pinch Points at Ends of Bridge** - The zebra crossings encircling the Shannon Bridge roundabout are needed and welcome, though the paths leading to some of them could benefit from more space for pedestrians.

- **Improvements after introduction of the cycle lane** - As this report was underway, a two-way cycle lane was added to the Shannon Bridge. Although it does not add any space for pedestrians, the new lanes separate the pedestrian from motor traffic and make a dramatic improvement in the pedestrian experience on the bridge. We advocate for the retention of the lane.

- **All 4 Bridges - Narrower carriageways and wider footpaths on all 4 bridges**, with the wider footpaths provided on the side with heaviest footfall i.e. the side used by those walking the three bridges route. See example below for Thomond Bridge

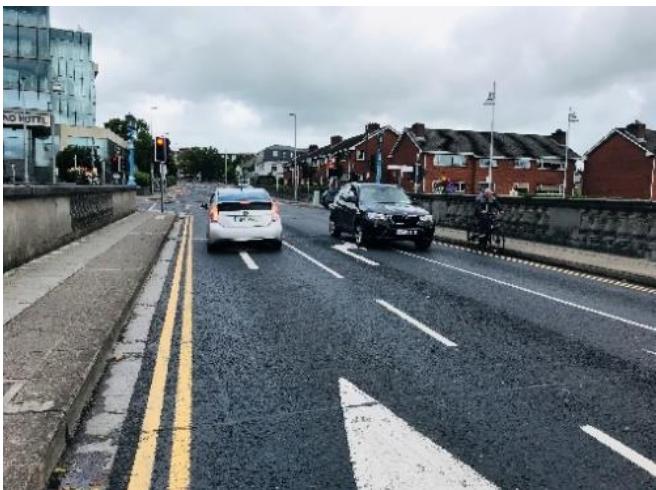
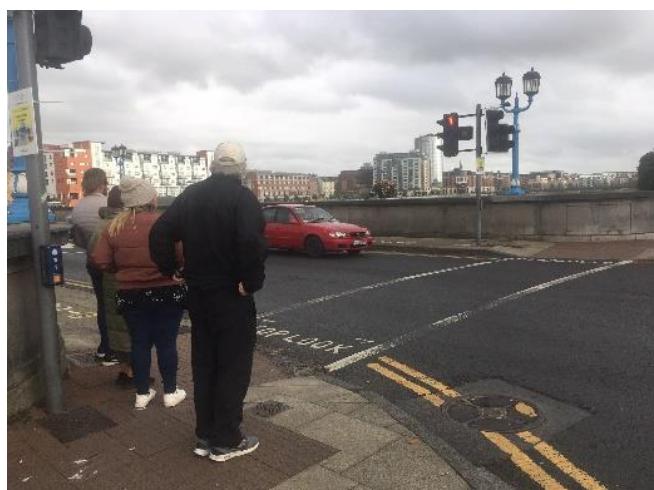
- **Poor Space Allocation** - 2-3 lanes (c. 7m) allocated for motor traffic, with 1.8m wide footpaths.
- **Pinch Point at Crossing Point** - the pedestrian crossing at Sarsfield Bridge and Clancy's Strand is a pinch point for pedestrians, partly due to the relative narrowness of the path on Sarsfield Bridge and partly due to the curved path at the junction to facilitate motor traffic turning the corner. There isn't enough room to pass when anyone is waiting for the green man.
- **Excessive Wait Time** - The waiting time to cross is excessive and unduly favours motor traffic to the detriment of pedestrians.

- **Thomond Bridge - Improved safety measures** at the zebra crossing on the Thomond Bridge arm of the junction with Clancy Strand.
- **Thomond Bridge - Provision of a zebra crossing** at on the Clancy Strand arm of the junction with Thomond Bridge
- **Matthew Bridge - Realignment of the Rutland Street carriageway** to remove the right turn lane, thus addressing the pinch point at the bridge and providing a pedestrian area in front of the Hunt Museum deserving of one of Limerick' main attractions.
- **Sarsfield Bridge - Shorter pedestrian wait time** at the lights to give increased pedestrian priority.

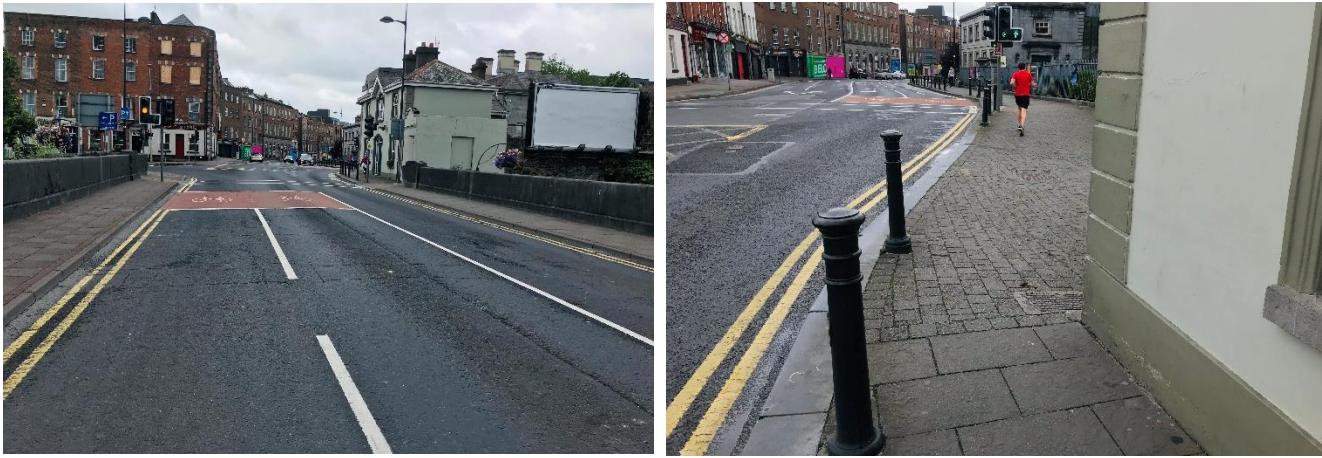
Matthew Bridge

- **Poor Space Allocation** - 2-3 lanes (c. 7m) allocated for motor traffic, with 1.8m wide footpaths by comparison.

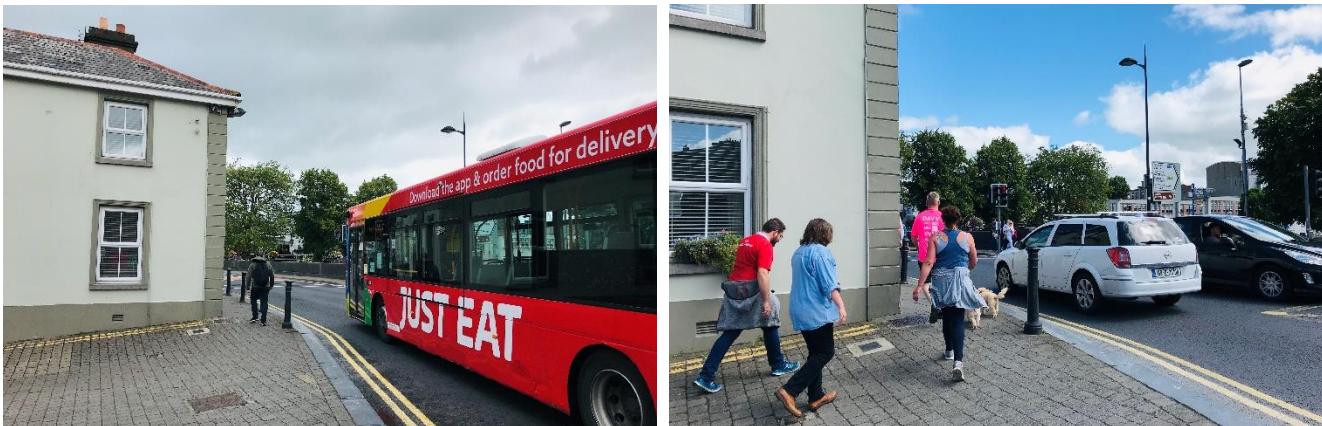
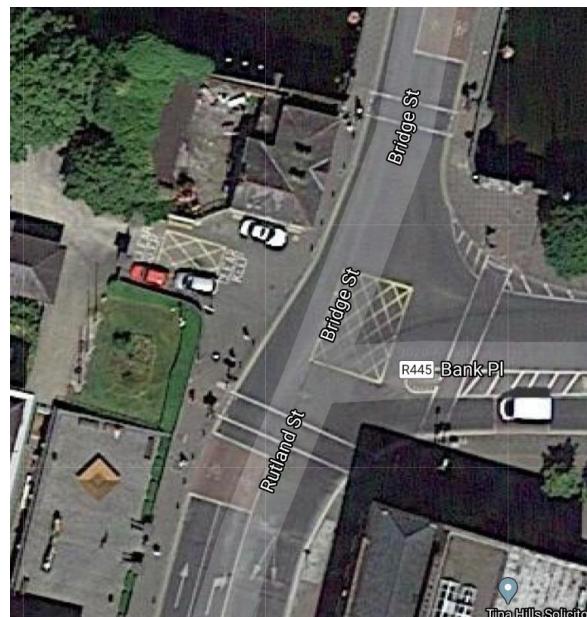
- **Pinch Points at Ends of Bridge** - At the Hunt Museum side of the bridge, the footpath narrows further at the corner of a building, with the effective width at this point reduced yet further with the placement of a bollard within the already narrow footpath space. This presents a safety issue as pedestrians must step out into traffic to pass one another. Note how the pinch point is created as a result of requiring enough road space for four lanes of traffic on Rutland Street.

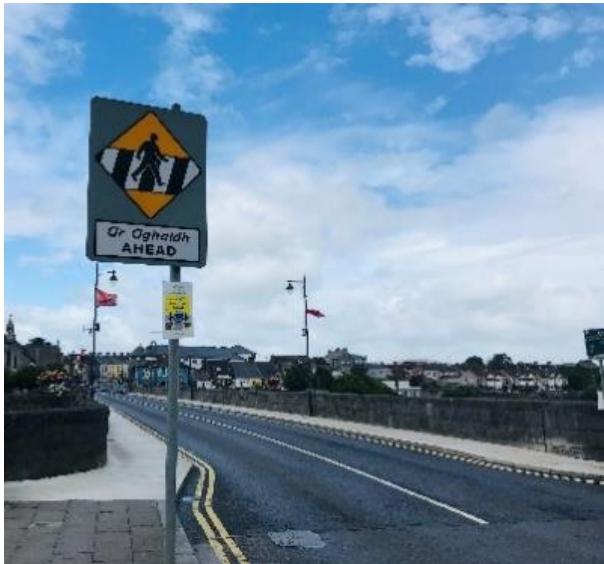
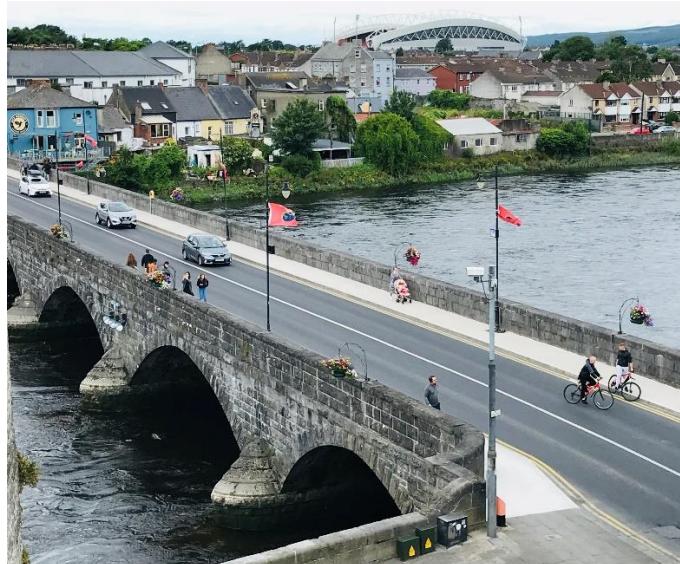
Thomond Bridge

- **Poor Space Allocation** - Two lanes (c. 6m) allocated for motor traffic, with 1.8m wide footpaths by comparison on the bridge that leads to our city's historic medieval quarter and our best known landmark, King John's Castle.

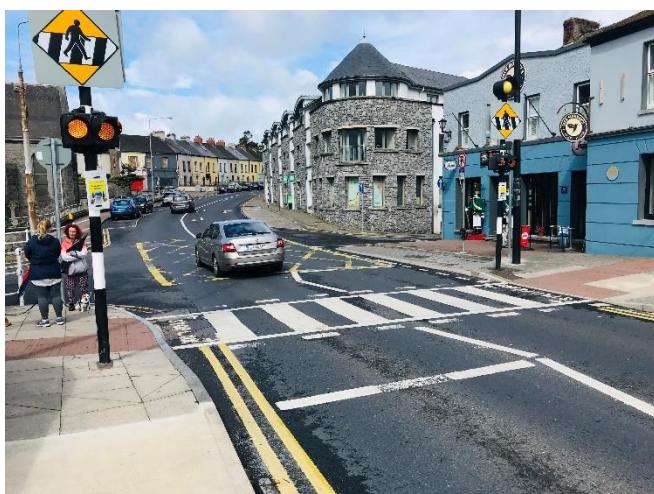
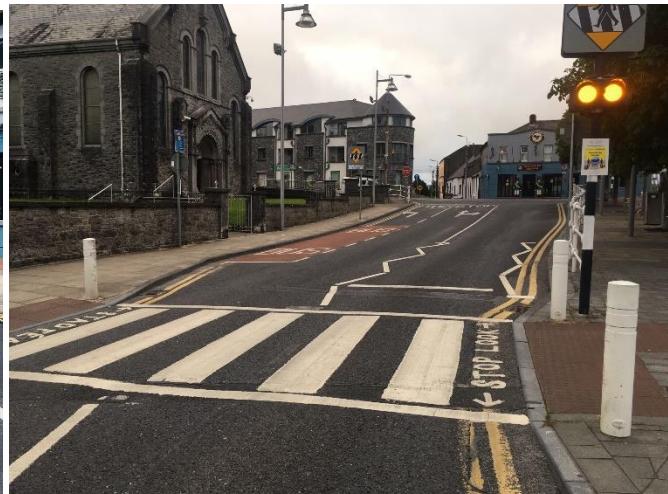
- **Pedestrian Crossings on North Side Require Attention**

- **Unsafe Crossing** - Pedestrian experience of using the zebra crossing on the bridge itself at its junction with Clancy Strand suggests that this is not a safe crossing. In particular, cars approach from the Thomondgate side at speed and may not always have visibility of an awaiting pedestrian.
- **Poorly Located Crossing** - While there is a zebra crossing on the Clancy Strand arm of the junction, it is located 40m away from the bridge, meaning that many pedestrians will choose to cross unaided at the junction rather than opt for the 80m detour to use the crossing.

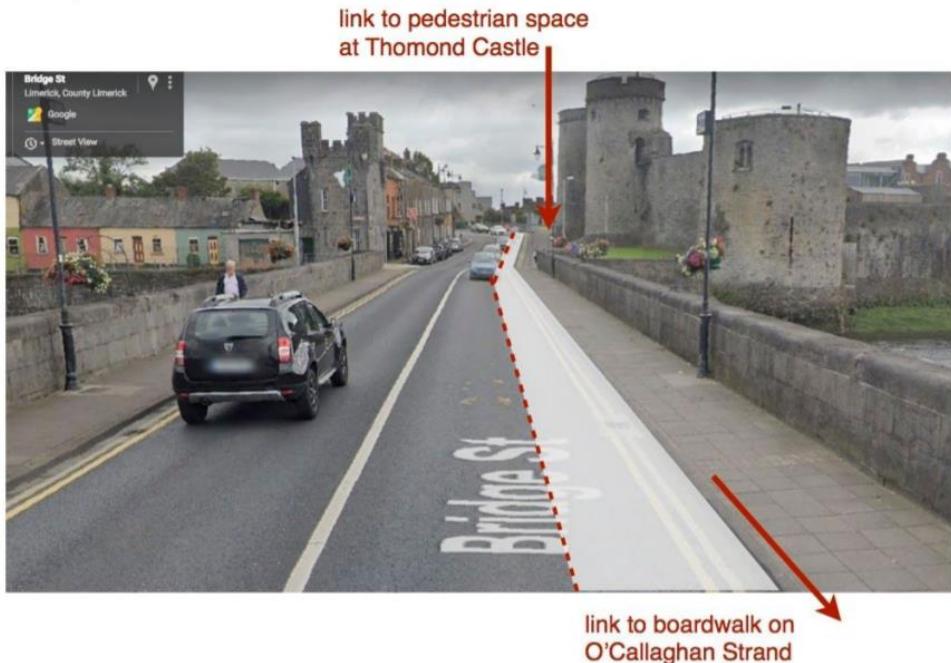
Proposed reduction in carriageway width to Thomond Bridge
To support a reduction in speed and improved public realm by widening the footpath to south side

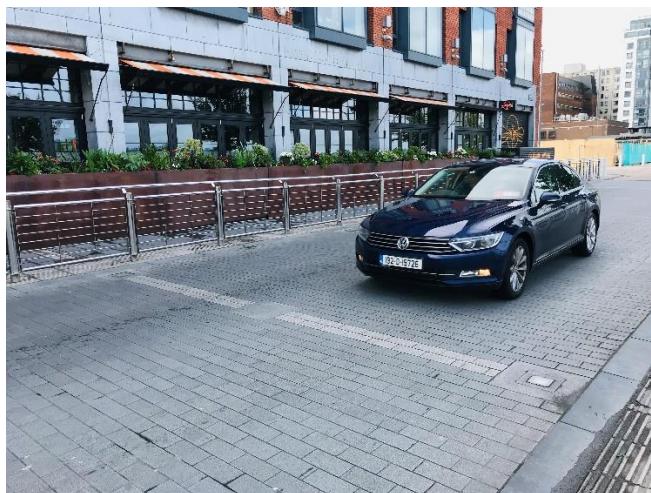
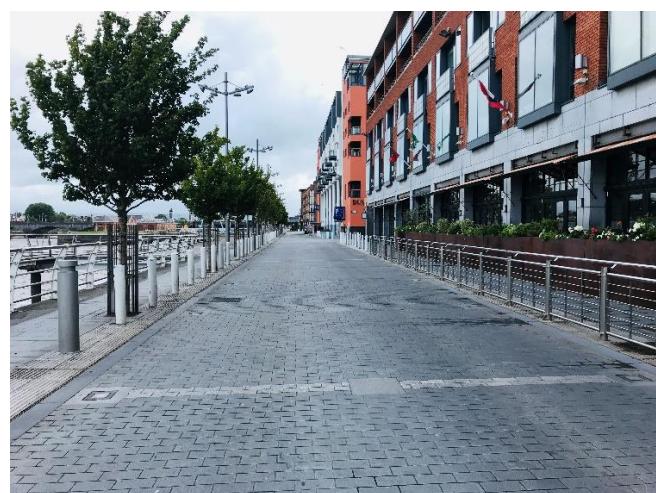
- ***“The key condition for the design of any shared surface is that drivers, upon entering the street, recognise that they are in a shared space”*** (Government of Ireland’s Design Manual for Urban Roads and Streets, page 108). Unfortunately, both the design and layout of the space and the level of signage here fails to adequately inform motorists they are in a shared space. Most motorists aren’t aware of this and, as a result, many of them drive at high speeds along the quays.
- **Wide, straight carriageways** encourage higher traffic speeds than can be considered compatible with a ‘shared space’.
- **Absence of traffic calming measures** - This contrasts notably with O’ Callaghan Strand (not designated as a ‘shared space’) where the traffic-calming measures provided have resulted in lower traffic speeds and a more comfortable and safe pedestrian experience

- **Pedestrianise a Portion of the South Quays**, namely the area from Lower Cecil Street through to Arthur's Quay Park (qualified below), creating a people friendly space suitable for outdoor dining at the existing restaurants and could facilitate mobile traders, markets, and events.
 - Access to Q-Park Harveys Quay would be maintained via Bedford Row (converted to a two-way street to facilitate connection to Henry Street). This would require a c. 40m section of the quays at the junction with Bedford Row to be retained for vehicular use.

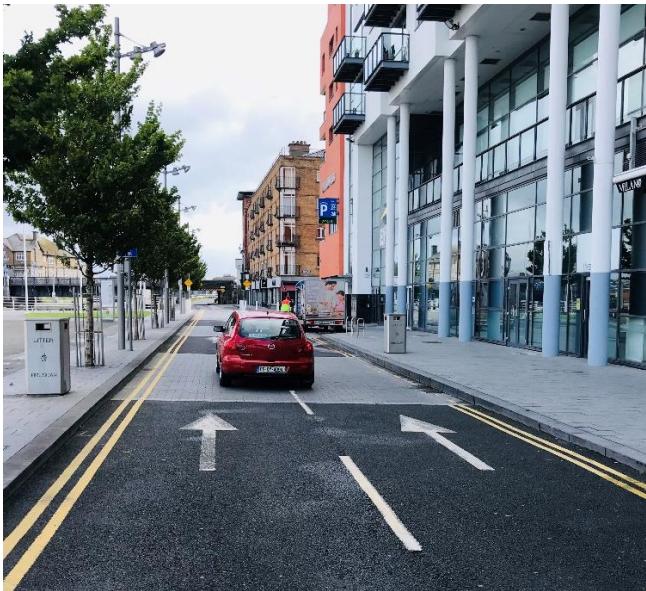
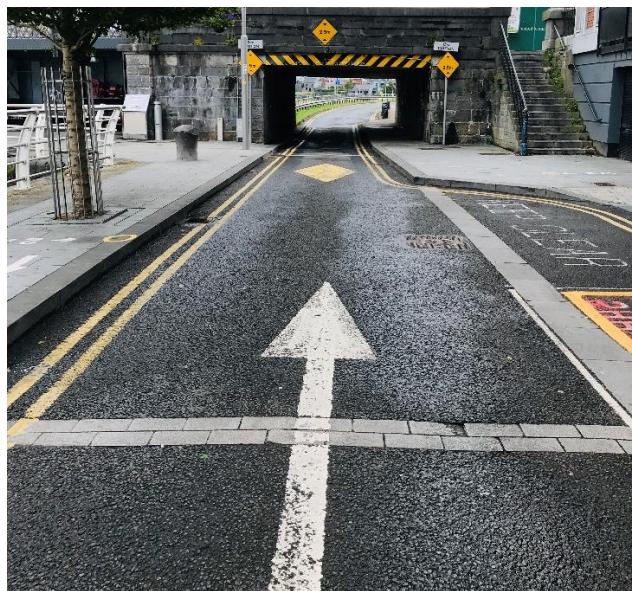
- **Design & Layout Informs Motorist Behaviour** - Motorists cannot be faulted for treating this as a ‘road’ rather than a ‘shared space’. The images below show how the clear visual signals provided by the design and layout of the space inform the motorist that they are on a road like any other and that they have priority in this space over other road users.

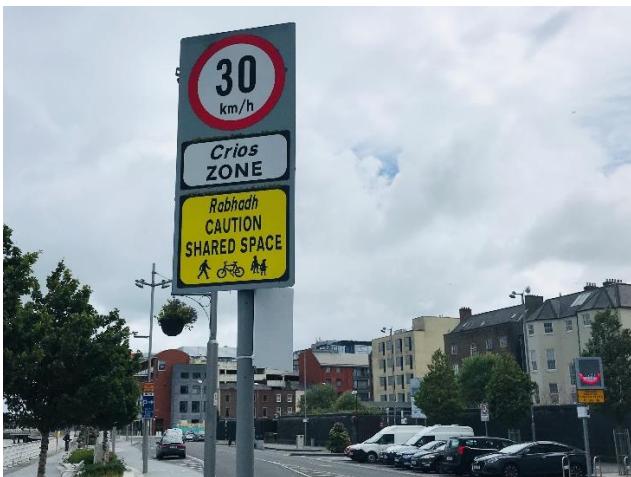
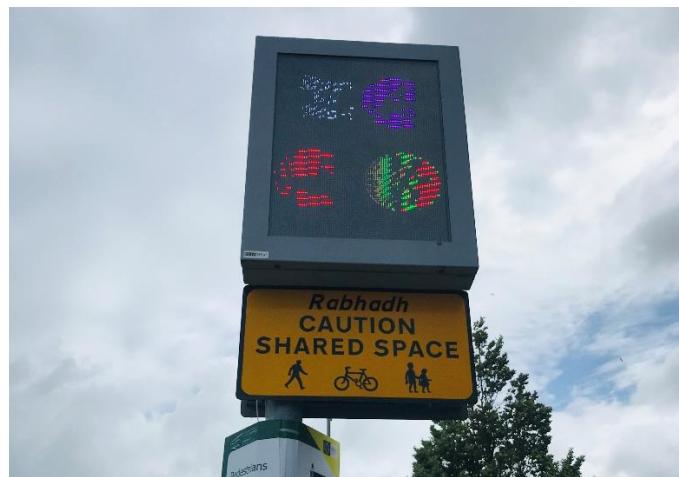
- **Ineffective Signage** - While signage indicating the shared zone is provided at a number of entry points to the zone, it appears largely ineffective relative to more intuitive signals provided to the motorist by the design and layout of the area as highlighted above.

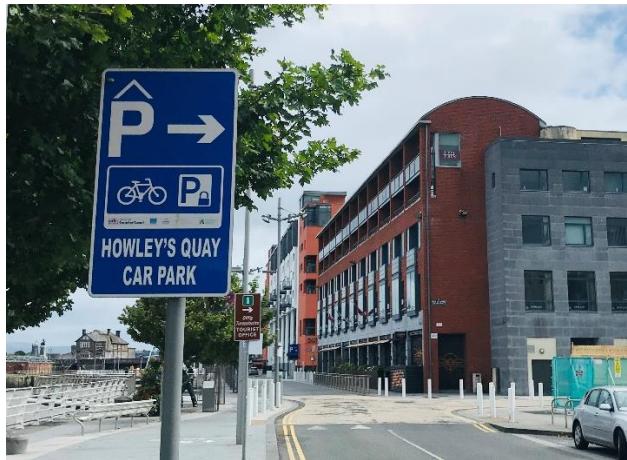
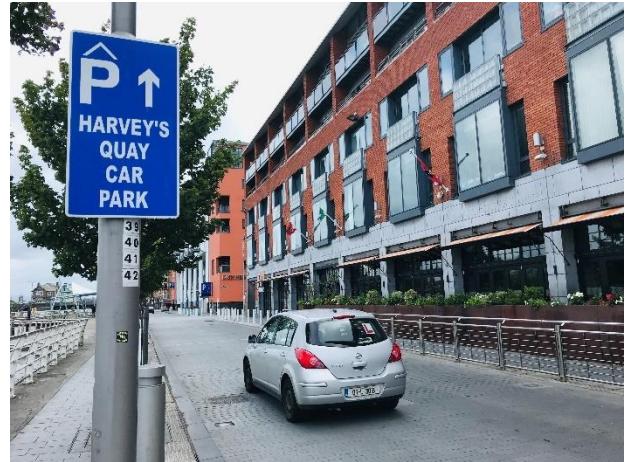
- **Abundance of Carpark Signage** - We observed that there appear to be more signs for carparks than for shared zones in the area between Shannon Bridge and Sarsfield Bridge.

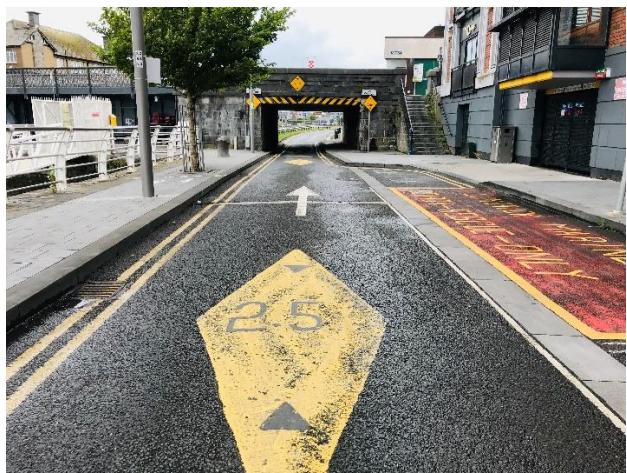
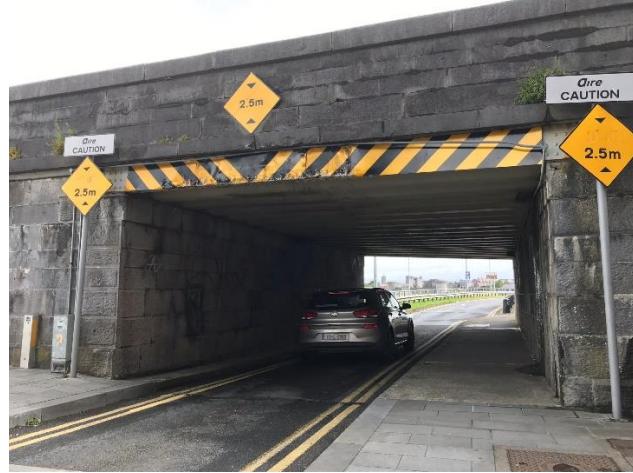
- **Warning Signage Protects Bridge Structure & Machinery Rather Than People** - We also observed that there are more 'caution' signs on and approaching the Sarsfield Bridge underpass than on the entire 450m section from here to Shannon Bridge. It is notable that these signs seek to protect concrete structures and steel machinery rather than pedestrians using the space.

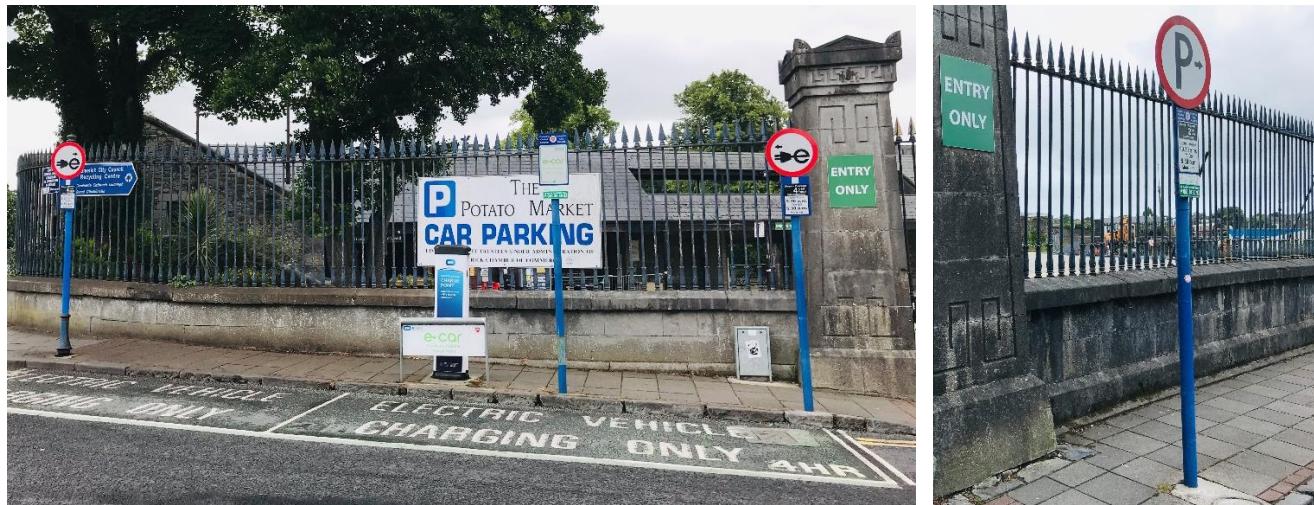
- **Allocation of Pedestrian Space is Abysmal** - There is an abundance of space in this area but only a tiny fraction is allocated for pedestrians.
- **Pedestrian Space is Cluttered and Restricted** - What little space that is allocated for pedestrian use is cluttered with signage and infrastructure for the benefit of motorists.
 - Poles located in footpath:

- **Short-term: Improve Existing Footpaths**
 - Increase footpath widths
 - Relocate poles from footpath space
 - Relocate EV charging terminal from footpath
 - Install measures to prevent encroachment of parked cars on footpath
- **Long Term: Repurpose Area as a Public Plaza**
 - Repurpose the entire area into a public plaza

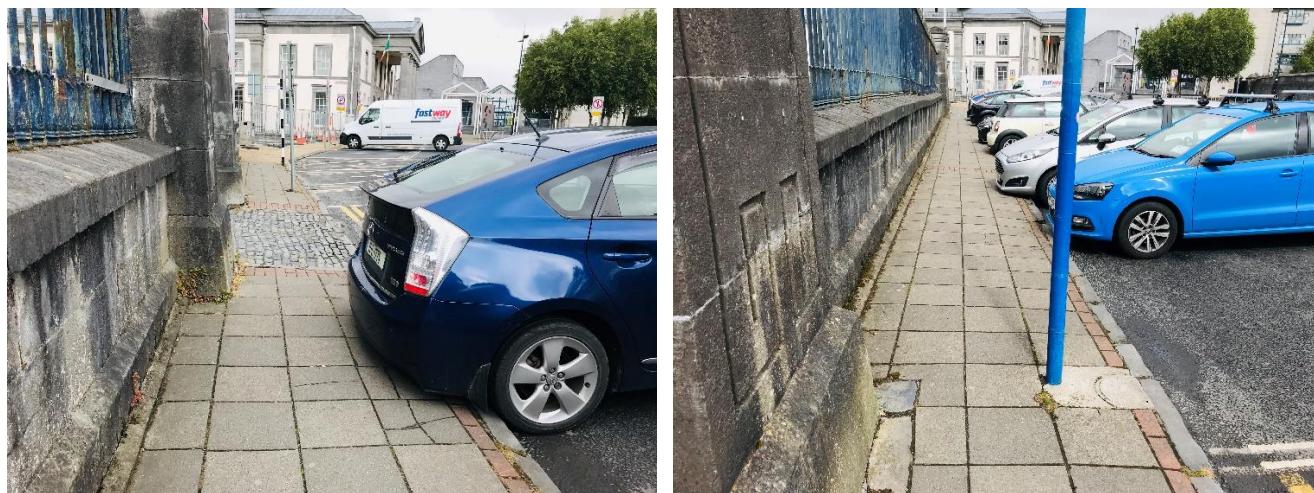
- Noses / tails of parked cars encroach on footpath space:

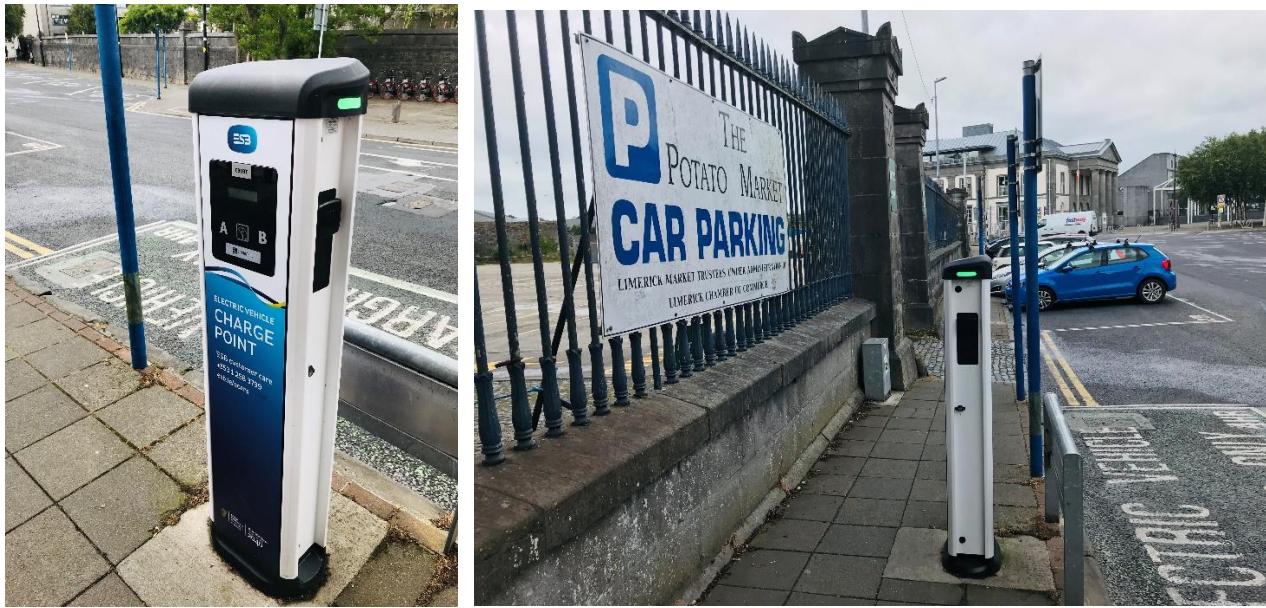
- EV charging terminal located in footpath:

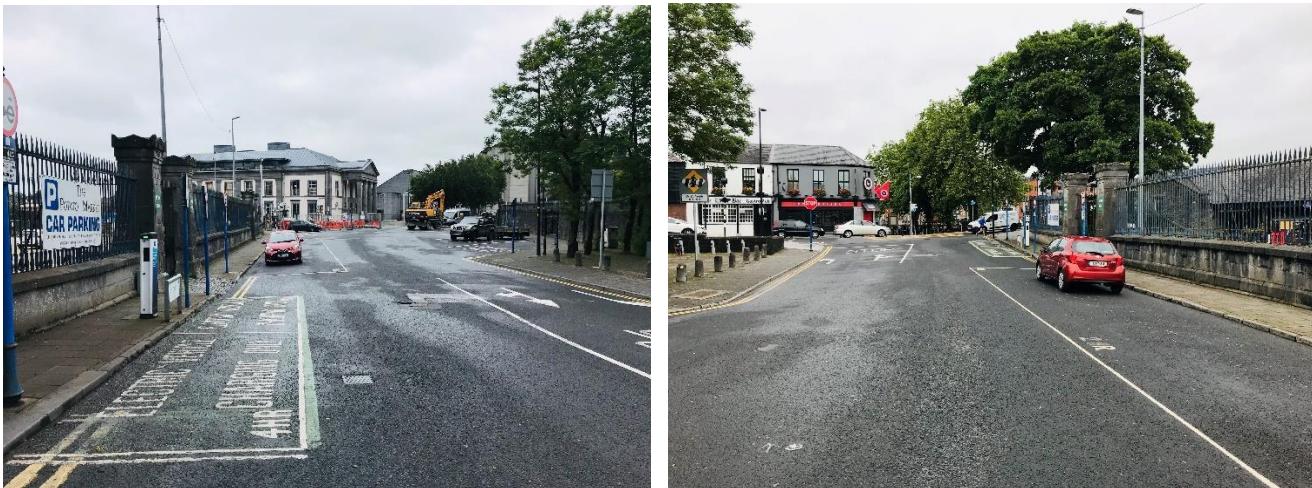
- **Overall Space is Underutilised** - The area (bounded by the Potato Market, the old Courthouse, City Hall and St Mary's Cathedral) is used as a car / coach park when it could be a public plaza serving as a hub for the Three Bridges Walk and linking to the Medieval Quarter and other tourist attractions in the city.

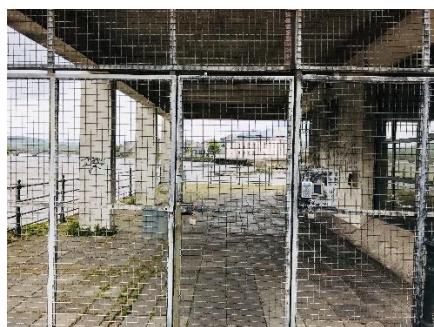
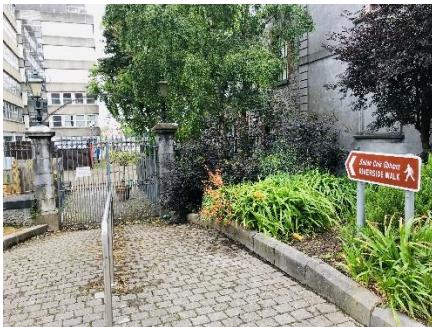
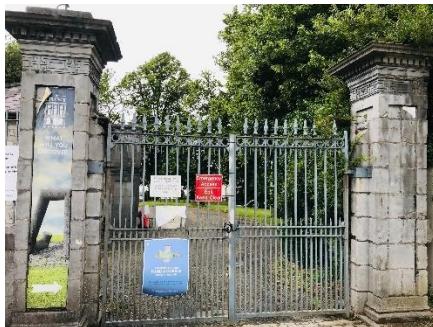
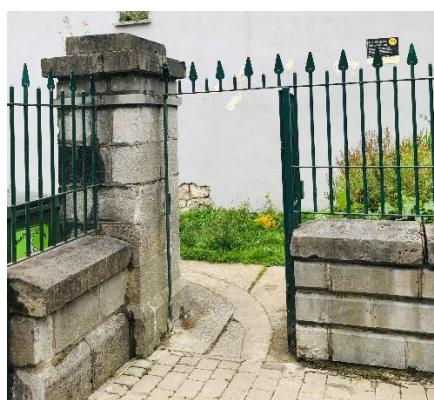
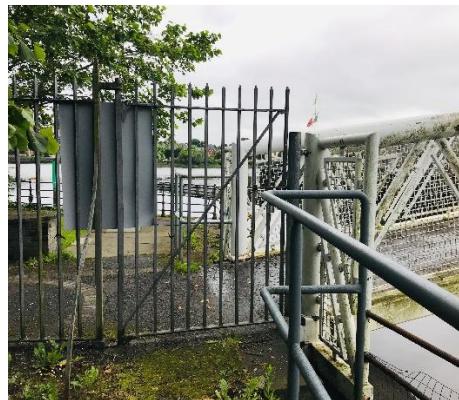
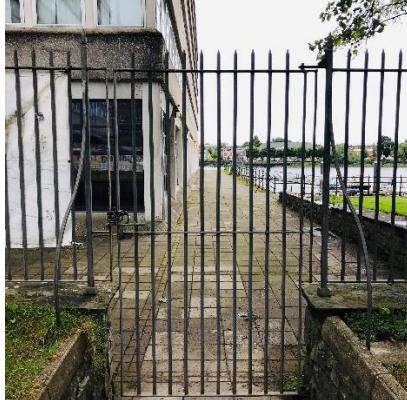
- **Uncertain Opening Times** - There are as many as 12 access points (gates) to the Riverside Walk, but no information signs on the gates stating opening and closing times, as you would see in public parks
- Neither does there appear to be coordination of the opening and closing of the various gates. This results in people either avoiding the route (taking a detour) or having to retrace their steps when they encounter a locked gate.
- Many people local to Limerick are at least aware that the gates are closed at variable times but, without information signs, it is ridiculously confusing for tourists intent on taking Limerick's flagship walk. We have all met tourists turning back from a locked gate assuming their walk is over

- **Agree Riverside Walk Opening Times & Provide Information Signage**
 - We suggest that information signs be placed at each access point to advise the public of the opening times, as is common in public parks around the city and county.

- We understand that the various gates are the responsibility of different local groups / bodies (e.g. Hunt Museum, Milk Market Trustees etc.). We suggest that Limerick Council lead a coordination exercise to agree a fixed (with seasonal variation) schedule of opening times for the entire route.

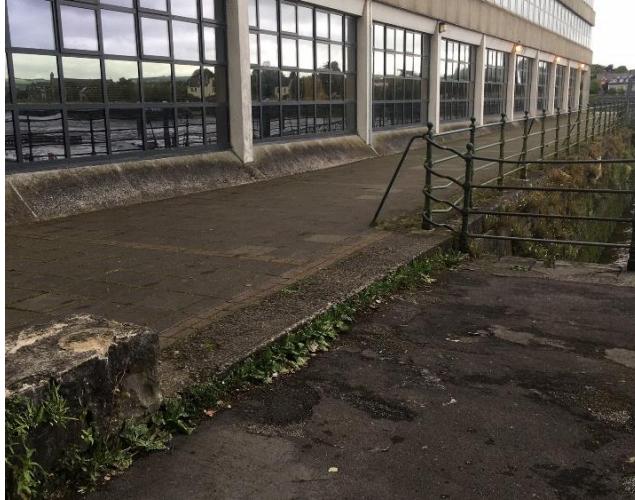
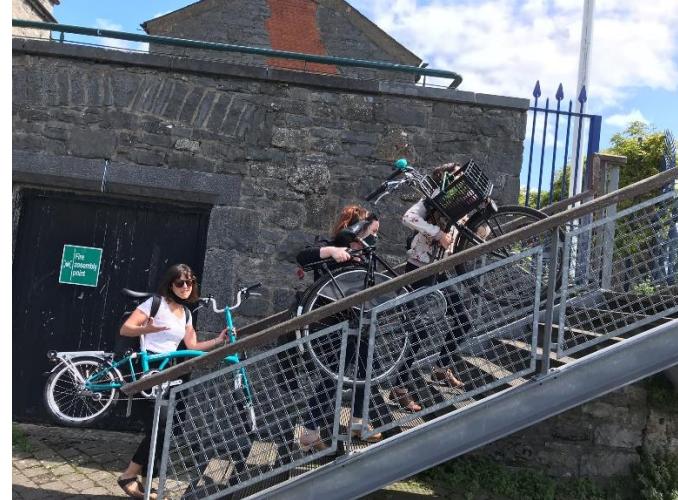
- **Access for All** - There are a number of points where the Riverside Walk (and by extension the Three Bridges Walk) is inaccessible to wheelchair users.
- Two such areas are a) at the back of Sarsfield House, and b) at the Widows' Alms Houses (see below).

- Consider options to facilitate wheelchair access at the points highlighted.
 - In the interim, place signage at access points to the Riverside Walk advising the public that sections of the walk ahead are inaccessible to wheelchair users and advising an alternative route

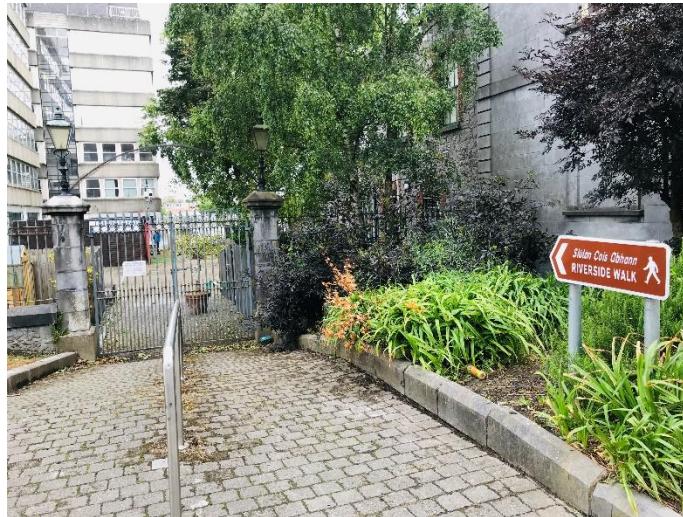
- **General Signage for Riverside Walk & Three Bridges Walk** - One of the oddities of the Three Bridges Walk, compared to similar walks in other cities, is that informational and directional signage on the walk itself is almost non-existent.
 - There's excellent information available on Limerick Council's webpage and there are some remaining orphaned signs from when the walk was launched as a Slí na Sláinte some years back but signage is sporadic and difficult to find. It's almost as though we're trying to keep it a secret from outsiders.
 - Somewhat ironically, there are a good number of signs signalling the Riverside Walk but, as mentioned in previous observations, they often point at locked gates with little in the way of explanation. In contrast, those sections of the Three Bridges Walk that are permanently open appear to have no signage whatsoever.

- **Provide General Signage for Three Bridges Walk:**
 - As an extension of the above recommendation, we suggest that directional arrows be placed around the route to give tourists confidence that they are following the correct route.

- Signage denoting an 'alternative' route should be provided to direct the public when the Riverside Walk gates are closed.
- **Address the Wheelchair Accessibility Issues**
