# **ATHEA FLOOD RELIEF SCHEME**

## **HYDROLOGY REPORT**

**JULY 2022**

**RYAN HANLEY**

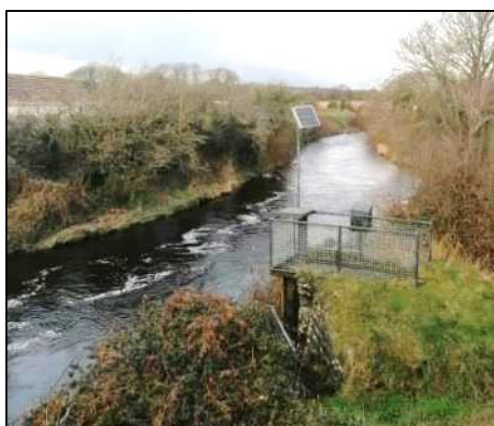
Figure 3-3: View of Inch Bridge gauge

There has been a continuous record at this gauge since 1949. The River Feale Arterial Drainage Scheme was completed in 1959. Water level (stage) data is available at this gauge since 1960 (60 years). Flow gaugings data (134 No. gaugings), gauge zero data, and rating curve data is available since 1972. There are no flow gaugings available prior to 1960. Annual Maxima data is available for the gauge from 1960 onwards. No rating review was conducted for this gauge by the CFRAM study other than a check of the November 1997, January 1998 and March 1998 gaugings. It was noted in the CFRAM as being the only appropriate station for flood estimation within the Galey River study area. Station 23001 Inch Bridge has a reported quality rating of A2.

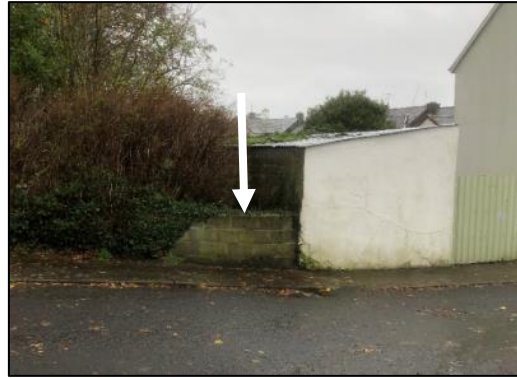
**Figure 3-7: Wall at The Lane which is reported to be overtopped followings periods of heavy rainfall.**

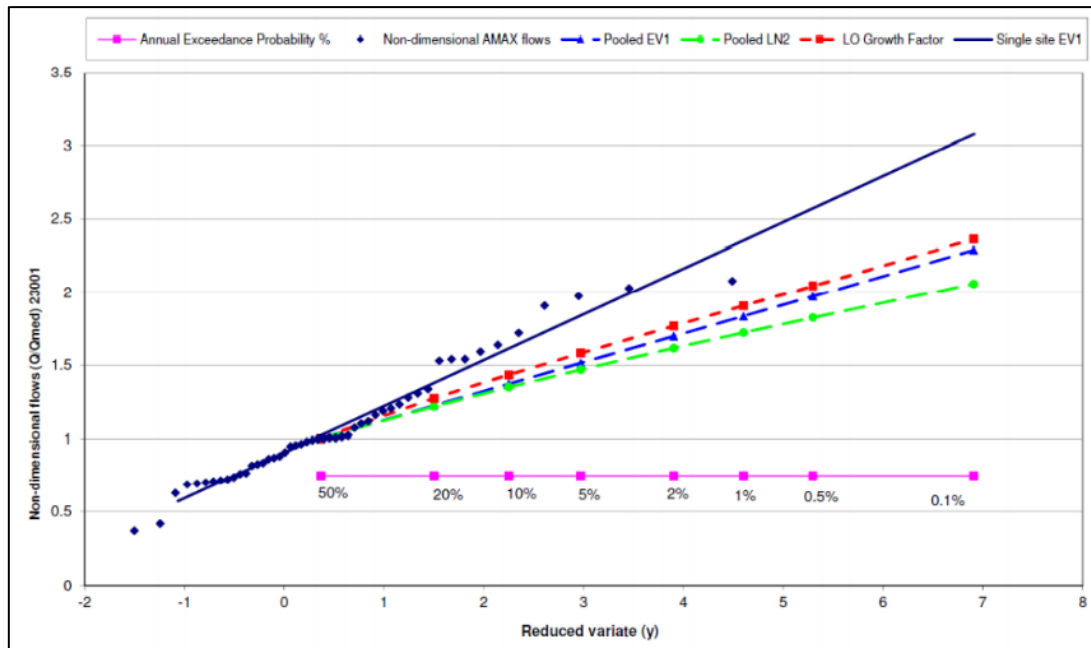
**Figure 3-11: CFRAM Flood Frequency Curves for Inch Bridge gauge**

In the CFRAM study, the Inch Bridge gauge was identified as being suitable for flood frequency analysis and flood growth curves were determined, analysed and plotted against each other (see Figure 3-11). The AMAX series was plotted against an EV1 based distribution-based frequency curve adopted to the AMAX data and three frequency curves, based on pooling group results, plotted against the reduced variate and an Annual Exceedance Probability (AEP) scale.

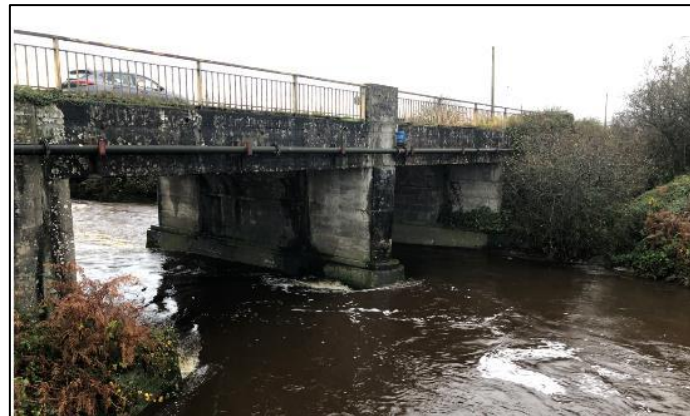
Figure 7-5: Upstream face of Inch Bridge (24<sup>th</sup> November 2020)
