ENVIRONMENTAL IMPACT ASSESSMENT REPORT

Appendix 9-1 Statement of Significance P08 250925

Cleeves Riverside

Statement of Significance

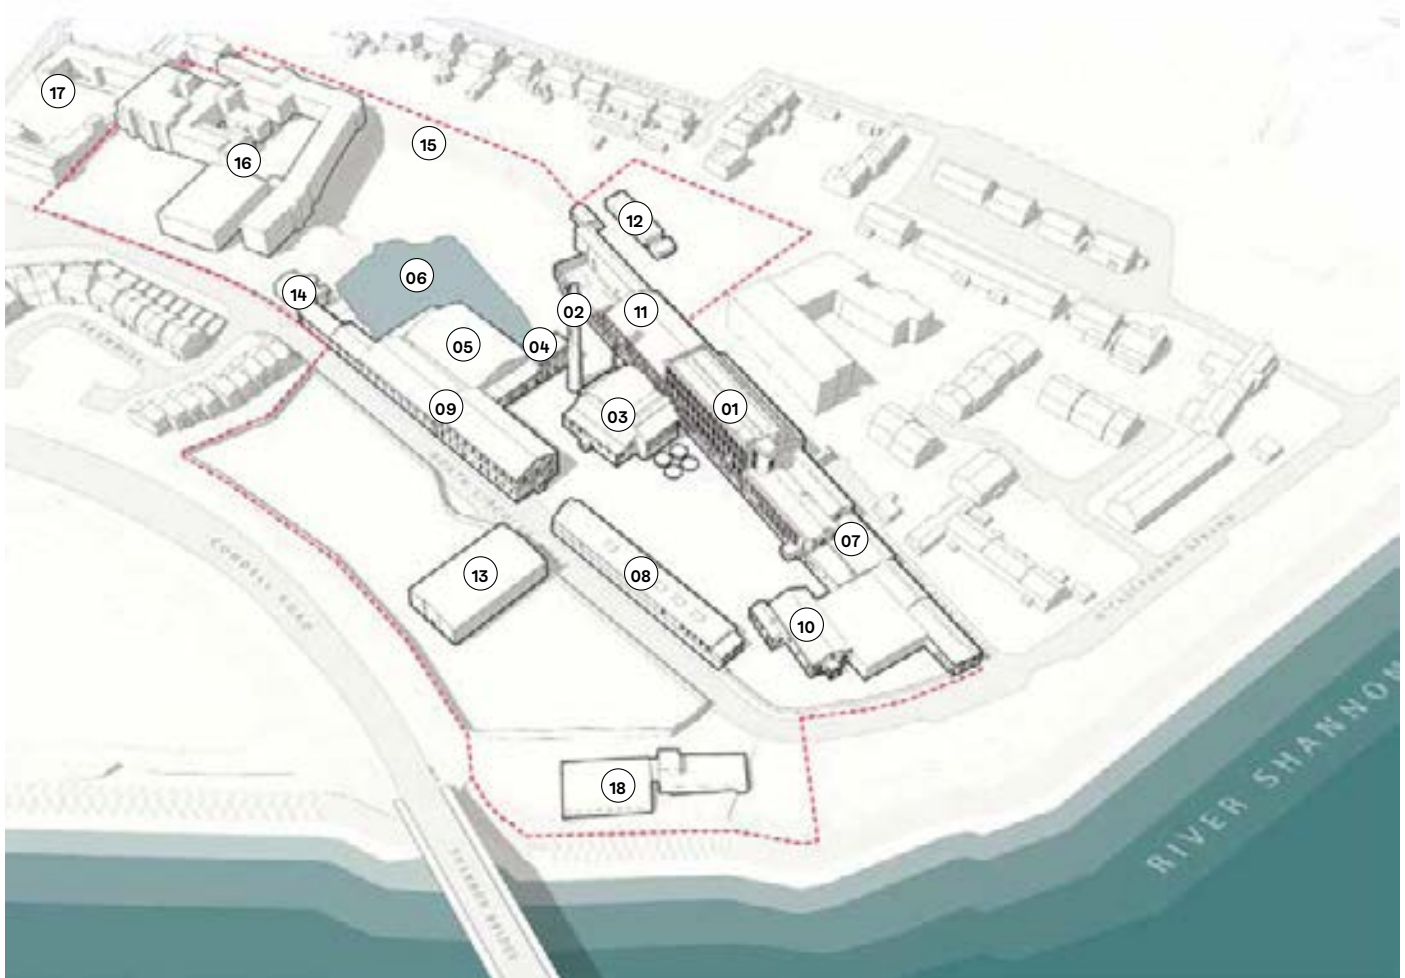
Fig.5 Diagram identifying the existing structures on the site

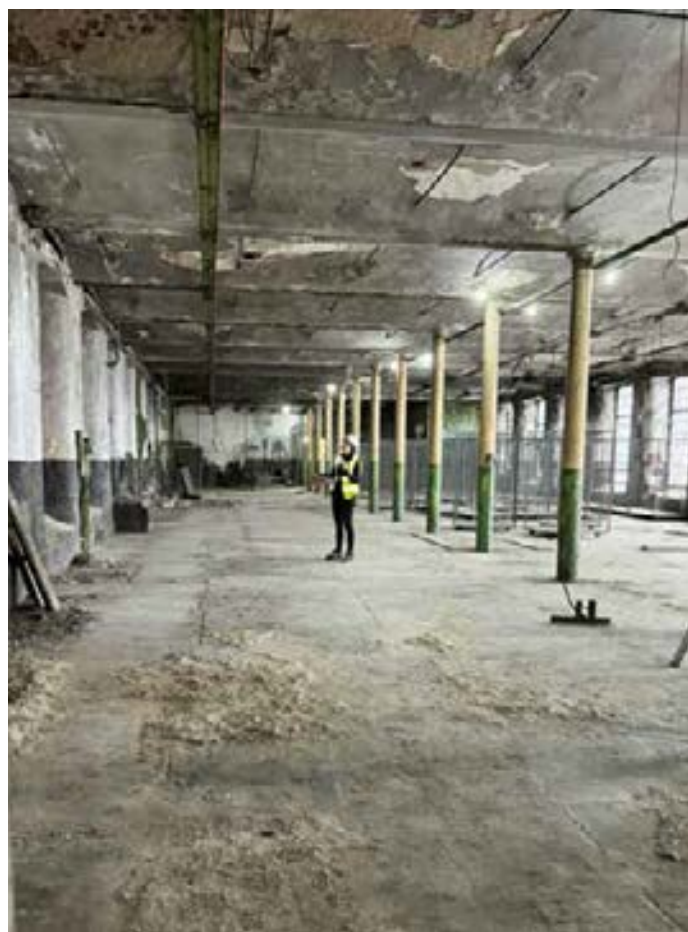
Fig.8 Interior of the Main Mill, second floor

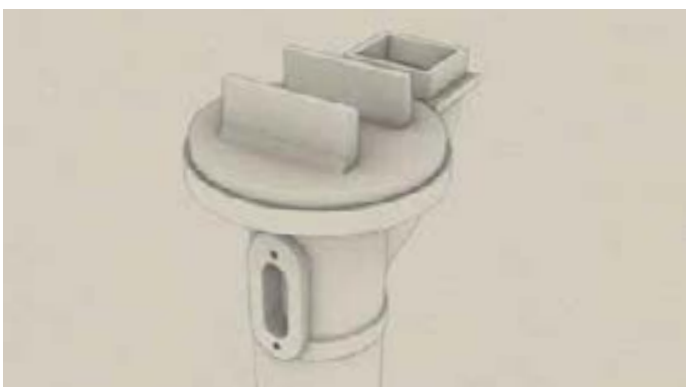
foot of the column above is socketing over and sits onto the beams.(Fig.10) The top of the columns at Level 03 include a shoe that is socketed into the column head. This shoe carries an oak block onto which the roof assembly is secured. Offset from the column heads at Level 03 is an integral cast vent scoop / branch, which allows for air to be routed into the hollow of the column assembly. (Fig.11) This is connected to the roof void via a slim timber box that rises into the roof void above. Columns at Levels 00 and 01 include castings identified for 'York Street Foundry, Belfast' dated 1851, with those on Levels 02 and 03 dated 1853. Columns are coated in paint with a bitumen primer substrate which may be the foundry coating.

Fig.11 Model of third floor the column head at truss bearing

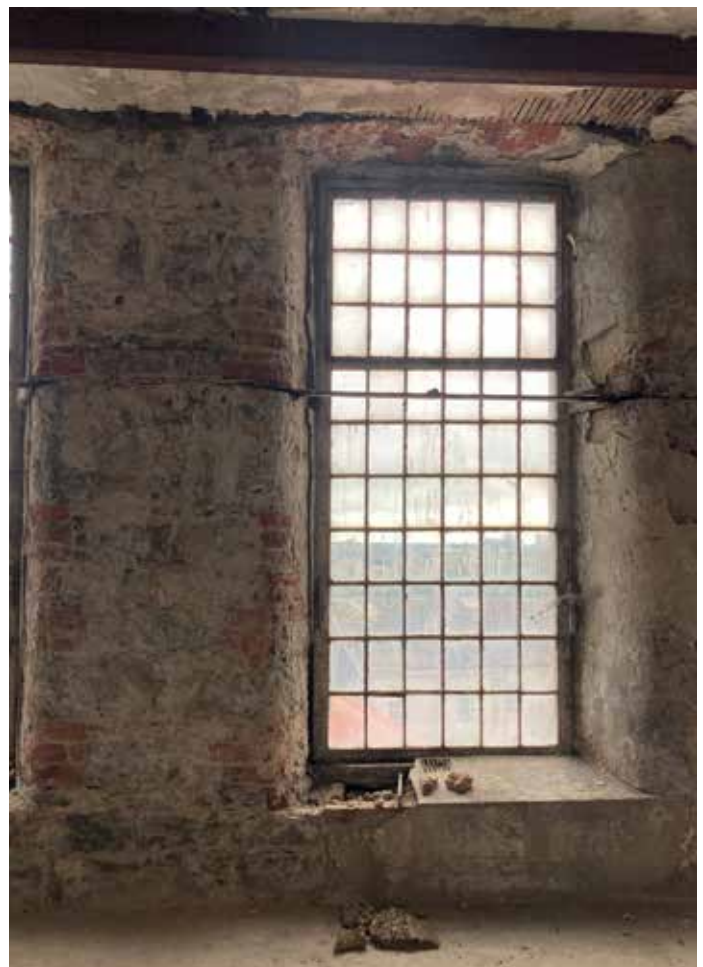
In addition to the iron frame an iron flat bar was embedded in the external walls. The band extends around the whole plan at mid height across windows on each level. Formed of lengths riveted and lap joints embedded within the masonry piers. This feature of the structure has become the principal cause of displacement in the external walls due to iron corrosion and masonry jacking.

Fig.12 Window bay with iron band and jacking of masonry

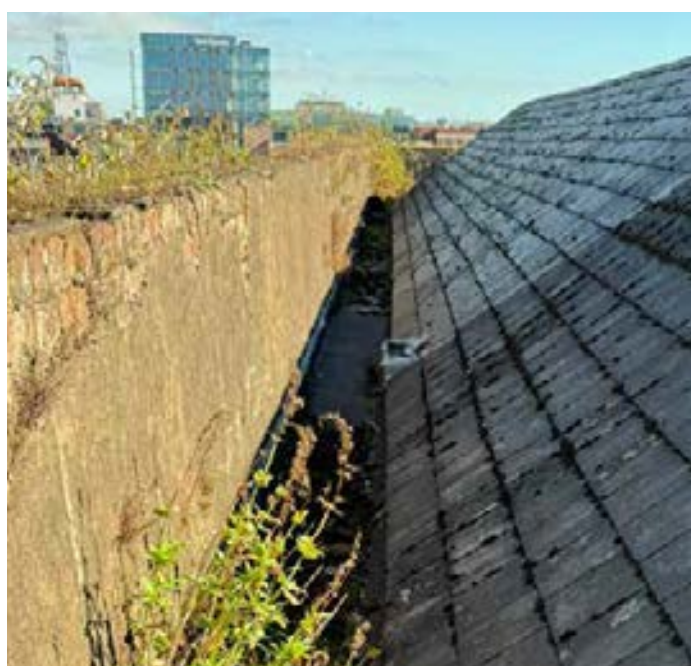
The mill is topped with a solid brick masonry parapet with Roman cement render finish. A dramatically over-scaled torus profile cornice extends around the whole of the building. It is presumed to be formed of stone cantilever from the wall head and secured by a substantial parapet wall set over. Later phases of consolidation appear to have been executed in cement applied over the original. Behind the parapet two pitched roofs drain to a parapet gutter that currently drains at two locations. The roof has been recovered in asbestos mineral slate. The gutter is formed from tapering cast iron components. Each is unique and individually numbered. Unlike the structural ironwork, the gutters were cast in Limerick by H.Lee & Sons. (Fig.14)

Fig.13 View along the north parapet.

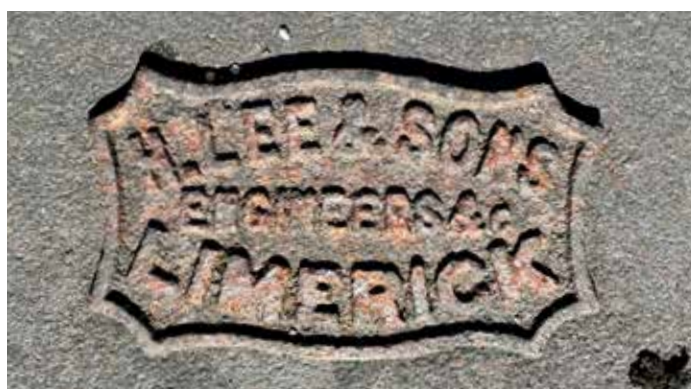
Fig.14 Gutter casting foundry plate

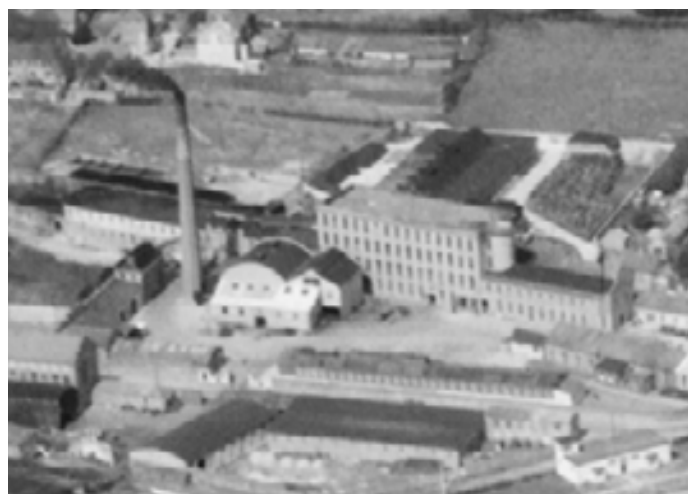
The weaving mills were substantially altered after 1927. Under the management of the Dairy Disposal Company (1927-1970) the complex was subject to adaptation and modernisation with most changes appearing to occur in the 1950s. Aerial images from 1947 (Fig.20) show the latter 10 bay building with a second storey and a flat roof. The earlier 13 bay building appears to have a more complex roof-scape. By 1951 the 13 bay building had been enveloped under a single roof. (Fig.21)

Fig.20 Photo of the site c.1947

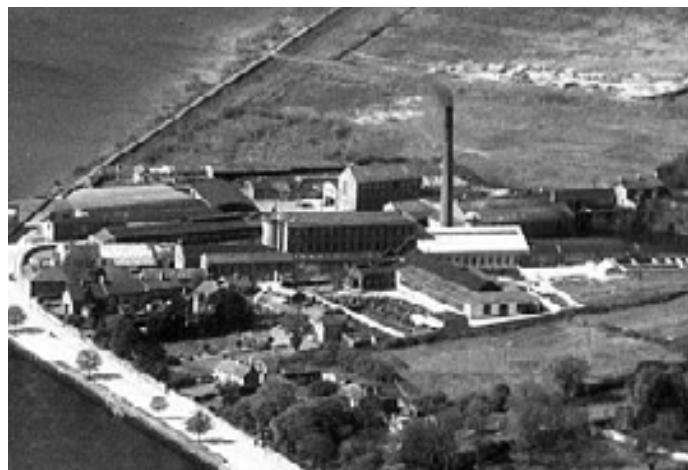
Fig.21 Photo of the site c.1951

The aerial images from the 1950s showing the roof in a tone matching the other roof suggest that this roof was likely new in 1951.

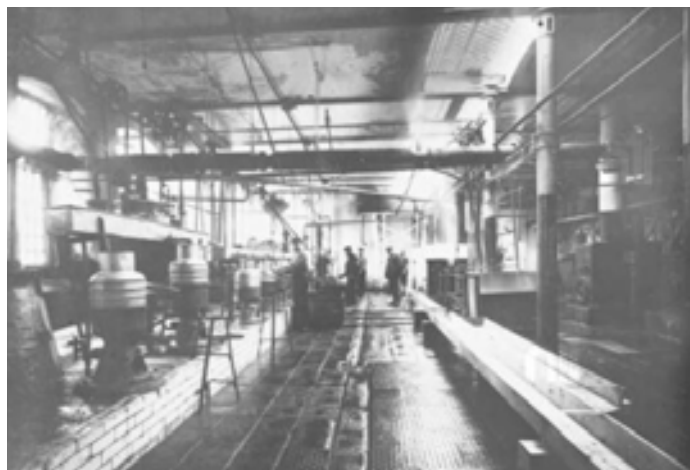
The first 13 bay weaving mill featured a continuous gap in the soffit that can be seen on a photo of c.1900 (Fig.19) with a glass lantern over. This will have provided much needed light above the weaving looms allowing the quality of the linen to be managed.

Fig.19 The Milk Separating Room c.1900. Formerly part of the Weaving Mill

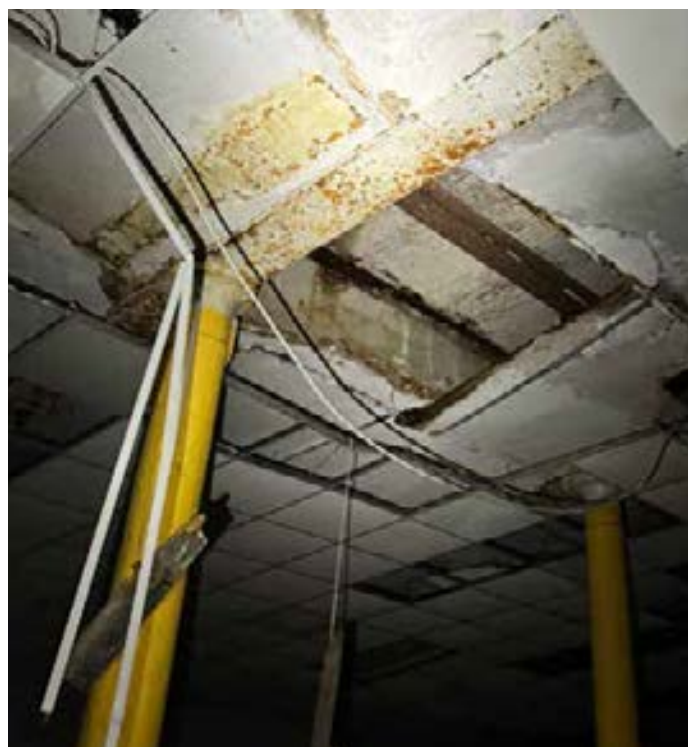
Fig.24 Within first weaving mill, opening in the floor for roof lantern

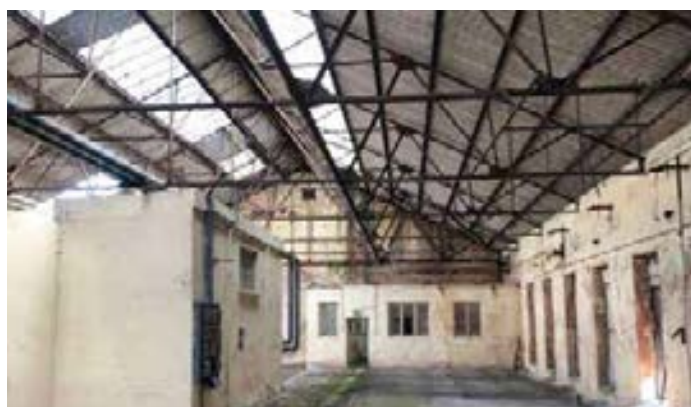
Fig.22 First floor of the Milk Separating Room. Formerly phase one of the Weaving Mill. 1951 roof structure with asbestos sheet covering.

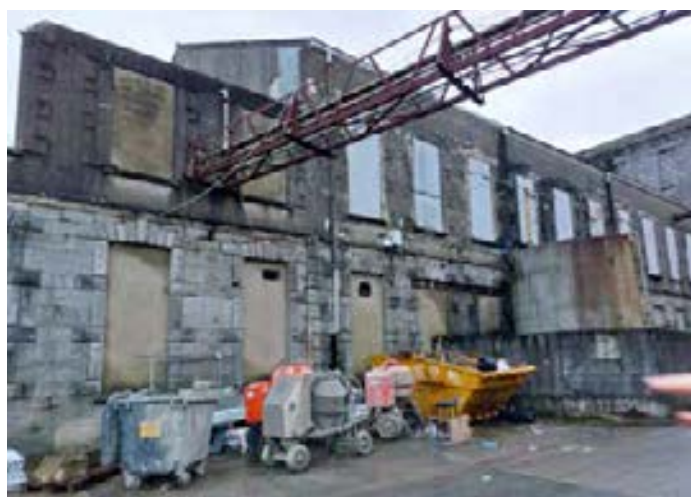
Fig.23 Junction between Weaving Mill phases with 1950s first floor over

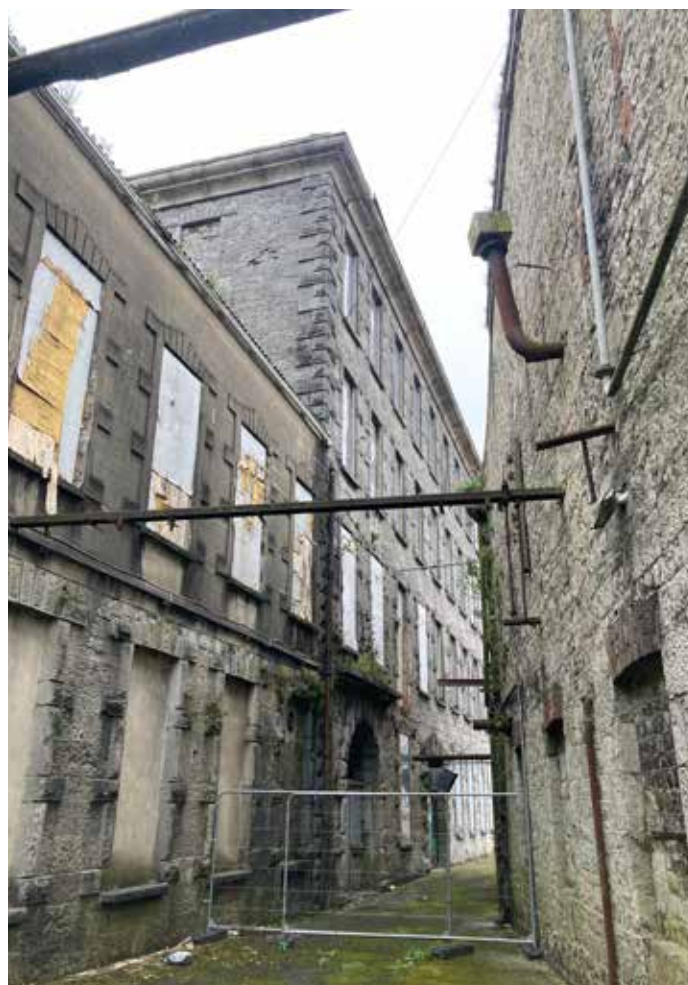
Fig.25 Main Mill 1851-53, Engine House to the right 1884, Weaving Mill 1855; 1951 first floor addition to the Weaving Mill.

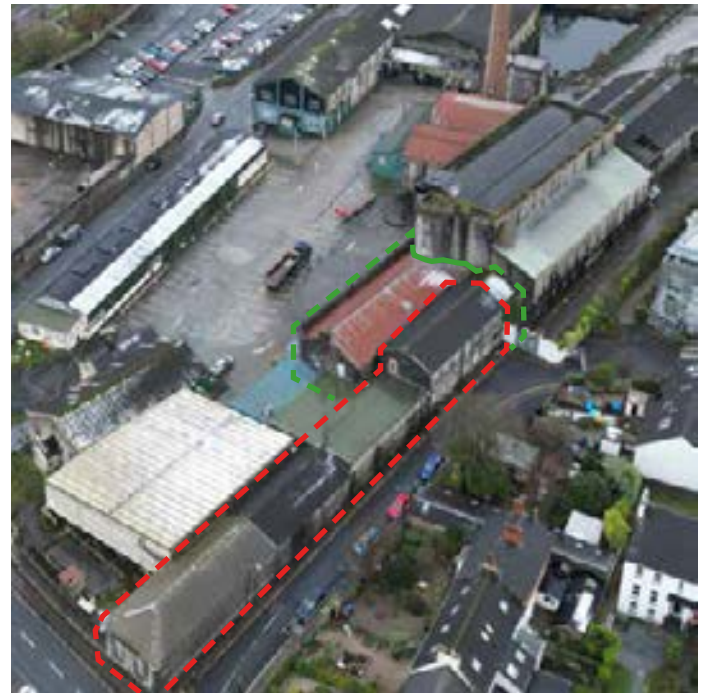
Fig.26 Aerial view of the former offices and Linen Store
RED - Linen Store, Counting House and Office
GREEN - Later addition of the building to the front c.1905

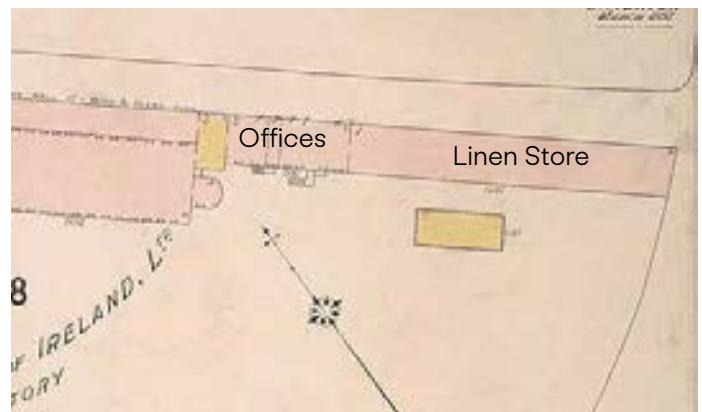
The 1897 Goad Insurance Map shows the extent of this building, with the through passage indicated as described by James Campbell.(Fig.27)

Fig.27 1897 Goad Insurance Map
Note the buildings present and the passage through the Office

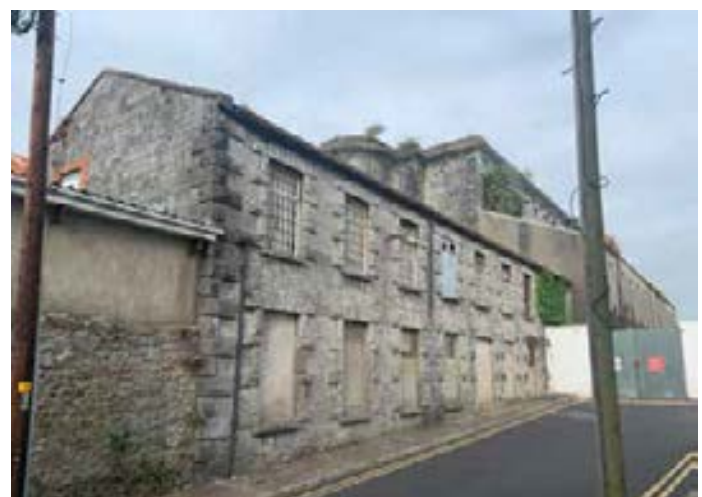
Fig.28 Office Building elevation onto Stone Town Terrace,
Former entrance door notable in the 5th bay from the east end

Office - The office has been lined out with much of the historic surfaces concealed. The former entrance and street level windows have been closed over and some windows replaced with vents at first floor. The elevation onto the mill yard has been wholly concealed by the later extension.

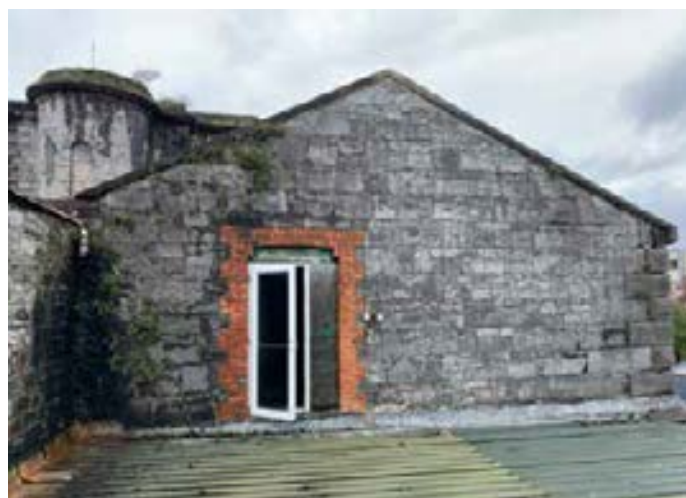
Linen Store (c.1855) - The building extending to the end of the boundary was built as the Linen Store. It is of stone construction with a concrete floor and once had 16no queen post trusses of timber and iron of which 5 are visible. These carried a slate roof which has been replaced by profiled metal sheet. The north and east walls form the boundary of the site. The external appearance matches that of the Main Mill and Weaving Mills. Two blind windows onto O'Callaghan Strand are not reflected in the internal masonry confirming their architectural device as part of the complex's aspiration as a civic venture. The wall along Stone Town Terrace is of coursed rubble with tight joints, presenting the secondary quality of this largely unseen wall. There is one small blocked doorway though this wall.

Fig.29 Office Building (1855) east elevation where the flat roof of the former Linen Store abuts

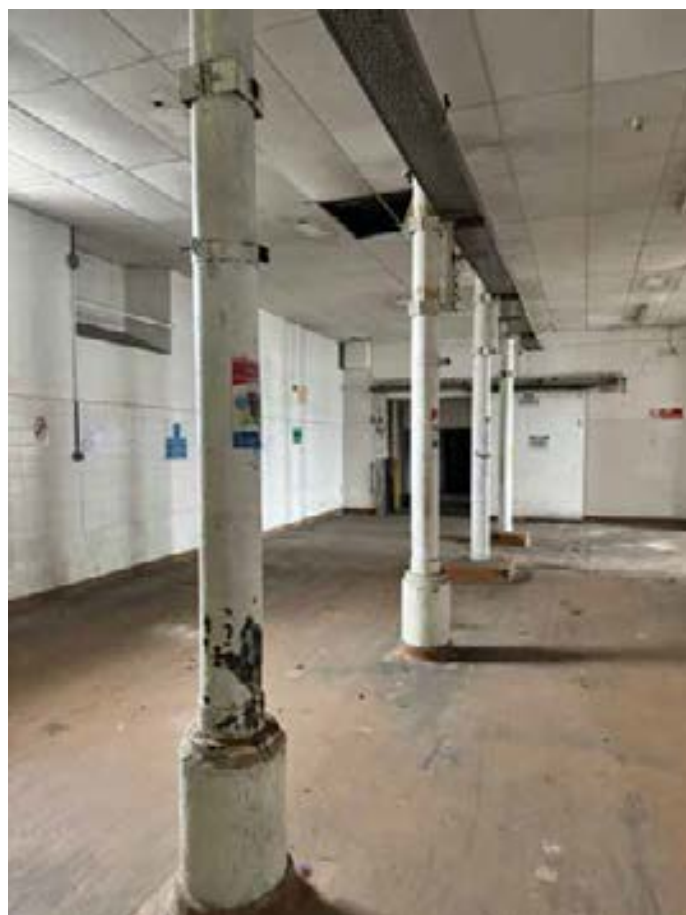
Fig.30 Interior of the ground floor of the Office, largely adapted for use as the 'Dairy Building' in the C20th.

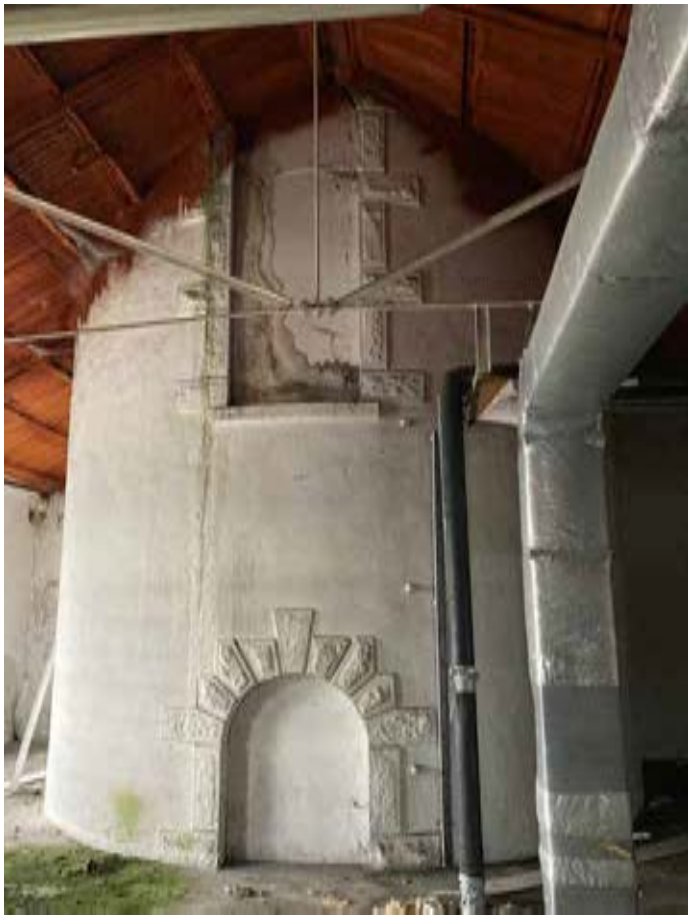
At the interface of the new building, Main Mill and Office existing windows were opened up to form doorways allowing for access. The windows of the mill stair were blocked up due to the abutment of the new building.

Fig.31 Main Mill stair at the junction of the c.1905 extension

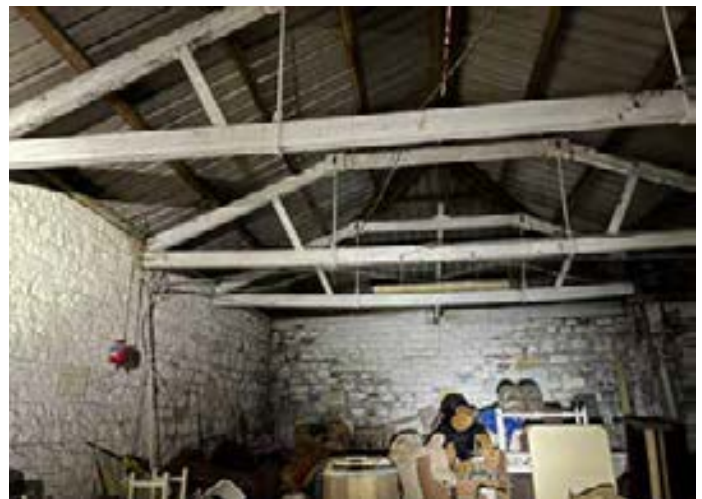
Fig.34 Interior of the Linen Store showing the boundary walls from the inside face and queen post trusses above

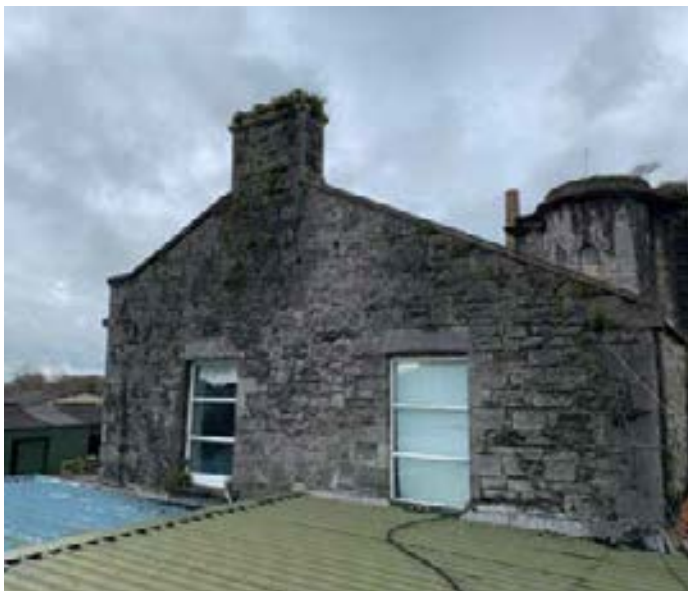
Fig.32 East gable of the c.1905 extension with later flat roof elements abutting

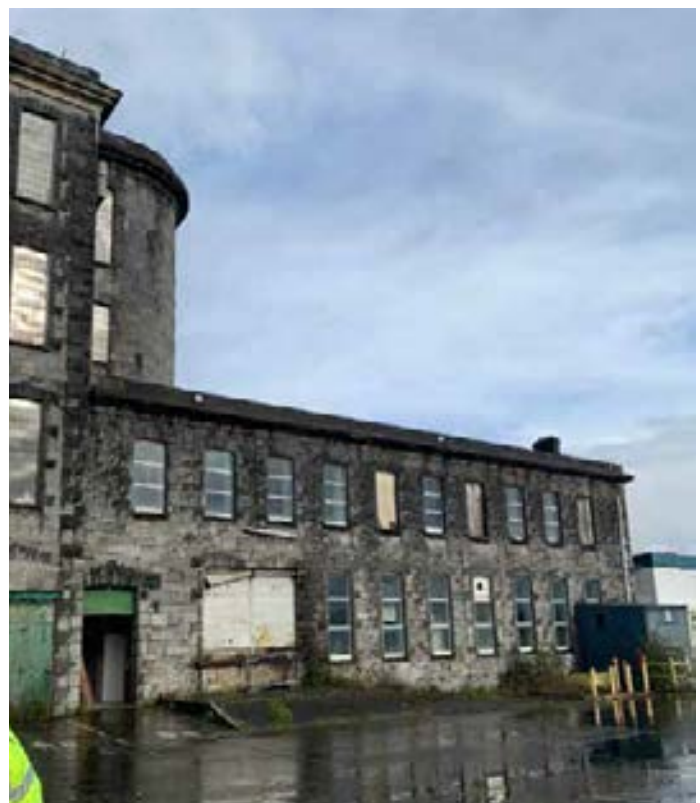
Fig.37 Extension c.1905, elevation onto the mill yard

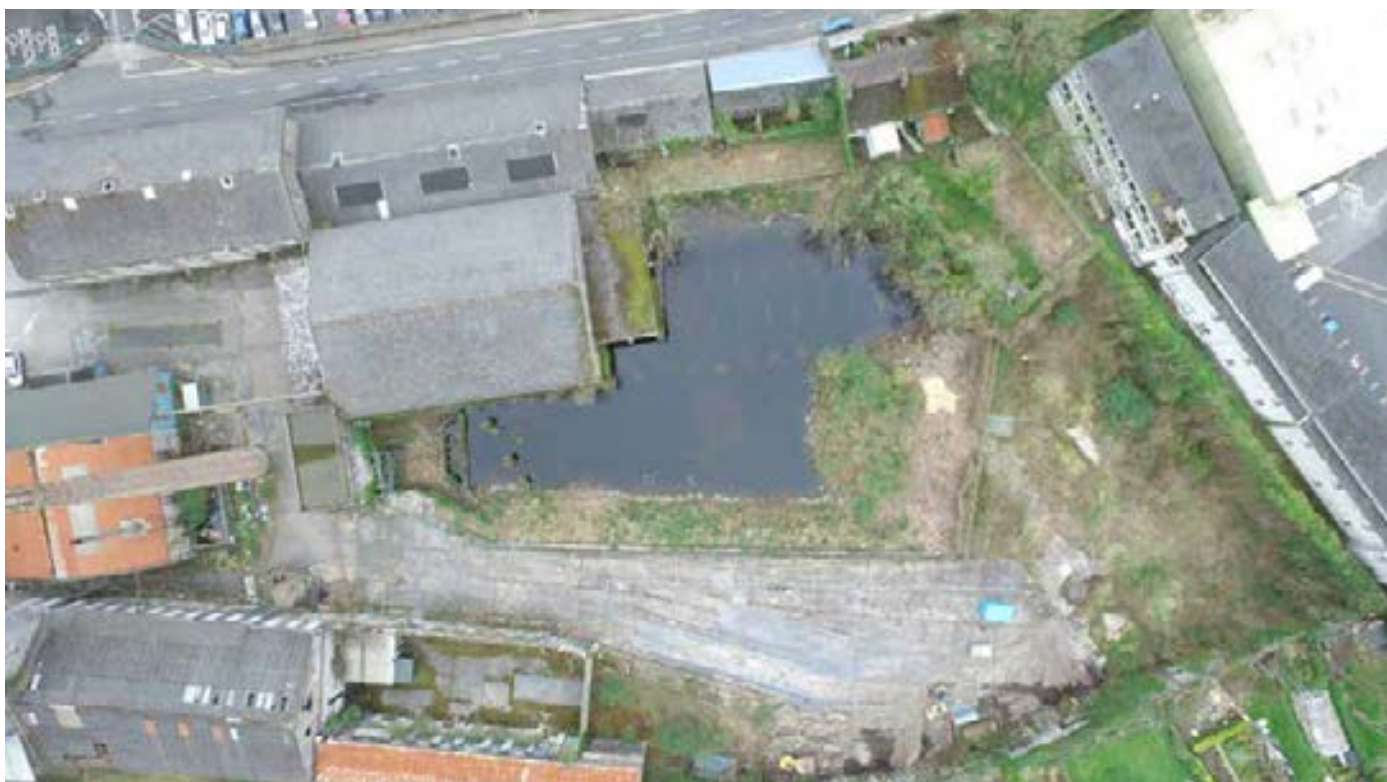
Fig.38 Aerial view of the reservoir with the Infiltration Gallery and Dye-House / Vat-House

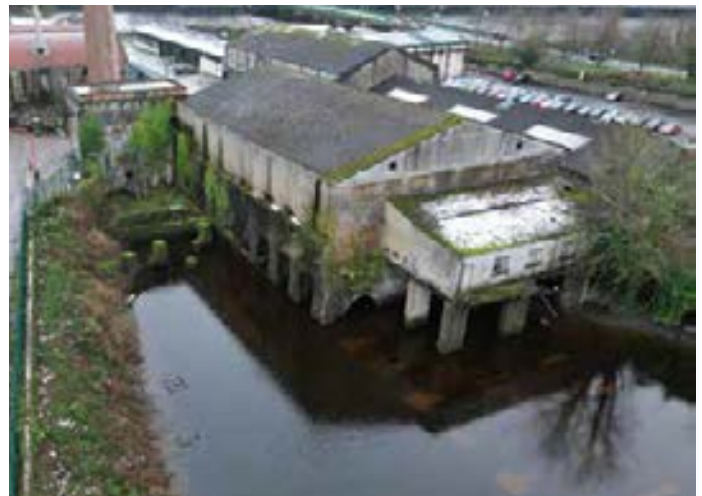
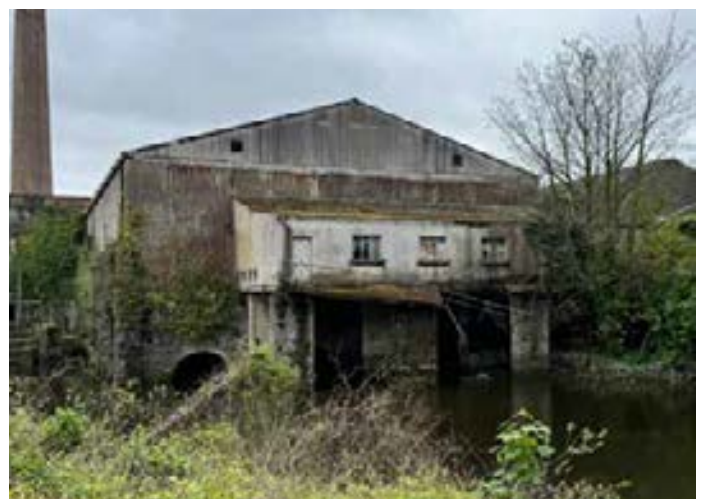
Fig.40 Cable of Infiltration Gallery, structure over and rear extension

The loss of the original Dye-House structure leaves nothing of the flax period above the Infiltration Gallery. The c.1955 structure built over, rear extension and front extension are all of negative significance arising after 1927 and for their utilitarian quality.

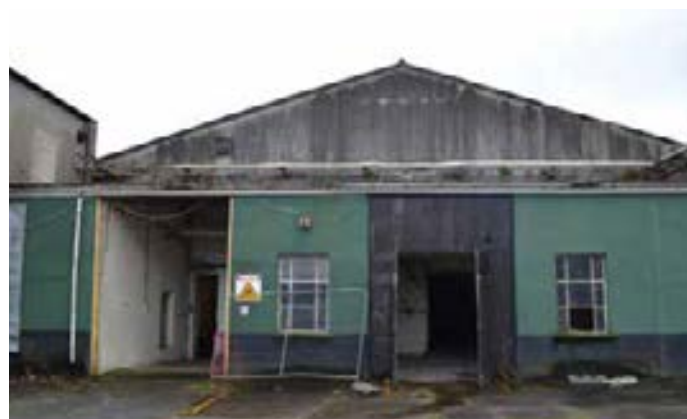
Fig.43 Front extension c.1960 with vehicle access points. Right infilled

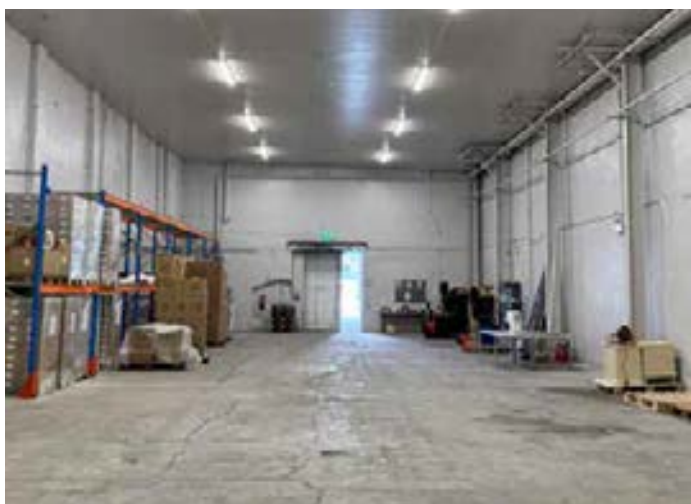
Fig.42 Interior of one of the two cold store rooms

wall head, beams span from the external walls onto the dividing wall. These appear to be hung from the trusses. The beams carry ceiling joists for a timber boarded soffit and above expanded metal mesh has been used to reinforce foamed concrete. The walls have been lined with approx 1" of cork overlined in a heavy expanded mesh that is secured to the walls with wire. The interior has been rendered with a cement, encapsulating the cork. This appears to have been done to create a cold store.

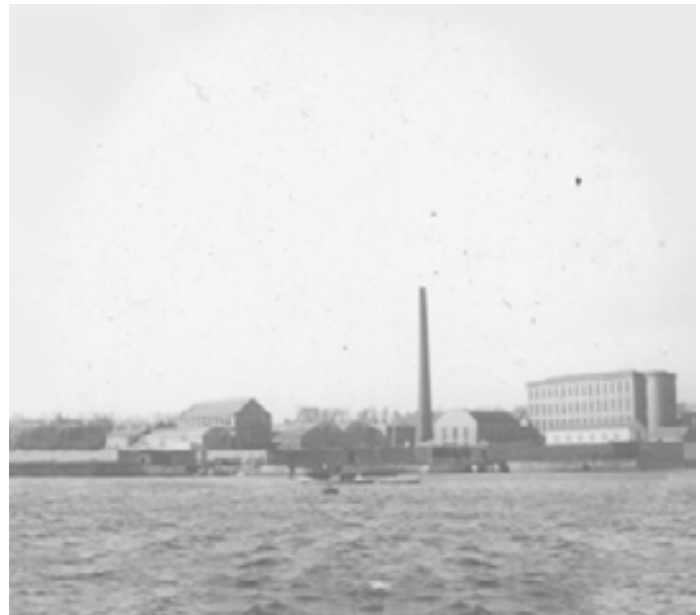
The barrel roof profile is visible on early photographs of the site (Fig.46) which also shows the building over the Infiltration Gallery with a double barrel profile.

Fig.46 Photo of the site c.1900

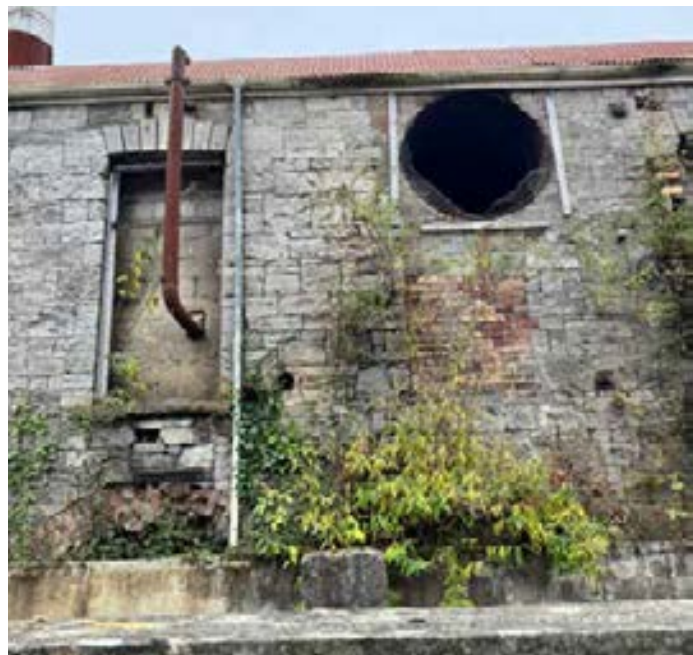
Fig.51 Space between the boiler house and chimney

Large brick and stone plinth likely route for original flue with later round opening in the wall of the boiler house providing for a flue in the late C20th

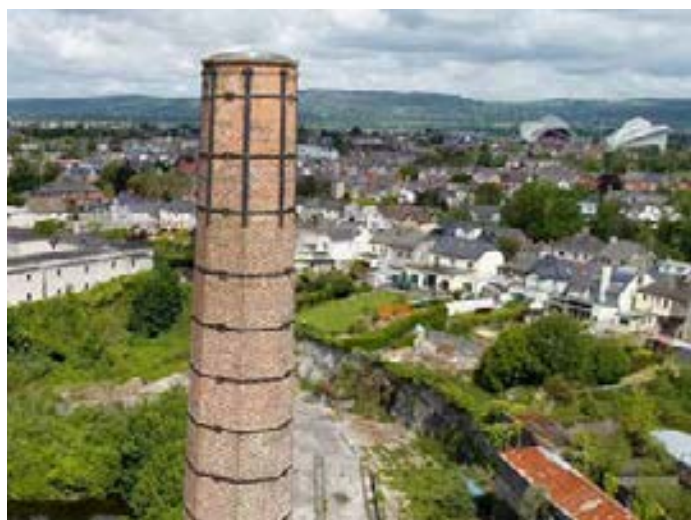
Fig.50 Brick Chimney 1852, with bands and modern capping

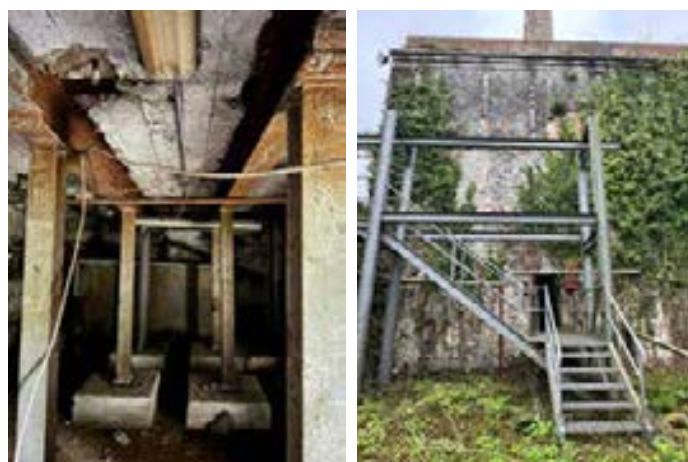
Fig.55 Water Tank building

Left photo - basement space with steel and concrete floor

The building is of limestone and brick construction with a cast iron tank above. The front and side elevations are of high quality masonry with the back elevation of rubble stone. The cornice continues around the whole of the building. The tank is set over the inner leaf of masonry. The building extends over four storeys with the lower storey visible from the reservoir. The ground floor of the building is used as storage space with windows that match those of the Infiltration Gallery alterations of the early 1950s. The basement is accessed from the exterior lower ground via an opening in the wall. Within the basement space it is possible to see a mid C20th steel frame with in-situ reinforced concrete slab. It is likely that the building as a whole was altered in the 1950s. The ground floor arched opening was in-filled and two openings were punched through the arches of the side elevation. Each had a steel framed window inserted. These changes have reduced the aesthetic simplicity of its original form.

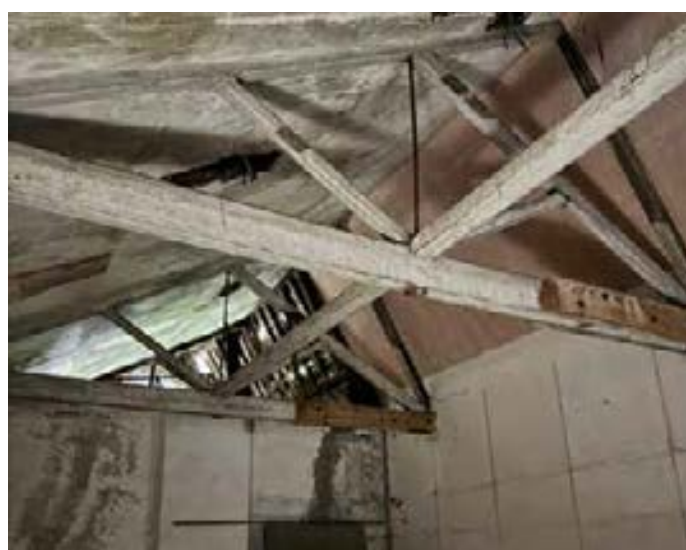
Fig.58 Roof structure of the long building

Of the long building, the elements of original fabric of the Flax Phase; the vaulted base holds 'high significance' and the fragment of roof structure and much altered facade holds 'medium significance'. The changes and structures of the C20th have resulted in the loss of original fabric and as such have 'negative significance'.

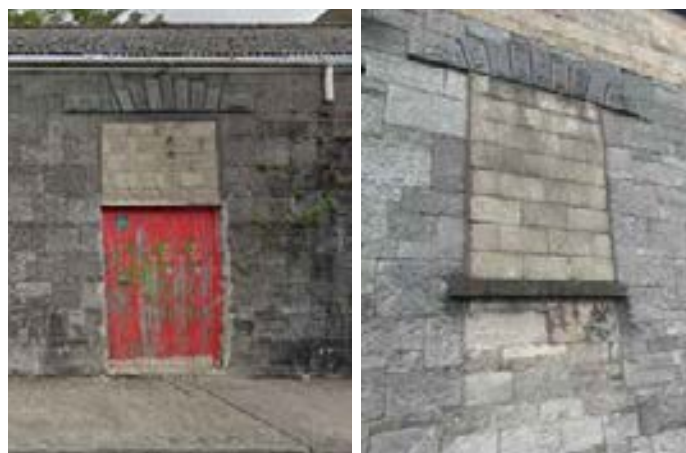
Fig.61 Adjusted window opening - shop entrance and reduced height

of the element in use by the house is largely lost to decay. The facade addressing the street has survived with each window reduced in height. The cills were raised and the masonry below in-filled (Fig.60).

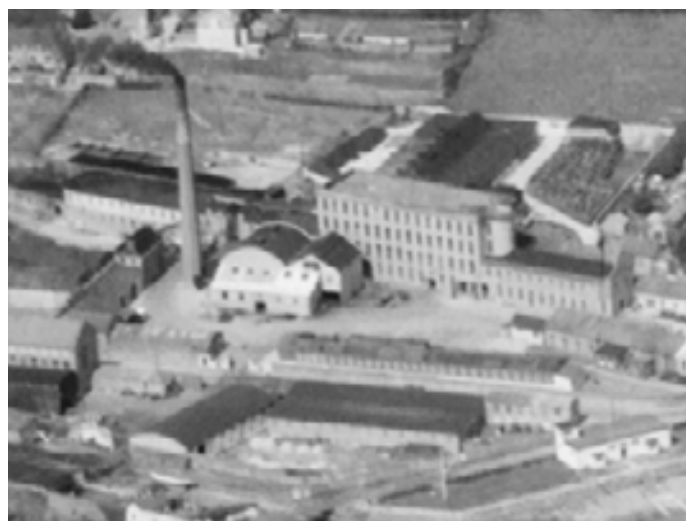
Fig.66 Photo of the site c.1947 - Workshop present with windows and curved roof visible

Dairy Disposal Phase - The Workshops were not present until after 1924. They appear in a photo of 1947 (Fig.65) in which the curved roof form and roof vents are visible. The Workshops are predominantly of timber construction with steel posts. The wall addressing the boundary has a masonry plinth with coved cornice top set between the steel posts of the building structure. Above the plinth each bay was timber framed with a 12 pane fixed light. The roof is formed of timber lattice (Belfast) truss with sarking boards and a felt roof. Five rectangular vents / roof lights set above.

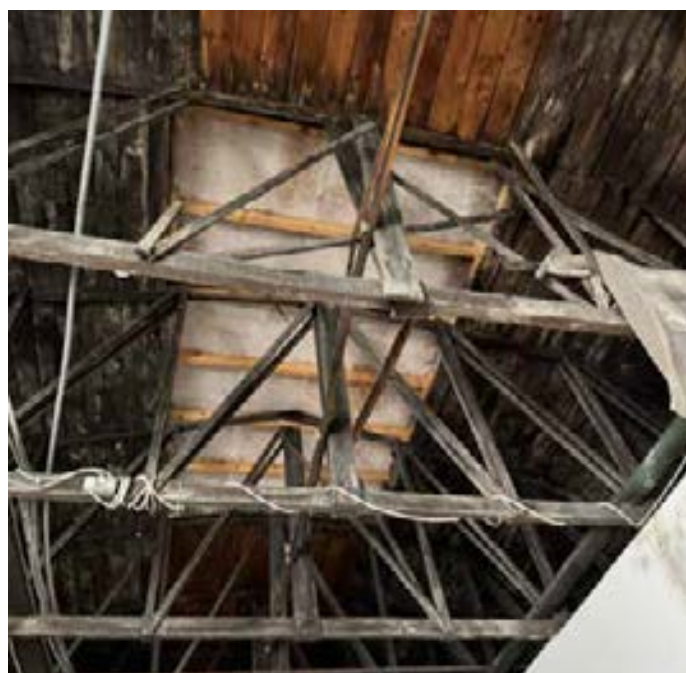
Fig.67 Photo of the workshop roof, lattice truss and vent opening

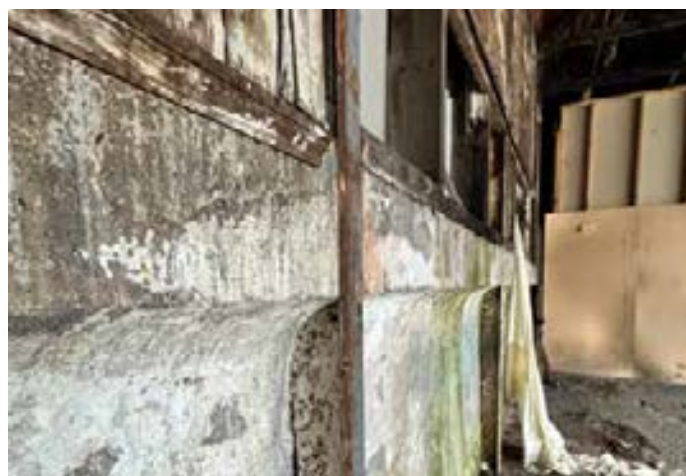
Fig.68 Photo of the corniced plinth and steel posts

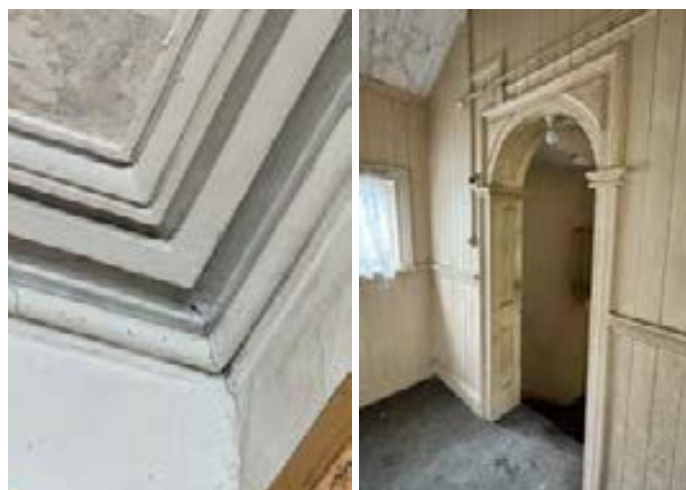
Fig.78 First floor cornice and decorative timber arch between stair and rear bathroom

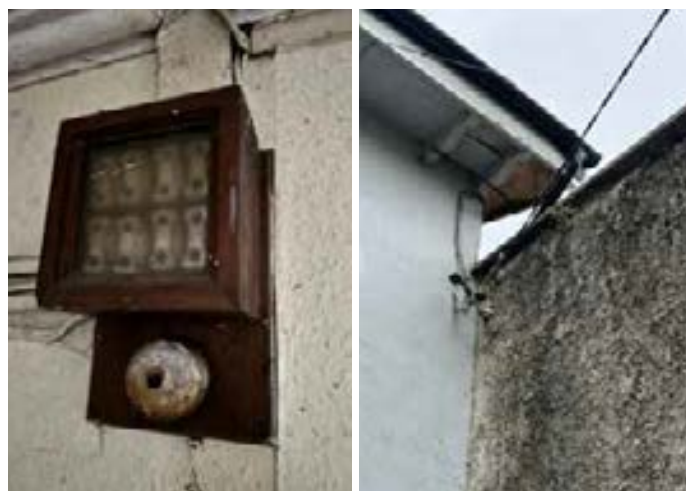
Fig.80 Fuses to left house and junction of right house to gable wall of the mill complex - overhanging closed eaves

Dairy Disposal Phase - The bakelite switches and fuse board date from after 1927 and are likely to be part of the servicing of the building in the 1940s. The house on the right was also modernised around this time. The replacement fire surrounds date from the 1930s and 1950s. The slim double doors were removed and colourful glass inserted in place of the Victorian over light.

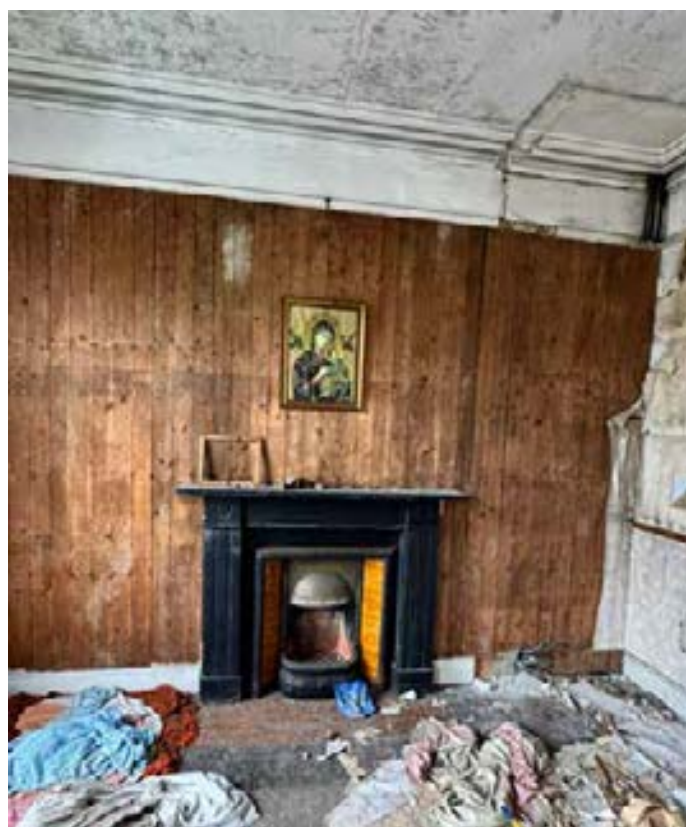
Fig.79 First floor room of the left house - timber boarded wall and Victorian fireplace

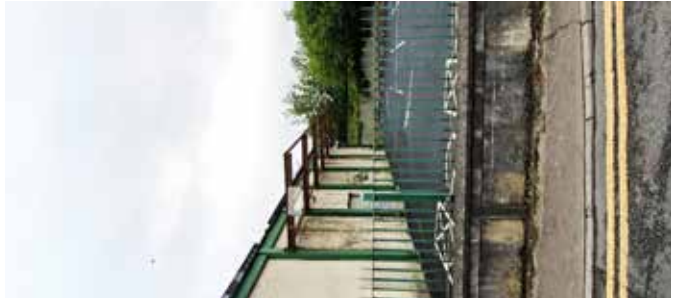
WAREHOUSE

modern construction. A length of wall approx. 56m was removed to make way for the warehouse and replaced with a low rise wall with painted steel railings and an access way into the car park.

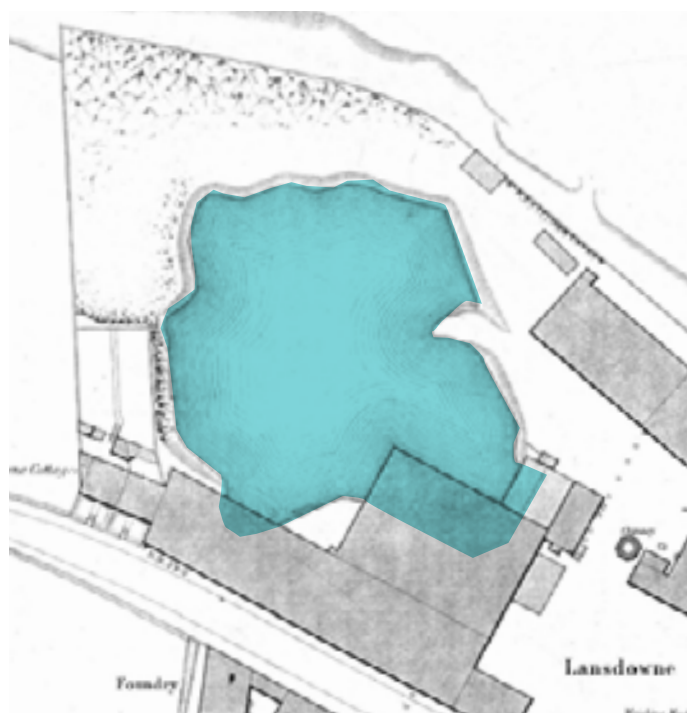
Fig.82 1870 Map of Limerick - Quarry and reservoir

The reservoir has 'Scientific interest' and 'Technical interest'. It is of 'high significance' for its role in the design and operation of the factories. The later changes such as the infilling of the edge has 'negative significance' due to it eroding the legibility of the earlier form of the reservoir. The piers within the reservoir are assessed under section 5. Infiltration Gallery.

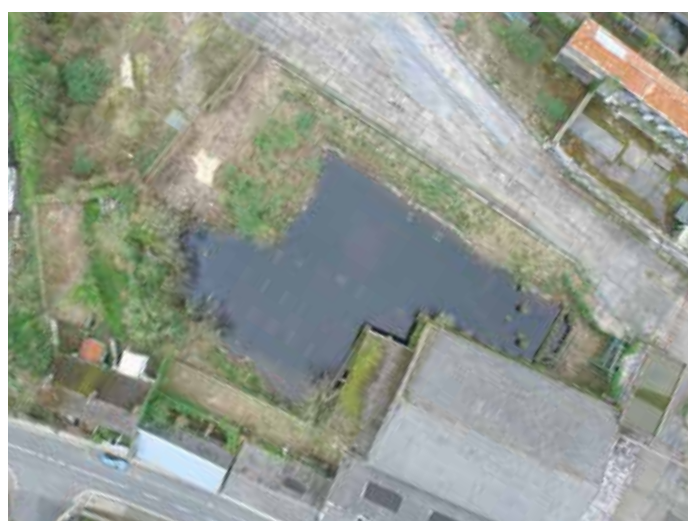
Fig.83 Aerial photo with 1960s piers visible

Golden Vale Phase - In the 1950s the reconstruction of the building over the Infiltration Gallery may have exploited the pre-existing piers submerged within the reservoir.

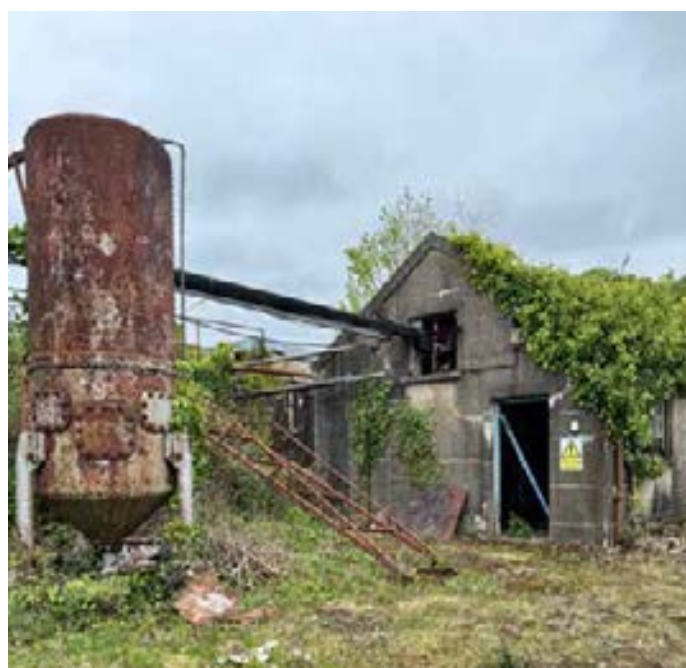
Fig.87 Remnants of the upper reservoir

Golden Vale Phase - The structures appear unchanged and were likely maintained with new equipment when required. The buildings are in a derelict state of repair.

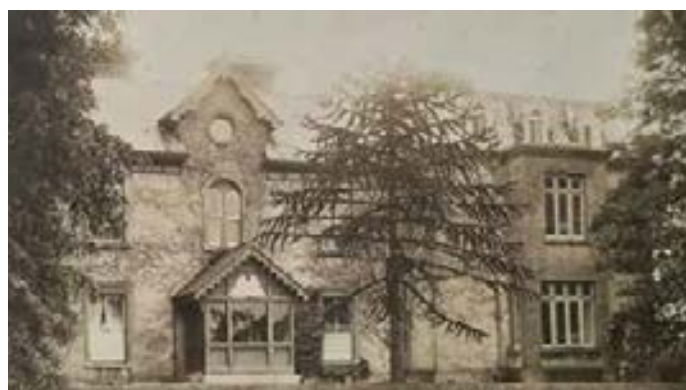
Fig.88 Fernbank House c.1910

Shortly after 1900 the original building appears to have been extended, doubling in size. The photo of circa 1910 capture a new element with a mansard roof lined with decorative scalloped roof slates set behind a stone coped parapet. The roof has small dormer windows offering a French aesthetic. The windows had an Edwardian aesthetic. Both buildings appear to have been rough rendered over a stone plinth.
