ENVIRONMENTAL IMPACT ASSESSMENT REPORT

Appendix 9-1 Statement of Significance P08 250925

Cleeves Riverside

Statement of Significance

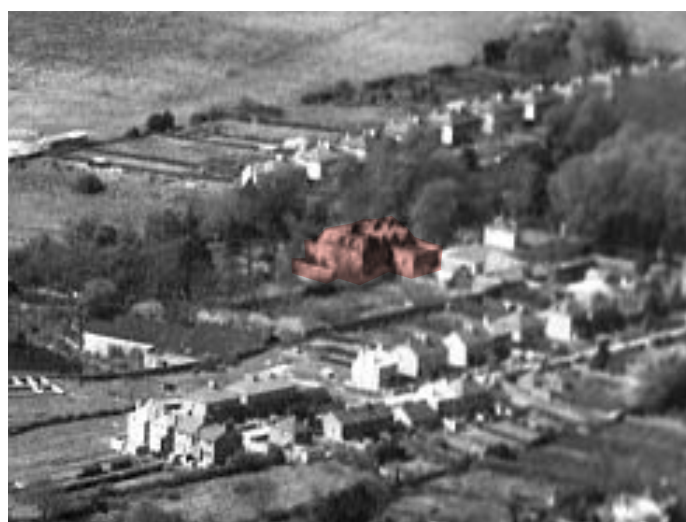
Fig.90 Photo of the rear of Fernbank House c.1951

its Victorian footprint although this may simply be out of date. Aerial photography of 1951 taken from the north-east aspect captures the Cleeve's site and Fernbank House from the rear. The mansard of the c. 1900 extension and gables of the earlier Victorian building are visible with a flat roof extension housing the kitchen and other new buildings to the rear.

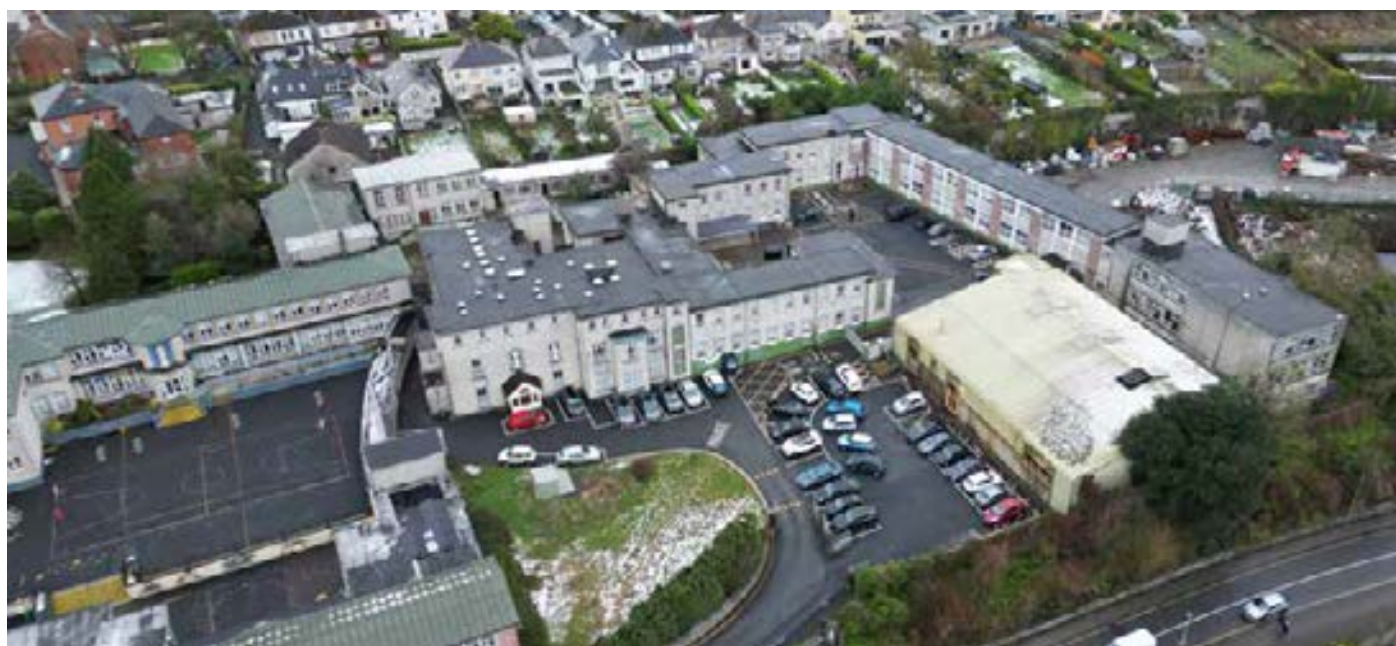
Fig.92 Aerial photo of the school 2025

The rooms to the rear and on upper floors of the original houses have become much altered. The interior of the c.1900s building does not survive to the same extent as the Victorian villa. Major structural changes have occurred with the loss of the roof and addition of a storey. These changes extend to the rear with a chapel and classrooms. The original and early buildings have been subsumed within the Salesians estate which is predominantly of the mid and late C20th.

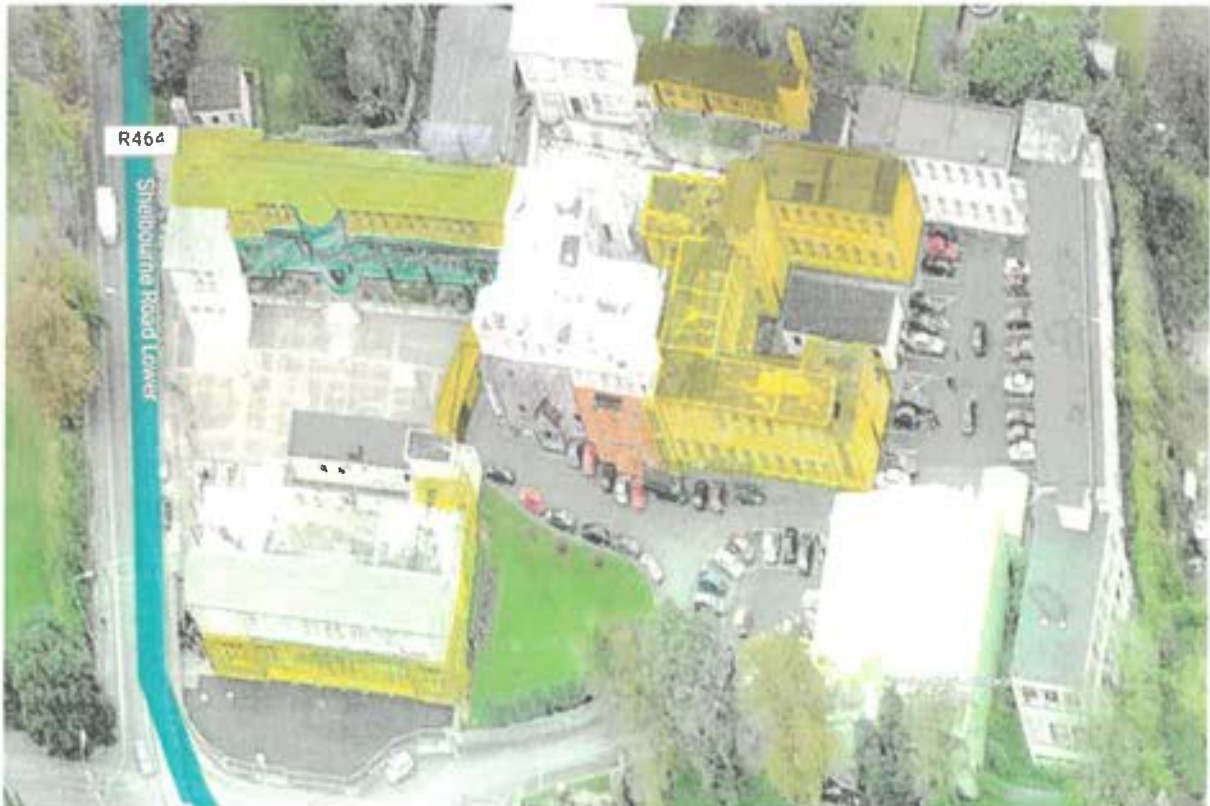
Figure 3: Overlay on the aerial view of the site from Bing Maps, showing an outline chronology of the site. The original extent of the house constructed in 1878 is shown in purple. The 1905 extension is shown in Orange. The National School, constructed c. 1947, is shown in blue, and the extensive additions to the site in c. 1955 are highlighted in yellow. The building to the right hand side of the photo, now in separate use, appears to have been constructed as a hostel c. 1958. The date for the addition of the top floor to the original house and its extension may be c. 1969. The Chapel extension to the rear of the original house (not visible in the aerial view) appears to have been constructed c. 1949, but has been altered/replaced c. 1969.

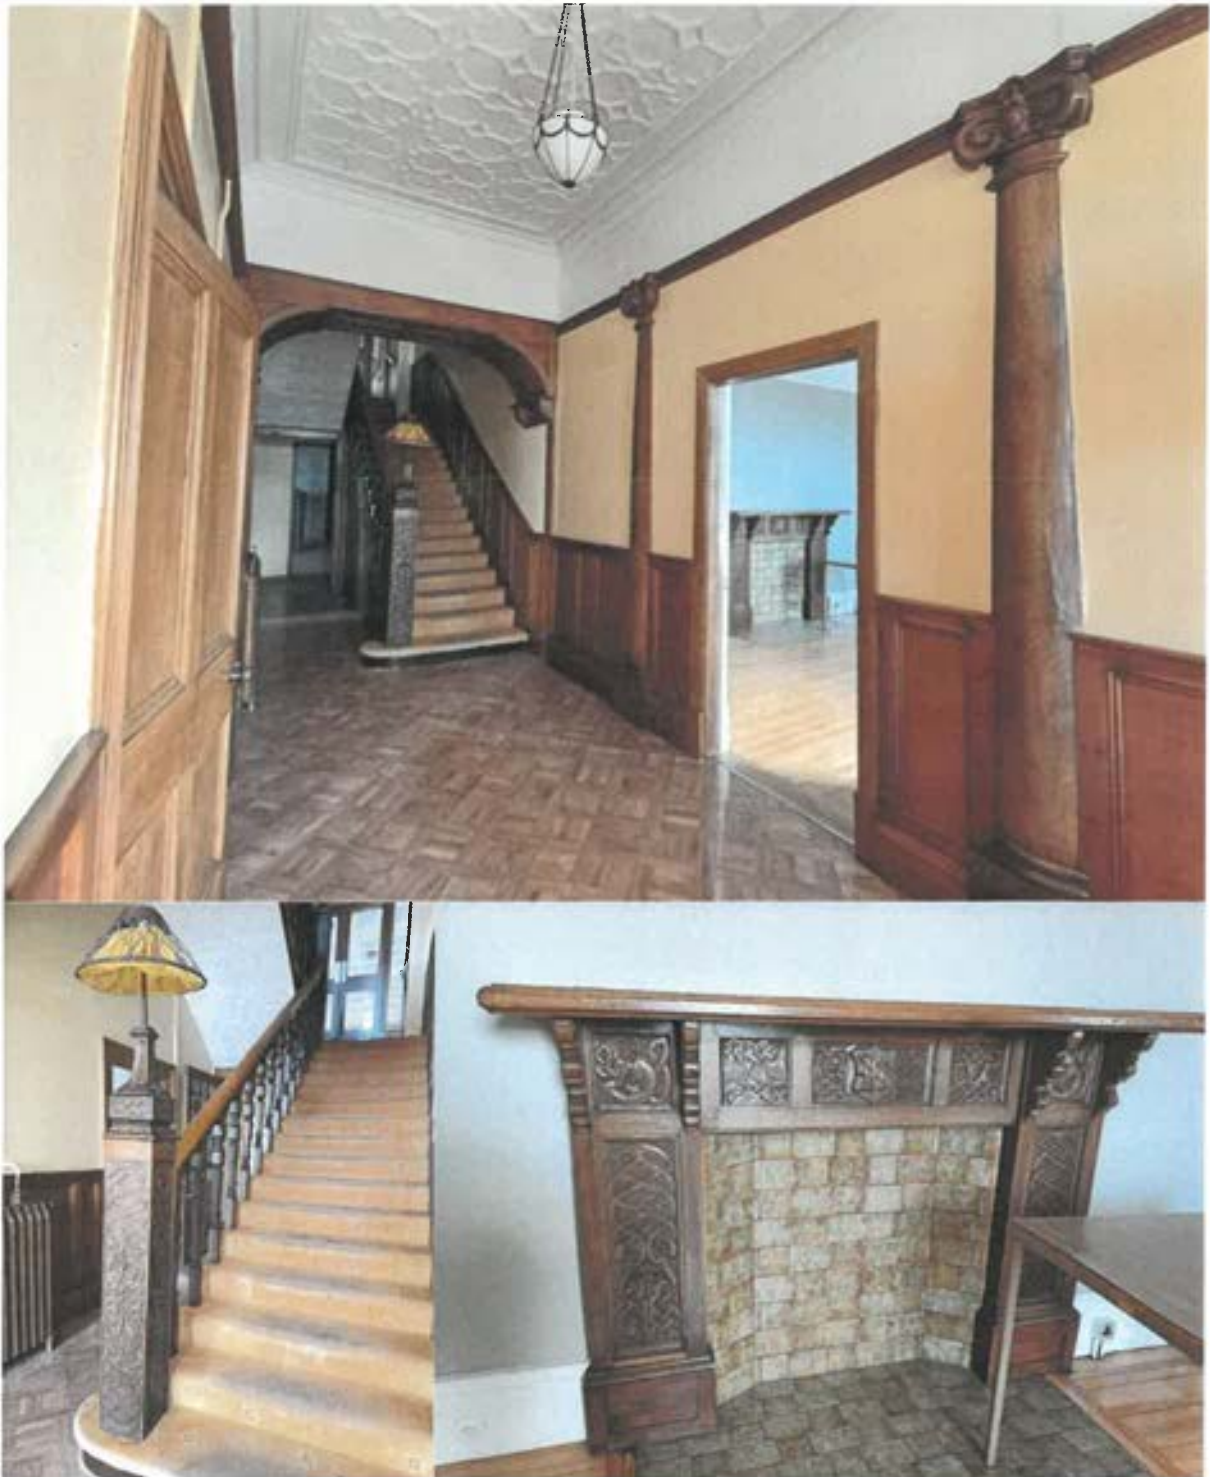
The interiors are largely functional spaces with little or no architectural quality or significance. However, there are some internal spaces that are considered to be of interest, including the Entrance Hall and Stair Hall. While the layout of the Entrance Hall appears to have been altered from its original form, both rooms retain decorative joinery of quality and interest. There are also some fittings, including a carved timber mantelpiece, at Ground Floor Level of Fernbank House which are of interest.

Figure 6: Representative photos showing the Entrance Hall, Staircase and carved timber mantelpiece.

Features within the footprint of the former Fernbank House are of some artistic interest, including the carved timber fixtures and fittings in the Entrance and Stair Hall, and the carved timber fireplace to the Ground Floor Eastern Reception Room in the early 20th century addition to the house. The modern stained glass windows to the former Chapel are also considered to be of some artistic interest. However, these fittings are not of sufficient interest to warrant the inclusion of the building on the Record of Protected Structures.

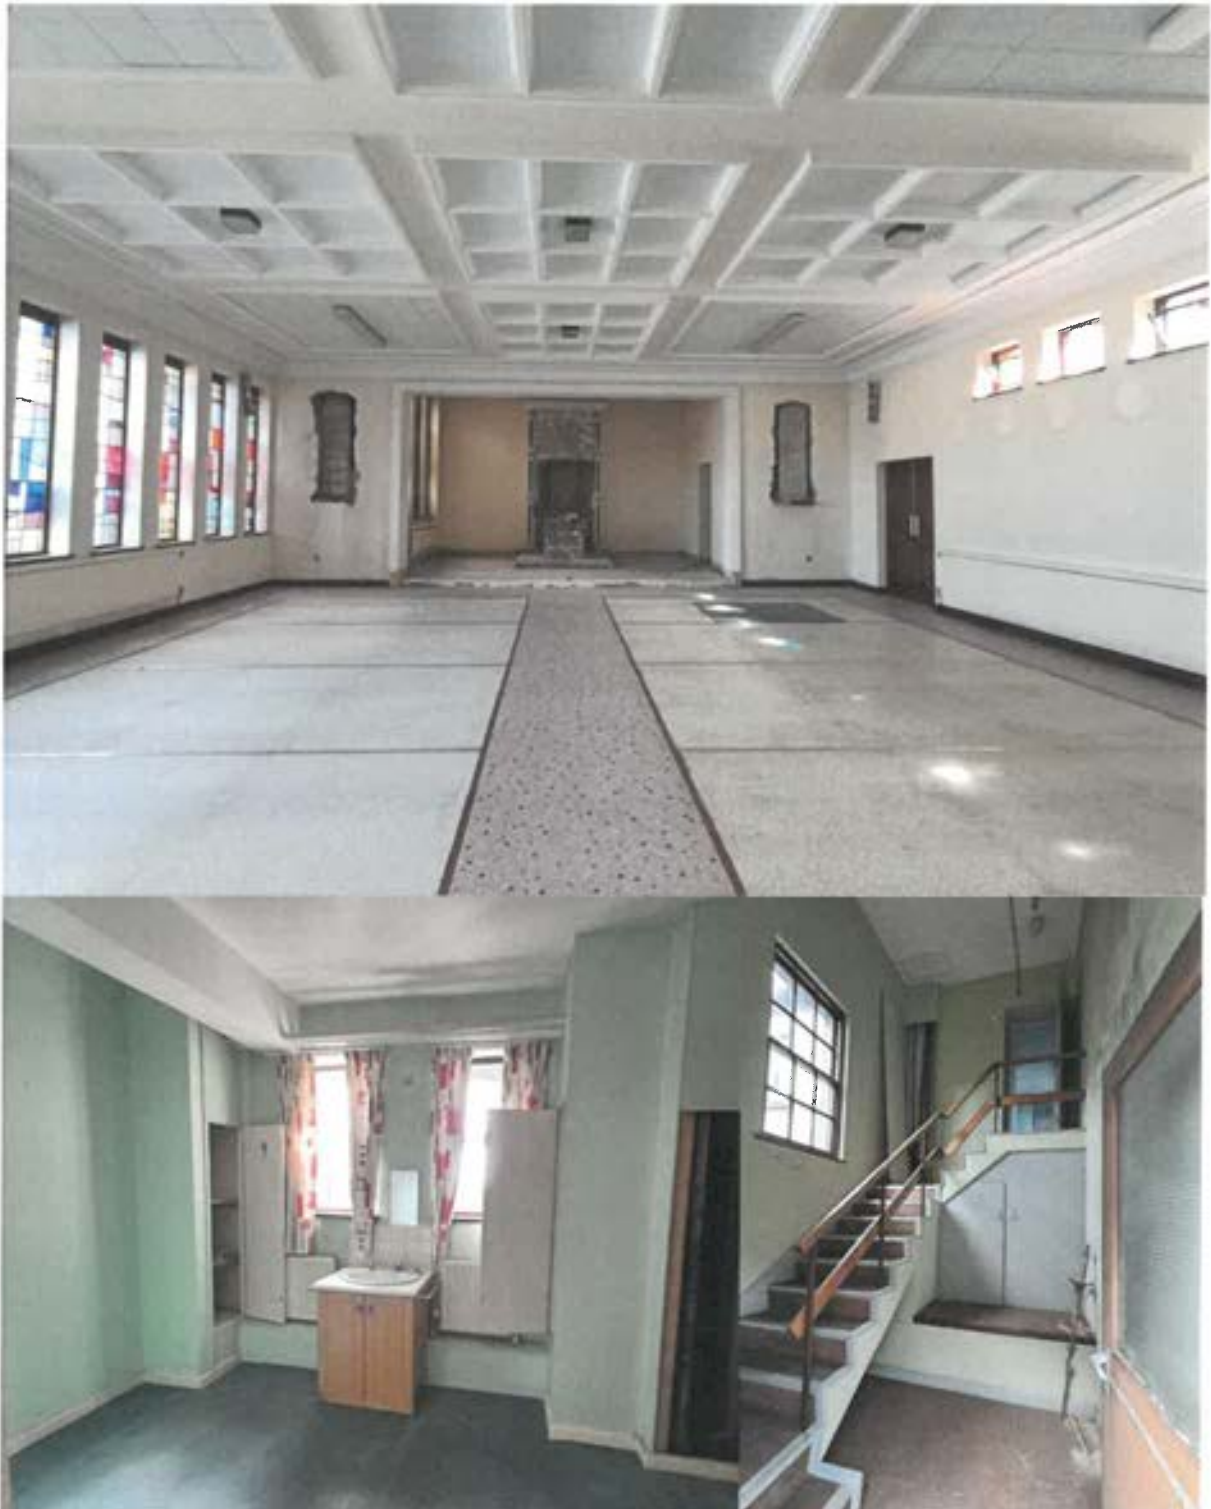
The former Chapel has been deconsecrated, and the original fittings removed. There are relatively standard stained glass panels on the western wall. The Chapel is not considered to be of particular architectural quality or significance.

Figure 7: Representative photos showing the interiors of the modern spaces, including the Chapel, a cell and a staircase.

As illustrated in the photos included above, and appended below, the interiors of the building are generally considered to be standard for the period in which they were built, and of limited interest. The spaces are largely functional, and lacking in architectural features or ornamentation.

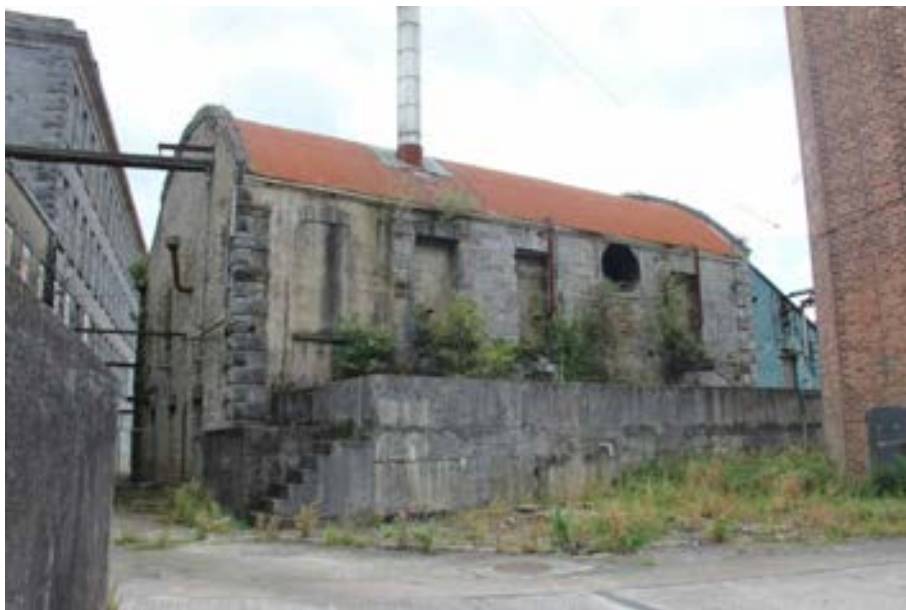
Photograph 2 External view of the Engine House. Note curved corrugated sheeting and chimney stack protruding from the roof.

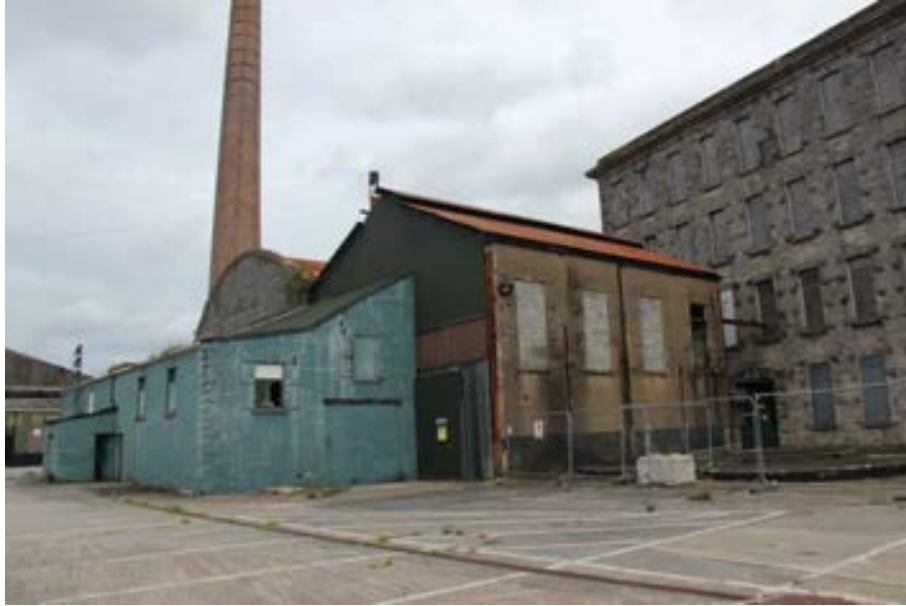
Gable to gable with centre ridge vented corrugated sheeted pitched roof covering.

Photograph 3 General view of Building 2, with Corrugated Steel roof covering. Note split pitch of Building 3.

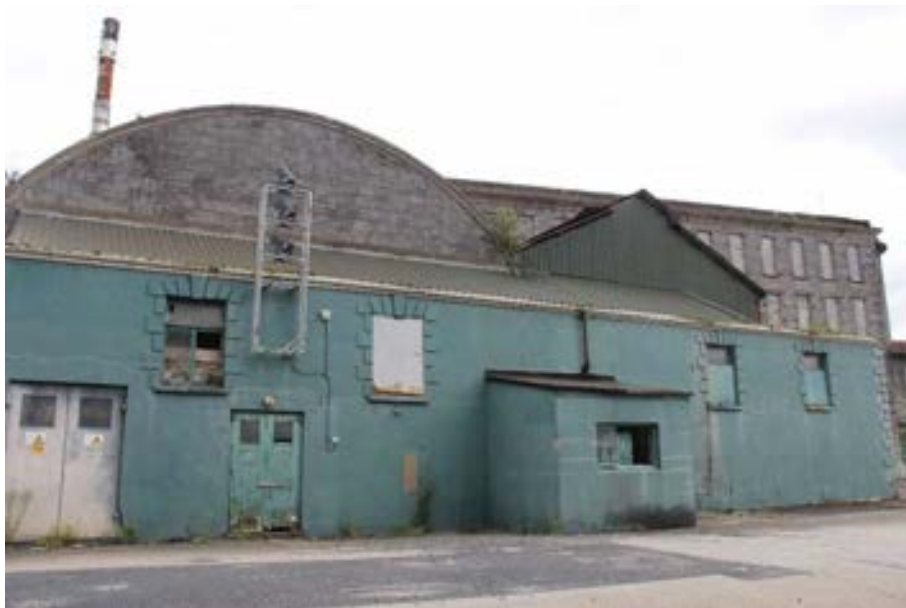
Photograph 4 General view of Building 3.

The roof covering of Building 3 is also corrugated sheeting, with the covering a split pitch, a lean to the Engine House, then a shallower pitch, mid plane, to the front wall of the extension. There is a concrete barge to the roof edge on each end elevation.

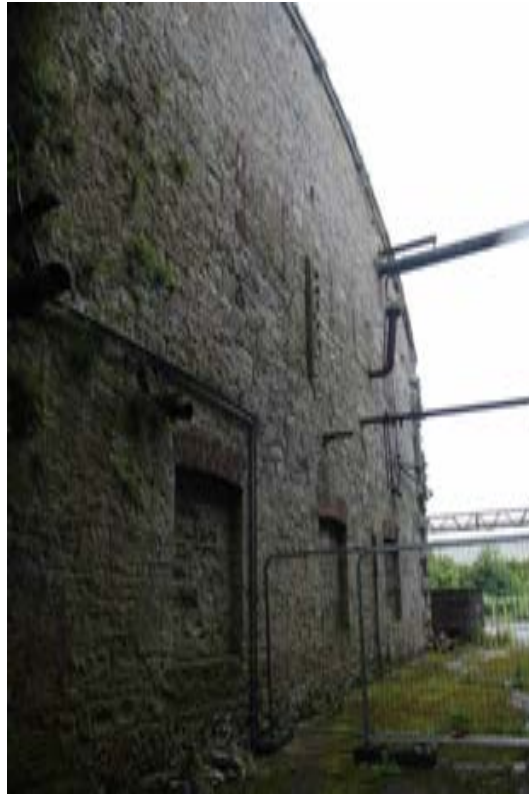
Photograph 5 Northeast elevation of the Engine House, random rubble natural stone construction.

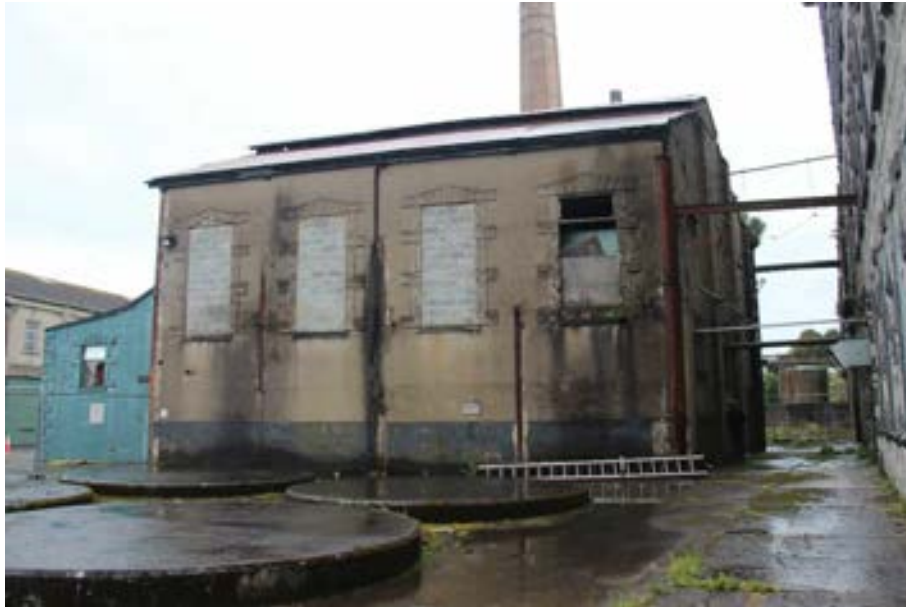
The frame is visible on the eastern elevation, where the render has fallen away.

Some sections of the external walls are rendered, most notably the eastern elevation, which is finished with a ruled Ashlar Stucco and rusticated stone imitation window surrounds, an attempt to match the Engine House and Mill itself.

Photograph 6 Eastern elevation of the extension to the Engine House.

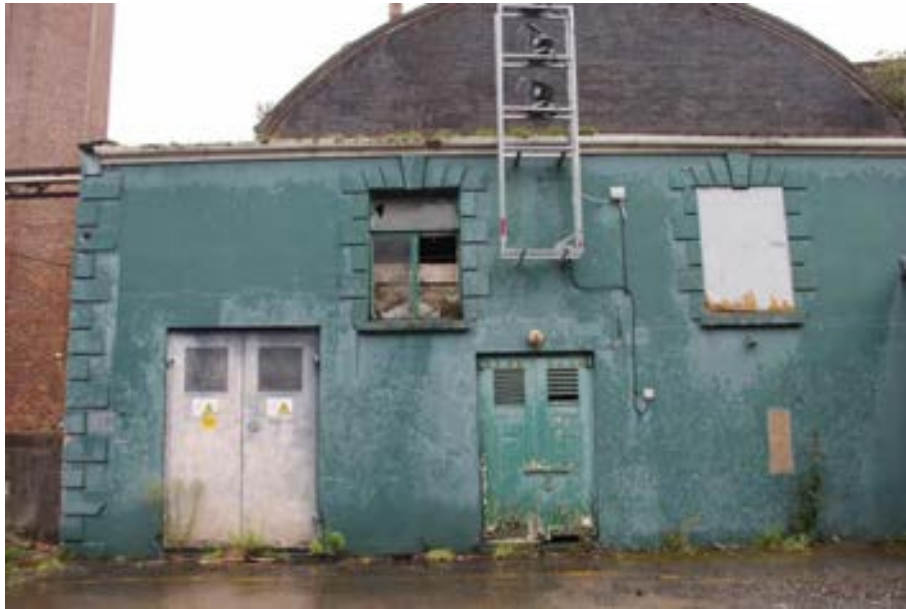
The external elevations are painted, with an Ashlar Stucco render and raised replica masonry quoins and window surrounds, to match the original buildings, all be without the rustication effect on the quoins and window surrounds.

Photograph 7 Southern elevation of the building 3 extension.

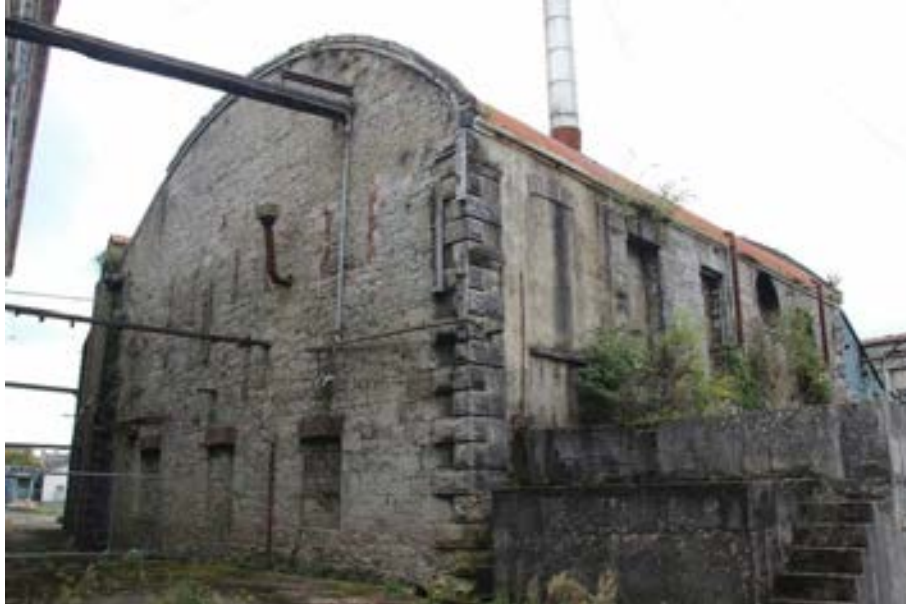
The only openings present to the Engine House externally now, are to the western elevation. These are now all infilled with masonry. (See Photograph 2 above).

Photograph 8 General view, from the northwest of the Engine House building.

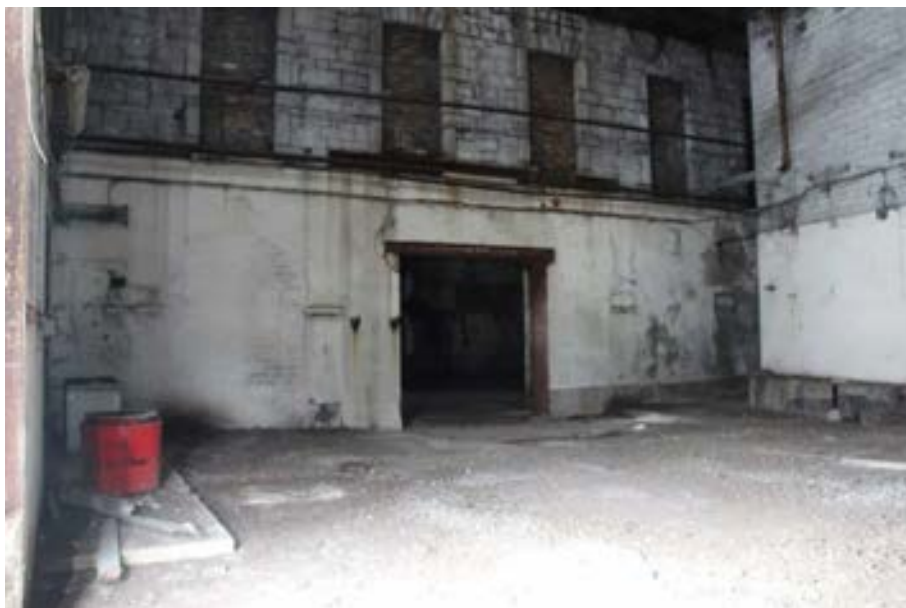
On the original eastern elevation, now internal, there were also openings, which are also infilled with masonry, with the exception of a circulation opening on the ground floor, not original to the building.

Photograph 9 Eastern elevation of the Engine House, now internal.

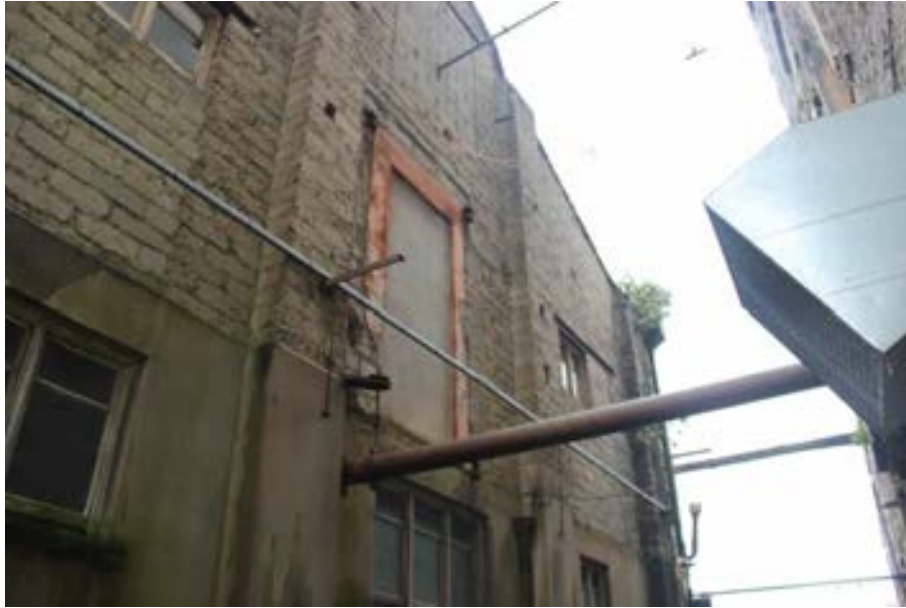
Photograph 10 General view of the northern elevation of Building 2.

The northern elevation has five openings, with surviving timber casement windows, and two door assemblies.

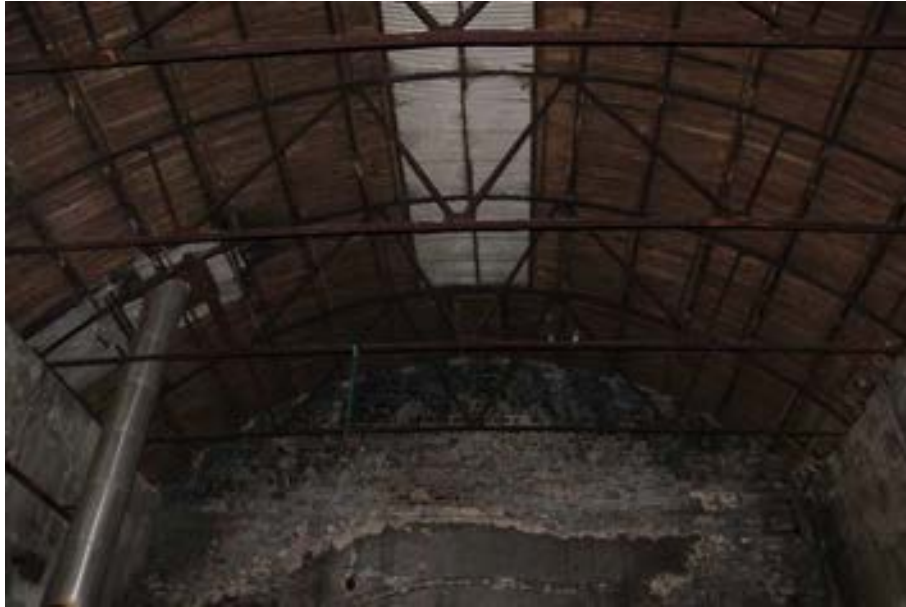
The structure of the Engine House roof is of wrought iron Belfast Trusses, with timber purlins spanning across the trusses beneath timber parging, onto which the roof covering is affixed.

Photograph 12 View of the Roof Build-up of the Engine House.

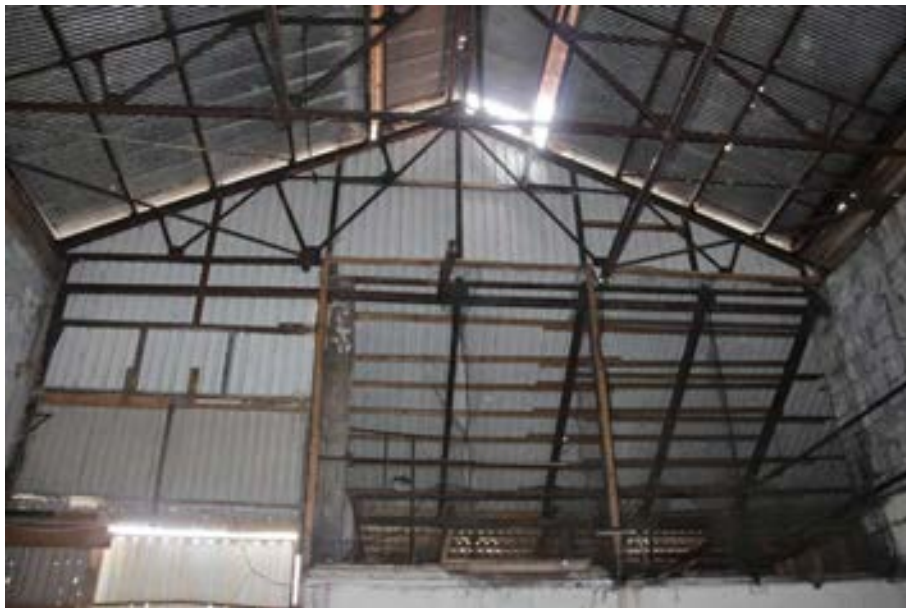
The roof structure to building 2 consists of steel fink roof trusses, with steel bracing between each truss, and purlins running over the topside of the trusses, onto which the roof covering is affixed.

Photograph 13 General view of the roof trusses to building 2.

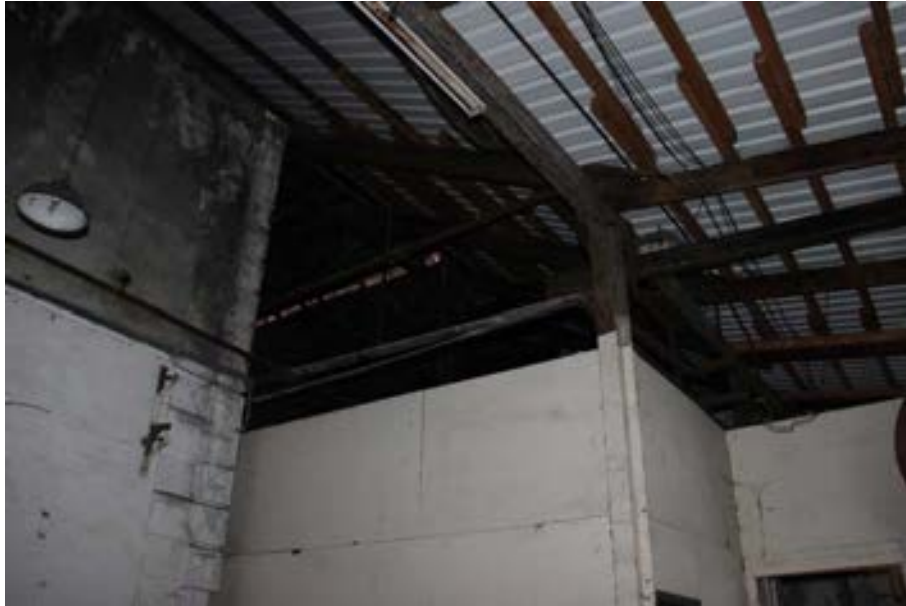
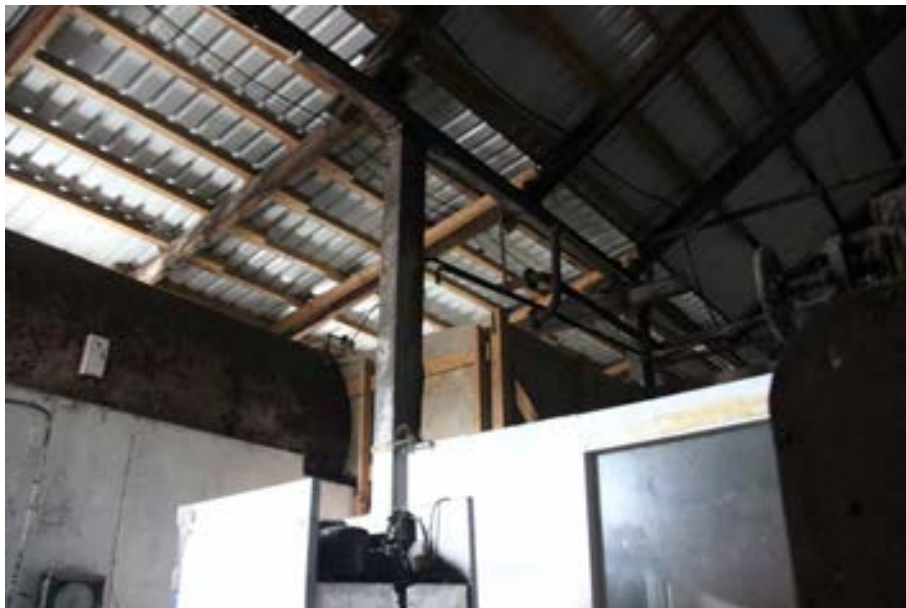
The roof structure of building 3 consists of rolled steel beams, sitting on steel frames internally, onto which timber purlins, running from beam to beam sit. The roof covering is then affixed to the timber purlins.

Photograph 14 General view of the roof structure to building 3.

Photograph 15 Alternate view of the roof of building 3.

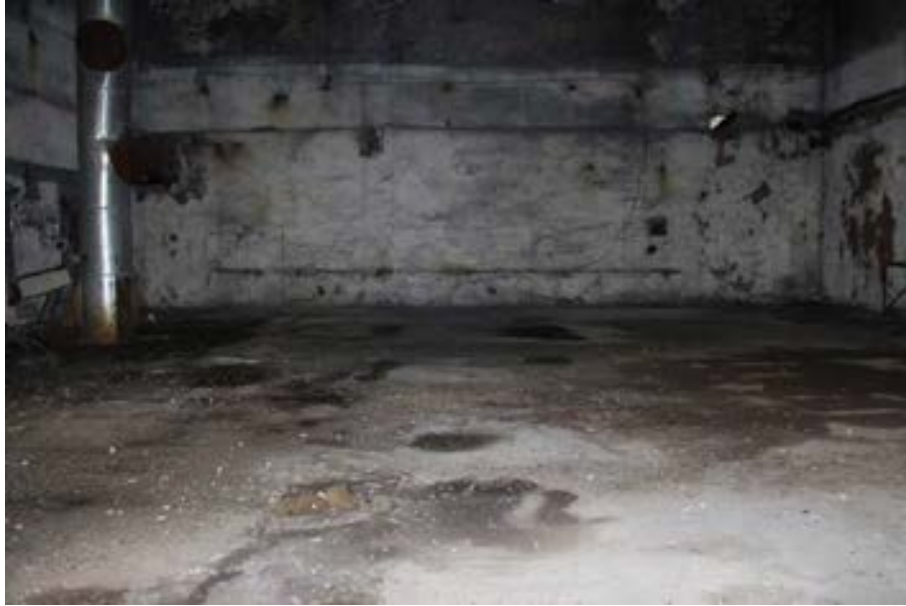
Generally an open plan interior, the internal elevations of the Engine House are of mass masonry natural limestone construction with a cementitious render applied to the lower levels of the walls.

Photograph 16 General view of an internal wall elevation to the Engine House.

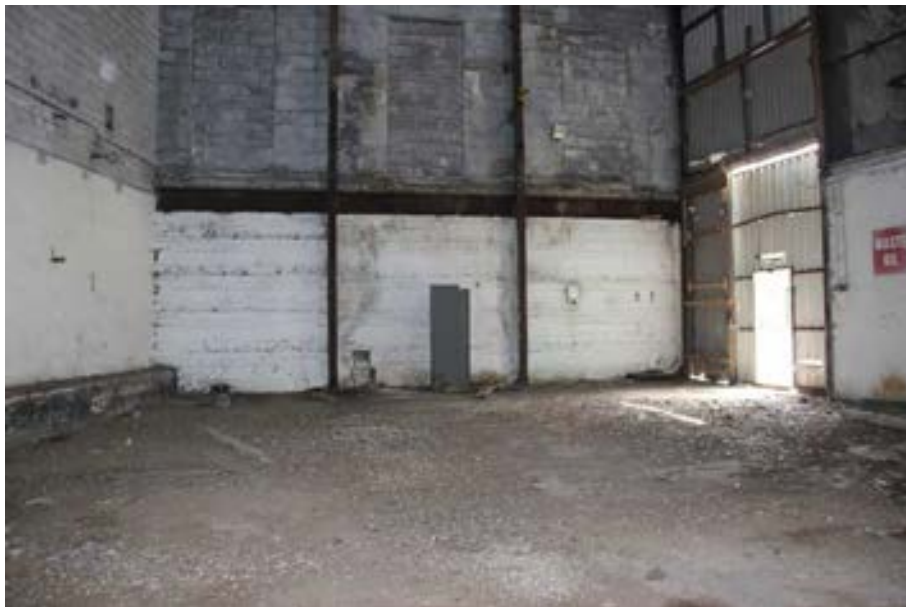
The internal elevations of the external walls are a mixture of cast insitu mass concrete (most likely the original walls) with modern concrete blockwork overhead. The northeastern rooms of the building were not accessible on the day of inspection, with the survey plans showing two rooms internally on the ground floor.

Photograph 17 Internal elevations of Building 2

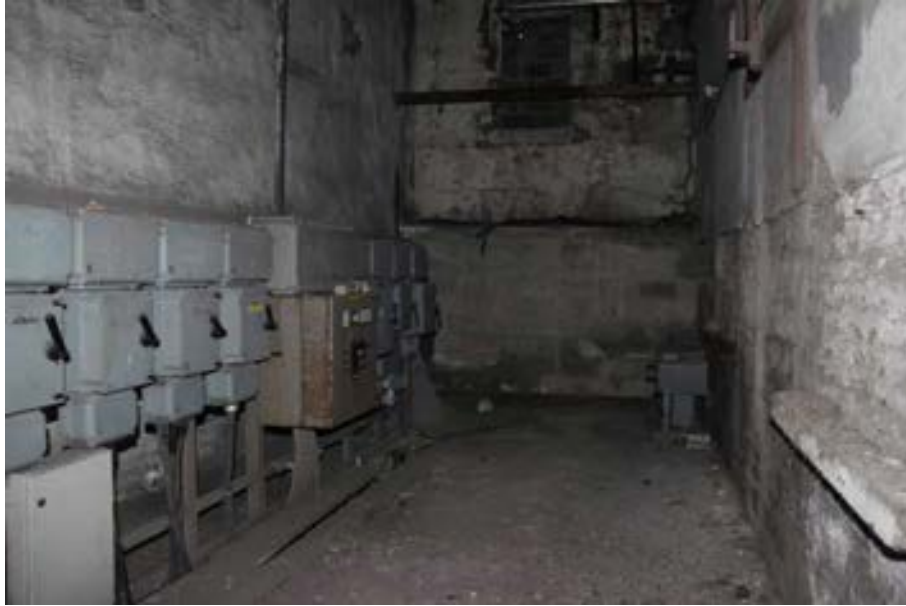
The external walls are of mass masonry construction. The western section of the building houses service panels and an electrical substation. There is a Mesh Screen partitioning to the service panel room.

Photograph 18 Room containing electrical fuse panels.

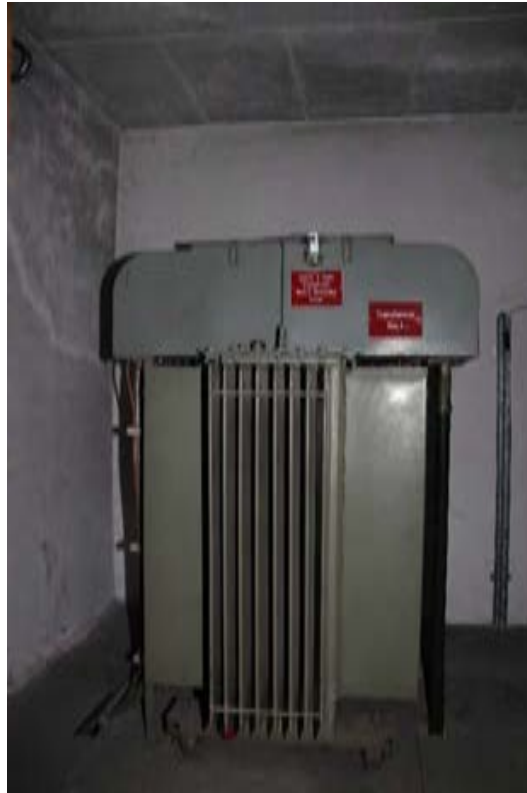
Photograph 19 Electrical Transformer, located in the room on the southern section by the porched entrance.

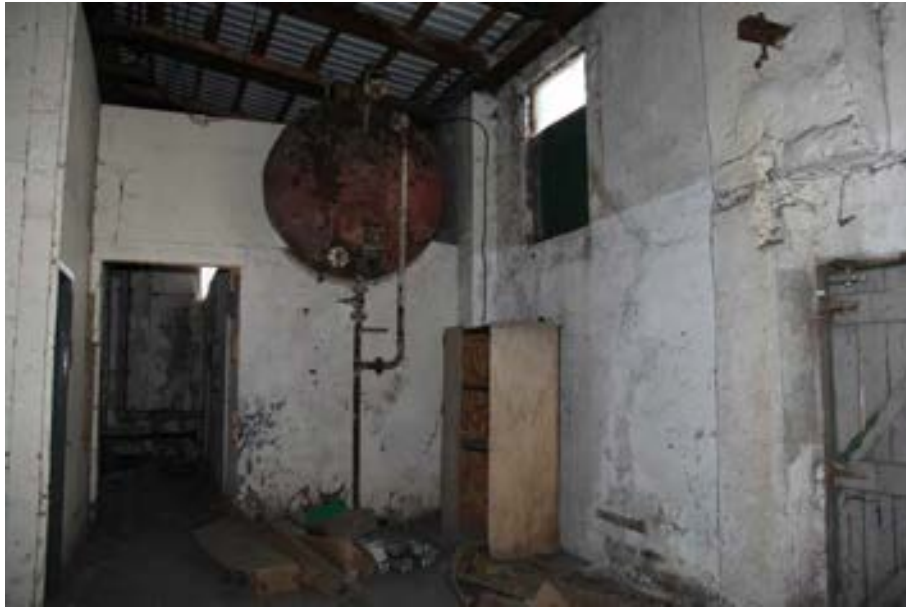
Photograph 20 Masonry support for a fuel tank, with timber partitions to the LHS.

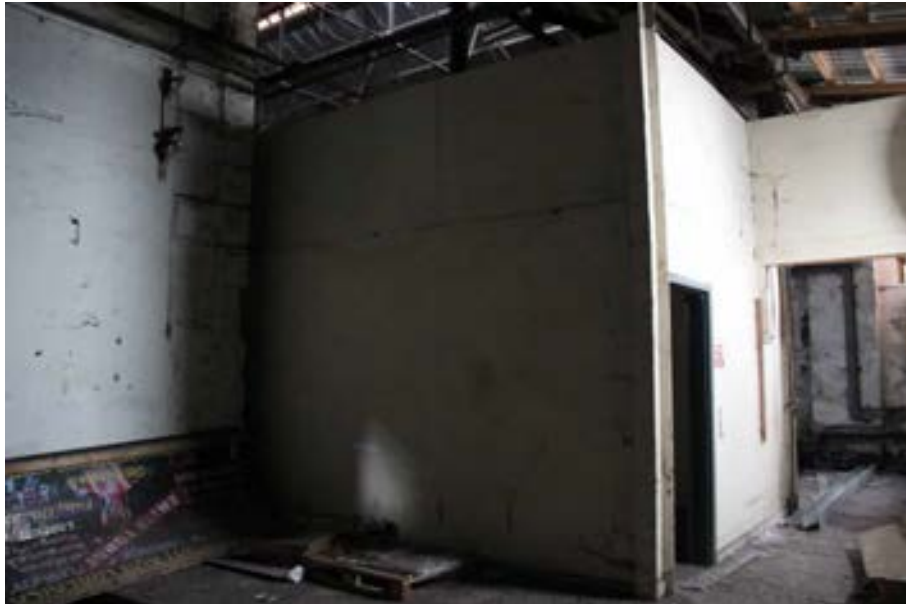
Photograph 21 Exterior of timber stud partitioned room.

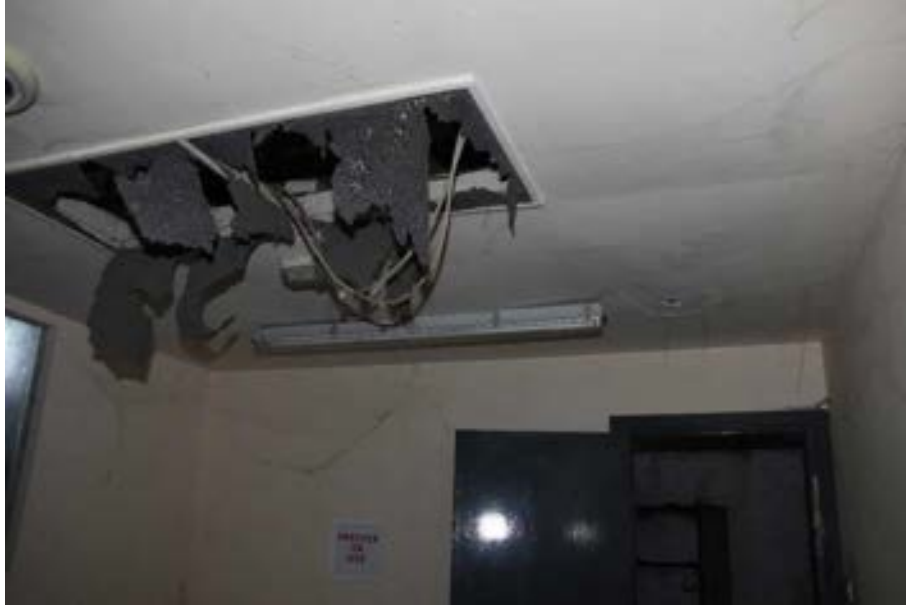
Photograph 22 Example of the modern plasterboard ceiling to one of the building 3 rooms.

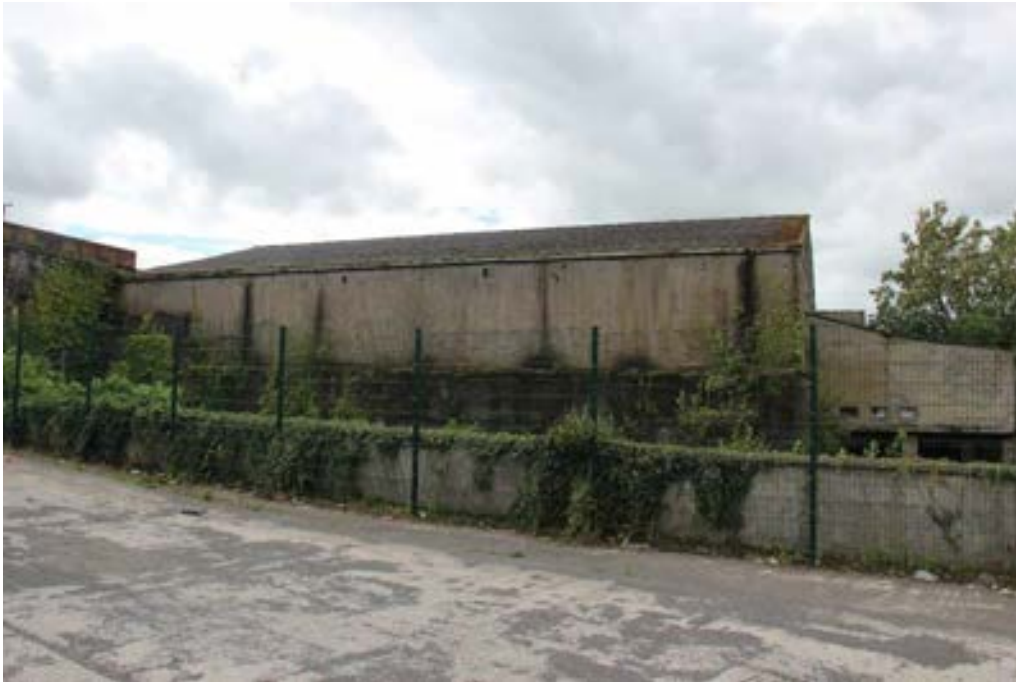
Photograph 1 - View of Infiltration Gallery from North

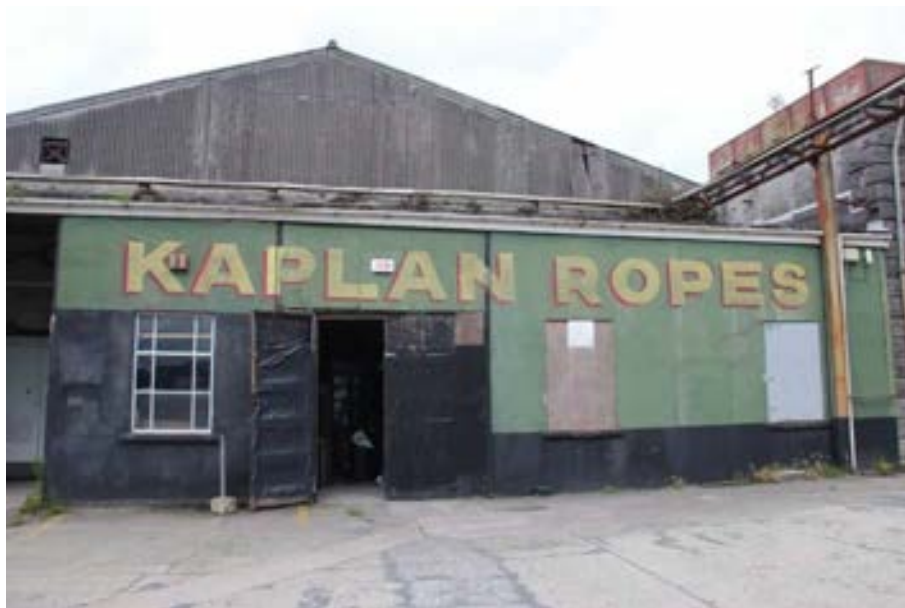
As noted above, there is suspected remnants of the façade of the dye house building located within the front section of the current warehouse building, covered in by the lean to building.

Photograph 2 Front elevation of subject building.

There is noted painted over natural limestone masonry to the front façade, internally of the warehouse building, which is backed up by modern concrete blockwork and cast insitu concrete walling.

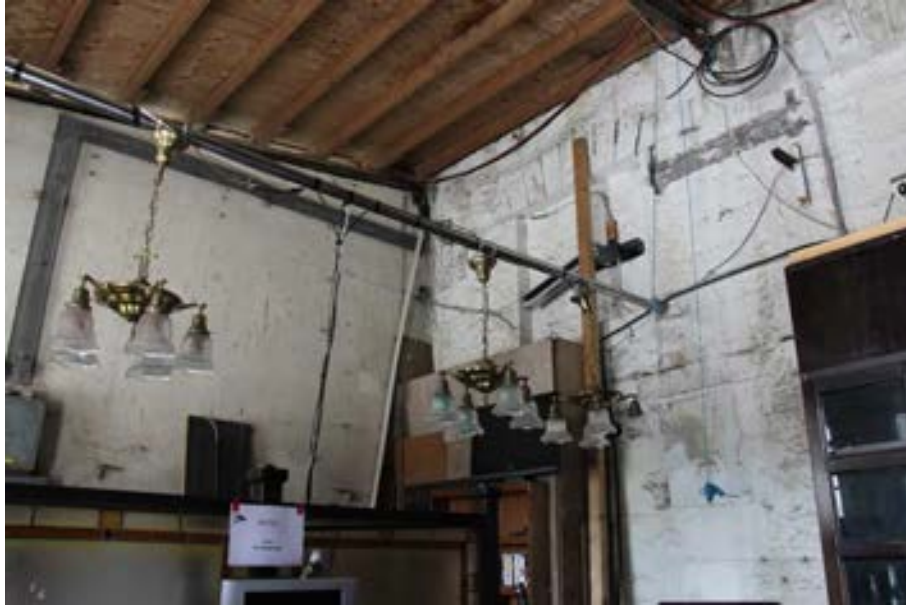
Photograph 3 - Example of the suspected original façade of the dye house, surviving within the current warehouse complex.

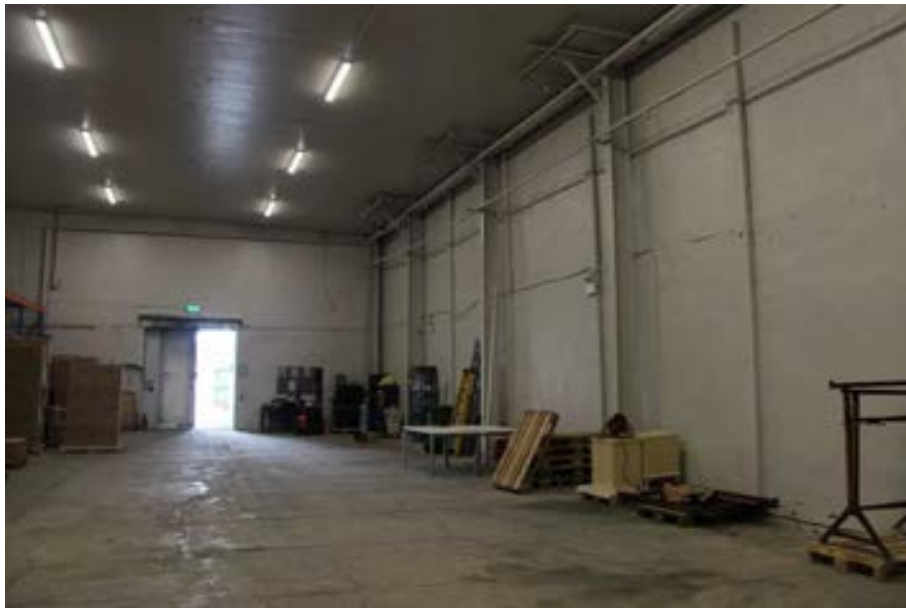
It was noted that all the visible fabric, where the wall was expected to be found, is covered over in modern built fabric e.g. modern concrete blockwork.

Photograph 4 - Current view of location of wall between the Cheese Plant and original Dye House, northern elevation.

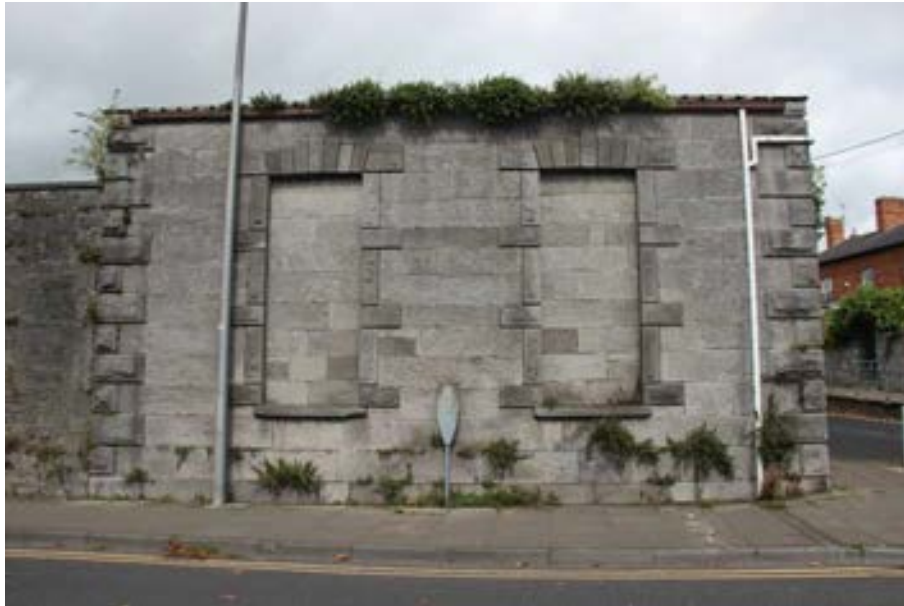
Photograph 1 – Linen Store Southeast Elevation

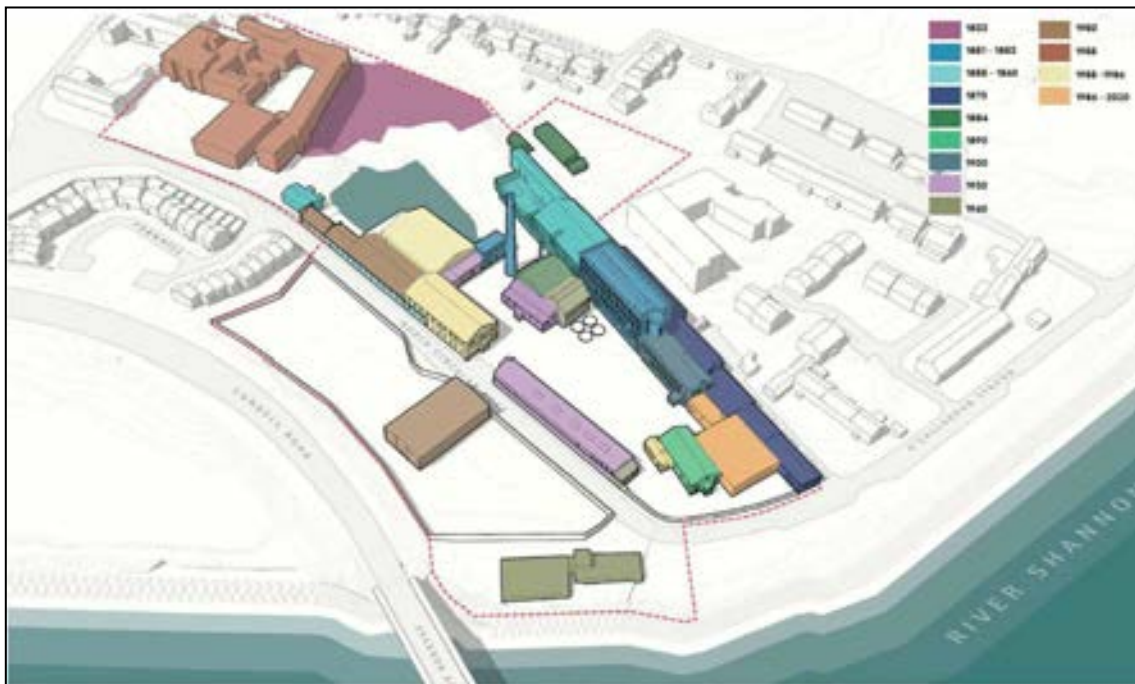
The evolution of the site is detailed in the building age diagram below.

Figure 5 - Building Ages Diagram, Limerick 2030
