ENVIRONMENTAL IMPACT ASSESSMENT REPORT

Appendix 9-1 Statement of Significance P08 250925

Cleeves Riverside

Statement of Significance

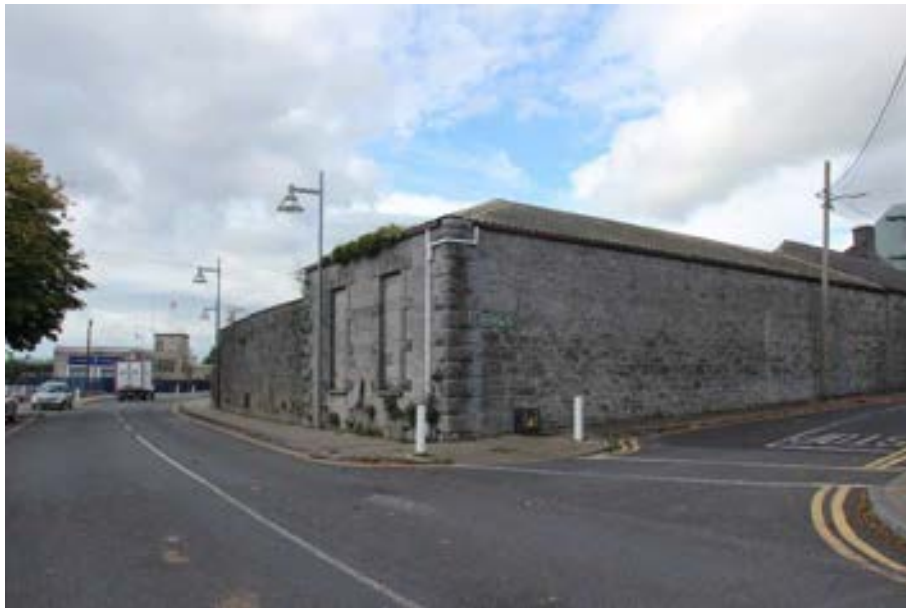
The roof covering, a hipped gable to O'Callaghan Strand, and pitched roof, thereafter, has a replacement modern pressed corrugated sheeting covering to the first section, starting at the junction of O'Callaghan Strand and Stonetown Terrace, with extruded aluminium rainwater goods.

Photograph 2 The first section of the Dairy Building, at the junction of Stonetown Terrace and O'Callaghan Strand.

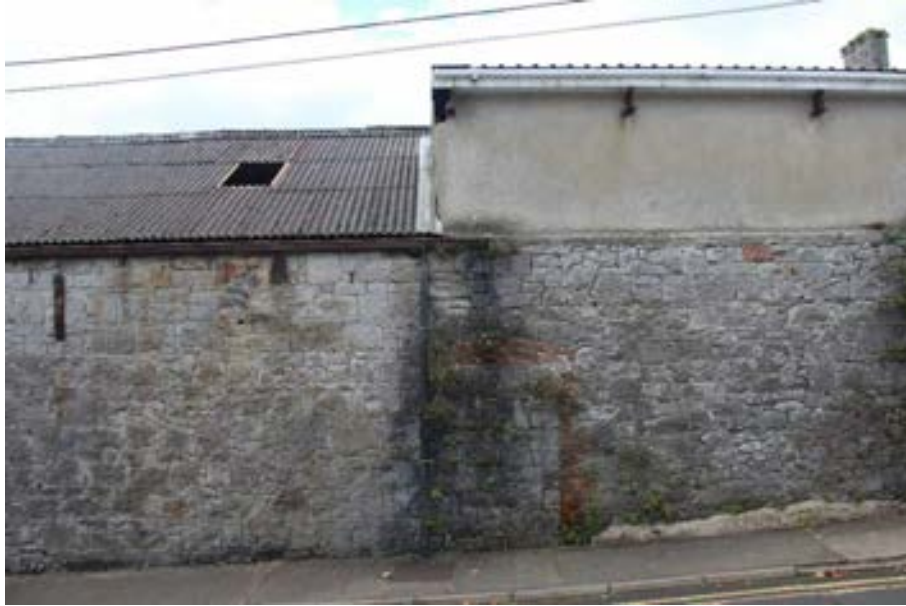
The next roof section is covered in a fibrous corrugated sheeting, also with extruded aluminium rainwater goods.

Photograph 3 View of the second and third section of the subject complex.

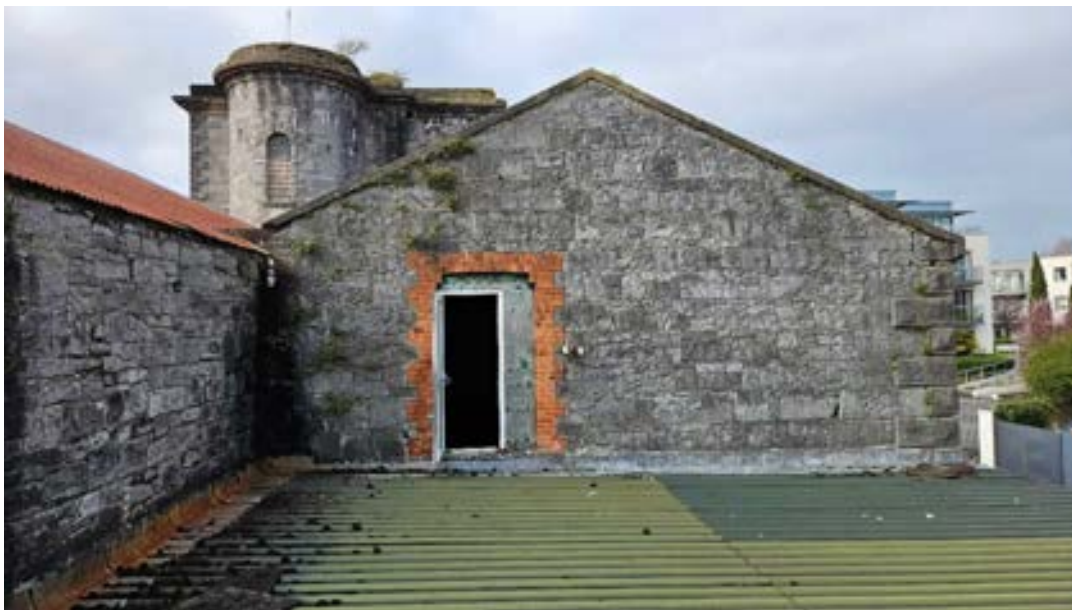
The final section, running up to the gable of the adjoining building, has had the roof pitch changed to a near flat roof covering, with a pressed corrugated sheeted covering, also with extruded aluminium rainwater goods.

Photograph 4 General view of the roof covering of section three, terminating back to the gable end of the adjoining building.

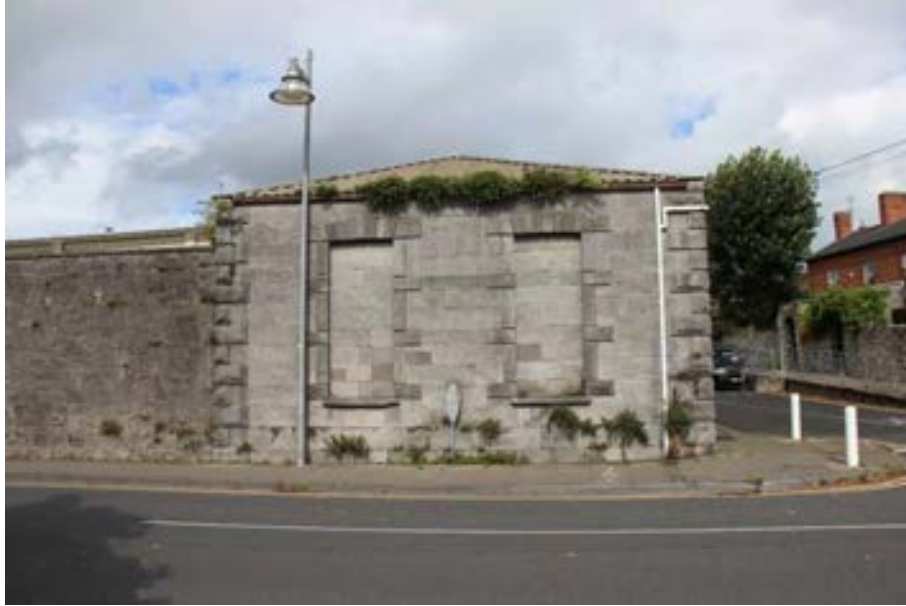
The gable, facing onto O'Callaghan Strand is of coursed Ashlar Natural Limestone, with two blind window openings, also infilled with Ashlar masonry. The Quoin stones and window surround masonry are of margined and rusticated masonry units, with tooled window cills.

Photograph 5 Gable facing onto O'Callaghan Strand.

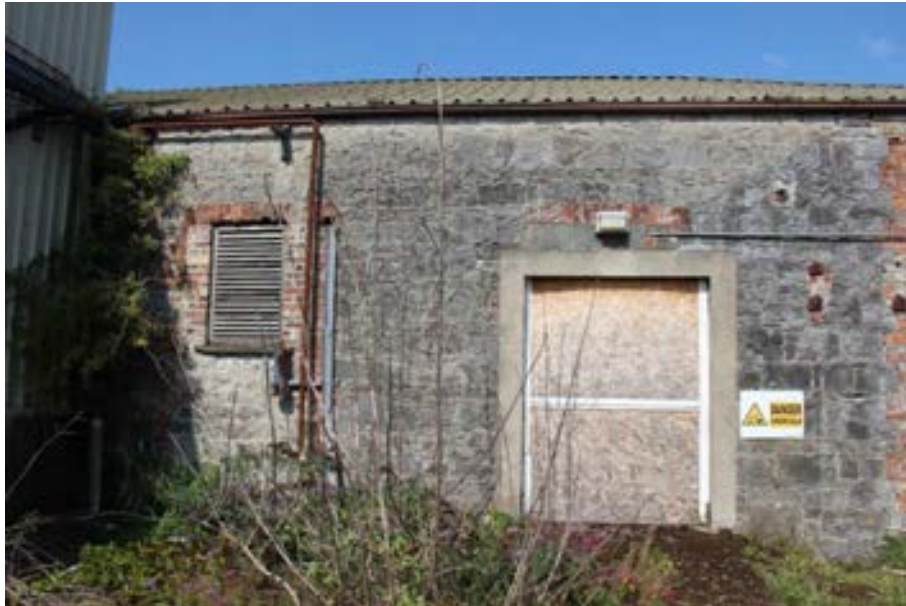
There are only two noted openings, both to the southwest elevation. One window opening with a louvered assembly, and a retrofitted door opening.

Photograph 6 General view of the opening to the SW elevation.

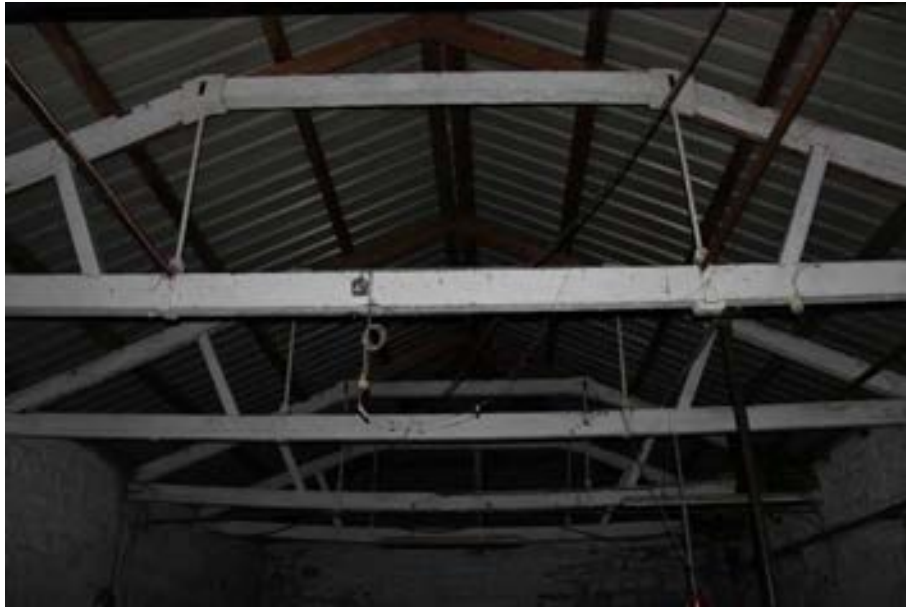
the case of these trusses are formed using a combination of cast iron plates and wrought iron bars (serving as the posts).

Photograph 7 General view of the roof structure to the first section.

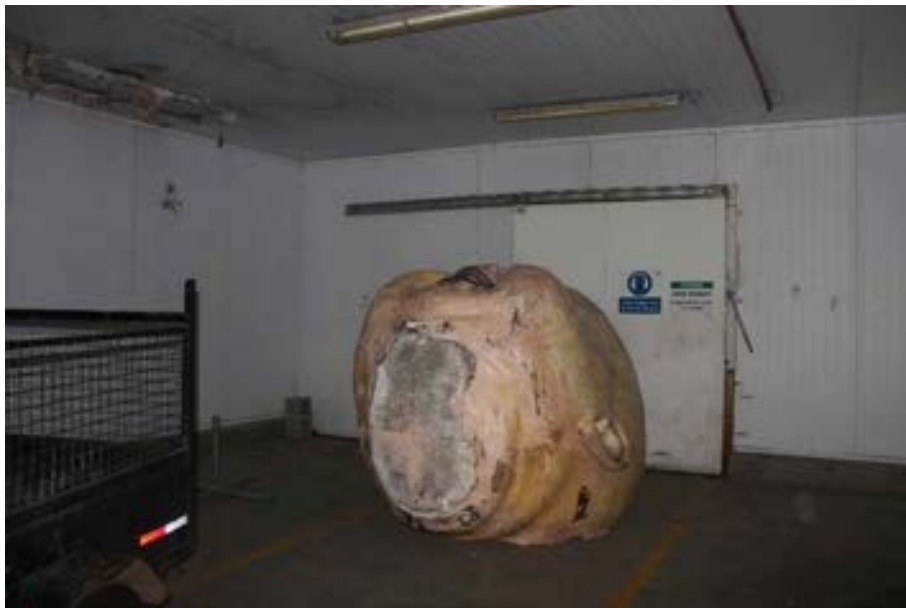
The second and third sections of the roof void were inaccessible, with the second section now a cold room, with insulated panels to the ceiling and walls. The same is true for the third section and the last room leading back to the office gable.

Photograph 8 General view of the second section of the Dairy Building, all the envelope is outside the cold room panelling.

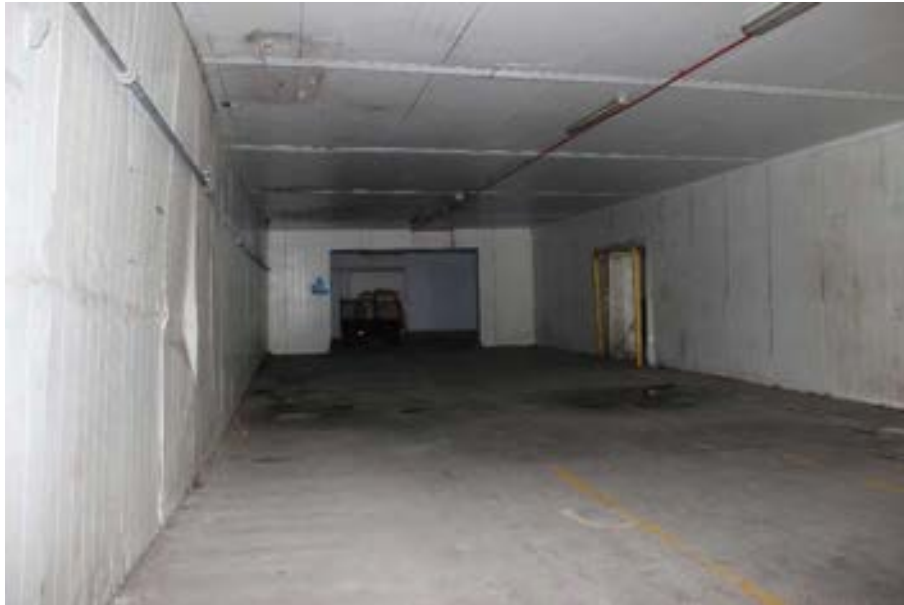
Photograph 9 General view of Section three, also a full panelled cold room.

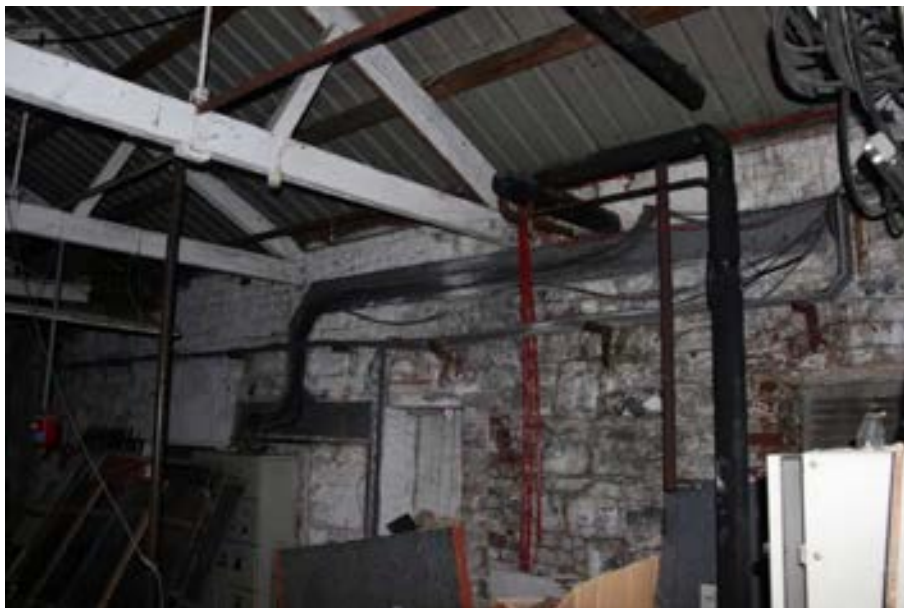
As per the roof structure / ceilings, the only section with exposed fabric is the first section. As with the external walls, the internal walls are constructed of coursed random rubble natural limestone, now finished in a white paint throughout the first section.

Photograph 10 General view of the internal elevation of the Dairy Building, first section. This is the only section where the internal wall fabric can be viewed.

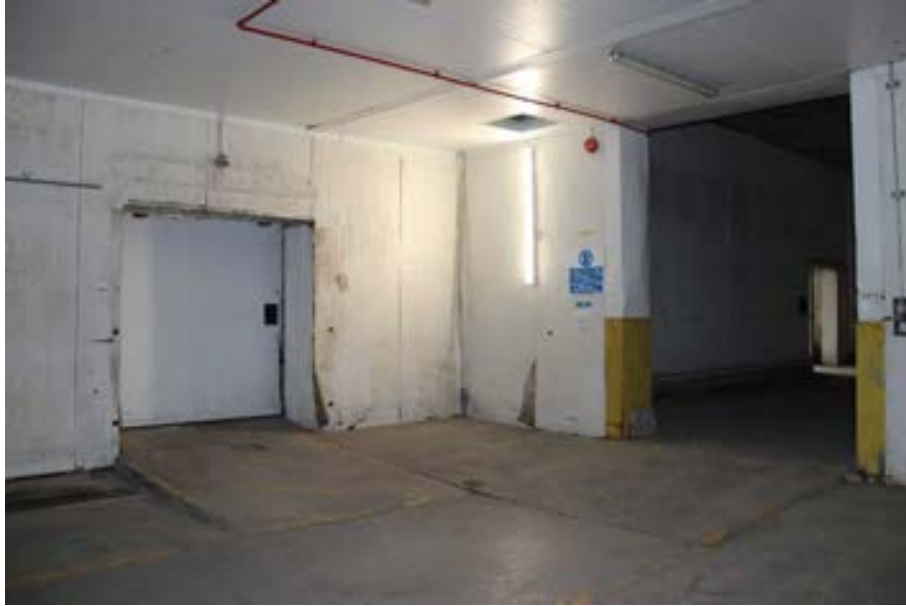
The internal floor to all three sections is a modern concrete floor, with evidence of surviving historic fabric.

Photograph 11 General view of the internal spaces, note concrete flooring.

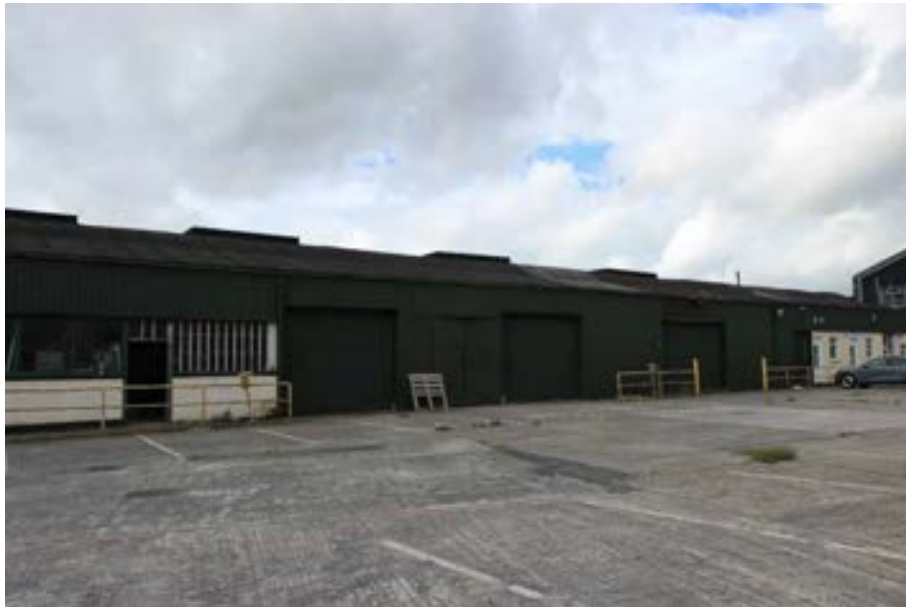
The external roof covering of the main building is finished with a modern bituminous felt. There is evidence of ventilation shafts to the roof, long covered over. The small lean-to addition to the eastern elevation is covered with a modern pressed metal corrugated sheeting.

Photograph 2 General view of the northern elevation of the workshop. Note the bitumen felt roof covering.

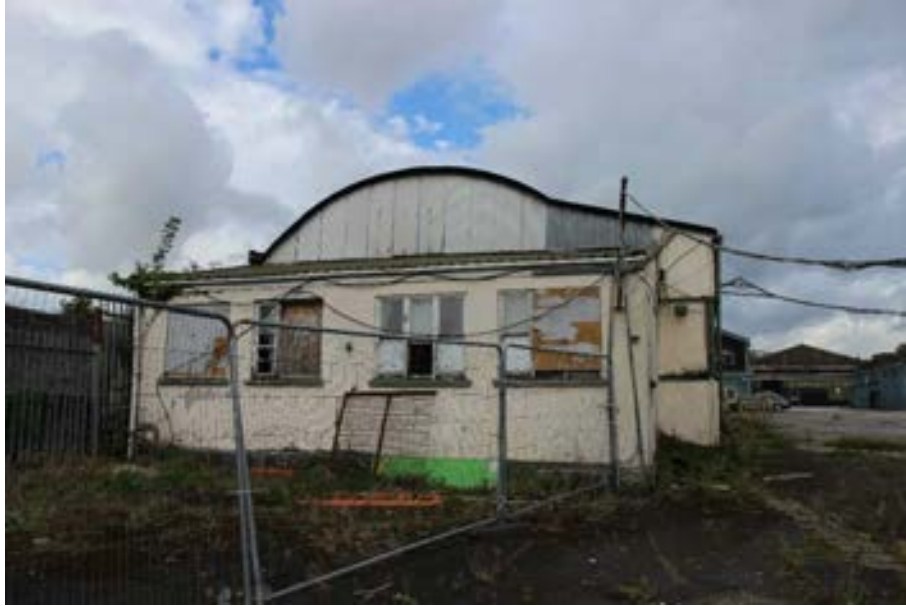
Photograph 3 Lean to building, eastern elevation. With a pressed metal roof covering.

The main roof has cast iron rainwater goods. The lean to has PVC rainwater goods.

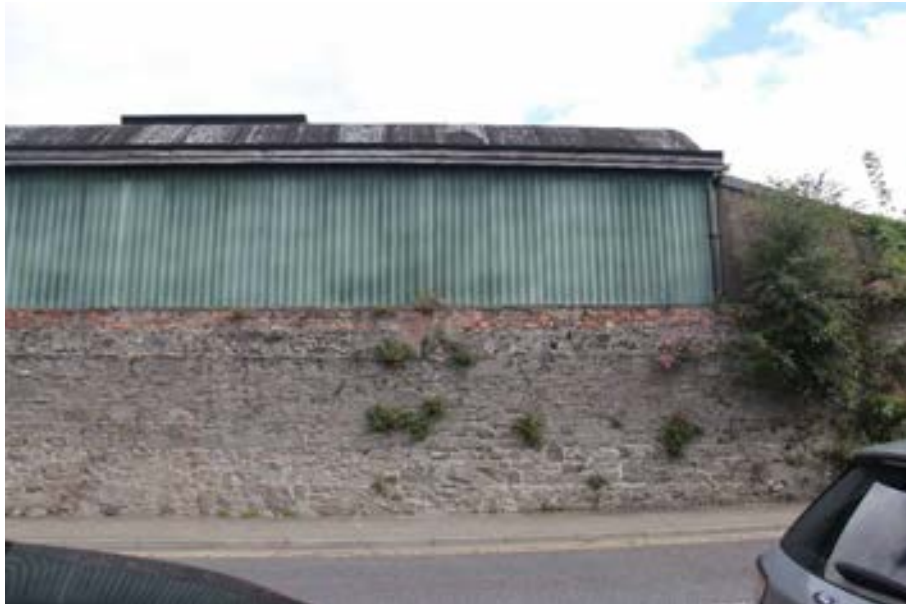
The elevation facing onto the North Circular Road corrugated sheeting cladding, the western gable end is also finished in a corrugated sheeted cladding, with the lower level rendered mass masonry.

Photograph 4 Example of the external wall cladding to the southern elevation.

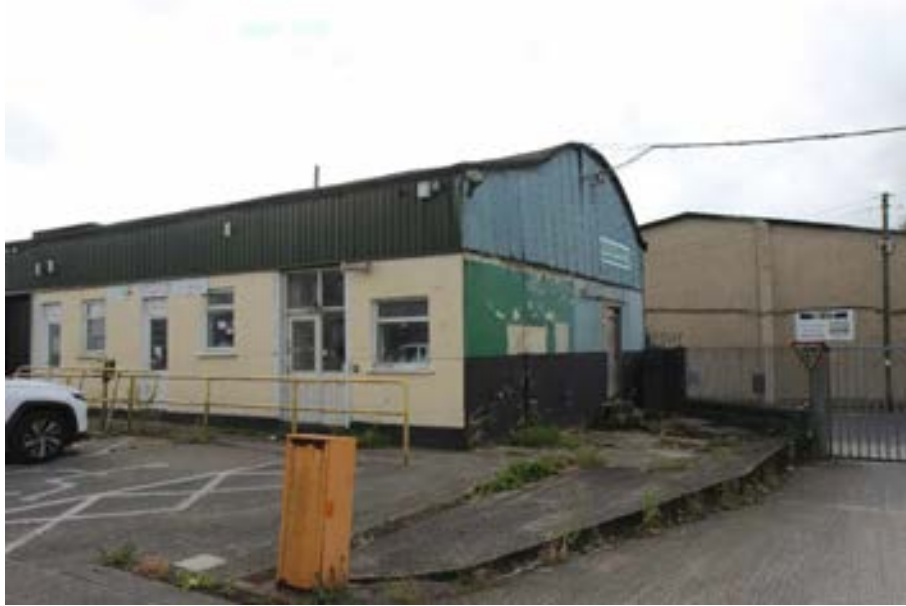
The northern elevation is a mixture of pressed metal wall cladding to the upper level at the eastern end, and full height at the western end, with the centre section of the elevation glazed on the eastern end, with a concrete wall to the lower section of the elevation. The cills are covered in a pressed metal. Possibly timber beneath.

Photograph 5 Western section of the Workshop building, with the west elevation also on view.

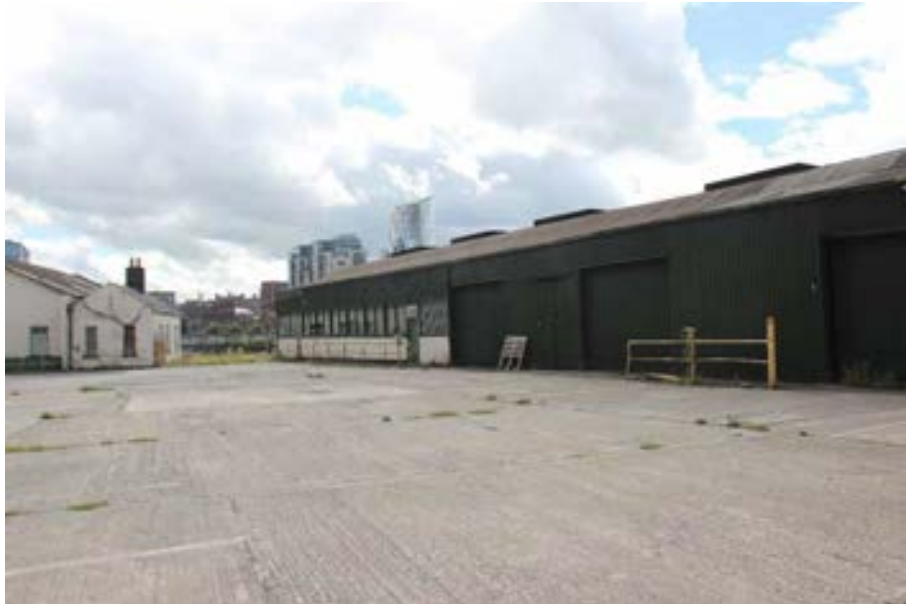
Photograph 6 View to the mid and eastern section of the northern elevation, note the different finishes present.

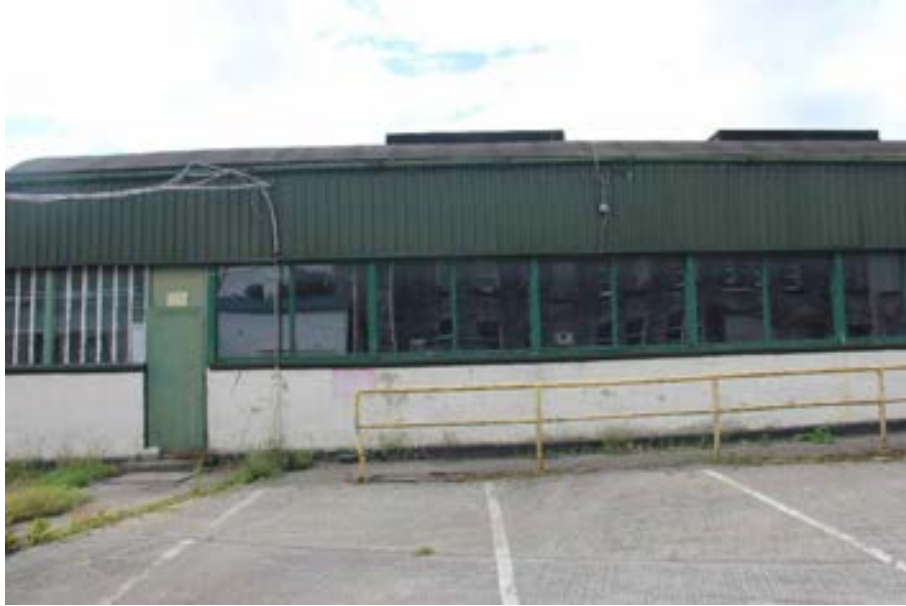
Photograph 7 Example of the fenestration to the eastern section of the northern elevation.

On the northern elevation, there are three window openings, consisting of modern PVC window assemblies. There are three door openings, one a timber assembly with timber and glazed surrounding screen, the remaining two are modern PVC assemblies.

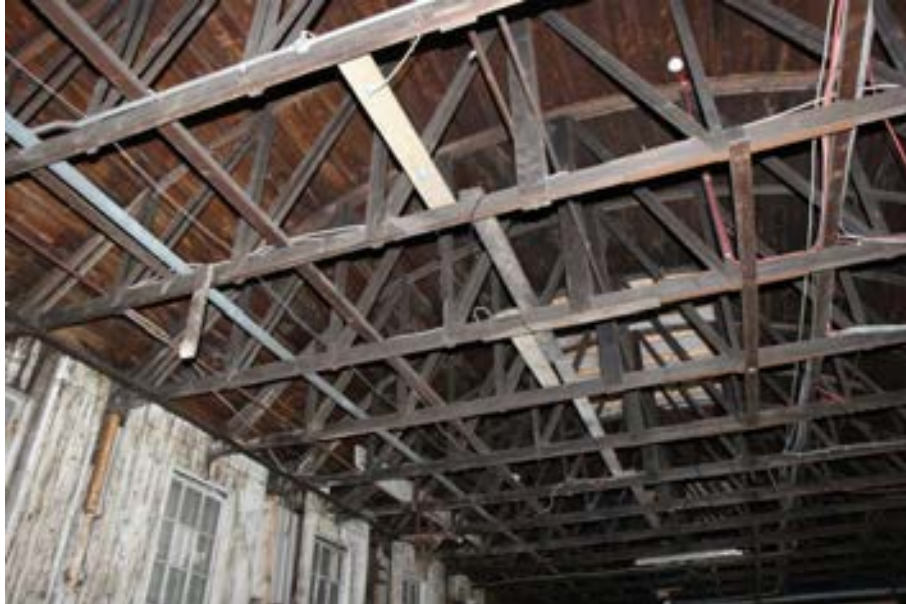
The underside of the roof buildup is exposed internally. There are timbering sarking boards spanning across the array of timber Belfast Trusses, running the full length of the main building. The trusses are supported on rolled steel beams, spanning a mixture of rolled steel columns to the southern elevation and cast-iron columns, in part, to the northern elevation.

Photograph 8 View of the roof structure, an array of Belfast trusses. Note the underside of the timber sarking boards.

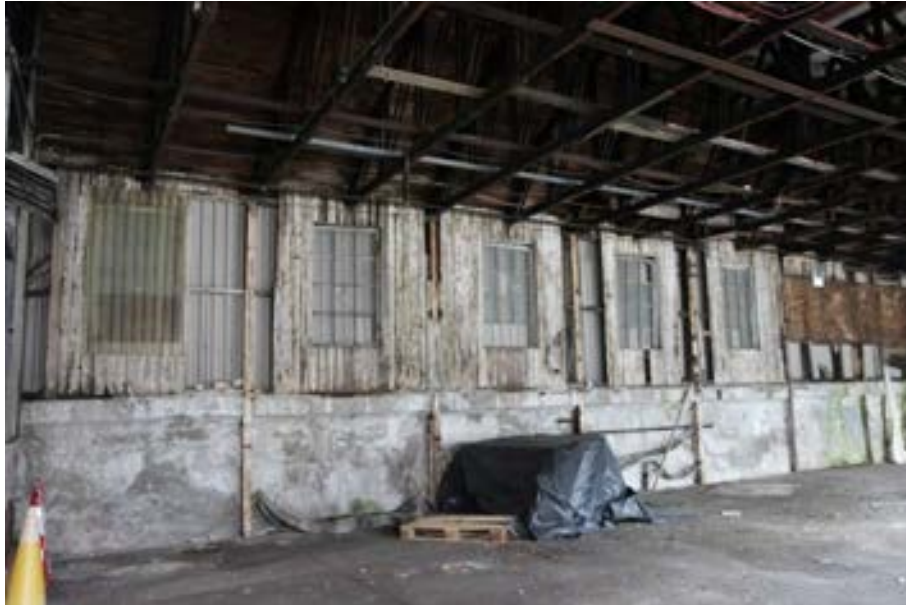
The internal wall elevations of the main workshop building are a mixture of concrete at the lower level, infilled between the structural rolled steel columns, and at upper level to eaves with timber cladding, with fixed windows centrally to each panel, what was the original external appearance of the building on the southern elevation.

Photograph 9 Internal elevation view of the southern external wall.

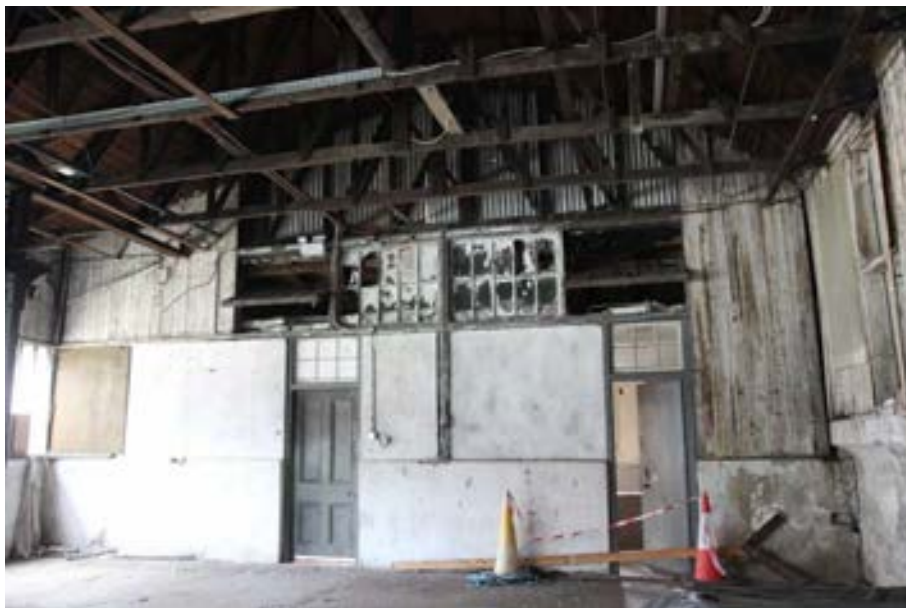
Photograph 10 Partition screen to eastern end of the workshop building.

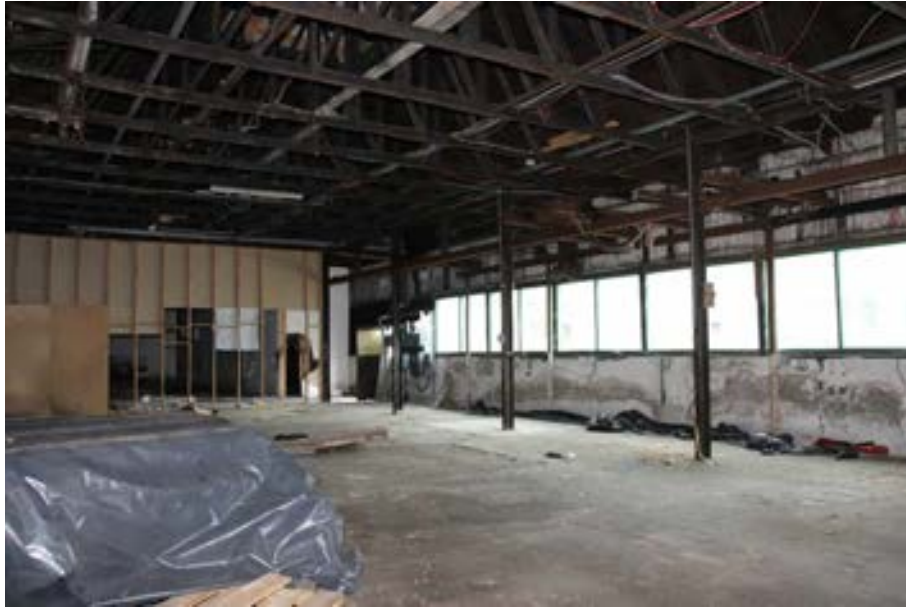
There are a number of internal partitioned rooms to the western section of the building, with the rooms to the southern area inaccessible on the day of inspection. The rooms to the northern area have timber stud partition walls with modern skimmed plaster slab finishes.

Photograph 11 View, facing westwards. Note concrete infill to the lower section of the northern wall.

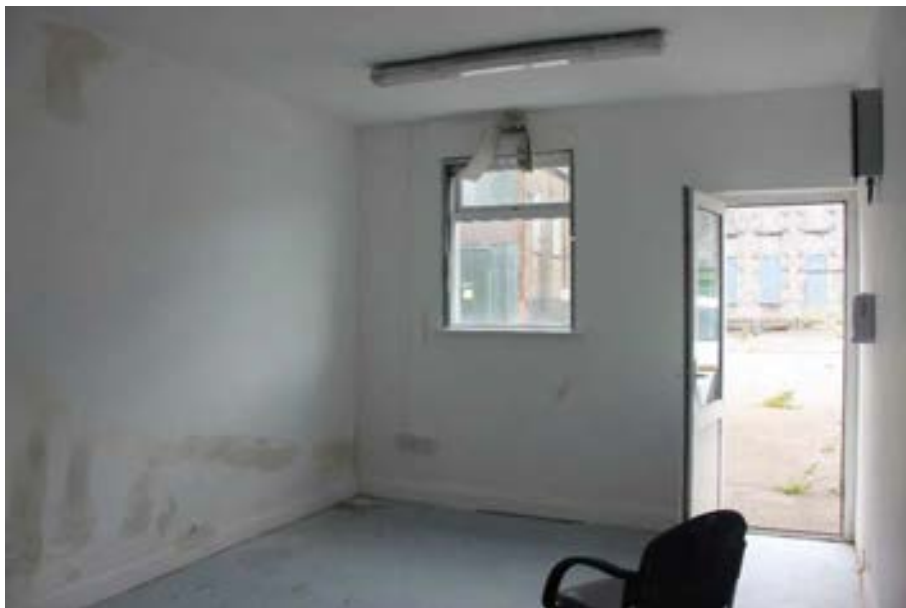
The ceilings within these rooms are also modern skimmed plaster slabbed ceilings.

Photograph 12 Internal view of one of the rooms to the northwest section of the building. All modern finishes and detailing.

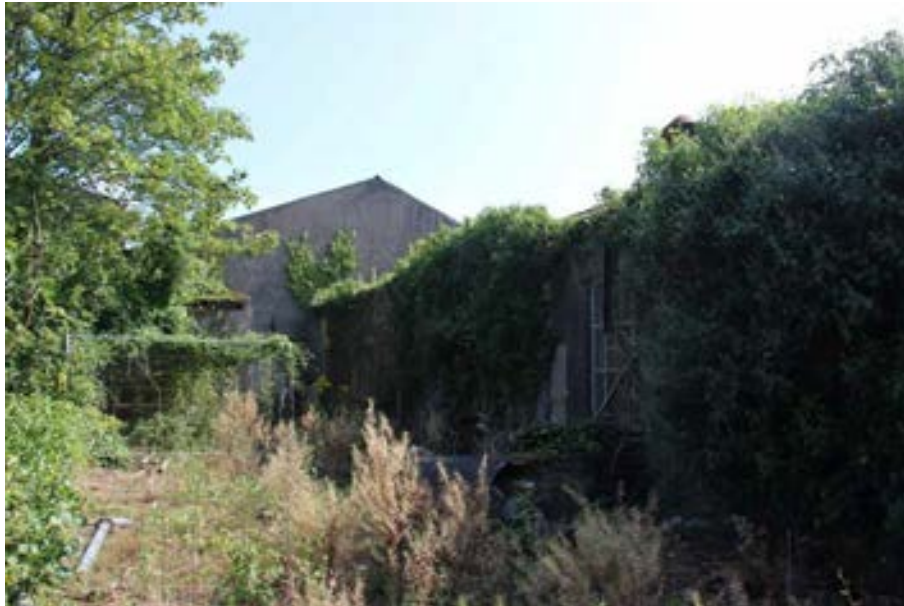
Photograph 1 - View of Cheese Plant from North
