## Building Record Report

Building 10 Admin & Labs  
Former Cleeves Condensed Milk Factory

**Client:** Limerick 2030

**Date:** 15<sup>th</sup> of October 2025

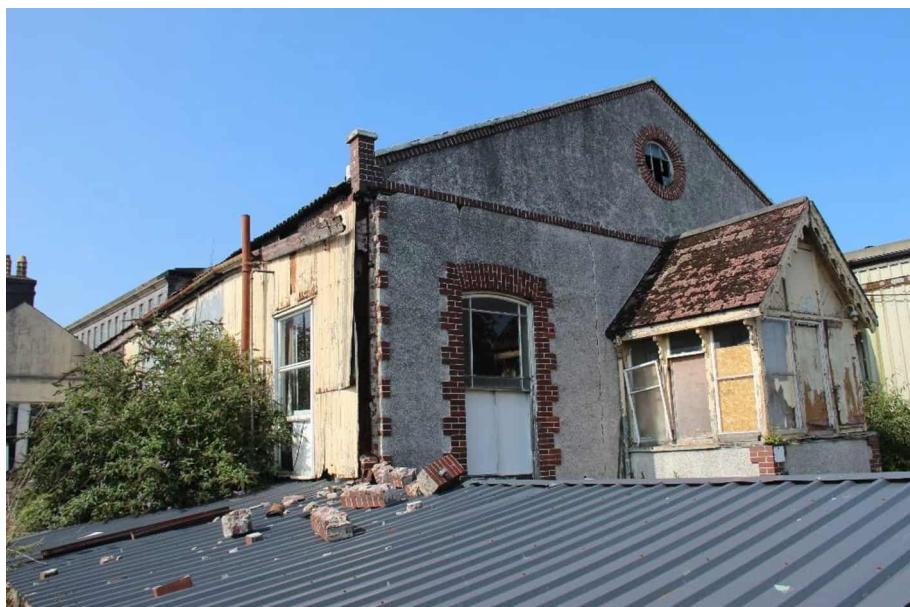
**Photograph 1 - View of Admin & Labs Building from South**

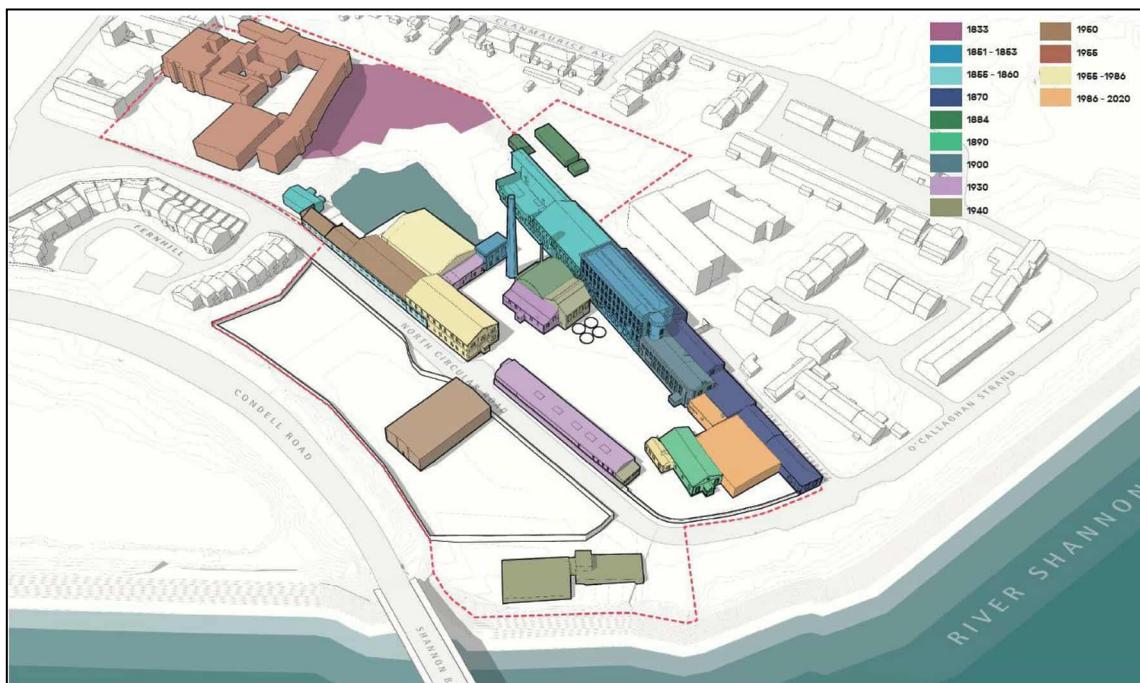
The evolution of the site is detailed in the building age diagram below.

Figure 5 - Building Ages Diagram, Limerick 2030

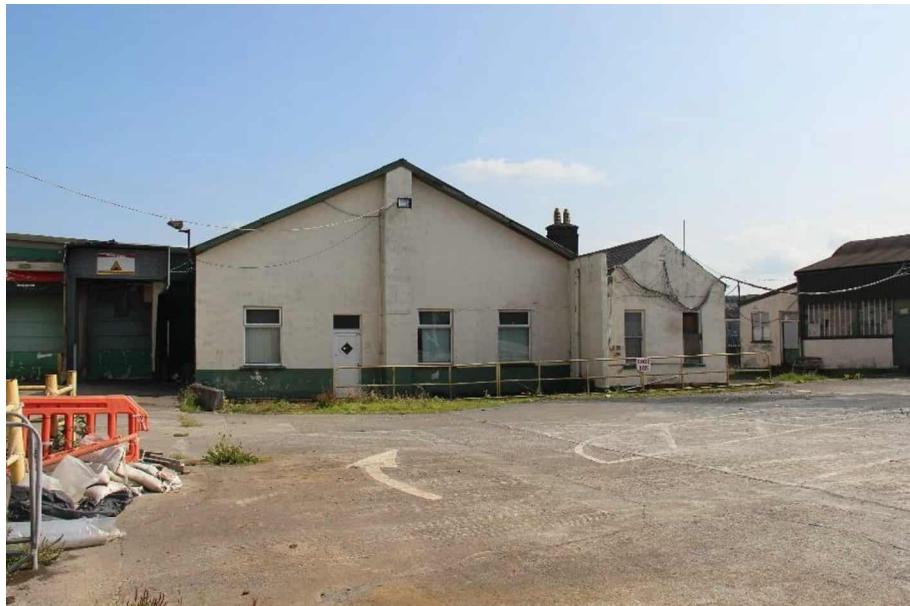
The former Administration and Laboratory comprises of two semi detached buildings, one most likely served as a welfare building, while the main building was the administration and laboratory building.

**Photograph 2 Administration and Laboratory building to the LHS, welfare building to the RHS**

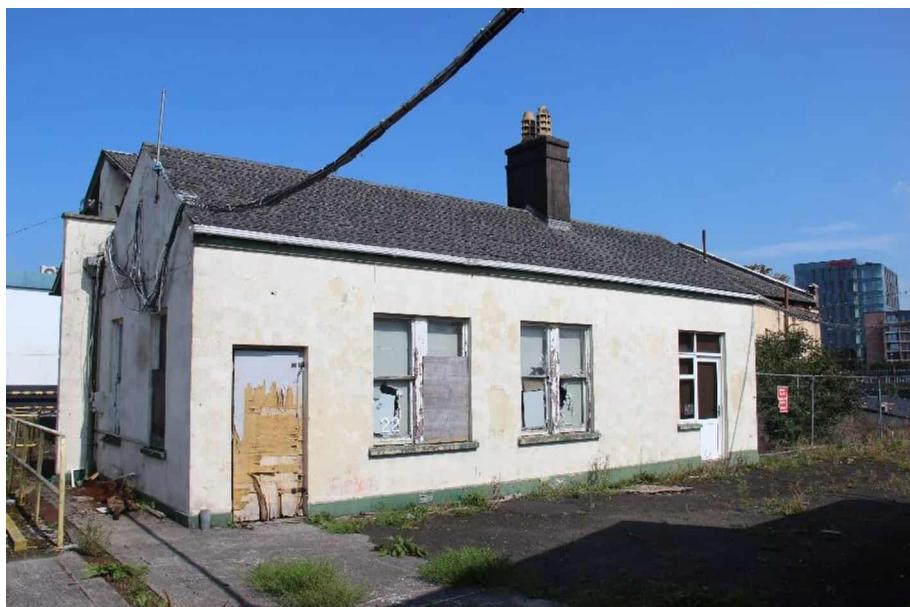
The roof to the welfare building comprises a single cementitious rendered chimney stack, protruding from the ridge line of the roof, with two clay pots. There is visible rolled lead sheet counter flashing to the chimney abutments, onto a gable to gable pitched roof, covered with fibre cement slate.

**Photograph 3 General view of the “welfare” building.**

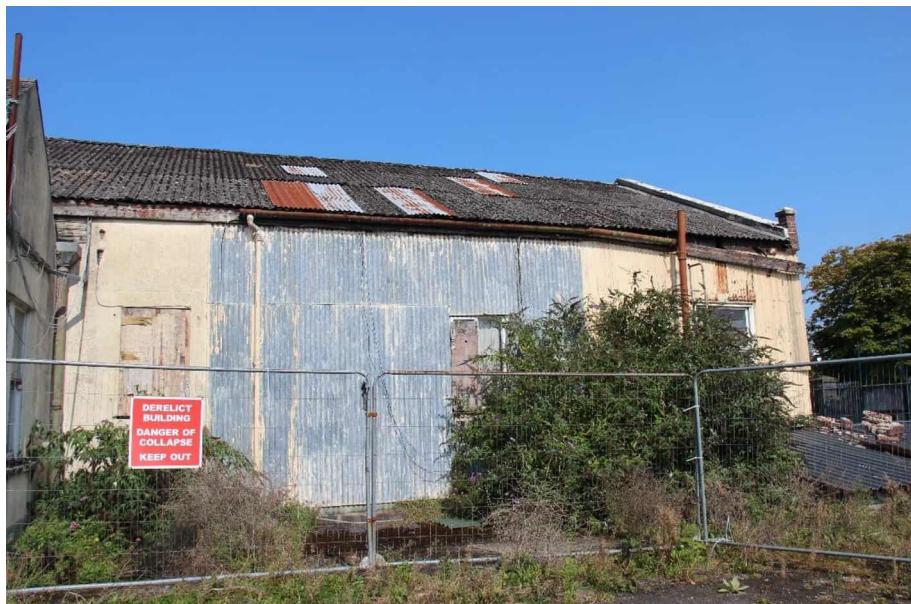
The external walls of the Administration and Laboratory building are finished in multiple materials, namely cementitious render to the western gable and northern return, with some natural stone exposed, albeit painted. The southern elevation, to the east of the welfare building, is finished in a mixture of cementitious render finishes with corrugated sheeted panels to the rear section of this elevation.

**Photograph 4 View of the southern elevation, showing the corrugated sheeted panels.**

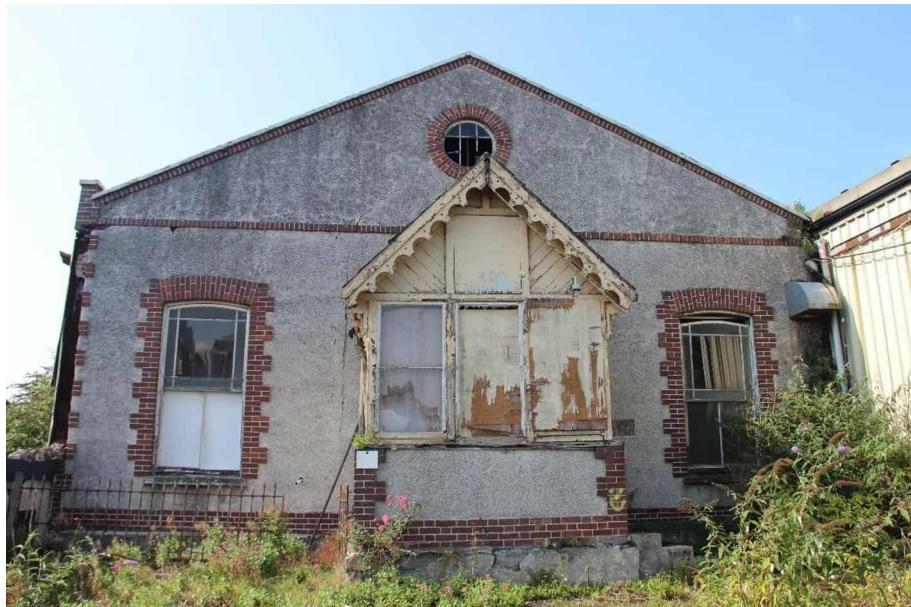
There is a decorative porch to the eastern elevation, with a fibre cement roof covering, decorative gable fascia's, a full bay fenestration of sash up down window assemblies and masonry plinth walls. The remainder of the gable has brick on edge banding at eaves, to the pitched gables, and decorative brick surrounds to the openings, with brick quoins and gable piers.

**Photograph 5 Eastern gable of the Administration and Laboratory Building.**

There is a noted central gable bulls eye window. The remainder of the elevation is finished in a rough cast cementitious render.

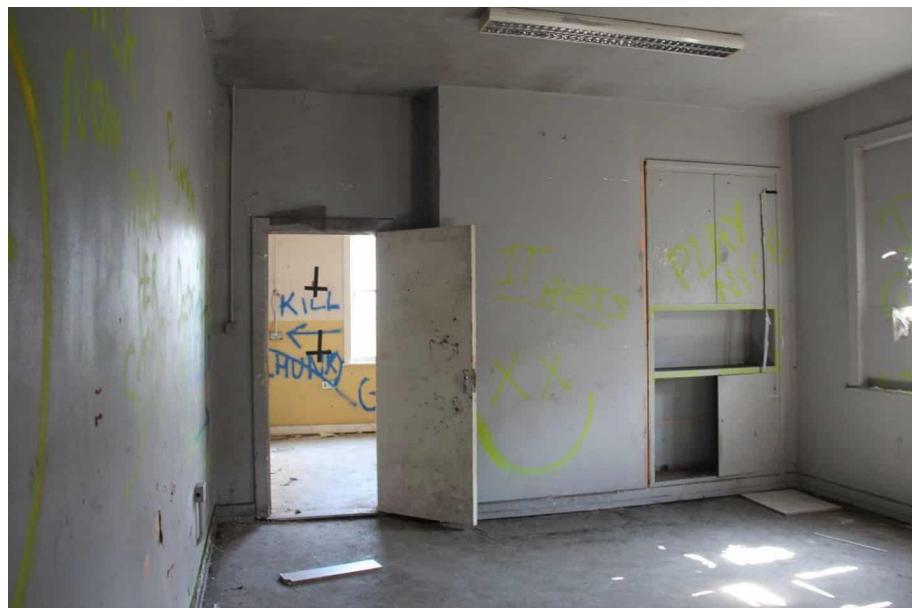
The smaller building comprises a modern plaster slab ceiling, with a skim plaster finish, painted.

**Photograph 6 General internal view of the “welfare” building, with a modern plaster slab ceiling, and modern plaster slabbed drylined internal walls.**

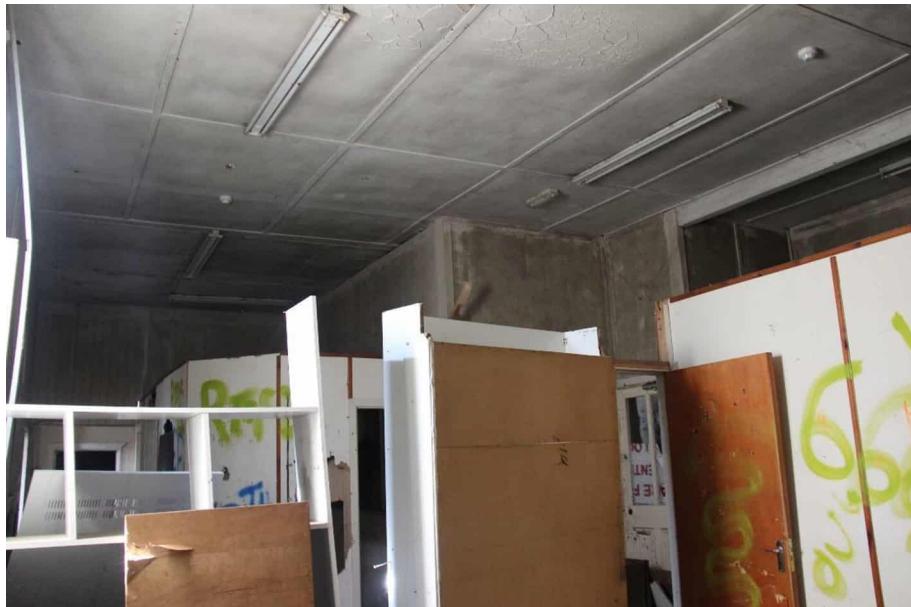
The administration and laboratory building is noted to be finished with a mid-twentieth century ceiling application, which has the appearance of “beauty board.” This is present throughout the Administration and Laboratory building.

**Photograph 7 Example of the ceiling to the Administration and Laboratory building.**

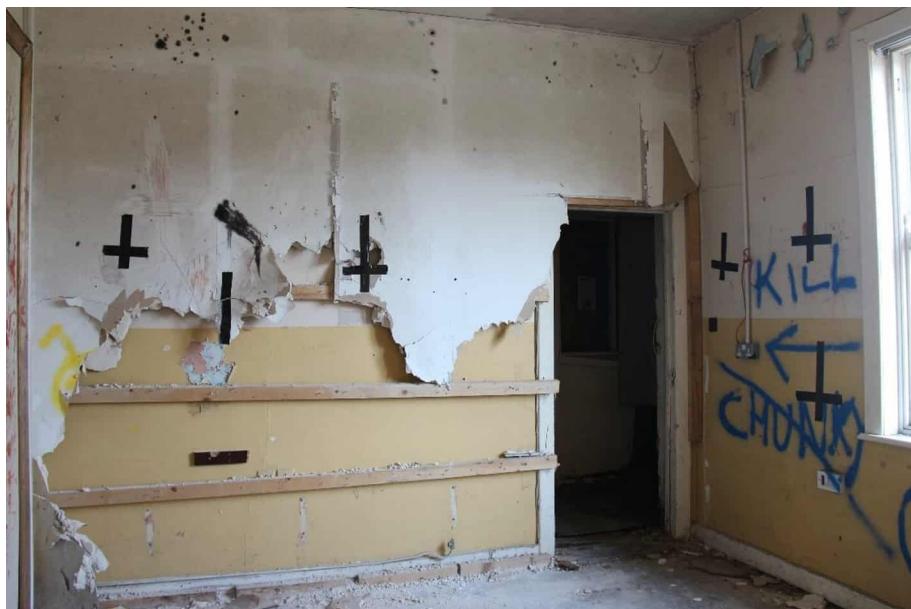
The internal walls to the “welfare” building are drylined modern plaster slabs, with a skinned and painted finish. The original internal wall finishes are noted to be visible, which are rendered mass masonry.

**Photograph 8 View of the damaged internal lining within the “welfare” building.**

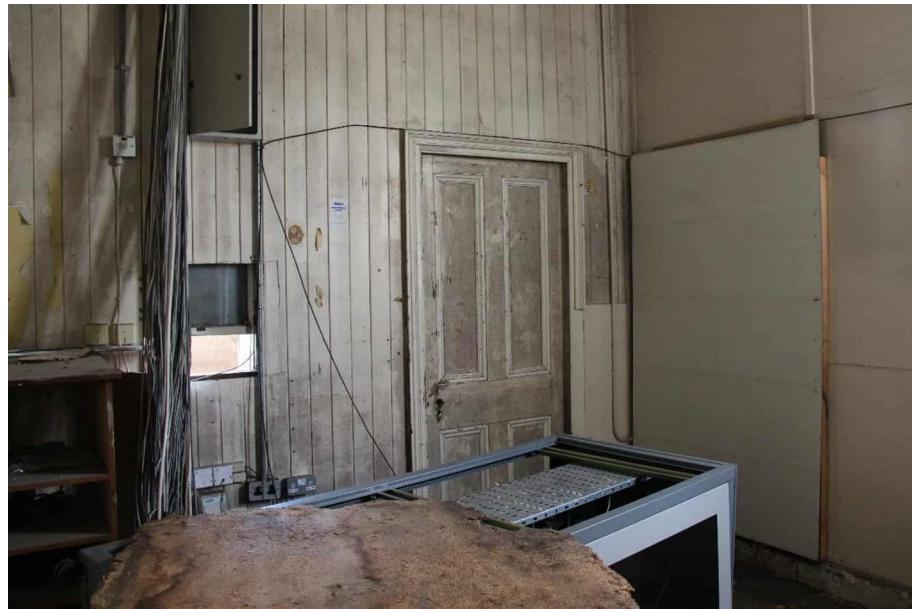
The internal walls of the Administration and Laboratory building are noted to be tongue and grooved panelling throughout. On the external walls, they are fixed as a drylining and are affixed both sides on the internal partition walls.

**Photograph 9 Example of the variance of internal wall finishes, with T&G Panelling visible and more recent “beauty board” panelling.**

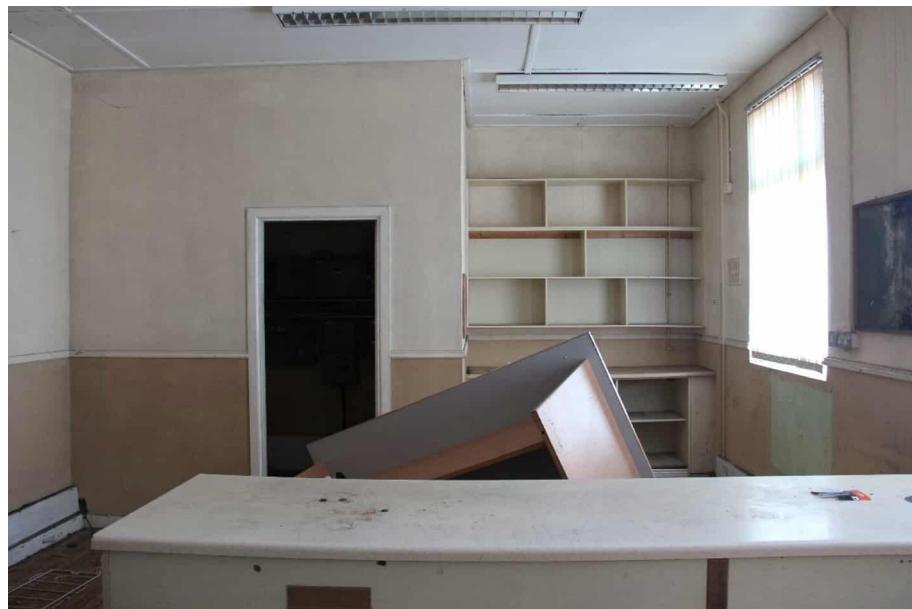
In the front offices there are modern plaster slabs fitted to both the external walls and internal walls, these may be directly onto the original panelling however (as with the laboratory).

**Photograph 10 Front office, with modern plasterboard applied to the walls.**

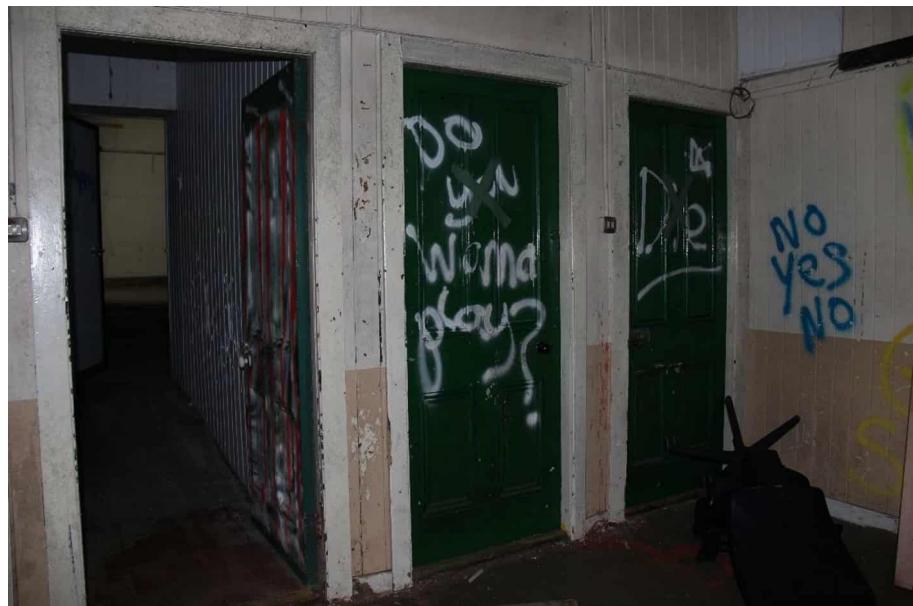
The internal door assemblies are a mixture of modern hollow core doors, original four panel doors and half glass panelled doors. The architraves to the doors are noted to be plain, with no decorative carved mouldings etc.

**Photograph 11 Examples of panelled doors, to the toilet area of the main building.**

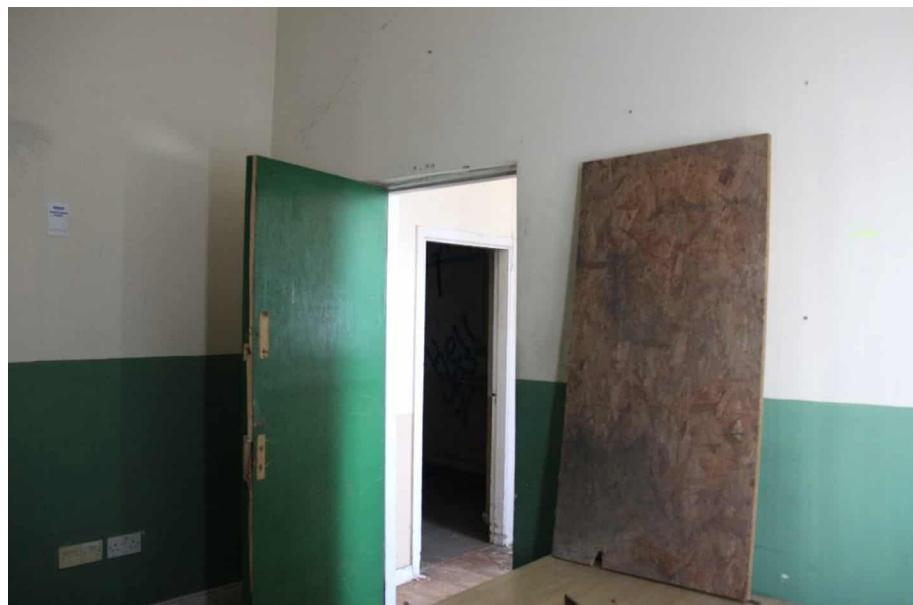
**Photograph 12 Example of a hollow core door leaf, found mostly to the western section of the main building.**

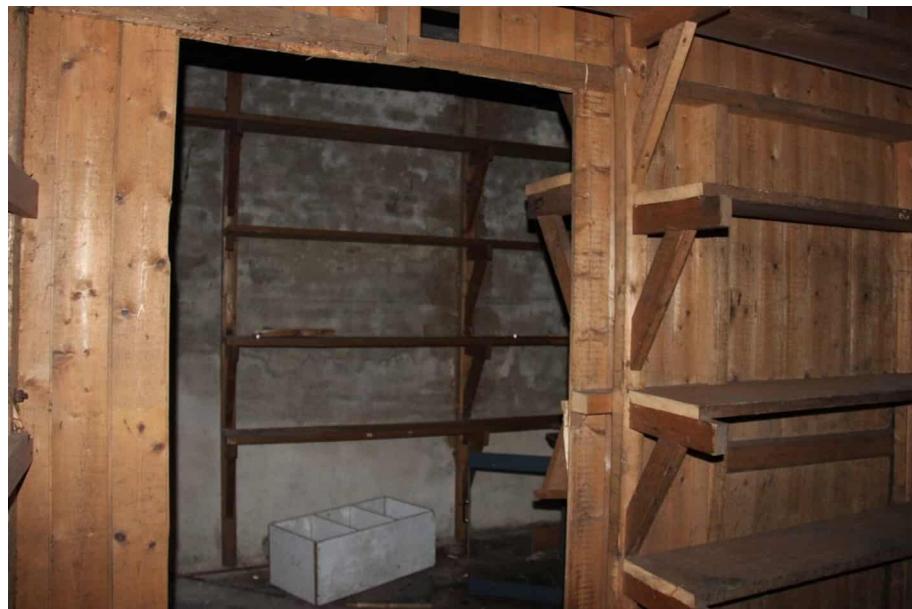
**Photograph 13 Timber panelled and shelved storage room.**

There are a number of surviving joinery and unit installations however, with a timber panelled and timber shelved storage room, in good repair and the shelving and units of the offices and laboratory still extant in the respective rooms.

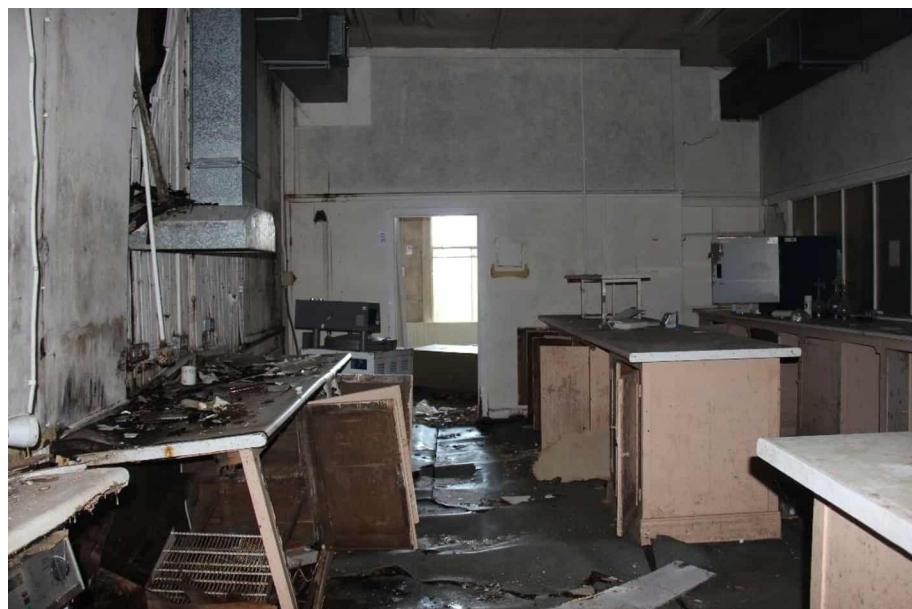
**Photograph 14 General view of the laboratory and the surviving units therein.**

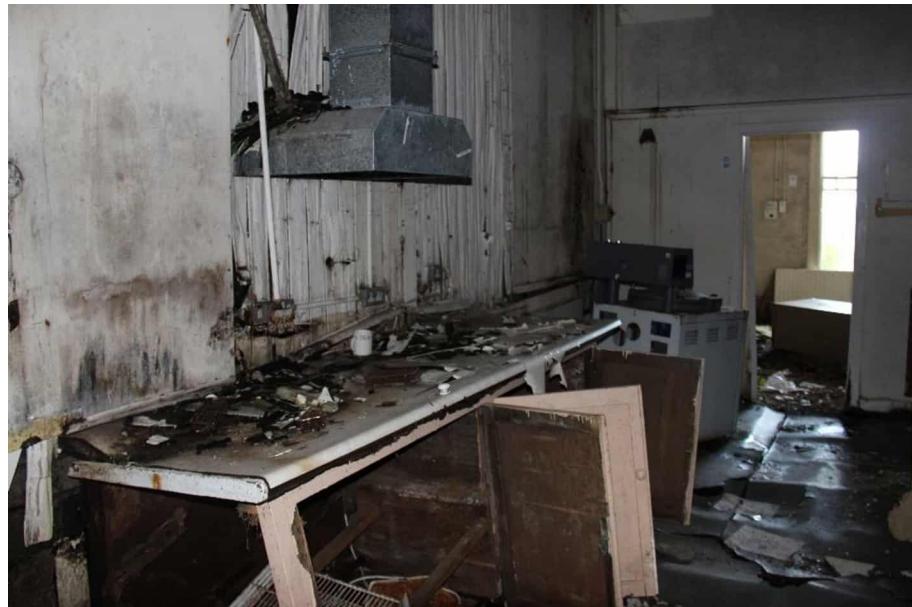
The internal floors are a mixture of modern concrete floors and timber sprung floors. The concrete floors are mostly located to the office and welfare rooms of the building.

There are timber sprung floors within the remainder of the rooms of the buildings, most notably to the laboratories.

**Photograph 15 Laboratory with an example of the timber sprung floors, all decimated with rot now.**

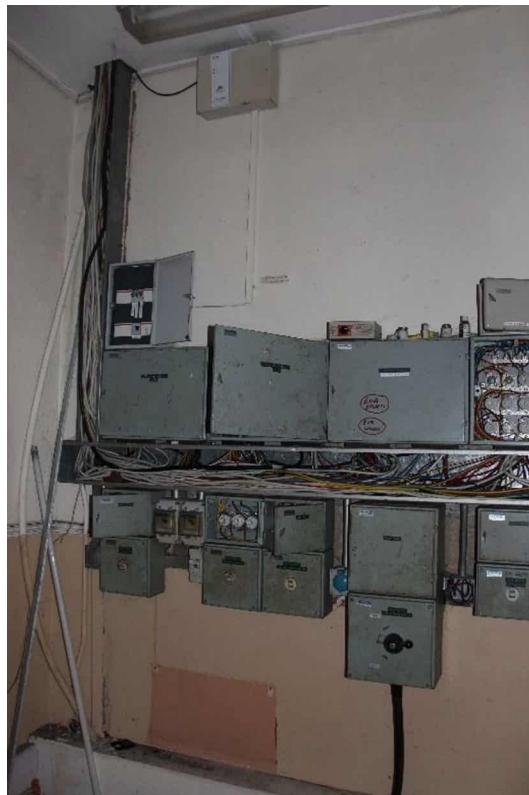
The services installations are noted to be mostly modern, with fluorescent tubed fittings throughout the buildings, modern electrical sockets and light switches mounted to the walls etc. With telecom points and fire detection systems etc also present.

**Photograph 16** Surviving fuse boxes, meters, alarm systems etc.

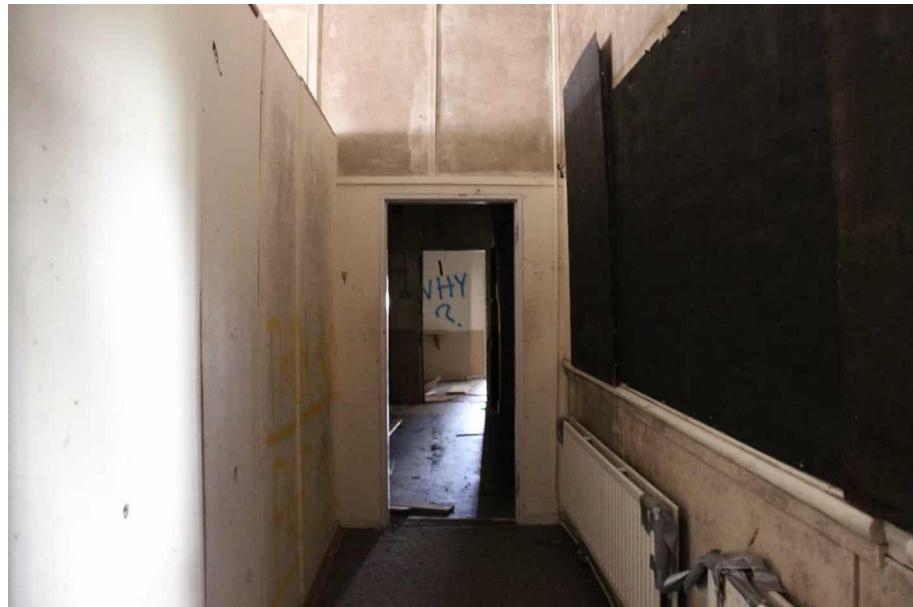
From a heating perspective, there are modern radiators (water heated), also noted throughout.

**Photograph 17 Rear Hallway with modern hot water rads installed.**

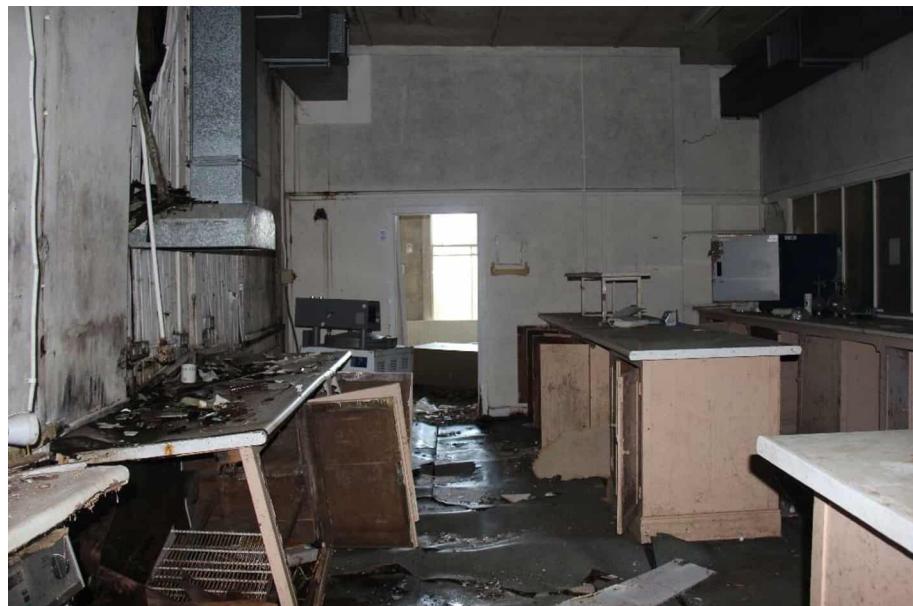
**Photograph 18 General view of the laboratory, note extraction ducting.**

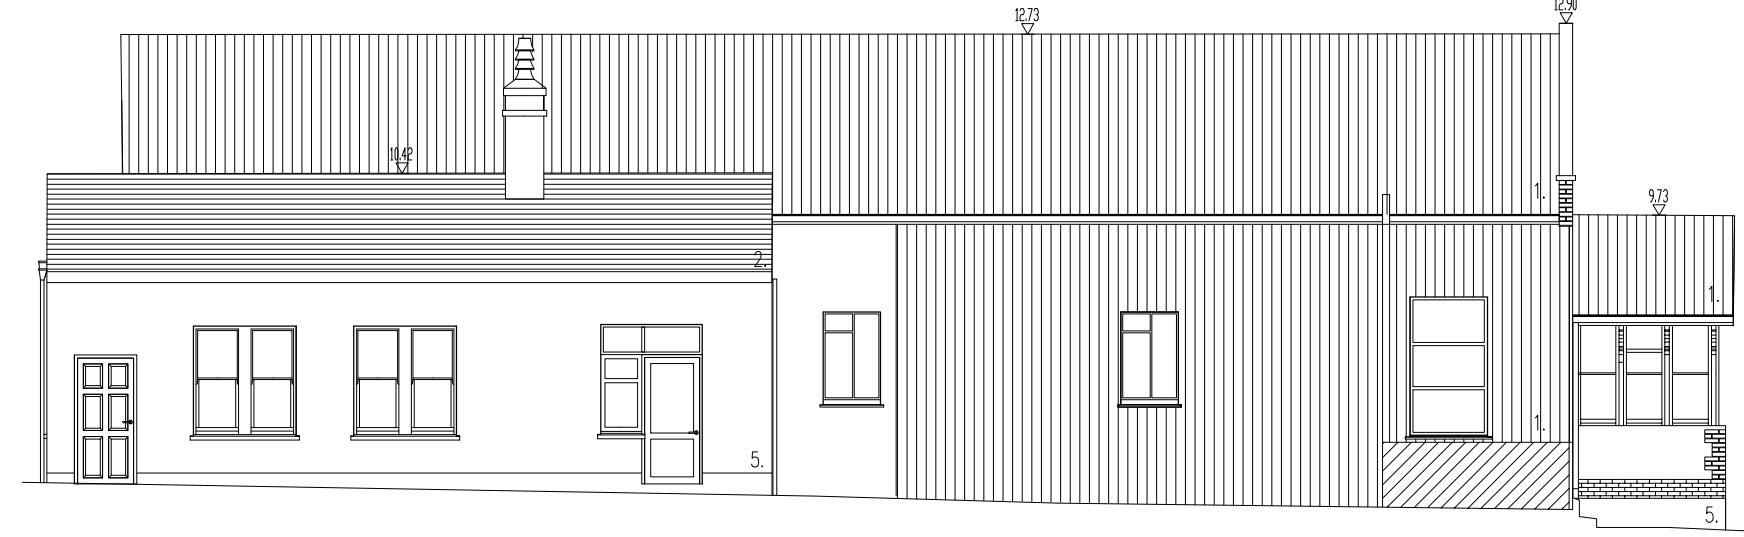
Elevation A-A

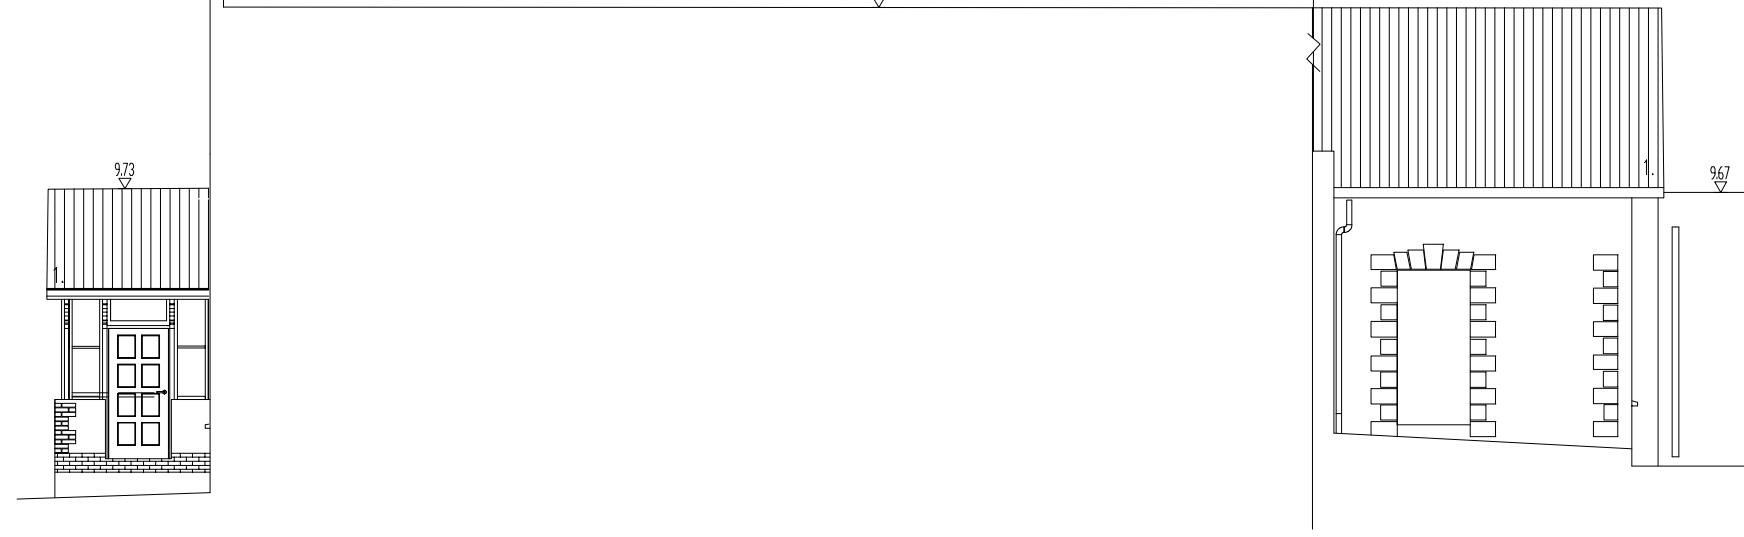
Elevation D-D

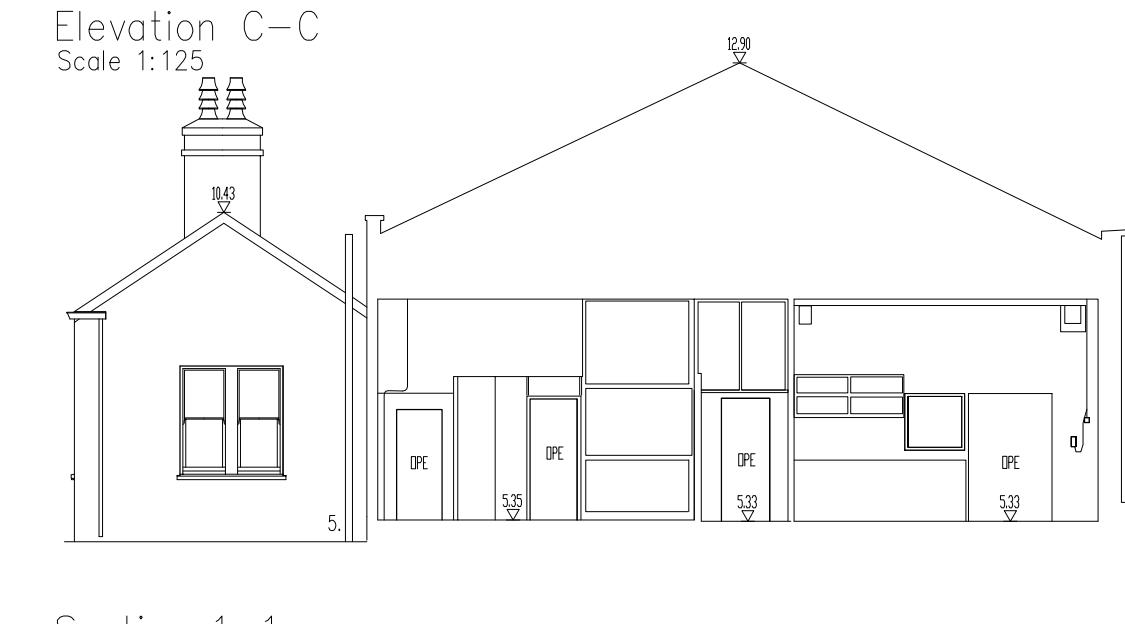
Section 1-1

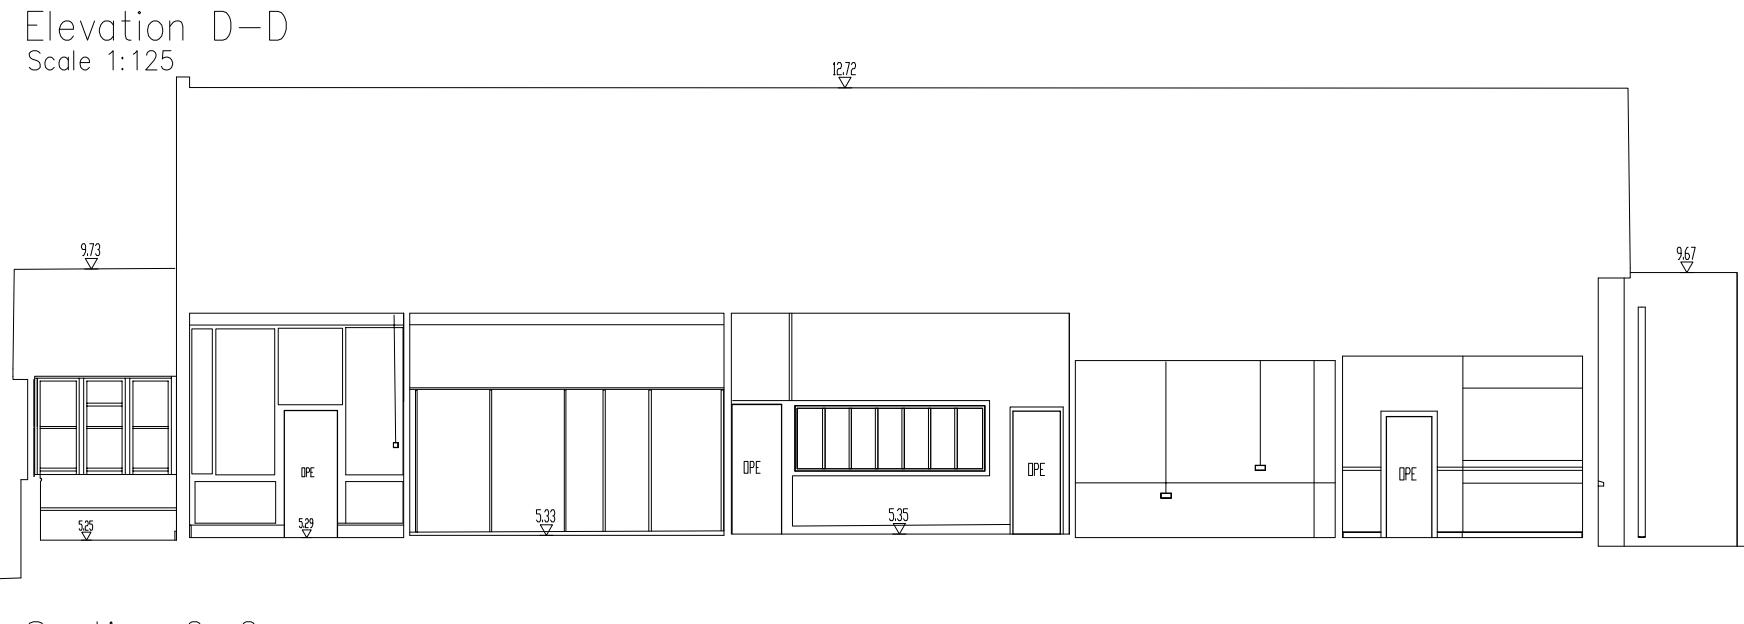
Section 2-2
