## Building Record Report

Building 5 Infiltration Gallery  
Former Cleeves Condensed Milk Factory

**Client:** Limerick 2030

**Date:** 15<sup>th</sup> of October 2025

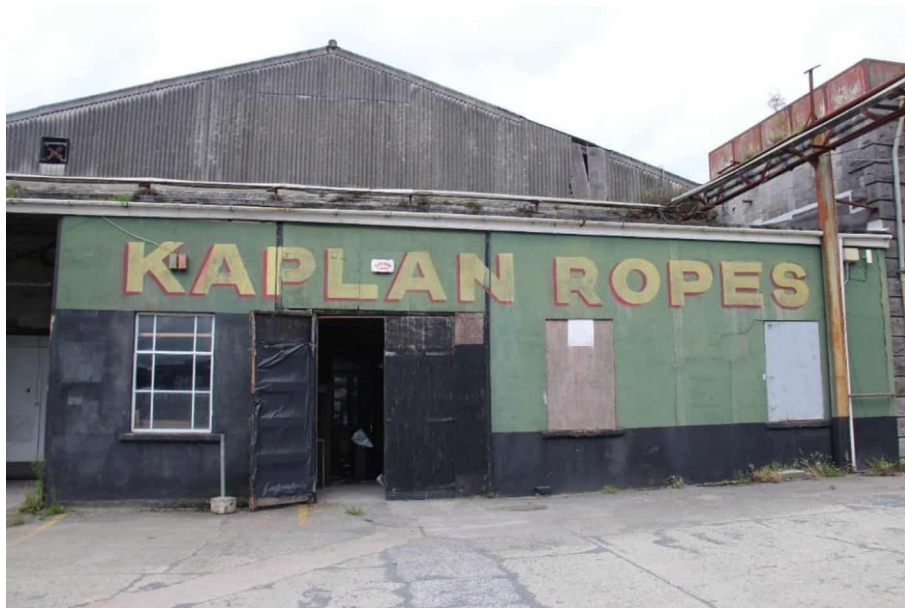
**Photograph 2 Front elevation of subject building.**

There is noted painted over natural limestone masonry to the front façade, internally of the warehouse building, which is backed up by modern concrete blockwork and cast insitu concrete walling.

As noted above, there is suspected remnants of the façade of the dye house building located within the front section of the current warehouse building, covered in by the lean to building.

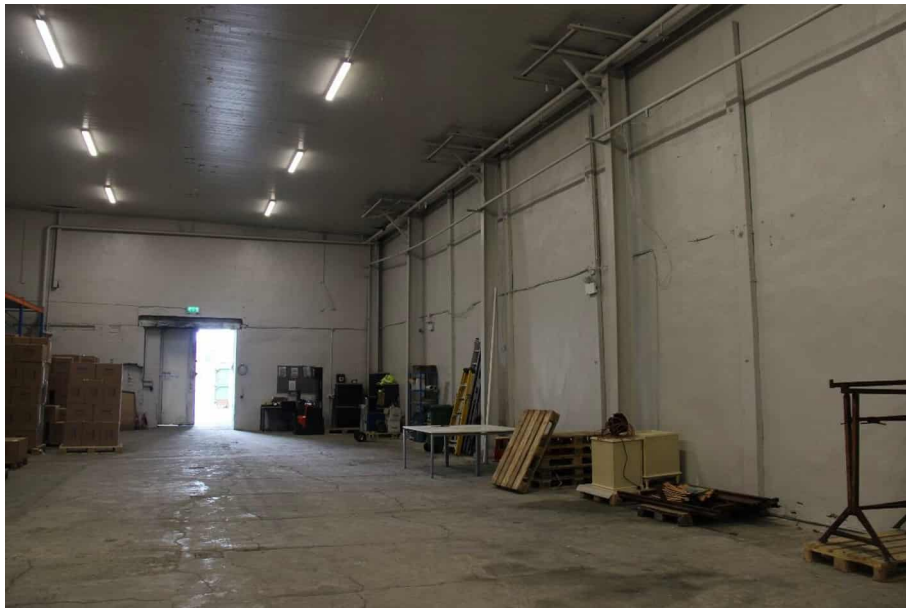
**Photograph 4 - Current view of location of wall between the Cheese Plant and original Dye House, northern elevation.**

The remit of this report was to identify remaining sections of the partition wall between the Cheese Plant and Infiltration Gallery (original over gallery building), if any.

It was noted that all the visible fabric, where the wall was expected to be found, is covered over in modern built fabric e.g. modern concrete blockwork.
