Building Record Report

Building 7 Dairy Building & Linen Store
Former Cleeves Condensed Milk Factory

Client: Limerick 2030

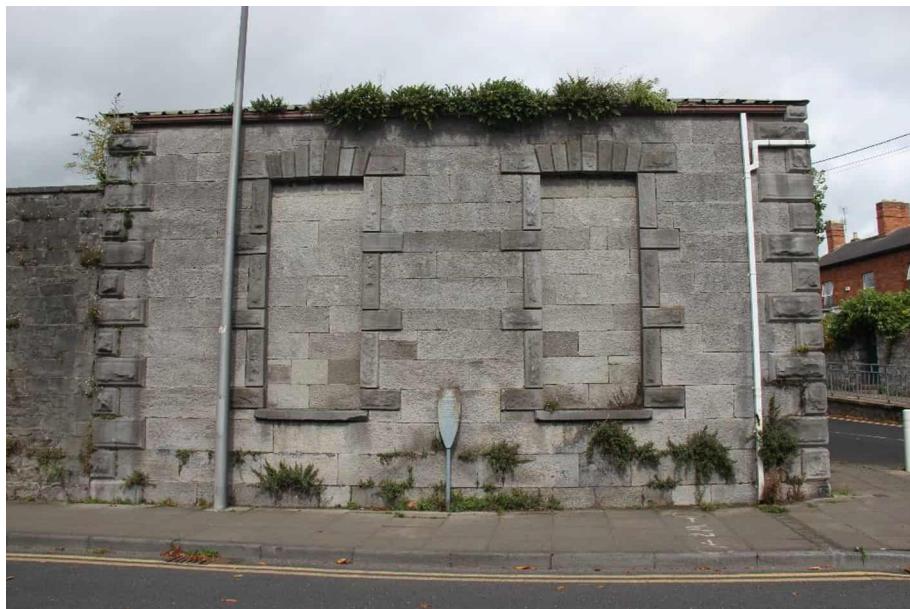
Photograph 1 – Linen Store Southeast Elevation

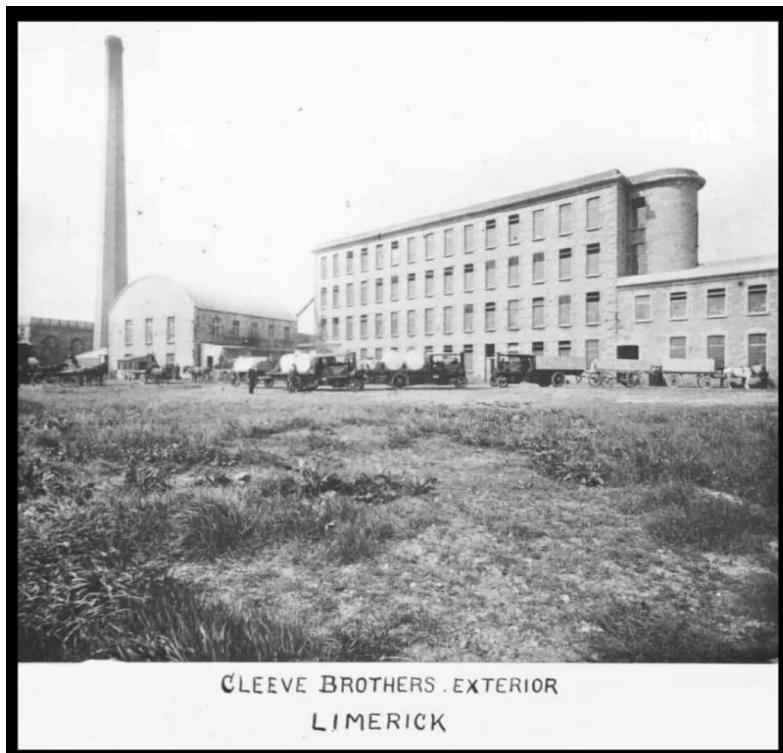
Figure 3 - Cleeves Limerick, Thomas Holmes, National Library of Ireland, 1890 - 1910

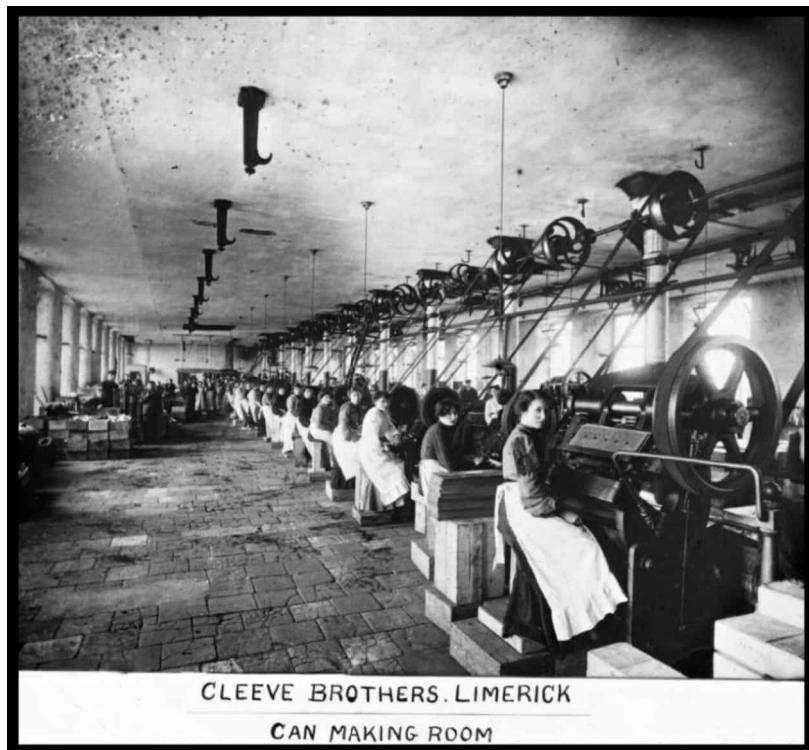
Figure 4 - Cleeves Limerick, Thomas Holmes, National Library of Ireland, 1890 - 1910

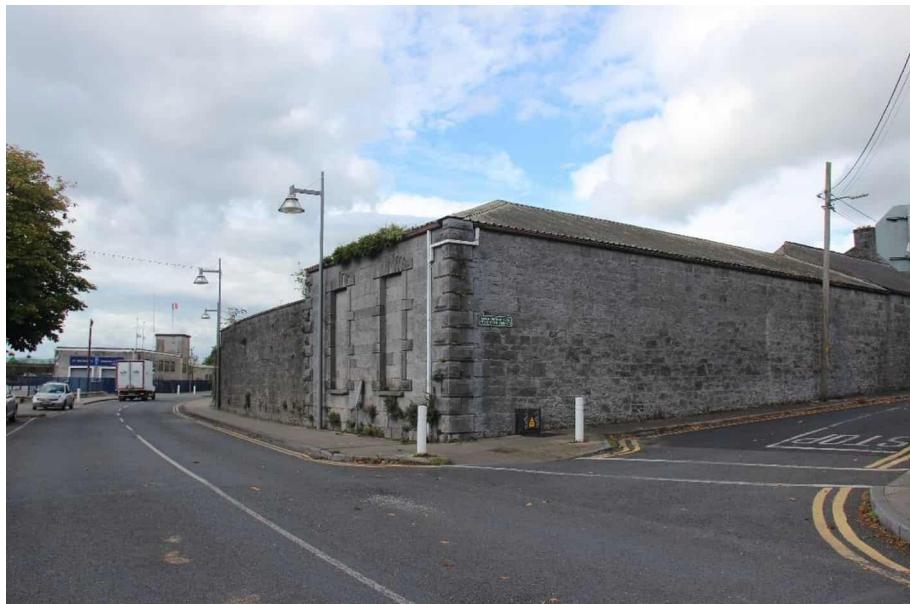
Photograph 2 The first section of the Dairy Building, at the junction of Stonetown Terrace and O'Callaghan Strand.

The roof covering, a hipped gable to O'Callaghan Strand, and pitched roof, thereafter, has a replacement modern pressed corrugated sheeting covering to the first section, starting at the junction of O'Callaghan Strand and Stonetown Terrace, with extruded aluminium rainwater goods.

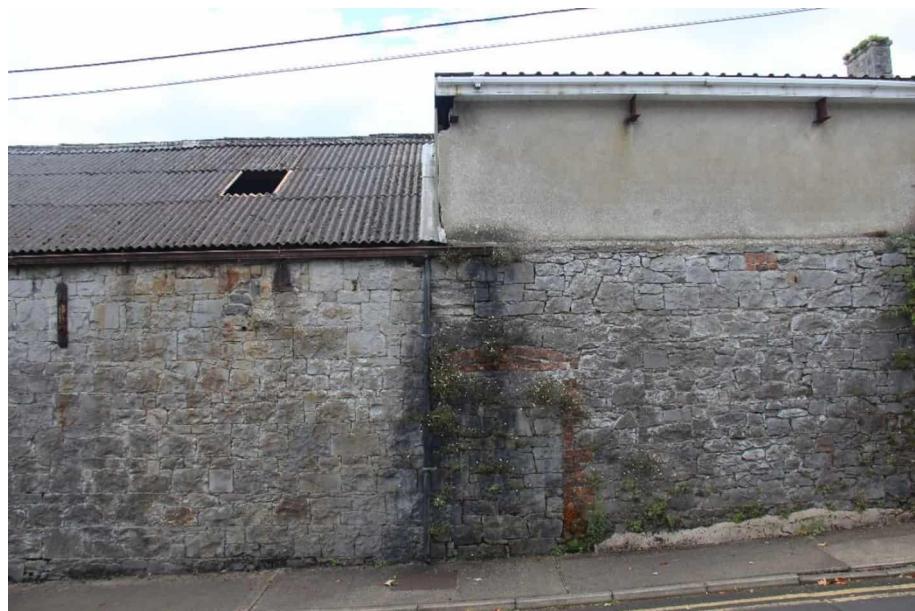
Photograph 3 View of the second and third section of the subject complex.

The next roof section is covered in a fibrous corrugated sheeting, also with extruded aluminium rainwater goods.

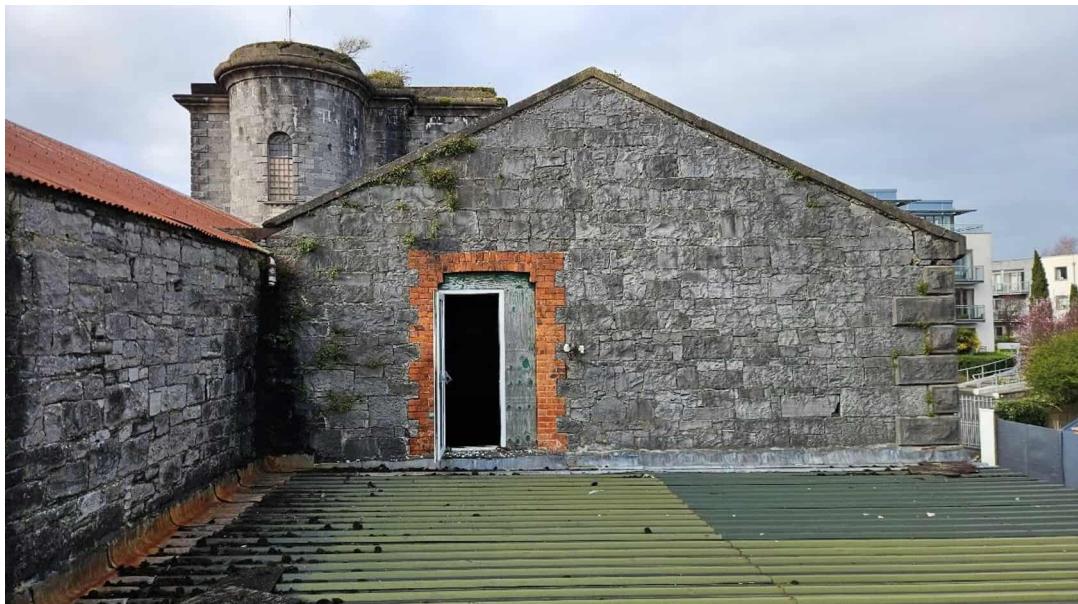
Photograph 4 General view of the roof covering of section three, terminating back to the gable end of the adjoining building.

The final section, running up to the gable of the adjoining building, has had the roof pitch changed to a near flat roof covering, with a pressed corrugated sheeted covering, also with extruded aluminium rainwater goods.

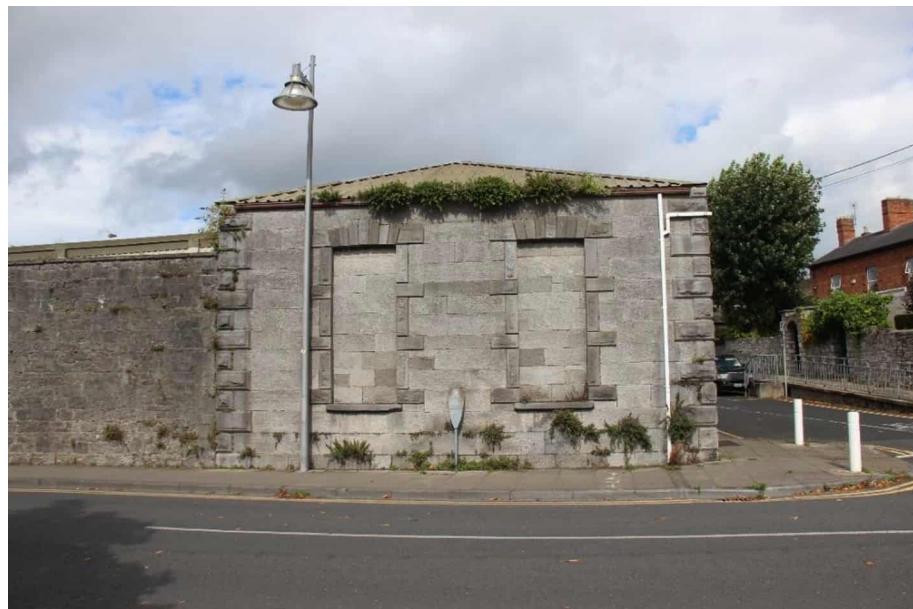
Photograph 5 Gable facing onto O'Callaghan Strand.

The gable, facing onto O'Callaghan Strand is of coursed Ashlar Natural Limestone, with two blind window openings, also infilled with Ashlar masonry. The Quoin stones and window surround masonry are of margined and rusticated masonry units, with tooled window cills.

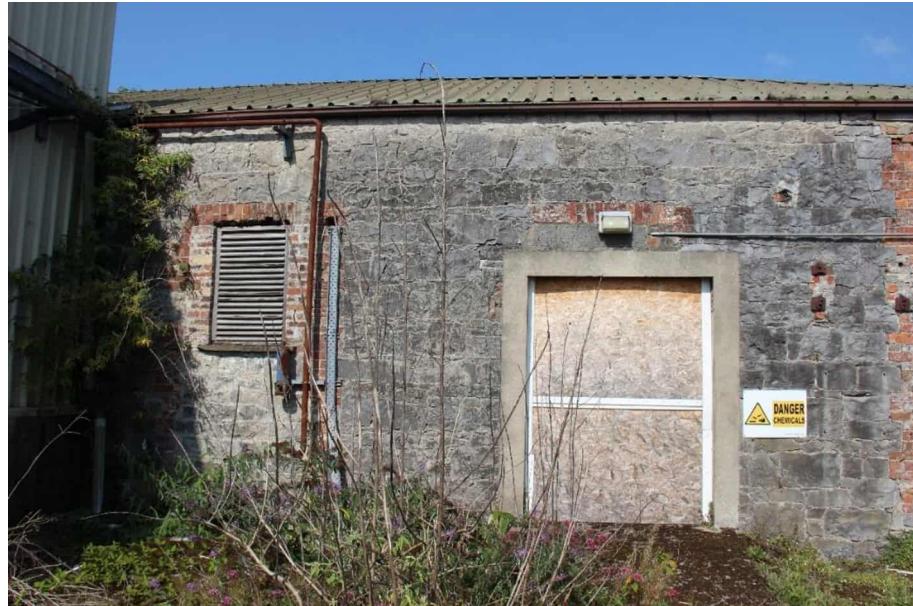
Photograph 6 General view of the opening to the SW elevation.

There are only two noted openings, both to the southwest elevation. One window opening with a louvered assembly, and a retrofitted door opening.

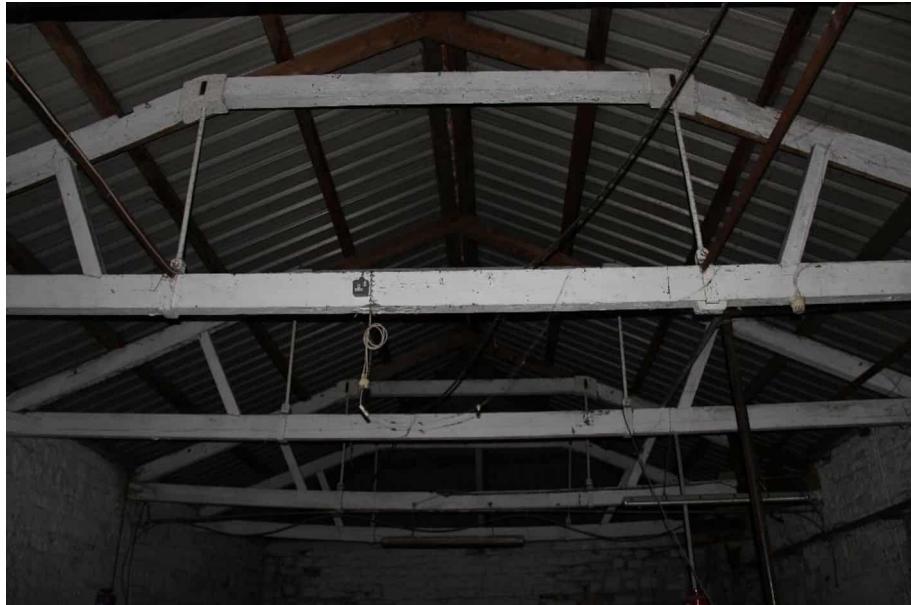
the case of these trusses are formed using a combination of cast iron plates and wrought iron bars (serving as the posts).

Photograph 7 General view of the roof structure to the first section.

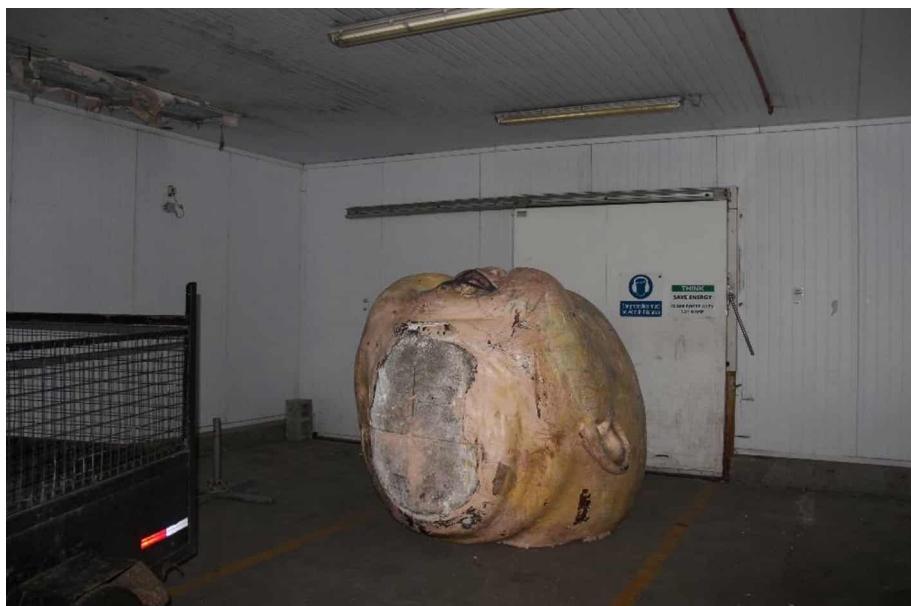
The second and third sections of the roof void were inaccessible, with the second section now a cold room, with insulated panels to the ceiling and walls. The same is true for the third section and the last room leading back to the office gable.

Photograph 8 General view of the second section of the Dairy Building, all the envelope is outside the cold room panelling.

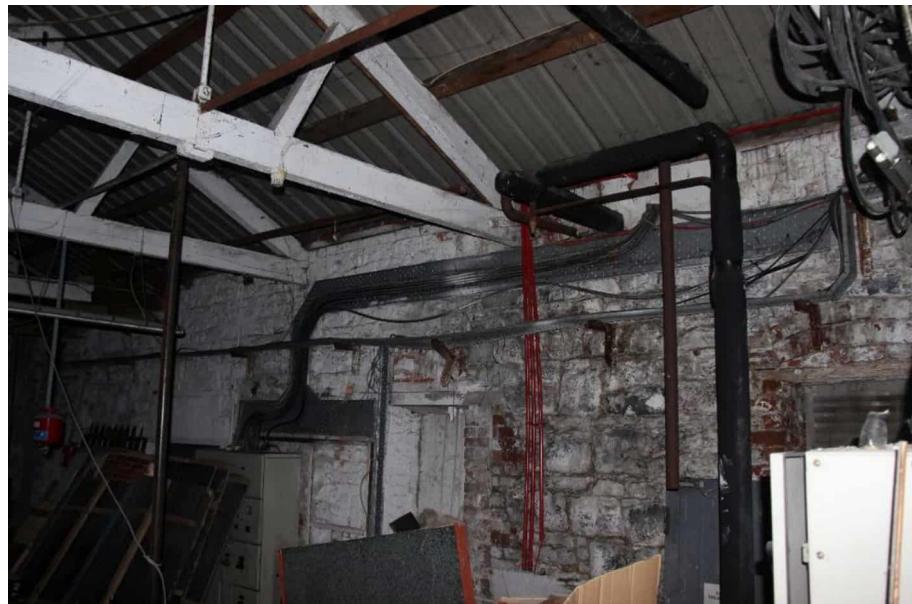
As per the roof structure / ceilings, the only section with exposed fabric is the first section. As with the external walls, the internal walls are constructed of coursed random rubble natural limestone, now finished in a white paint throughout the first section.

Photograph 10 General view of the internal elevation of the Dairy Building, first section. This is the only section where the internal wall fabric can be viewed.

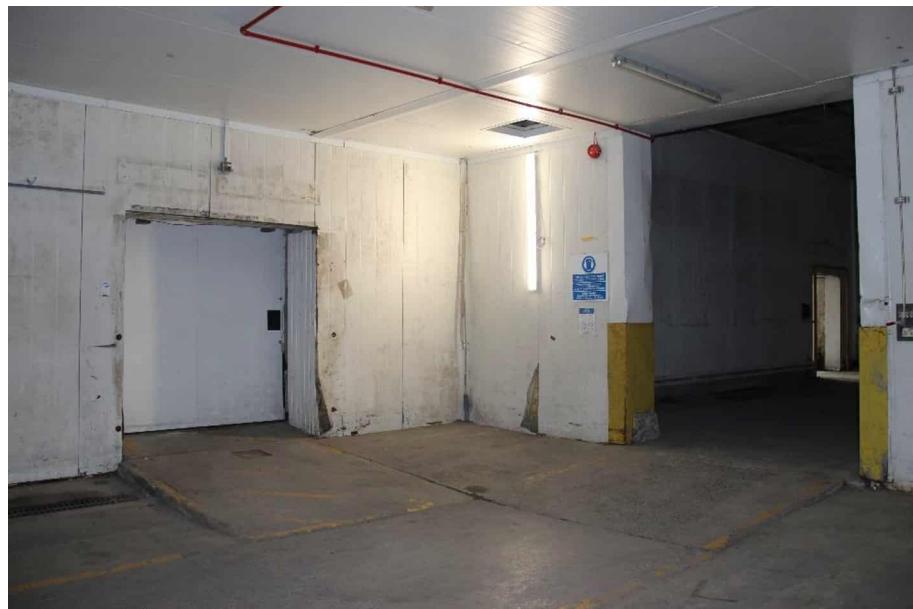
The internal floor to all three sections is a modern concrete floor, with evidence of surviving historic fabric.

Photograph 11 General view of the internal spaces, note concrete flooring.
