Building Record Report

Building 8 Workshop Building
Former Cleeves Condensed Milk Factory

Client: Limerick 2030

Date: 15th of October 2025

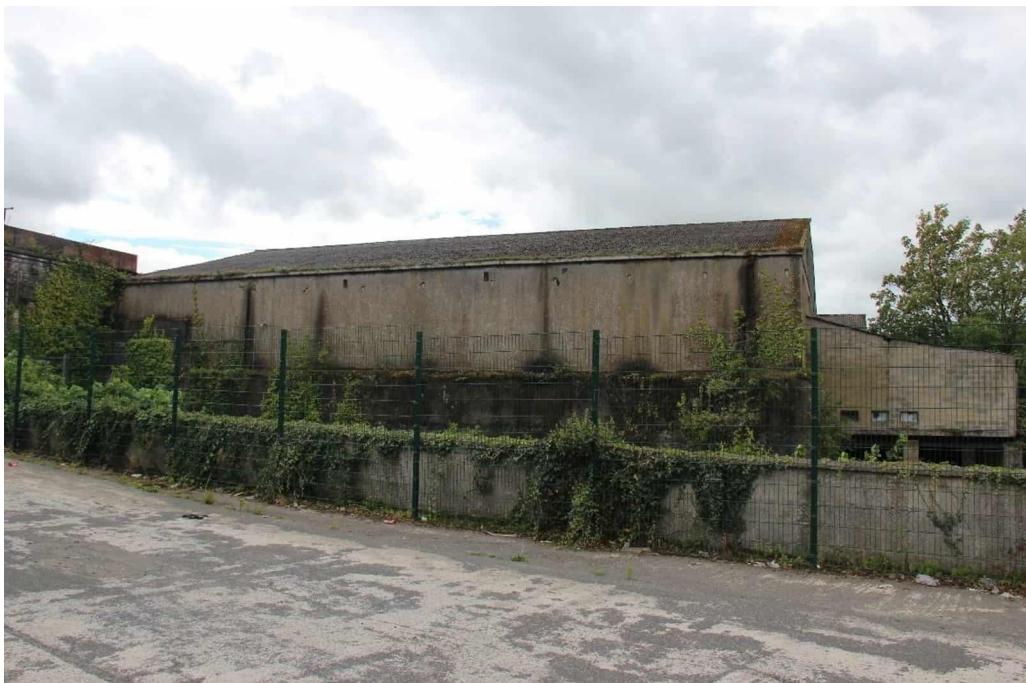
Photograph 1 - View of Infiltration Gallery from North

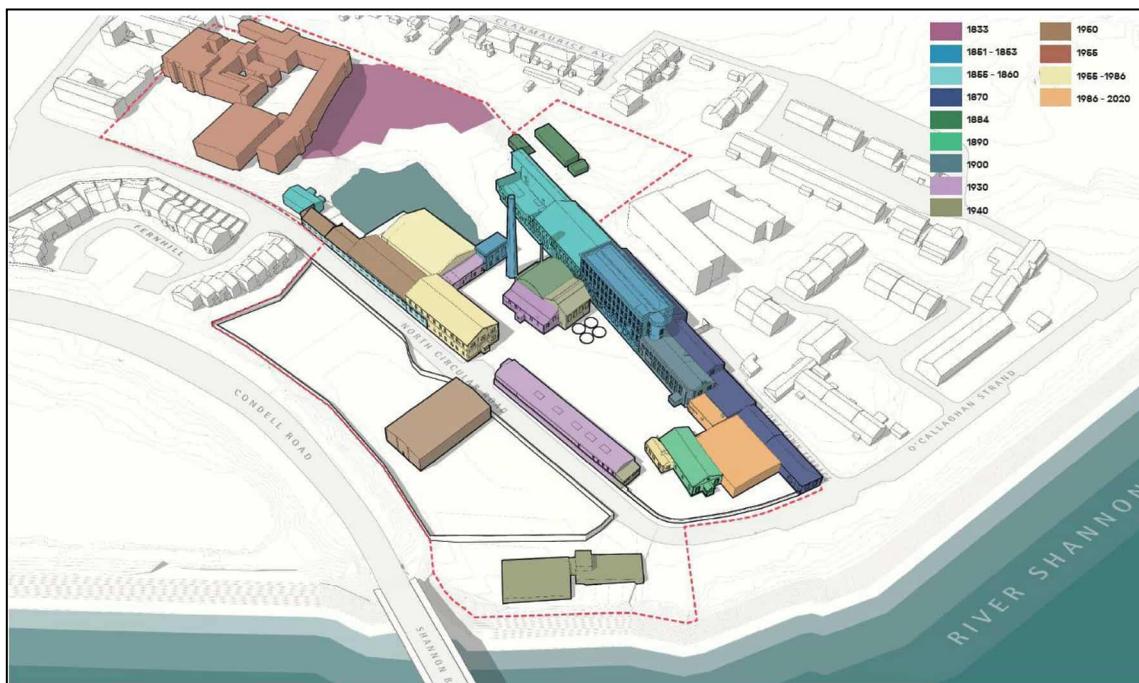
The evolution of the site is detailed in the building age diagram below.

Figure 5 - Building Ages Diagram, Limerick 2030

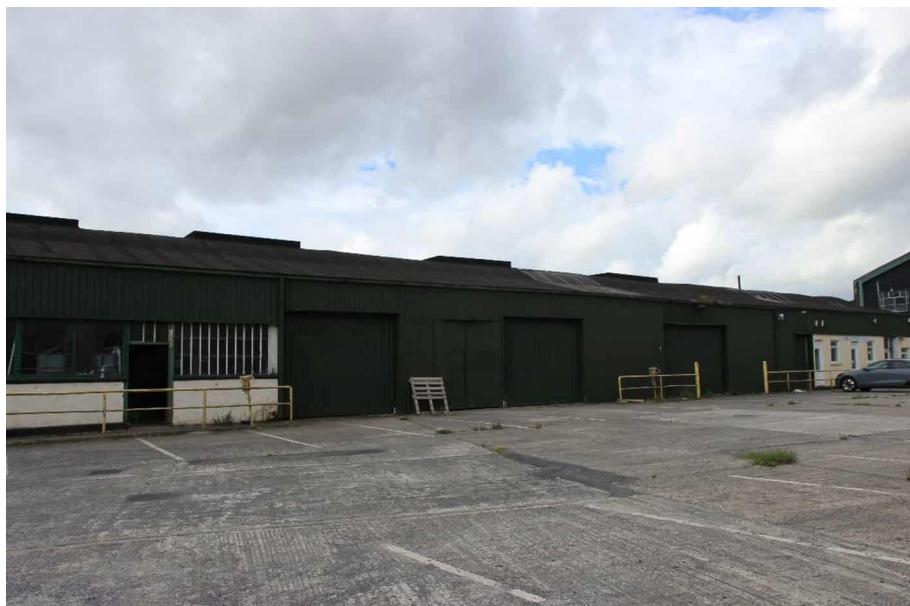
The external roof covering of the main building is finished with a modern bituminous felt. There is evidence of ventilation shafts to the roof, long covered over. The small lean-to addition to the eastern elevation is covered with a modern pressed metal corrugated sheeting.

Photograph 2 General view of the northern elevation of the workshop. Note the bitumen felt roof covering.

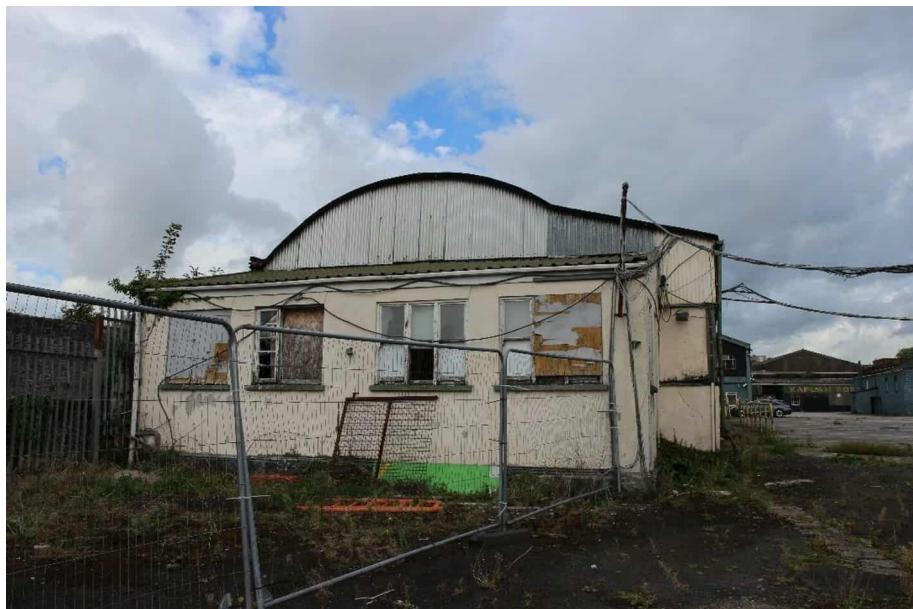
Photograph 3 Lean to building, eastern elevation. With a pressed metal roof covering.

The main roof has cast iron rainwater goods. The lean to has PVC rainwater goods.

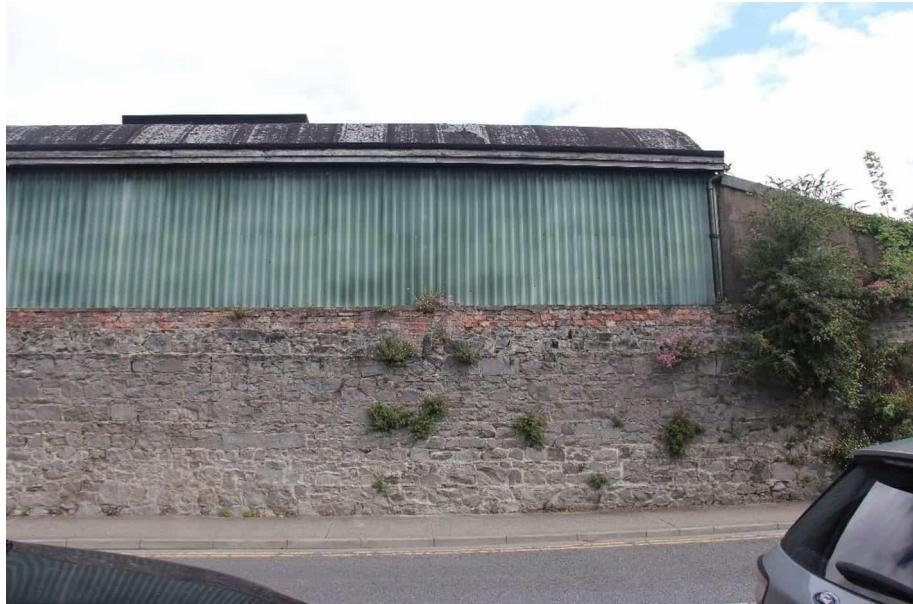
The elevation facing onto the North Circular Road corrugated sheeting cladding, the western gable end is also finished in a corrugated sheeted cladding, with the lower level rendered mass masonry.

Photograph 4 Example of the external wall cladding to the southern elevation.

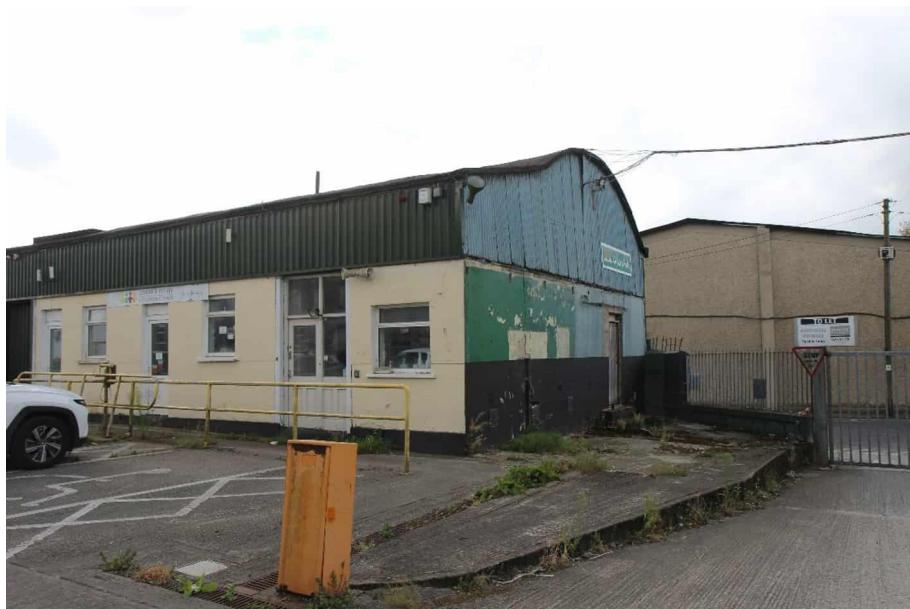
The northern elevation is a mixture of pressed metal wall cladding to the upper level at the eastern end, and full height at the western end, with the centre section of the elevation glazed on the eastern end, with a concrete wall to the lower section of the elevation. The cills are covered in a pressed metal. Possibly timber beneath.

Photograph 5 Western section of the Workshop building, with the west elevation also on view.

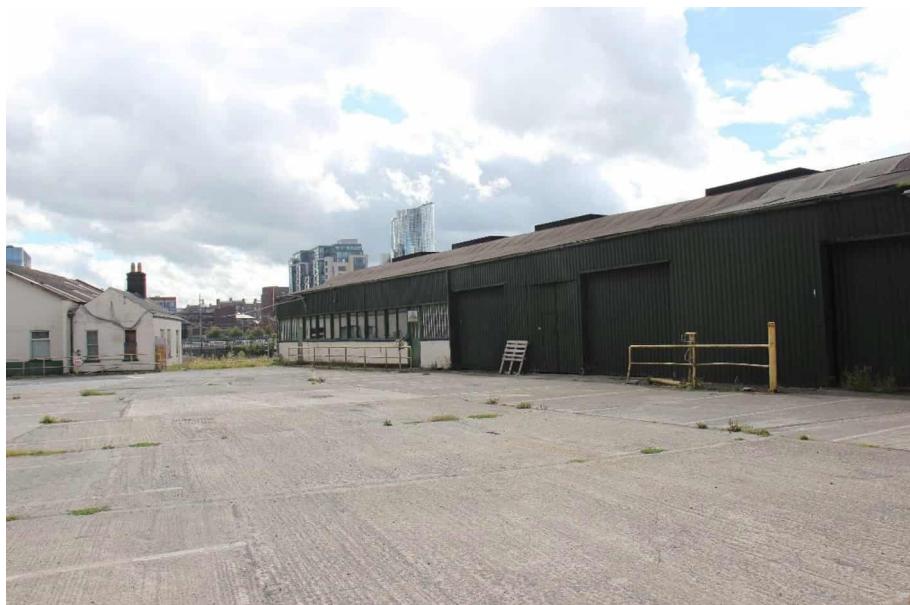
Photograph 6 View to the mid and eastern section of the northern elevation, note the different finishes present.

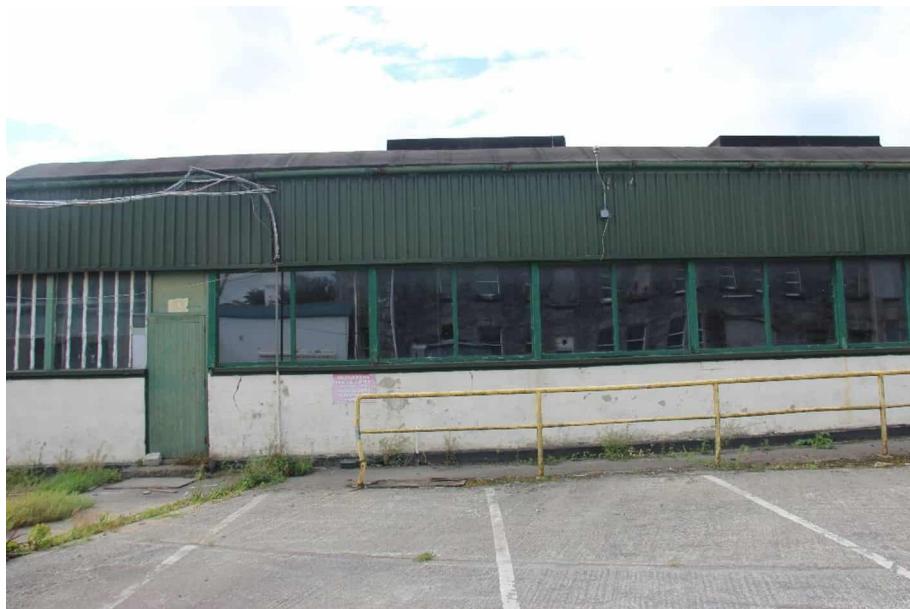
Photograph 7 Example of the fenestration to the eastern section of the northern elevation.

On the northern elevation, there are three window openings, consisting of modern PVC window assemblies. There are three door openings, one a timber assembly with timber and glazed surrounding screen, the remaining two are modern PVC assemblies.

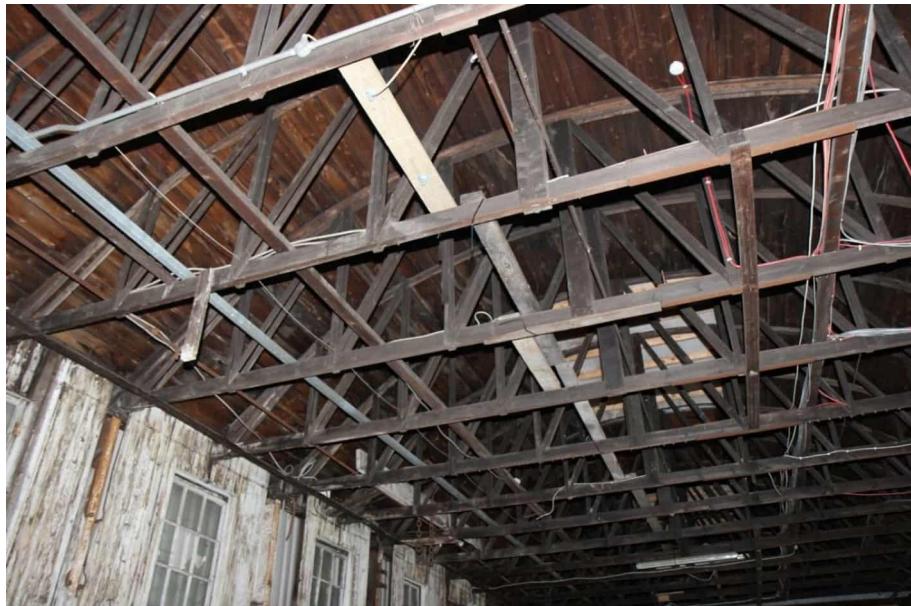
The underside of the roof buildup is exposed internally. There are timbering sarking boards spanning across the array of timber Belfast Trusses, running the full length of the main building. The trusses are supported on rolled steel beams, spanning a mixture of rolled steel columns to the southern elevation and cast-iron columns, in part, to the northern elevation.

Photograph 8 View of the roof structure, an array of Belfast trusses. Note the underside of the timber sarking boards.

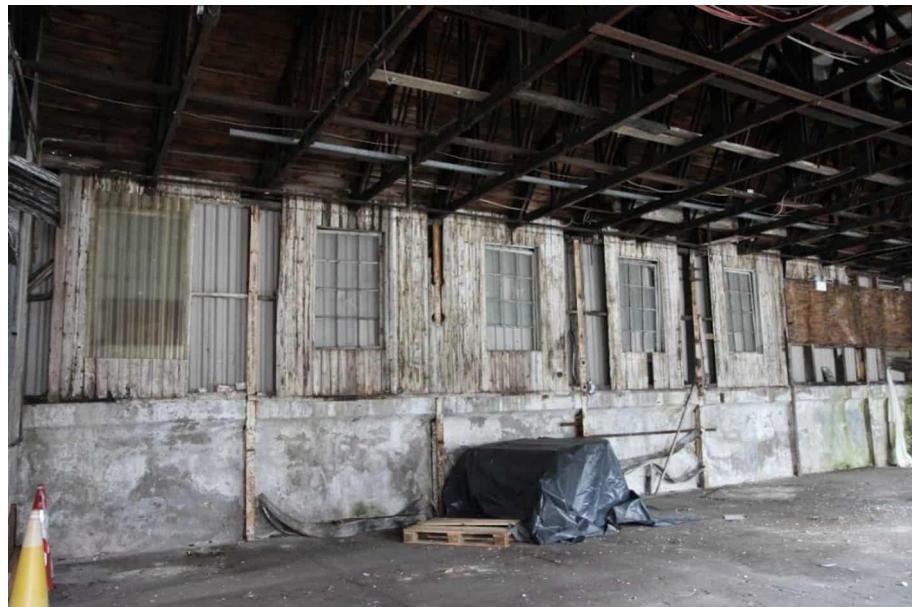
The internal wall elevations of the main workshop building are a mixture of concrete at the lower level, infilled between the structural rolled steel columns, and at upper level to eaves with timber cladding, with fixed windows centrally to each panel, what was the original external appearance of the building on the southern elevation.

Photograph 9 Internal elevation view of the southern external wall.

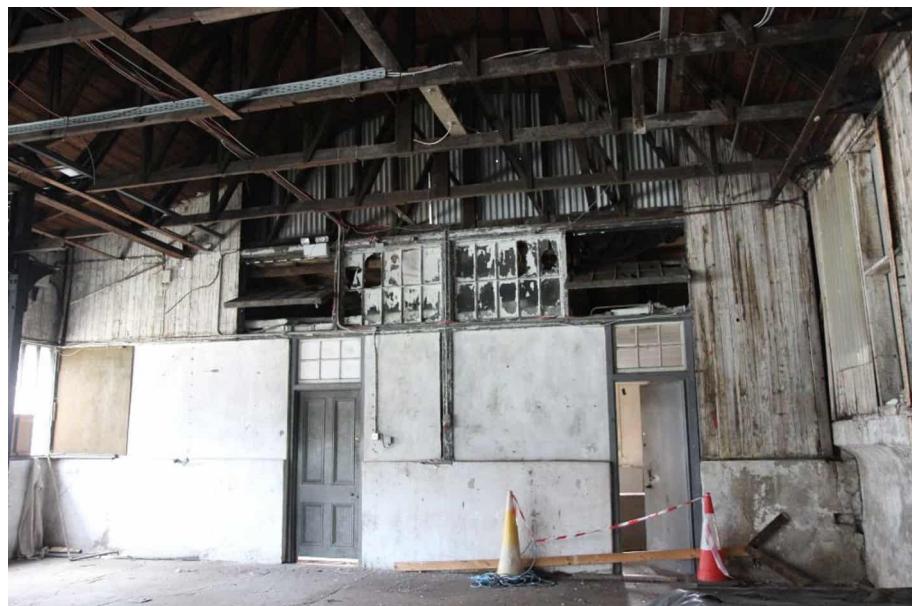
Photograph 10 Partition screen to eastern end of the workshop building.

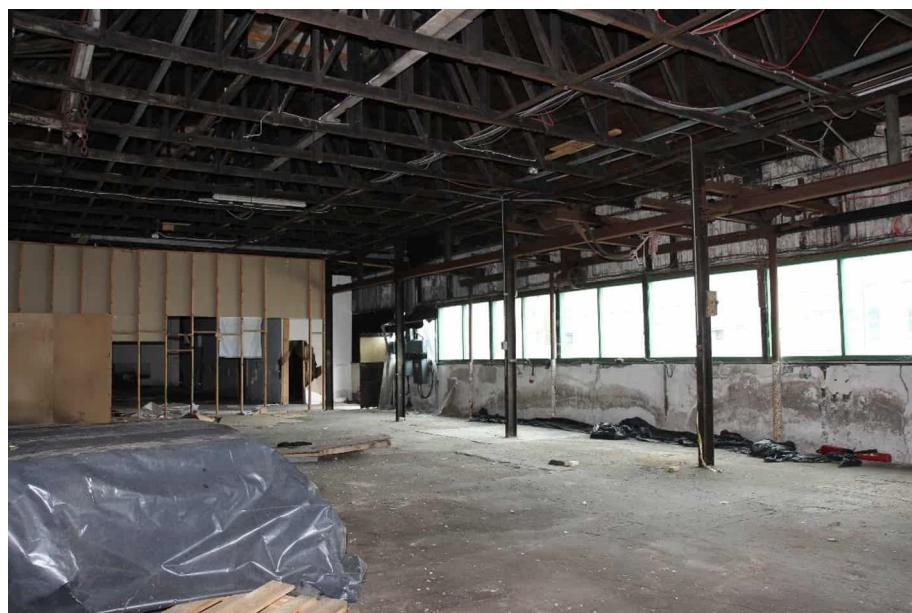
Photograph 11 View, facing westwards. Note concrete infill to the lower section of the northern wall.

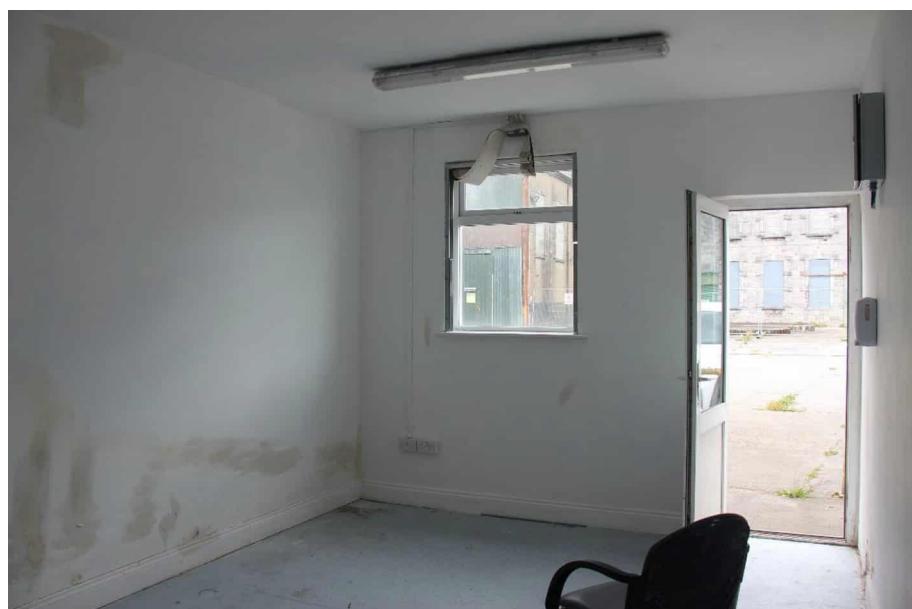
There are a number of internal partitioned rooms to the western section of the building, with the rooms to the southern area inaccessible on the day of inspection. The rooms to the northern area have timber stud partition walls with modern skimmed plaster slab finishes.

The ceilings within these rooms are also modern skimmed plaster slabbed ceilings.

Photograph 12 Internal view of one of the rooms to the northwest section of the building. All modern finishes and detailing.

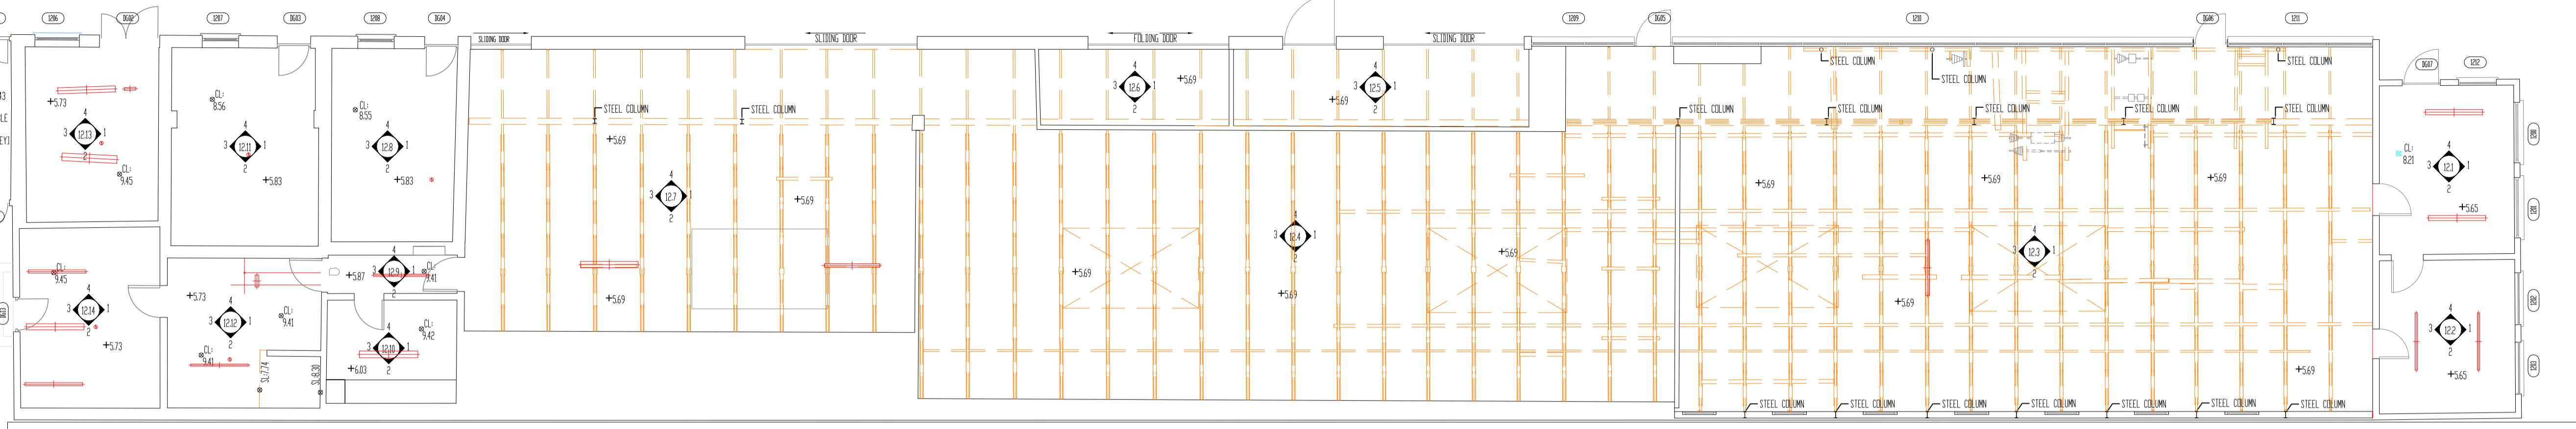
Description of Fabric

The workshop building is for the most part an open plan building, with the main structure a rolled column and beam steel frame, with some cast iron elements, supporting a timber Belfast trussed roof, covered with a bitumen felt.
