Building Record Report

Building 9 Cheese Plant
Former Cleeves Condensed Milk Factory

Client: Limerick 2030

Date: 15th of October 2025

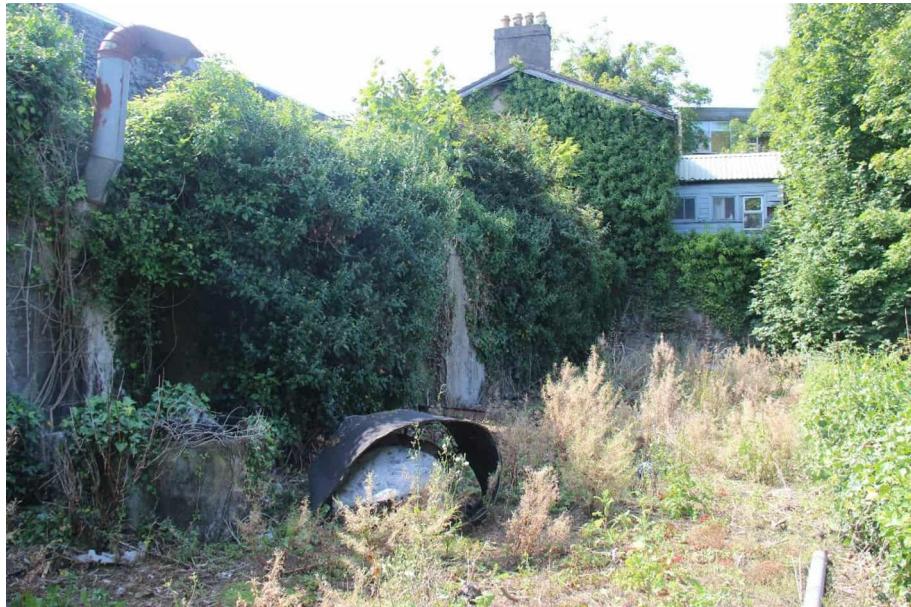
The north circular road elevation is constructed of coursed ashlar natural limestone, with margined and rusticated quoin stone and window opening arches. The rear elevation is heavily overgrown with vegetation. The rear walls are rendered with a cementitious mortar, where visible.

Photograph 4 General view of the rear of the Cheese Plant complex. Note overgrowth to rear walls.

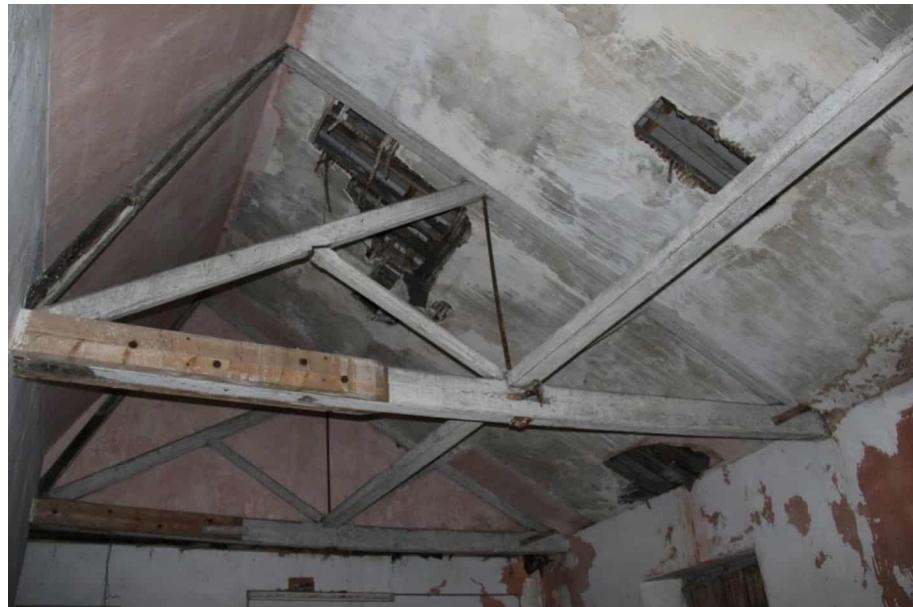
The internal ceiling extends to the underside of the roof covering, which has the original lath and plaster splayed ceiling still intact.

Photograph 5 Internal view of the splayed ceiling in the first section of the subject building.

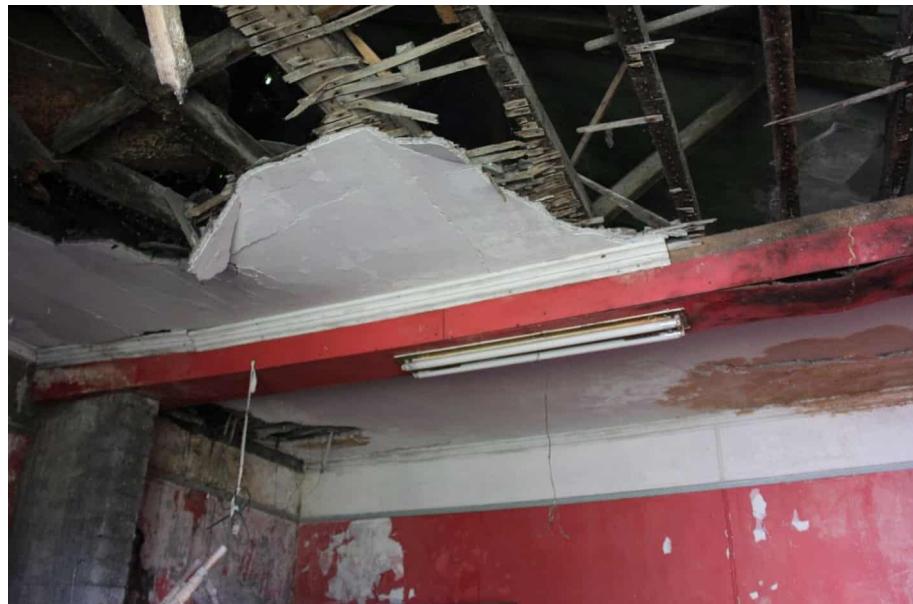
The ceilings to the end room have failed locally, with the roof structure exposed internally.

Photograph 6 View of the failed ceiling of the end room. Note laths and sections of coving.

The remnants of plaster coving are evident to the ceiling, all in very poor repair and most likely not original.

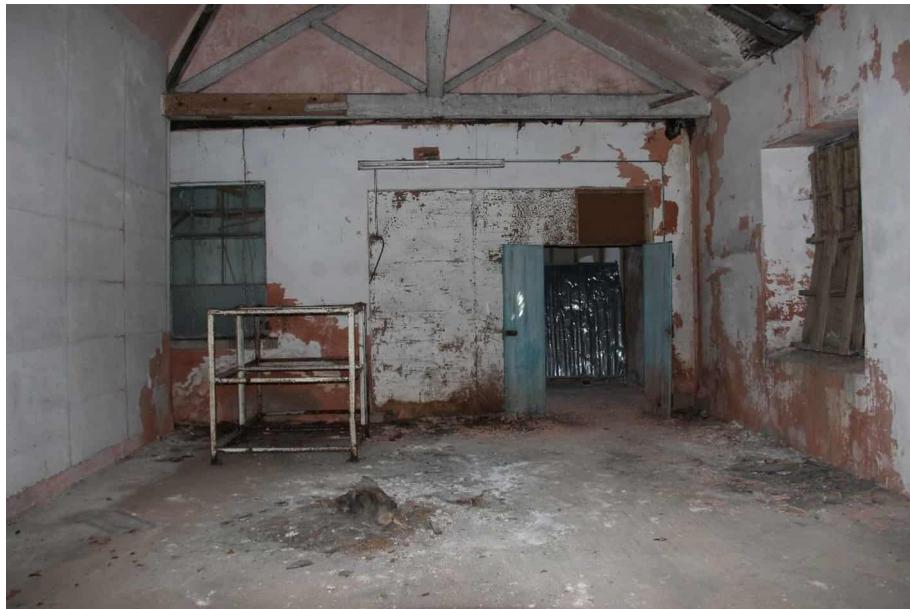
The internal walls of the building, where accessible are finished in a modern gypsum-based plaster throughout.

Photograph 7 General view of the internal of the first section of the subject building.

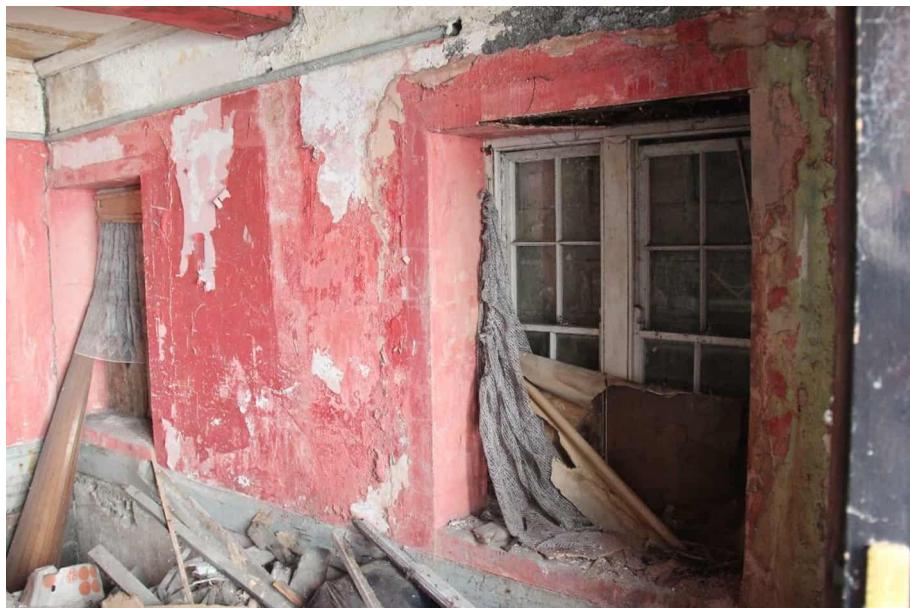
The end room walls appear to have been drylined (evident from the failed window soffit).

Photograph 8 View of the internal elevation of the external wall to the end room.

There is evidence of picture rails surviving in this room, though most likely not original.

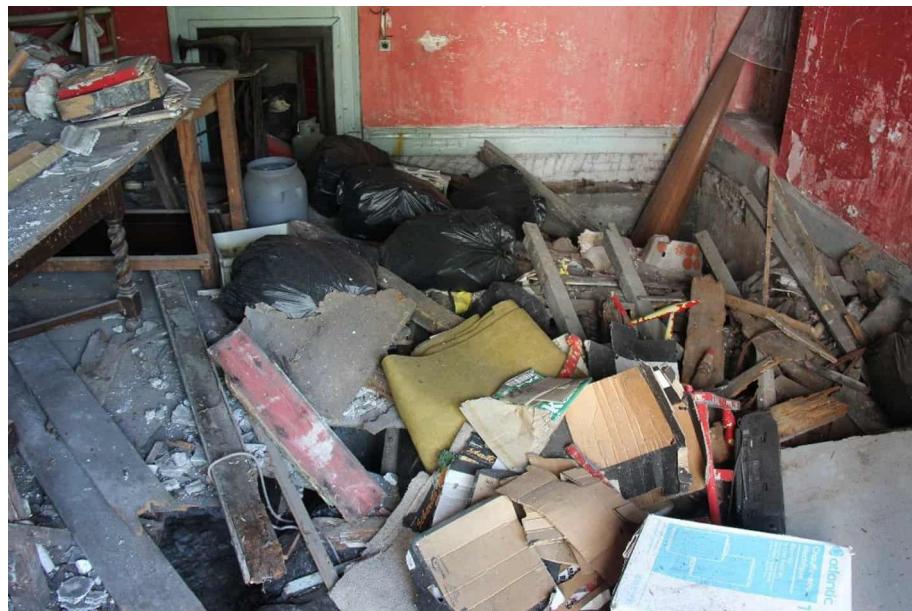
The main section of the building is finished with a concrete floor, the end room is finished with a suspended timber floor, now long since failed.

Photograph 9 View of the floor of the end room. Sprung timber floor. Failed.

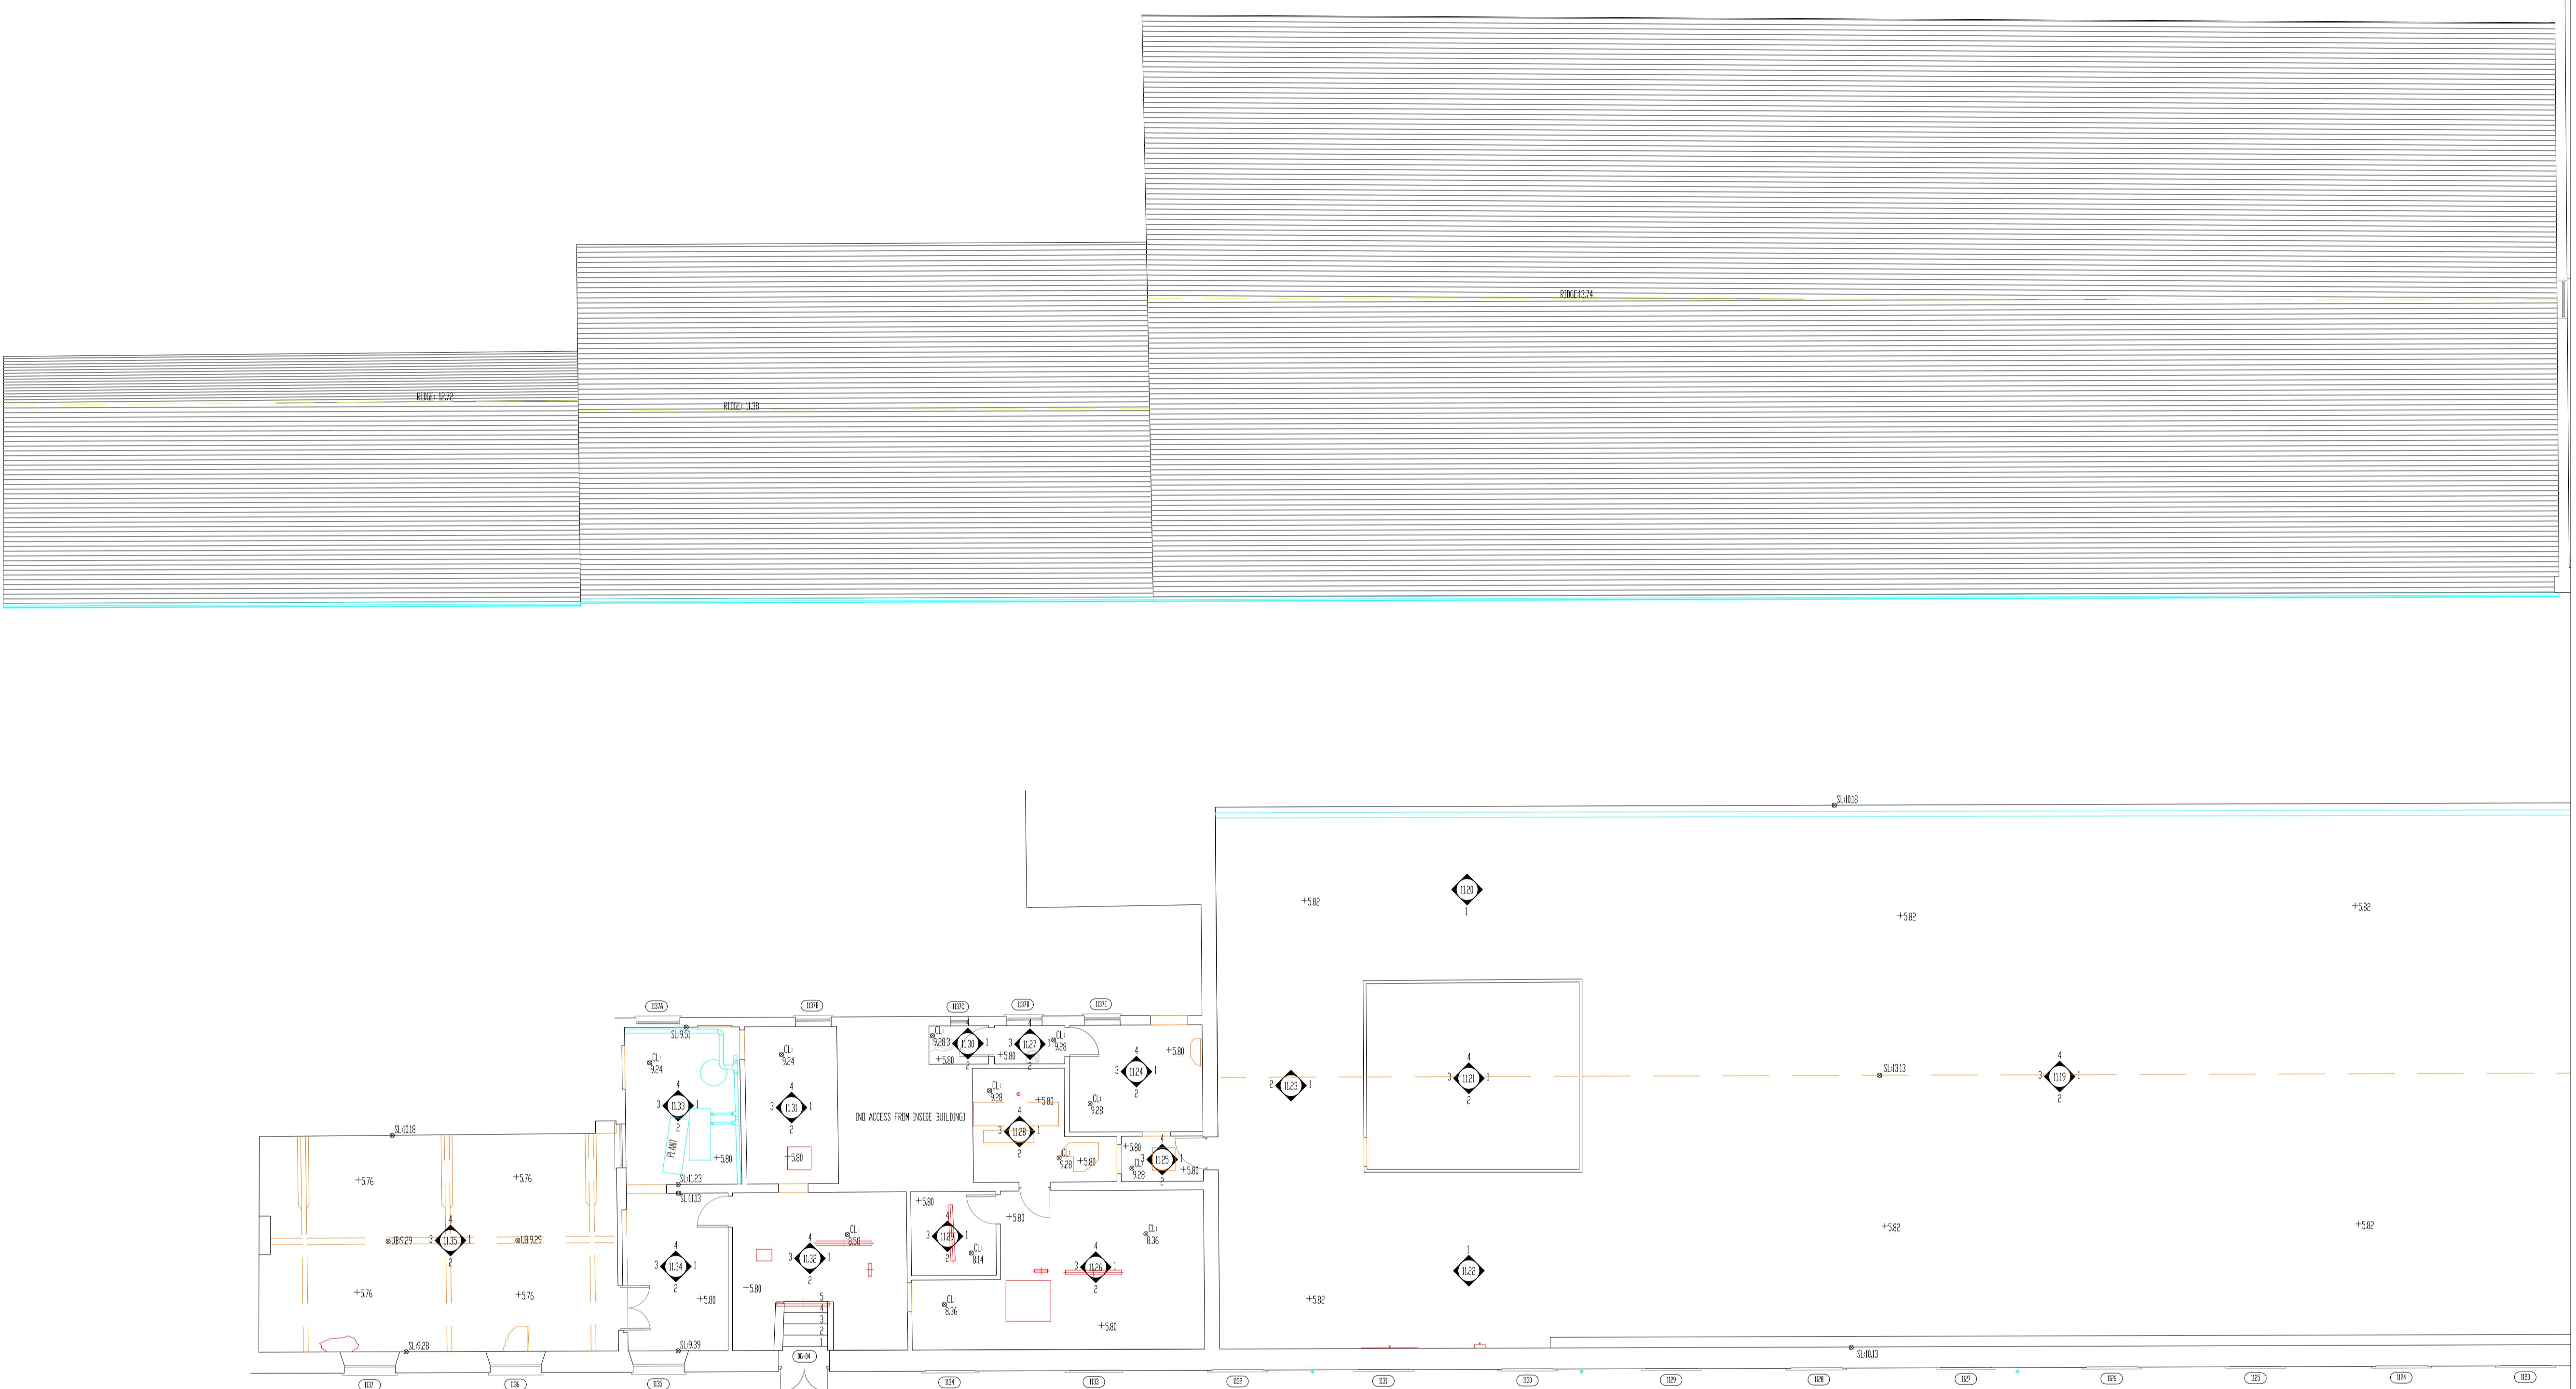
Description of Fabric

The end of the “long building” on the North Circular Road has an asymmetrical roof, and is constructed of coursed ashlar natural limestone, with margined and rusticated quoin stone and window opening arches.

External walls
The north circular road elevation is constructed of coursed ashlar natural limestone, with margined and rusticated quoin stone and window opening arches. The rear elevation is heavily overgrown with vegetation. The rear walls are rendered with a cementitious mortar, where visible.

Internal Walls
The internal walls of the building, where accessible are finished in a modern gypsum-based plaster throughout. The end room walls appear to have been drylined (evident from the failed window soffit). There is

Internal Floors
The main section of the building is finished with a concrete floor, the end room is finished with a suspended timber floor, now long since failed
