Project Opera, Bank Place, Rutland St., Patrick St., Ellen St. and Michael St., Limerick

Architectural Heritage Report

22 November 2018

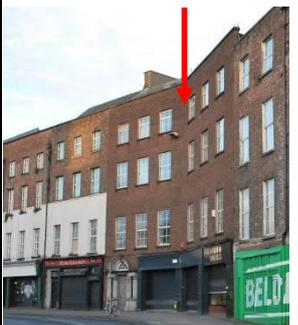
<p>5 Rutland Street is a three-bay four-storey over basement red brick building built as a townhouse, which retains its original limestone doorcase incorporated within a partially surviving nineteenth-century shopfront.</p>		Candidate Protected Structure	<p>Building is generally as per initial inspections, with further water ingress visible to the party wall with No. 4.. The basement and shop have been cleared out and have not been in use for a number of years. Opening up of some of the plasterboard linings has revealed some additional features, such as dado rails in place to upper floor rooms. Elements of early roof structure are also in situ.</p>

<p>Significant internal joinery surviving, including the original mid-18th century staircase.</p>				<p>The top flight of the staircase has been badly damaged by the insertion of a crude fire lobby. The balustrade to this area was removed causing damage to the balusters. The balustrade is retained to the building and all elements not in situ should be placed in to safe keeping for later restoration.</p>
6 & 7 Rutland St	<p>The building comprises a five-storey over basement building on the site of two earlier residential plots. It is situated at a point along Rutland Street where the street kinks which results in a non co-linear façade line. It comprises in-situ reinforced concrete (RC) structure with external RC columns and 4no. internal columns supporting flat RC slabs</p>	Doorway RPS 317	Reg. No. 21513008 (Doorway)	LCC remedial works not carried out to this building.

<p>Historic door case set in front elevation, in the Palladian style with a double fluted limestone Doric pilaster and window either side of the main doorway.</p>

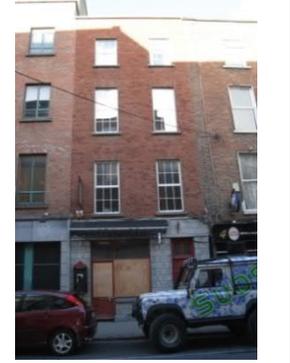
<p>3 Ellen Street is a two-bay four story terraced building which has copied the Georgian proportions of the neighbouring buildings to the front facade. The building is narrow and deep, and projects to the rear much further than the adjoining Georgian buildings.</p>	N/A	N/A	<p>LCC remedial works not carried out to this building.</p> <p>Not inspected by JCA Feb. 2017</p>

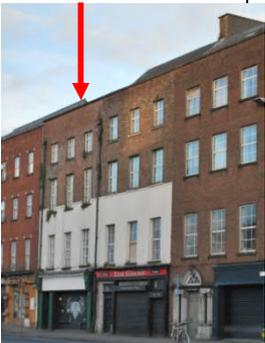
Address	RPS	NIAH Candidate Protected Structure	Conservation Category	Assessment of Significance
4 Rutland St

N/A	N/A	C	<p>Heavily modified internally, with a new staircase and wall partitions inserted, although the basement is retained (with modifications) and the vault beneath the street is still extant. The front elevation is retained, while the rear elevation and roof have been reconstructed. The roof profile also has been altered in the reconstruction.</p> <p>Some remnants of original cornices visible above suspended ceiling to ground floor. Early timber boards retained to first floor, front room. Other early features may be retained behind modern finishes.</p>
5 Rutland St

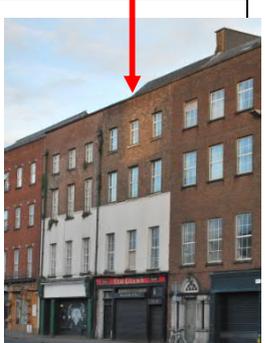
N/A	<p>Reg. No. 21513009</p> <p>Candidate Protected Structure</p>	A	<p>Of high architectural significance. Retains original 18th century features including the staircase, lugged architraves and run plaster cornices. Plan form intact.</p> <p>One of the earliest buildings retained to the site, comprising an early phase of the Newtown Pery development.</p> <p>Limestone door surround to Rutland St. retained, and elements of historic shopfront.</p>

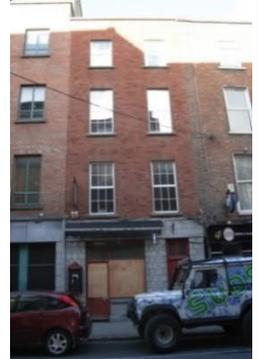
Address	RPS	NIAH Candidate Protected Structure	Conservation Category	Assessment of Significance
4 Ellen St

N/A	N/A	B	<p>This building retains its original roof trusses.</p> <p>Staircase is modern to lower floors, original stair intact to upper floors. Plan form is retained.</p> <p>Remains of a substantial building can be seen to the rear of this terrace of houses on Ellen Street. This can be seen to have been a large stone building, having brick to the openings.</p>
5 Ellen St

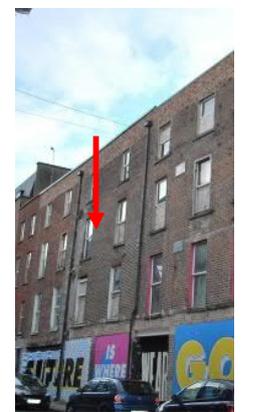
N/A	N/A	B	<p>The building appears to comprise half of a larger, two bay building which was subdivided. The building is in poor condition but retains early features and finishes, including a staircase.</p> <p>The rear elevation forms a complete elevation with the adjoining terraced buildings on Ellen Street, without singular yards or other divisions between the properties.</p>
6 Ellen St

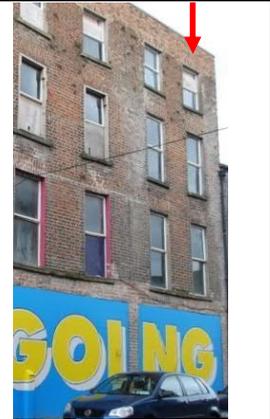
Remains of a substantial building can be seen to the rear of this terrace of houses on Ellen Street. This can be seen to have been a large stone building, having brick to the openings.
8 Ellen St	N/A	N/A	A	The rear elevation forms a complete elevation with the adjoining terraced buildings on Ellen Street, without singular yards or other divisions between the properties.

The interior of this building retains the majority of its original features, including the staircase, doors, fireplaces, cornices, timber floors, etc.
9 and 9a Ellen St	N/A	Reg. No. 21513018	A	This complex of buildings is likely to incorporate an earlier structure (predating John Quinn's) dating from the late 18th or early 19th century.
