A UNIVERSAL DESIGN STATEMENT

Job/Drawings No: CRP01-FCBS-1A-02-DR-AA-2052
Revision No: P03
CRQ - FLAX MILL PHASE 1 REPAIR
PROPOSED SECOND FLOOR PLAN

Ref: 01-FCBS-1A-XX-DR-AA-2201
FLAX MILL PHASE 1 REPAIR
R STRATEGY - SW ELEVATION ZONE 1
50 @ A1 / 1:100 @ A3
ath Studio Checked: JS
FCBS Project No: 2024

Job/Drawng No	Revision	CRP01-FCBS-1A-XX-DR-AA-2203
CRQ - FLAX MILL PHASE 1 REPAIR	P05	
REPAIR STRATEGY - SW ELEVATION ZONE 3

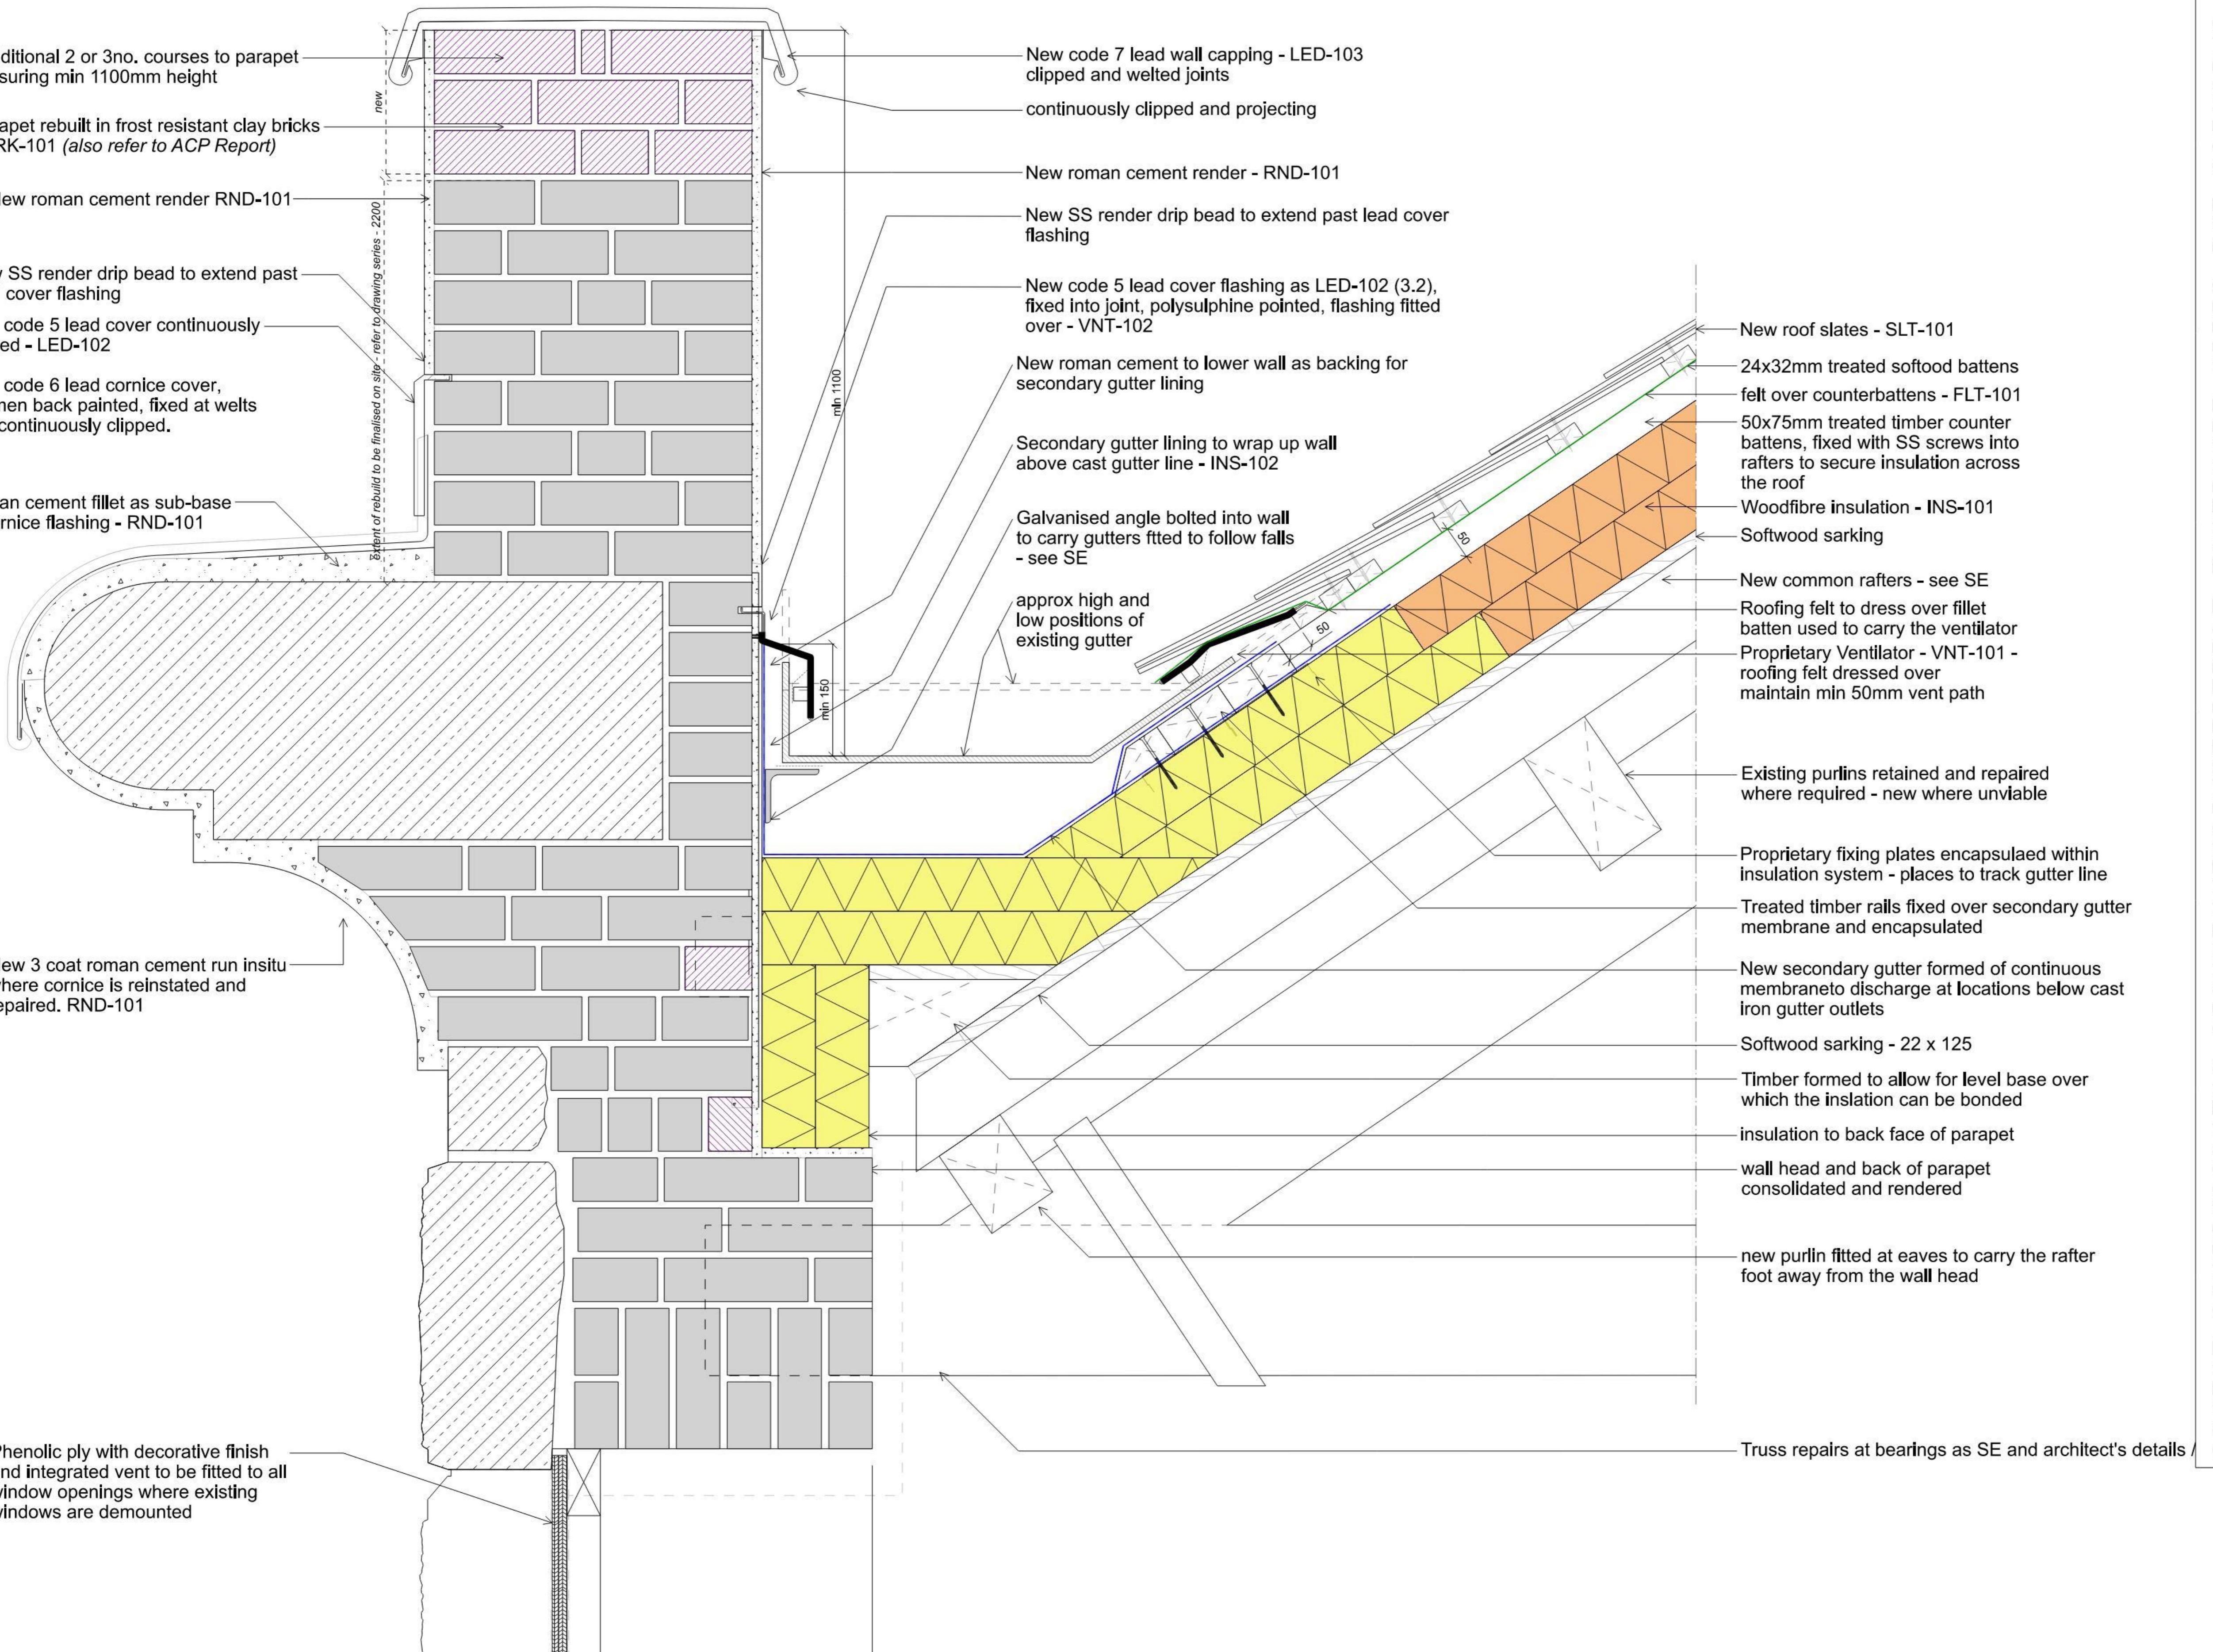
Job/Drawings No: CRP01-FCBS-1A-XX-DR-AA-3102 Revision: P02
Status: A4
CRQ - FLAX MILL PHASE 1 REPAIR
EXISTING FABRIC ASSEMBLY
CAST IRON ROOF GUTTERS
Scale : 1:10 @ A1
Drawn: Bath Studio Checked: JS
FCBS Project No: 2027-1

Rainwater Drainage
The cast gutters have survived for 170 years with little evidence of structural failure or maintenance demand. The drainage capacity is, however, significantly less than needed. A failure to rapidly drain and the subsequent overtopping of gutters has been a primary factor in rainwater ingress.

Cast Iron Valley Gutter Condition and Defects
Summary:
- Both downpipes failed with elements missing;
- Gutters thinning to ~5mm must be replaced;
- Parapet and valley gutters corroded but functional;
- Underside corrosion has resulted in thinning of the cast iron from about 13mm to 5mm.
- Most of the gutters have developed pitting in the gutter base. Some have holes few of which have been plugged with ferrous pins in the past.

Thinning - Thinning of the casting is most likely due to underside corrosion due to condensate and a lack of ventilation. Limited air movement and the damp environment has led to the very gradual failure of the iron. It is of note that the thinning of the iron is localised to the areas where damp timber has been trapped against the iron. There is potential for the most pronounced thinning to be concealed at the interface of the rafters.

Fractures - Several gutters have fractures to the edges due to thermal stress and little opportunity for movement. There are fewer stress failures than might be expected. This may be an indication of the strength and quality of the iron. Many timber bearers carrying gutters have failed, often replaced by masonry for propping.

Capacity - Outlets provide inadequate capacity. Outlets have failed. Cast downpipes are missing and / or broken.

Repair, Enhancement and Reinstatement Requirements
The repair and reinstatement of the gutters is an important part of the building's conservation. Improvements in rainwater drainage have been informed by an assessment of drainage capacity which must be reviewed by the specialist. Additional outlets and the adaption of the existing cast iron will be essential. A secondary gutter is designed to provide a fall safe. Refer to proposal drawings.

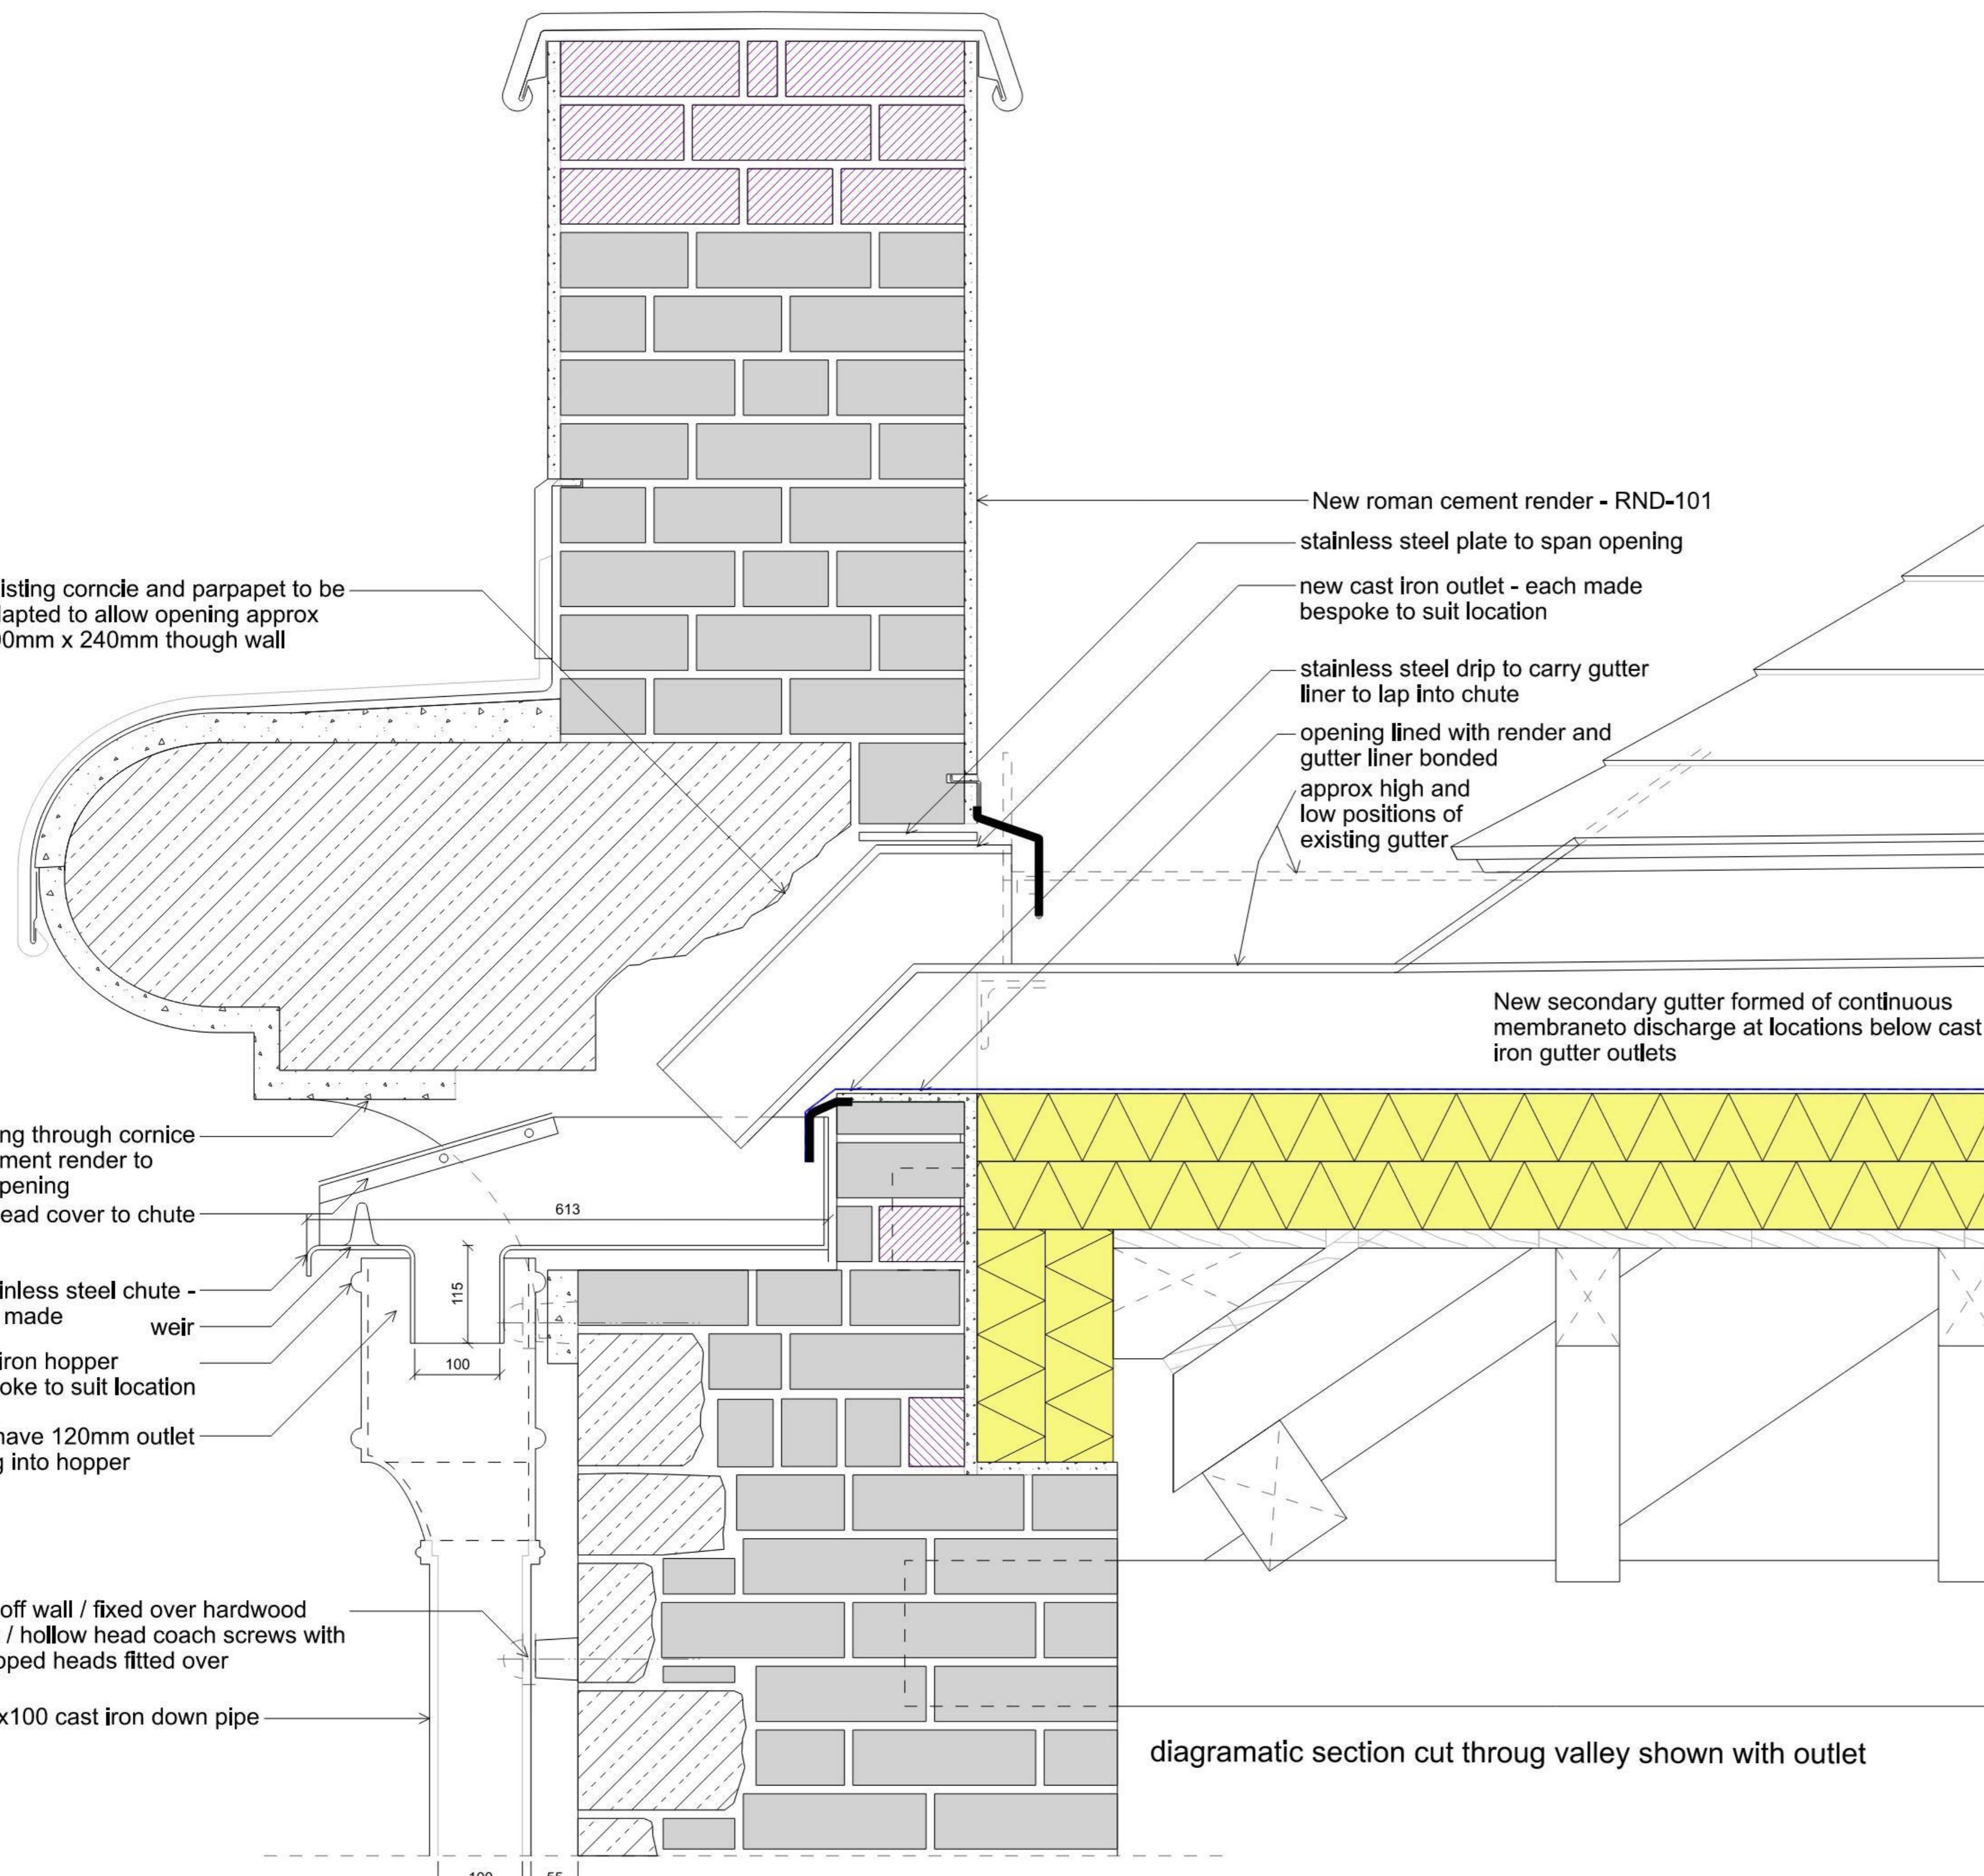
PARAPET SECTION @ GUTTER OUTFALL

The parapet is subject to consolidation and rebuilding to address poor condition and structural movement. As part of this work the parapet is to be reinstated in a form that improves its future durability. This will require care and co-ordination of the various elements.

Cornice - To be rest where required. Loose render to be removed and existing to be robustly prepared. New roman cement stucco render to be run in-situ. New lead cover to be fitted.

Masonry General - To be consolidated and repaired. The lower section the inside face of the parapet and the shelf at the wall head are to be cleaned and consolidated. Where necessary the wall head is to be rebuilt. Pockets and voids are to be infilled. The wall is to be rendered to achieve a smooth, flat surface of sufficient uniformity to permit the installation of the glass slab insulation boards.

Parapet Gutter - To be overhauled, repaired, adapted and reinstated. Gutters to be set over repaired and reinstated roof, formed with insulation over sarking. A new sub-gutter is to be formed at the eaves as a backup to minimise the risk of water ingress at the wall head and to protect the construction generally. Note that great care will be required to plan the setting out for the reinstatement of the gutters. The galvanized steel angle is to be fitted and regular centres to reflect the gutter dimensions. A rubber strip can be used over the angle to allow for thermal movement between the iron gutter and angle. The gutter is to be places with a 25mm gap from the wall to allow for ventilation. The proprietary flashing carrier will allow for the vent path to be maintained (VNT-101). The flashing will need to be chased into the wall in an alignment that tracks the gutter. Ensure measures are taken to prevent rubbish dropping into the sub-gutter below.

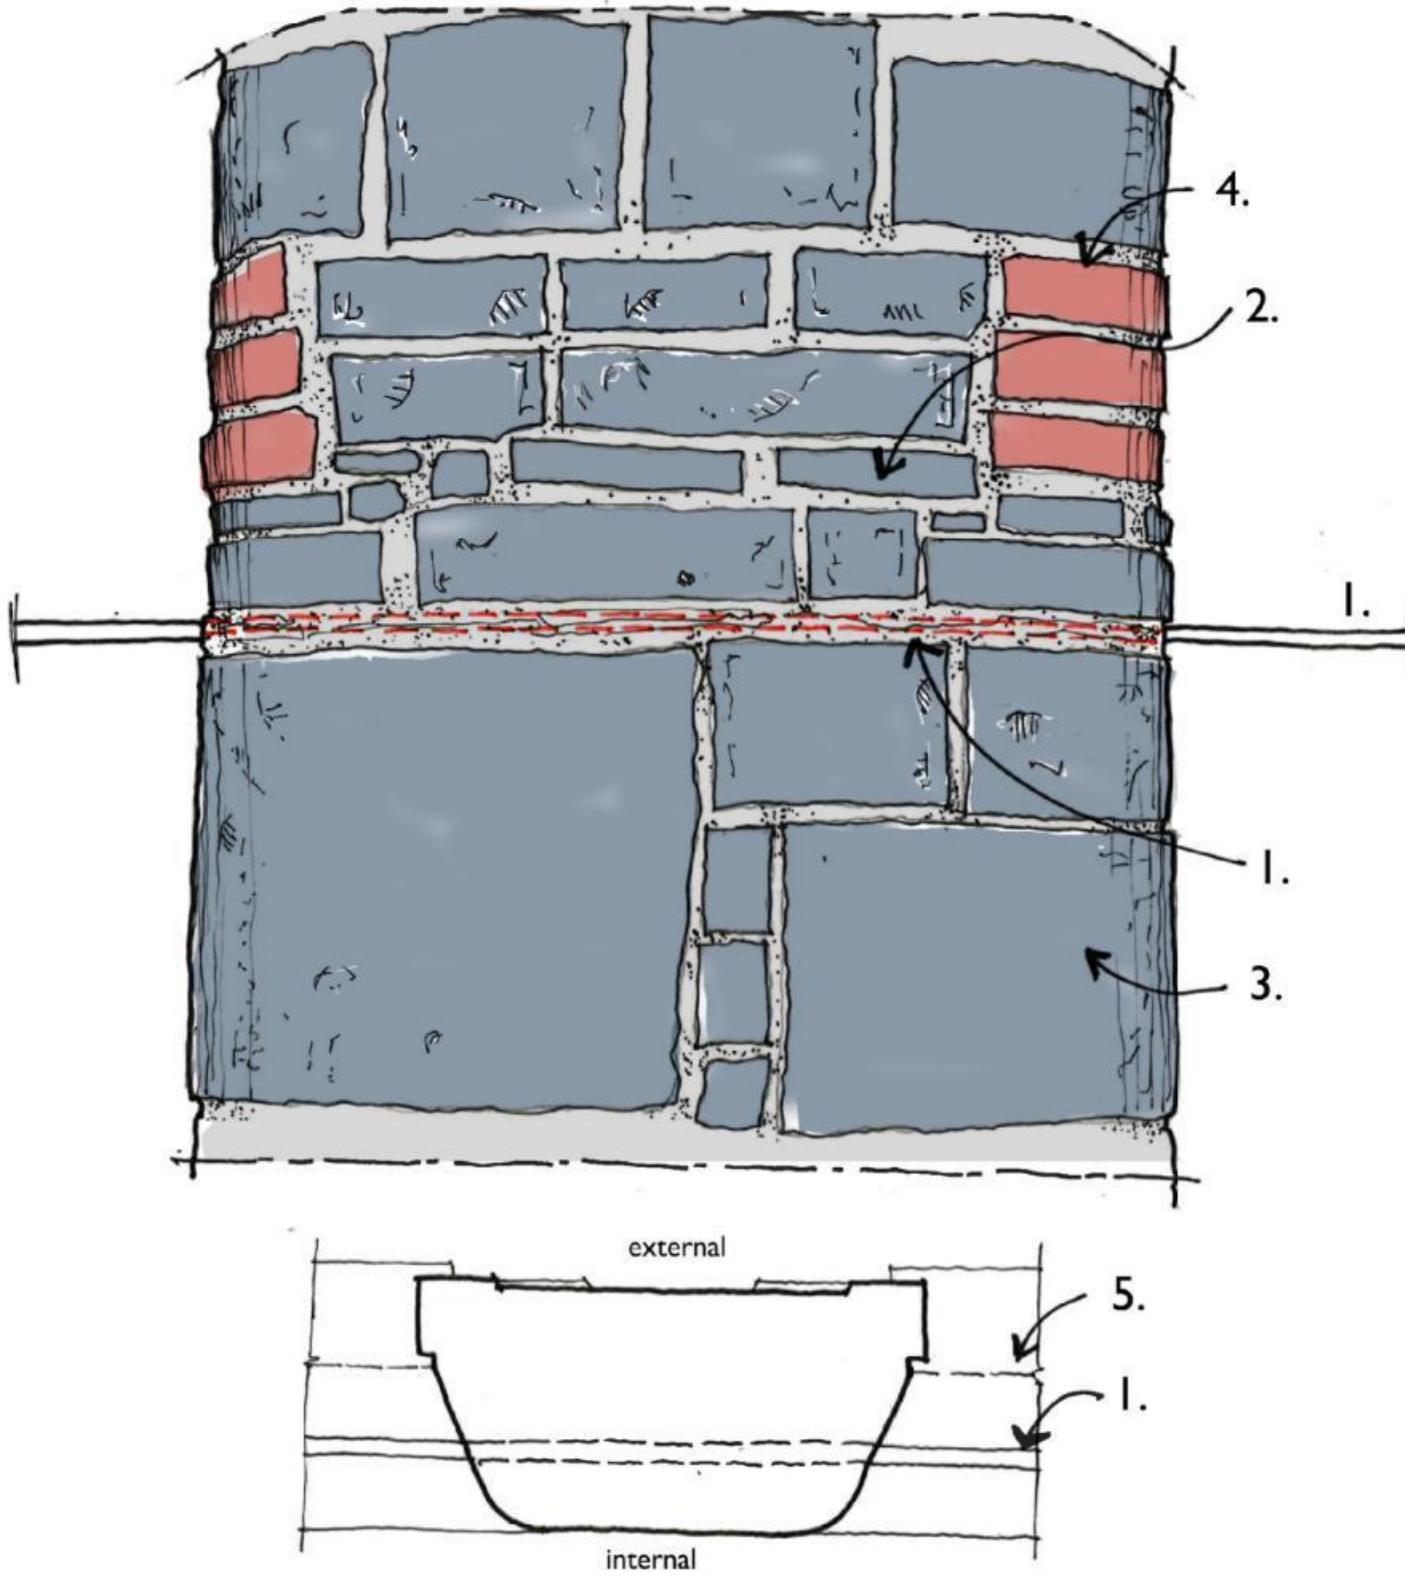
EXISTING MASONRY PIER

1. Iron bar embedded in wall and spanning between piers.
2. Smaller masonry units set above the iron bar.
3. Larger masonry units used to cap the pier below the iron bar.
4. Red clay bricks used at corners and sides of piers.
5. Line of window reveal.

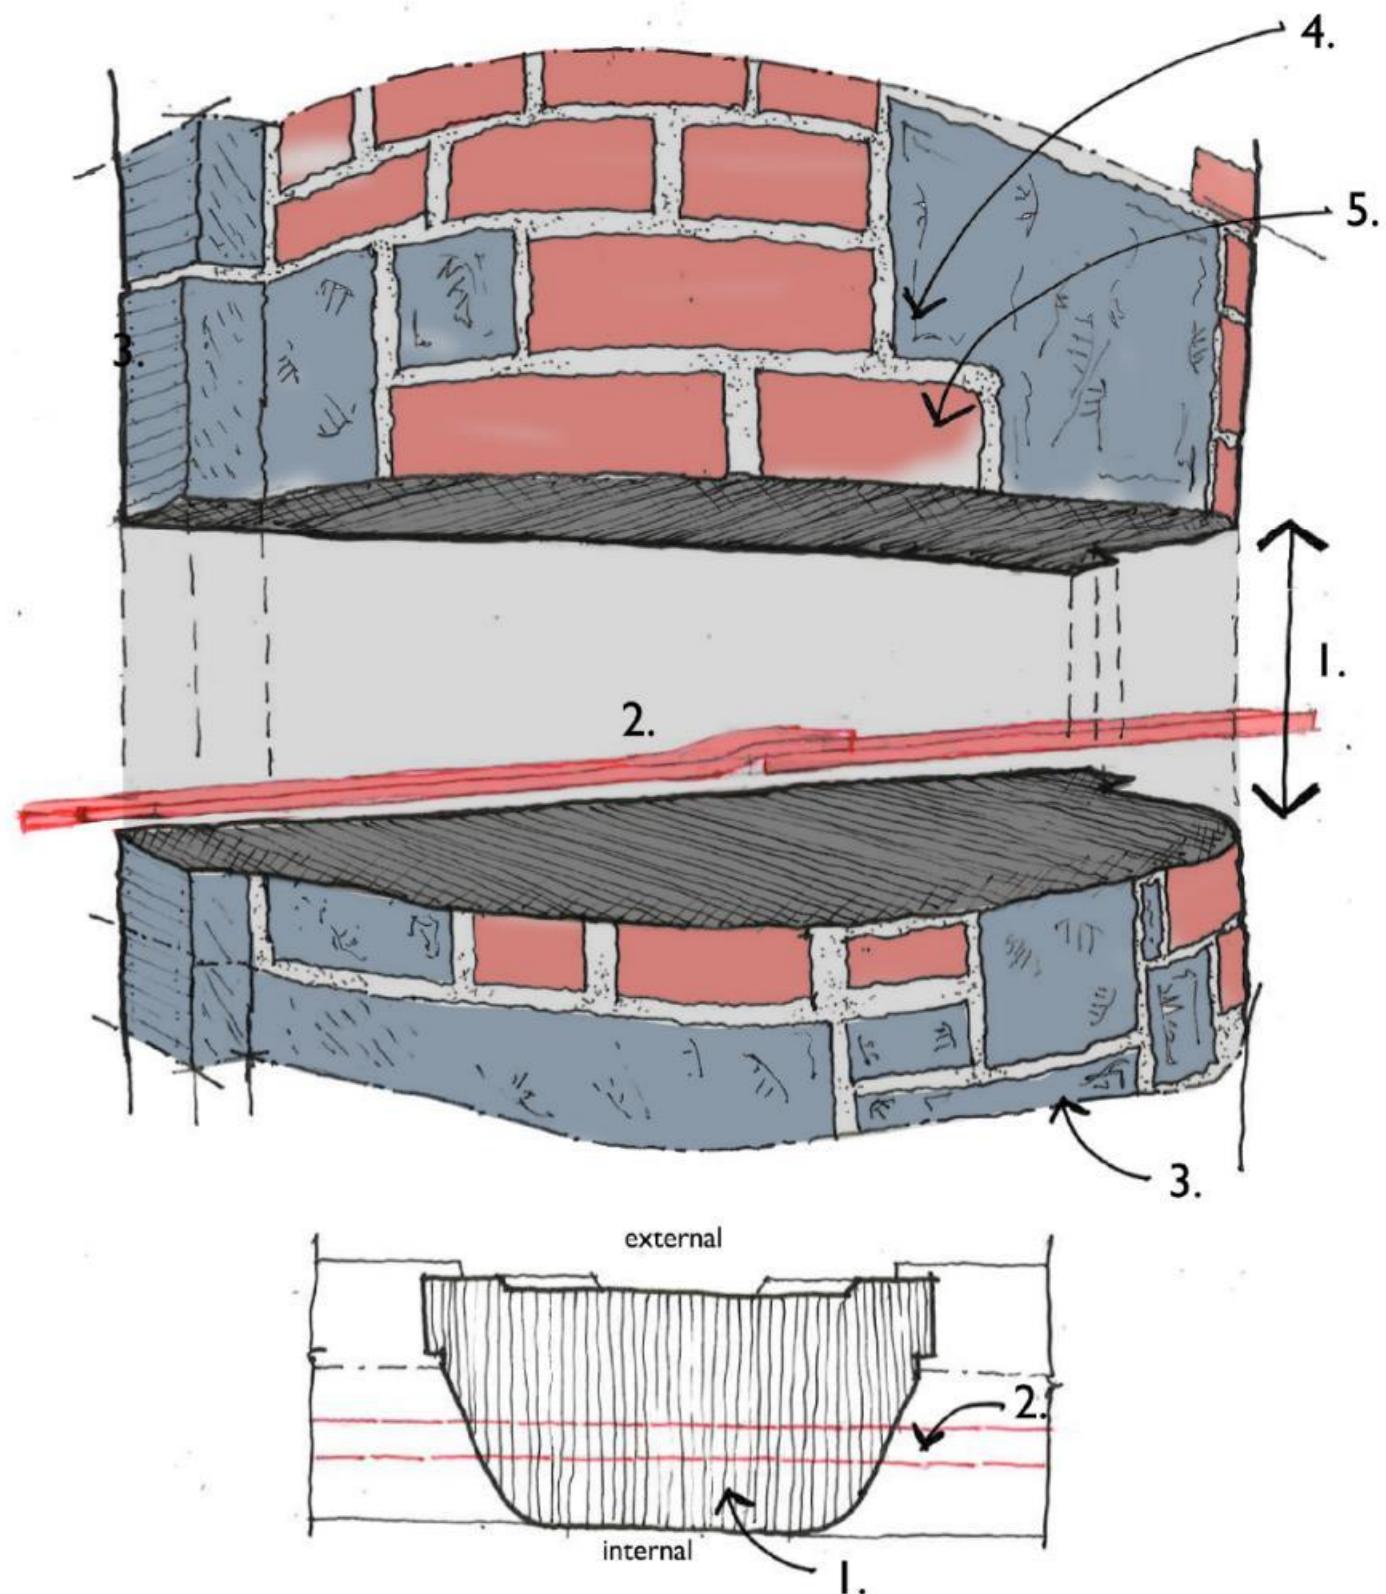
TOTAL OPENING UP: SE REPAIR Type 1

This degree of opening up and the subsequent propping of retained masonry above is shown as a worst-case scenario. The objective is to minimise the extent of opening up while enabling the complete removal of the iron band and reinstatement of masonry.

1. Section of masonry completely opened up with upper section temporarily supported.
2. Whole iron band exposed to permit removal.
3. Bottom extent of takedown to stop at soonest point of stability. This may not be a level plane as illustrated.
4. Upper extent of opening to work to solid and ideally substantial masonry units to avoid instability in the course of the reinstatement works.
5. Sound and well bonded masonry to be retained.

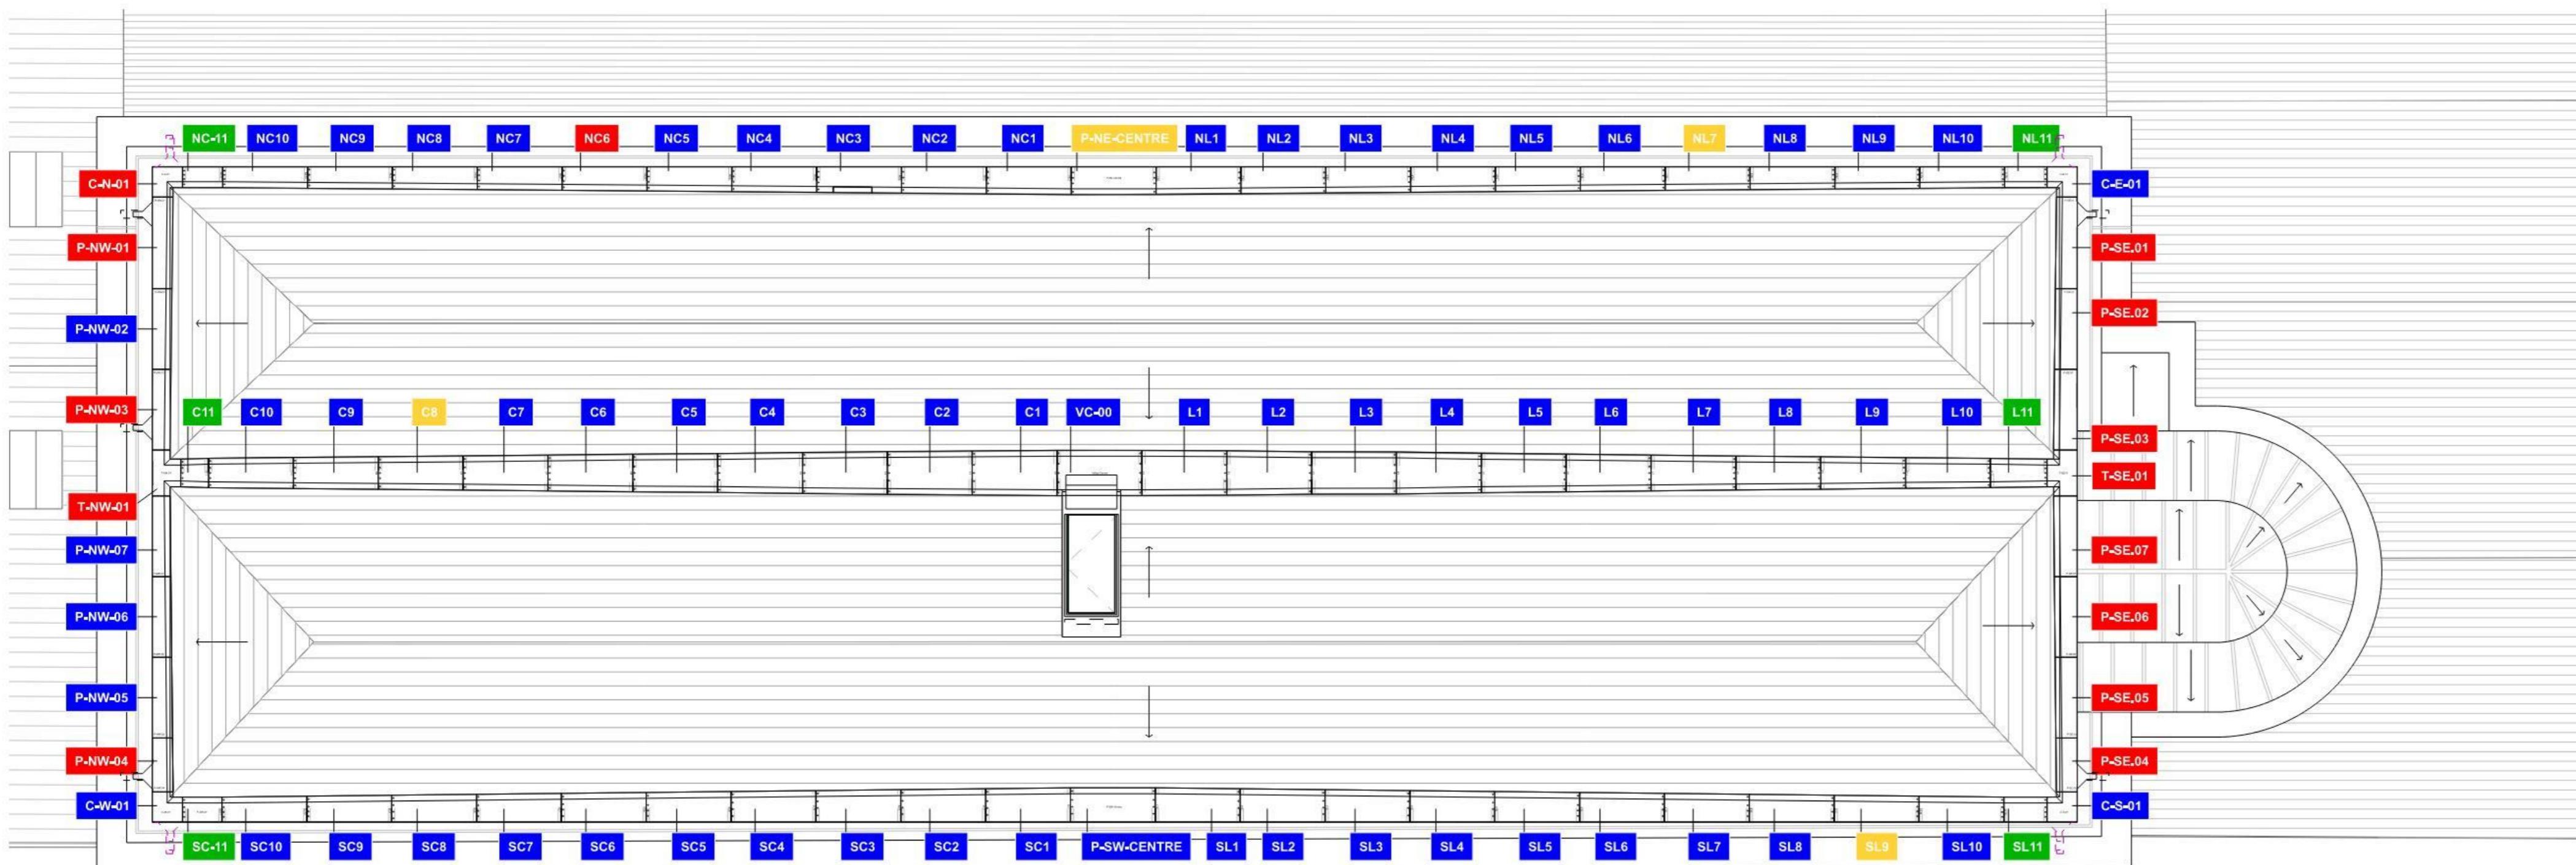
01 Gutter Overhaul/Removal/Replacement Strategy Plan

Replace due to failure or design

Provisional replacement based on in-situ assessment

Provisional / Adaption to suit movement joint assembly

Overhaul
