Appendix 19-1 Asbestos Survey Report

## ASBESTOS SURVEY REPORT

**Location: The Cleeves Site,  
North Circular Road, Limerick**

**Report No. PE24-1226**

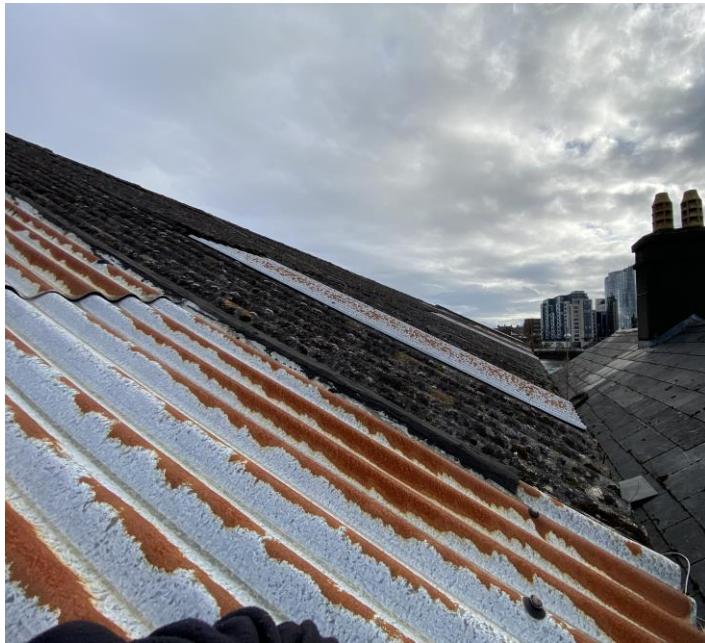
Created By	Andrew Hickey
Date	12th November 2024
Site Details	The Cleeves Site, North Circular Road, Limerick
Client Name	Limerick Twenty Thirty Strategic Development DAC
Survey Type	R/D Asbestos Survey
Site Ref	PE 24-1226
Building Ref.	Building 9
Location	Roof
Extent/ Amount	305 m <sup>2</sup> approx. floor area

Survey Date	6.11.2024	Sample No.	BS 222528
Survey Company	Phoenix Environmental Safety Ltd.		
Testing Laboratory.	G & L Consultancy Ltd.

MATERIAL ASSESSMENT		PRIORITY ASSESSMENT	
Product type	Cement sheeting	Normal occupant activity	N/A
Extent of damage	Medium	Likelihood of disturbance	N/A
Surface treatment	None	Human exposure potential	N/A
Asbestos type	Chrysotile	Maintenance activity	N/A
Material assessment score: N/A		TOTAL SCORE: N/A	Priority assessment score: N/A

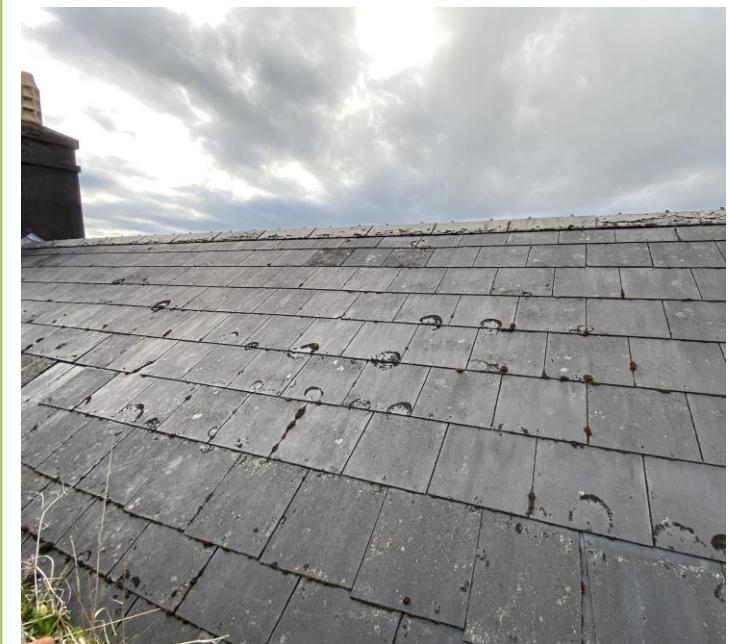
Created By	Andrew Hickey
Date	12th November 2024
Site Details	The Cleeves Site, North Circular Road, Limerick
Client Name	Limerick Twenty Thirty Strategic Development DAC
Survey Type	R/D Asbestos Survey
Site Ref	PE 24-1226
Building Ref.	Building 9
Location	Side roof & rear porch area
Extent/ Amount	70 m <sup>2</sup> approx. floor area

Survey Date	6.11.2024	Sample No.	BS 222529
Survey Company	Phoenix Environmental Safety Ltd.		
Testing Laboratory.	G & L Consultancy Ltd.

MATERIAL ASSESSMENT		PRIORITY ASSESSMENT	
Product type	Cement slates	Normal occupant activity	N/A
Extent of damage	Medium	Likelihood of disturbance	N/A
Surface treatment	None	Human exposure potential	N/A
Asbestos type	Chrysotile & Crocidolite	Maintenance activity	N/A
Material assessment score: N/A		TOTAL SCORE: N/A	Priority assessment score: N/A

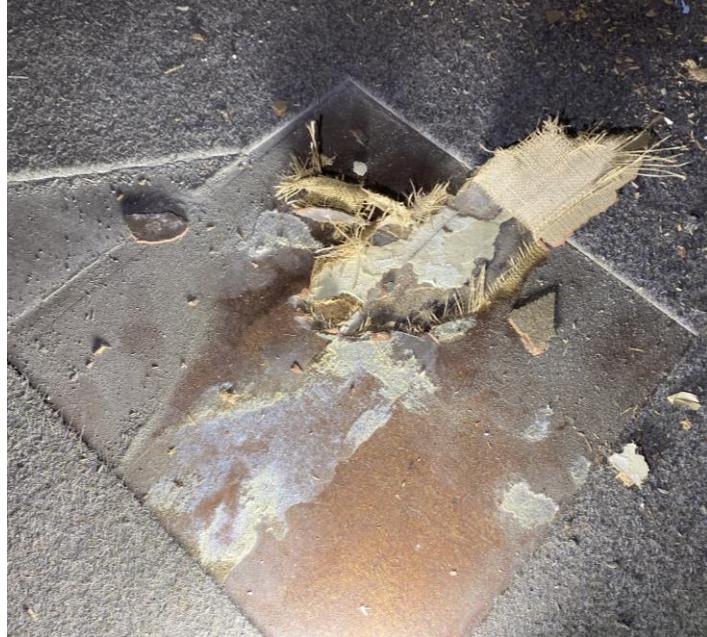
Created By	Andrew Hickey
Date	12th November 2024
Site Details	The Cleeves Site, North Circular Road, Limerick
Client Name	Limerick Twenty Thirty Strategic Development DAC
Survey Type	R/D Asbestos Survey
Site Ref	PE 24-1226
Building Ref.	Building 9
Location	Main office area
Extent/ Amount	75 m <sup>2</sup> approx.

Survey Date	6.11.2024	Sample No.	BS 222533
Survey Company	Phoenix Environmental Safety Ltd.		
Testing Laboratory.	G & L Consultancy Ltd.

MATERIAL ASSESSMENT		PRIORITY ASSESSMENT	
Product type	Paper	Normal occupant activity	N/A
Extent of damage	Medium	Likelihood of disturbance	N/A
Surface treatment	Covered with Marmoleum	Human exposure potential	N/A
Asbestos type	Chrysotile	Maintenance activity	N/A
Material assessment score: N/A		TOTAL SCORE: N/A	Priority assessment score: N/A

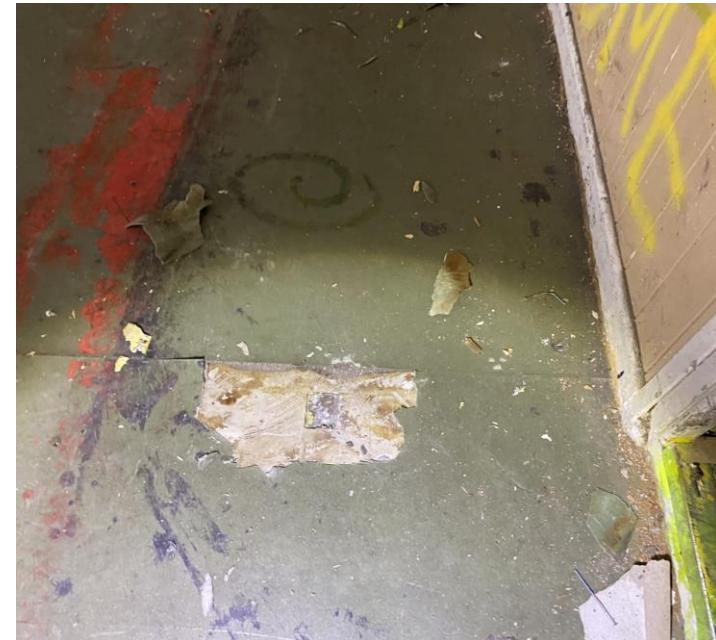
Created By	Andrew Hickey
Date	12th November 2024
Site Details	The Cleeves Site, North Circular Road, Limerick
Client Name	Limerick Twenty Thirty Strategic Development DAC
Survey Type	R/D Asbestos Survey
Site Ref	PE 24-1226
Building Ref.	Building 9
Location	Office and lobby area
Extent/ Amount	50 m <sup>2</sup> approx.

Survey Date: 6.11.2024      Sample No.: BS 222534  
Survey Company: Phoenix Environmental Safety Ltd.  
Testing Laboratory: G & L Consultancy Ltd.

MATERIAL ASSESSMENT		PRIORITY ASSESSMENT	
Product type	Floor tiles	Normal occupant activity	N/A
Extent of damage	Medium	Likelihood of disturbance	N/A
Surface treatment	Composite material	Human exposure potential	N/A
Asbestos type	Chrysotile	Maintenance activity	N/A
Material assessment score: N/A		TOTAL SCORE: N/A	Priority assessment score: N/A

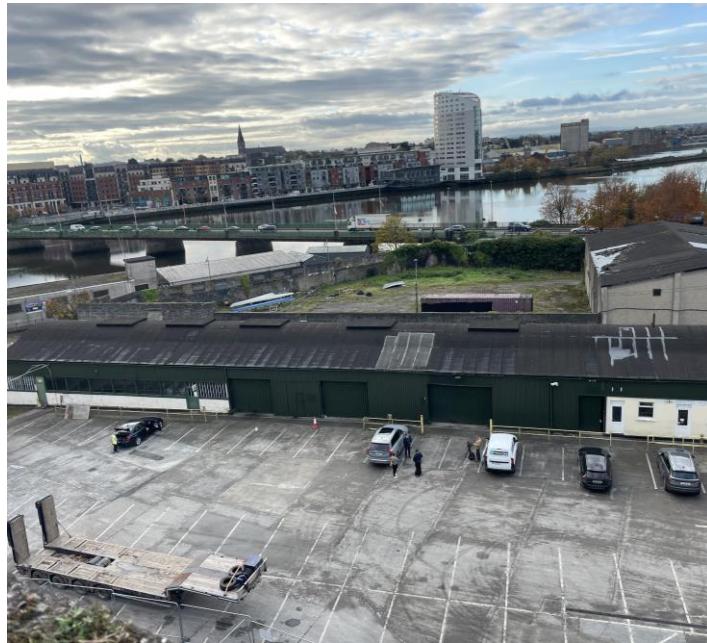
Created By	Andrew Hickey
Date	12th November 2024
Site Details	The Cleeves Site, North Circular Road, Limerick
Client Name	Limerick Twenty Thirty Strategic Development DAC
Survey Type	R/D Asbestos Survey
Site Ref	PE 24-1226
Building Ref.	Building 10
Location	Roof
Extent/ Amount	700 m <sup>2</sup> approx. floor area

Survey Date	6.11.2024	Sample No.	BS 222535
Survey Company	Phoenix Environmental Safety Ltd.		
Testing Laboratory.	G & L Consultancy Ltd.

MATERIAL ASSESSMENT		PRIORITY ASSESSMENT	
Product type	Felt	Normal occupant activity	N/A
Extent of damage	Low	Likelihood of disturbance	N/A
Surface treatment	Well bound material	Human exposure potential	N/A
Asbestos type	Chrysotile	Maintenance activity	N/A
Material assessment score: N/A		TOTAL SCORE: N/A	Priority assessment score: N/A

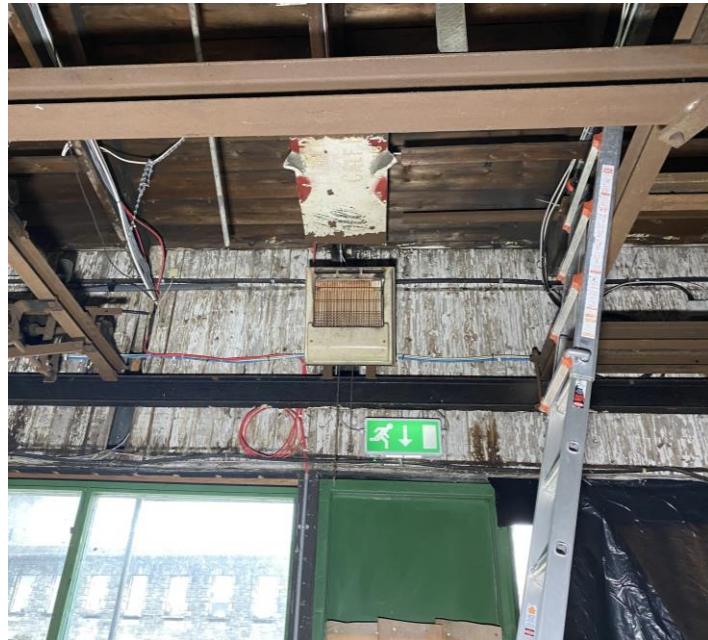
Created By	Andrew Hickey
Date	12th November 2024
Site Details	The Cleeves Site, North Circular Road, Limerick
Client Name	Limerick Twenty Thirty Strategic Development DAC
Survey Type	R/D Asbestos Survey
Site Ref	PE 24-1226
Building Ref.	Building 10
Location	High level
Extent/ Amount	Over 2 high heaters & on 1 timber truss

Survey Date	6.11.2024	Sample No.	BS 222537
Survey Company	Phoenix Environmental Safety Ltd.		
Testing Laboratory.	G & L Consultancy Ltd.

MATERIAL ASSESSMENT		PRIORITY ASSESSMENT	
Product type	Millboard	Normal occupant activity	N/A
Extent of damage	High	Likelihood of disturbance	N/A
Surface treatment	None	Human exposure potential	N/A
Asbestos type	Chrysotile	Maintenance activity	N/A
Material assessment score: N/A		TOTAL SCORE: N/A	Priority assessment score: N/A

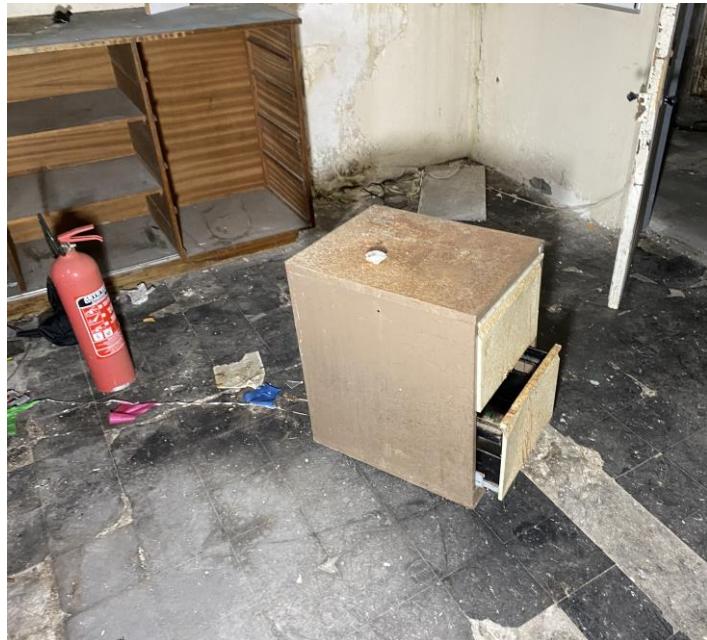
Created By	Andrew Hickey
Date	12th November 2024
Site Details	The Cleeves Site, North Circular Road, Limerick
Client Name	Limerick Twenty Thirty Strategic Development DAC
Survey Type	R/D Asbestos Survey
Site Ref	PE 24-1226
Building Ref.	Building 10
Location	Storeroom
Extent/ Amount	20 m <sup>2</sup> approx.

Survey Date: 6.11.2024      Sample No.: BS 222536  
Survey Company: Phoenix Environmental Safety Ltd.  
Testing Laboratory: G & L Consultancy Ltd.

MATERIAL ASSESSMENT		PRIORITY ASSESSMENT	
Product type	Floor tiles and bitumen adhesive	Normal occupant activity	N/A
Extent of damage	Medium	Likelihood of disturbance	N/A
Surface treatment	Composite & well bound material	Human exposure potential	N/A
Asbestos type	Chrysotile	Maintenance activity	N/A
Material assessment score: N/A		TOTAL SCORE: N/A	Priority assessment score: N/A

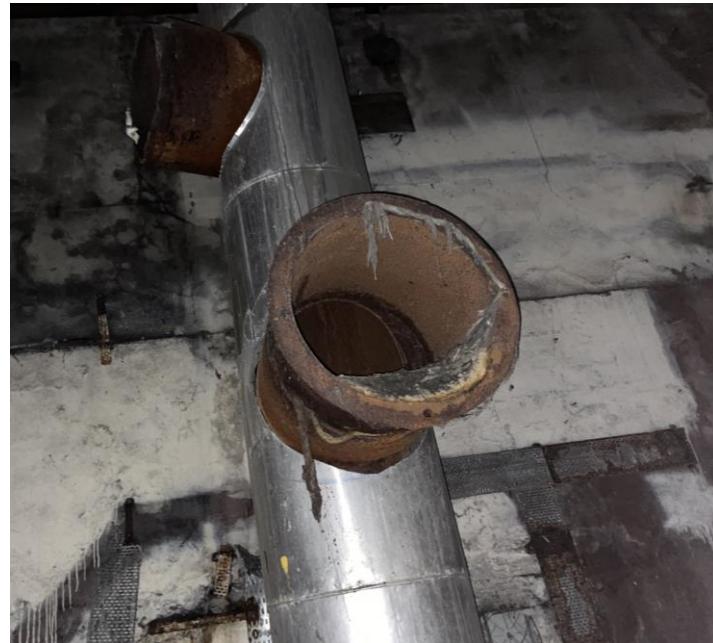
Created By	Andrew Hickey
Date	12th November 2024
Site Details	The Cleeves Site, North Circular Road, Limerick
Client Name	Limerick Twenty Thirty Strategic Development DAC
Survey Type	R/D Asbestos Survey
Site Ref	PE 24-1226
Building Ref.	Building 11
Location	Boiler room
Extent/ Amount	Around flue pipe

Survey Date	6.11.2024	Sample No.	BS 222539
Survey Company	Phoenix Environmental Safety Ltd.		
Testing Laboratory.	G & L Consultancy Ltd.

MATERIAL ASSESSMENT		PRIORITY ASSESSMENT	
Product type	Rope seals	Normal occupant activity	N/A
Extent of damage	High	Likelihood of disturbance	N/A
Surface treatment	Unsealed	Human exposure potential	N/A
Asbestos type	Chrysotile	Maintenance activity	N/A
Material assessment score: N/A		TOTAL SCORE: N/A	Priority assessment score: N/A

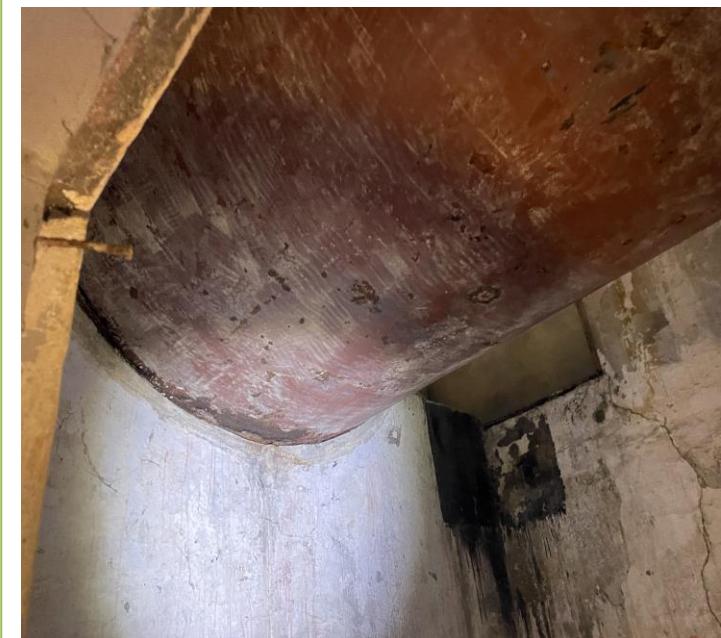
Created By	Andrew Hickey
Date	12th November 2024
Site Details	The Cleeves Site, North Circular Road, Limerick
Client Name	Limerick Twenty Thirty Strategic Development DAC
Survey Type	R/D Asbestos Survey
Site Ref	PE 24-1226
Building Ref.	Building 11
Location	Boiler room
Extent/ Amount	Throughout

Survey Date	6.11.2024	Sample No.	BS 222541
Survey Company	Phoenix Environmental Safety Ltd.		
Testing Laboratory.	G & L Consultancy Ltd.

MATERIAL ASSESSMENT		PRIORITY ASSESSMENT	
Product type	Thermal insulation residue	Normal occupant activity	N/A
Extent of damage	High	Likelihood of disturbance	N/A
Surface treatment	Unsealed	Human exposure potential	N/A
Asbestos type	Amosite	Maintenance activity	N/A
Material assessment score: N/A		TOTAL SCORE: N/A	Priority assessment score: N/A

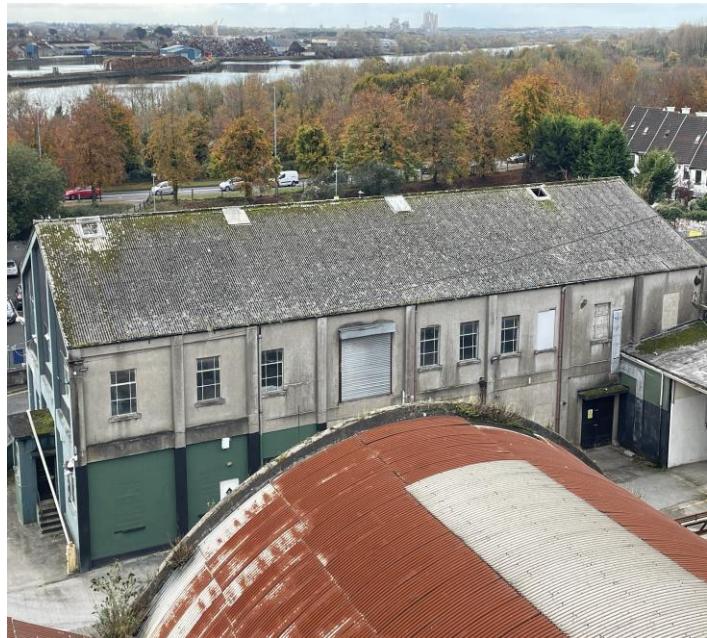
Created By	Andrew Hickey
Date	12th November 2024
Site Details	The Cleeves Site, North Circular Road, Limerick
Client Name	Limerick Twenty Thirty Strategic Development DAC
Survey Type	R/D Asbestos Survey
Site Ref	PE 24-1226
Building Ref.	Building 12
Location	Roof
Extent/ Amount	650 m <sup>2</sup> approx.

Survey Date	6.11.2024	Sample No.	BS 222545
Survey Company	Phoenix Environmental Safety Ltd.		
Testing Laboratory.	G & L Consultancy Ltd.

MATERIAL ASSESSMENT		PRIORITY ASSESSMENT	
Product type	Cement sheeting	Normal occupant activity	N/A
Extent of damage	Medium	Likelihood of disturbance	N/A
Surface treatment	Cement	Human exposure potential	N/A
Asbestos type	Chrysotile & Crocidolite	Maintenance activity	N/A
Material assessment score: N/A		TOTAL SCORE: N/A	Priority assessment score: N/A

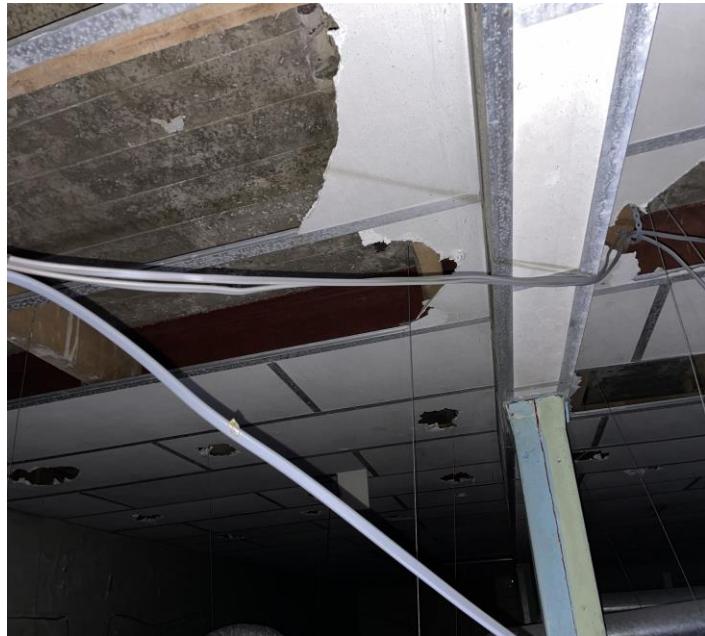
Created By	Andrew Hickey
Date	12th November 2024
Site Details	The Cleeves Site, North Circular Road, Limerick
Client Name	Limerick Twenty Thirty Strategic Development DAC
Survey Type	R/D Asbestos Survey
Site Ref	PE 24-1226
Building Ref.	Building 12
Location	Ceiling
Extent/ Amount	440 m <sup>2</sup> approx.

Survey Date	6.11.2024	Sample No.	BS 222546
Survey Company	Phoenix Environmental Safety Ltd.		
Testing Laboratory.	G & L Consultancy Ltd.

MATERIAL ASSESSMENT		PRIORITY ASSESSMENT	
Product type	Insulation board	Normal occupant activity	N/A
Extent of damage	Medium	Likelihood of disturbance	N/A
Surface treatment	Composite & well bound material	Human exposure potential	N/A
Asbestos type	Chrysotile & Amosite	Maintenance activity	N/A
Material assessment score: N/A		TOTAL SCORE: N/A	Priority assessment score: N/A

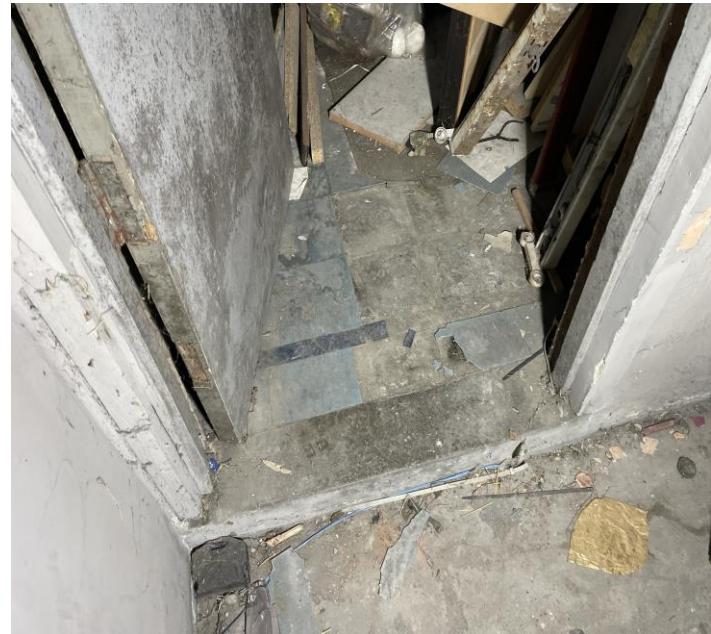
Created By	Andrew Hickey
Date	12th November 2024
Site Details	The Cleeves Site, North Circular Road, Limerick
Client Name	Limerick Twenty Thirty Strategic Development DAC
Survey Type	R/D Asbestos Survey
Site Ref	PE 24-1226
Building Ref.	Building 12
Location	Storeroom
Extent/ Amount	10 m <sup>2</sup> approx.

Survey Date	6.11.2024	Sample No.	BS 222549
Survey Company	Phoenix Environmental Safety Ltd.		
Testing Laboratory.	G & L Consultancy Ltd.

MATERIAL ASSESSMENT		PRIORITY ASSESSMENT	
Product type	Floor tiles and bitumen adhesive	Normal occupant activity	N/A
Extent of damage	Medium	Likelihood of disturbance	N/A
Surface treatment	Composite & well bound material	Human exposure potential	N/A
Asbestos type	Chrysotile	Maintenance activity	N/A
Material assessment score: N/A		TOTAL SCORE: N/A	Priority assessment score: N/A

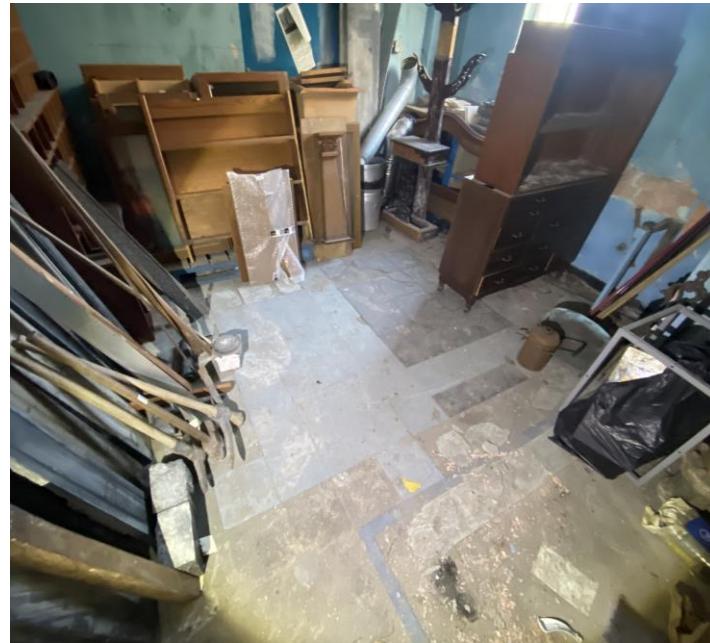
Created By	Andrew Hickey
Date	12th November 2024
Site Details	The Cleeves Site, North Circular Road, Limerick
Client Name	Limerick Twenty Thirty Strategic Development DAC
Survey Type	R/D Asbestos Survey
Site Ref	PE 24-1226
Building Ref.	Building 13
Location	Roof
Extent/ Amount	20 m <sup>2</sup> approx.

Survey Date	6.11.2024	Sample No.	BS 222550
Survey Company	Phoenix Environmental Safety Ltd.		
Testing Laboratory.	G & L Consultancy Ltd.

MATERIAL ASSESSMENT		PRIORITY ASSESSMENT	
Product type	Floor tiles	Normal occupant activity	N/A
Extent of damage	Medium	Likelihood of disturbance	N/A
Surface treatment	Composite material	Human exposure potential	N/A
Asbestos type	Chrysotile	Maintenance activity	N/A
Material assessment score: N/A		TOTAL SCORE: N/A	Priority assessment score: N/A

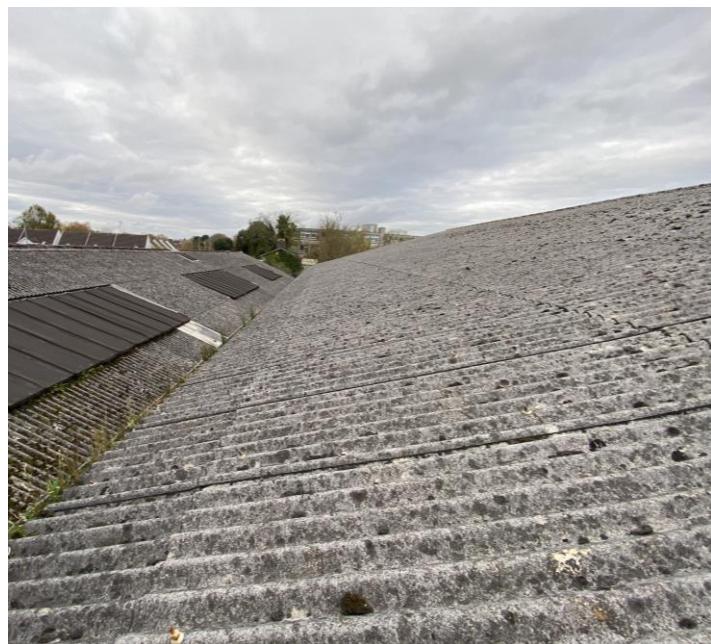
Created By	Andrew Hickey
Date	12th November 2024
Site Details	The Cleeves Site, North Circular Road, Limerick
Client Name	Limerick Twenty Thirty Strategic Development DAC
Survey Type	R/D Asbestos Survey
Site Ref	PE 24-1226
Building Ref.	Building 14
Location	Roof
Extent/ Amount	900 m <sup>2</sup> approx. floor area

Survey Date	6.11.2024	Sample No.	BS 222551
Survey Company	Phoenix Environmental Safety Ltd.		
Testing Laboratory.	G & L Consultancy Ltd.

MATERIAL ASSESSMENT		PRIORITY ASSESSMENT	
Product type	Cement sheeting	Normal occupant activity	N/A
Extent of damage	Weathered	Likelihood of disturbance	N/A
Surface treatment	None	Human exposure potential	N/A
Asbestos type	Chrysotile	Maintenance activity	N/A
Material assessment score: N/A		TOTAL SCORE: N/A	Priority assessment score: N/A

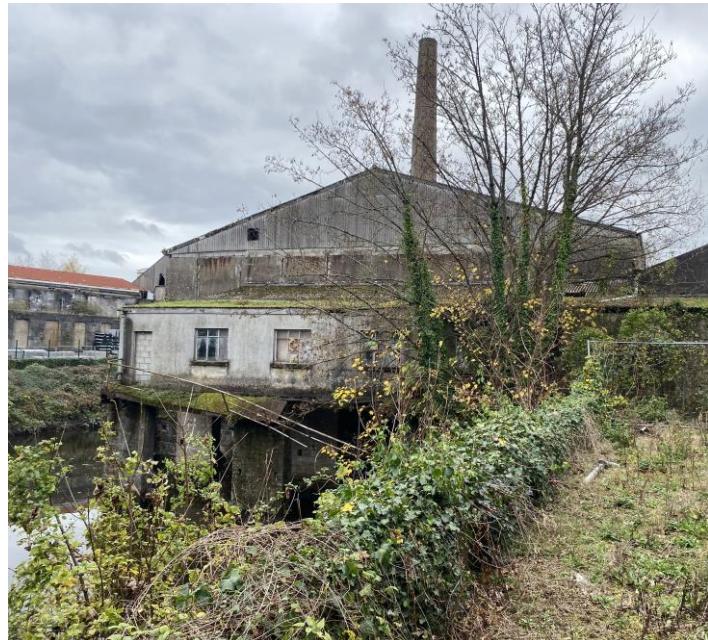
Created By	Andrew Hickey
Date	12th November 2024
Site Details	The Cleeves Site, North Circular Road, Limerick
Client Name	Limerick Twenty Thirty Strategic Development DAC
Survey Type	R/D Asbestos Survey
Site Ref	PE 24-1226
Building Ref.	Building 14
Location	Roof
Extent/ Amount	175 m <sup>2</sup> approx. floor area

Survey Date	6.11.2024	Sample No.	BS 222552
Survey Company	Phoenix Environmental Safety Ltd.		
Testing Laboratory.	G & L Consultancy Ltd.

MATERIAL ASSESSMENT		PRIORITY ASSESSMENT	
Product type	Cement sheeting	Normal occupant activity	N/A
Extent of damage	Medium	Likelihood of disturbance	N/A
Surface treatment	None	Human exposure potential	N/A
Asbestos type	Chrysotile & Crocidolite	Maintenance activity	N/A
Material assessment score: N/A		TOTAL SCORE: N/A	Priority assessment score: N/A

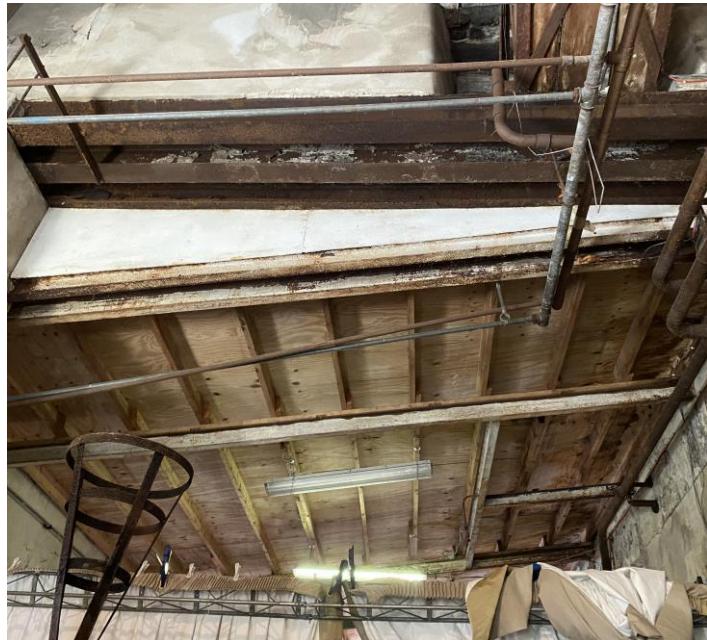
Created By	Andrew Hickey
Date	12th November 2024
Site Details	The Cleeves Site, North Circular Road, Limerick
Client Name	Limerick Twenty Thirty Strategic Development DAC
Survey Type	R/D Asbestos Survey
Site Ref	PE 24-1226
Building Ref.	Building 14
Location	Ceiling
Extent/ Amount	5 linear meters approx.

Survey Date	6.11.2024	Sample No.	N/A
Survey Company	Phoenix Environmental Safety Ltd.		
Testing Laboratory.	G & L Consultancy Ltd.

MATERIAL ASSESSMENT		PRIORITY ASSESSMENT	
Product type	Insulation board	Normal occupant activity	N/A
Extent of damage	Low	Likelihood of disturbance	N/A
Surface treatment	None	Human exposure potential	N/A
Asbestos type	Crocidolite (presumed)	Maintenance activity	N/A
Material assessment score: N/A		TOTAL SCORE: N/A	Priority assessment score: N/A

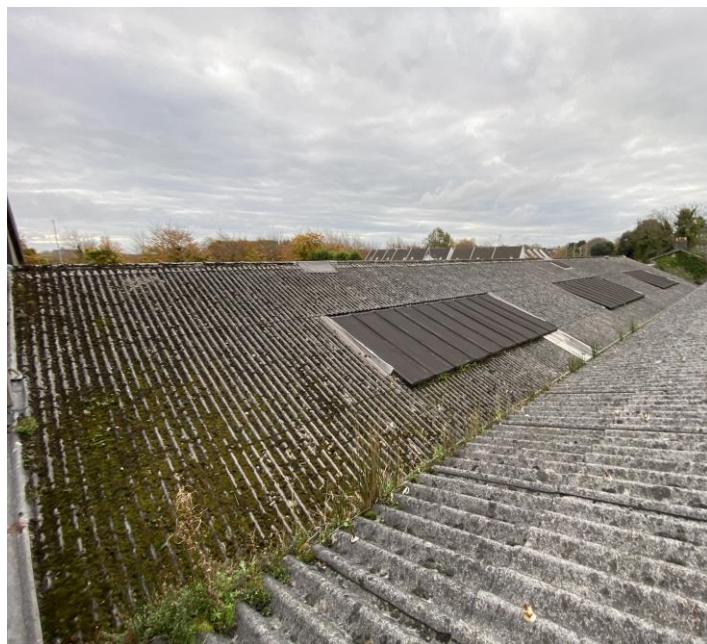
Created By	Andrew Hickey
Date	12th November 2024
Site Details	The Cleeves Site, North Circular Road, Limerick
Client Name	Limerick Twenty Thirty Strategic Development DAC
Survey Type	R/D Asbestos Survey
Site Ref	PE 24-1226
Building Ref.	Building 15
Location	Roof
Extent/ Amount	565 m <sup>2</sup> approx. floor area

MATERIAL ASSESSMENT		PRIORITY ASSESSMENT	
Product type	Cement sheeting	Normal occupant activity	N/A
Extent of damage	Weathered	Likelihood of disturbance	N/A
Surface treatment	None	Human exposure potential	N/A
Asbestos type	Chrysotile	Maintenance activity	N/A
Material assessment score: N/A		TOTAL SCORE: N/A	Priority assessment score: N/A

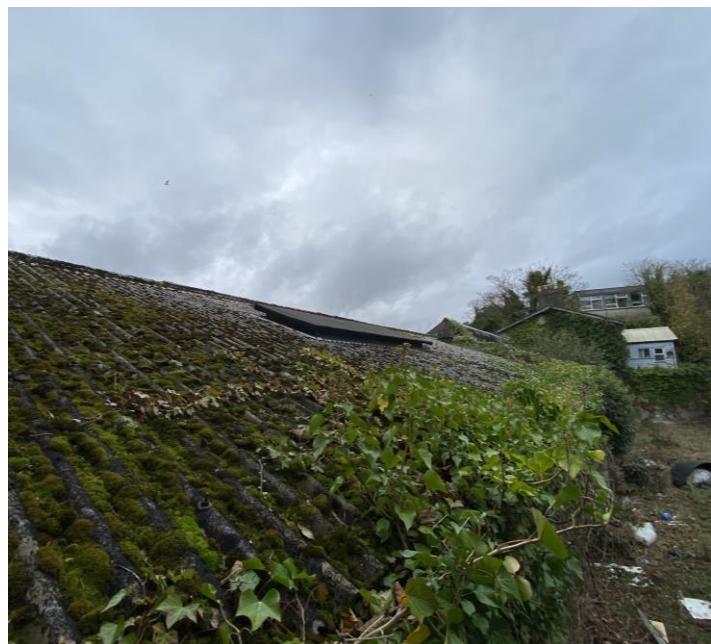
Created By	Andrew Hickey
Date	12 <sup>th</sup> November 2024
Site Details	The Cleeves Site, North Circular Road, Limerick
Client Name	Limerick Twenty Thirty Strategic Development DAC
Survey Type	R/D Asbestos Survey
Site Ref	PE 24-1226
Building Ref.	Building 16
Location	Roof
Extent/ Amount	165 m <sup>2</sup> approx.

MATERIAL ASSESSMENT		PRIORITY ASSESSMENT	
Product type	Cement sheeting	Normal occupant activity	N/A
Extent of damage	Medium	Likelihood of disturbance	N/A
Surface treatment	None	Human exposure potential	N/A
Asbestos type	Chrysotile & Crocidolite	Maintenance activity	N/A
Material assessment score: N/A		TOTAL SCORE: N/A	Priority assessment score: N/A

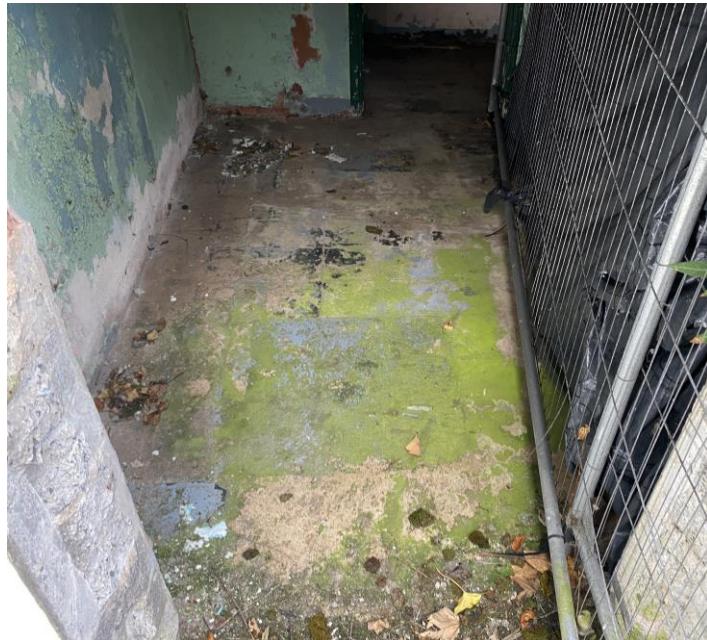
Created By	Andrew Hickey
Date	12th November 2024
Site Details	The Cleeves Site, North Circular Road, Limerick
Client Name	Limerick Twenty Thirty Strategic Development DAC
Survey Type	R/D Asbestos Survey
Site Ref	PE 24-1226
Building Ref.	Building 16
Location	Rear entrance area
Extent/ Amount	40 m <sup>2</sup> approx.

MATERIAL ASSESSMENT		PRIORITY ASSESSMENT	
Product type	Floor tiles and bitumen adhesive	Normal occupant activity	N/A
Extent of damage	High	Likelihood of disturbance	N/A
Surface treatment	Composite & well bound material	Human exposure potential	N/A
Asbestos type	Chrysotile	Maintenance activity	N/A
Material assessment score: N/A		TOTAL SCORE: N/A	Priority assessment score: N/A

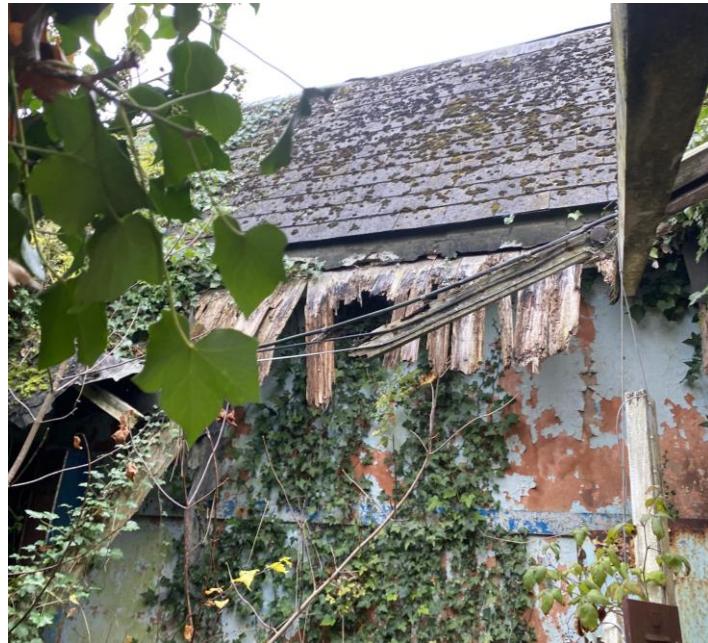
Created By	Andrew Hickey
Date	12th November 2024
Site Details	The Cleeves Site, North Circular Road, Limerick
Client Name	Limerick Twenty Thirty Strategic Development DAC
Survey Type	R/D Asbestos Survey
Site Ref	PE 24-1226
Building Ref.	Building 17
Location	Rear pitch of the roof
Extent/ Amount	50 m <sup>2</sup> approx. floor area

MATERIAL ASSESSMENT		PRIORITY ASSESSMENT	
Product type	Cement slates	Normal occupant activity	N/A
Extent of damage	Medium	Likelihood of disturbance	N/A
Surface treatment	None	Human exposure potential	N/A
Asbestos type	Chrysotile & Crocidolite	Maintenance activity	N/A
Material assessment score: N/A		TOTAL SCORE: N/A	Priority assessment score: N/A

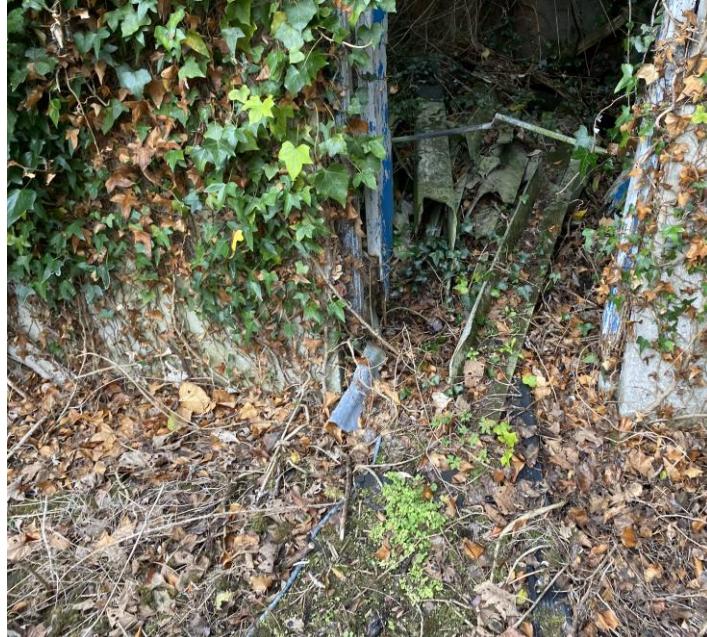
Created By	Andrew Hickey
Date	12th November 2024
Site Details	The Cleeves Site, North Circular Road, Limerick
Client Name	Limerick Twenty Thirty Strategic Development DAC
Survey Type	R/D Asbestos Survey
Site Ref	PE 24-1226
Building Ref.	Building 17
Location	Rear extension
Extent/ Amount	Not quantified

MATERIAL ASSESSMENT		PRIORITY ASSESSMENT	
Product type	Cement gutter & associated debris	Normal occupant activity	N/A
Extent of damage	High	Likelihood of disturbance	N/A
Surface treatment	None	Human exposure potential	N/A
Asbestos type	Chrysotile	Maintenance activity	N/A
Material assessment score: N/A		TOTAL SCORE: N/A	Priority assessment score: N/A

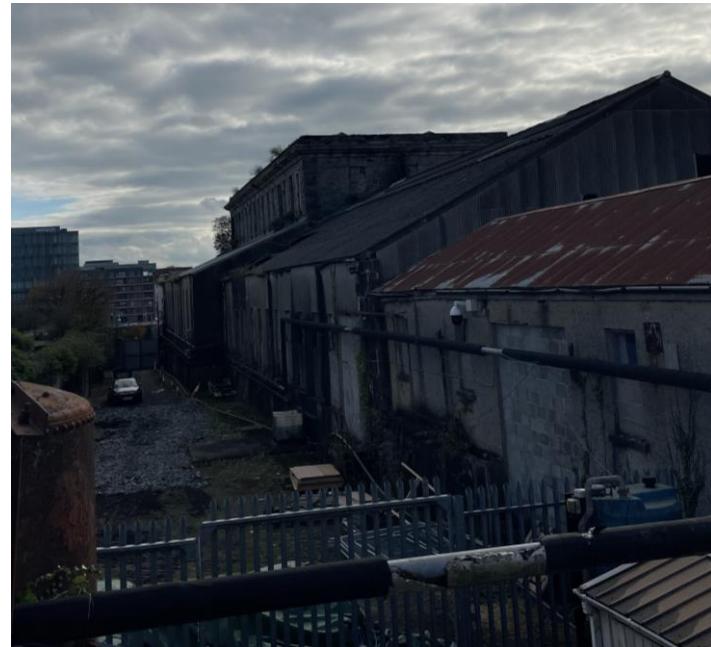
Created By	Andrew Hickey
Date	12th November 2024
Site Details	The Cleeves Site, North Circular Road, Limerick
Client Name	Limerick Twenty Thirty Strategic Development DAC
Survey Type	R/D Asbestos Survey
Site Ref	PE 24-1226
Building Ref.	Throughout site
Location	Roof areas
Extent/ Amount	Not quantified

MATERIAL ASSESSMENT		PRIORITY ASSESSMENT	
Product type	Cement gutters and downpipes	Normal occupant activity	N/A
Extent of damage	High	Likelihood of disturbance	N/A
Surface treatment	Cement	Human exposure potential	N/A
Asbestos type	Chrysotile & Amosite	Maintenance activity	N/A
Material assessment score: N/A		TOTAL SCORE: N/A	Priority assessment score: N/A

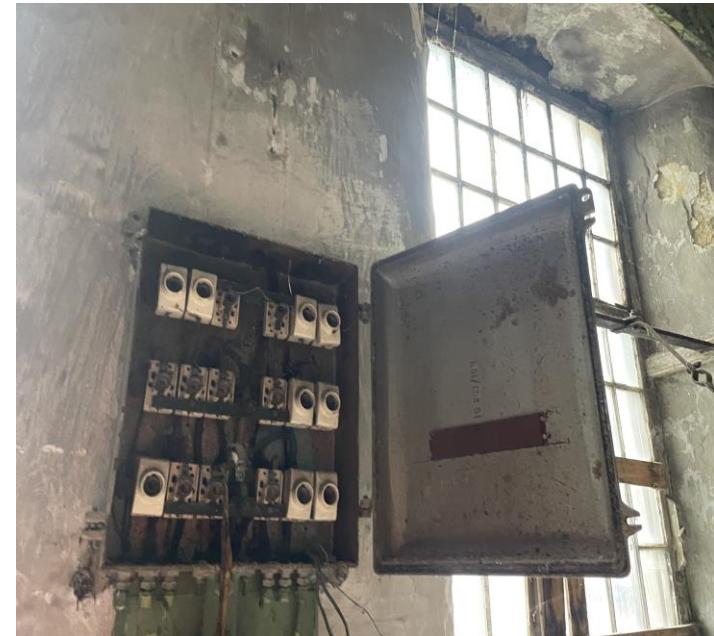
Created By	Andrew Hickey
Date	12th November 2024
Site Details	The Cleeves Site, North Circular Road, Limerick
Client Name	Limerick Twenty Thirty Strategic Development DAC
Survey Type	R/D Asbestos Survey
Site Ref	PE 24-1226
Building Ref.	Throughout site
Location	Old electrical boxes
Extent/ Amount	Doors of the electrical units

MATERIAL ASSESSMENT		PRIORITY ASSESSMENT	
Product type	Rope seals	Normal occupant activity	N/A
Extent of damage	Medium	Likelihood of disturbance	N/A
Surface treatment	None	Human exposure potential	N/A
Asbestos type	Chrysotile	Maintenance activity	N/A
Material assessment score: N/A		TOTAL SCORE: N/A	Priority assessment score: N/A

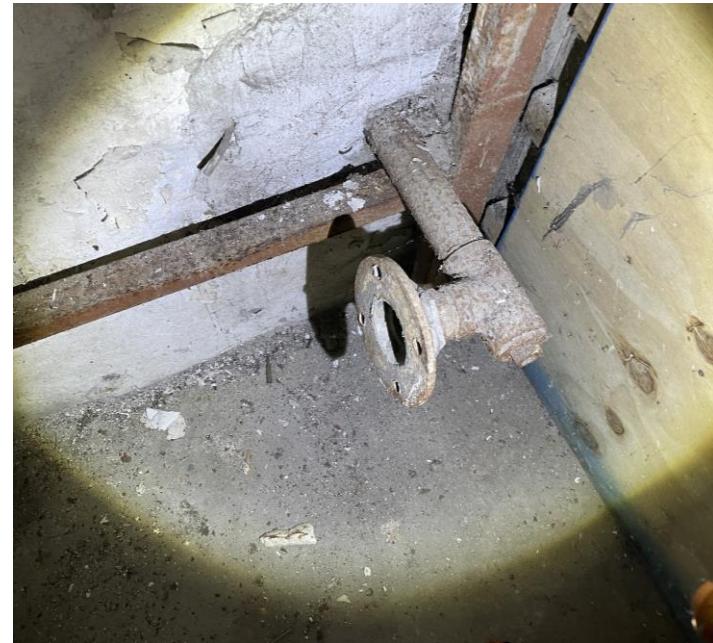
Created By	Andrew Hickey
Date	12th November 2024
Site Details	The Cleeves Site, North Circular Road, Limerick
Client Name	Limerick Twenty Thirty Strategic Development DAC
Survey Type	R/D Asbestos Survey
Site Ref	PE 24-1226
Building Ref.	Throughout site
Location	Pipework flanges
Extent/ Amount	1 per flange

MATERIAL ASSESSMENT	PRIORITY ASSESSMENT
Product type	CAF Gasket	Normal occupant activity
Extent of damage	Medium	Likelihood of disturbance
Surface treatment	None	Human exposure potential
Asbestos type	Chrysotile	Maintenance activity
Material assessment score: N/A		TOTAL SCORE: N/A
		Priority assessment score: N/A

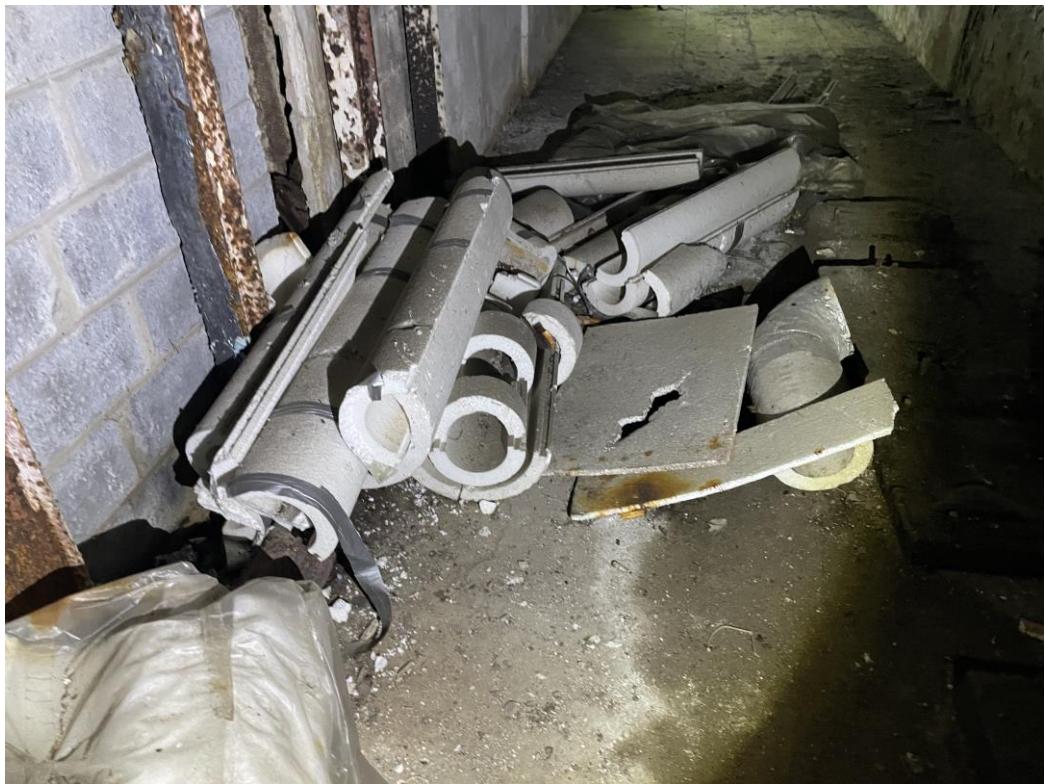
Pipework insulation in building 1

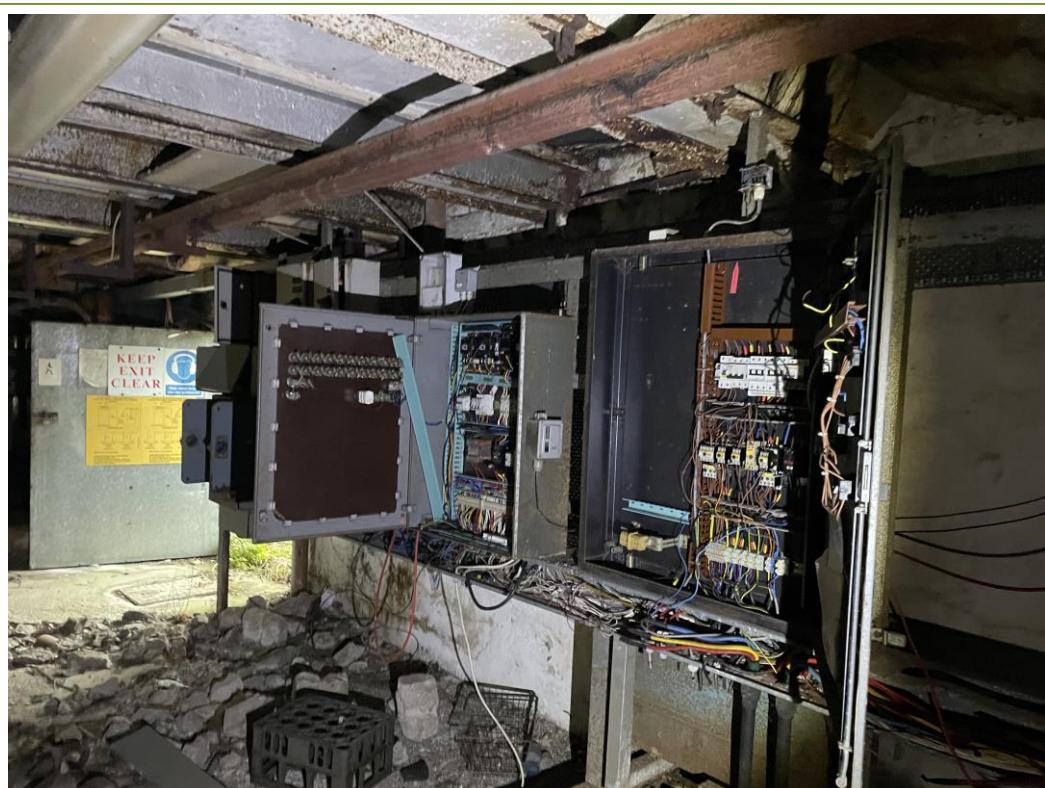
Spark arrestors and backing boards on redundant electrics in building 2

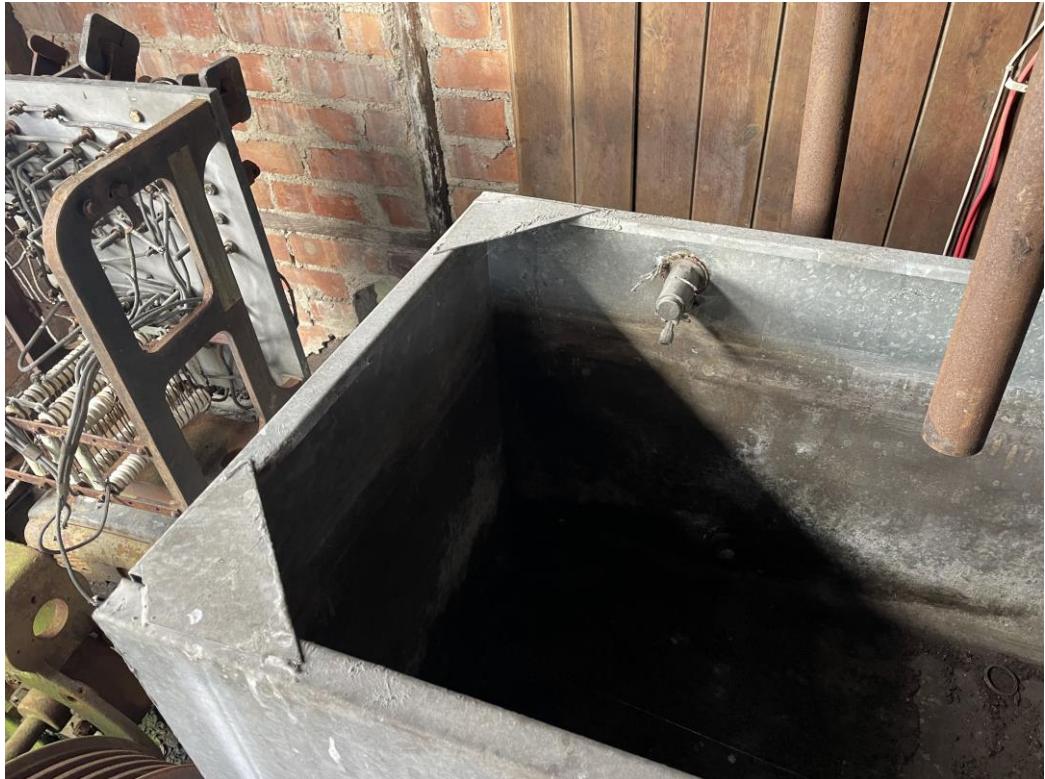
Rope on the tank in the attic in building 4

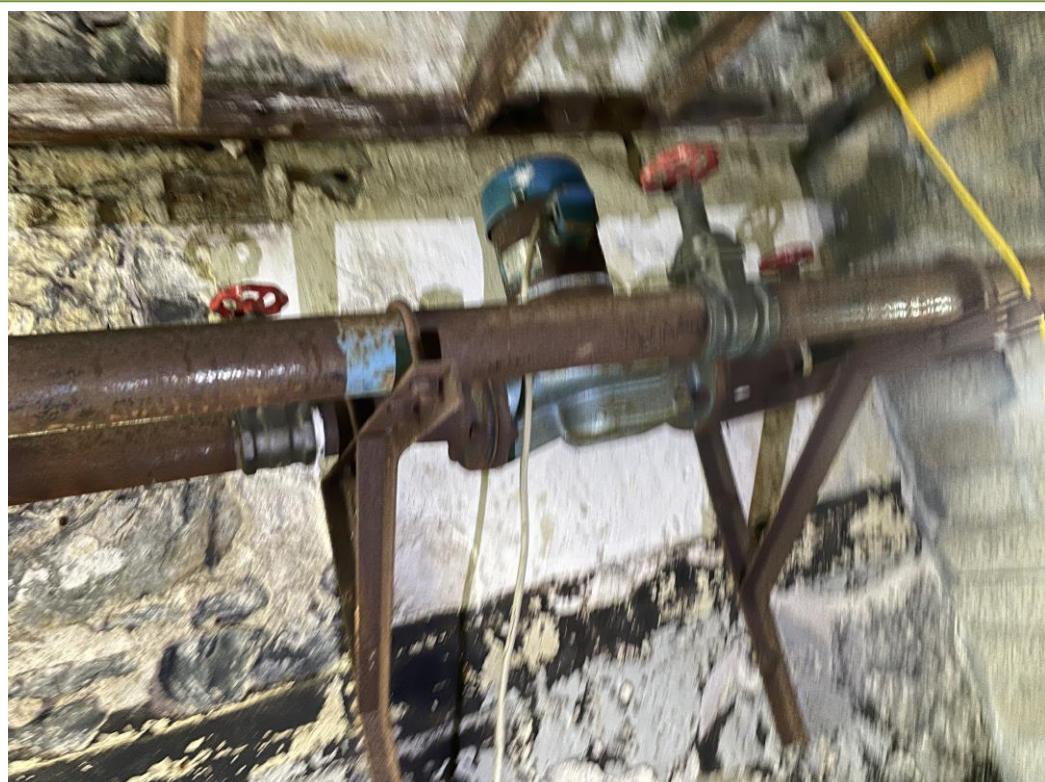
Rope on the pipework on the 3<sup>rd</sup> floor in building 4

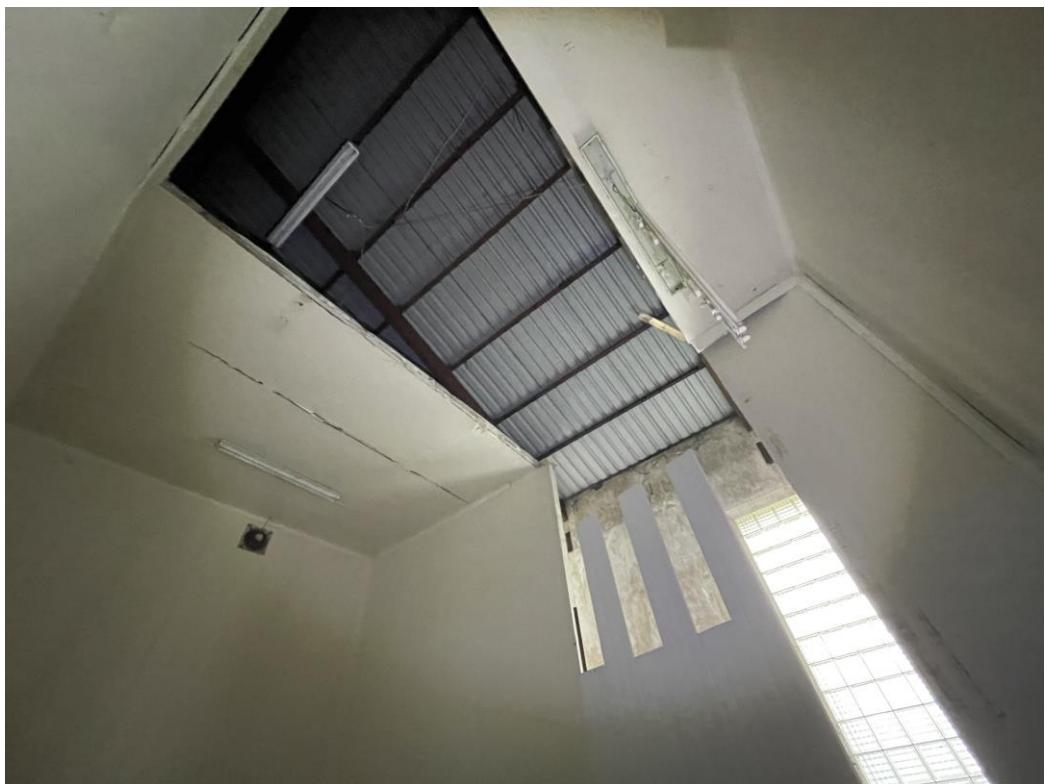
Lean-to roof in building 4

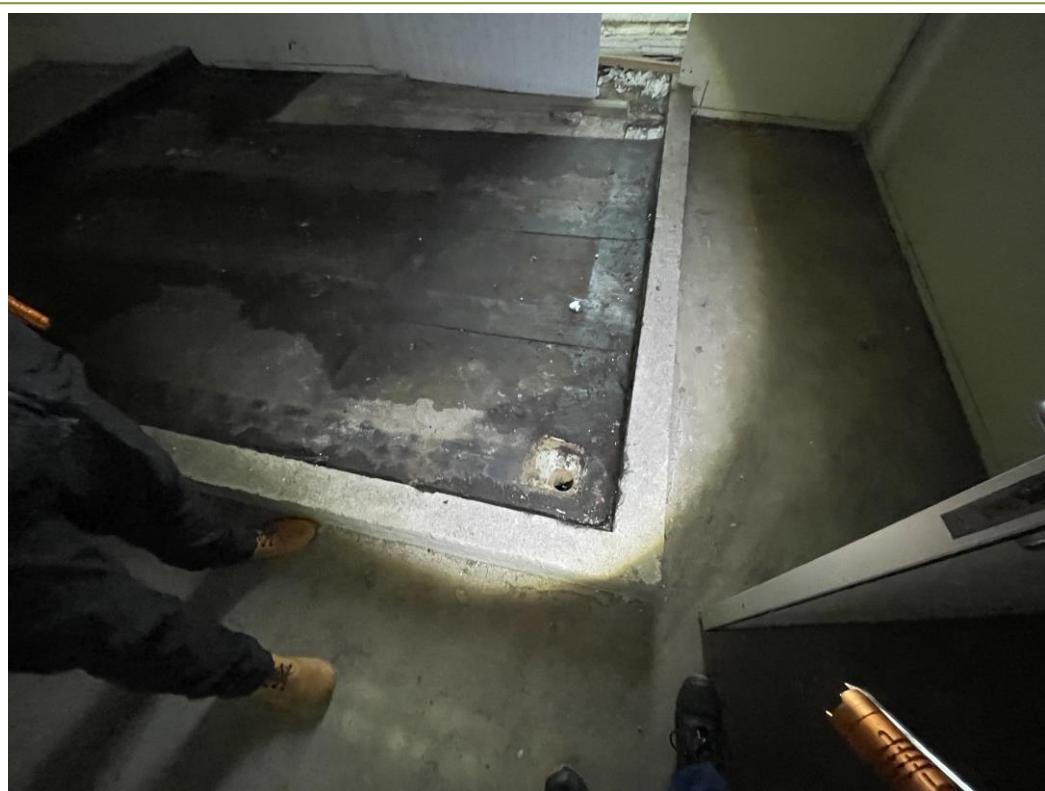
Felt on the 1<sup>st</sup> floor in building 4

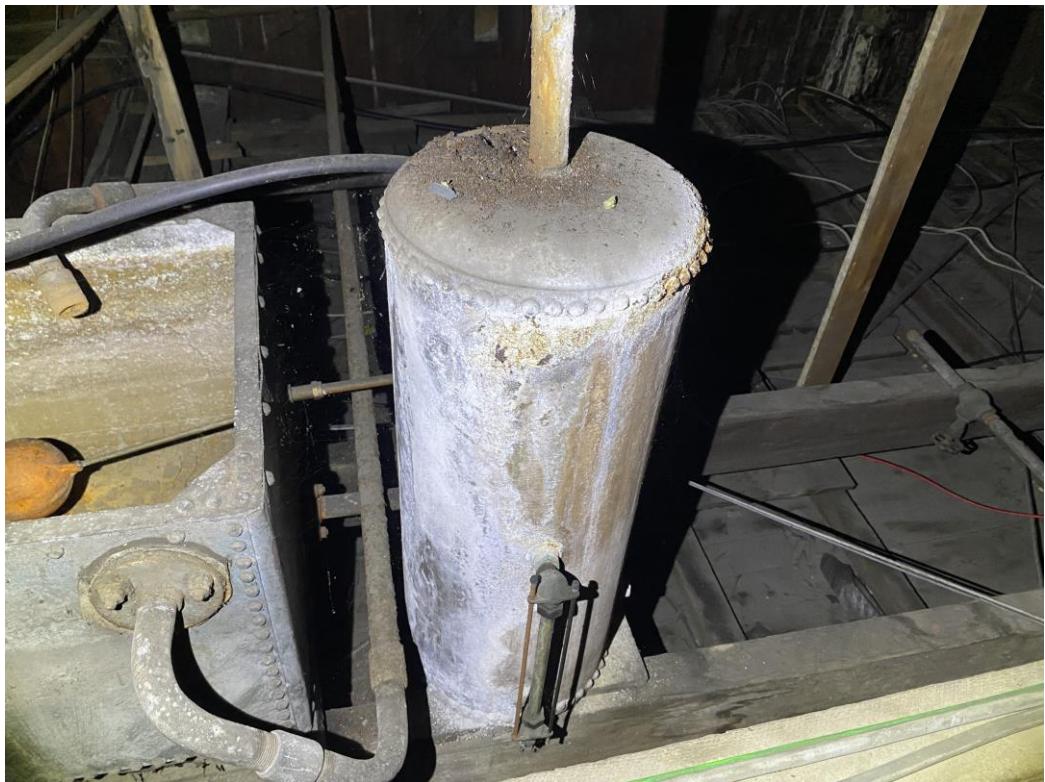
Coating sampled from the tank in the main attic of building 9

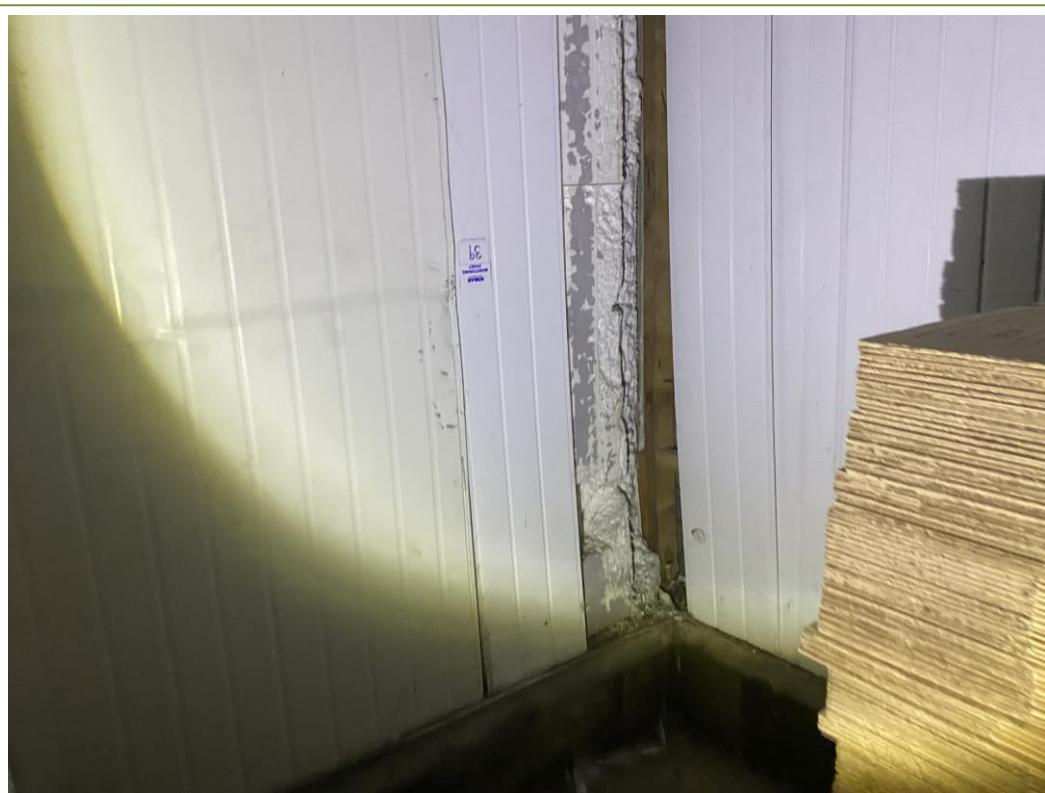
Polystyrene insulation in the wall panels of building 8
