Appendix 19-1 Asbestos Survey Report

## ASBESTOS SURVEY REPORT

**Location: The Cleeves Site,  
North Circular Road, Limerick**

**Report No. PE24-1226**

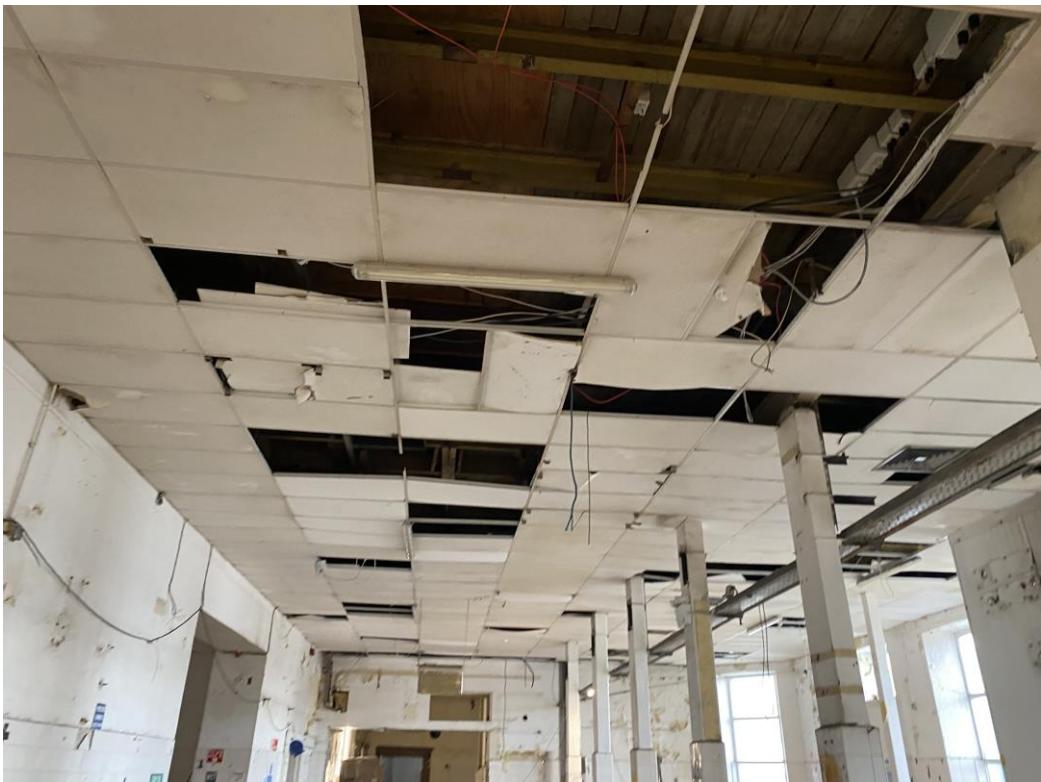
Plasterboard ceiling tiles in building 5

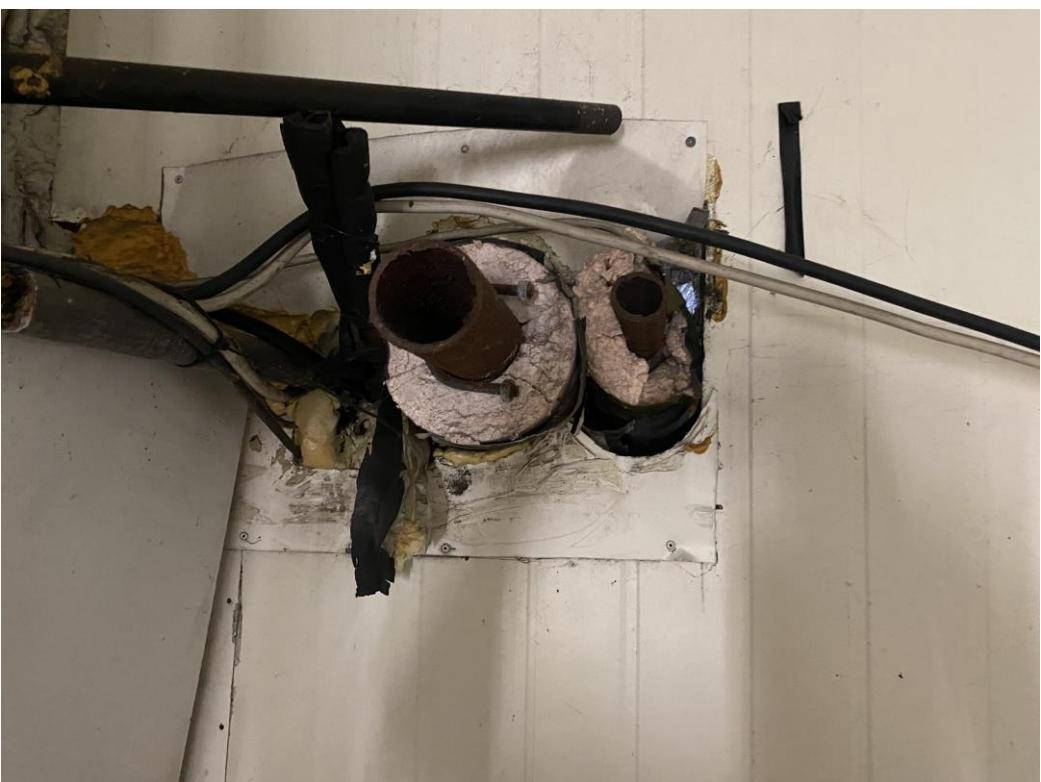
Pipework insulation sampled in building 5

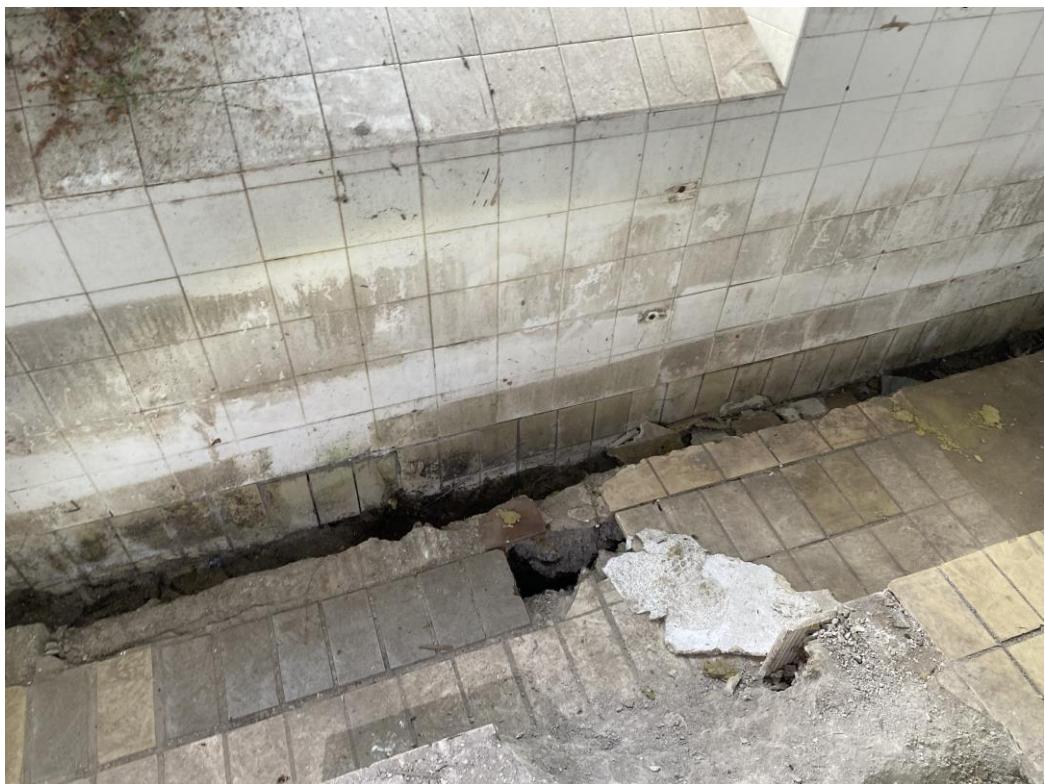
Ceramic floor tiles in building 5

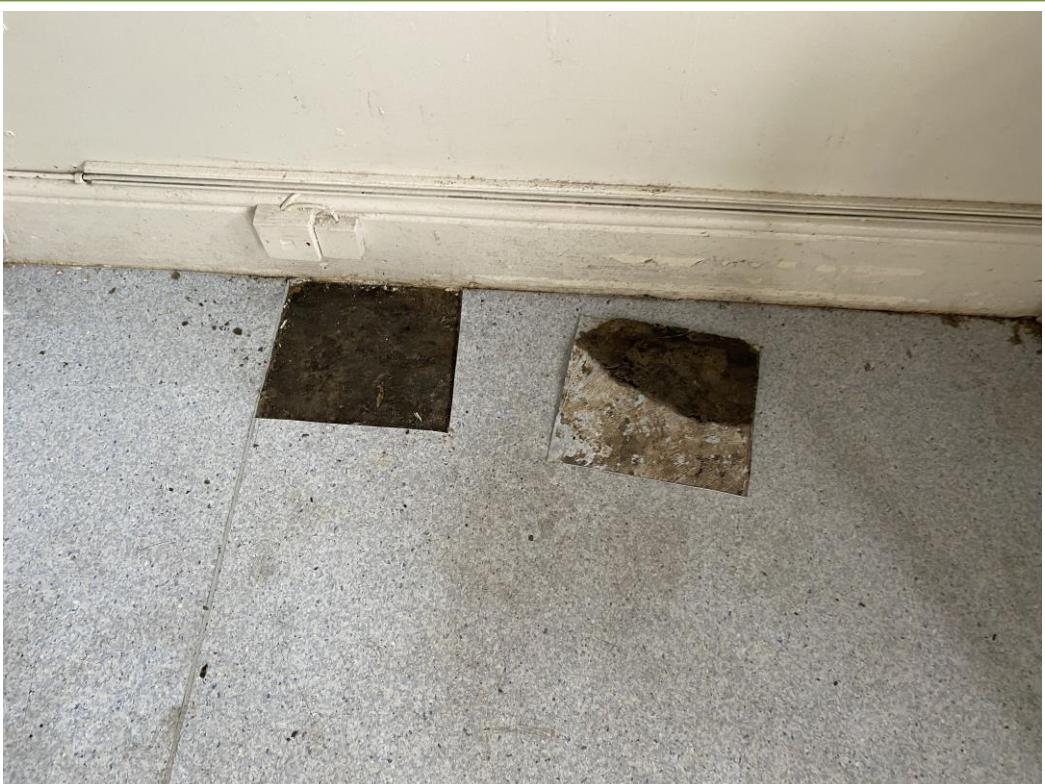
Black compound sampled in the security area of building 10

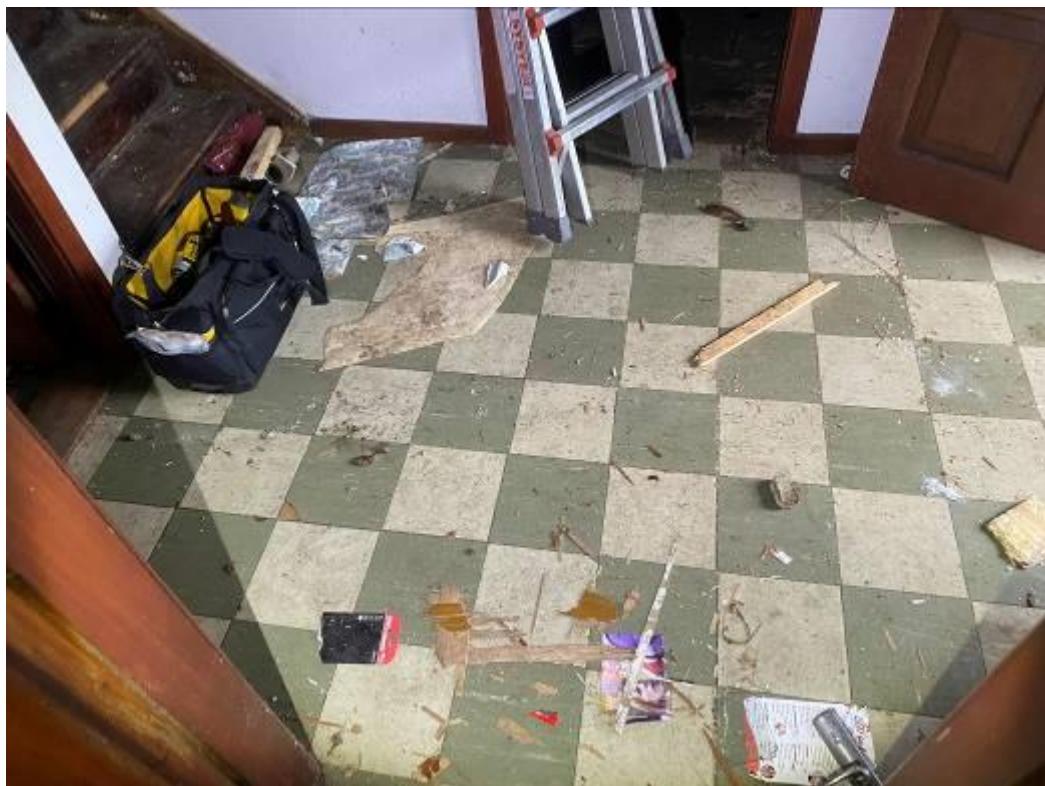
Floor tiles sampled from the hallway

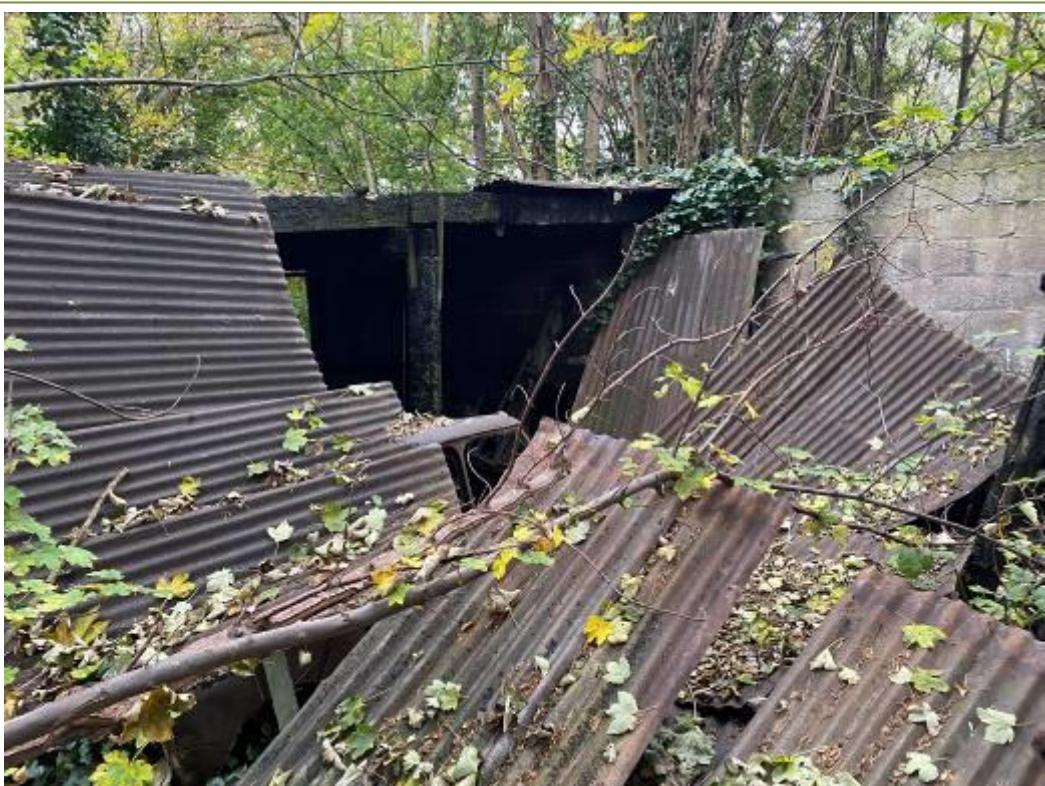
Metal cladding on the rear outbuilding
