Building Record Report

Building 14 Semi Detached Houses
Former Cleeves Condensed Milk Factory

Client: Limerick 2030

Date: 15th of October 2025

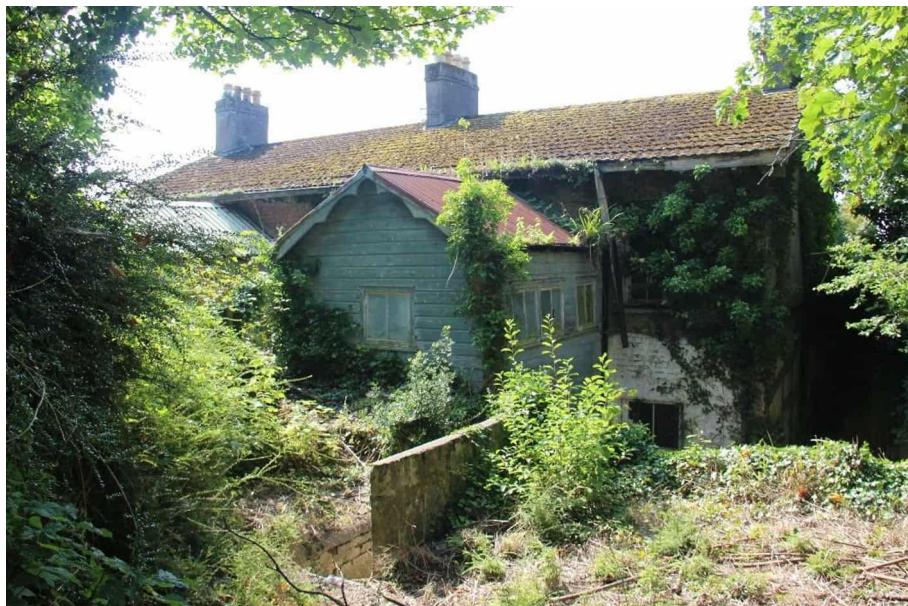
Photograph 1 - View of Rear of Building 14A

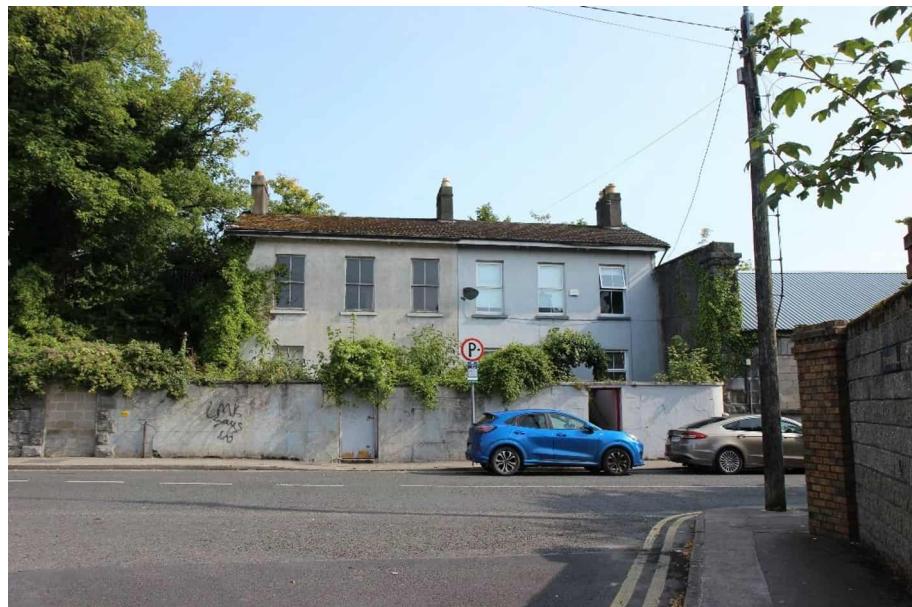
Photograph 2 - Front façade Building A (LHS)

Replacement cementitious slate roof, on cut timber roof with a timber fascia and soffit, the latter supported on timber brackets. There is a chimneystack on the gable servicing the ground and first floor front rooms and ground floor kitchen and back bedroom. There is also a party wall chimneystack servicing ground floor front room and first floor back bedroom.

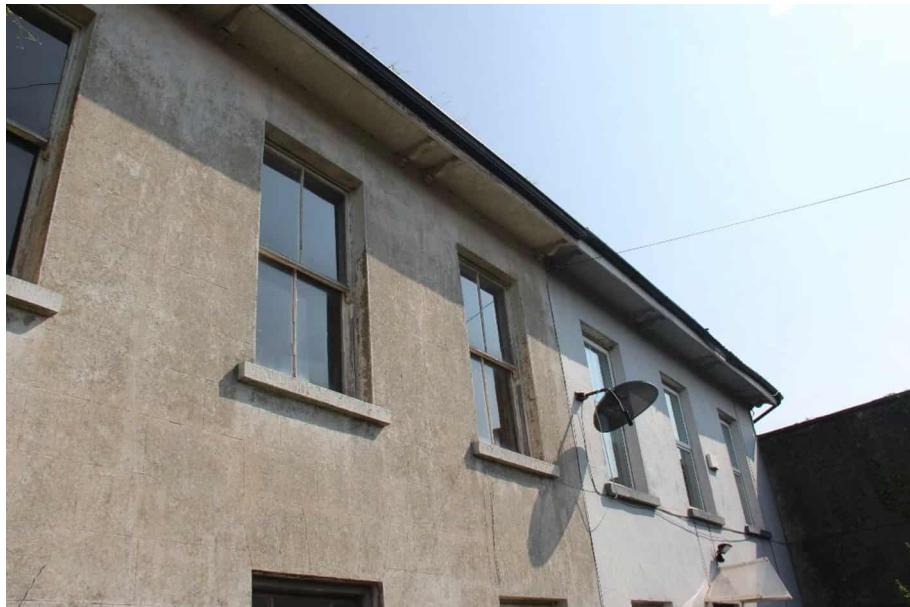
Front wall is smooth cementitious ruled-and-lined render. Rear wall is painted brick to ground floor and exposed brickwork to first floor. Gable end is cementitious smooth render and appears to have had a lean-to structure against it that is now absent. There is a timber frame and boarded extension (Return Annex) with a ground floor outbuilding built partially underneath and acting as part support.

Photograph 3 - Cementitious render ruled and lined.

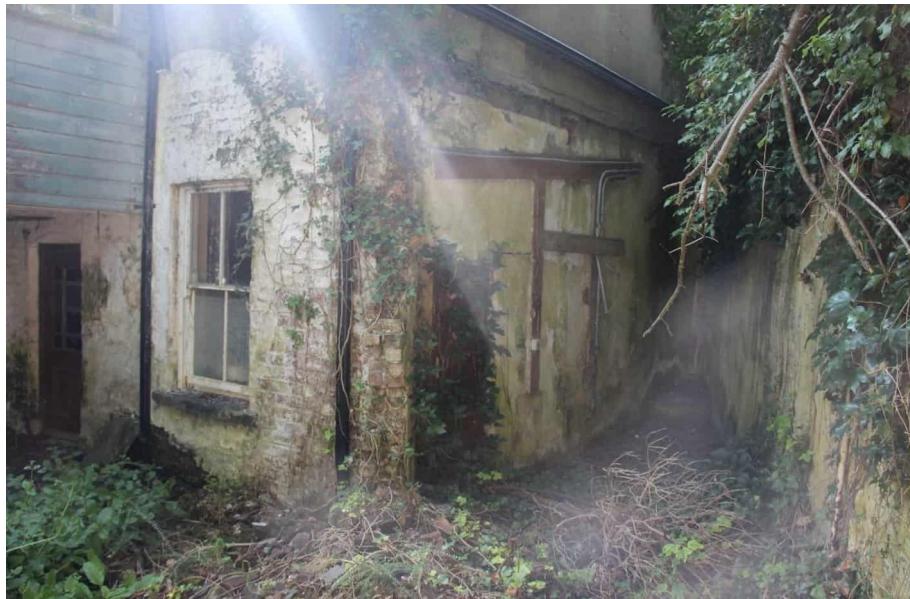
Photograph 4 - Rear and gable end elevations indicating former lean-to and door to kitchen.

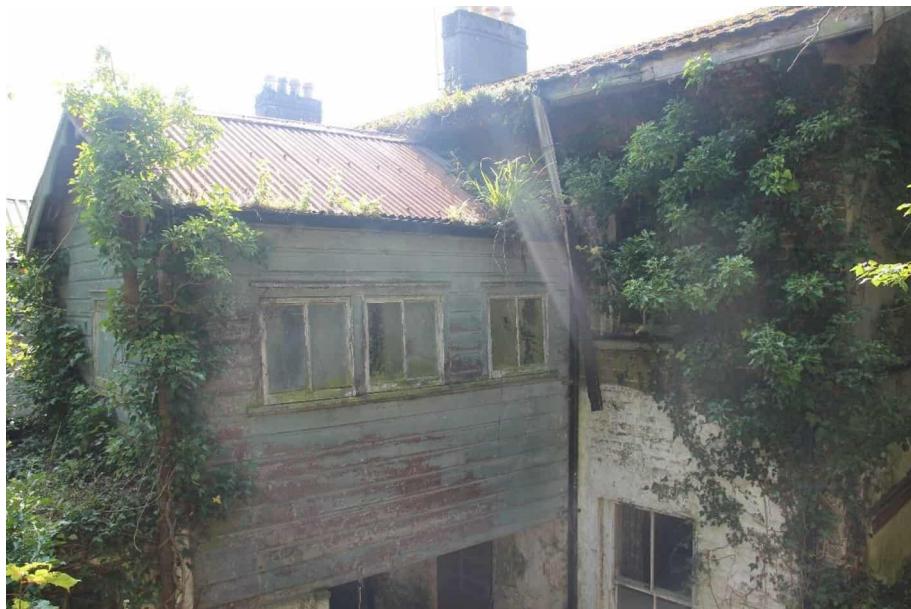
Internal structural elements within the outbuilding suggest that the Return Annex was supported on cast iron columns and perhaps the outbuilding was retrofitted later.

Photograph 5 - Timber clad Return Annex with corrugated iron room and painted brick to main building.

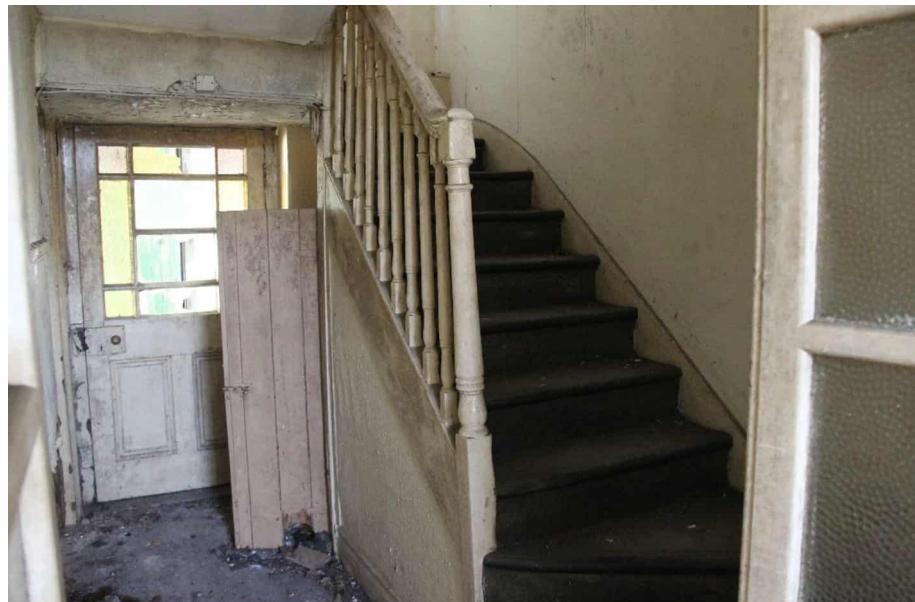
Photograph 7 - Internal face of rear door.

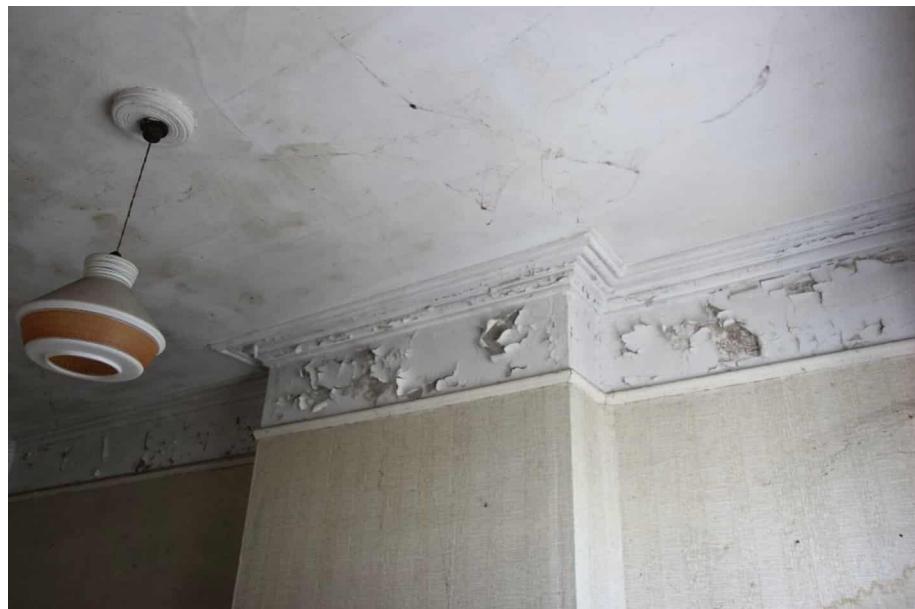
Ceilings to the main building are assumed to be lath-and-plaster and appear to be original. Coving is present to the ground floor front rooms, hall corridor and first floor landing. Ceilings are wallpapered and/or painted. Ceilings to the first floor Return Attic are timber boards.

Photograph 9 - Wallpapered and painted ceiling to front room. Coving intact.

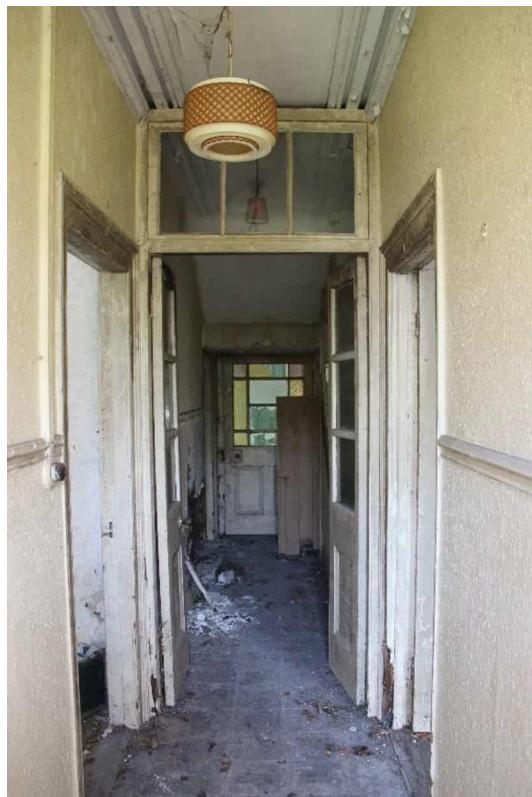
Internal partition walls (160mm) tapped solid and there is evidence that these are lath-and-plaster stud walls. These are largely finished in wallpaper and paint. There are picture rails in the front rooms and dado rails in the hall corridor. External walls (400mm) were solid brick construction, non-drylined and finished textured and non-textured wallpaper and paint.

Photograph 10 - Hall corridor walls with textured wallpaper and dado rails.

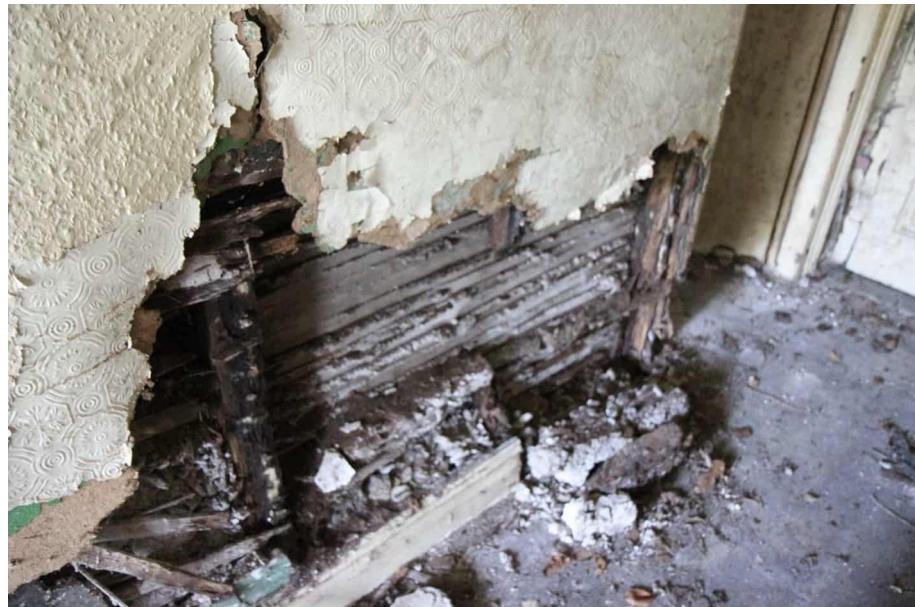
Photograph 11 - Lath-and-plastered stud wall to hall corridor.

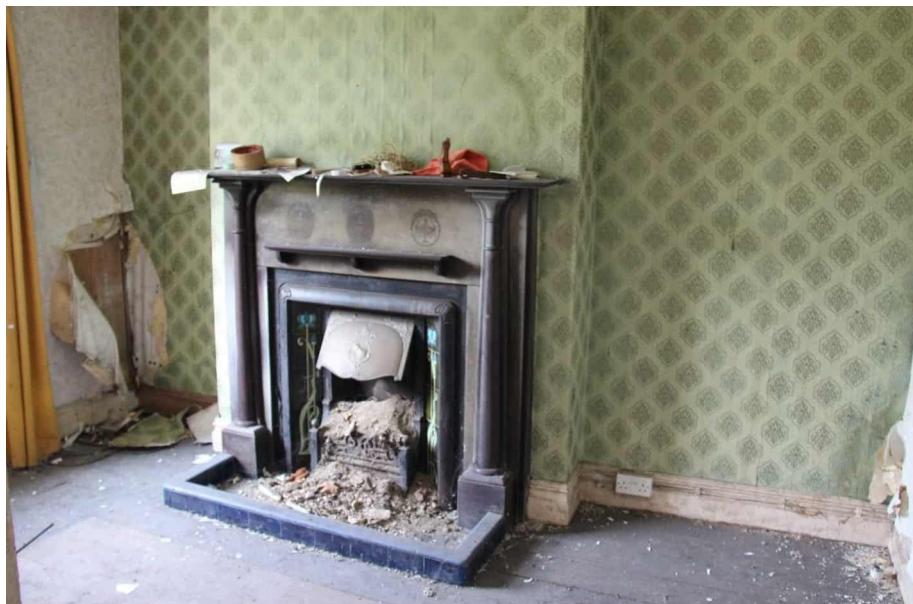
There is a fireplace in each of the front rooms and may be original. There is also a flue in the kitchen, and this has a range cooker fitted.

Photograph 12 - Fireplace front room 1st LHS.

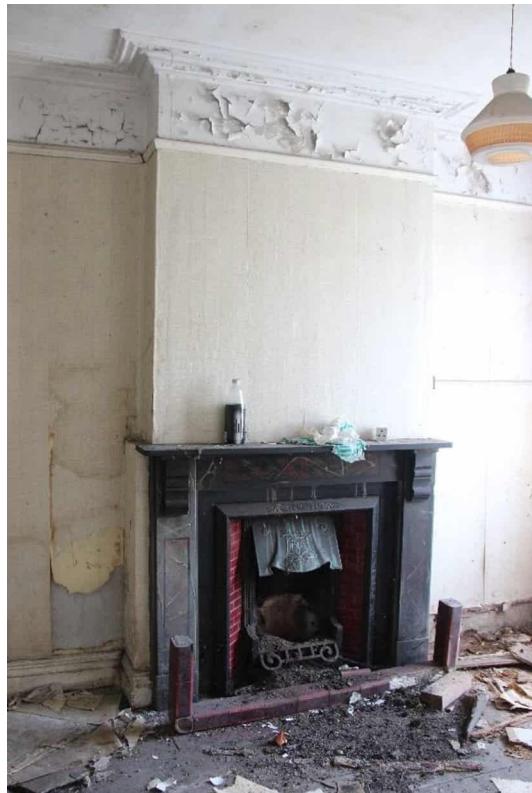
Photograph 13 - Fireplace front room 1st RHS.

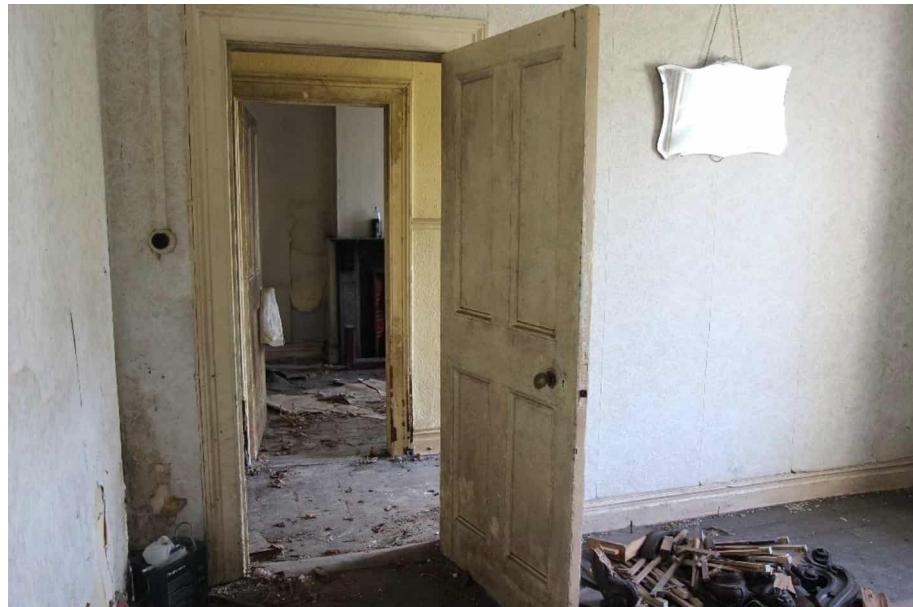
Internal doors to front rooms are original timber 4 panel doors with oval brass knobs. Doors to back rooms are timber vertical boards with brass and Bakelite knobs. Just beyond the doors to the front rooms is a set of double doors in the corridor with a clear glass overhead vestibule screen divided into three panes of clear glass. These are timber 4 panel doors with the upper three panels glazed. These serve to separate the front rooms from the staircase and back rooms.

Photograph 14 - Internal doors to front room - 4 panel solid timber with oval brass handle.

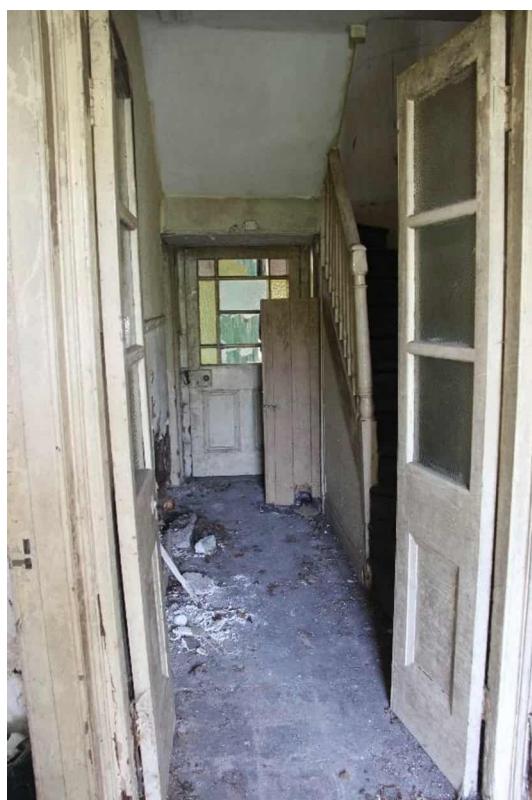
Photograph 15 - Double leaf door used to separate front of house from rear.

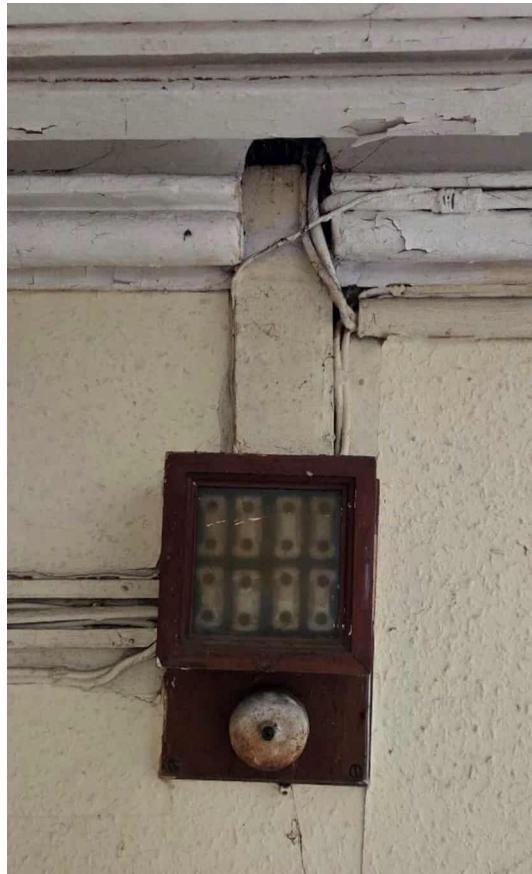
Photograph 16 - Early room service electric bell ring.

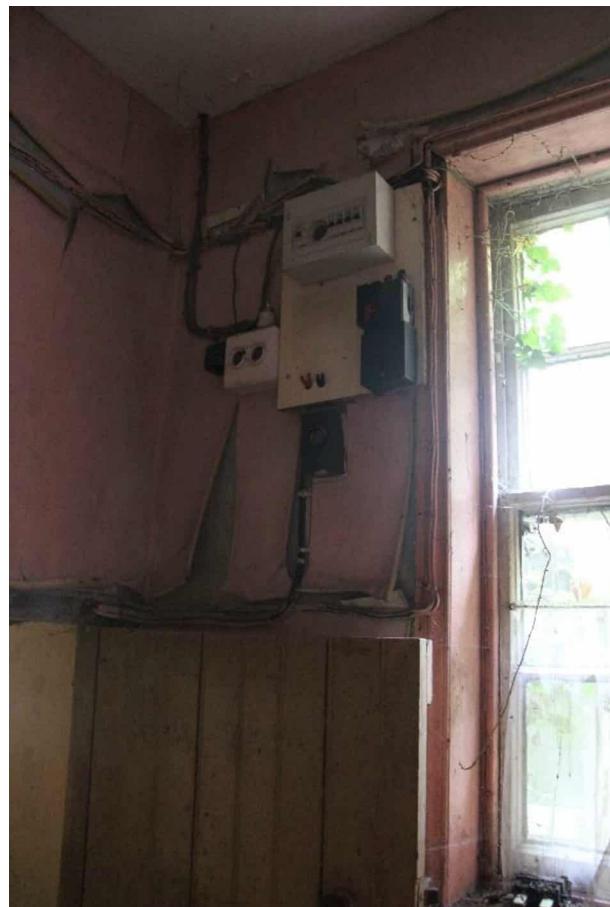
Electrical and mechanical installations are minimal. We are of the opinion that water was heated by the range cooker and that fireplaces heated the rooms.

Photograph 17 - Modern fuse box located in home office.

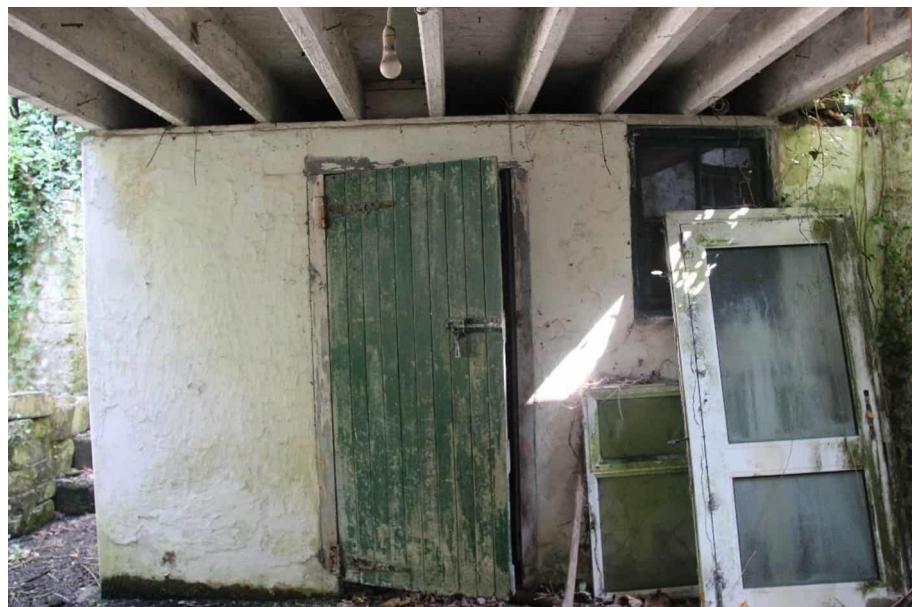
There is a brick, concrete and stone outbuilding that partly supports the first floor Return Annex and the following are general photographs of the structure.

Photograph 18 - Outbuilding front facade with exposed joists to underside of Return Annex.

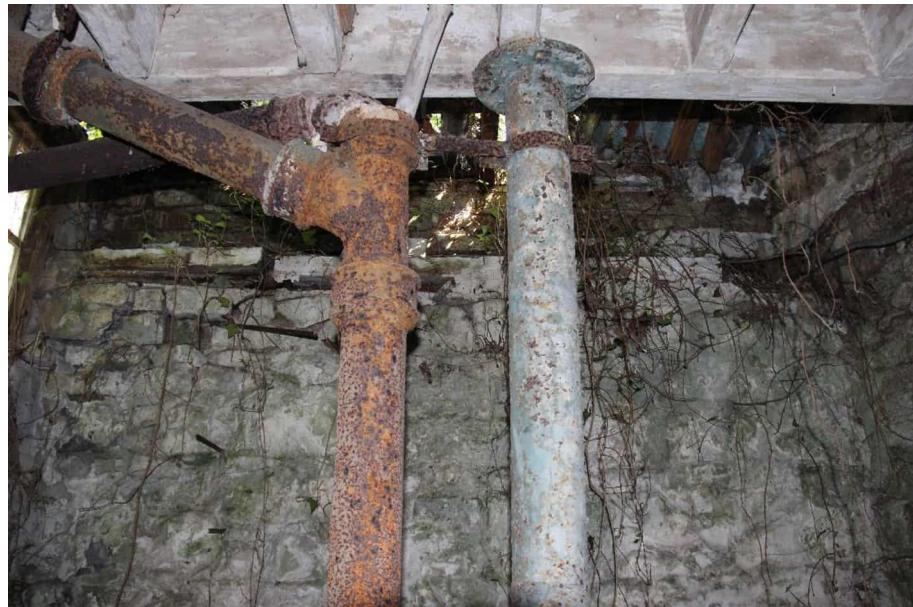
Photograph 19 - Cast iron support system for Return Annex floor.

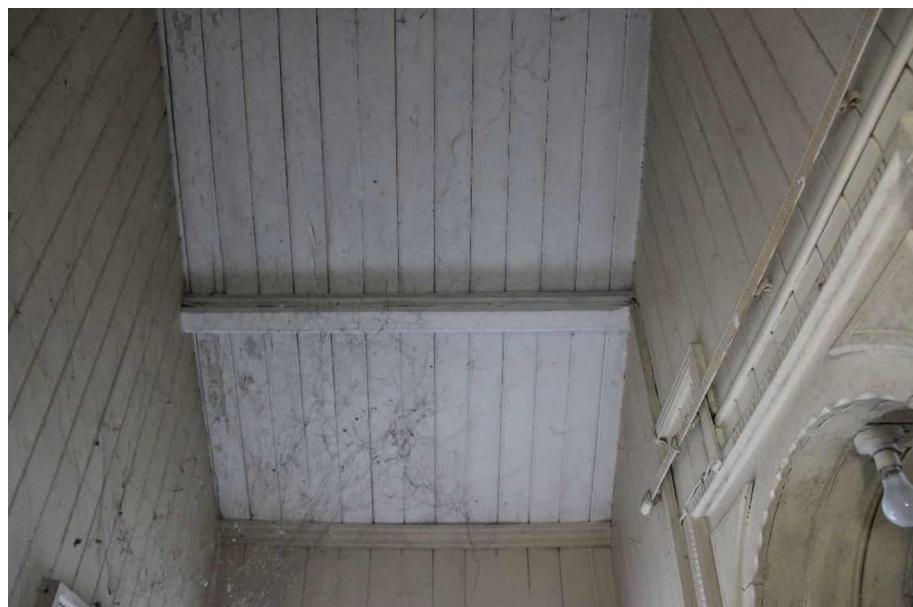
The Return Annex ceilings are timber boards and painted. Main building ceilings appear to be original lath-and-plaster and painted. Coving is present in the landing.

Photograph 20 - timber boarded ceiling to Return Annex.

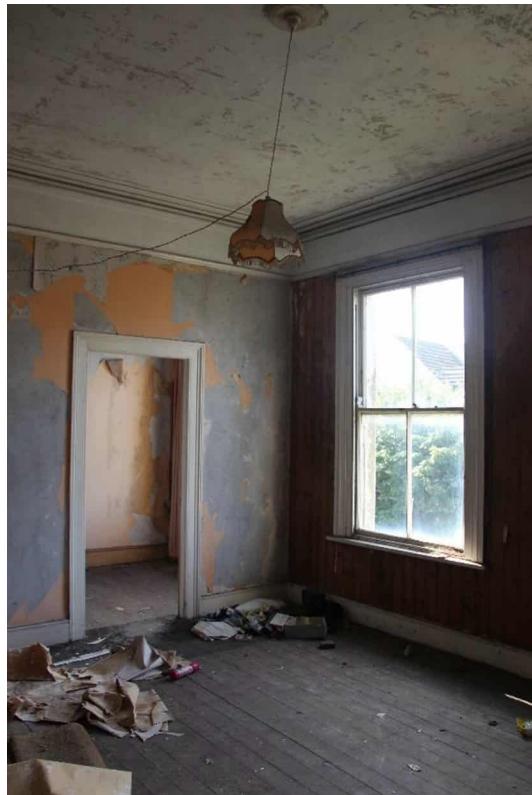
Photograph 21 - Lath-and-plaster ceilings to front room.

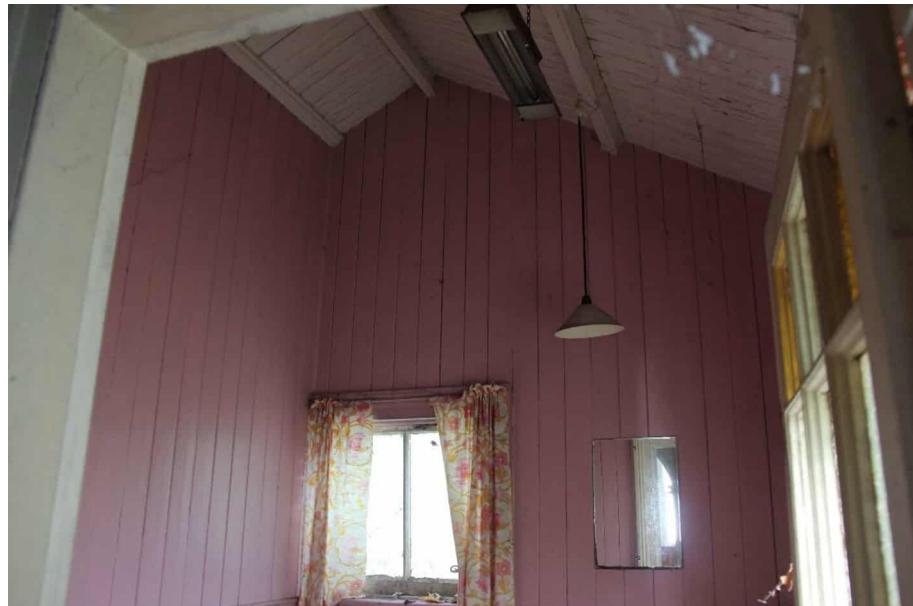
Return Annex walls are timber stud partition and external walls are timber frame (c.160mm) with vertical timber boards to the internal face painted white and separated by a dado rail.

Photograph 22 - Timber boarding to Return Annex walls.

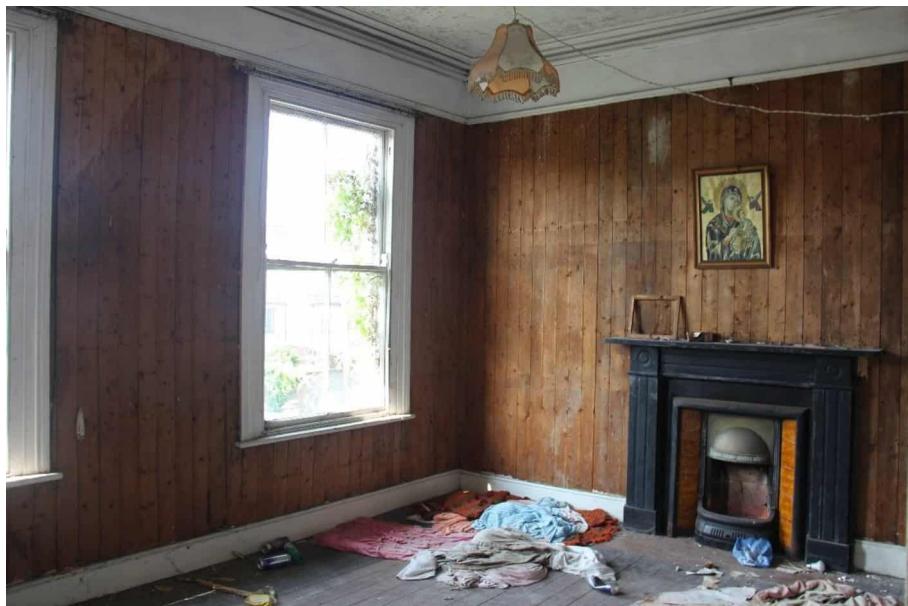
Photograph 23 Front room internal partition and inner face of external wall finished in timber boarding.

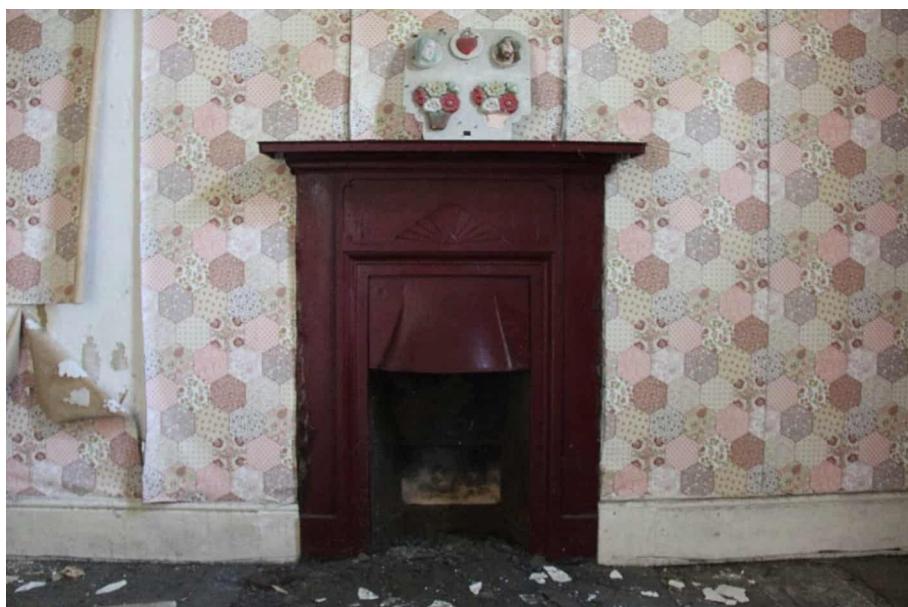
Photograph 24 - Original cast iron fireplace to rear bedroom.

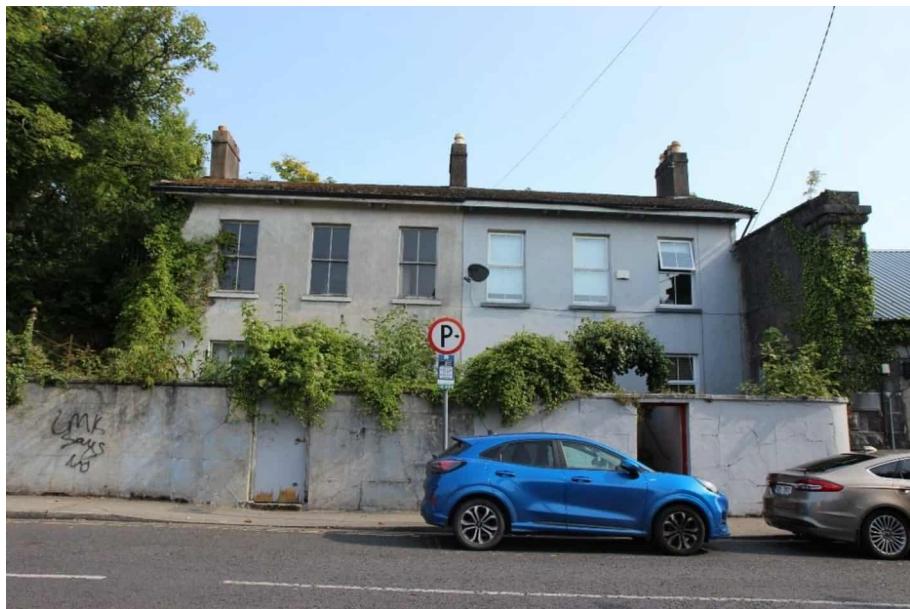
Photograph 27 - Front facade Building B (RHS)

Replacement cementitious slate roof, on cut timber roof structure with a timber soffit and fascia supported on timber brackets. There is a chimneystack on the gable servicing the ground and first floor front rooms and ground floor kitchen. There is also a party wall chimneystack servicing ground floor front room and first floor bedroom.

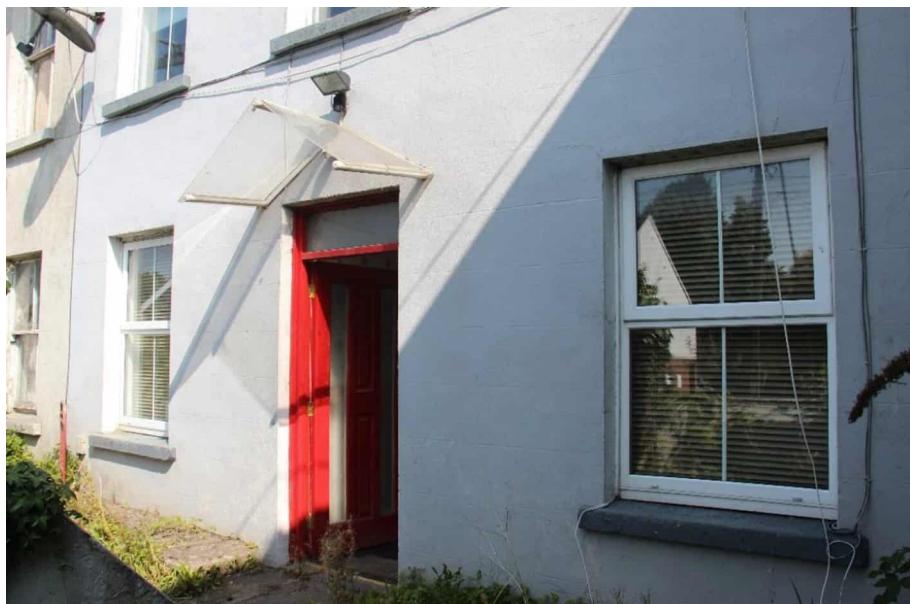
Smooth cementitious ruled-and-lined rendered front wall, the rear wall is painted brickwork on the ground floor and exposed brickwork on the first floor. There is a timber frame and timber boarded extension (Return Annex) to the rear, similar to Building A.

Photograph 29 - Front facade lower, cementitious render ruled and lined and painted.

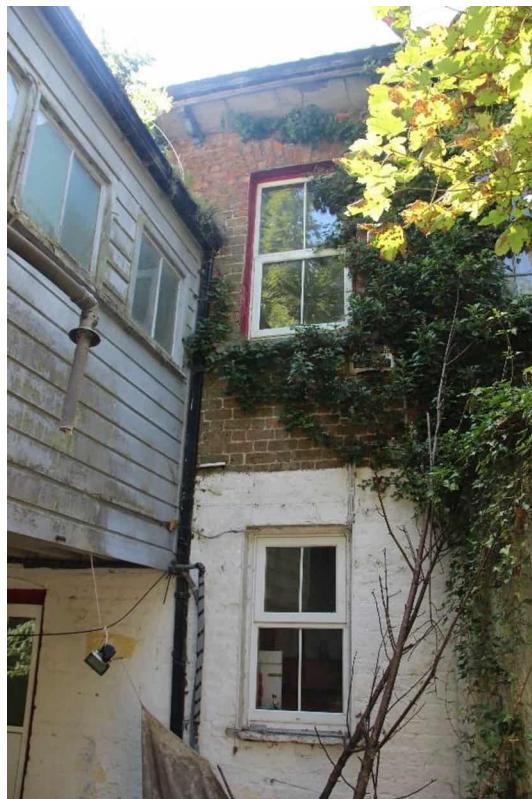
Photograph 30 - Main dwelling rear facade with painted brick and exposed brick.

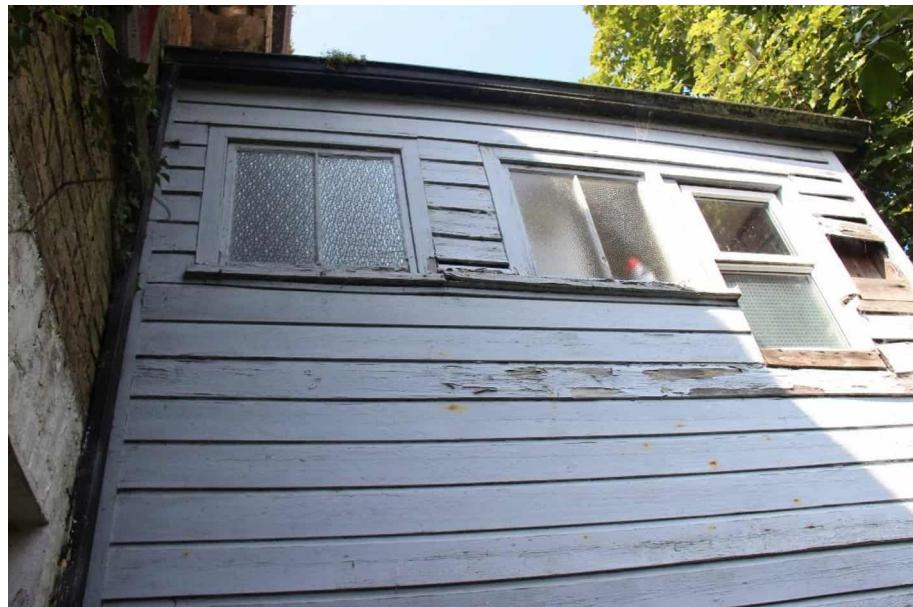
Photograph 31 - Return Annex timber cladded walls of site facade.

Windows are replacement double glazed uPVC top hung casement with some original timber casements remaining on the Annex Return. (See photograph 31 above).

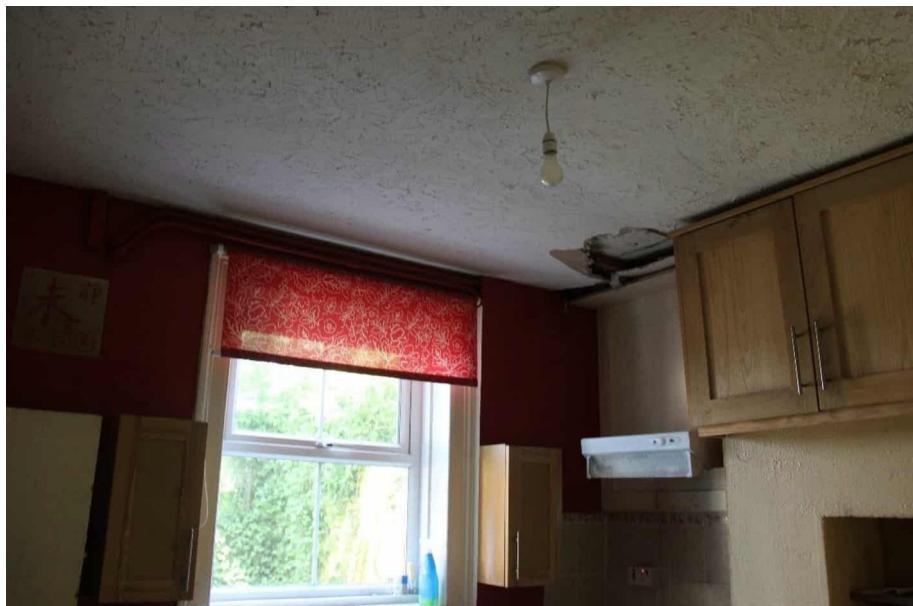
Ceilings are assumed to be lath-and-plaster. All have coving. Ceilings are painted and have a textured/stippled finish and may be plaster effect or painted paper-mâché.

Photograph 35 - Stippled ceiling in Kitchen - possible Artex.

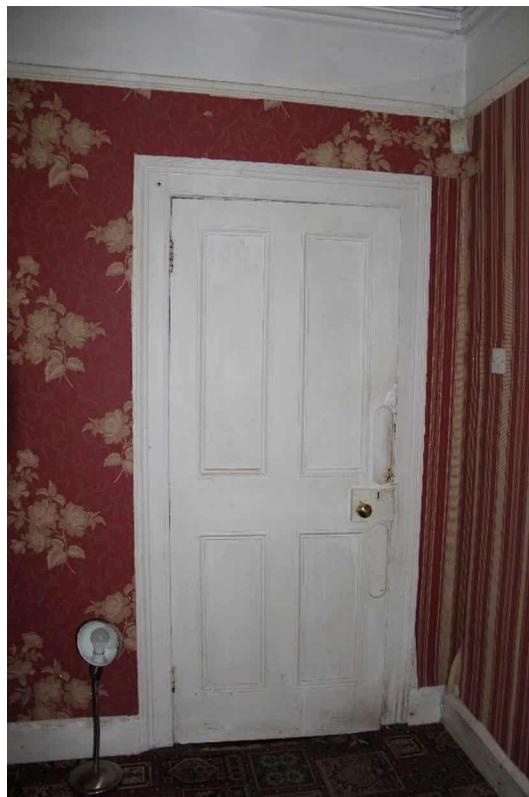
Internal doors to front rooms are original timber 4 panel doors with brass and Bakelite knobs. Doors to back rooms are timber vertical boards with silver-effect pull handle.

Photograph 38 - Front room, 4 panel solid timber door with brass doorknob.

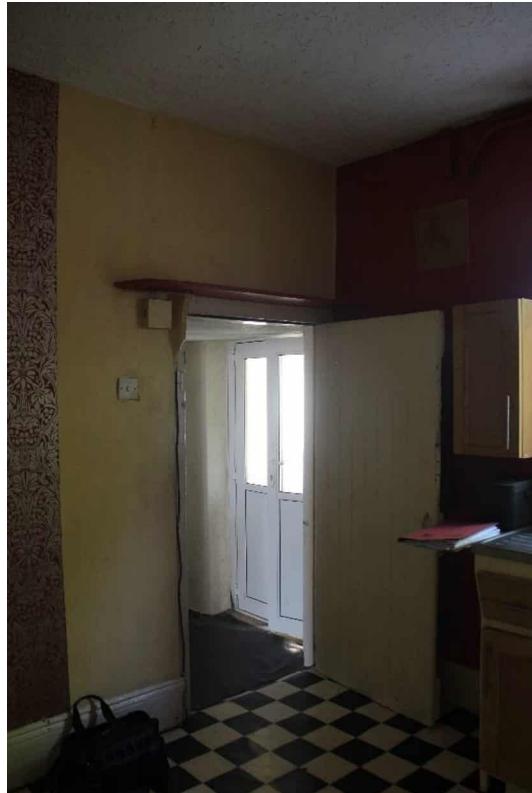
Photograph 39 - Rear room, vertical timber boarded door with curved silver-effect pull handle.

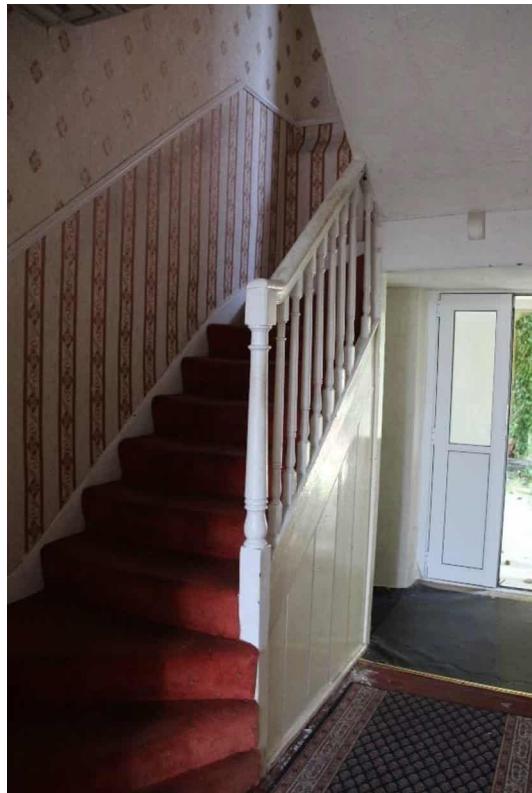
The staircase is a closed string timber and carpeted stairs with square newel head and rounded spindles. The handrail is square. It has timber vertical sidings and a cupboard underneath. The first steps are winders and there is a return and second flight to the first floor.

Photograph 40 - Timber closed string staircase with square headed newels and side panelling.

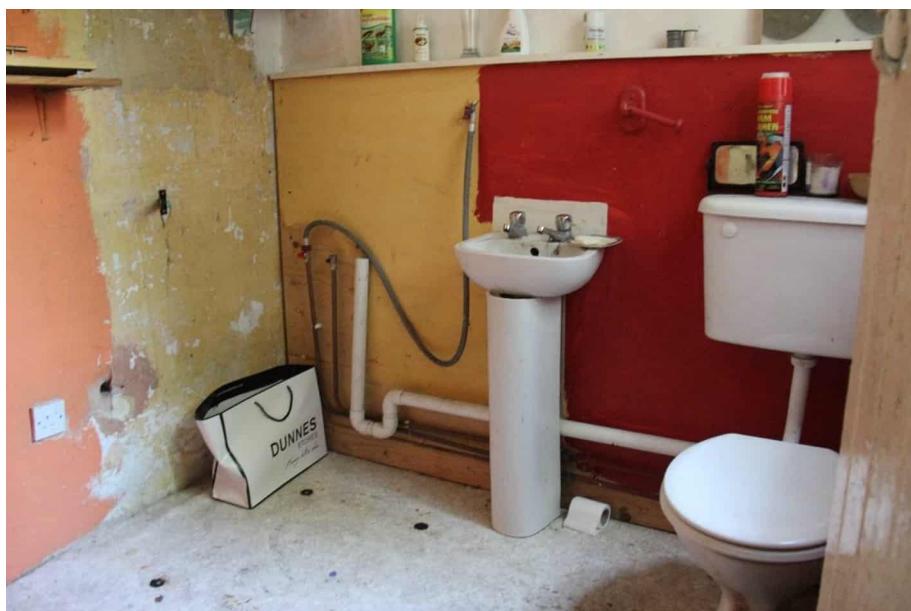
W.C., toilet and handbasin present but not tested.

Photograph 42 - Sanitary Facilities

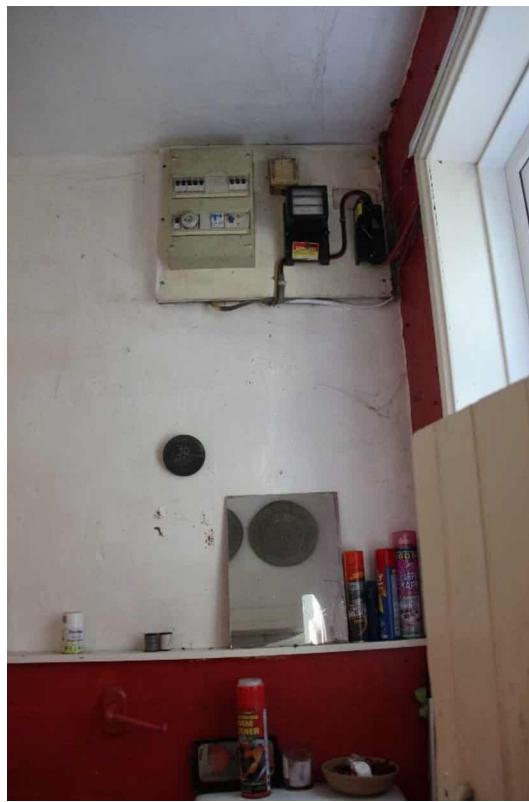
Electrical and mechanical installations are minimal. The fuse is located in the w.c. and is an out-of-date system. Fireplaces act as room heaters.

Photograph 43 - View of fuse box and meter

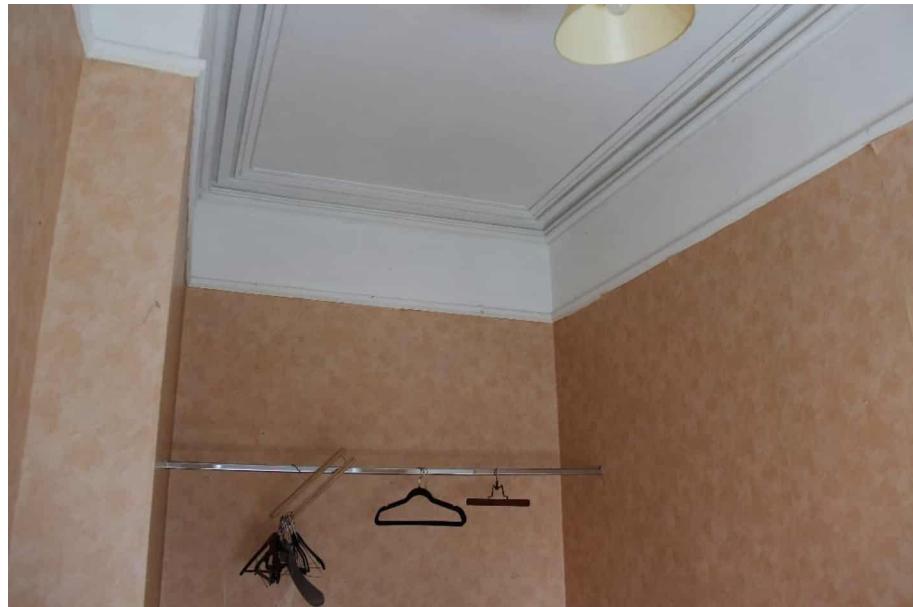
Return Annex ceilings are plastered. The w.c. and lobby landing has a smooth painted ceiling while the Bathroom ceiling has painted stippling. Main building ceilings appear to be original lath-and-plaster and painted.

Photograph 44 - smooth plastered ceilings with coving.

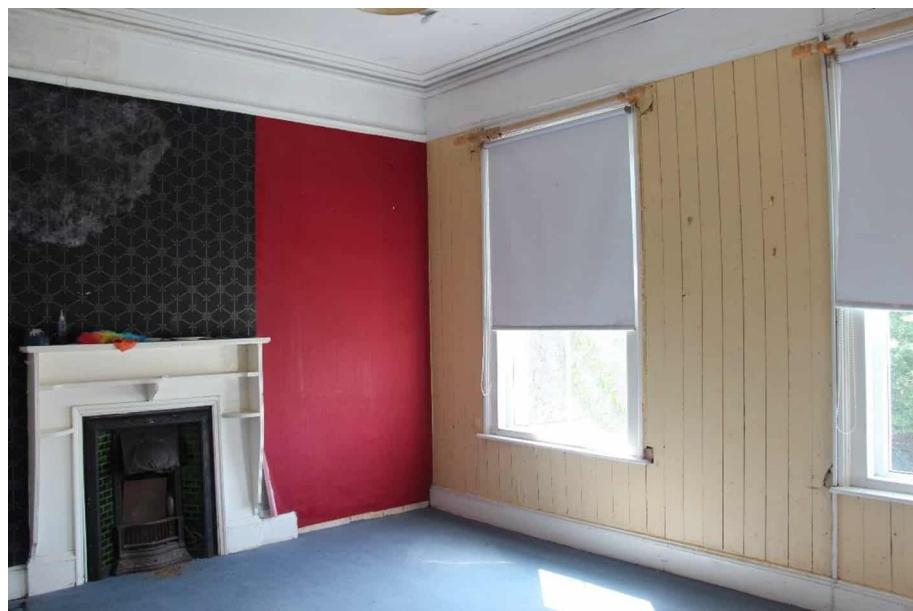
Main building walls are solid, and we are of the opinion that once again, these are brick external walls and stud with lath-and-plaster internal partitions. They are finished in a mixture of paint, wallpaper and vertical timber wainscoting/vertical timber boarding. Picture rails are common throughout.

Photograph 45 - Vertical timber boarding to front roof and wall papered end wall.

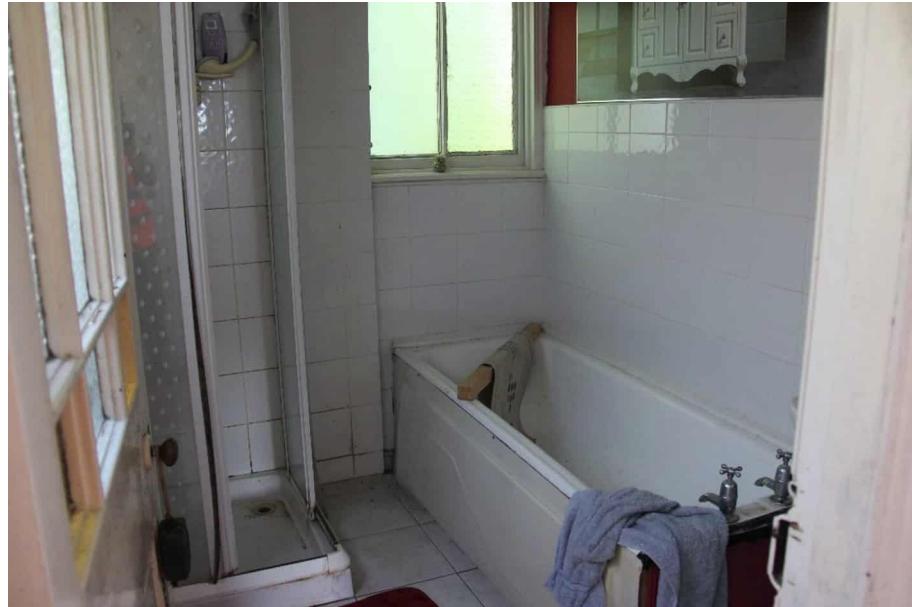
Return Annex w.c. contains a toilet. The Bathroom contains a shower, tub and handbasin. These were not tested.

Photograph 47 - Shower and bathtub separate to toilet.
