Abbeyfeale Emergency Works on the River Feale.

Appropriate Assessment Screening Report

Client	Irish Water / Limerick City and County Council
Project No.	3085
Project Title	Abbeyfeale Emergency Works on the River Feale
Report Title	Appropriate Assessment Screening Report

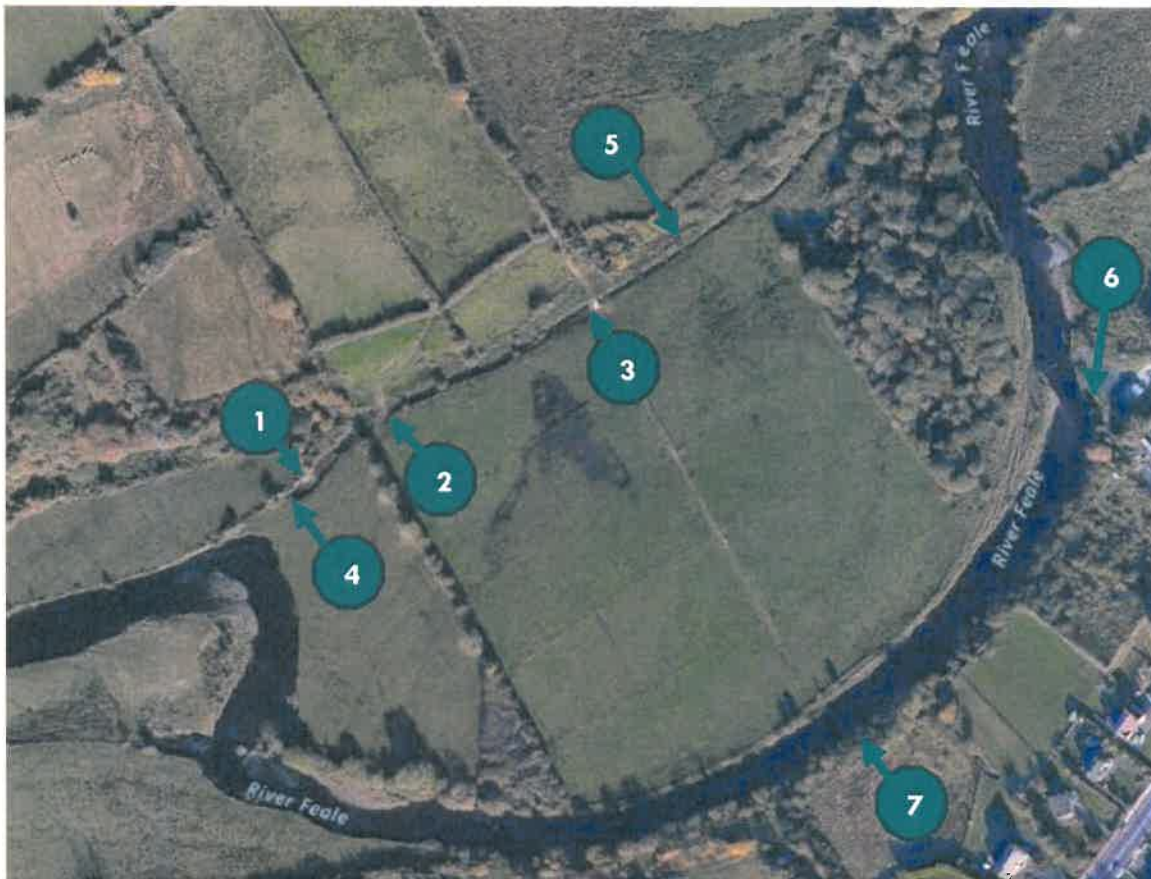
Figure 3.5: (1) Proposed Sheet Pile Weir site, (2) Former river crossing (A), (3) Former river crossing (B), (4) Breach channel, (5) Catchment Channel, (6) Existing intake, (7) River Feale Meander

(*b) The contractor shall be responsible for the design, provision, installation, maintenance, repair and removal of the temporary fording point and silt and pollution control system (straw bales and sedi-mats) at location 2 on Figure 3.5. The temporary fording point will be constructed to ensure conveyance of the catchment channel flows with minimum afflux and that vehicles will not enter the watercourse. Minimum culvert pipe sizes shall be 600mm diameter

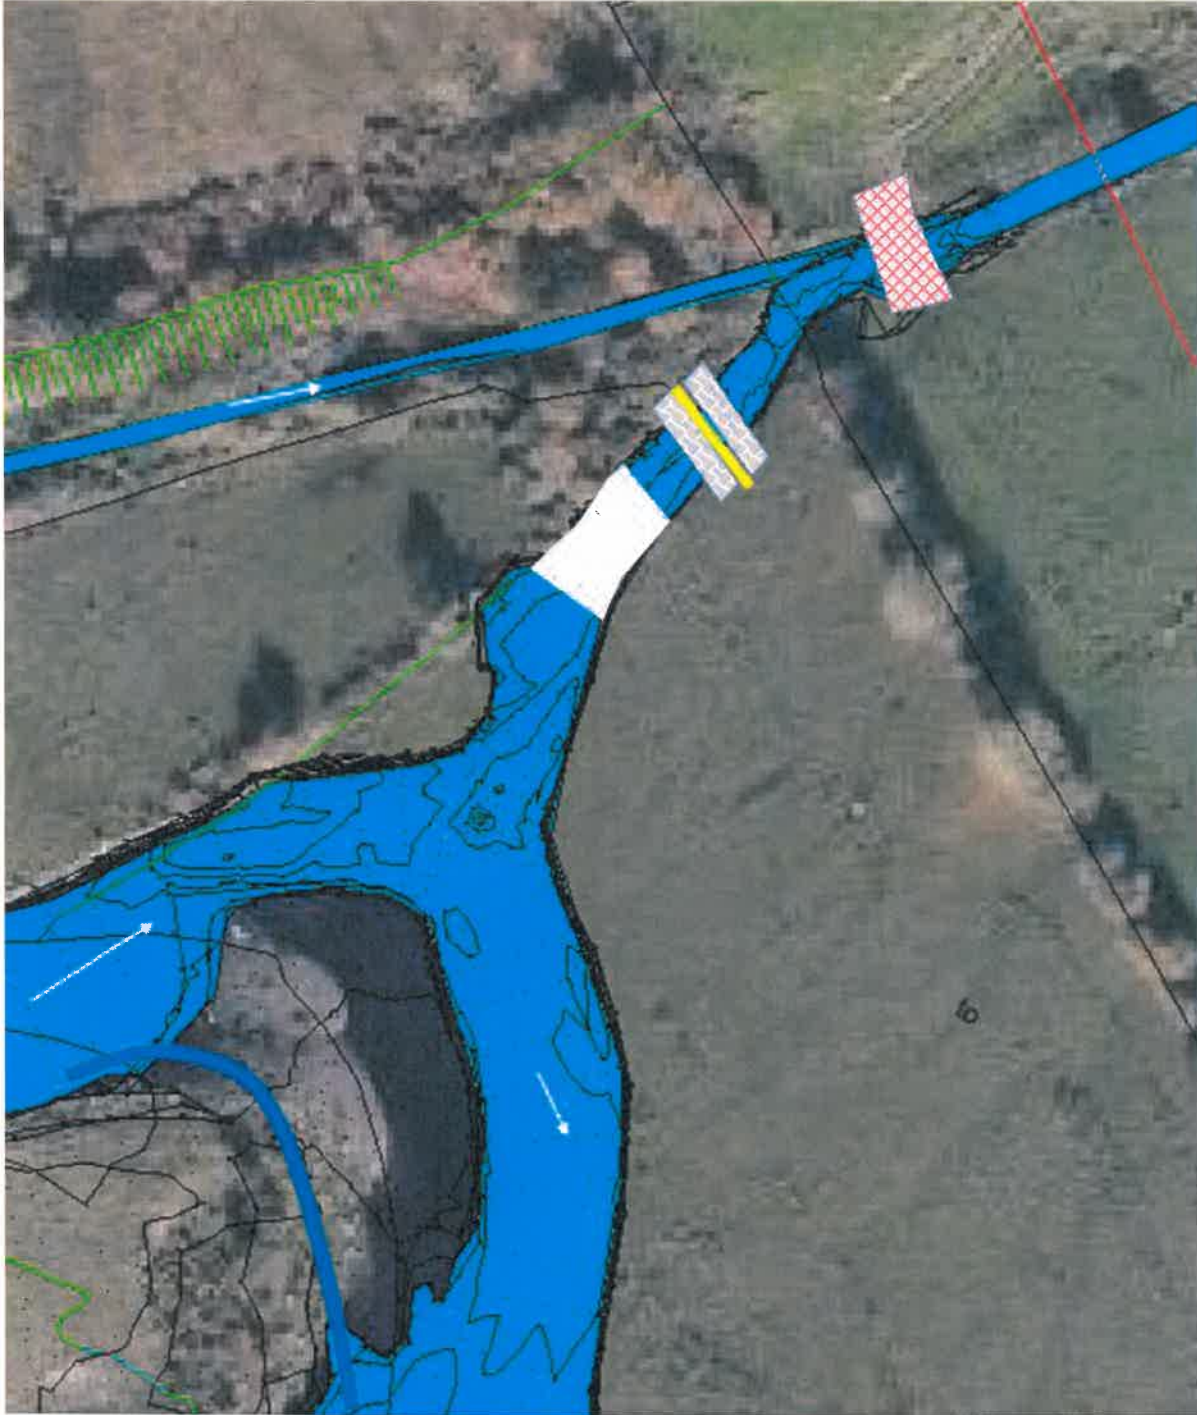
Figure 3.14 STEP 9 Remove all construction equipment and materials from the south and cross the catchment drain. Remove temporary ford construction; Remove the sand bags upstream of the ford; Remove all construction materials from site and reinstate the access road; Remove all construction equipment from site.

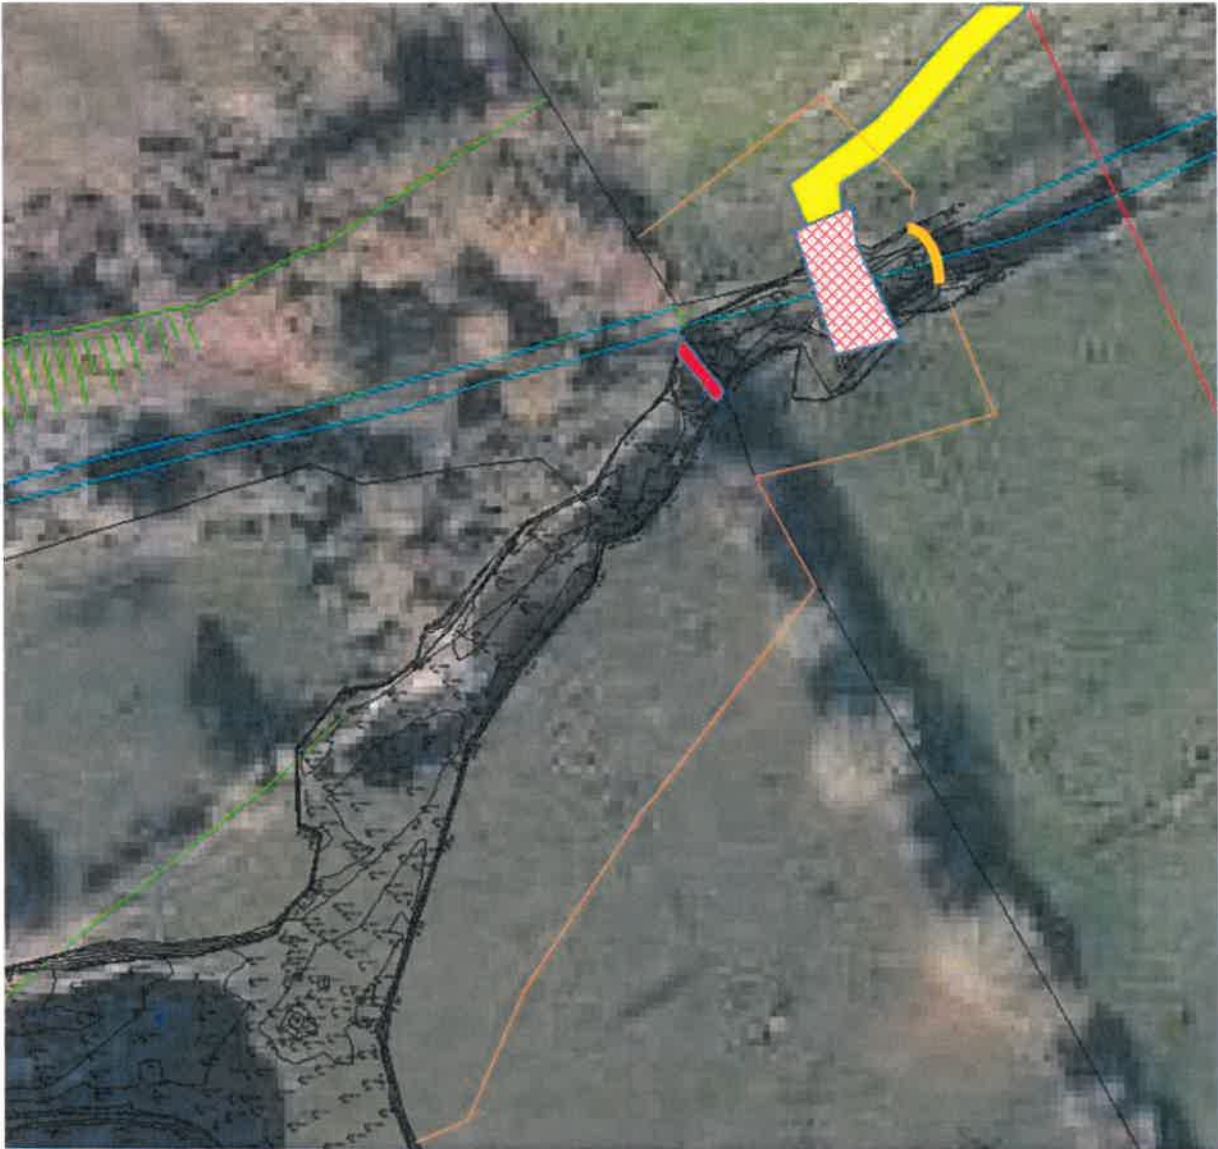
Figure 13.17 STEP 7a Remove construction debris from the channel. Turn off dewatering pumps and allow the upper reach of the breach channel to refill slowly to match the main channel level, Remove the primary breach channel blockage. Reinststate the south bank.

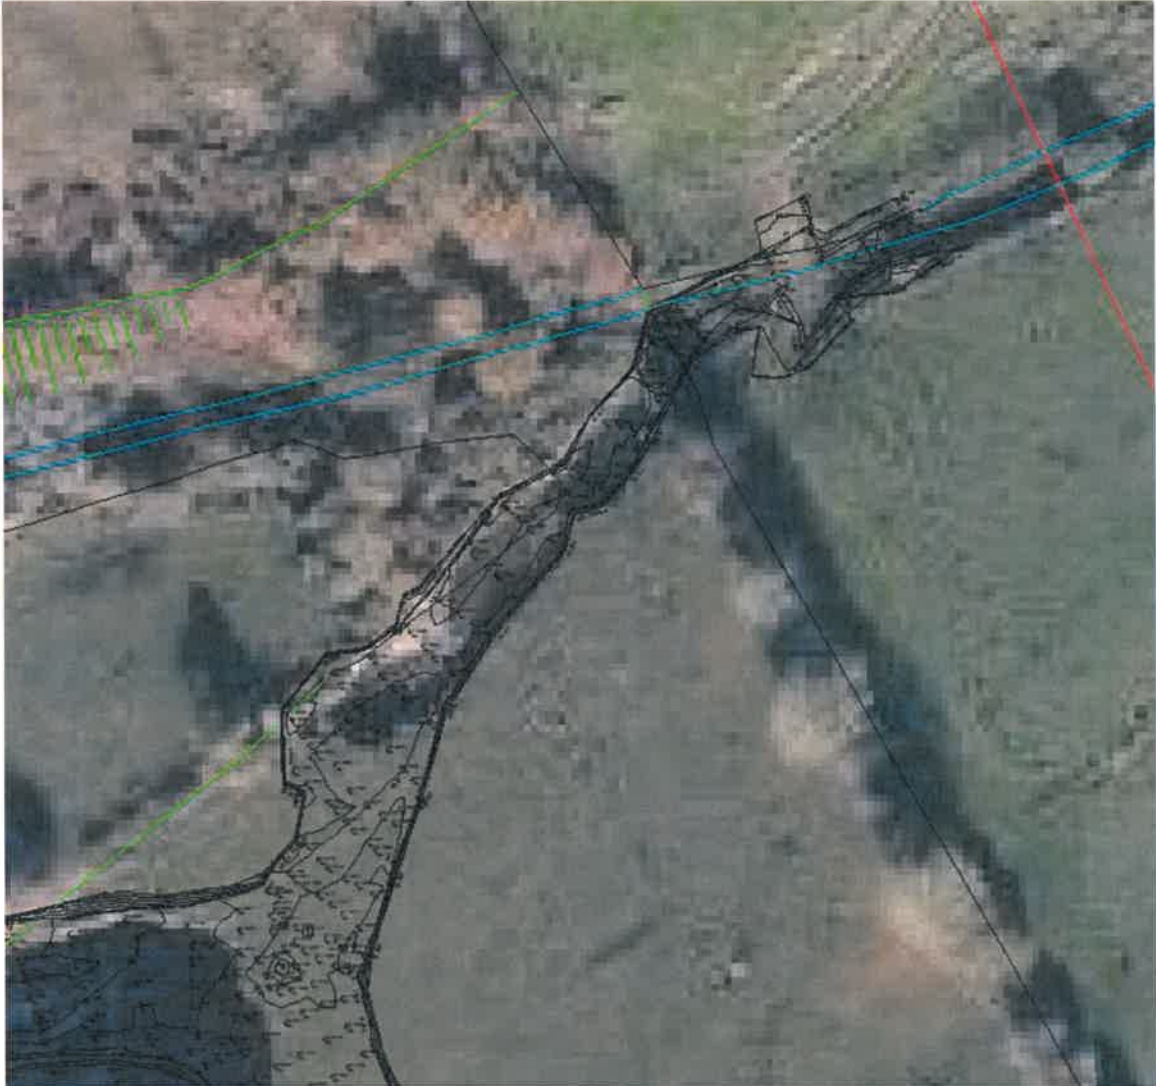
Figure 3.18 STEP 8a Remove all construction equipment and materials from the south and cross the catchment drain. Remove temporary ford construction, Remove the sand bags upstream of the ford. Remove all construction materials from site (including site fencing) and reinstate the access road, Remove all construction equipment from site.
