Presentation to Travel &
Transportation SPC

20th April 2021

Three Bridges Report - Update & Context

1. Provide Safe & Continuous Pedestrian Route between Sarsfield Bridge & Arthurs Quay Park

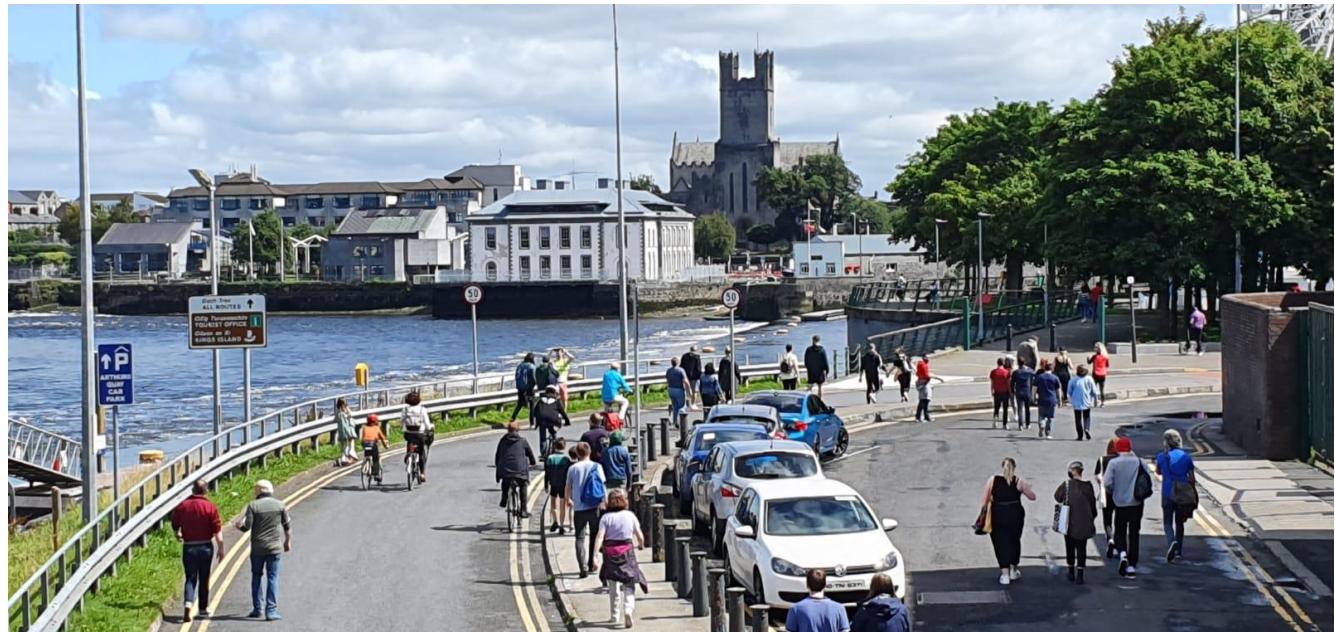
This 100 – 200m stretch between Sarsfield Bridge and Arthur’s Quay Park is the weakest link in the Three Bridges chain. The continuity of the walk is interrupted, requiring the pedestrian to execute two unassisted road crossings in order to continue on the Three Bridges route.

Absence of Safe Crossing Point (1) - There is no footpath under Sarsfield Bridge on the river side so pedestrians must (and we have observed pedestrians doing so) cross the road without any way of stopping traffic. Likewise there are no drop kerbs to facilitate wheelchair users.

- In the immediate term, **fix the pedestrian lights** between Honan's Quay and Arthur's Quay
- Provision of two **raised pedestrian crossings** (one quayside and one between Honan's Quay and Arthur's Quay Park)
- Provision of c. **100m of new footpath** on both sides between Sarsfield Bridge and Arthurs Quay Park.
- Slight **realignment (chicane) of the road** approaching Sarsfield Bridge to reduce the speed of motor traffic travelling under the bridge
- While the above recommendations assume the retention of the existing road use and are 'incremental' in nature, Limerick Pedestrian Network recommends a more fundamental change to the road use in this area, namely **removing through-traffic from the South Quays** to provide a truly pedestrian priority zone. See Recommendation no. 3 for further detail.

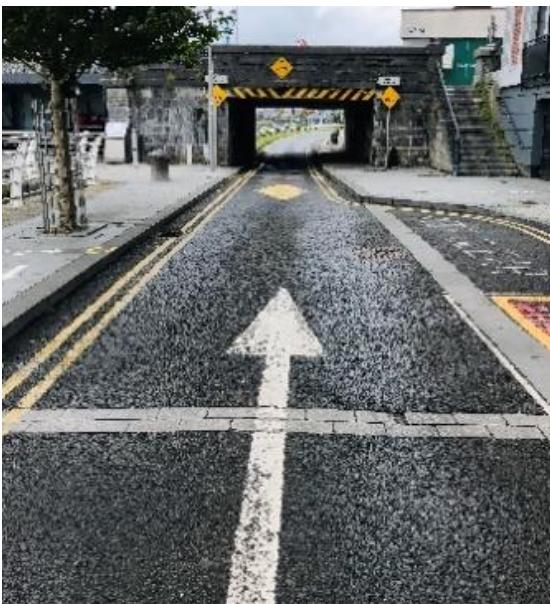
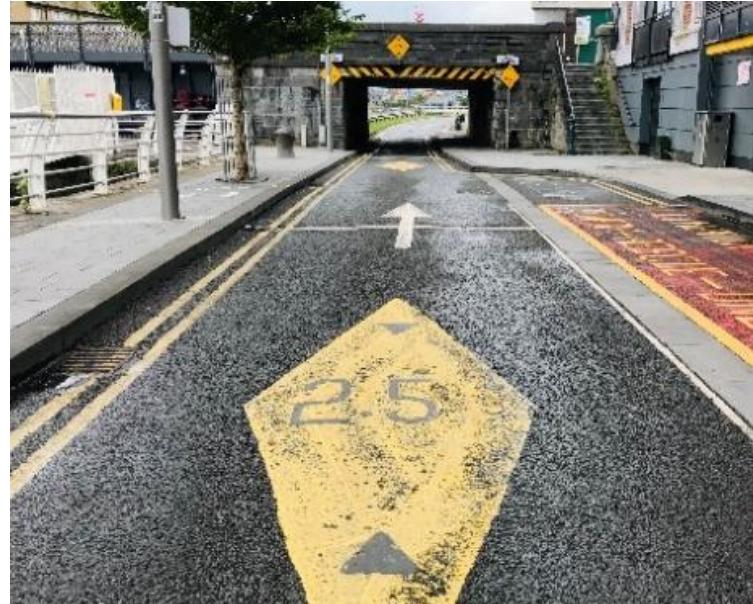
Clear Priority for Motor Traffic - Approaching the Sarsfield Bright underpass, there is clear priority for cars. Arrows painted on the road encourage motorists to go faster, which they do. All the 'caution' signage is aimed at protecting the bridge and vehicles. There is no signage or visual signals to warn drivers of damaging pedestrians. While the relatively narrow carriageway width acts to slow speed slightly, cars get a straight and unobstructed path under the bridge, whereas pedestrians must cross the road with no drop kerbs or zebra crossing to help.

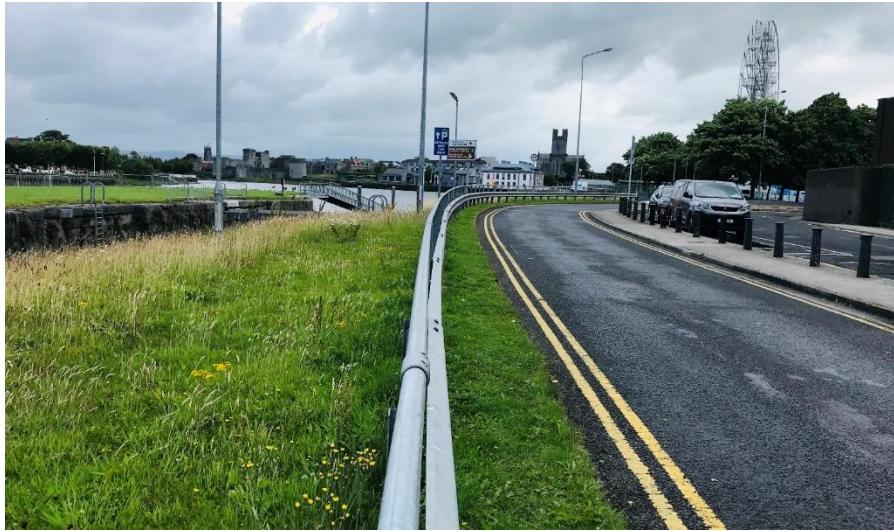
Absence of Footpath on River Side - There is room on the left here for a pedestrian pathway on the river side to provide a continuous and safe link from the quays to Arthur's Quay Park. Installing a pathway here would very much alleviate the current problem where pedestrians have to negotiate a narrow path before looping back into the park.

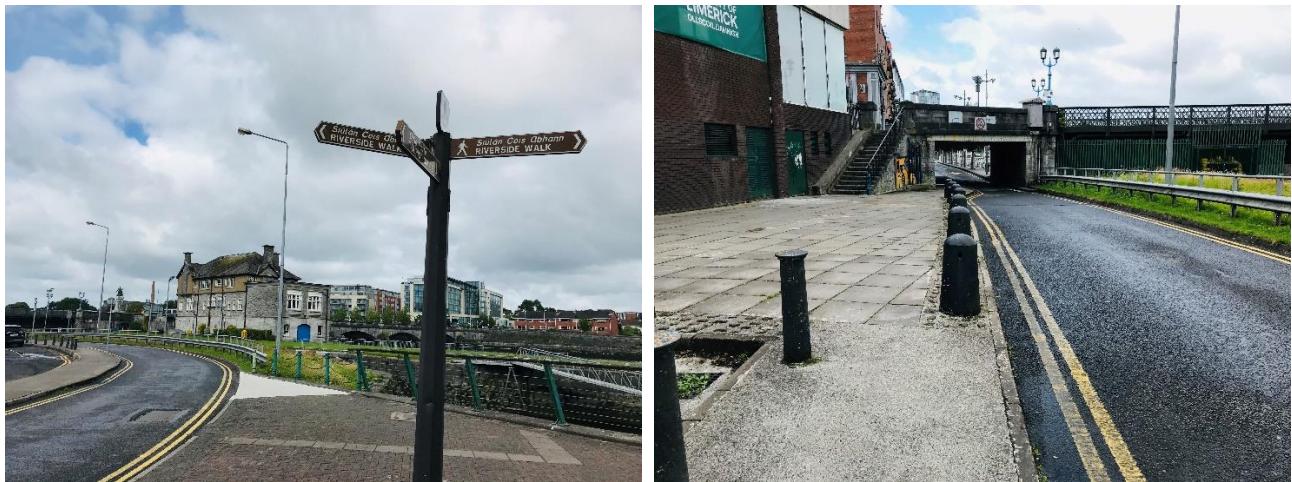
Absence of Safe Crossing Point (2) - Away from the traffic lights, the beginning of the path on the Arthur's Quay Park side offers a dropped kerb but there is no corresponding dropped kerb on the other side of the street.

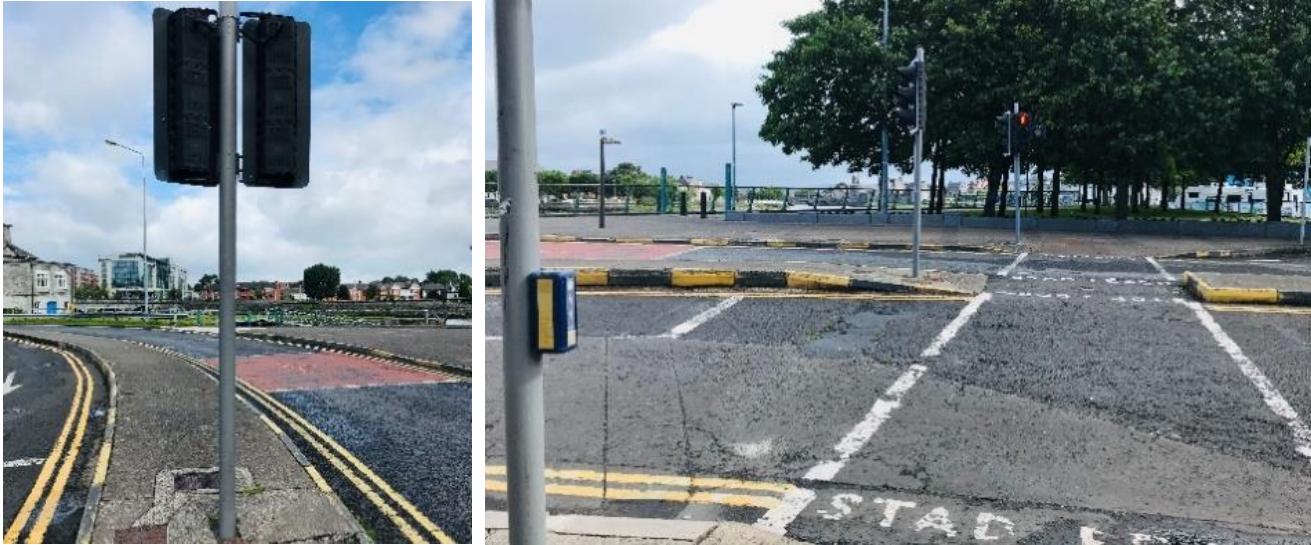
Defective Pedestrian Signals - The traffic lights across Honan's Quay to Arthur's Quay Park are confusing and dangerous for the pedestrian. As half of the road has been blocked off for years as part of the old Dunnes site, a pedestrian coming from the quays finds themselves on the centre median, where there is no pedestrian crossing button. To access the button, they have to cross half of the street, press the button, and then return to the centre median. Neither pedestrian crossing button appears to be working to summon a green man. Fault verified numerous times, waiting for 10 minutes each time with no success.

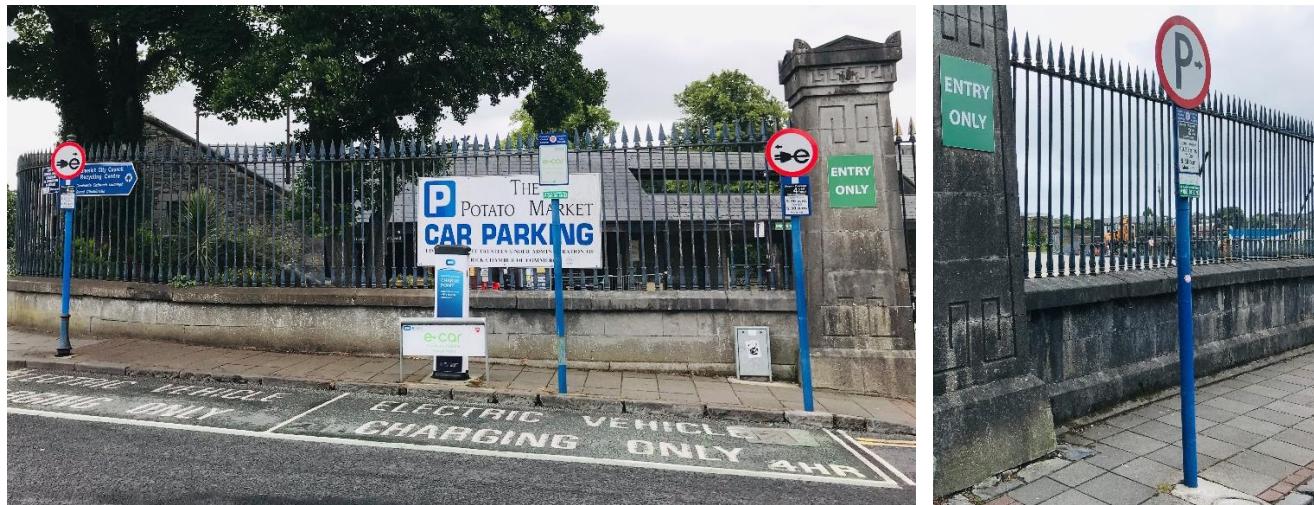
- **Allocation of Pedestrian Space is Abysmal** - There is an abundance of space in this area but only a tiny fraction is allocated for pedestrians.
- **Pedestrian Space is Cluttered and Restricted** - What little space that is allocated for pedestrian use is cluttered with signage and infrastructure for the benefit of motorists.
 - Poles located in footpath:

- **Short-term: Improve Existing Footpaths**
 - Increase footpath widths
 - Relocate poles from footpath space
 - Relocate EV charging terminal from footpath
 - Install measures to prevent encroachment of parked cars on footpath
- **Long Term: Repurpose Area as a Public Plaza**
 - Repurpose the entire area into a public plaza

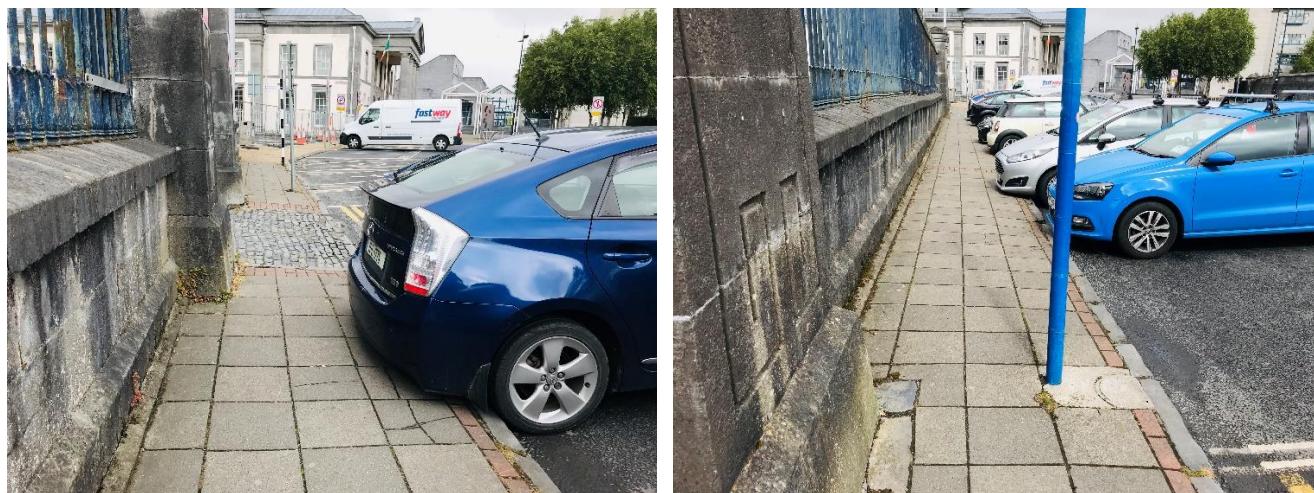
- Noses / tails of parked cars encroach on footpath space:

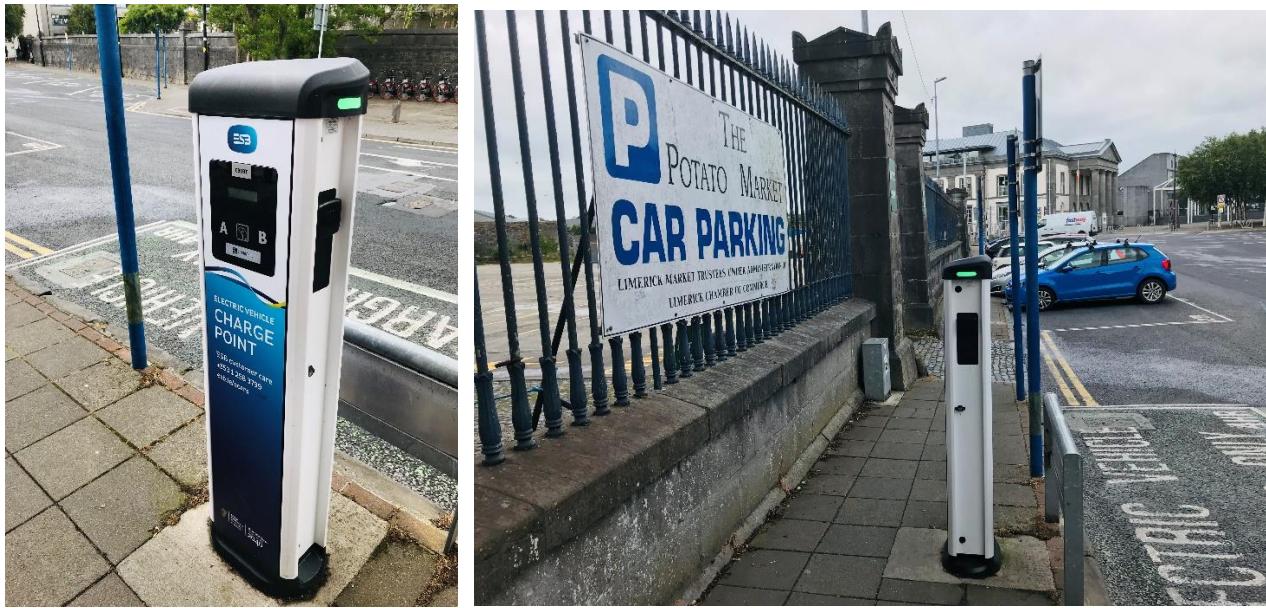
- EV charging terminal located in footpath:

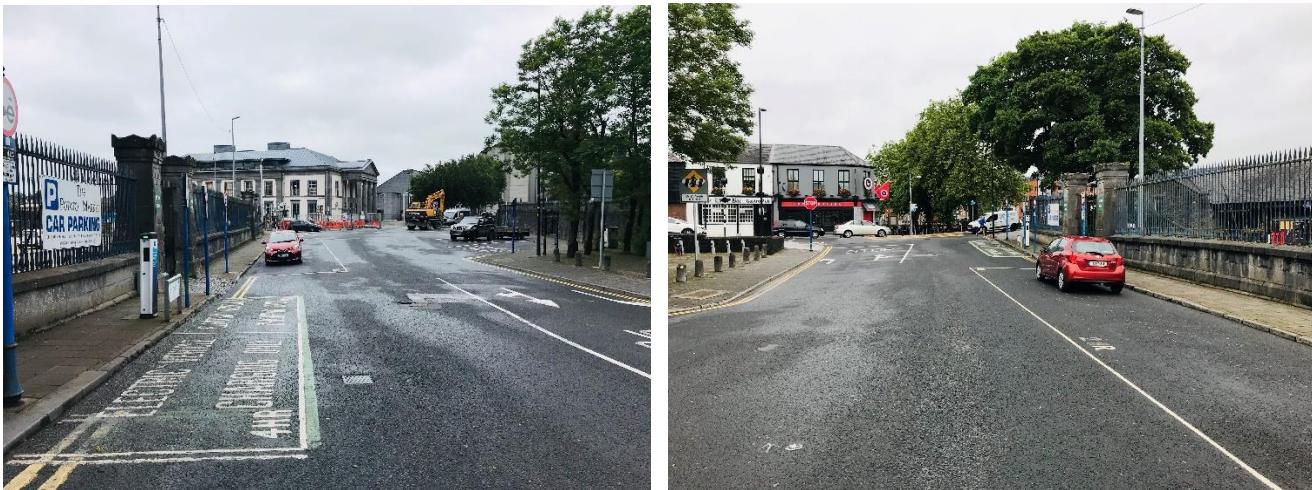
- **Overall Space is Underutilised** - The area (bounded by the Potato Market, the old Courthouse, City Hall and St Mary's Cathedral) is used as a car / coach park when it could be a public plaza serving as a hub for the Three Bridges Walk and linking to the Medieval Quarter and other tourist attractions in the city.

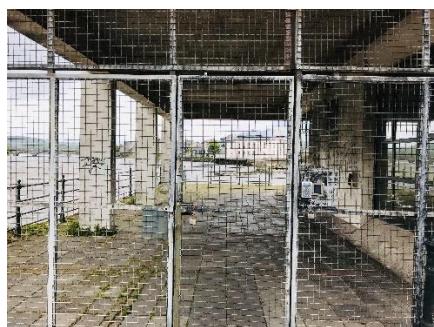
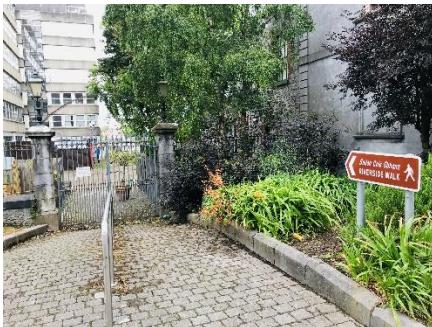
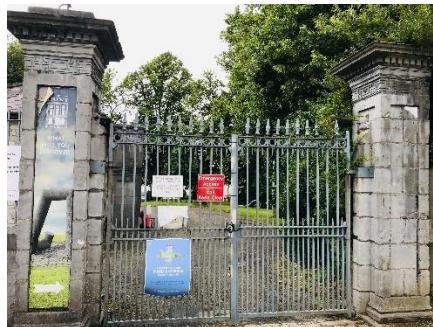
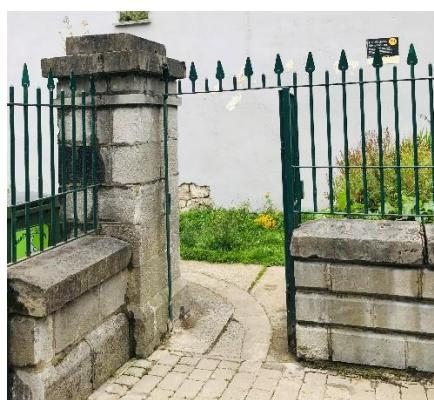
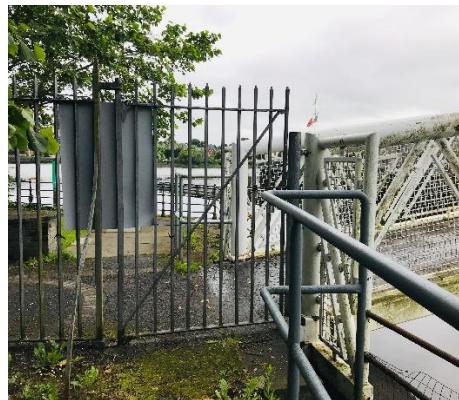
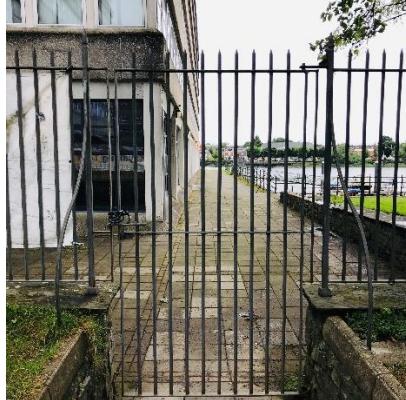
- **Uncertain Opening Times** - There are as many as 12 access points (gates) to the Riverside Walk, but no information signs on the gates stating opening and closing times, as you would see in public parks
- Neither does there appear to be coordination of the opening and closing of the various gates. This results in people either avoiding the route (taking a detour) or having to retrace their steps when they encounter a locked gate.
- Many people local to Limerick are at least aware that the gates are closed at variable times but, without information signs, it is ridiculously confusing for tourists intent on taking Limerick's flagship walk. We have all met tourists turning back from a locked gate assuming their walk is over

- **Agree Riverside Walk Opening Times & Provide Information Signage**
 - We suggest that information signs be placed at each access point to advise the public of the opening times, as is common in public parks around the city and county.

- We understand that the various gates are the responsibility of different local groups / bodies (e.g. Hunt Museum, Milk Market Trustees etc.). We suggest that Limerick Council lead a coordination exercise to agree a fixed (with seasonal variation) schedule of opening times for the entire route.

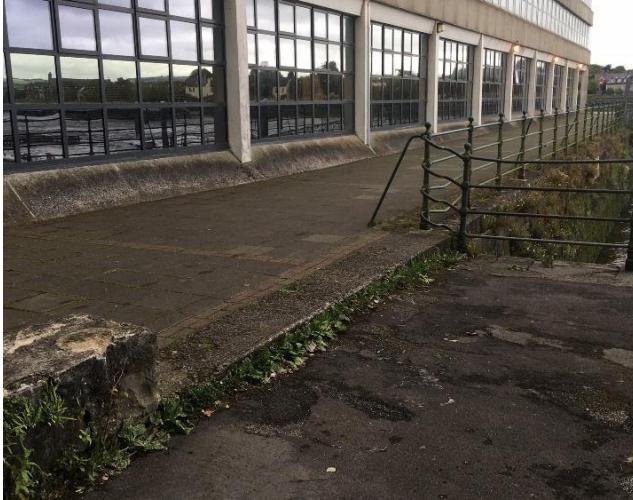
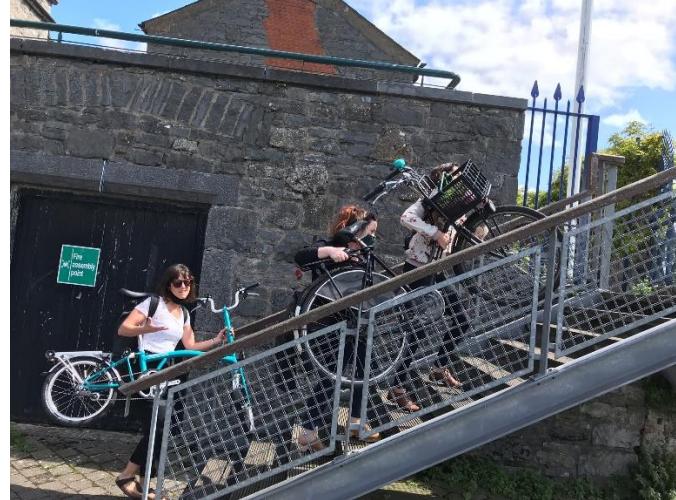
- **Access for All** - There are a number of points where the Riverside Walk (and by extension the Three Bridges Walk) is inaccessible to wheelchair users.
- Two such areas are a) at the back of Sarsfield House, and b) at the Widows' Alms Houses (see below).

- Consider options to facilitate wheelchair access at the points highlighted.
 - In the interim, place signage at access points to the Riverside Walk advising the public that sections of the walk ahead are inaccessible to wheelchair users and advising an alternative route

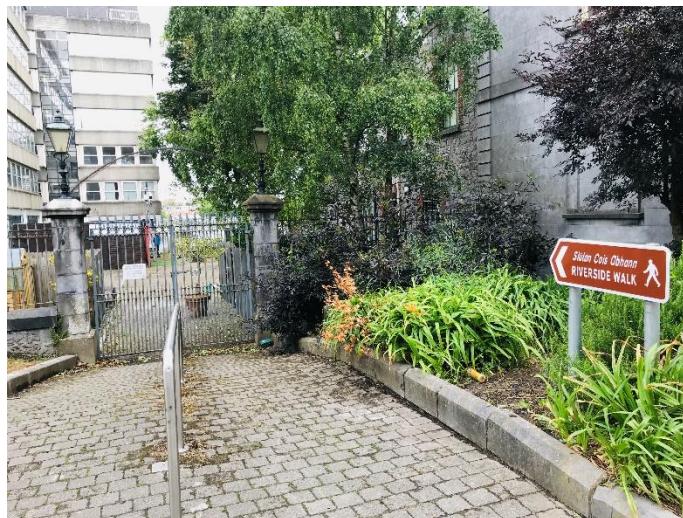
- **General Signage for Riverside Walk & Three Bridges Walk** - One of the oddities of the Three Bridges Walk, compared to similar walks in other cities, is that informational and directional signage on the walk itself is almost non-existent.
 - There's excellent information available on Limerick Council's webpage and there are some remaining orphaned signs from when the walk was launched as a Slí na Sláinte some years back but signage is sporadic and difficult to find. It's almost as though we're trying to keep it a secret from outsiders.
 - Somewhat ironically, there are a good number of signs signalling the Riverside Walk but, as mentioned in previous observations, they often point at locked gates with little in the way of explanation. In contrast, those sections of the Three Bridges Walk that are permanently open appear to have no signage whatsoever.

- **Provide General Signage for Three Bridges Walk:**
 - As an extension of the above recommendation, we suggest that directional arrows be placed around the route to give tourists confidence that they are following the correct route.

- Signage denoting an 'alternative' route should be provided to direct the public when the Riverside Walk gates are closed.
- **Address the Wheelchair Accessibility Issues**
