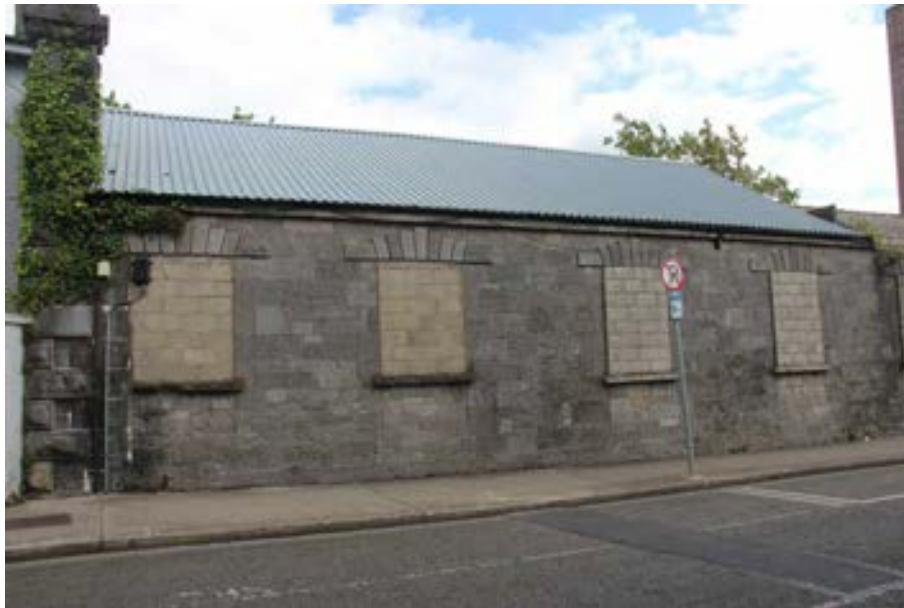
The front elevation roof plane is clad in a pressed metal corrugated sheeting, the rear roof plane, or north roof plane, is covered with fibre cement slate.

Photograph 2 North Circular Road elevation of the end section of the Cheese Plant. Note pressed metal sheeted roofing.

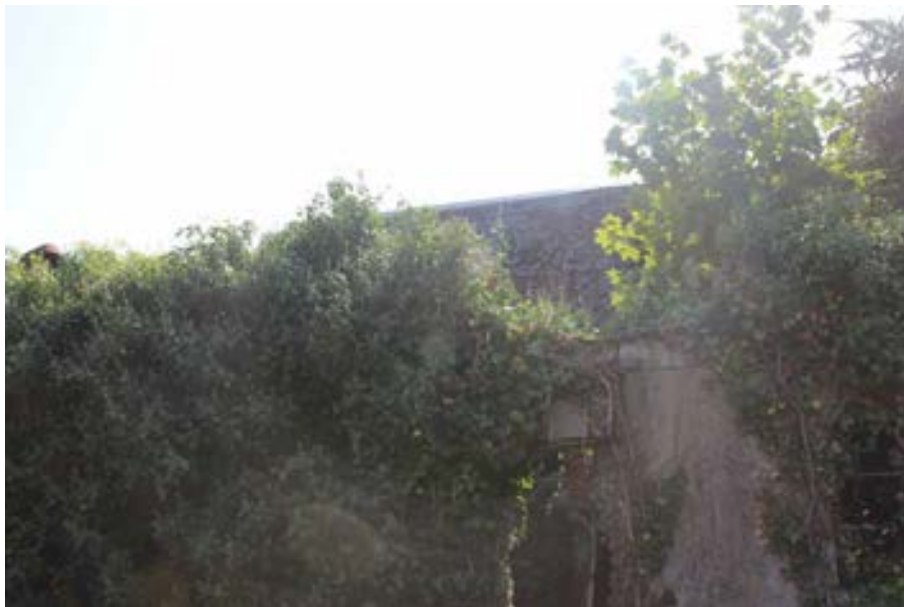
Photograph 3 View of the rear roof plane.

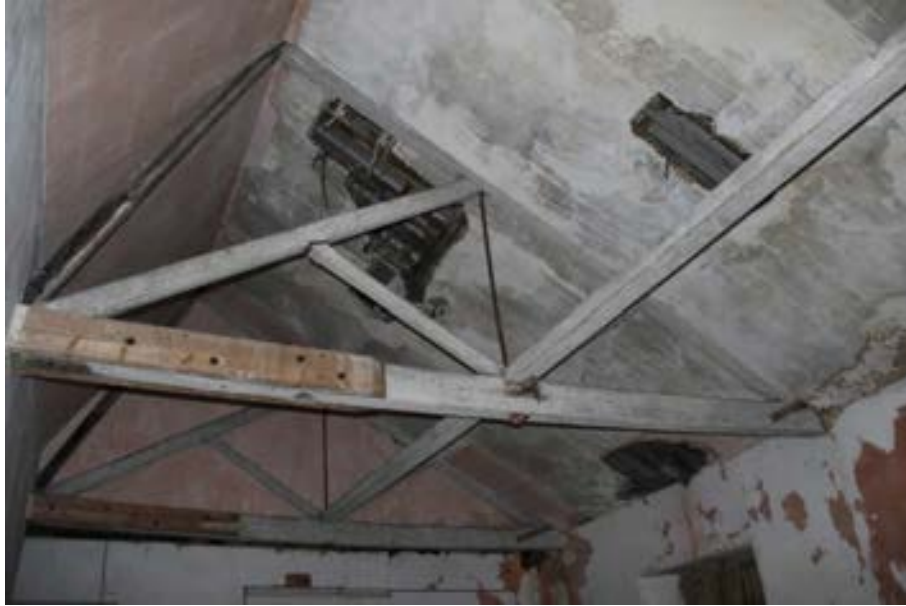
The internal ceiling extends to the underside of the roof covering, which has the original lath and plaster splayed ceiling still intact.

Photograph 5 Internal view of the splayed ceiling in the first section of the subject building.

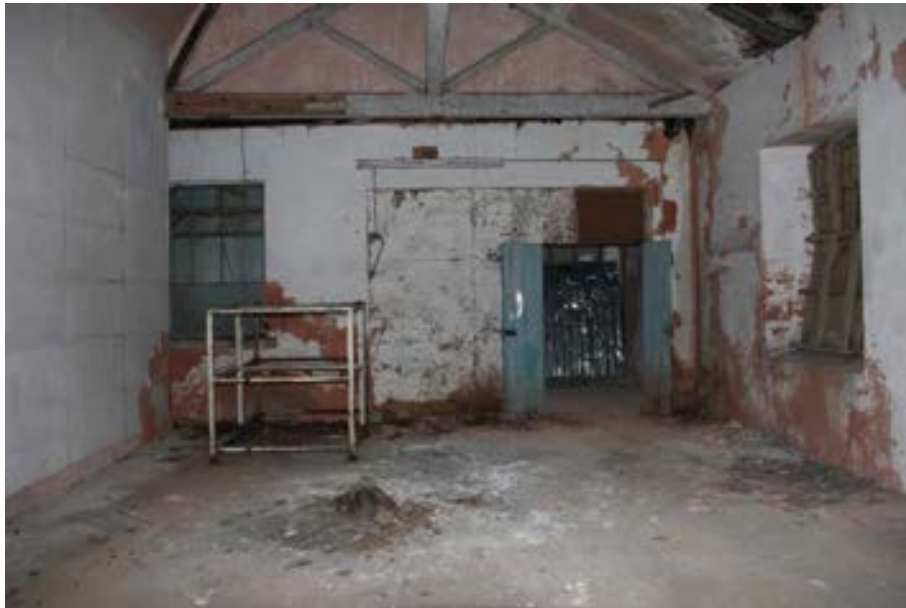
The internal walls of the building, where accessible are finished in a modern gypsum-based plaster throughout.

Photograph 7 General view of the internal of the first section of the subject building.

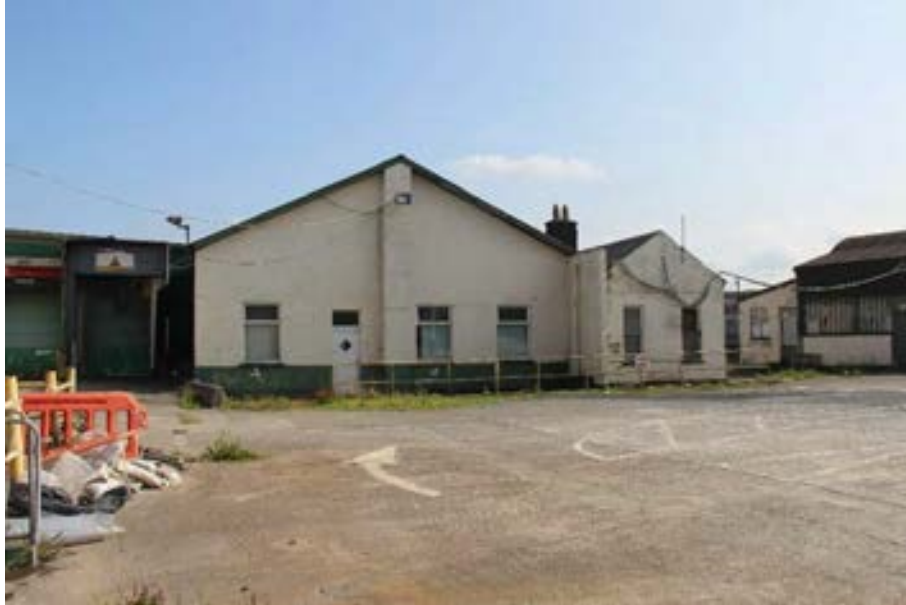
Photograph 2 Administration and Laboratory building to the LHS, welfare building to the RHS

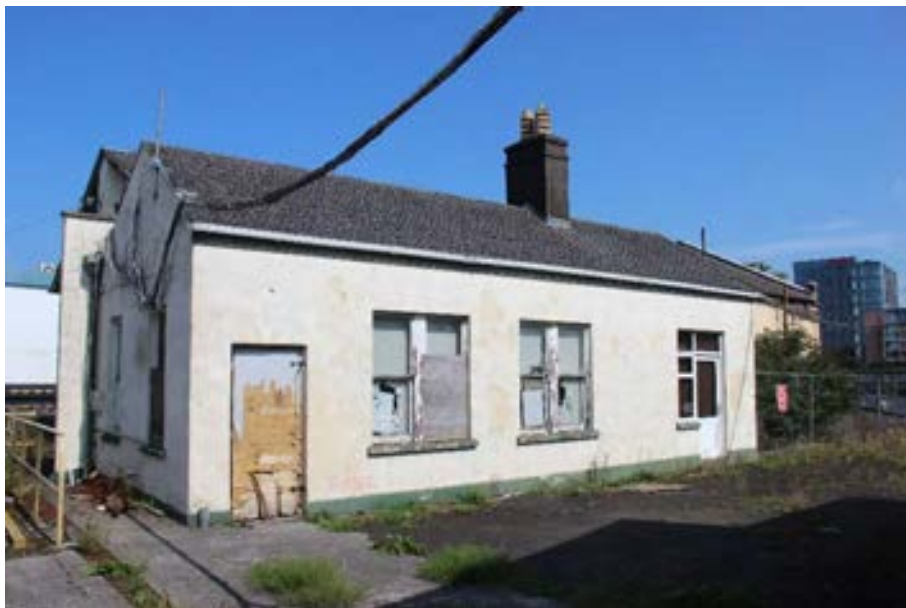
The roof to the welfare building comprises a single cementitious rendered chimney stack, protruding from the ridge line of the roof, with two clay pots. There is visible rolled lead sheet counter flashing to the chimney abutments, onto a gable to gable pitched roof, covered with fibre cement slate.

Photograph 3 General view of the “welfare” building.

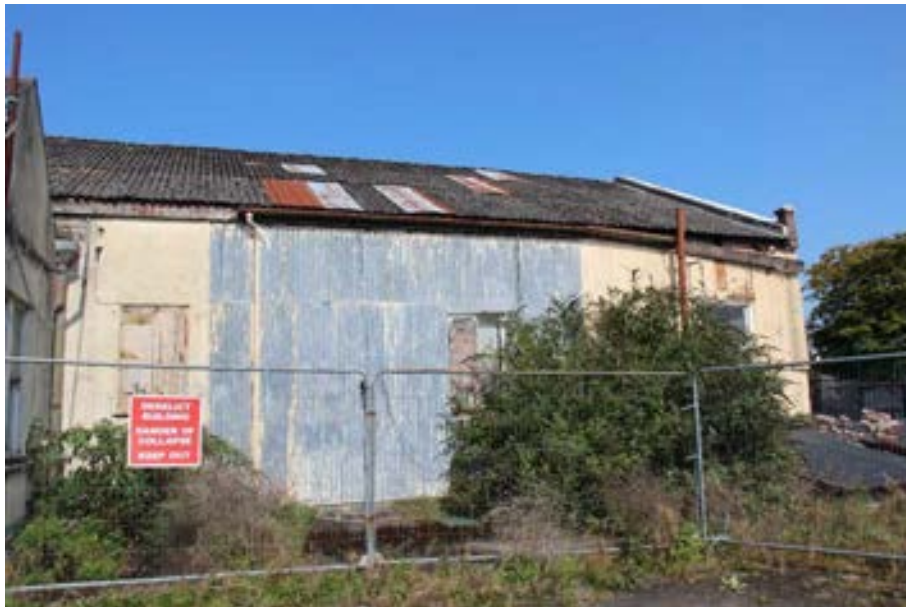
The external walls of the Administration and Laboratory building are finished in multiple materials, namely cementitious render to the western gable and northern return, with some natural stone exposed, albeit painted. The southern elevation, to the east of the welfare building, is finished in a mixture of cementitious render finishes with corrugated sheeted panels to the rear section of this elevation.

Photograph 4 View of the southern elevation, showing the corrugated sheeted panels.

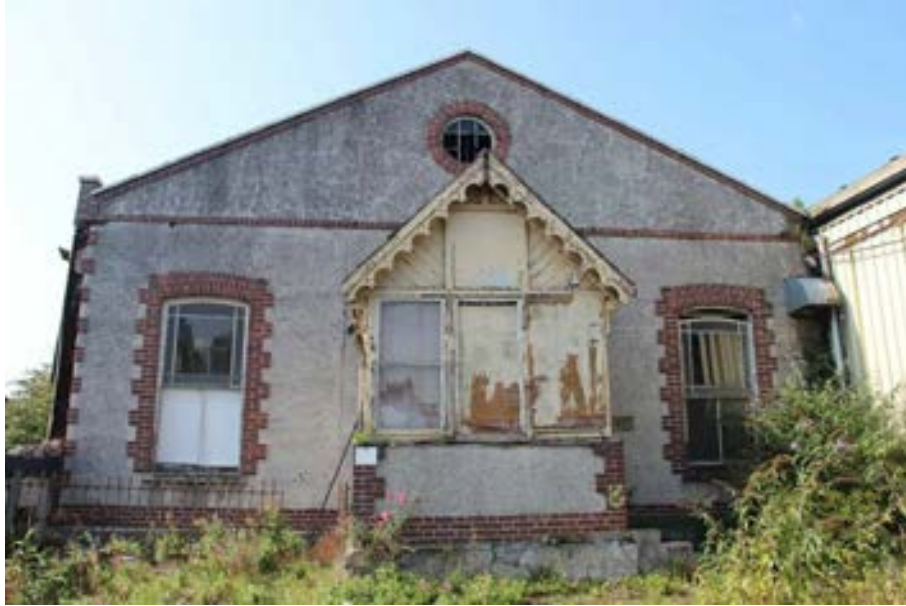
There is a decorative porch to the eastern elevation, with a fibre cement roof covering, decorative gable fascia's, a full bay fenestration of sash up down window assemblies and masonry plinth walls. The remainder of the gable has brick on edge banding at eaves, to the pitched gables, and decorative brick surrounds to the openings, with brick quoins and gable piers.

Photograph 5 Eastern gable of the Administration and Laboratory Building.

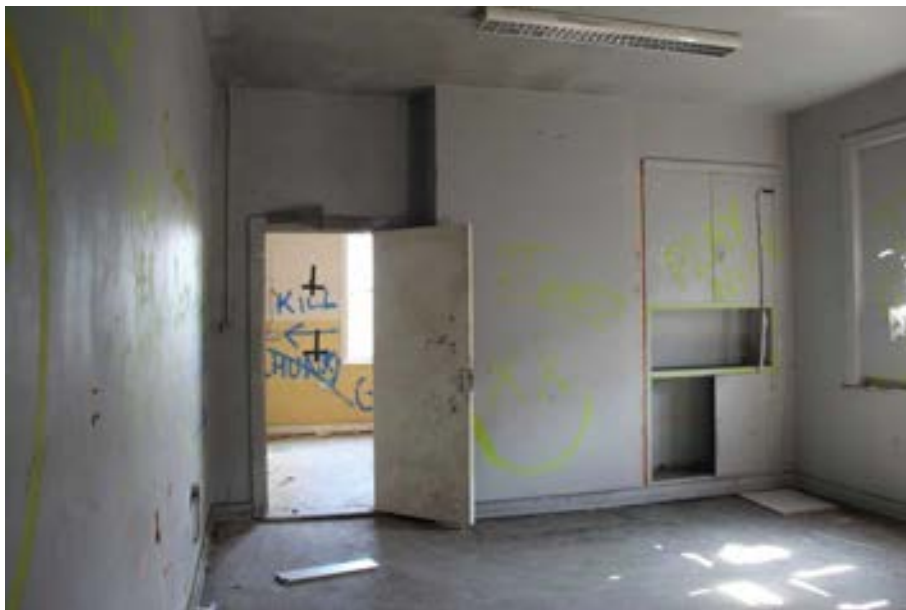
Photograph 6 General internal view of the “welfare” building, with a modern plaster slab ceiling, and modern plaster slatted drylined internal walls.

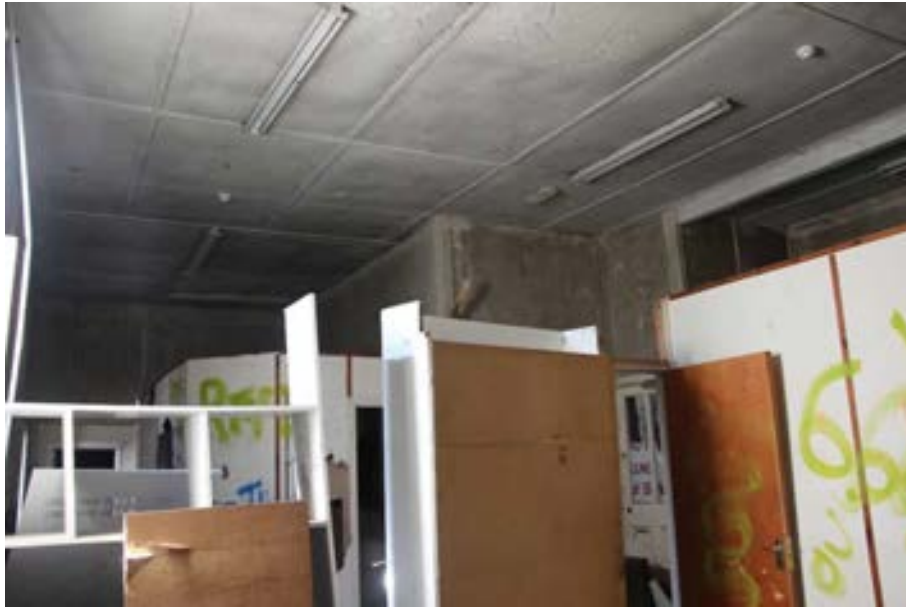
The administration and laboratory building is noted to be finished with a mid-twentieth century ceiling application, which has the appearance of “beauty board.” This is present throughout the Administration and Laboratory building.

Photograph 7 Example of the ceiling to the Administration and Laboratory building.

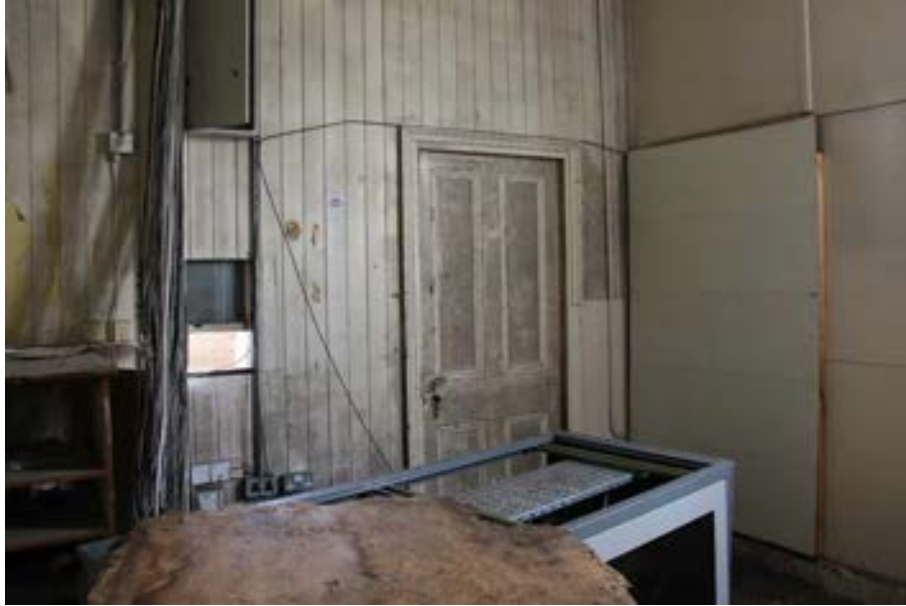
The internal walls of the Administration and Laboratory building are noted to be tongue and grooved panelling throughout. On the external walls, they are fixed as a drylining and are affixed both sides on the internal partition walls.

Photograph 9 Example of the variance of internal wall finishes, with T&G Panelling visible and more recent “beauty board” panelling.

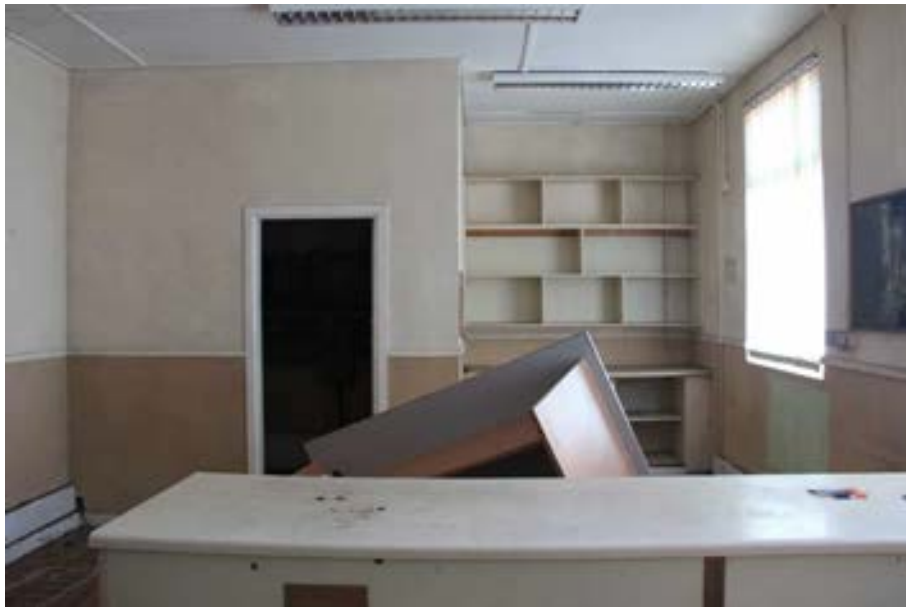
In the front offices there are modern plaster slabs fitted to both the external walls and internal walls, these may be directly onto the original panelling however (as with the laboratory).

Photograph 10 Front office, with modern plasterboard applied to the walls.

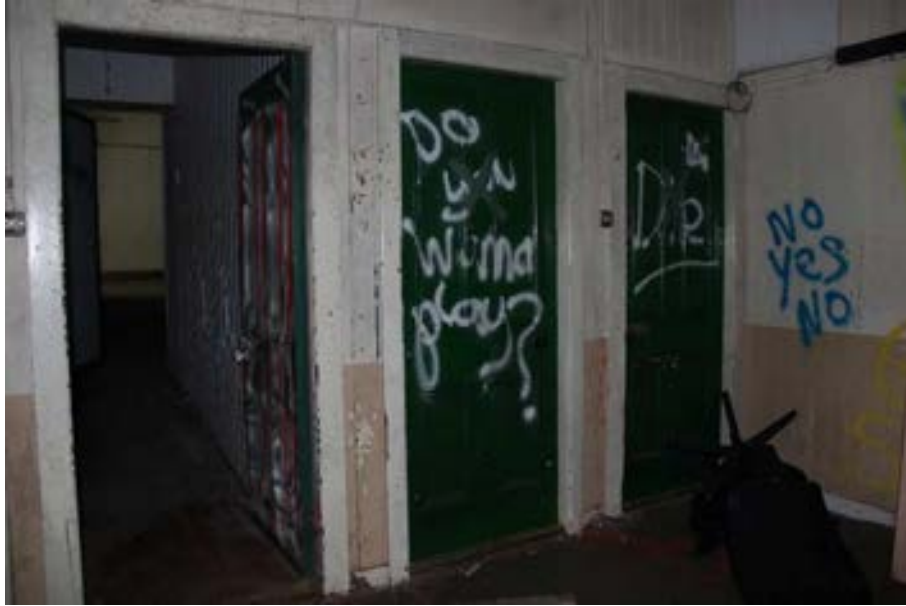
Photograph 11 Examples of panelled doors, to the toilet area of the main building.

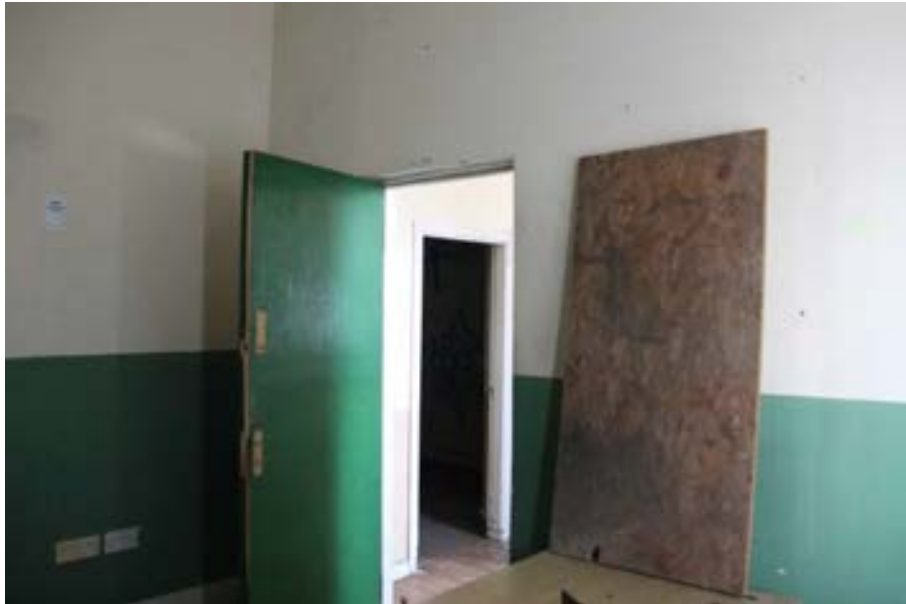
Photograph 12 Example of a hollow core door leaf, found mostly to the western section of the main building.

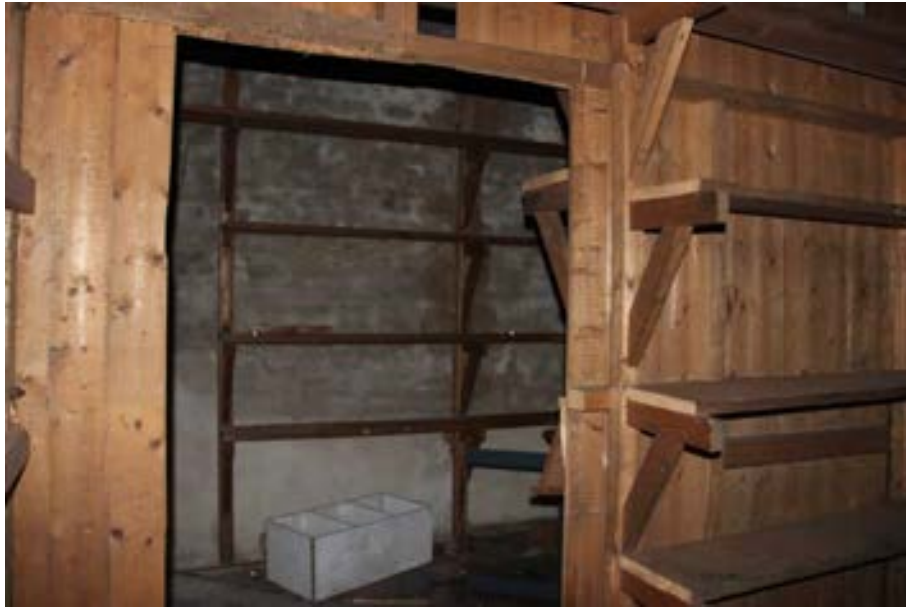
Photograph 13 Timber panelled and shelved storage room.

There are a number of surviving joinery and unit installations however, with a timber panelled and timber shelved storage room, in good repair and the shelving and units of the offices and laboratory still extant in the respective rooms.

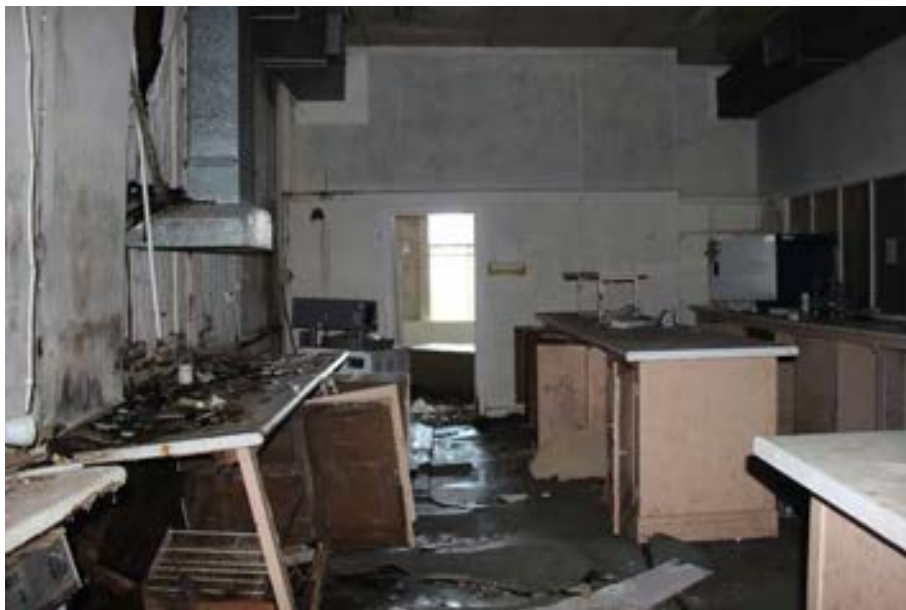
Photograph 14 General view of the laboratory and the surviving units therein.

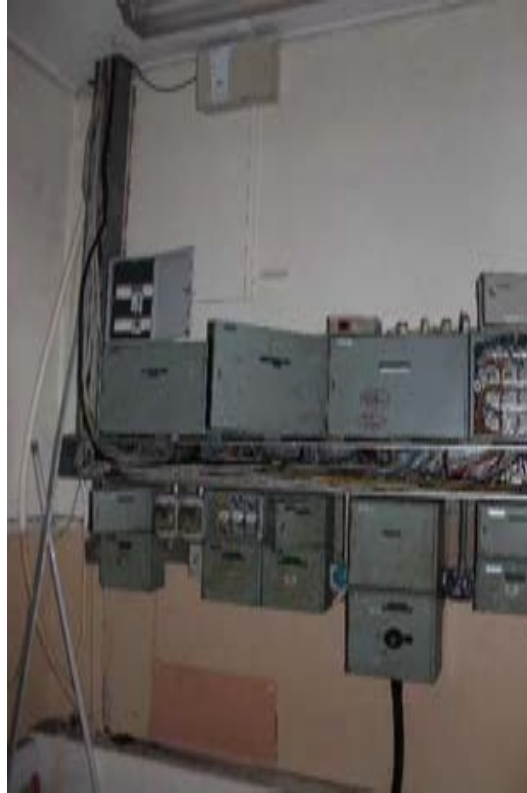
The services installations are noted to be mostly modern, with fluorescent tubed fittings throughout the buildings, modern electrical sockets and light switches mounted to the walls etc. With telecom points and fire detection systems etc also present.

Photograph 16 Surviving fuse boxes, meters, alarm systems etc.

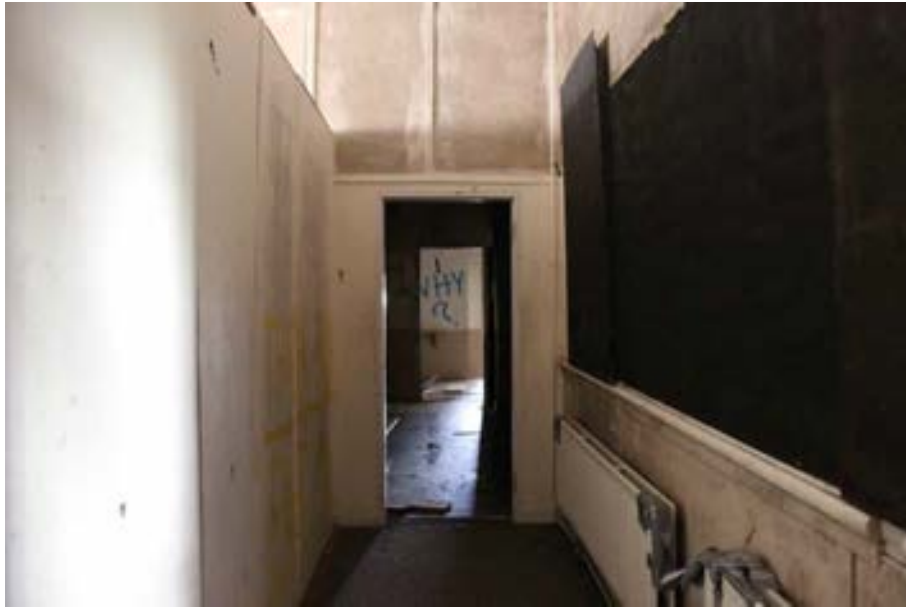
From a heating perspective, there are modern radiators (water heated), also noted throughout.

Photograph 17 Rear Hallway with modern hot water rads installed.

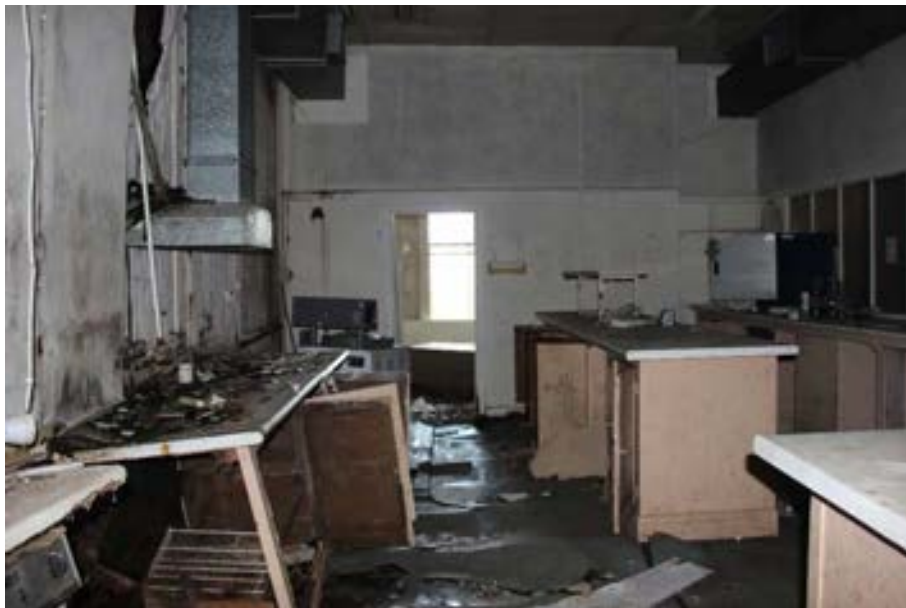
The remnants of foul air extraction systems are also present within the laboratories.

Photograph 18 General view of the laboratory, note extraction ducting.

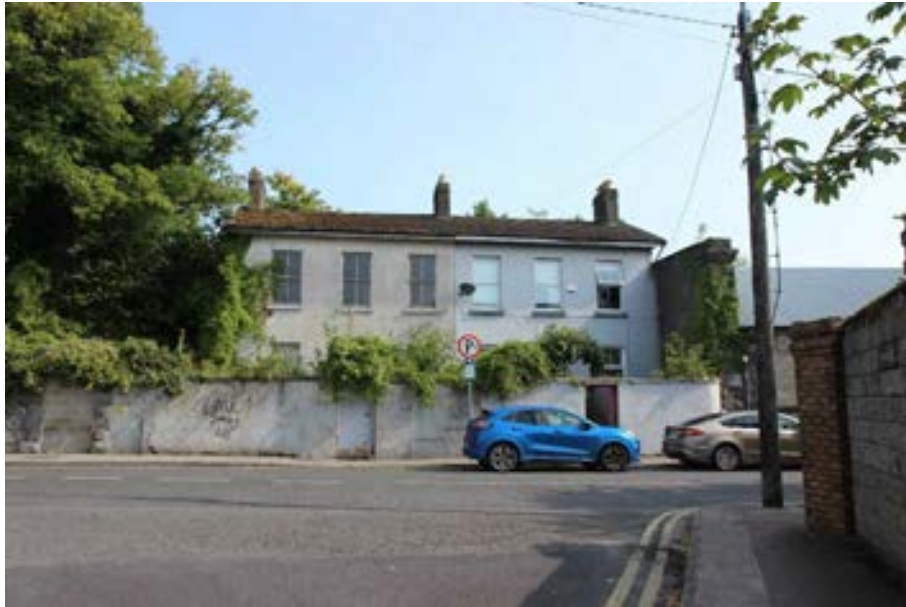
Photograph 2 - Front façade Building A (LHS)

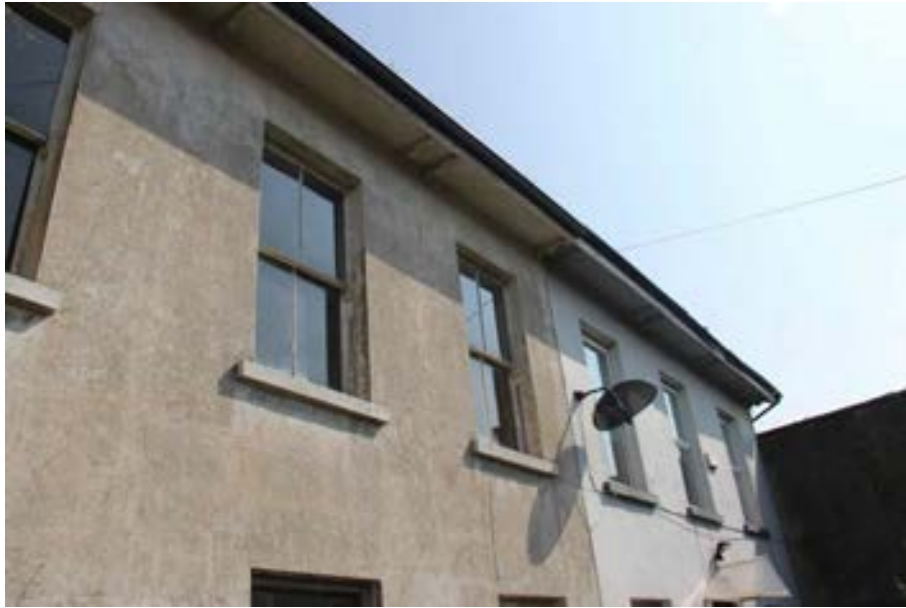
Photograph 3 - Cementitious render ruled and lined.

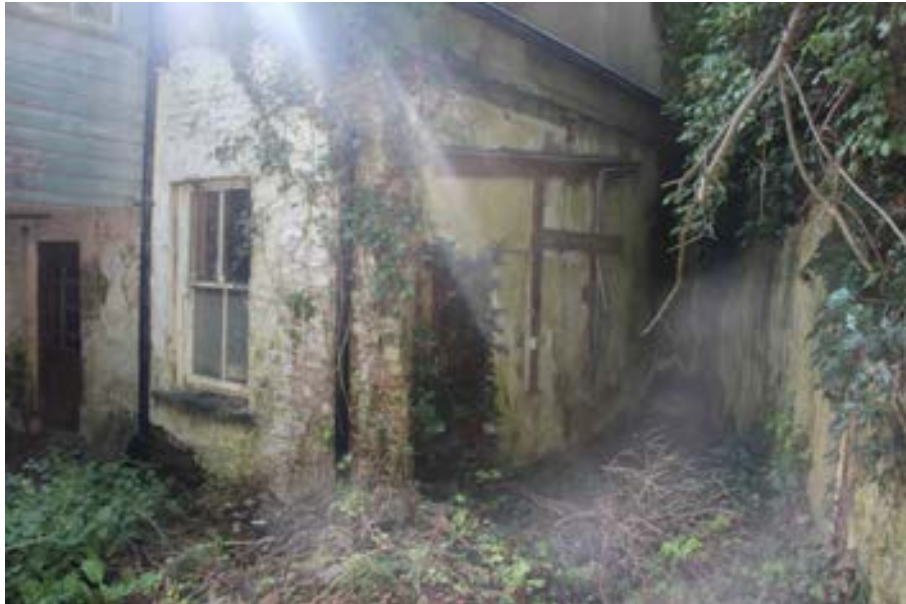
Photograph 4 - Rear and gable end elevations indicating former lean-to and door to kitchen.

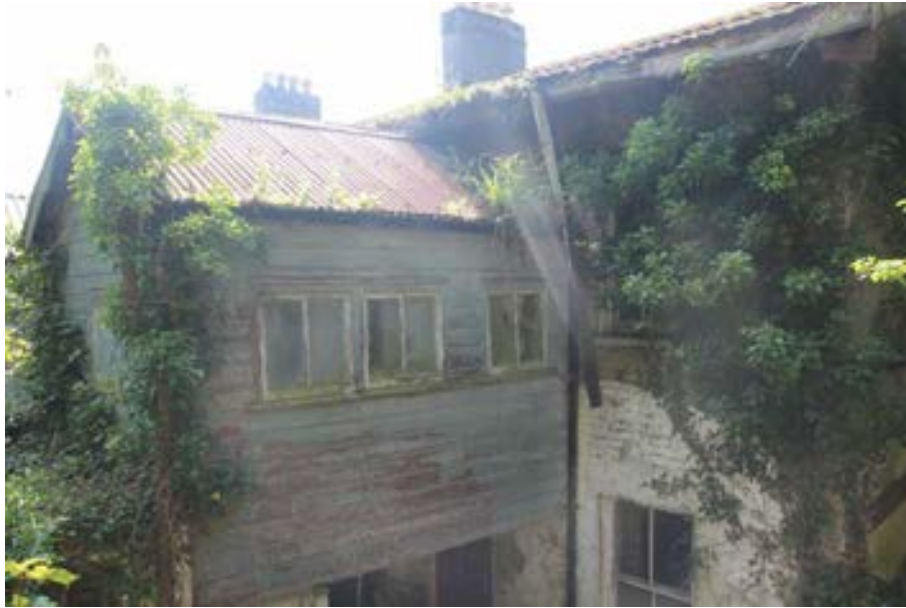
Internal structural elements within the outbuilding suggest that the Return Annex was supported on cast iron columns and perhaps the outbuilding was retrofitted later.

Photograph 5 - Timber clad Return Annex with corrugated iron roof and painted brick to main building.

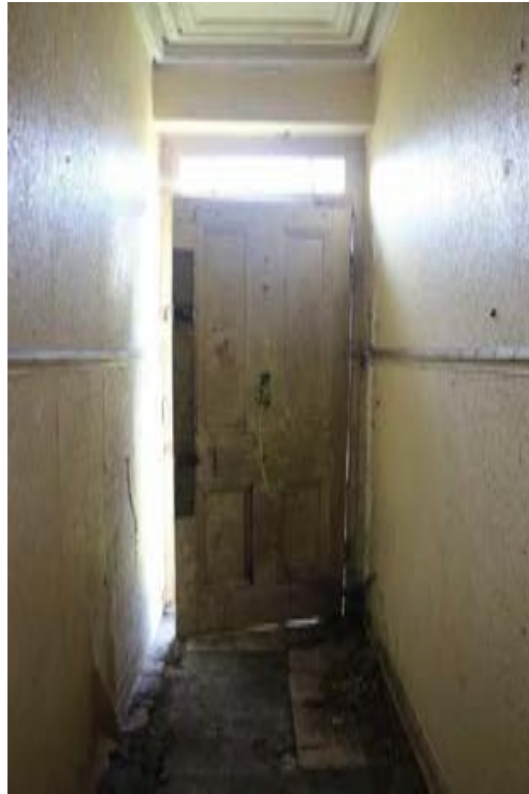
Main entrance door is a four-panel timber door and may be original. On the external side it is faced with ply sheeting with brass knob protruding. The door frame is still in place and paint layers, now peeling, reveal earlier paint coats. The overhead transom light is intact and appears original. The rear door is timber three panelled door with two lower timber panels and an upper glazed series of panes, that are stained glass. The upper section of this feature matches the transom light at the main entrance door. There is a third door from the kitchen that would have led into a lean-to extension (no longer extant). This is of timber vertical boards with a brass knob.

Photograph 6 - Internal face of Entrance door.

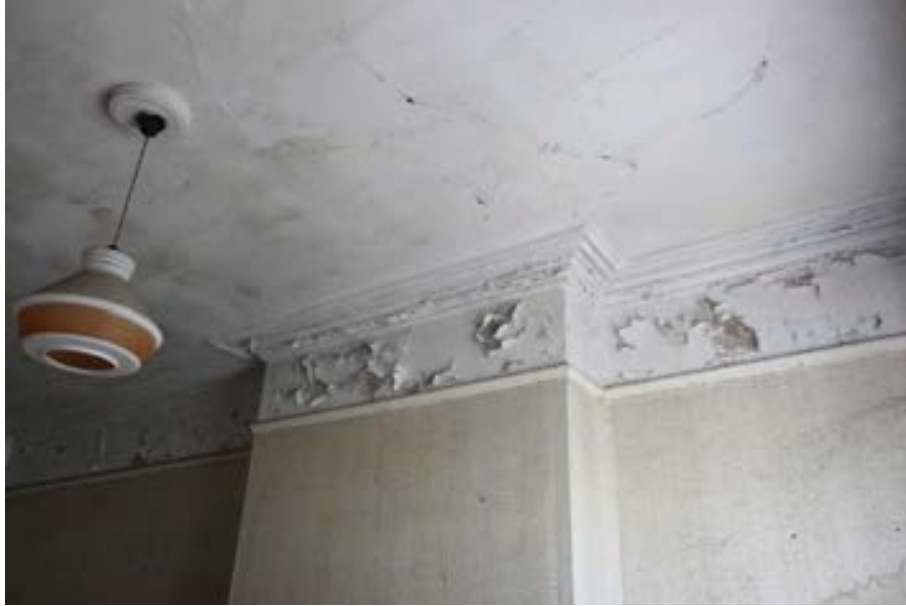
Photograph 9 - Wallpapered and painted ceiling to front room. Coving intact.

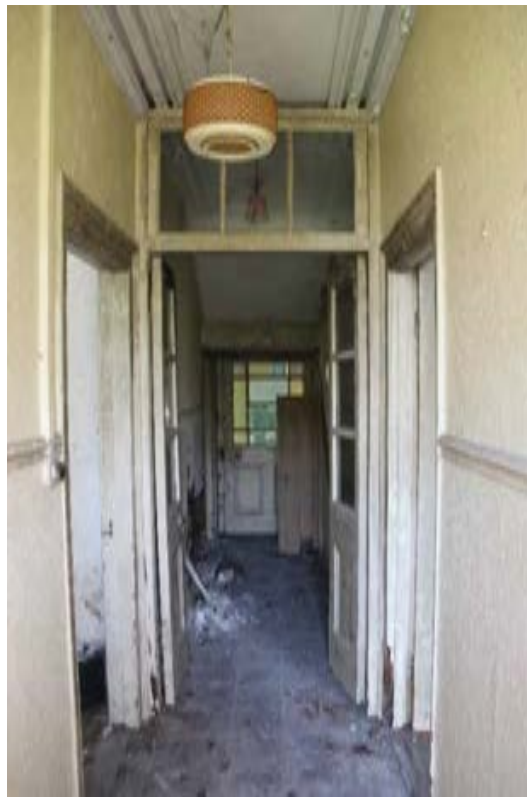
Photograph 10 - Hall corridor walls with textured wallpaper and dado rails.

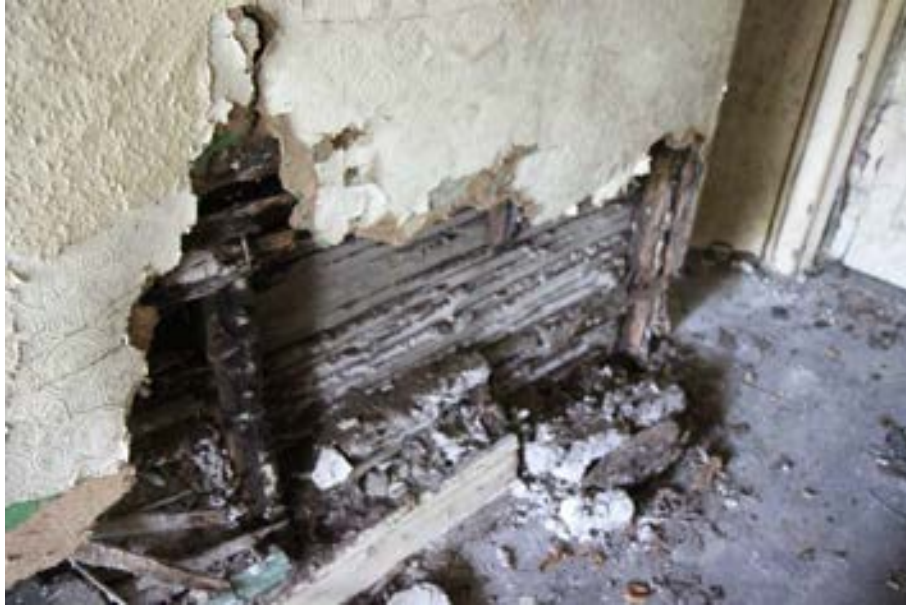
Photograph 11 - Lath-and-plastered stud wall to hall corridor.

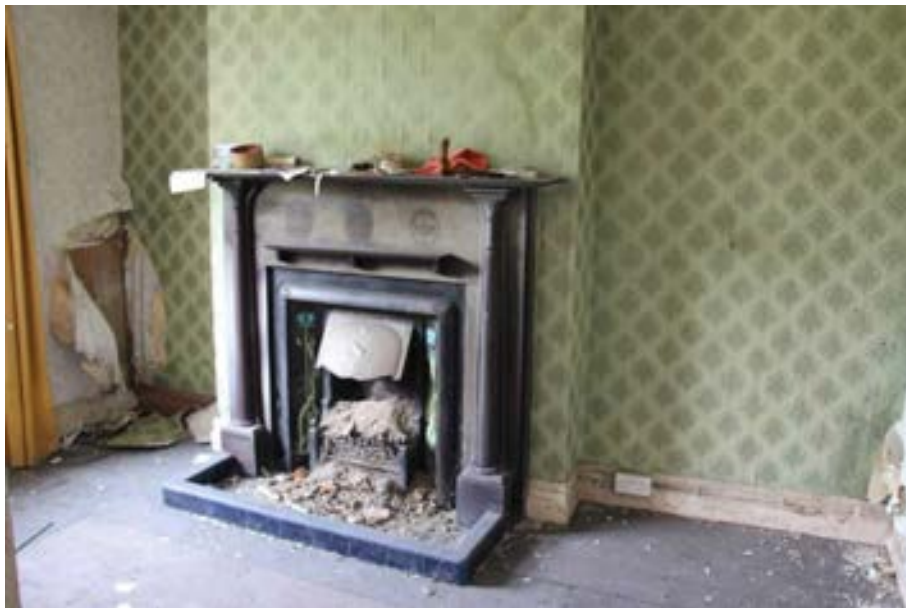
Photograph 12 - Fireplace front room 1st LHS.

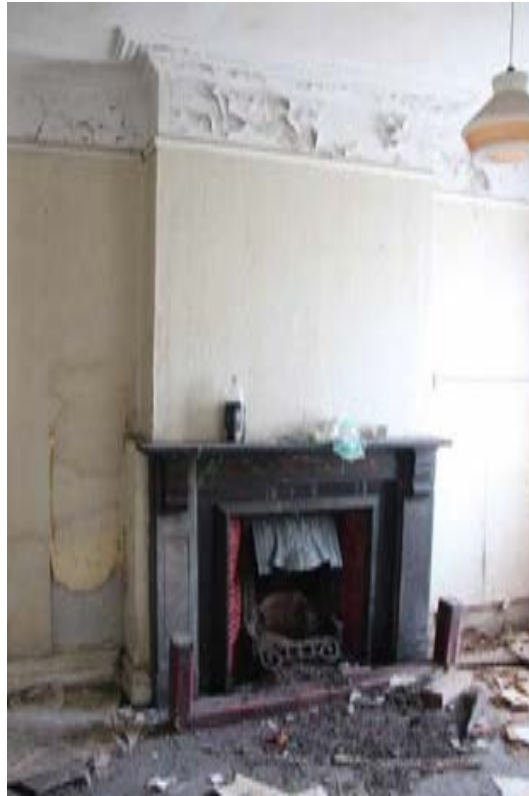
Photograph 13 - Fireplace front room 1st RHS.

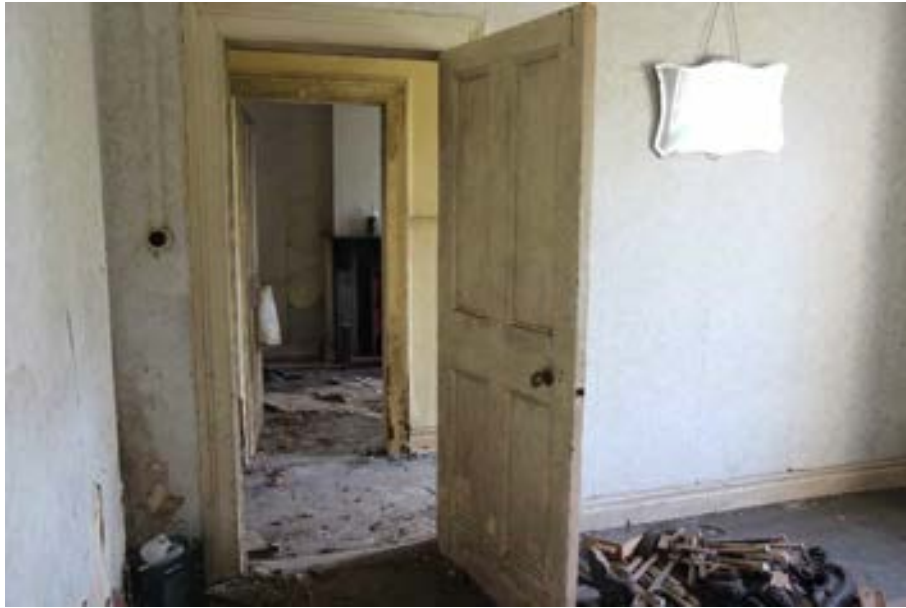
Photograph 14 - Internal doors to front room - 4 panel solid timber with oval brass handle.

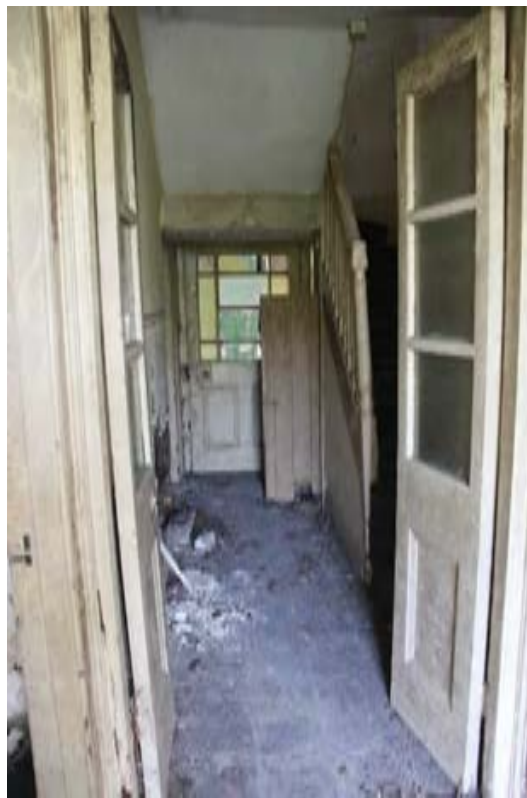
Photograph 15 - Double leaf door used to separate front of house from rear.

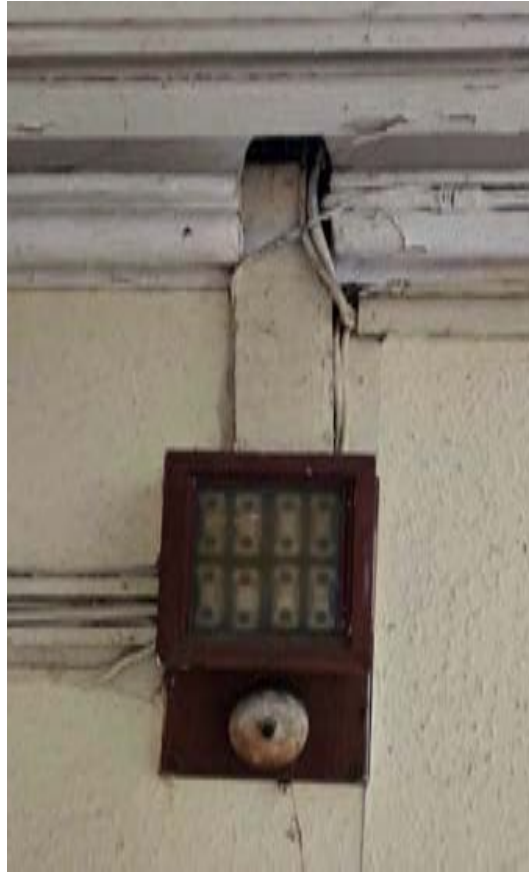
Photograph 16 - Early room service electric bell ring.

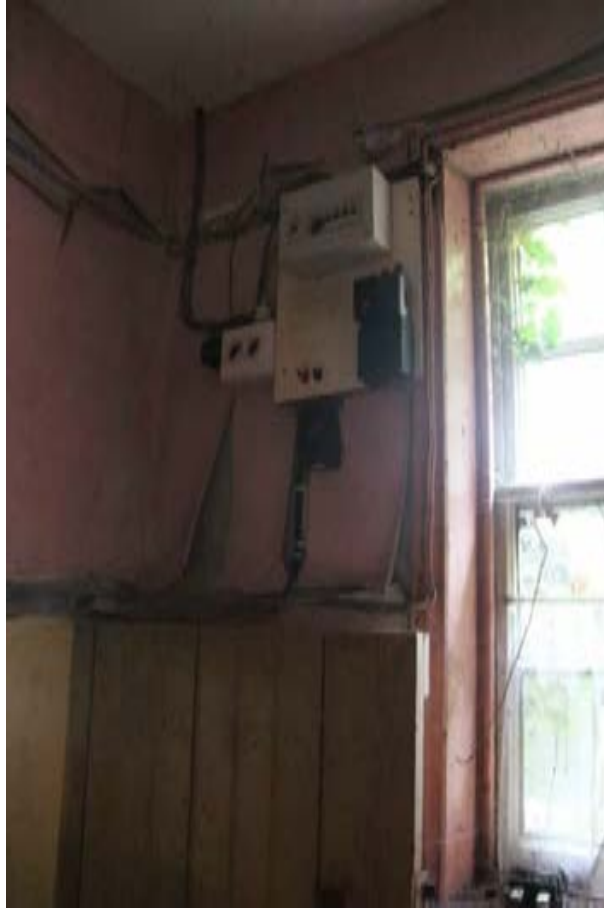
Photograph 17 - Modern fuse box located in home office.

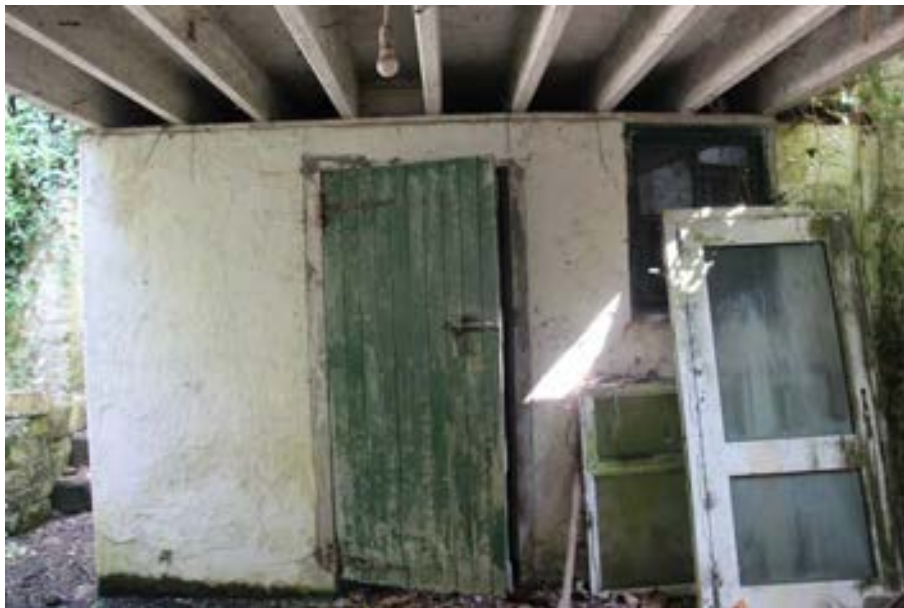
Photograph 18 - Outbuilding front facade with exposed joists to underside of Return Annex.

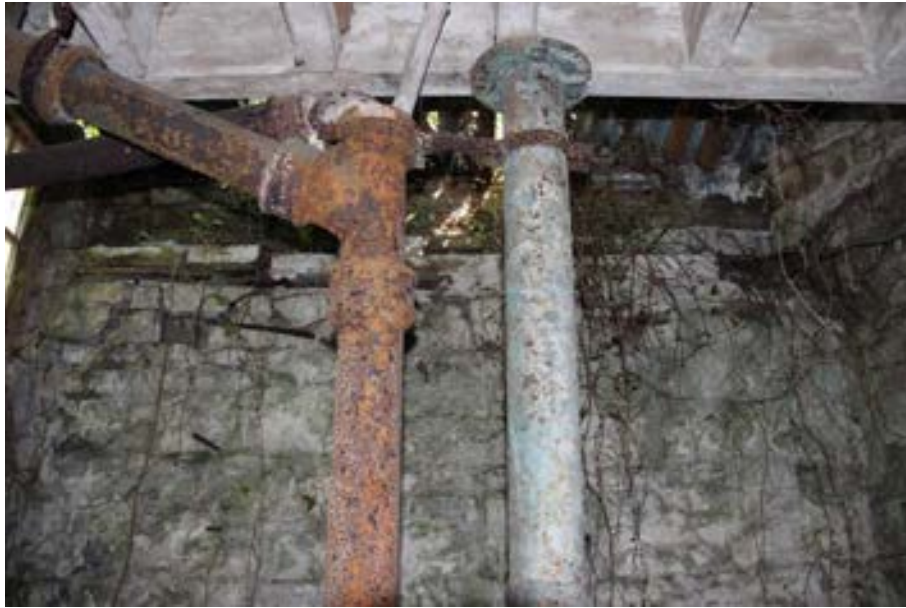
Photograph 19 - Cast iron support system for Return Annex floor.

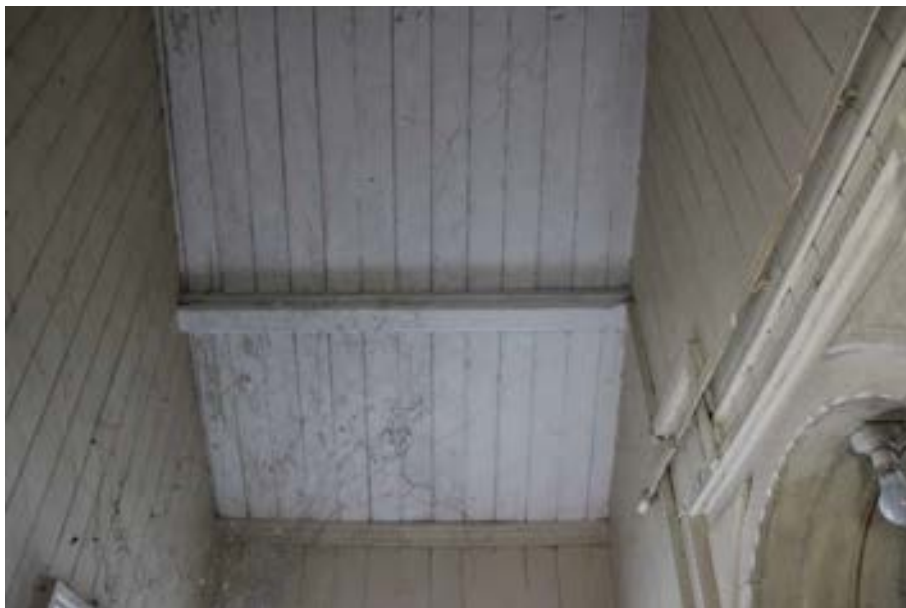
Photograph 20 - timber boarded ceiling to Return Annex.

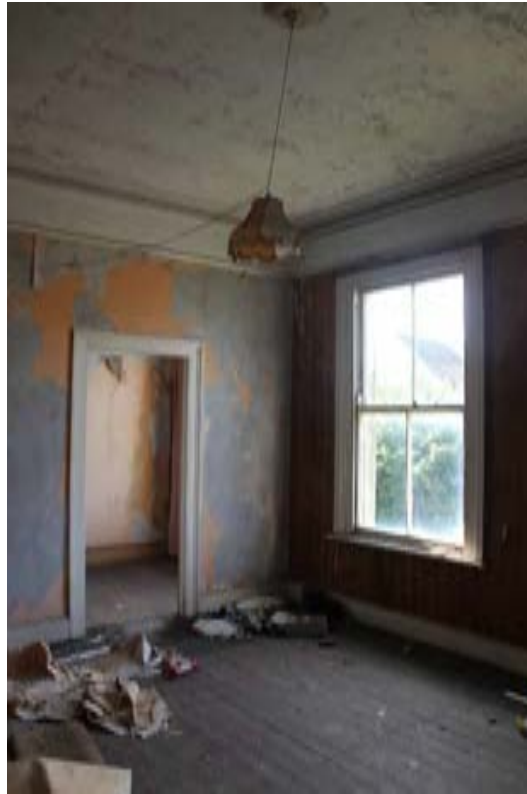
Photograph 21 - Lath-and-plaster ceilings to front room.

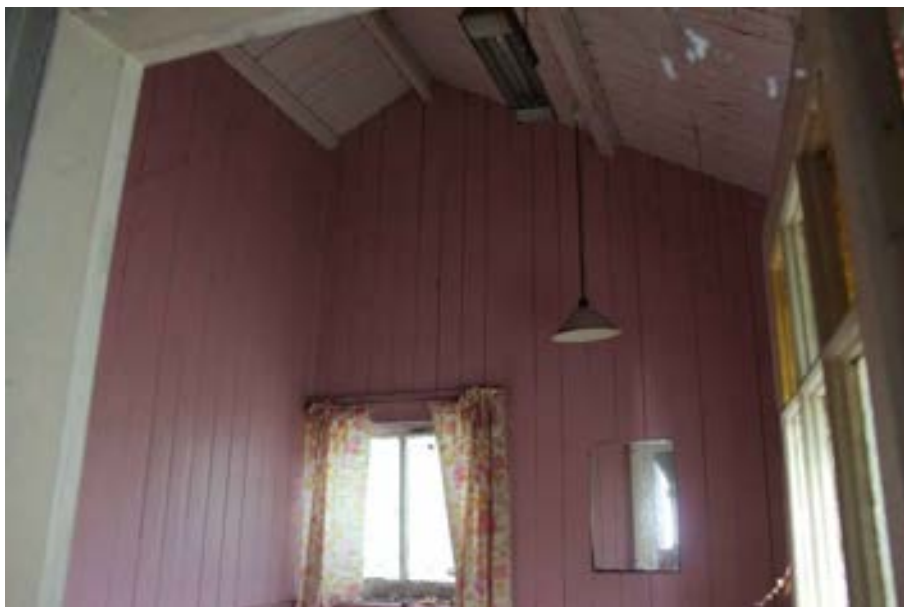
Photograph 22 - Timber boarding to Return Annex walls.

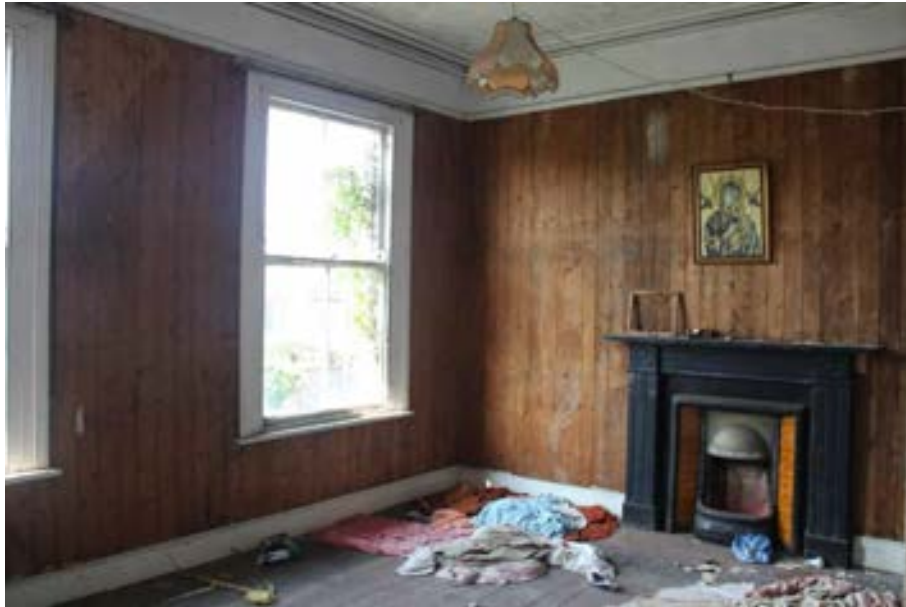
Photograph 23 Front room internal partition and inner face of external wall finished in timber boarding.

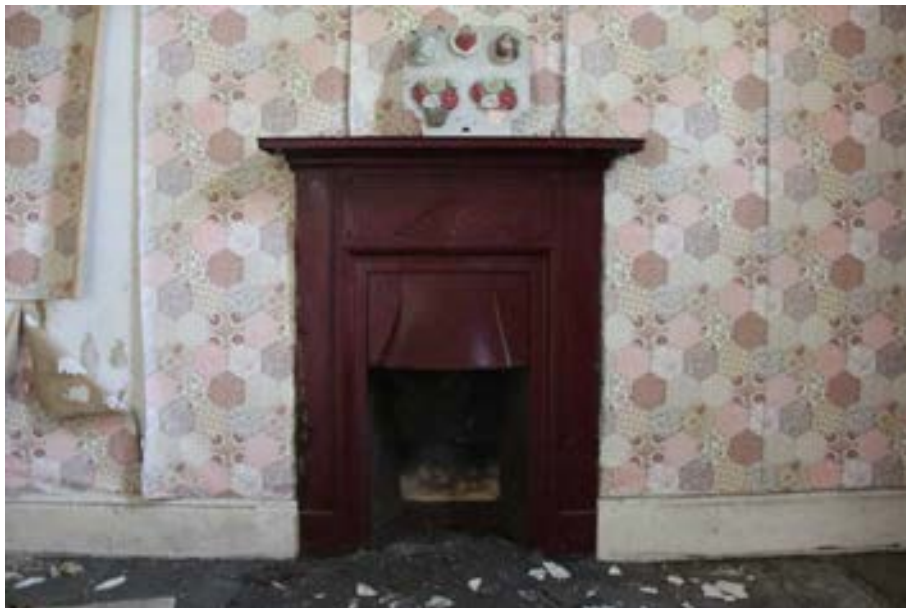
Photograph 24 - Original cast iron fireplace to rear bedroom.
