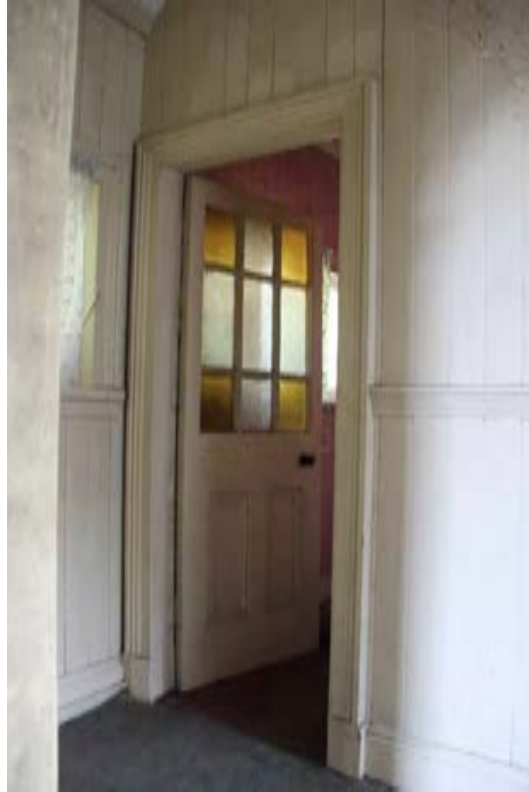
Photograph 25 - Return Annex timber door with glazed upper section.

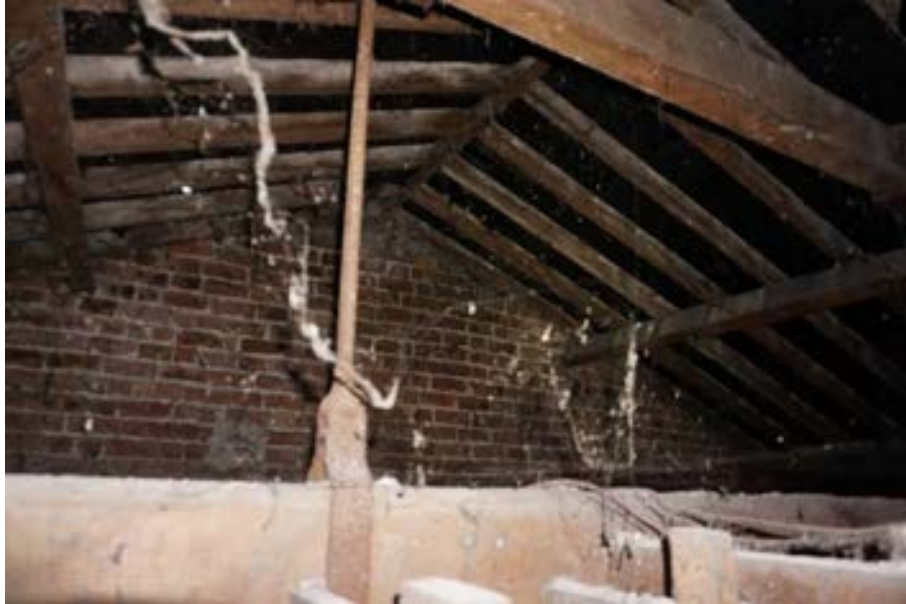
Attic has a cut timber roof consisting of cementitious replacement slates on bitumen underlay on original timber rafters on purlins with truss supports. Cast iron hangers are used to tie the truss members. The original lime parging is evident between the joists.

Photograph 26 - Roof Space indicating cast iron hanger.

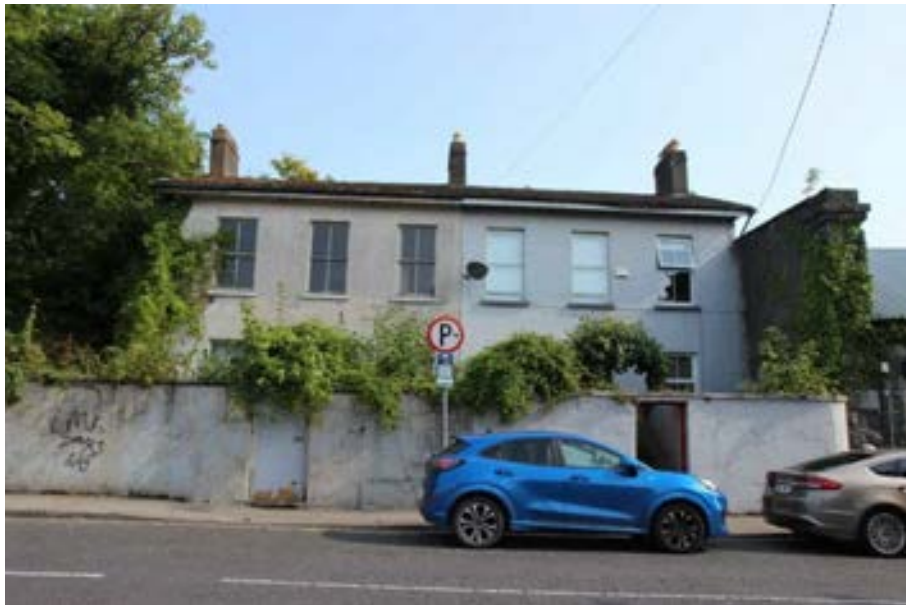
Photograph 27 - Front facade Building B (RHS)

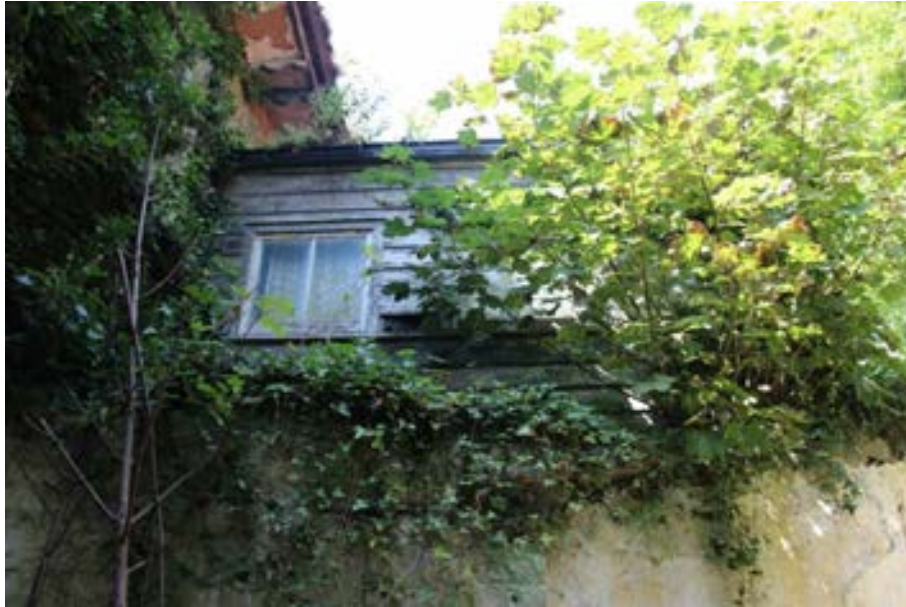
Photograph 28 - Return Annex with corrugated iron roof.

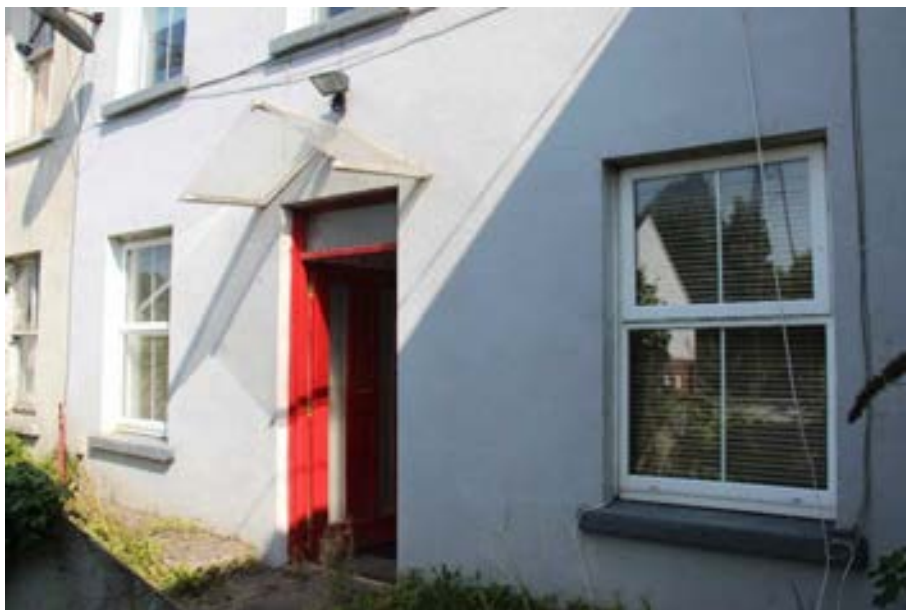
Photograph 29 - Front facade lower, cementitious render ruled and lined and painted.

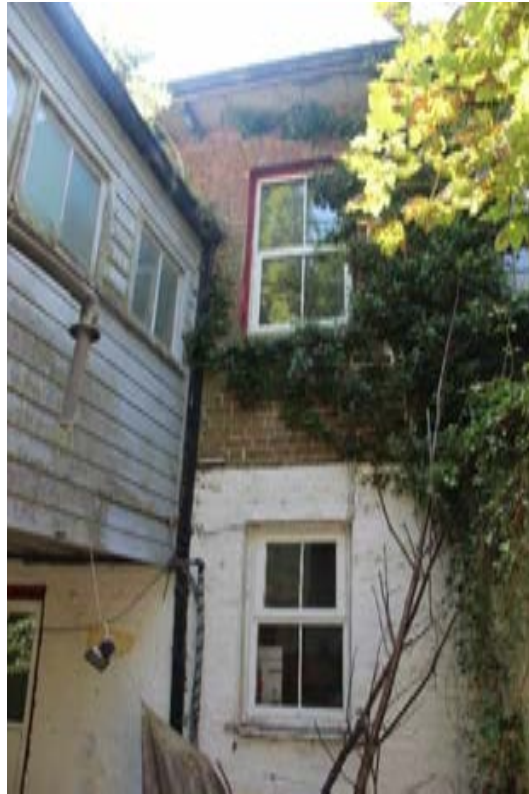
Photograph 30 - Main dwelling rear facade with painted brick and exposed brick.

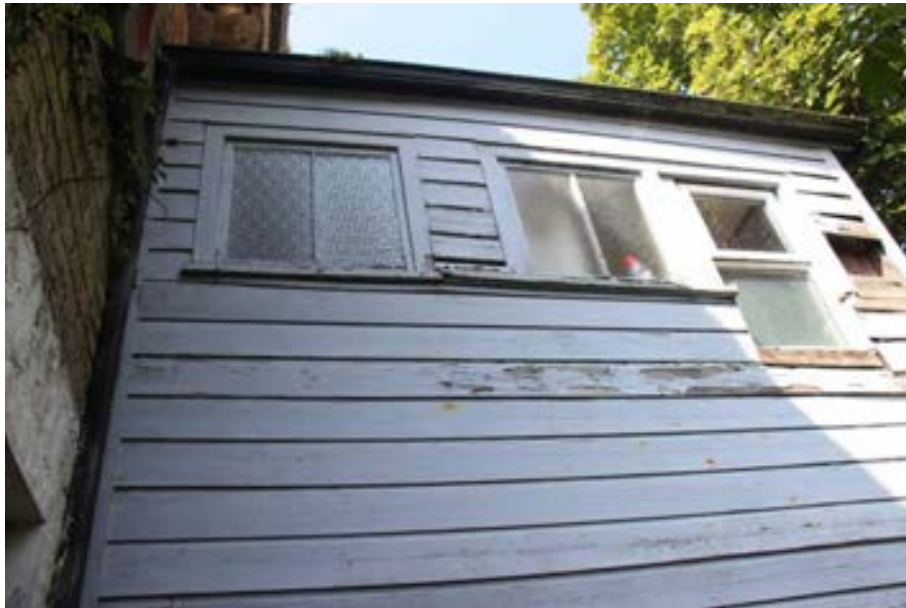
Photograph 31 - Return Annex timber cladded walls of site facade.

Windows are replacement double glazed uPVC top hung casement with some original timber casements remaining on the Annex Return. (See photograph 31 above).

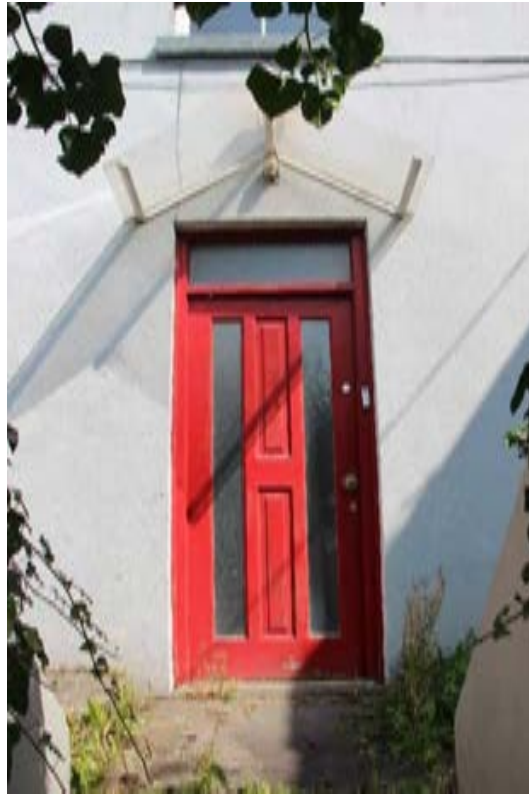
Photograph 32 - Modern replacement main entrance door.

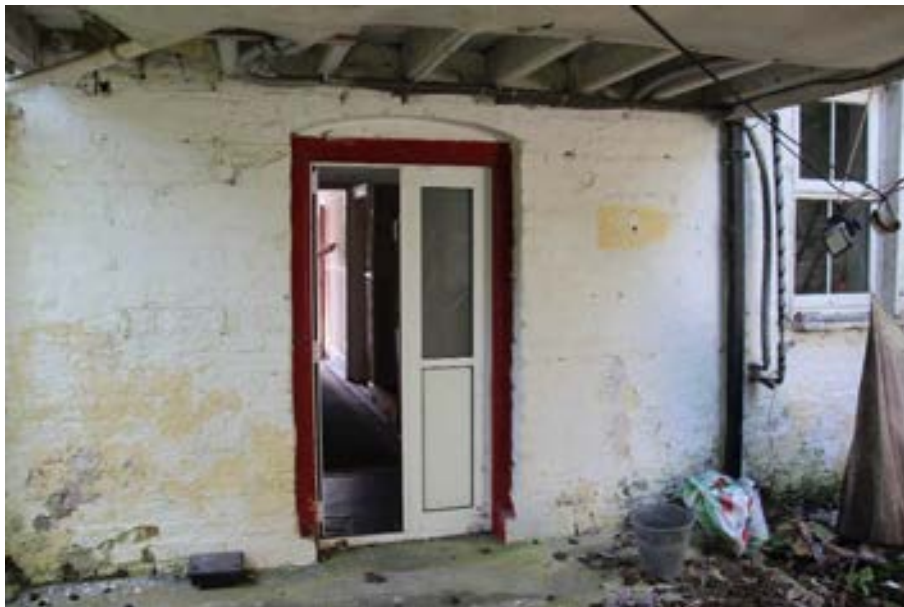
Photograph 33 - Modern replacement two leaf rear door.

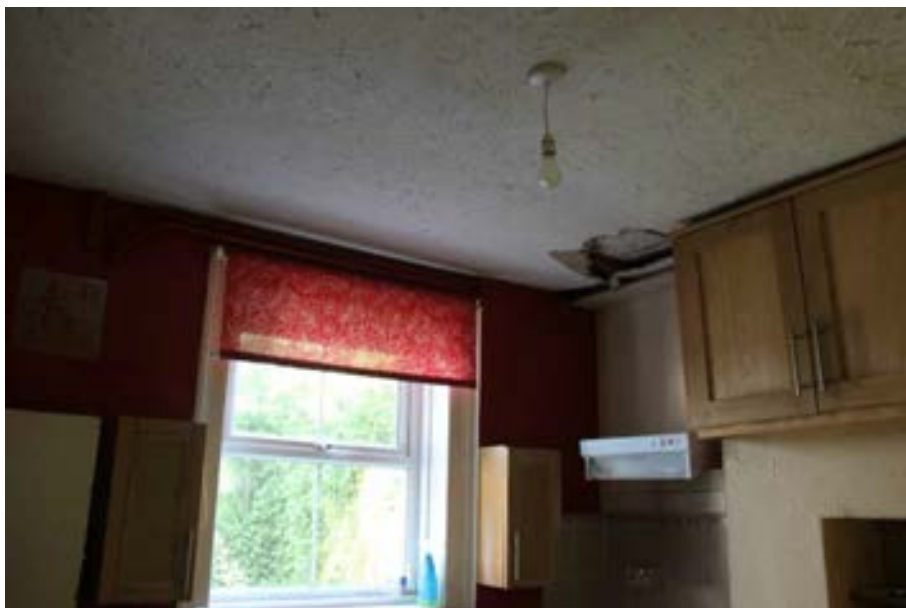
Photograph 35 - Stippled ceiling in Kitchen - possible Artex.

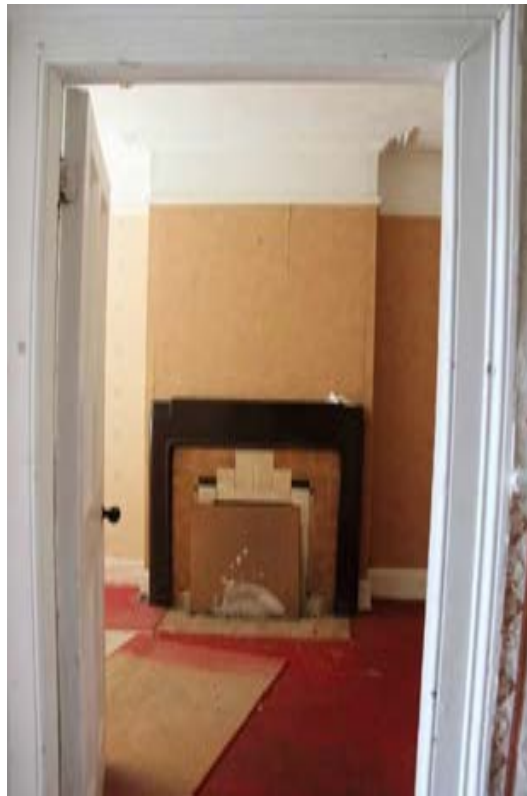
Photograph 36 - Replacement fireplace surround Room 1st LHS.

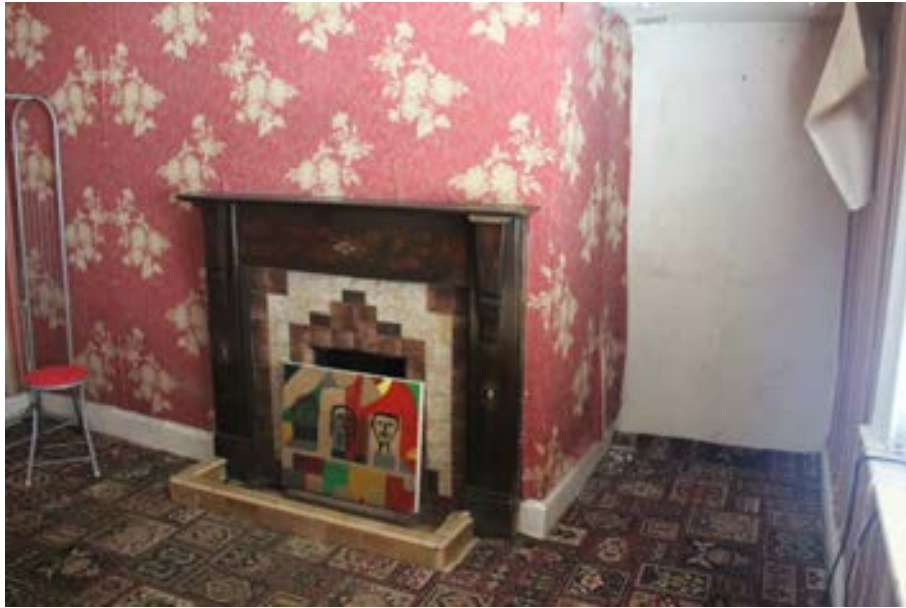
Photograph 37 - Replacement fireplace surround room 1st RHS.

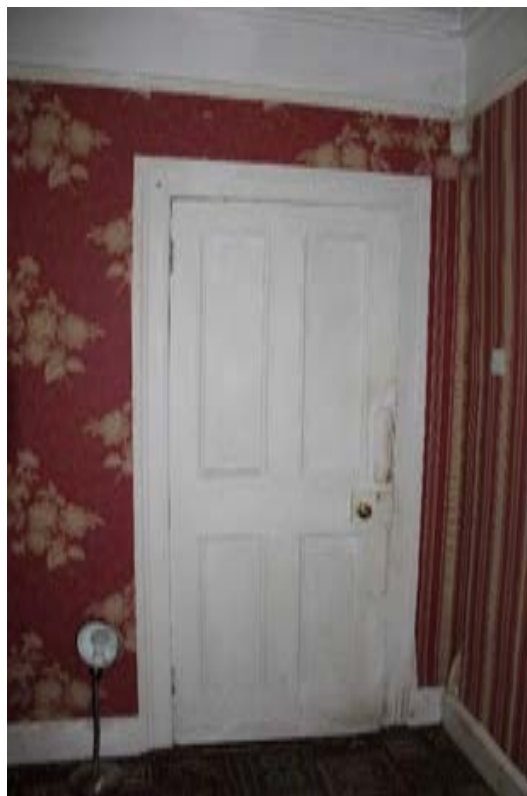
Photograph 38 - Front room, 4 panel solid timber door with brass doorknob.

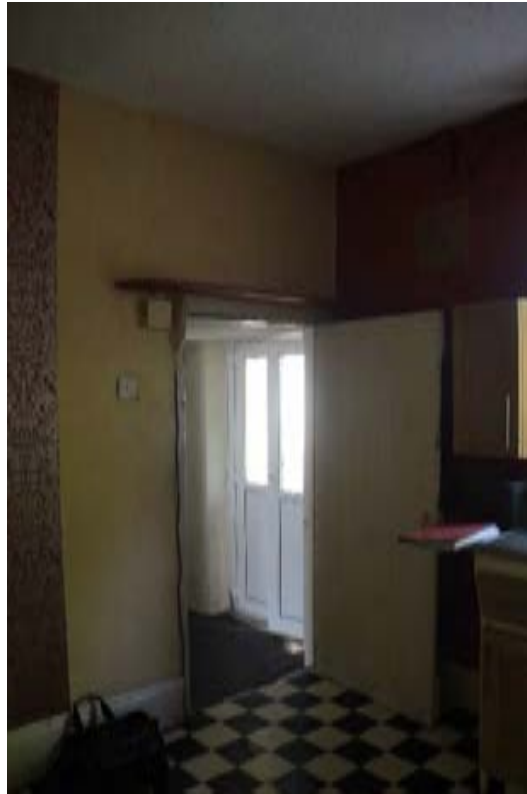
Photograph 39 - Rear room, vertical timber boarded door with curved silver-effect pull handle.

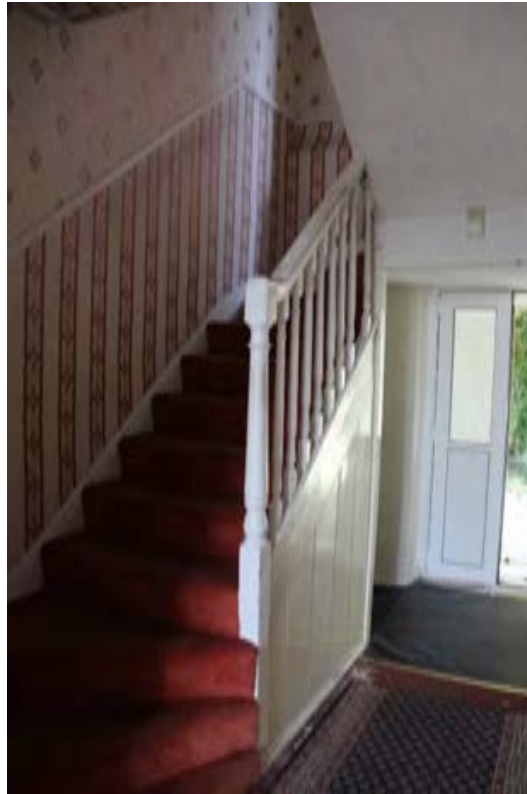
Photograph 40 - Timber closed string staircase with square headed newels and side panelling.

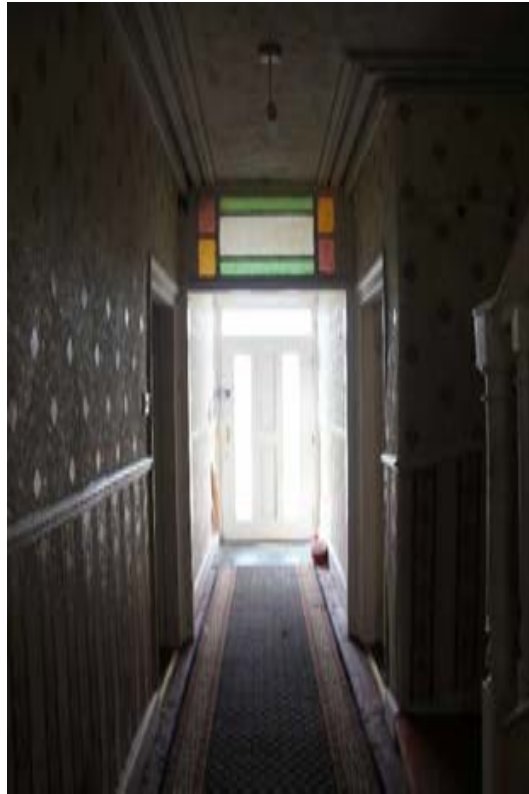
Photograph 41 - Stained glass vestibule screen to separate Hall.

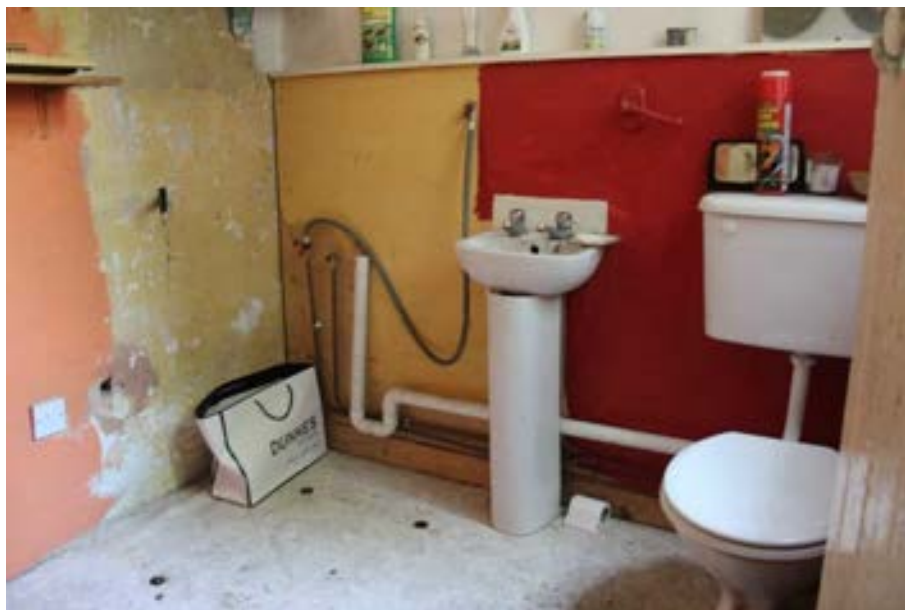
W.C., toilet and handbasin present but not tested.

Photograph 42 - Sanitary Facilities

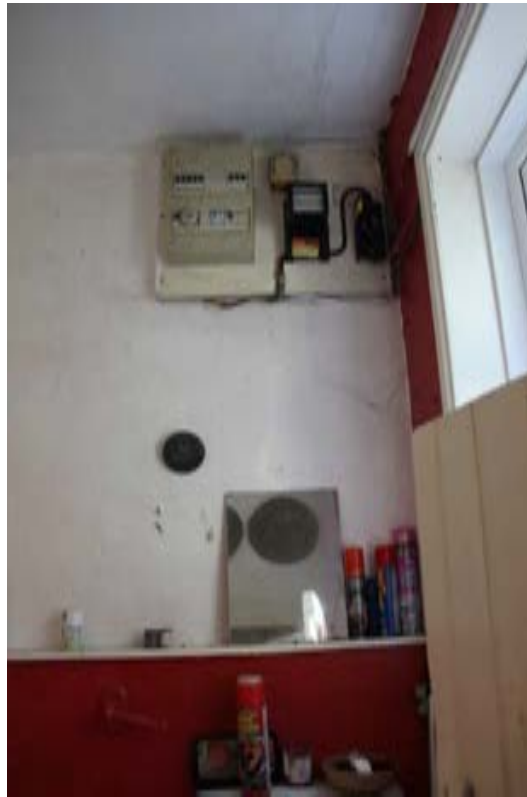
Electrical and mechanical installations are minimal. The fuse is located in the w.c. and is an out-of-date system. Fireplaces act as room heaters.

Photograph 43 - View of fuse box and meter

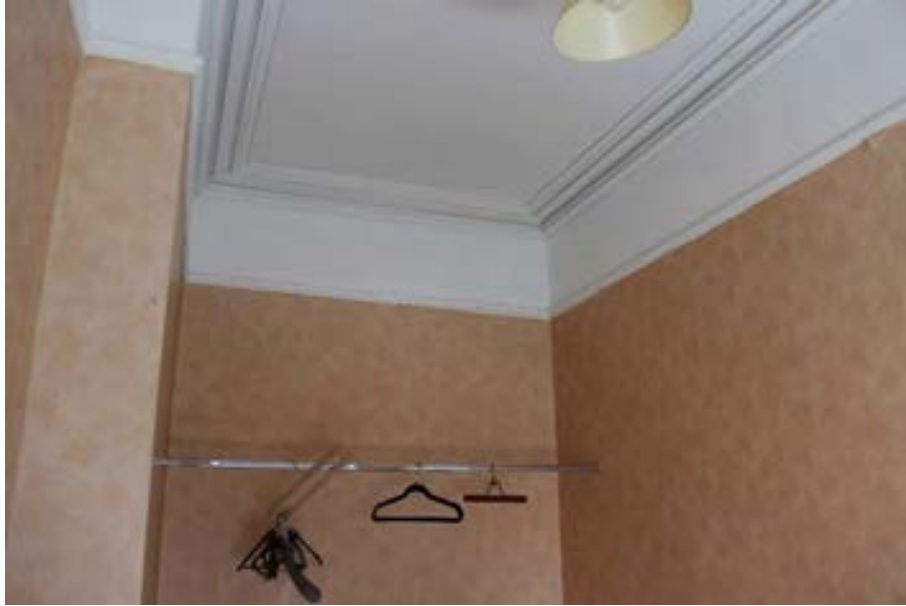
Photograph 44 - smooth plastered ceilings with coving.

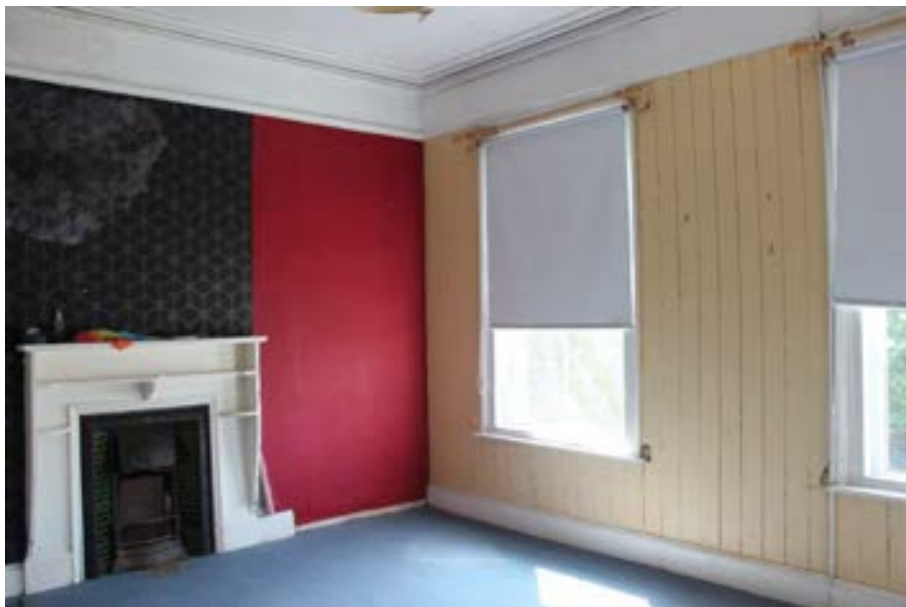
Photograph 45 - Vertical timber boarding to front roof and wall papered end wall.

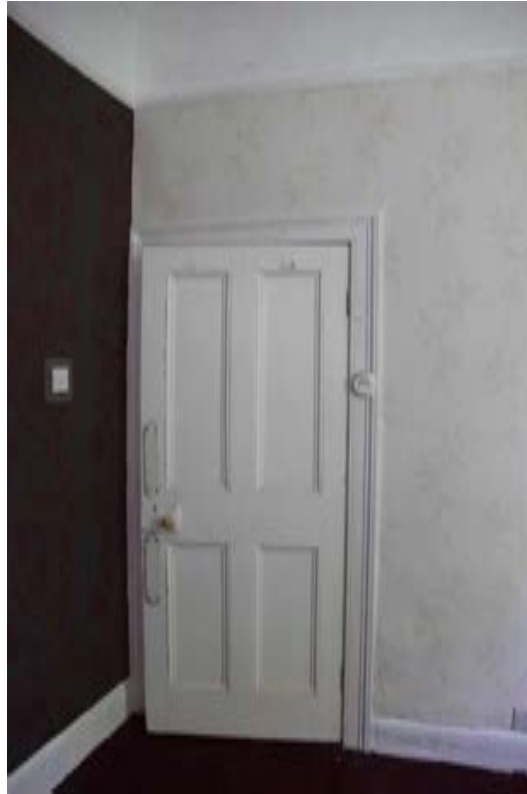
All door opes have architraves and these may have lead paint thereon. To be investigated.

Photograph 46 - Four panel door with brass doorknob.

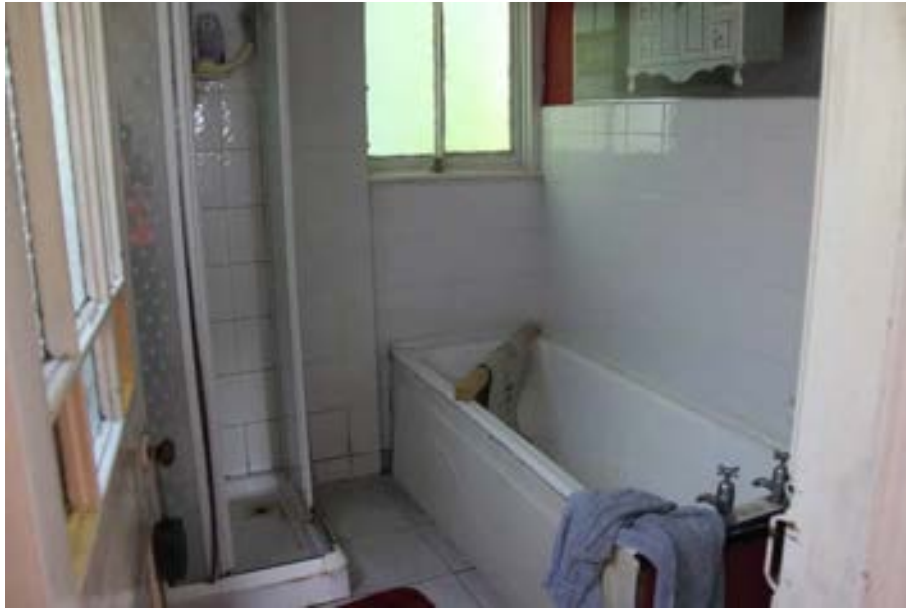
Photograph 47 - Shower and bathtub separate to toilet.

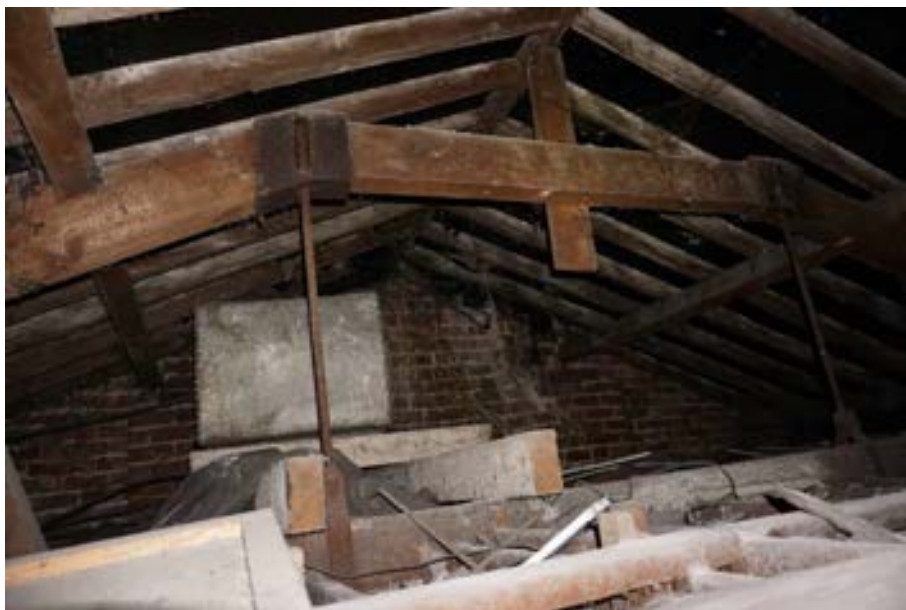
Attic has a cut timber roof consisting of cementitious replacement slates on bitumen underlay on original timber rafters on purlins with truss supports. Cast iron hangers are used to tie the truss members. The original lime parging is evident between the joists.

Photograph 48 - Truss with cast iron hanger.

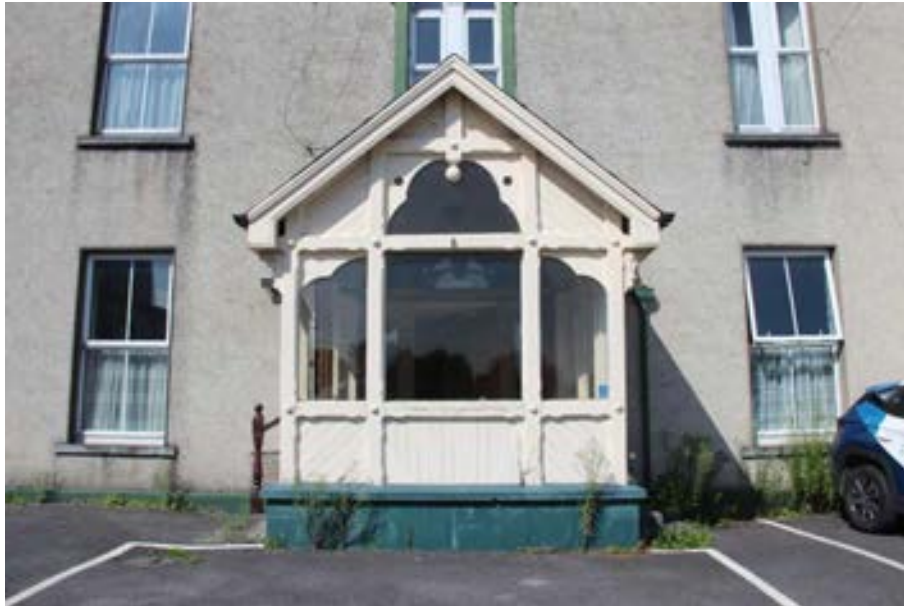
Photograph 1 - Fernbank House Front Entrance

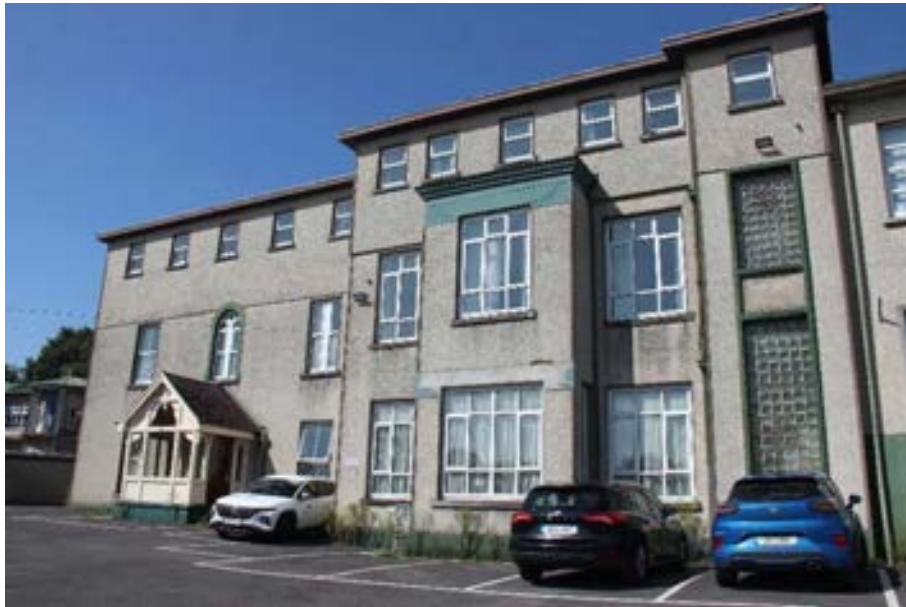
Photograph 2 - Original Cleeves Family Home (left) subsumed into school premises.

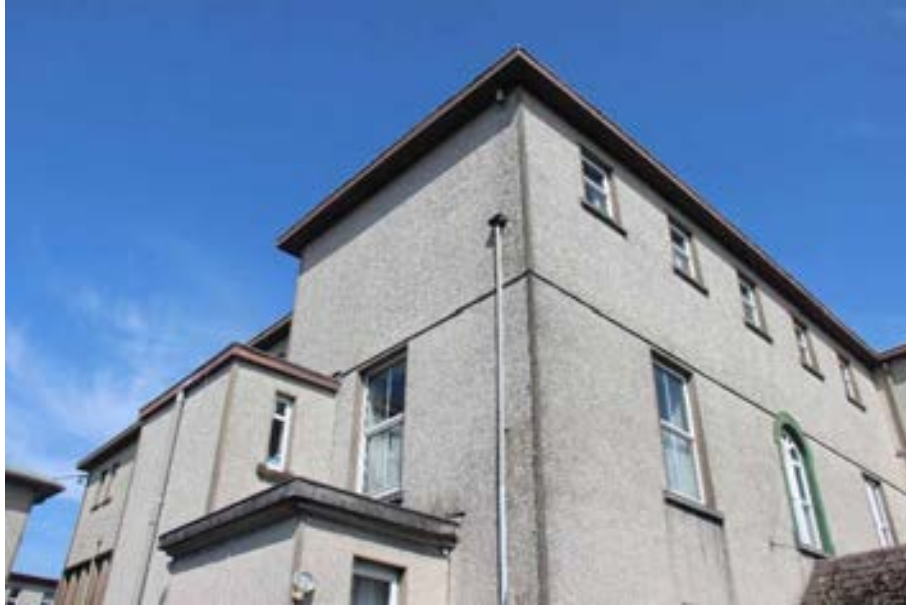
With the addition of the second floor to the original building, the main roof was lost. The current iteration is covered with a modern flat roof with the exception of the entrance porch roof. This is an 'A' pitched roof with cementitious tiles (possible Asbestos Containing Materials). Rainwater goods are mixture of cast iron, aluminium and PVC.

Photograph 3 - A series of modern flat roofs.

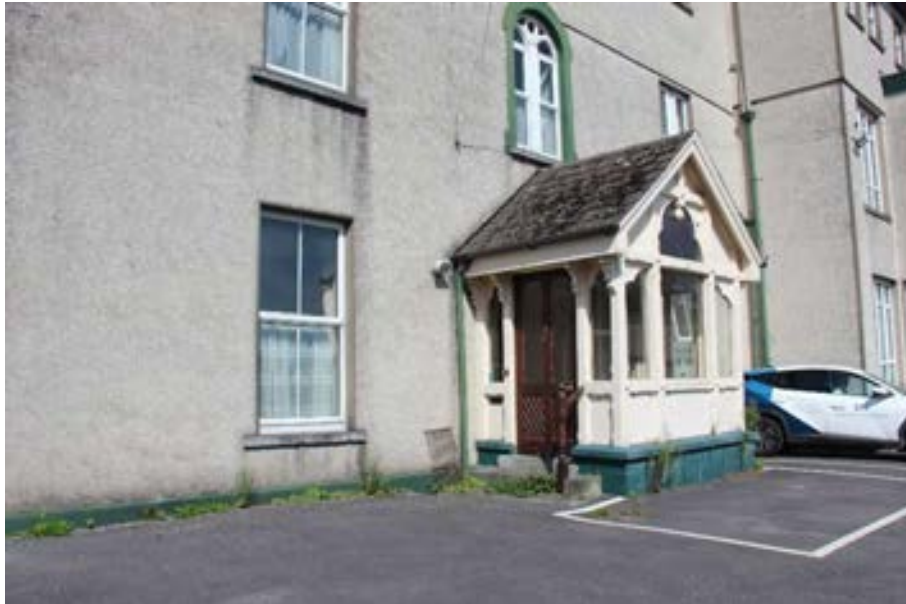
Photograph 4 - 'A' pitch with cementitious slates.

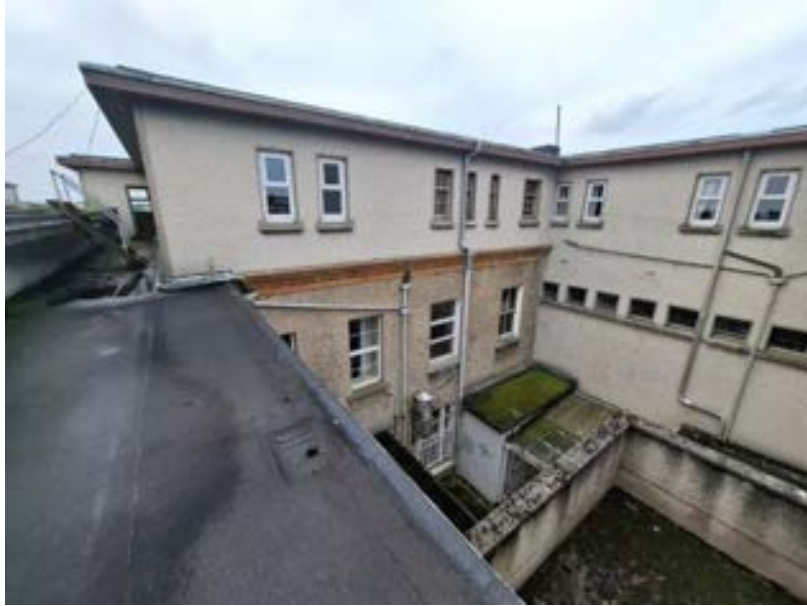
Photograph 5 - Earlier render remains on the original building at rear elevation.

Earlier cementitious render, and original brick cornice and string eaves course remain at the rear façade the latter indicating the original wall height. This may remain to the front façade under the render band. Original cills are limestone.

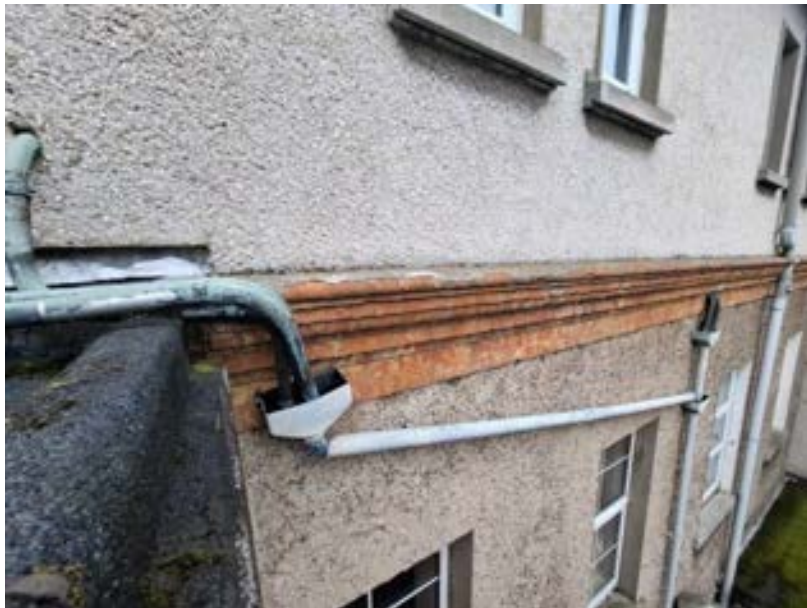
Photograph 6 - Brick cornice and string eaves course preserved along this section of building.

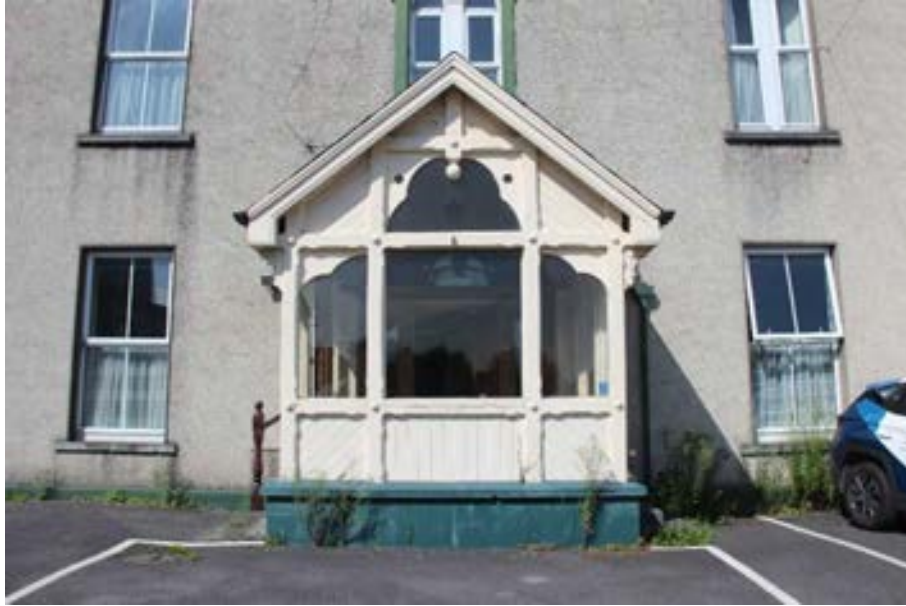
Porch walls are timber frame with fenestration and boarded out sections, with incorporation of a queen post truss in the gable. The entrance is located on the west side and there is a blind door opposite, seen from outside but hidden inside. The dwarf/kneeler wall is masonry and rendered.

Photograph 7 - Porch with timber frame and panelling over a masonry dwarf wall.

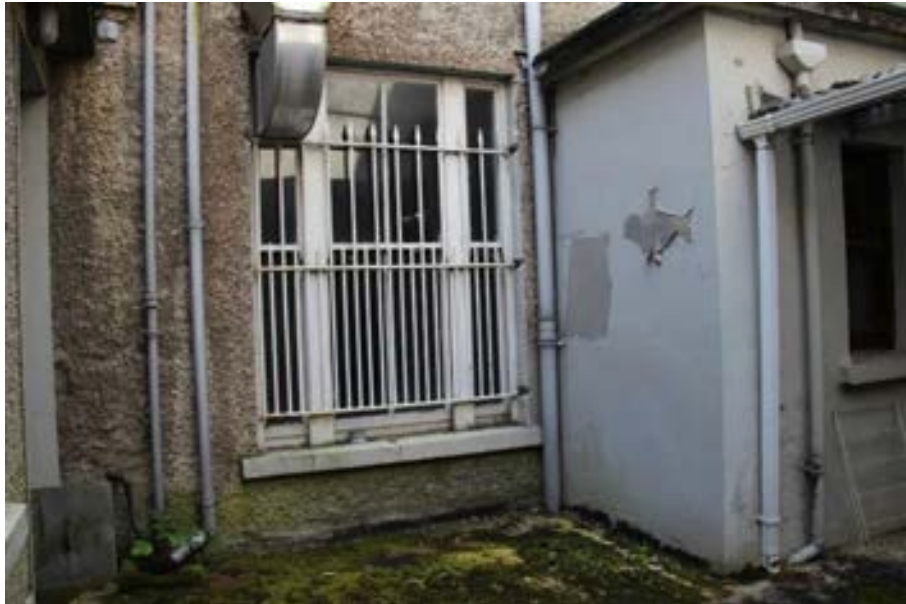
Photograph 8 - Original Wyatt timber window at kitchen.

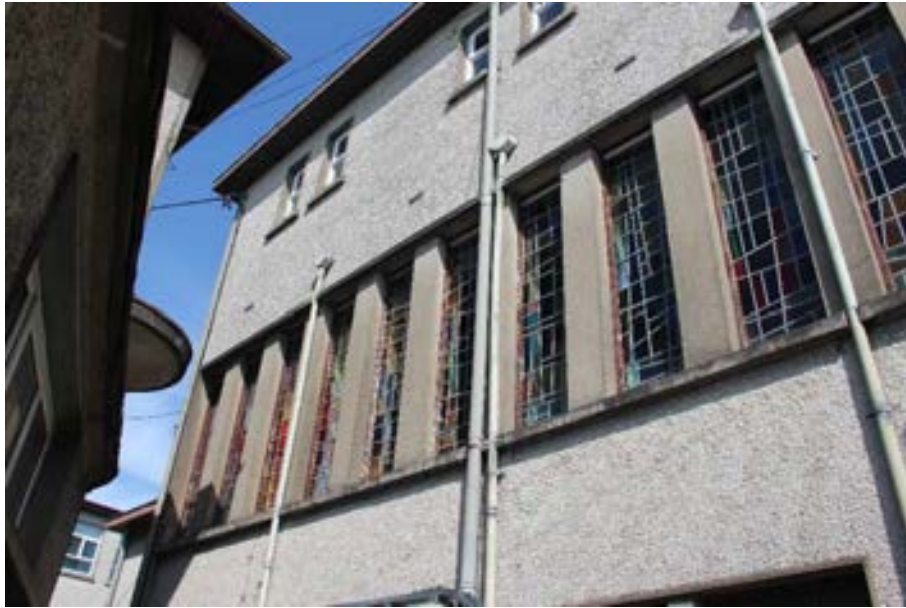
Photograph 9 - Modern stained glass in Chapel.

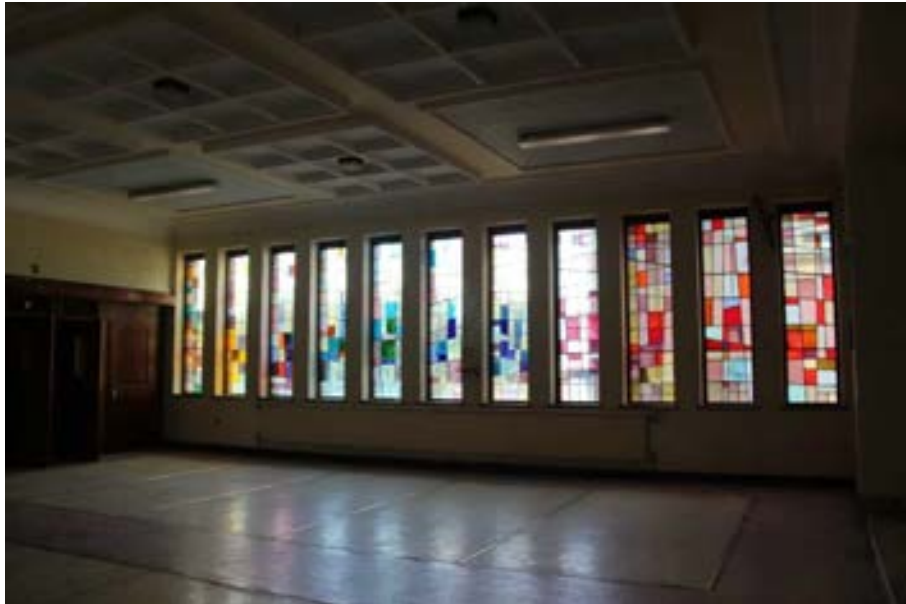
Photograph 10 - Internal aspect of chapel modern stained-glass windows – west wall.

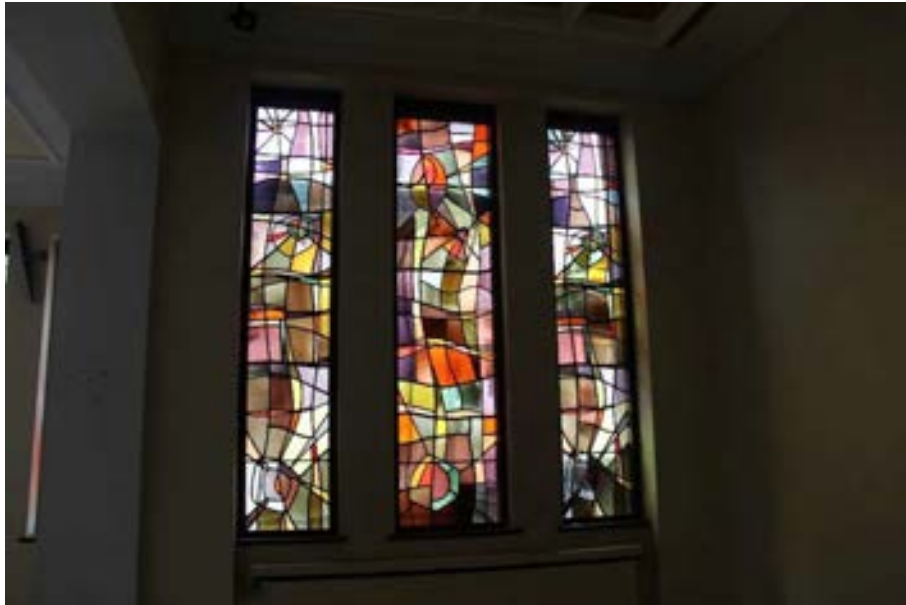
Photograph 11 - Internal aspect of chapel sanctuary windows – west wall.

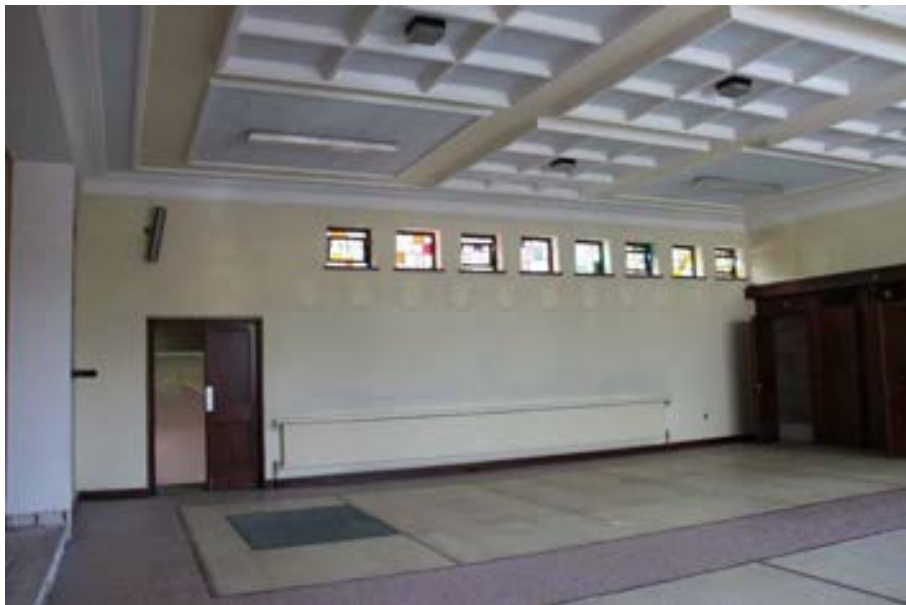
Photograph 12 - Internal aspect of stained-glass windows and vent lights to chapel - east wall.

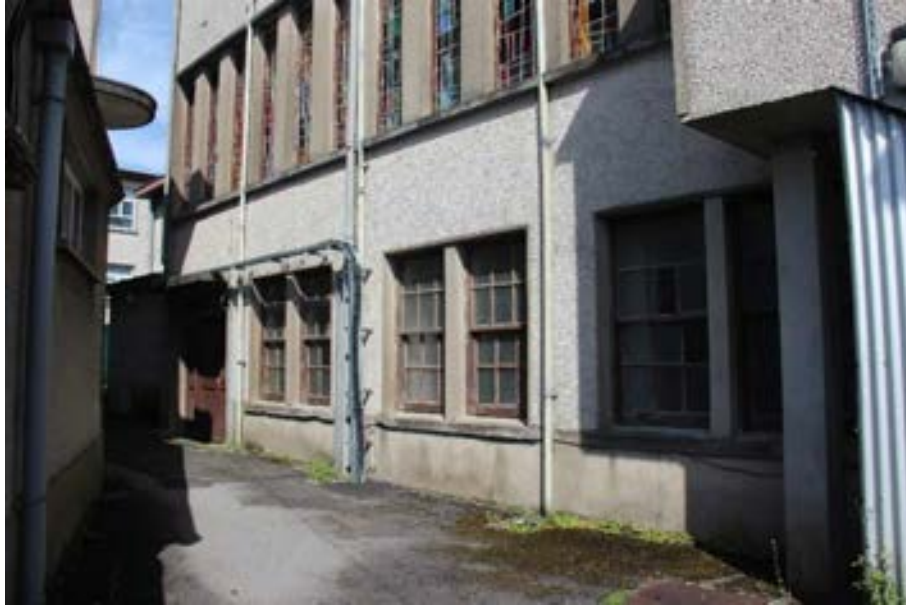
Photograph 13 - Modern timber sliding sash with obscured glazing.

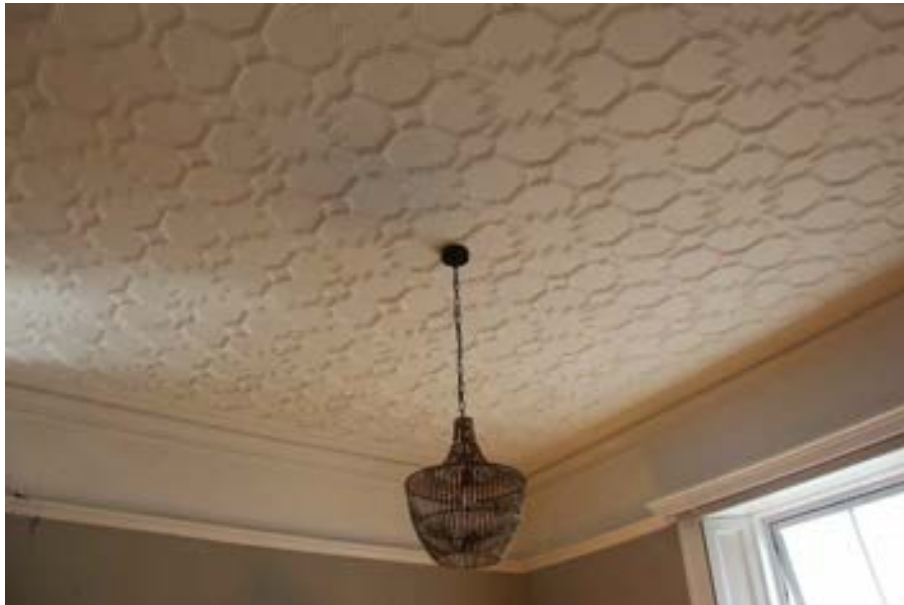
Photograph 15 - Modern decorative ceiling tiles 1st roof RHS.

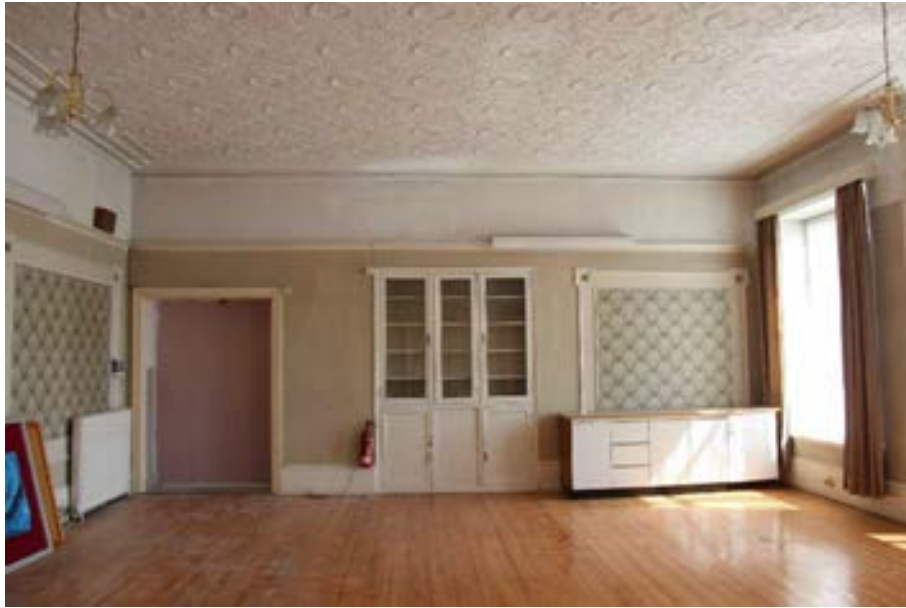
Photograph 16 - Modern decorative ceiling tiles room off 1st Room RHS.

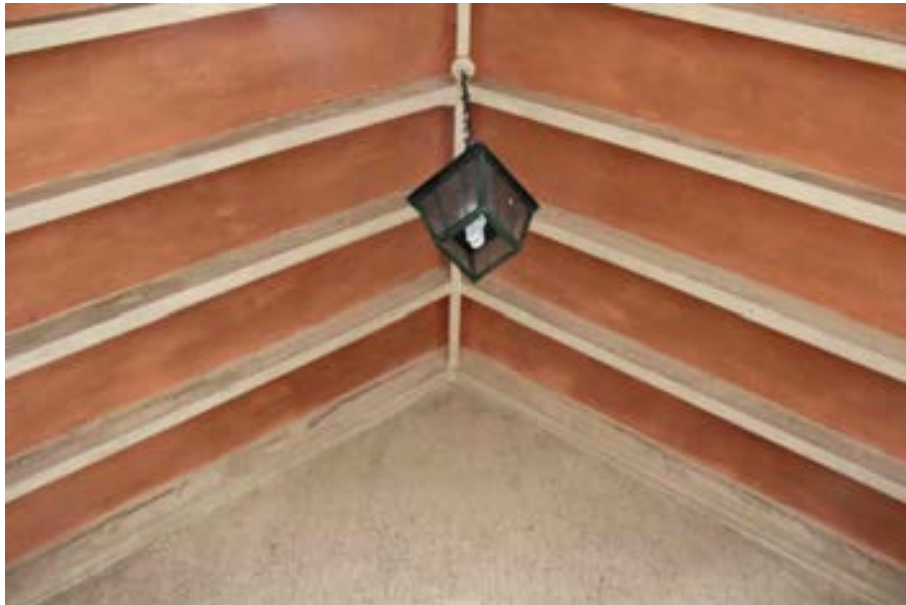
Photograph 17 - Porch plywood ceiling is taken up under the roof line.

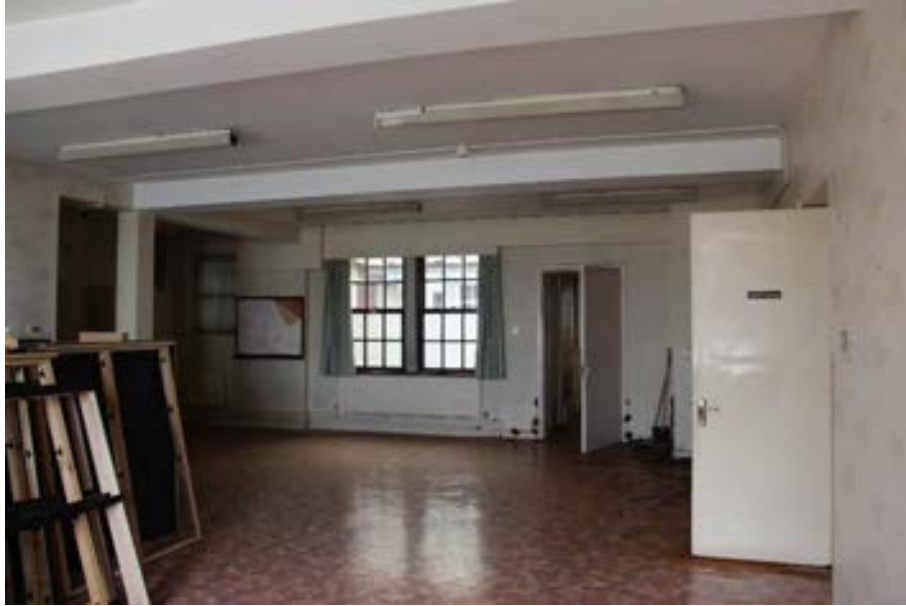
Photograph 18 - modern plasterboard ceiling to later extension.

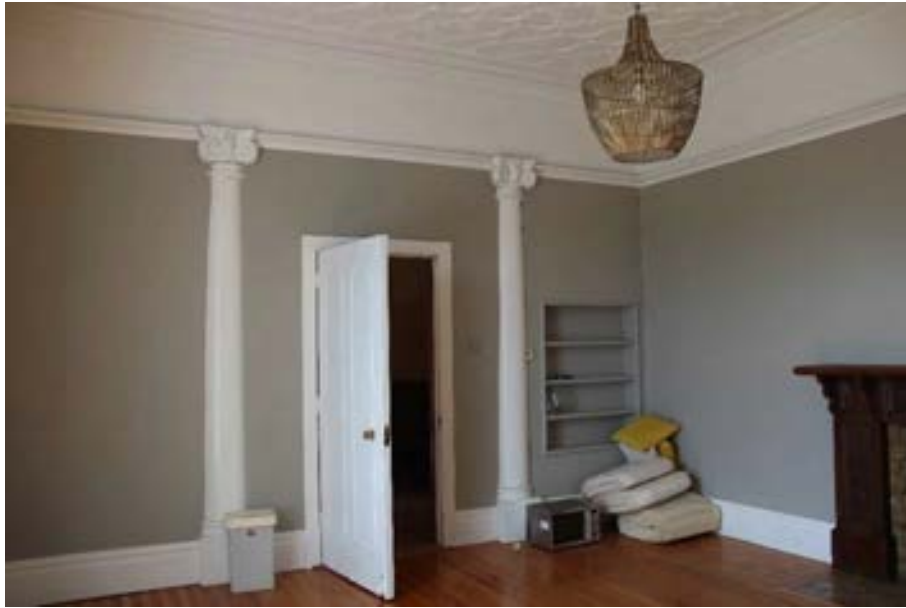
Photograph 20 - Decorative pilasters to partition 1st room RHS.

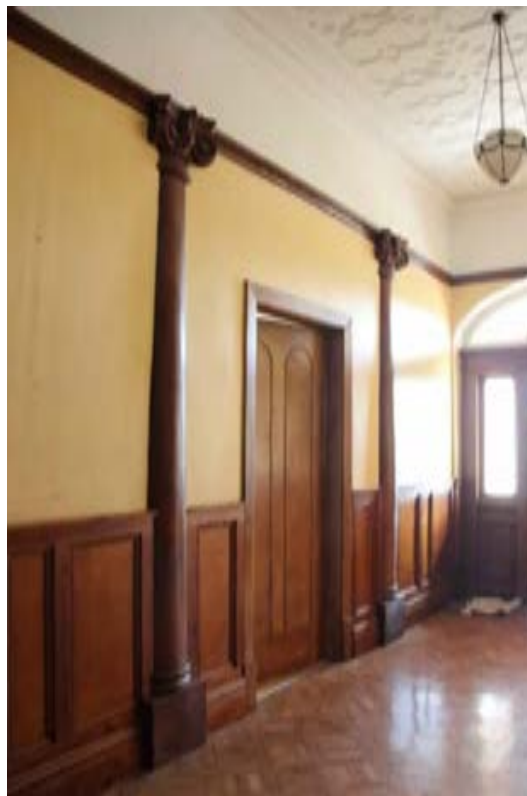
Photograph 21 - Wainscotting to Hall and pilasters with ionic heads.
