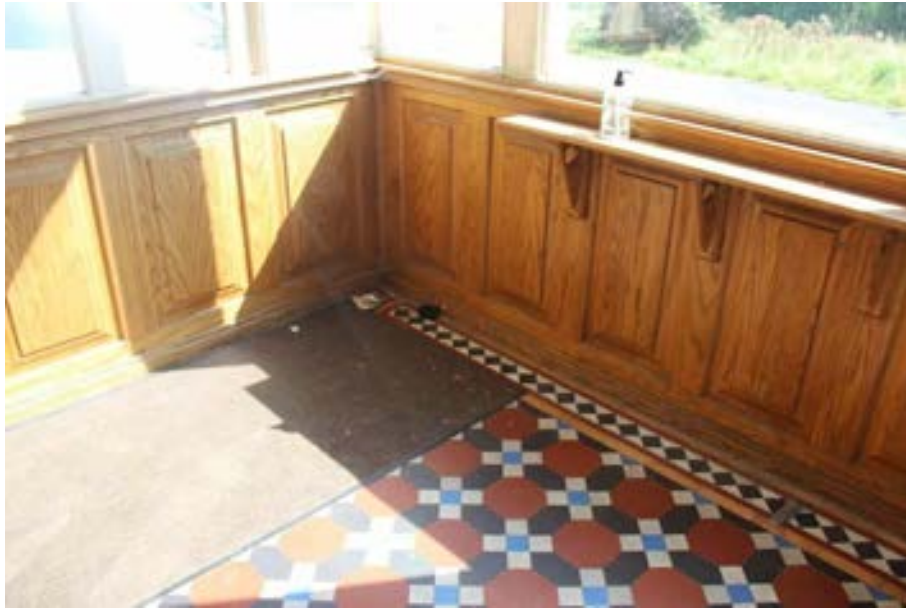
Photograph 22 - Porch walls are oak timber panelling.

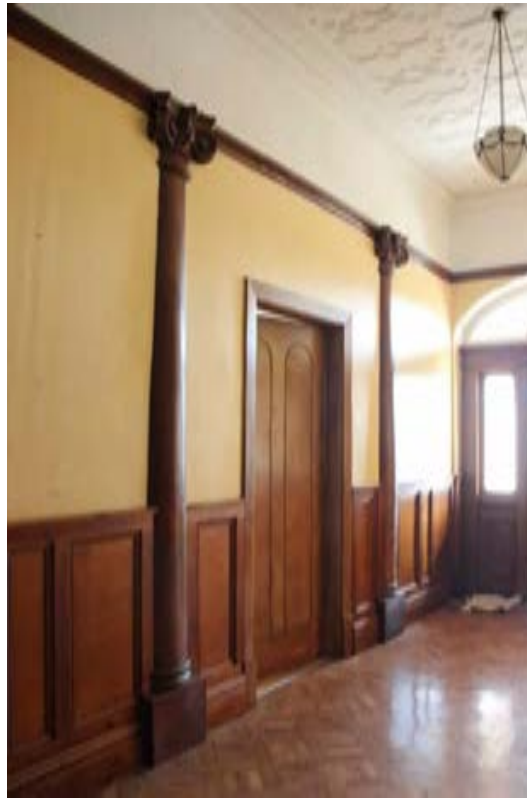
Doors off the hall in the earlier building are a mixture of 2 and 4 panels solid timber doors with a stained glass upper section to the door under the stairs. We are of the opinion that these may be replacement doors as they are not uniform in style.

Photograph 25 - a 2-panel solid timber door opposes a 4-panel solid timber door in the main hall.

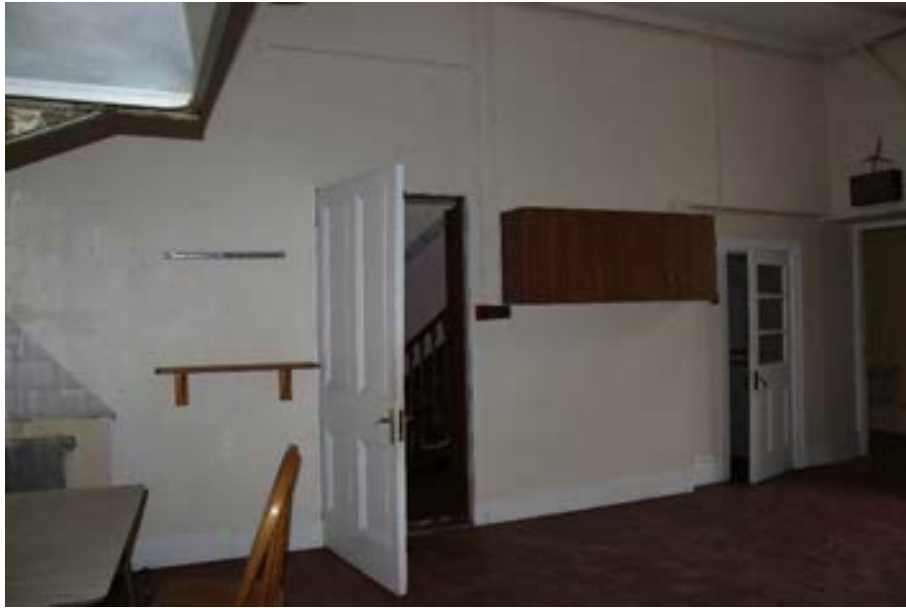
Photograph 27 - Modern hollow 4 panel door with brass-effect lever handle.

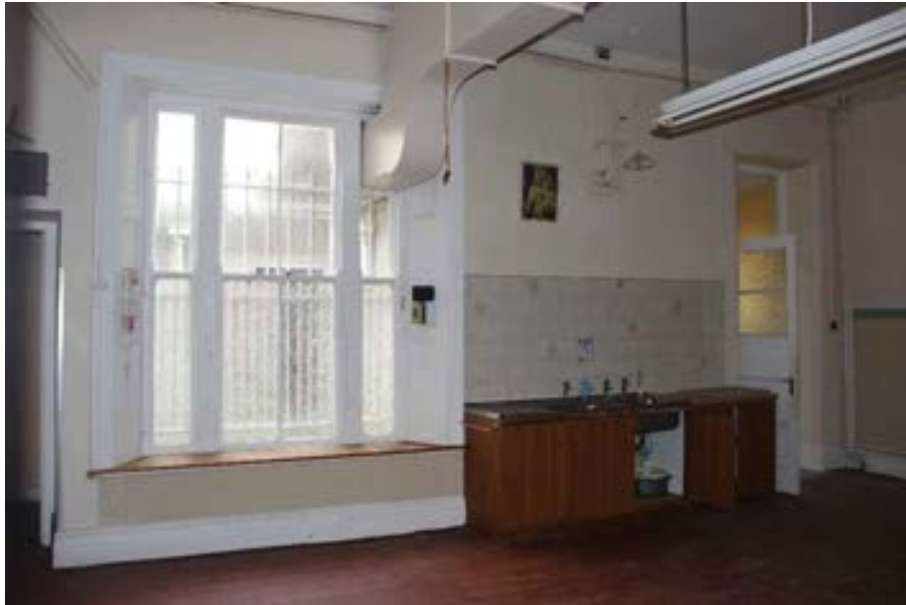
Photograph 31 - Shutter boxes extant in the Kitchen. Also, units with sink remain.

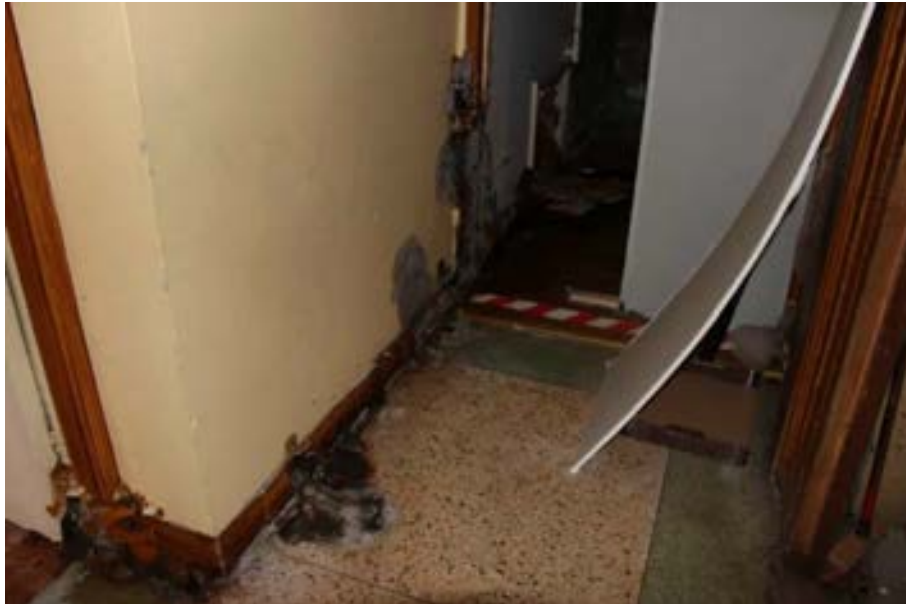
Photograph 35 - Terrazzo floor to later section of building.

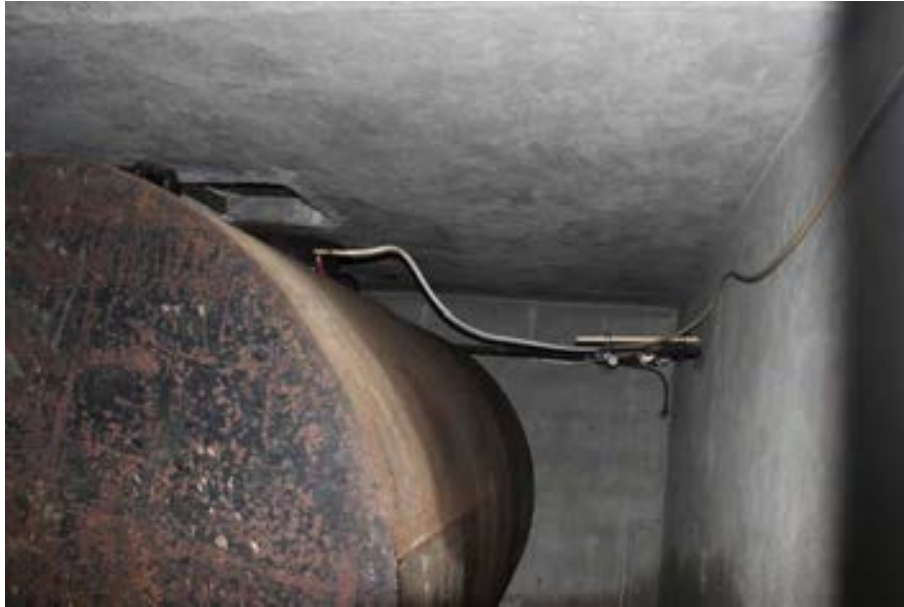
The services installations are noted to be mostly modern, with fluorescent tubed fittings throughout the building, modern electrical sockets and light switches mounted to the walls etc. As these have been dormant a fully electrical audit and assessment is advised. Radiators are used throughout.

Photograph 36 - Small basement rooms house the oil tanks and burner. Electrical distribution boards may also be located here.

Before the removal of any plant, it is recommended that a full asbestos survey be conducted.

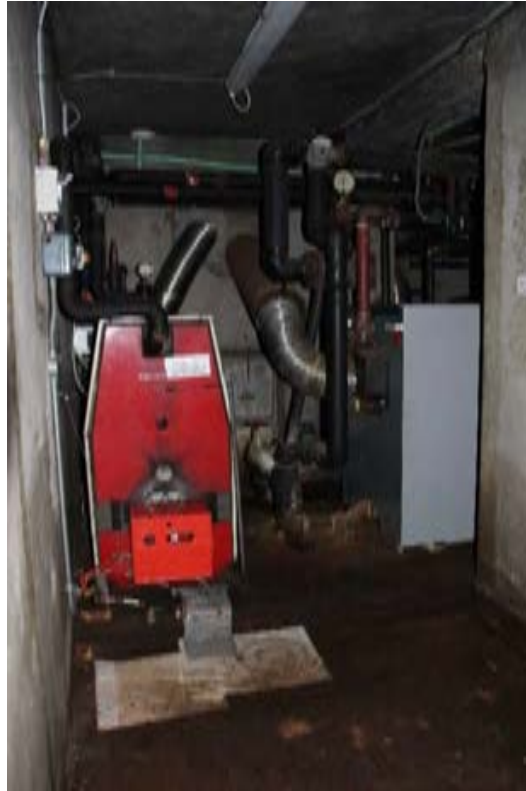
Photograph 37 - Surviving fuse boxes, meters, alarm systems etc.

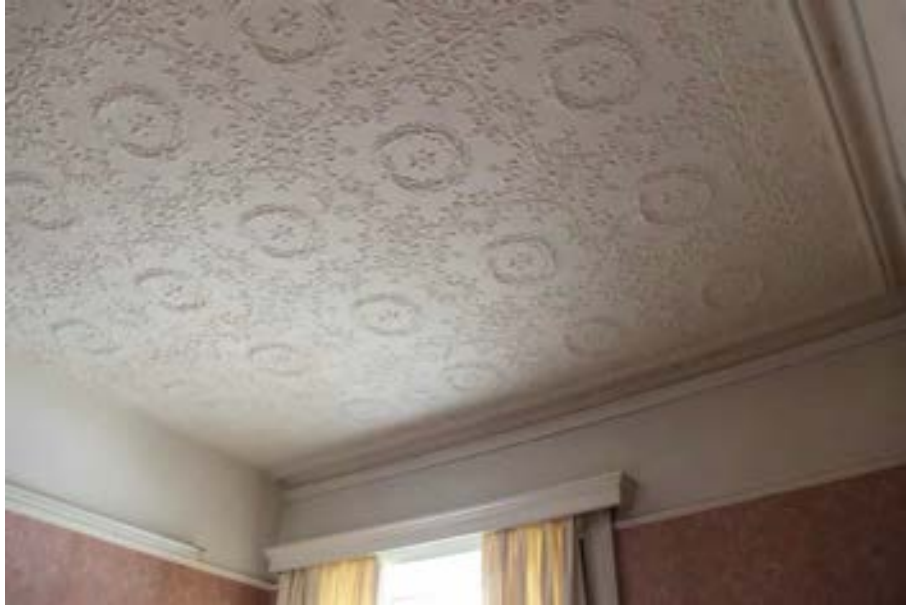
Photograph 39 - Modern decorative ceiling tiles affixed directly (not suspended).

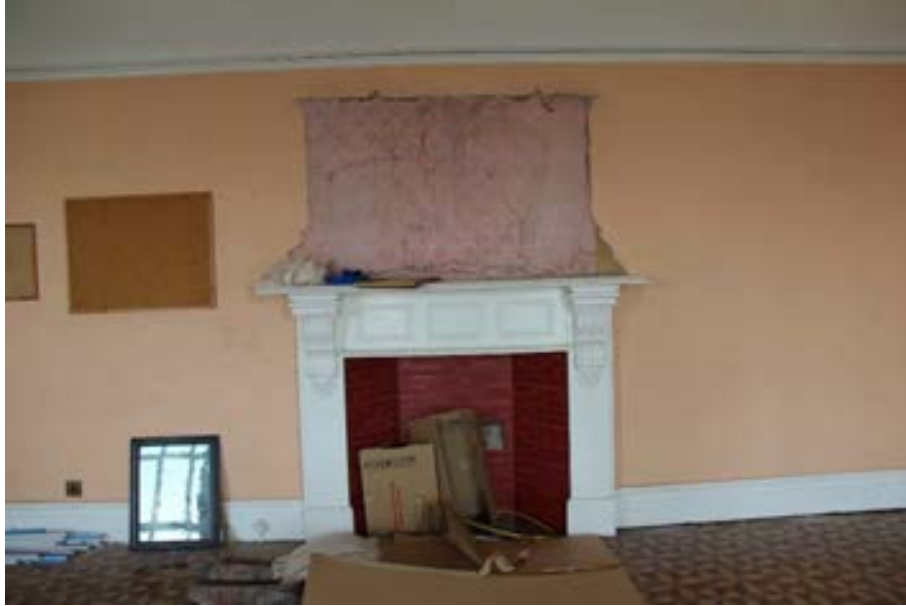
There is one remaining fireplace in the southeast room of the earlier building. This appears to have its original surround. It must be assumed that there may be other fireplaces that have become hidden.

Photograph 41 - Fireplace to front room (southeast).

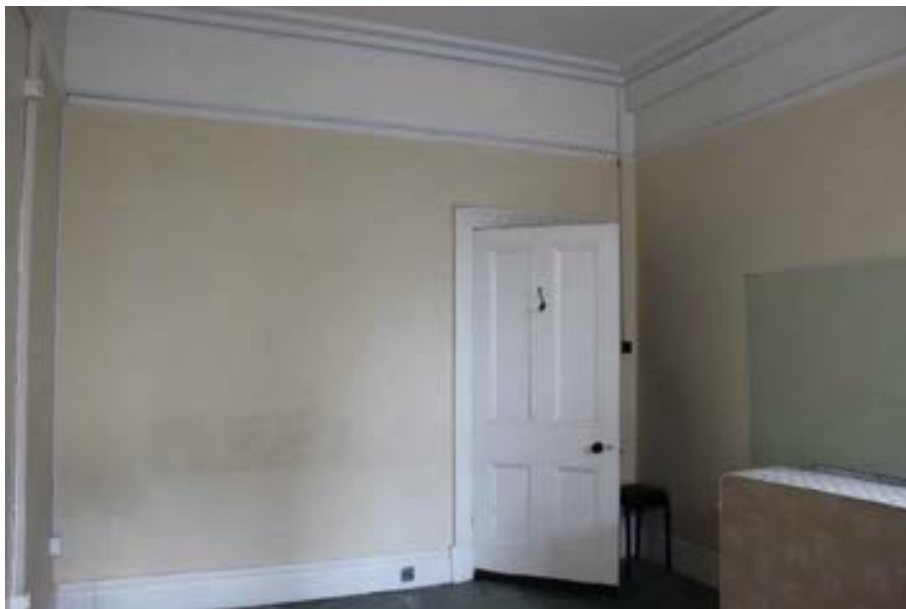
Photograph 42 - 4 panel solid timber door with timber knob in earlier building.

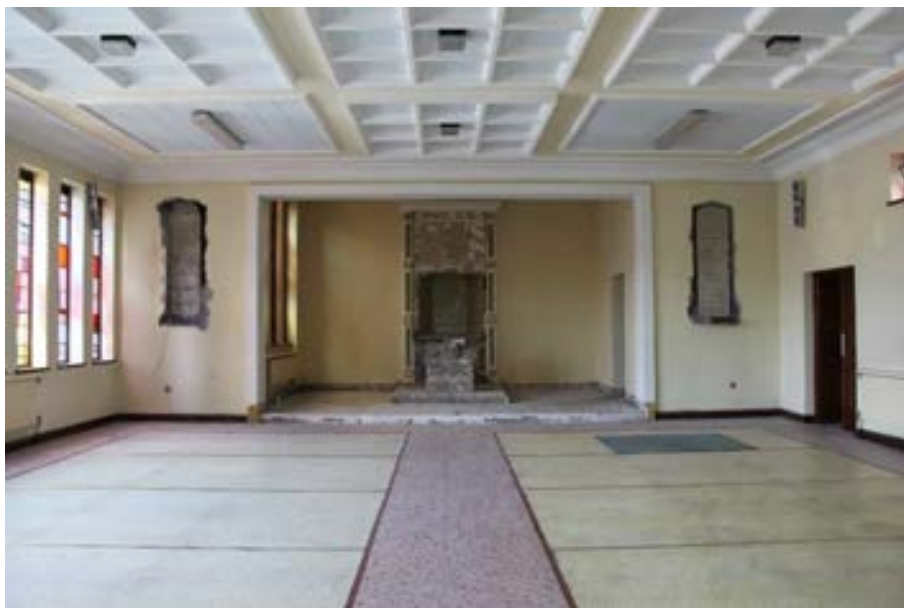
Photograph 50 - modern chapel floor with mosaic and linoleum floor covering. Alter removed.

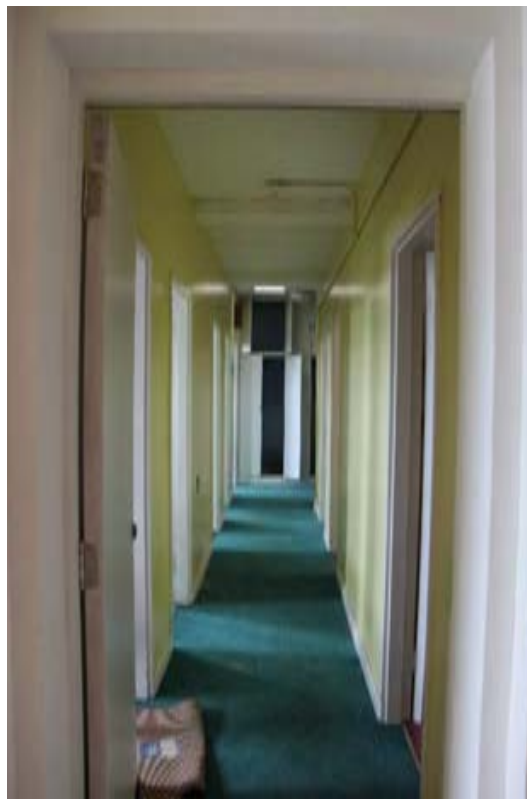
Photograph 51 - Corridor ceiling with rooflight at corridor junctions and support beams.

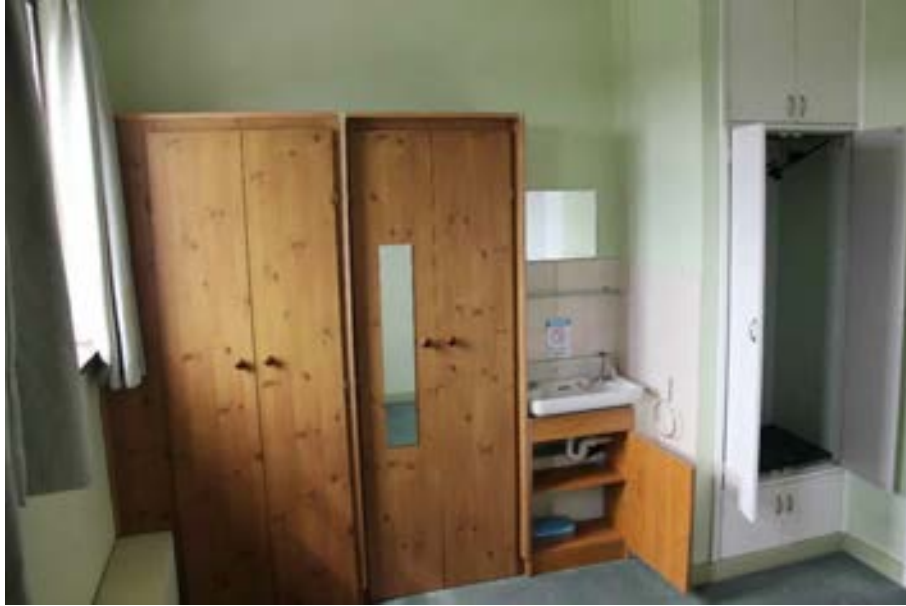
Photograph 54 - Built-in and free-standing furniture.

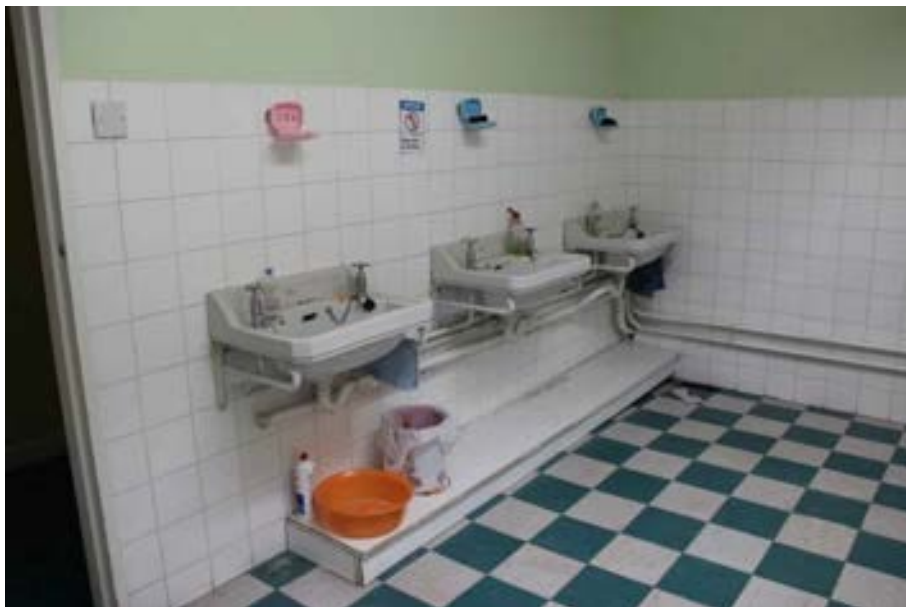
Photograph 55 - Sinks in central ablution block.

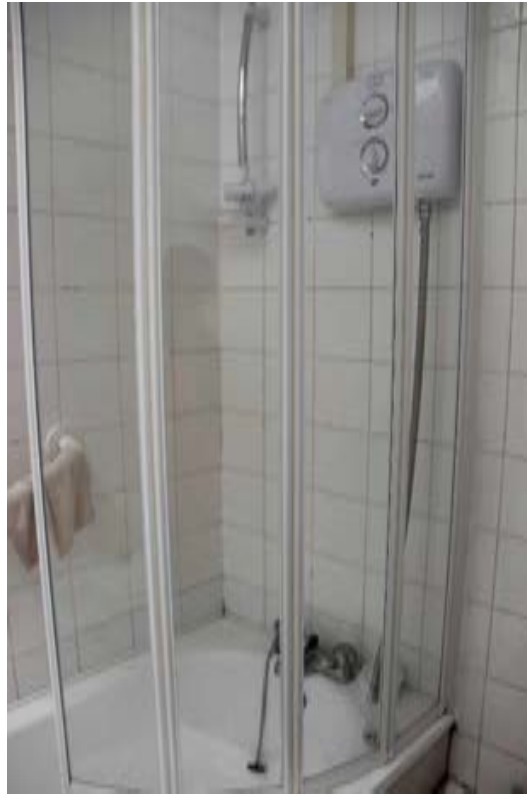
Photograph 56 - Modern shower facilities.

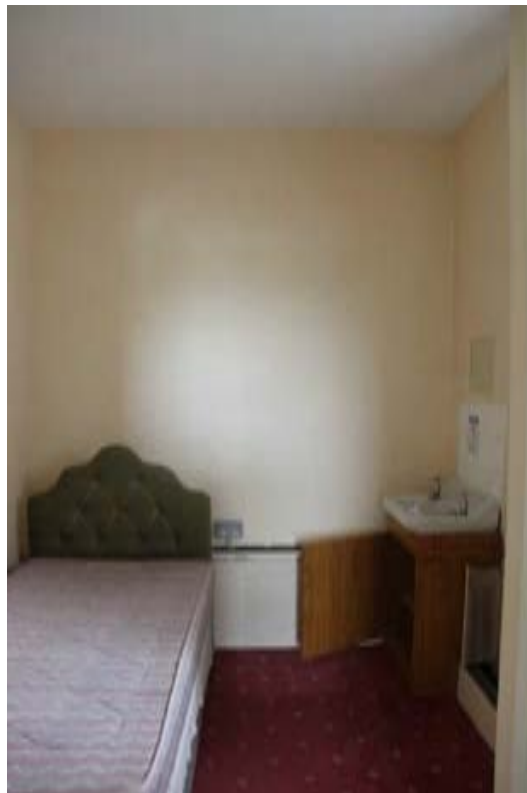
Photograph 57 - Typical cell with handbasin facilities.

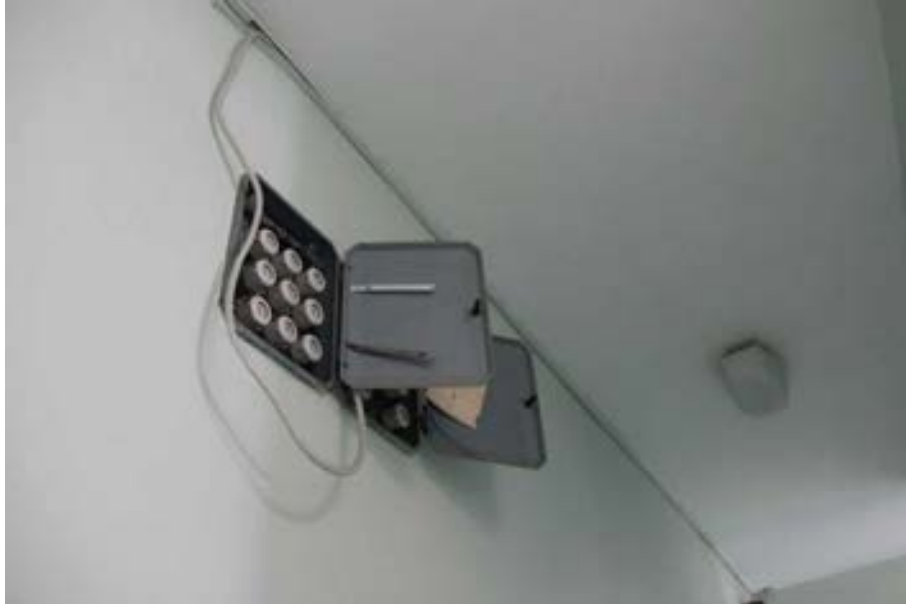
Photograph 58 - Fuse box on 2nd floor.

The services installations are noted to be mostly modern, with fluorescent tubed fittings throughout the buildings, modern electrical sockets and light switches mounted to the walls etc. It is recommended that prior to moving any plant, that an asbestos survey be conducted.

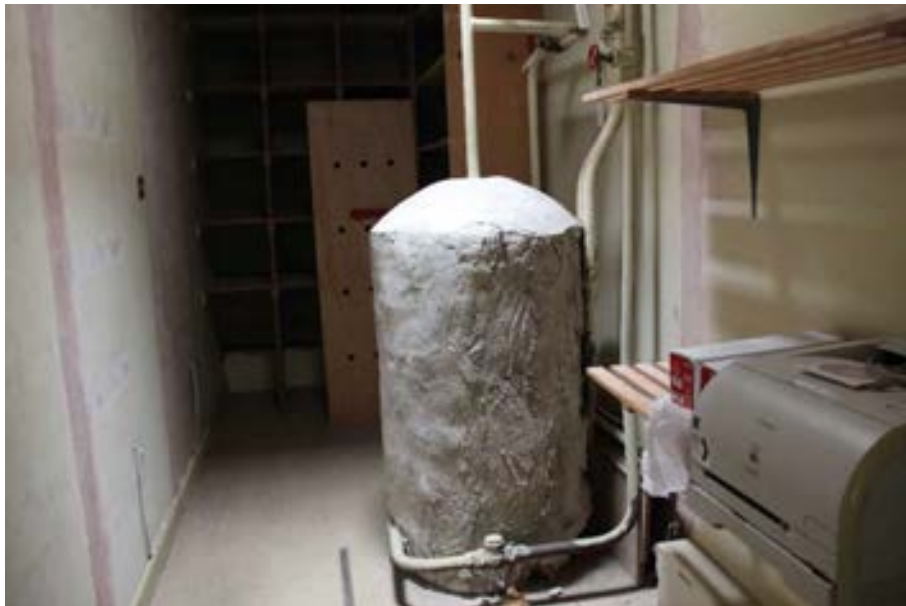
Photograph 59 - One of two walk-in Hot Presses on this level with cementitious layer to water cylinder. May have ACMs.

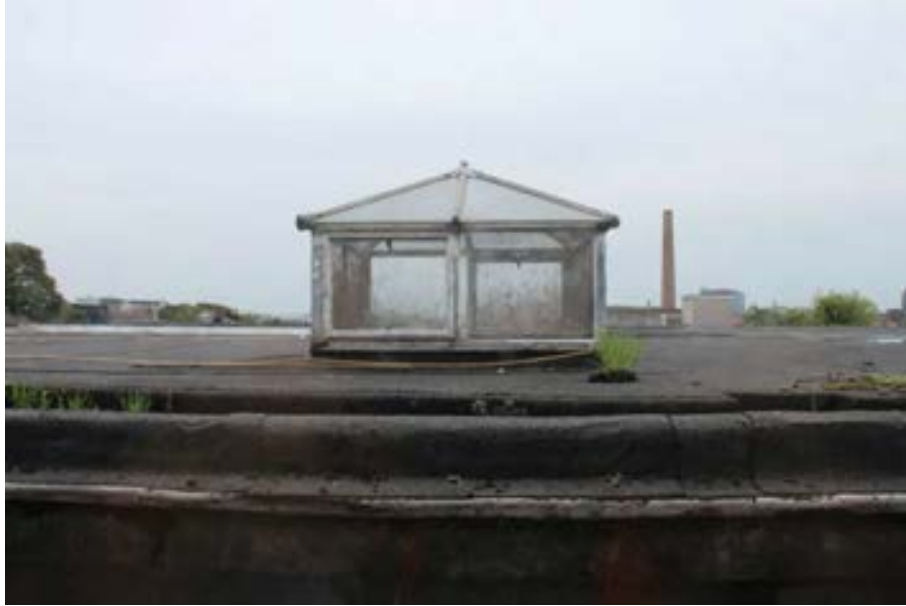
Ceiling hatch visible, but not accessible. The new roof structure is a flat roof, and any void was likely a space above dropped ceilings. As mentioned above the original roof over the main structure was removed to allow construction of an additional storey.

**Photograph 60 - Access to the external roof was limited and not permitted due to overlook and privacy.
Modern rooflight cover.**

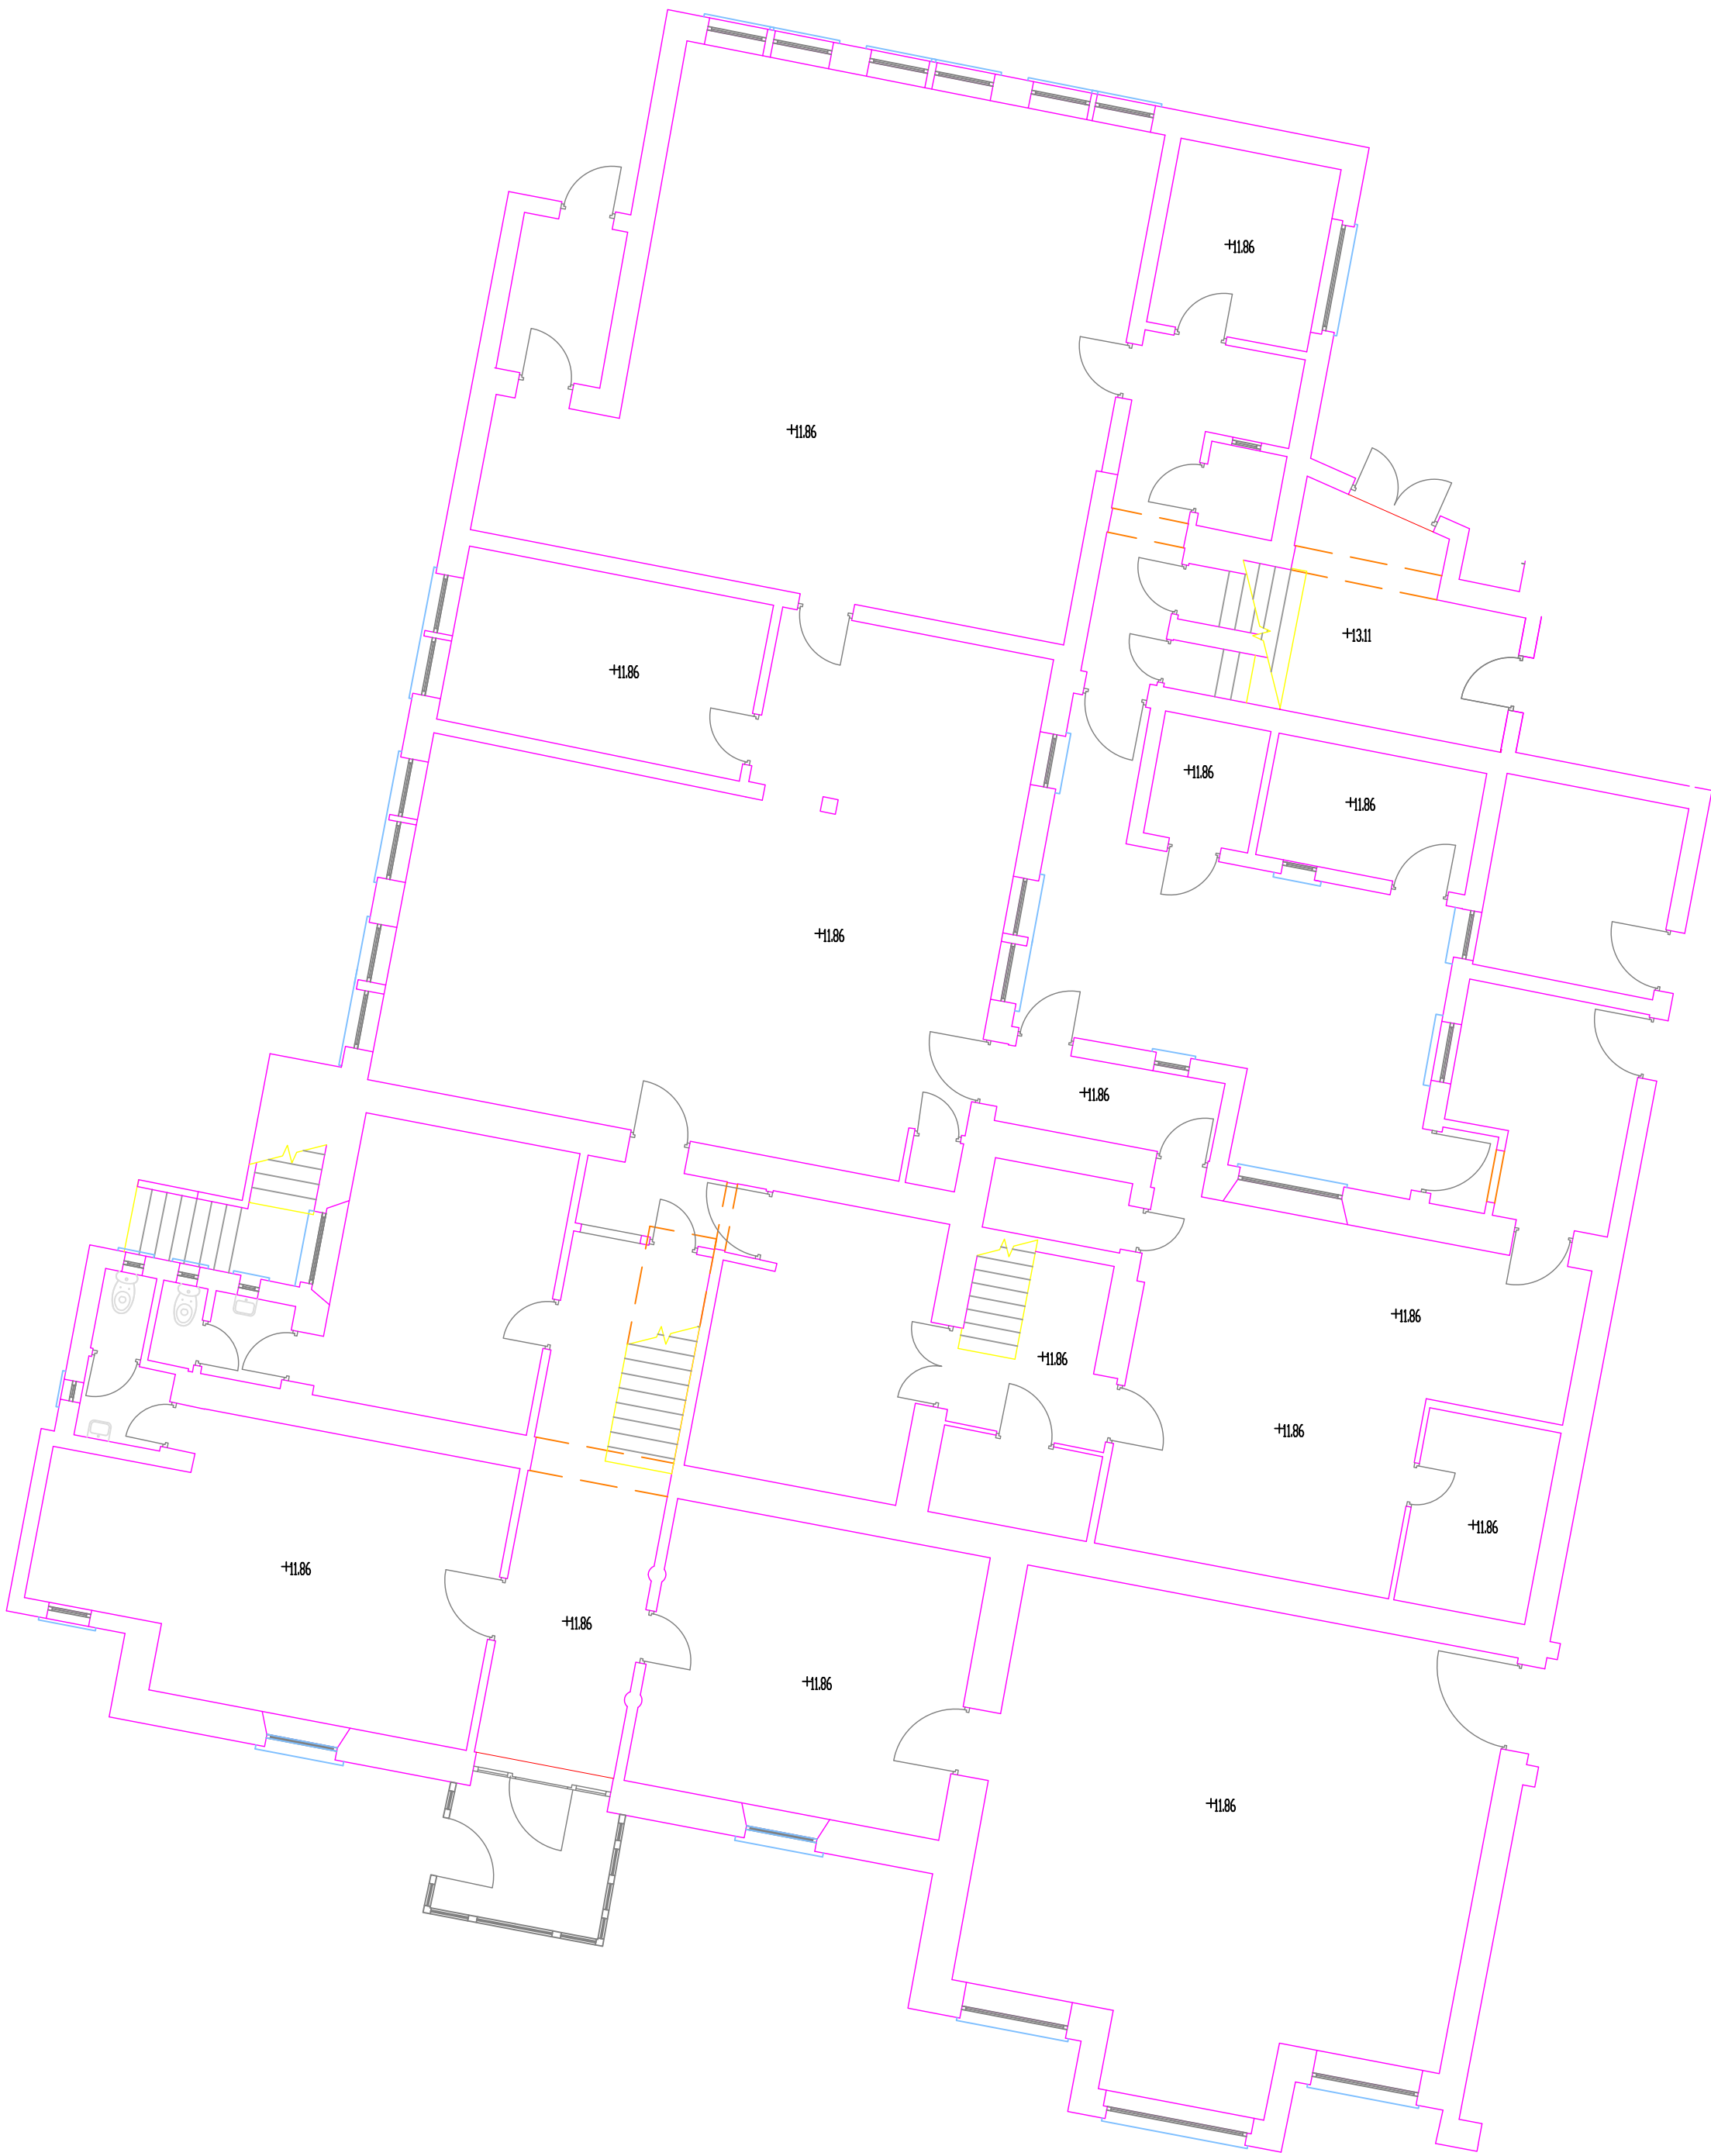
Ground Floor

With the exception of the Kitchen windows, all windows are modern. These are a mixture of white uPVC and timber top and side hung casements and sliding sash. Modern timber and stained glass are present in the Church and remain intact. There are also glass bricks to the staircase/staircore to the front façade (south) of the eastern extension. The Porch has modern single glazed windows.

The entrance door, now made internal due to the porch, is a solid timber 4 panel door with fanlight and sidelights. Doors off the Hall in the earlier building are a mixture of 2 and 4 panels solid timber doors with a stained glass upper section to the door under the stairs. We are of the opinion that these may be replacement doors as they are not uniform in style.

There are no noted significant internal decoration or joinery features within each building, which is not surprising, given the use of the buildings. Modern shelving units and cupboards and sinks in some rooms but limited inbuilt furniture. Loose furniture dotted in rooms throughout the floor.

The internal floors are largely timber in the original sections of the building with solid floors elsewhere. These are covered in linoleum, tile and carpet. Due to dry rot floors off the back staircase have disintegrated and pose a danger. The Porch floor is exposed and is decorated with time from the early 20th century. Terrazzo was also noted in the later part of the building.

The services installations are noted to be mostly modern, with fluorescent tubed fittings throughout the buildings, modern electrical sockets and light switches mounted to the walls etc. As these have been dormant a fully electrical audit and assessment is advised. Radiators are used throughout.

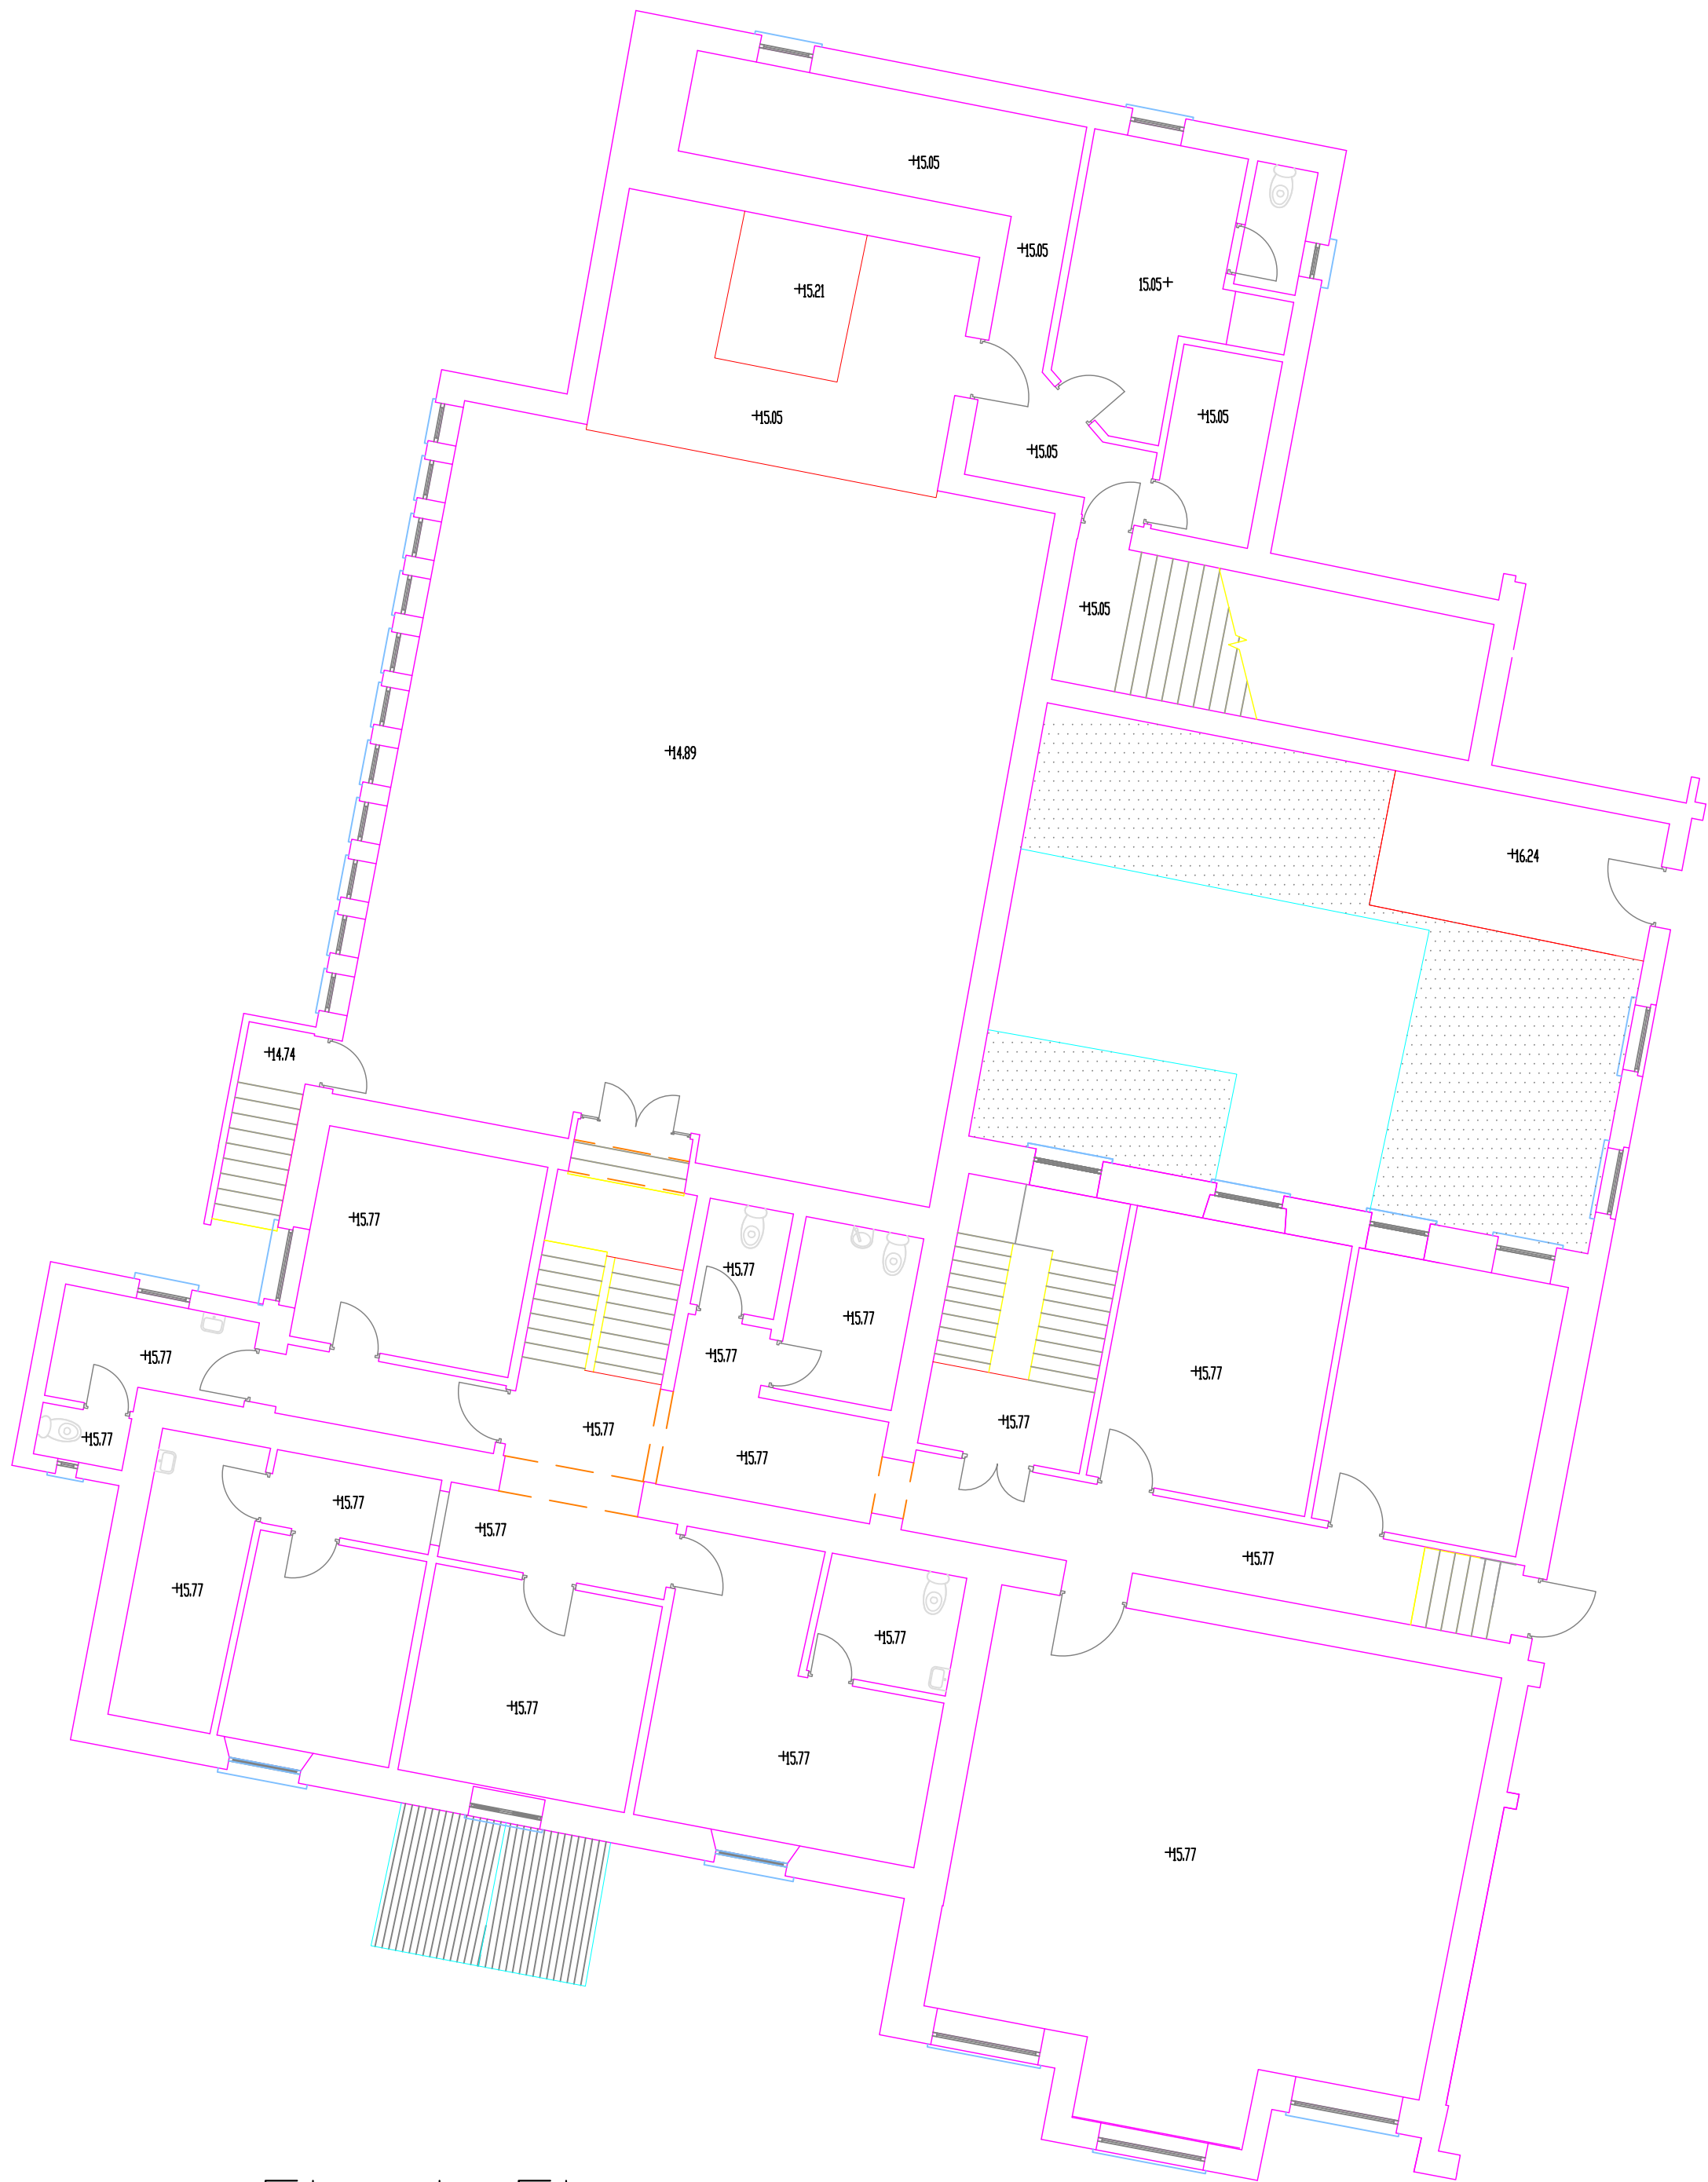
First Floor

With the exception of the Kitchen windows, all windows are modern. These are a mixture of white uPVC and timber top and side hung casements and sliding sash. Modern timber and stained glass are present in the Church and remain intact. There are also glass bricks to the staircase/staircore to the front façade (south) of the eastern extension. The Porch has modern single glazed windows.

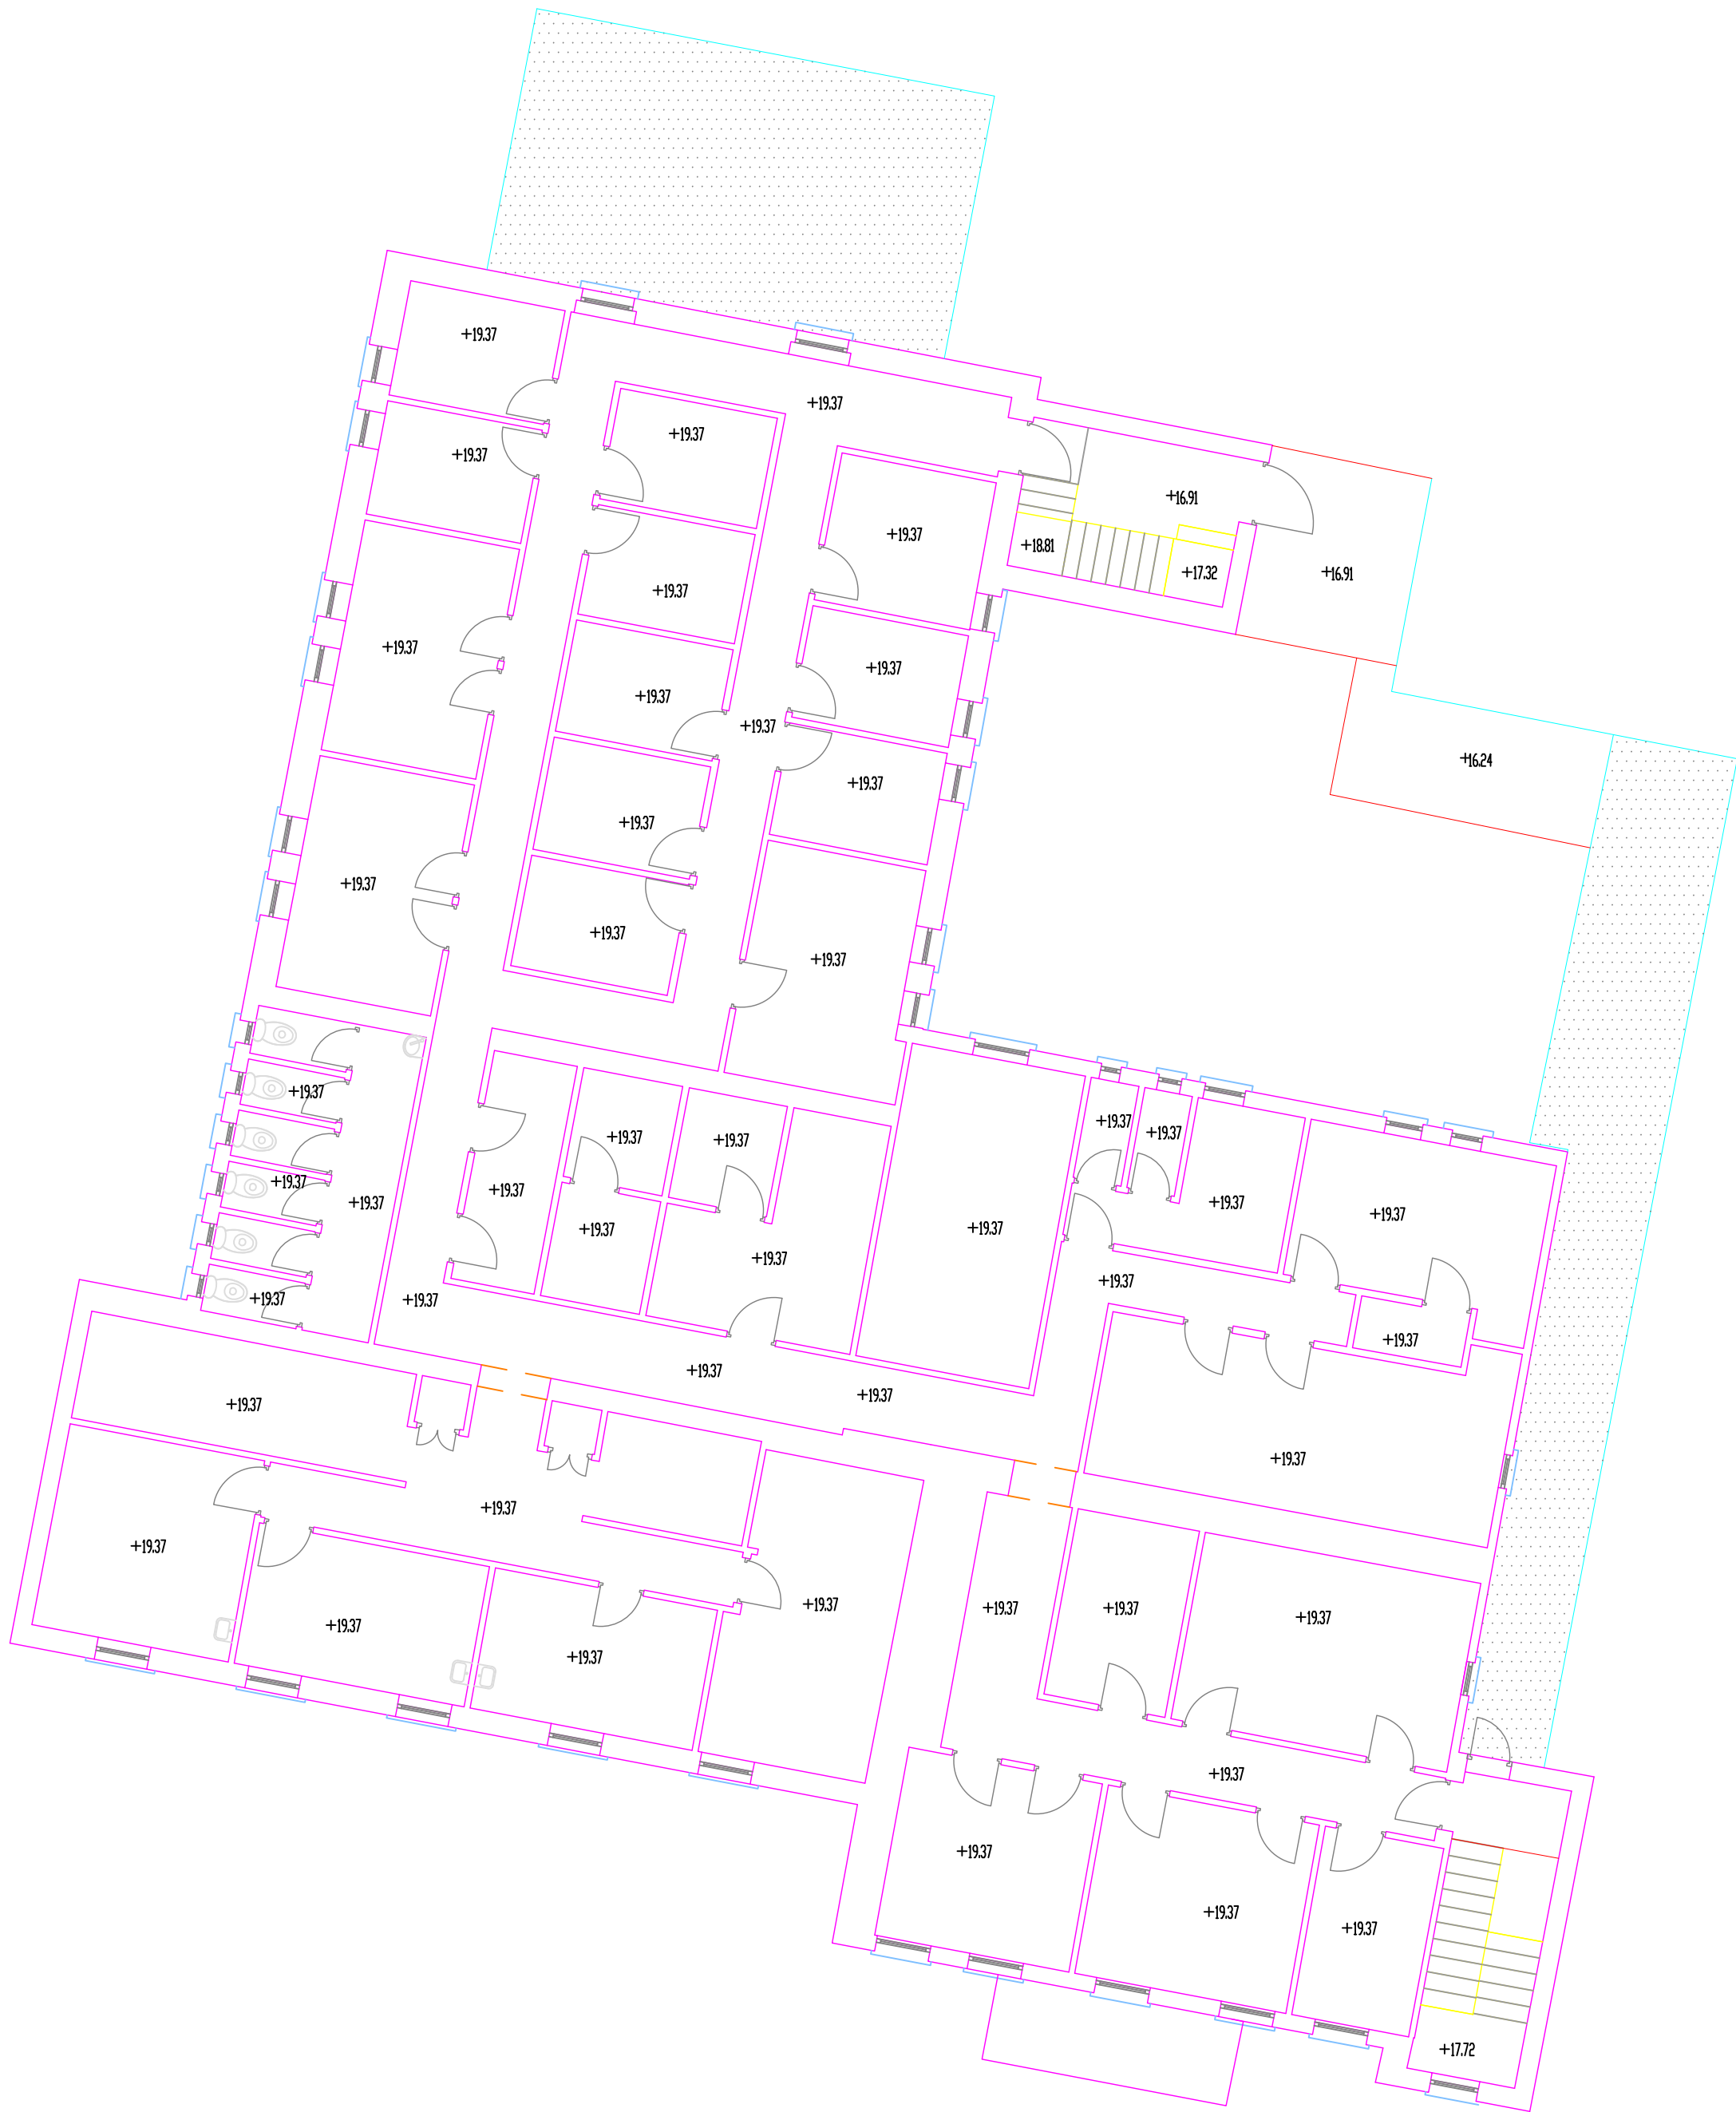
Second Floor

With the exception of the Kitchen windows, all windows are modern. These are a mixture of white uPVC and timber top and side hung casements and sliding sash. Modern timber and stained glass are present in the Church and remain intact. There are also glass bricks to the staircase/staircore to the front façade (south) of the eastern extension. The Porch has modern single glazed windows.

The services installations are noted to be mostly modern, with fluorescent tubed fittings throughout the buildings, modern electrical sockets and light switches mounted to the walls etc. The fuse box on this floor requires updating and as this building has been dormant, a fully electrical audit and assessment is advised. It is recommended that prior to moving any plant, that an asbestos survey be conducted.
