## Building Record Report

Building 16 Fernbank House  
Former Salesians Secondary School

**Client:** Limerick 2030

**Date:** 15<sup>th</sup> of October 2025

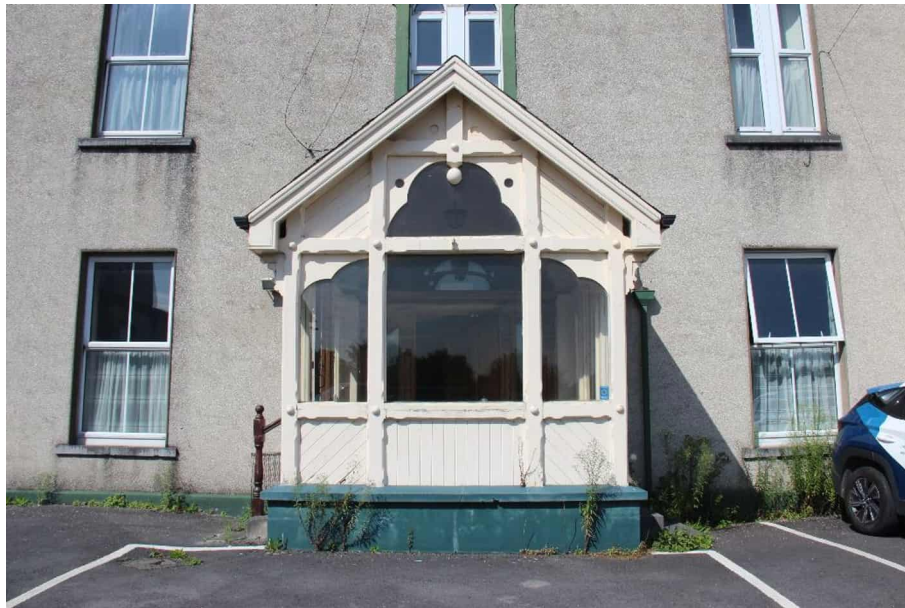
**Photograph 1 - Fernbank House Front Entrance**

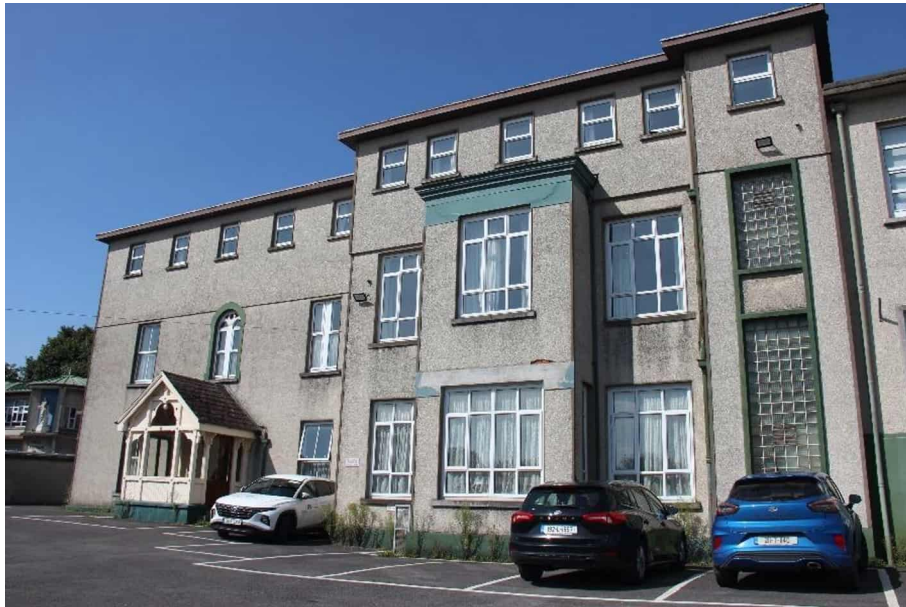
Photograph 2 - Original Cleeves Family Home (left) subsumed into school premises.

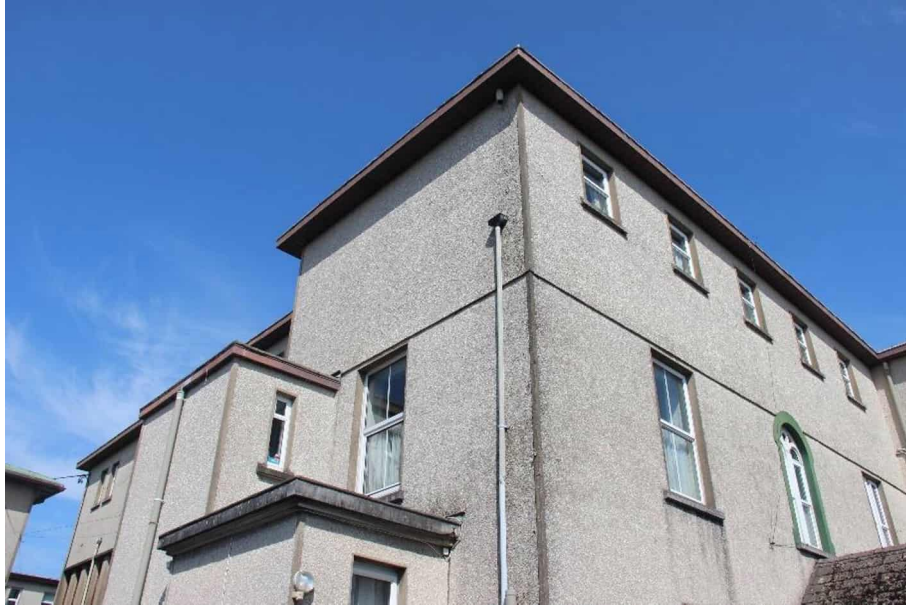
With the addition of the second floor to the original building, the main roof was lost. The current iteration is covered with a modern flat roof with the exception of the entrance porch roof. This is an 'A' pitched roof with cementitious tiles (possible Asbestos Containing Materials). Rainwater goods are mixture of cast iron, aluminium and PVC.

**Photograph 3 - A series of modern flat roofs.**

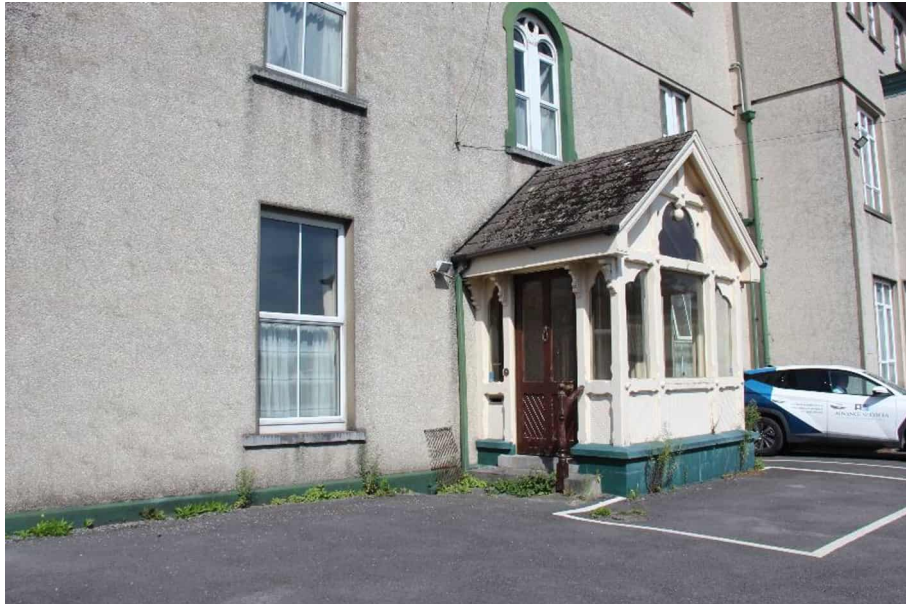
**Photograph 4 - 'A' pitch with cementitious slates.**

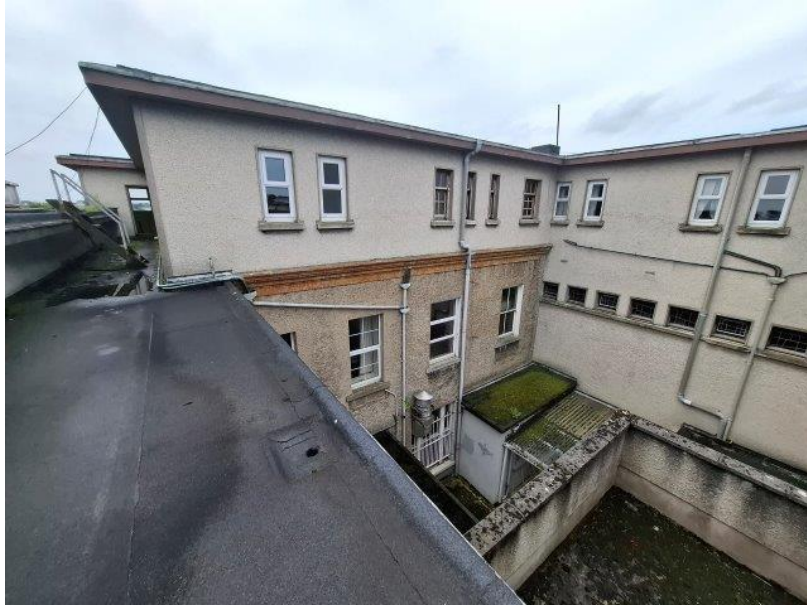
**Photograph 5 - Earlier render remains on the original building at rear elevation.**

Earlier cementitious render, and original brick cornice and string eaves course remain at the rear façade the latter indicating the original wall height. This may remain to the front façade under the render band. Original cills are limestone.

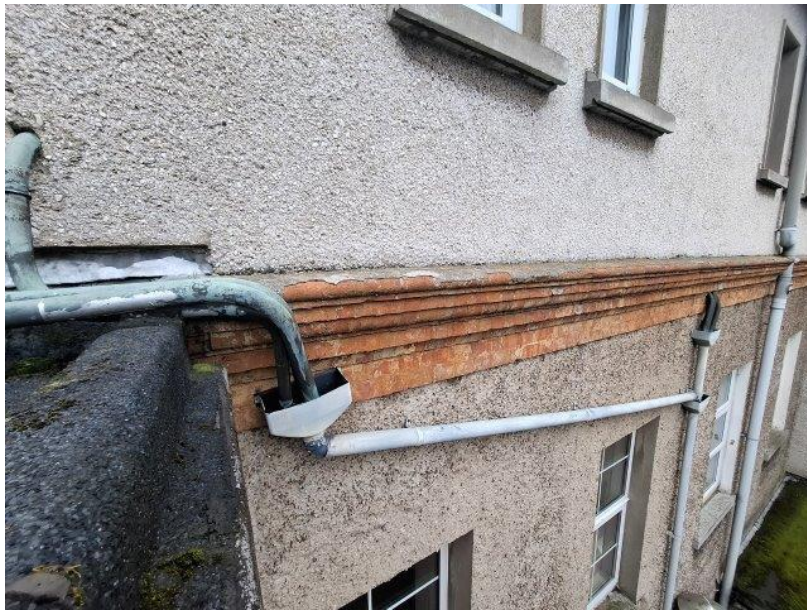
**Photograph 6 - Brick cornice and string eaves course preserved along this section of building.**

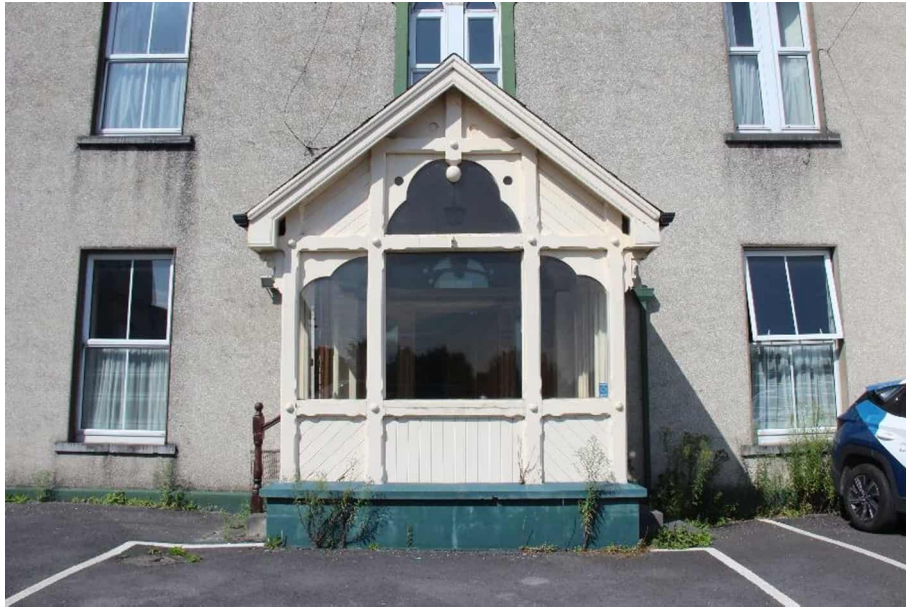
Porch walls are timber frame with fenestration and boarded out sections, with incorporation of a queen post truss in the gable. The entrance is located on the west side and there is a blind door opposite, seen from outside but hidden inside. The dwarf/kneeler wall is masonry and rendered.

**Photograph 7 - Porch with timber frame and panelling over a masonry dwarf wall.**

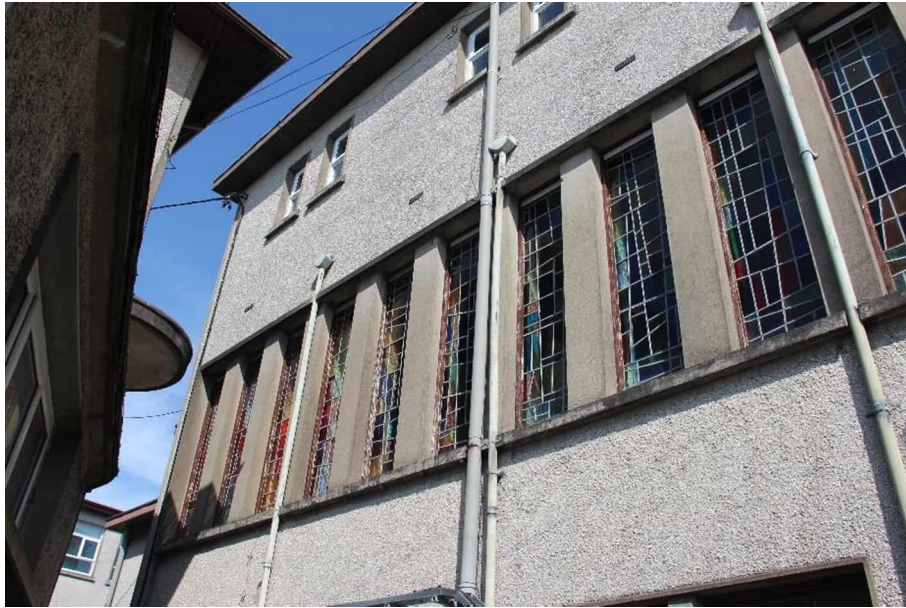
**Photograph 9 - Modern stained glass in Chapel.**

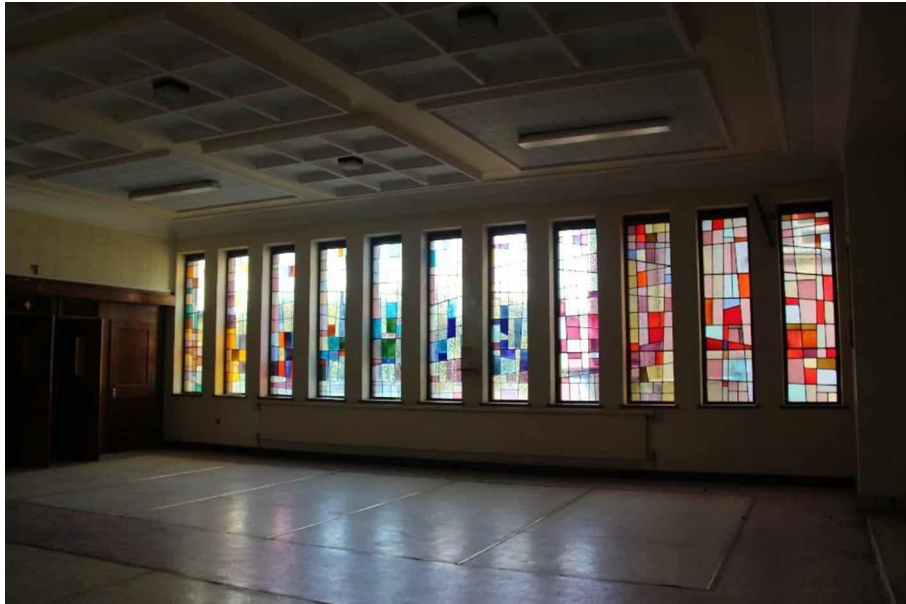
**Photograph 10 - Internal aspect of chapel modern stained-glass windows – west wall.**

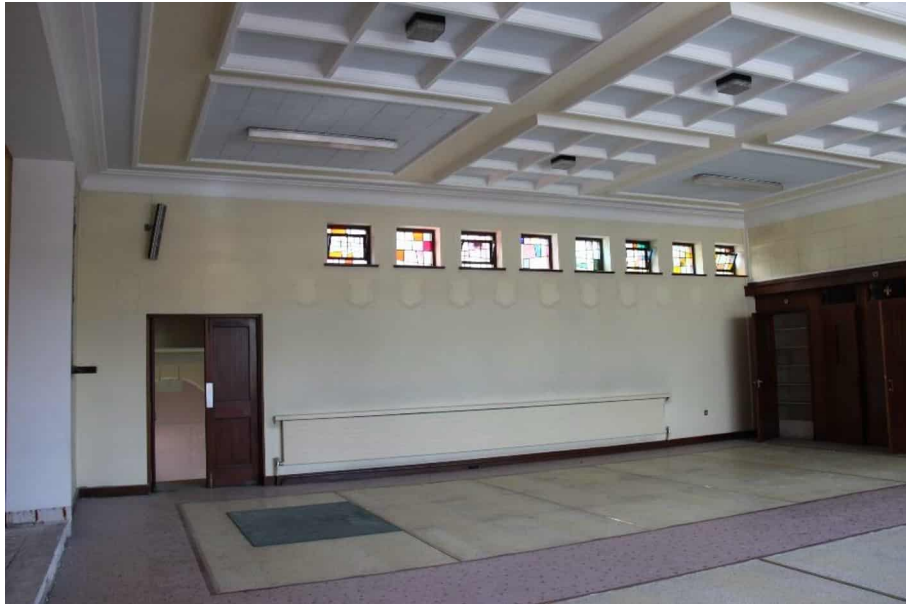
**Photograph 12 - Internal aspect of stained-glass windows and vent lights to chapel - east wall.**

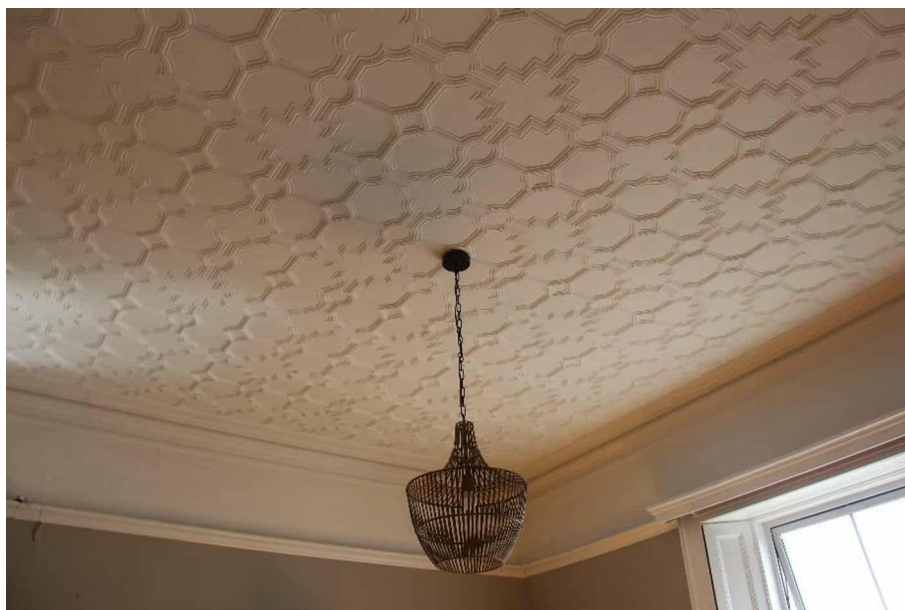
**Photograph 15 - Modern decorative ceiling tiles 1st roof RHS.**

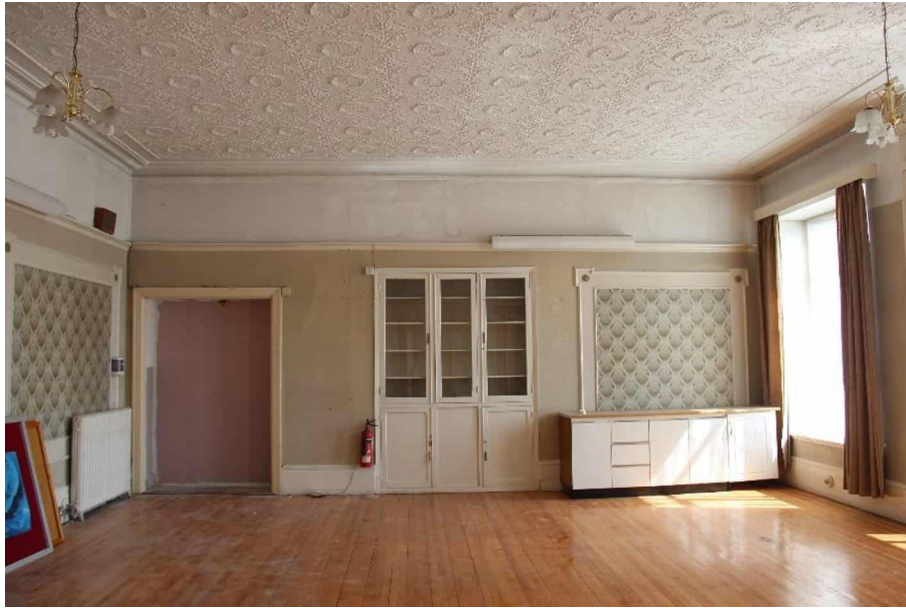
**Photograph 16 - Modern decorative ceiling tiles room off 1st Room RHS.**

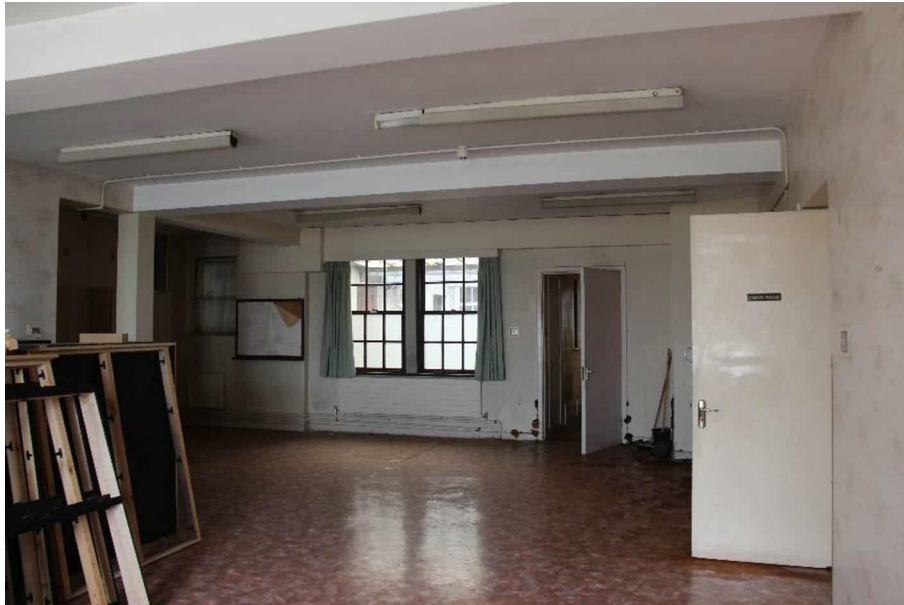
**Photograph 18 - modern plasterboard ceiling to later extension.**

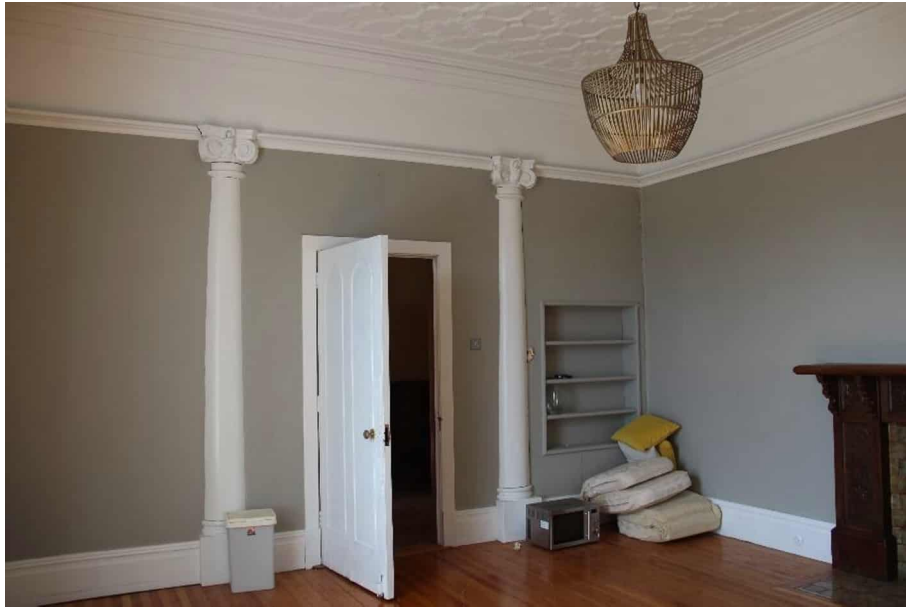
**Photograph 20 - Decorative pilasters to partition 1st room RHS.**

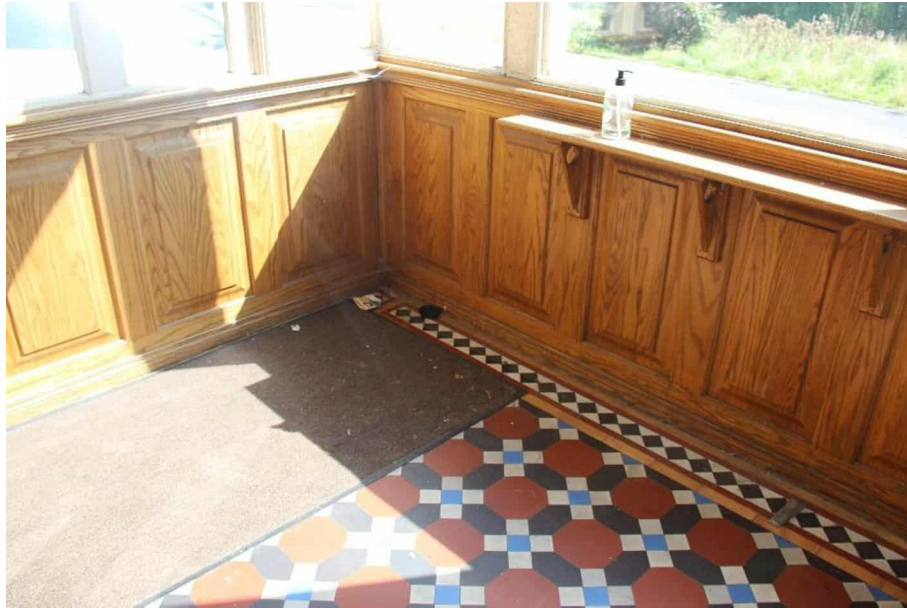
**Photograph 22 - Porch walls are oak timber panelling.**

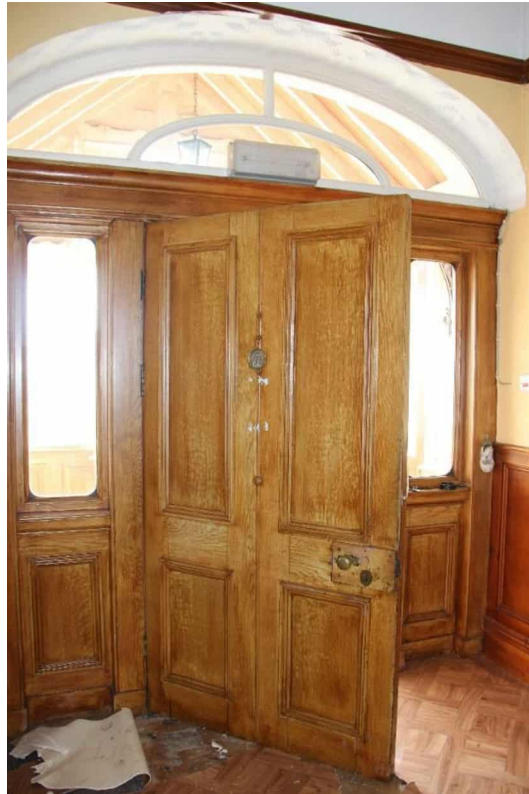
The entrance door, now made internal due to the porch, is a solid timber 4 panel door with fanlight and sidelights.

**Photograph 23 - the door is set under a fanlight.**

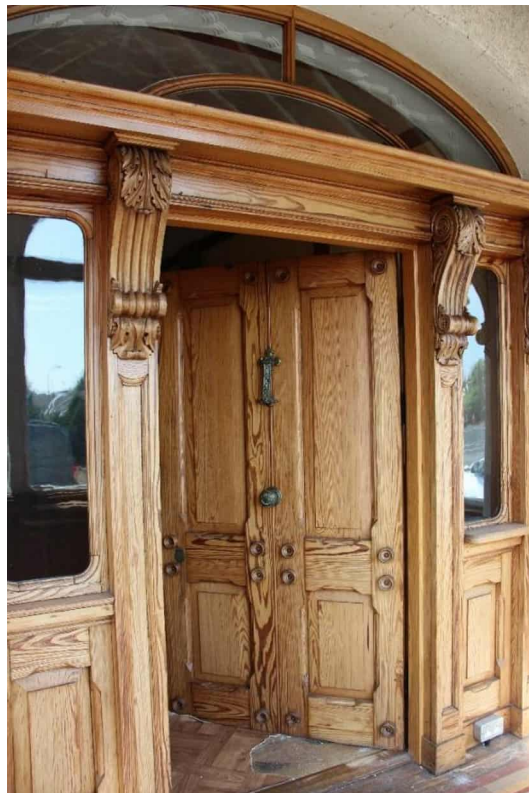
**Photograph 24 - with stylised oak corbels and scrolls, timber header and cornice with brass ironmongery**

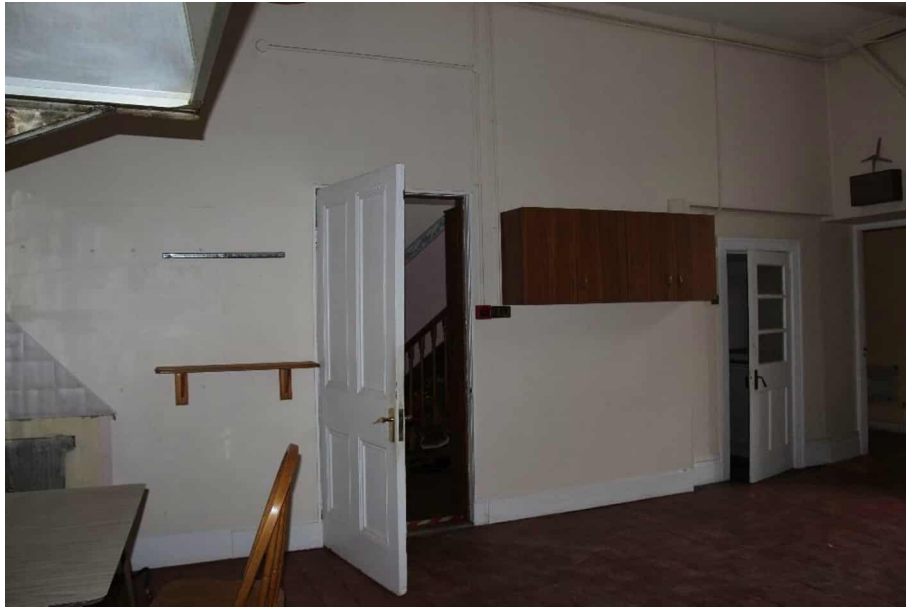
**Photograph 27 - Modern hollow 4 panel door with brass-effect lever handle.**

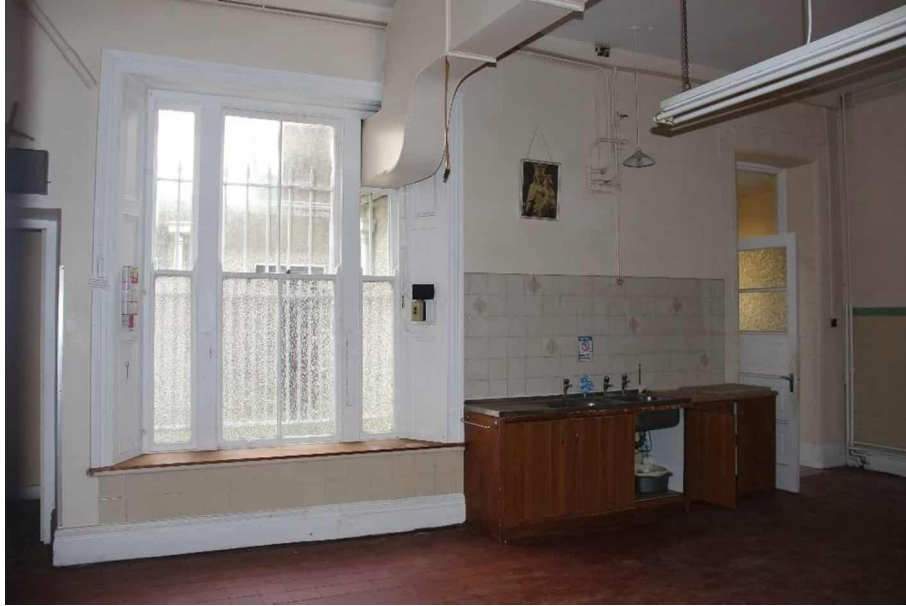
**Photograph 31 - Shutter boxes extant in the Kitchen. Also, units with sink remain.**

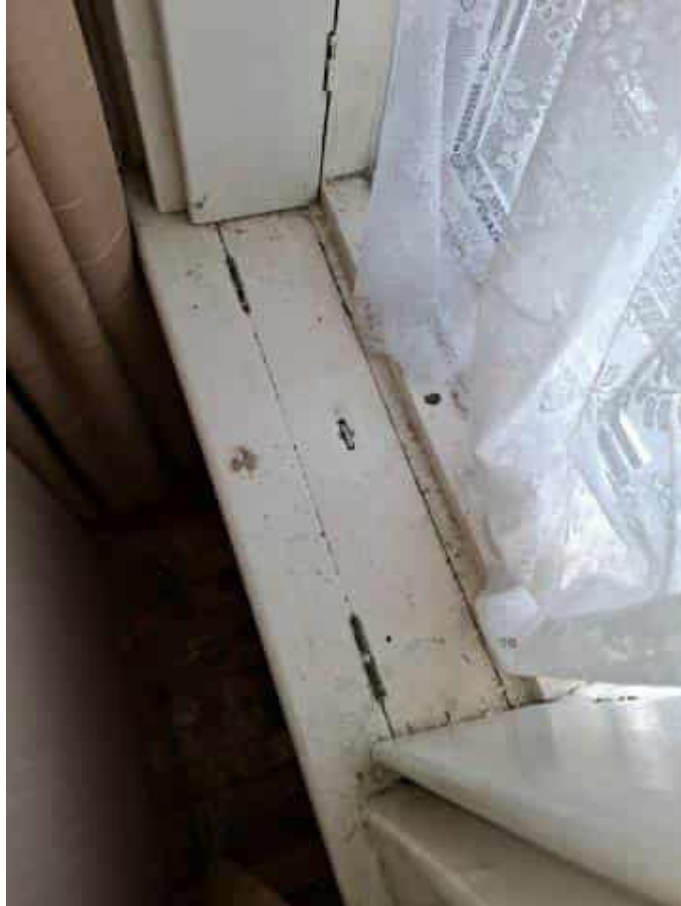
**Photograph 33 - Hidden shutter in the bay window in room off 1st room RHS.**

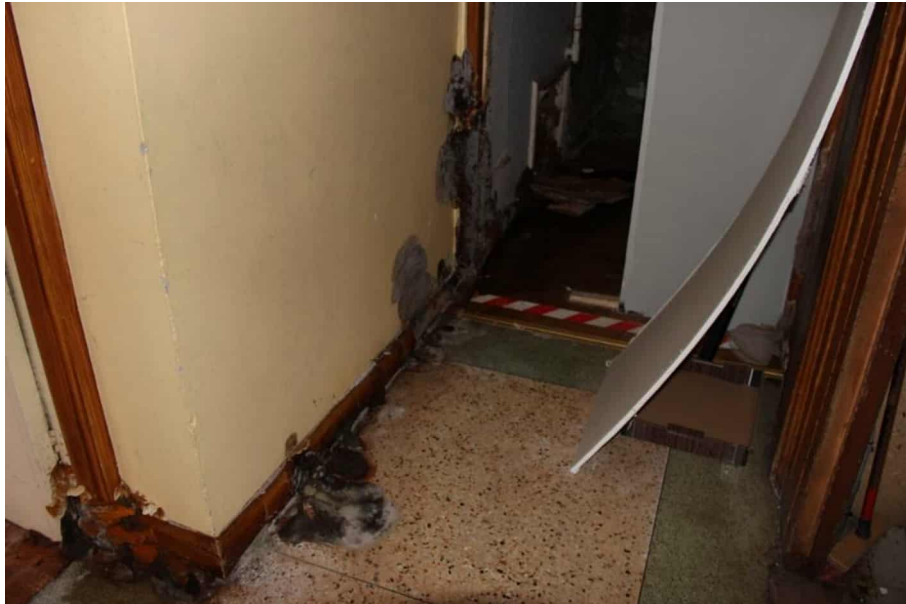
**Photograph 35 - Terrazzo floor to later section of building.**

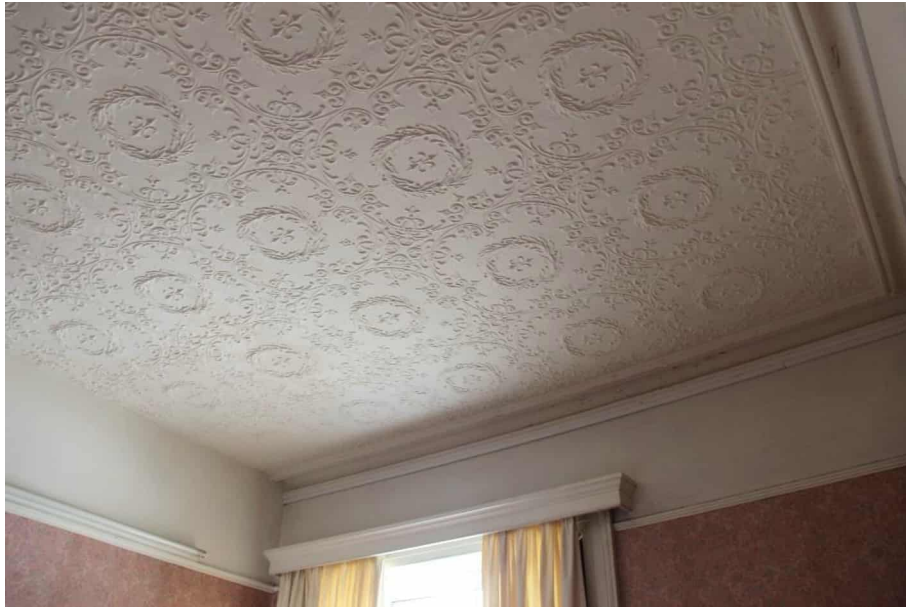
**Photograph 39 - Modern decorative ceiling tiles affixed directly (not suspended).**

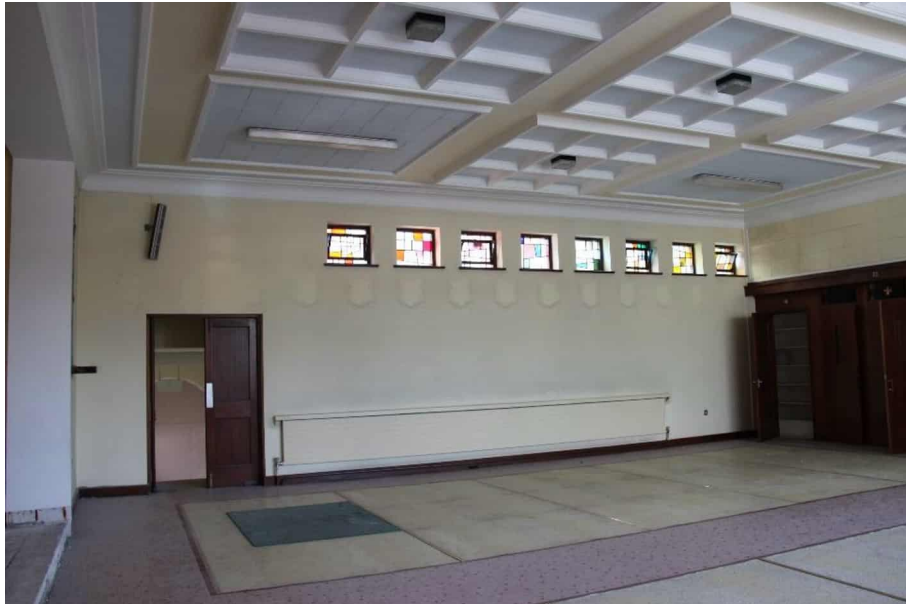
**Photograph 40 - Modern ceiling with acoustic liners in Chapel (Return).**

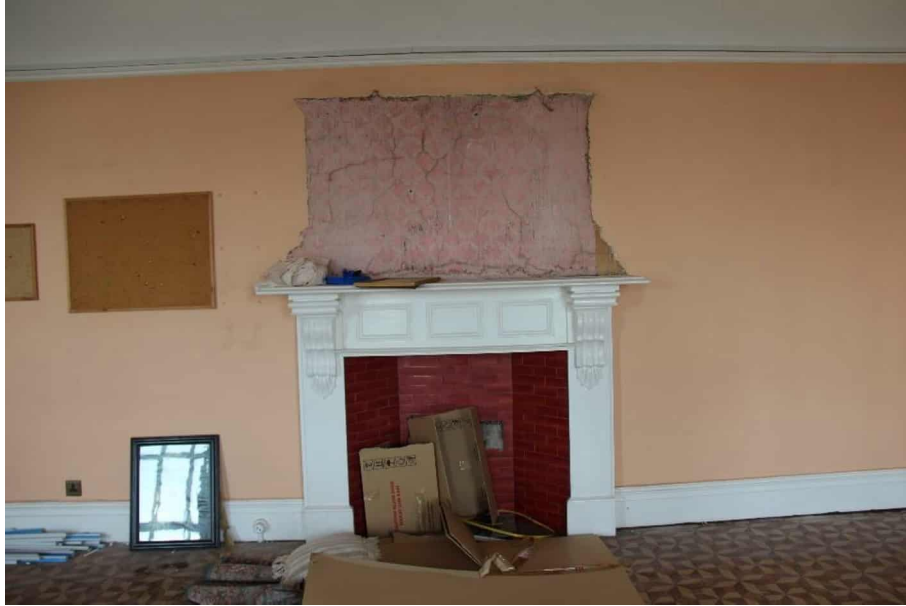
There is one remaining fireplace in the southeast room of the earlier building. This appears to have its original surround. It must be assumed that there may be other fireplaces that have become hidden.

**Photograph 41 - Fireplace to front room (southeast).**

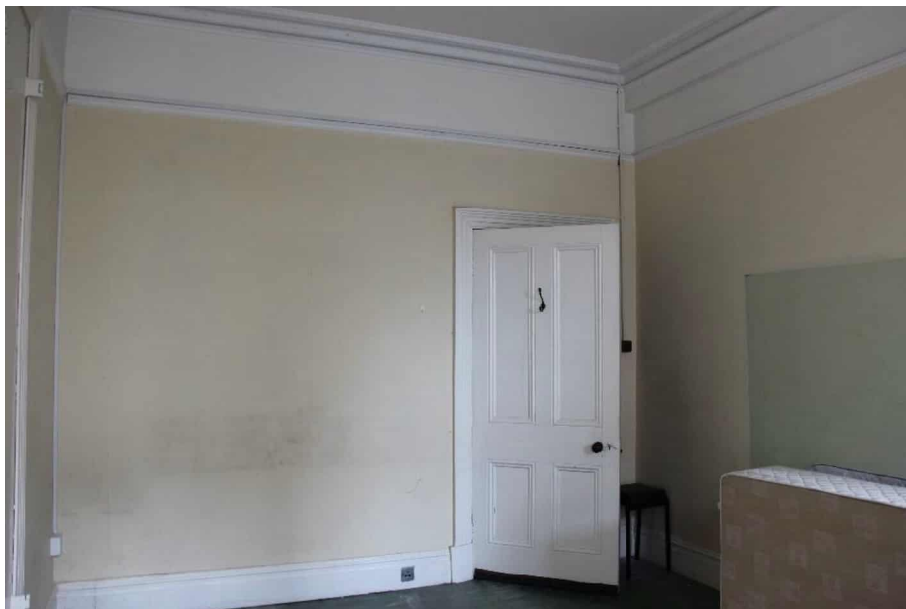
**Photograph 42 - 4 panel solid timber door with timber knob in earlier building.**

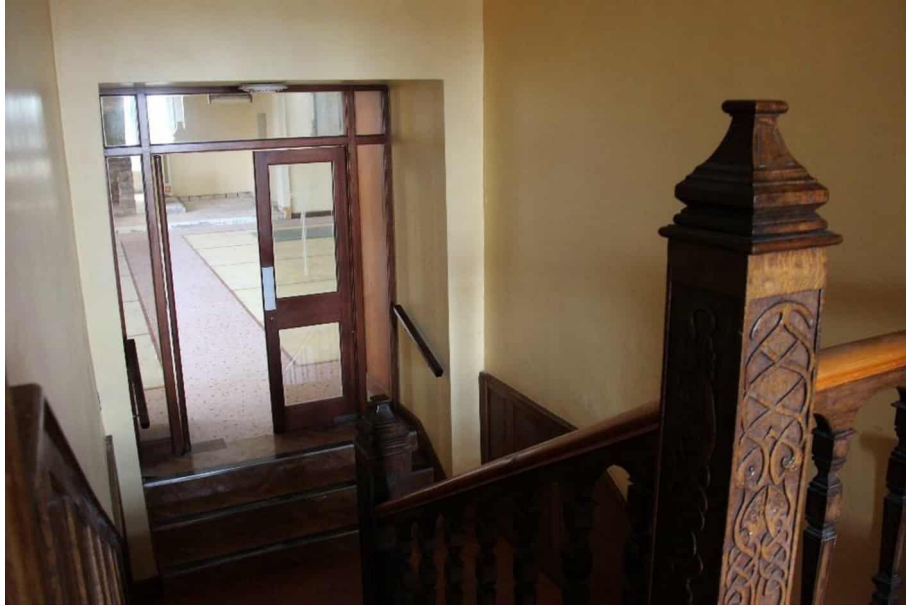
**Photograph 43 - Modern timber and glazing doors with vestibule screen to chapel.**

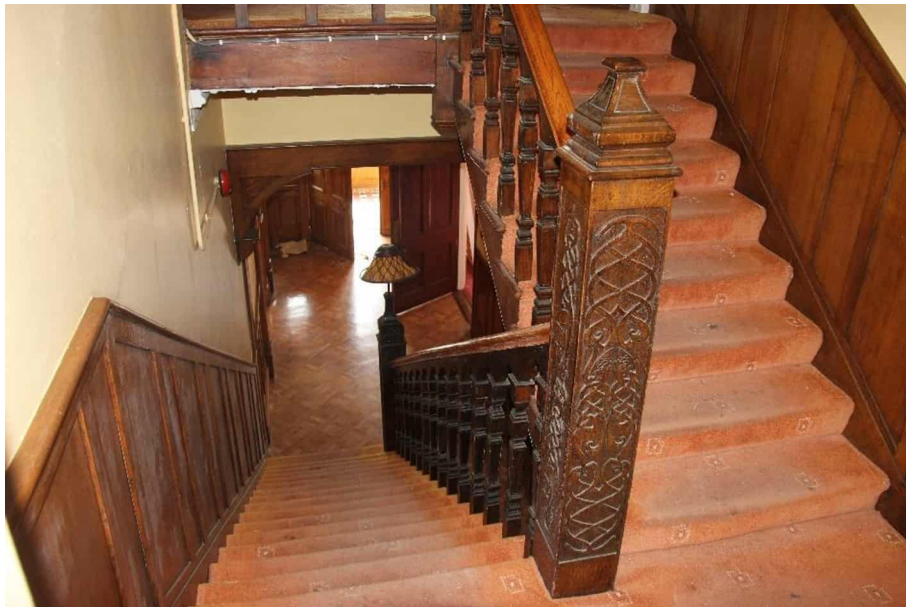
**Photograph 44 - Decorative newels and timber wainscoting to Return level or main staircase.**

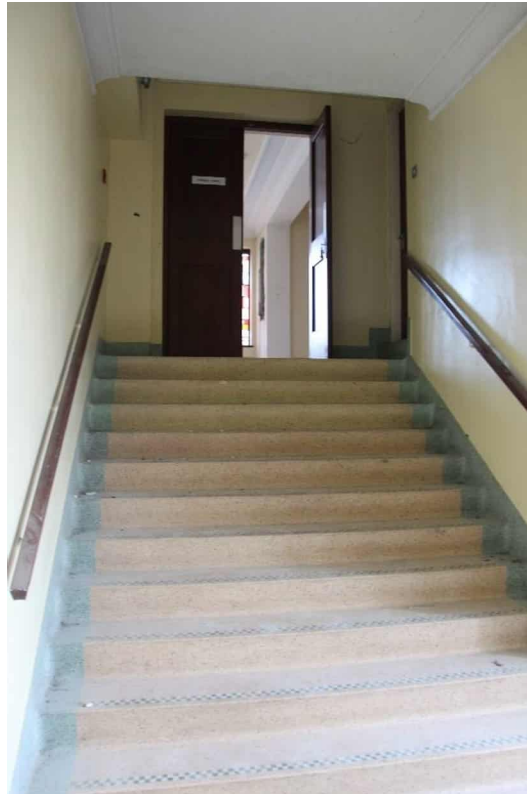
**Photograph 47 - modern Terrazzo staircase from chapel to lower level.**

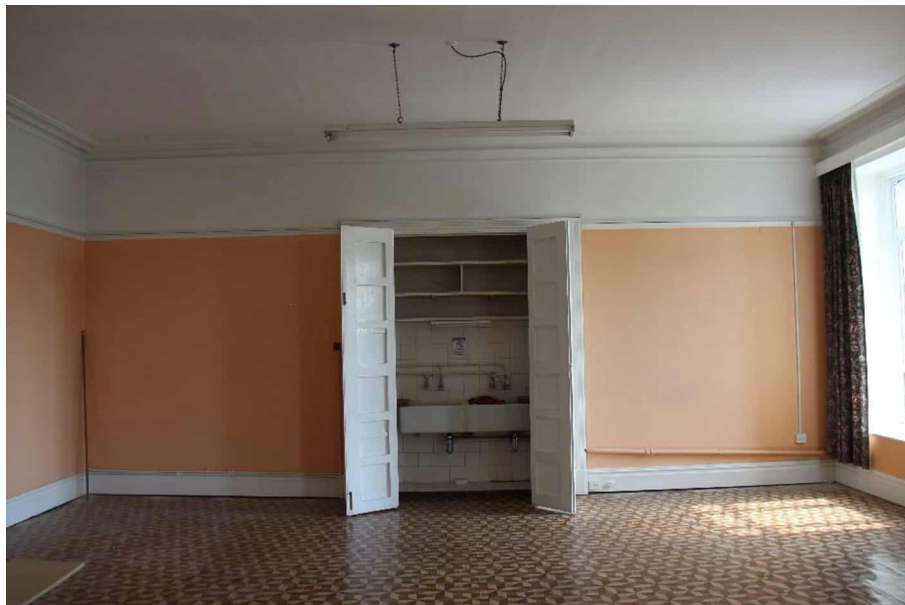
**Photograph 48 - Ablution cupboard in eastern wall of southeast (front) room).**

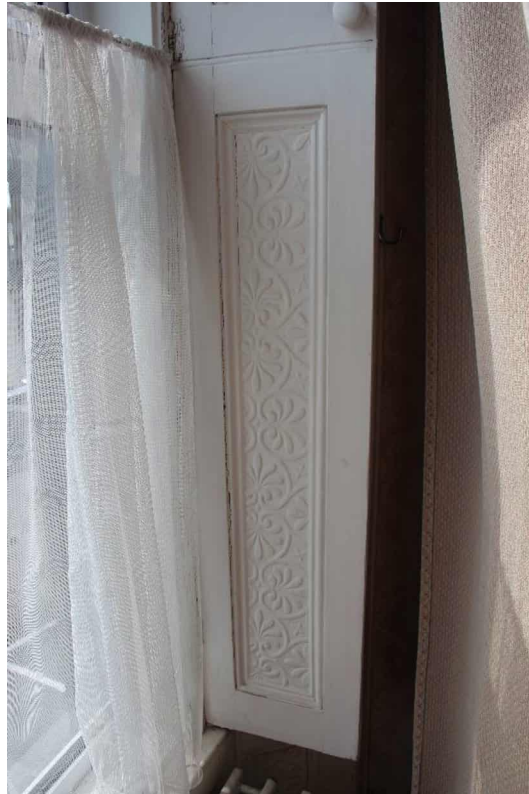
**Photograph 49 - Shutter boxes are present in the original/earlier building. Decorative application.**

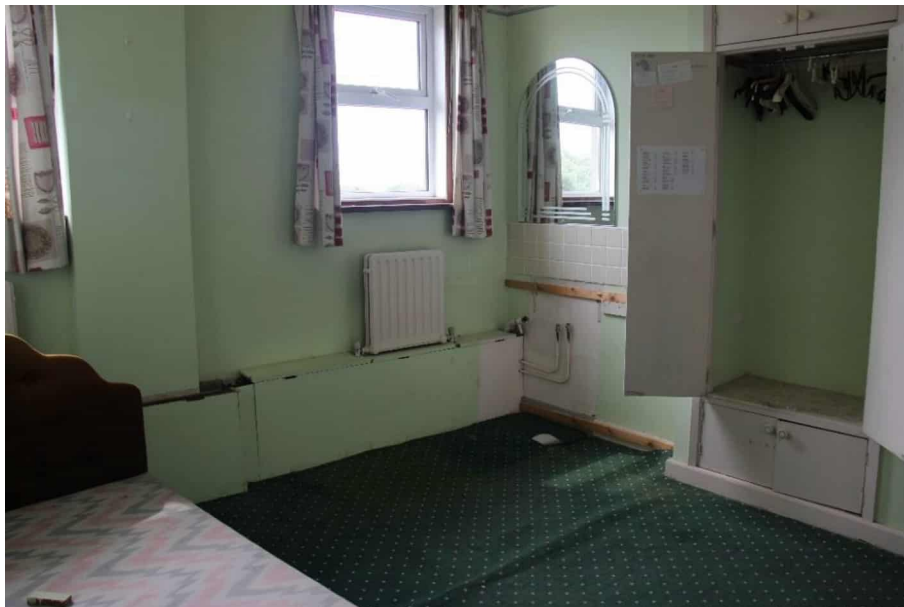
**Photograph 53 - Modern inbuilt presses in selected rooms.**

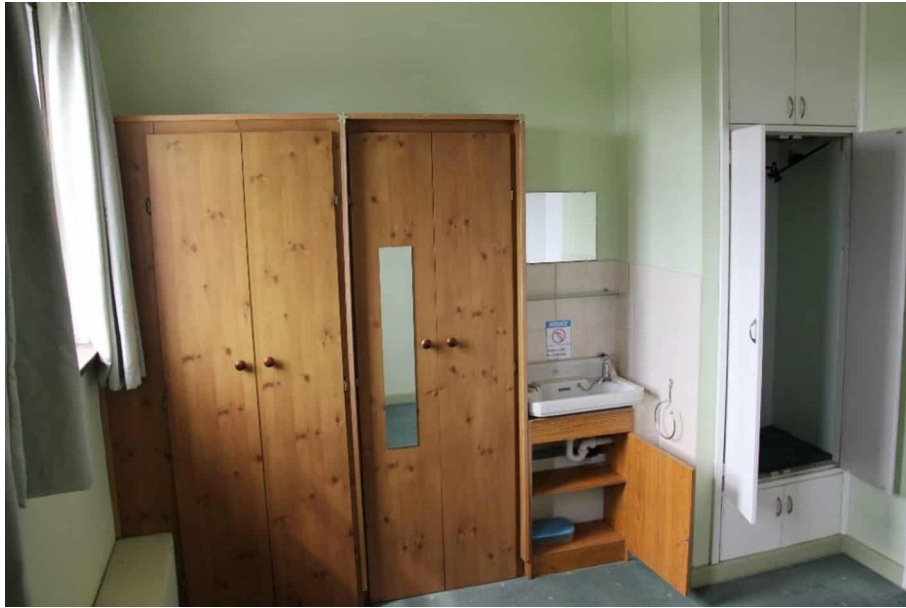
**Photograph 54 - Built-in and free-standing furniture.**

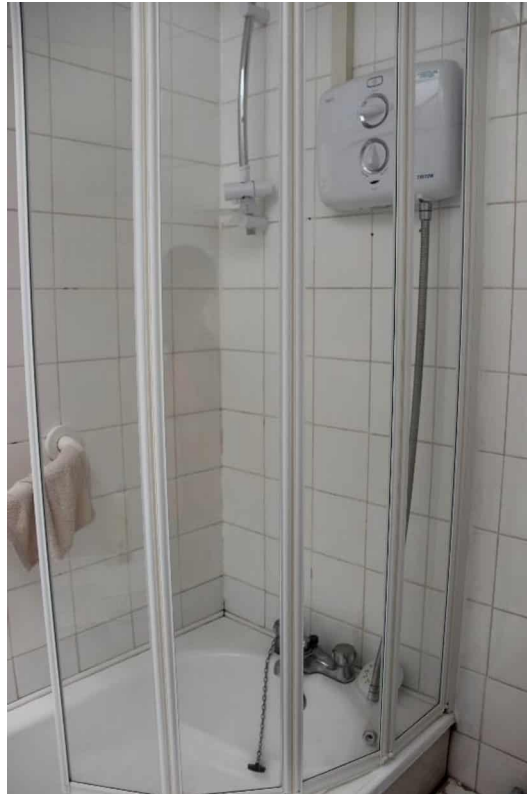
**Photograph 56 - Modern shower facilities.**

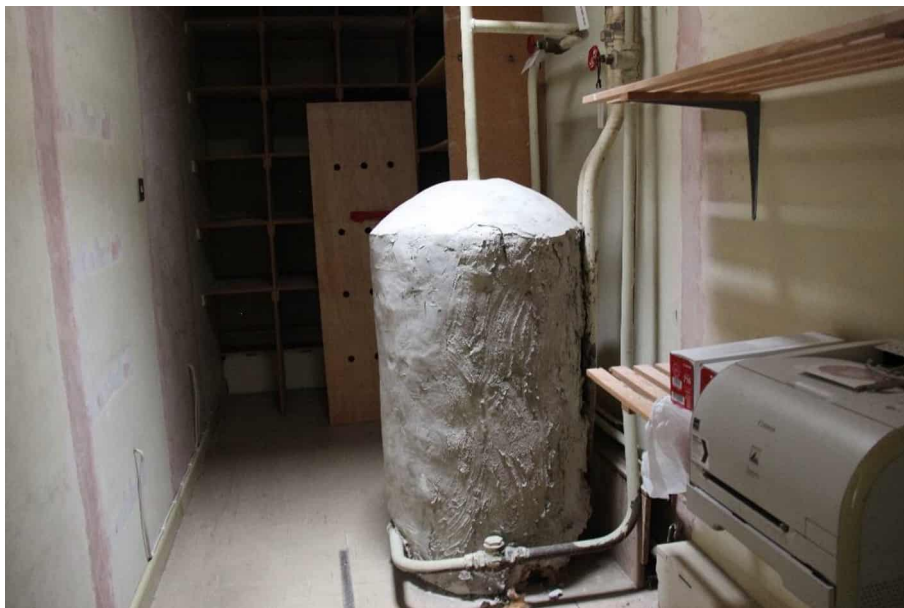
**Photograph 59 - One of two walk-in Hot Presses on this level with cementitious layer to water cylinder. May have ACMs.**

The services installations are noted to be mostly modern, with fluorescent tubed fittings throughout the buildings, modern electrical sockets and light switches mounted to the walls etc. It is recommended that prior to moving any plant, that an asbestos survey be conducted.

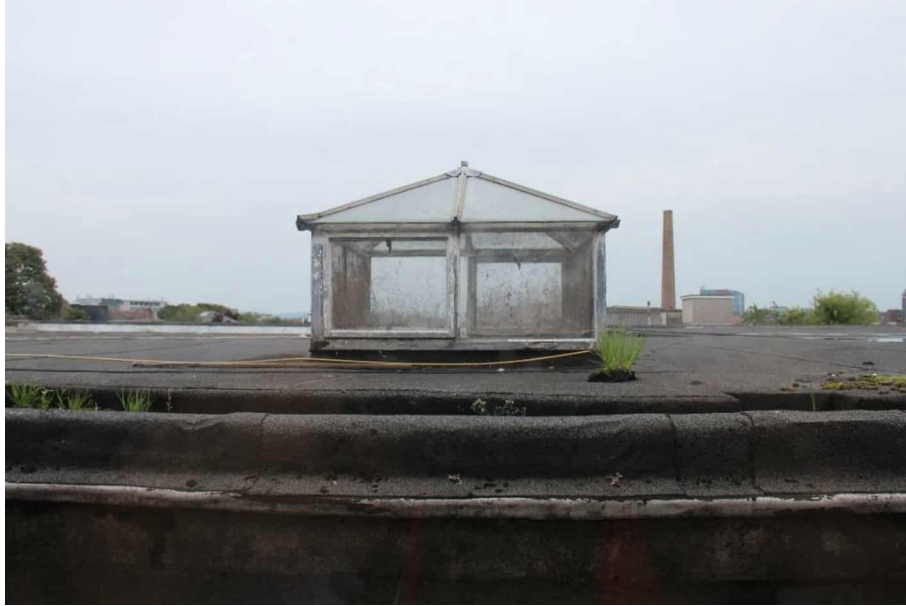
**Photograph 60 - Access to the external roof was limited and not permitted due to overlook and privacy.  
Modern rooflight cover.**
