## Building Record Report

Building 16 Fernbank House  
Former Salesians Secondary School

**Client:** Limerick 2030

**Date:** 15<sup>th</sup> of October 2025

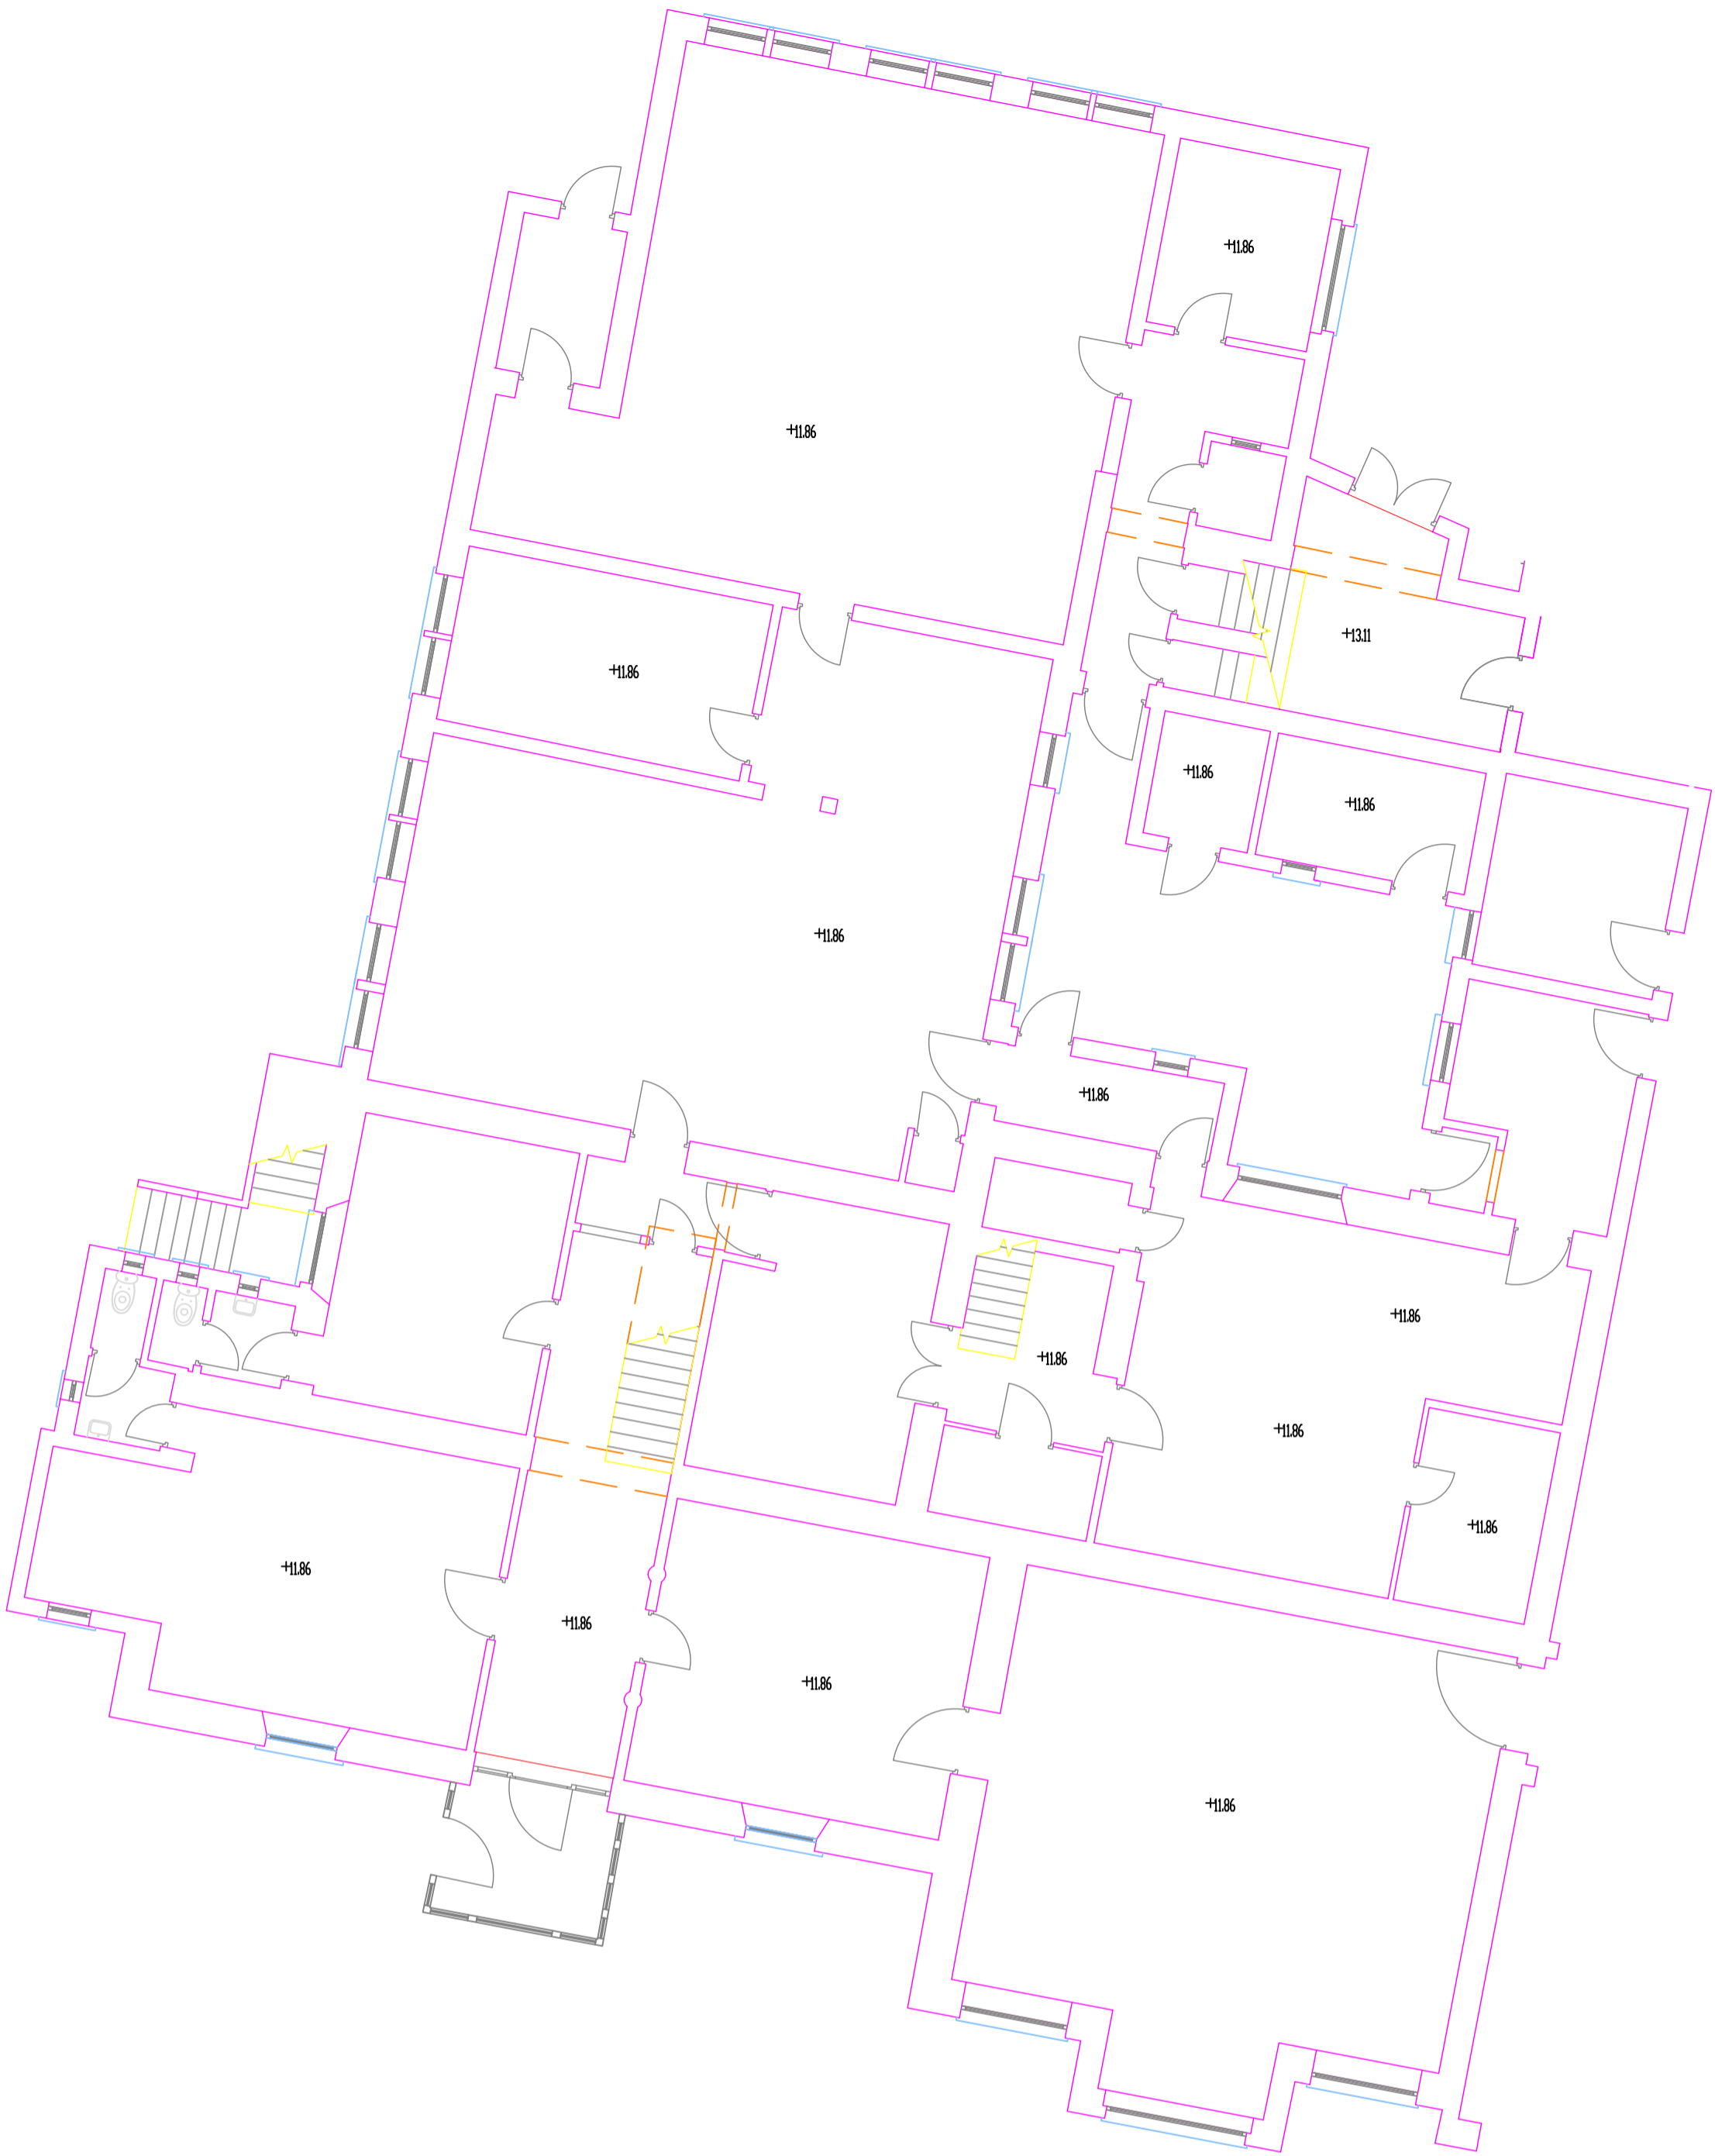
Ground Floor

The internal floors are largely timber in the original sections of the building with solid floors elsewhere. These are covered in linoleum, tile and carpet. Due to dry rot floors off the back staircase have disintegrated and pose a danger. The Porch floor is exposed and is decorated with time from the early 20<sup>th</sup> century. Terrazzo was also noted in the later part of the building.

The services installations are noted to be mostly modern, with fluorescent tubed fittings throughout the buildings, modern electrical sockets and light switches mounted to the walls etc. As these have been dormant a fully electrical audit and assessment is advised. Radiators are used throughout.

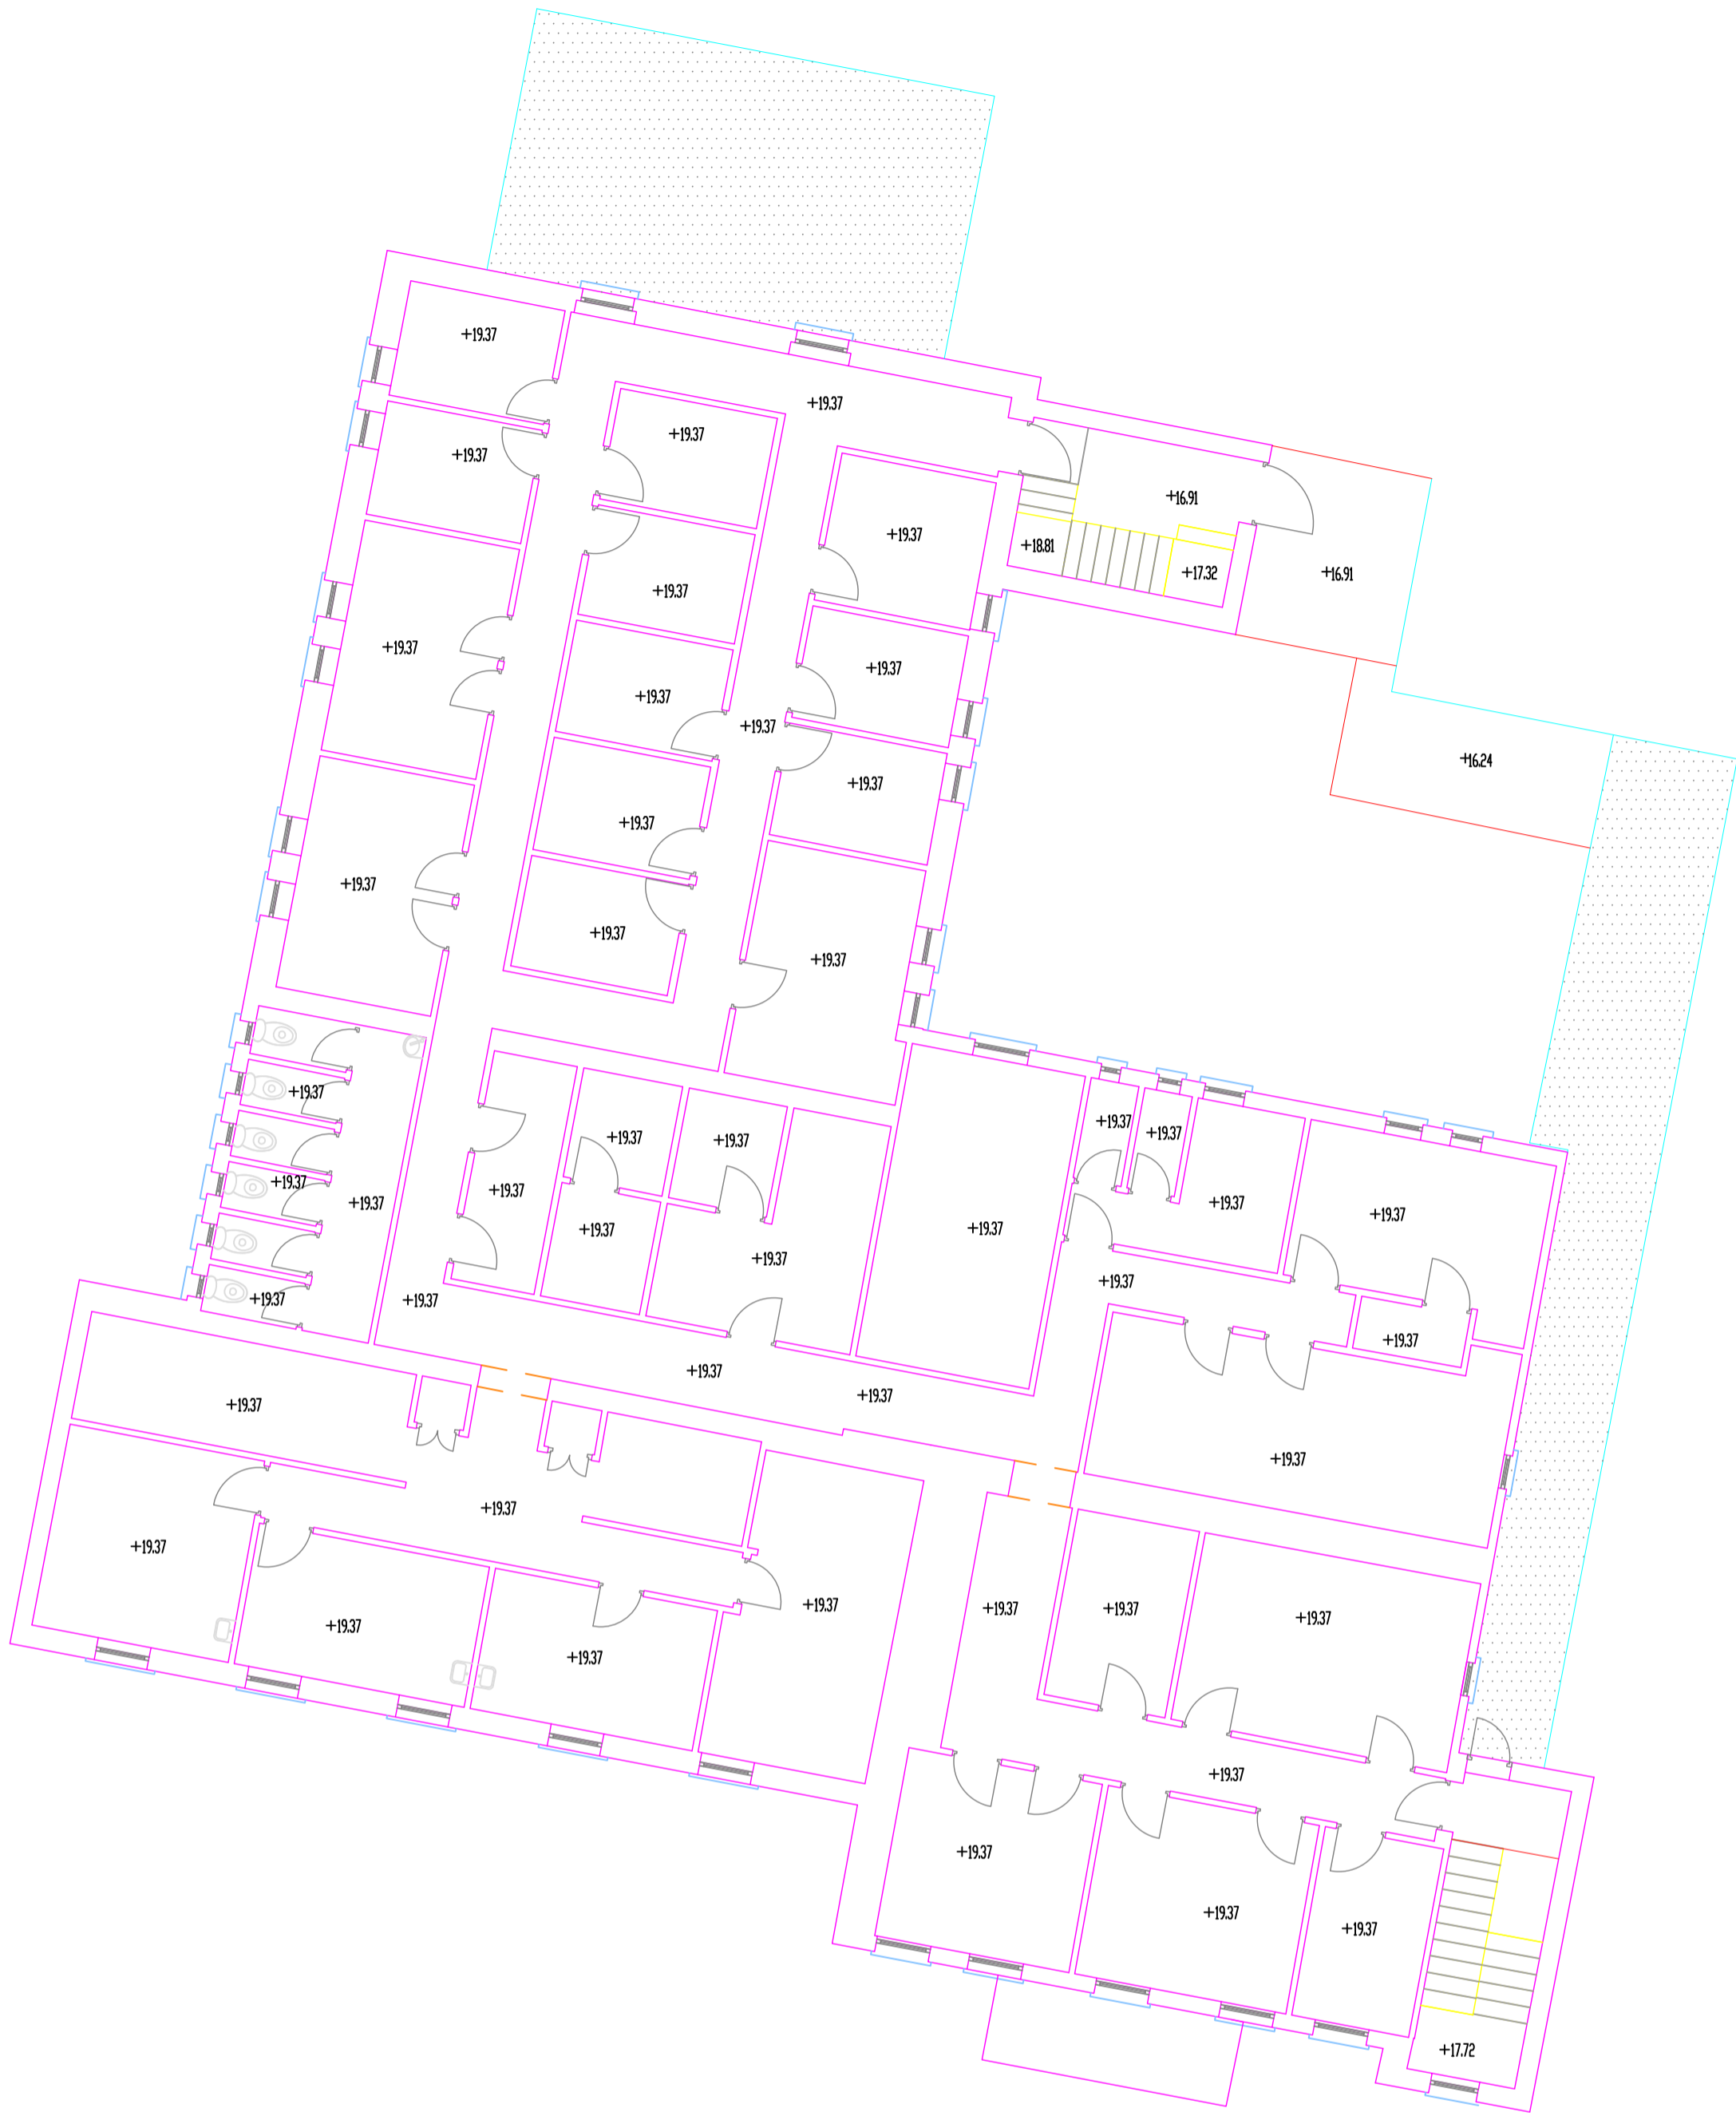
Second Floor

The services installations are noted to be mostly modern, with fluorescent tubed fittings throughout the buildings, modern electrical sockets and light switches mounted to the walls etc. The fuse box on this floor requires updating and as this building has been dormant, a fully electrical audit and assessment is advised. It is recommended that prior to moving any plant, that an asbestos survey be conducted.
